**NEW FARM SITE, LAND NORTH OF STANTON LANE, STANTON UNDER BARDON,  
HINCKLEY AND BOSWORTH BOROUGH, LEICESTERSHIRE**

**ARCHAEOLOGICAL EVALUATION REPORT**

Prepared for  
Boyer Planning  
by  
R. D. Savage

July 2023

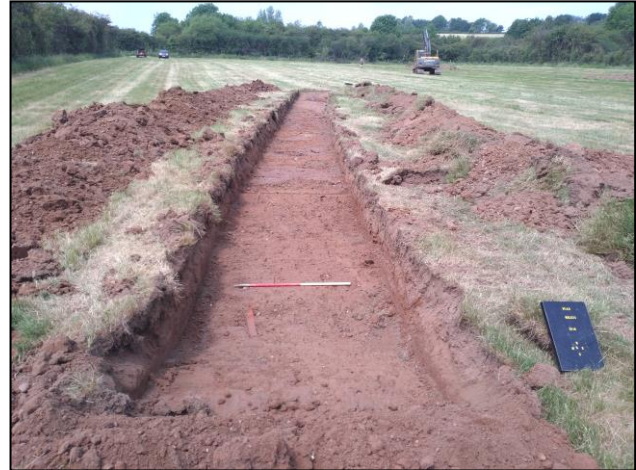
**Plate 1:** General shot of the northern field, looking north-west from the eastern end of Trench 14. Earthwork ridge-and-furrow is visible in the distance on the right-hand side of the picture.

At the commencement of the fieldwork the site was under rough grass, which appeared to have been mown for hay earlier in the summer. Earthwork ridge-and-furrow was visible at ground level only in the western end of the northern field, possibly because the high angle of the midsummer sun was impeding visibility.

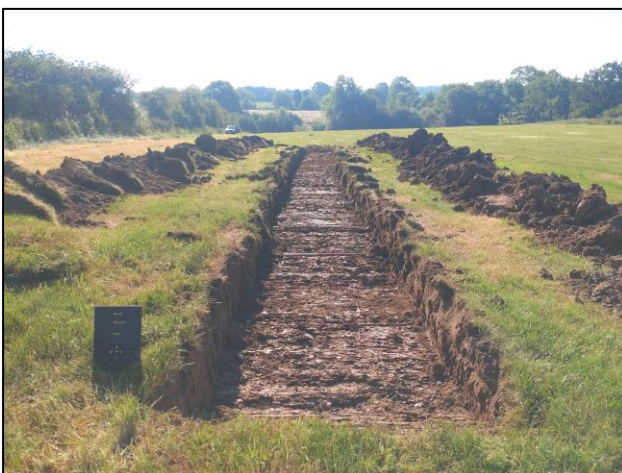
**Plate 2:** General shot of the larger southern field, looking east from the western end of Trench 3.

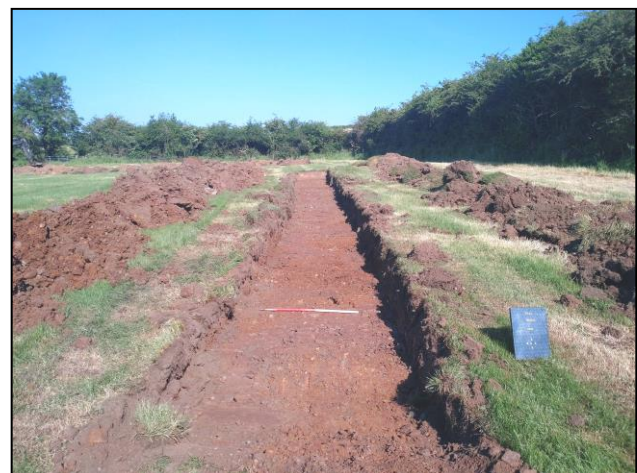
**Plate 3:** General shot of the western end of the southern field, looking west from the eastern end of Trench 3.

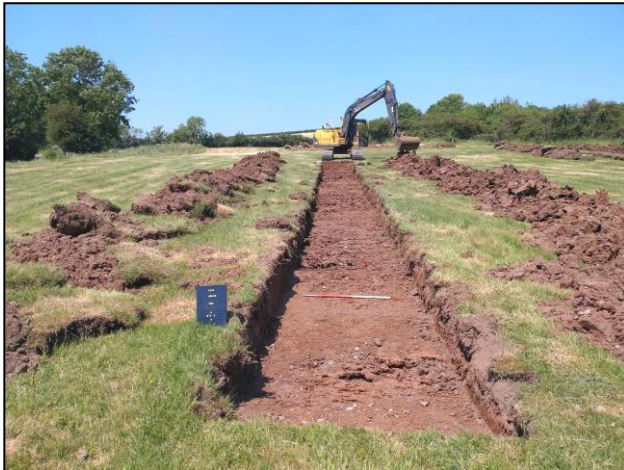
**Plate 4:** The eastern side of the southern field, looking west from the eastern end of Trench 7, showing the rising ground.

Stanton under Bardon lies in an area of hilly ground, dissected by the valleys of streams and small rivers. The new farm site is on an east-facing slope, falling from 170m to 160m AOD into the valley of a small stream, which divides the site from the neighbouring fields to the east (plates 4 and 5).

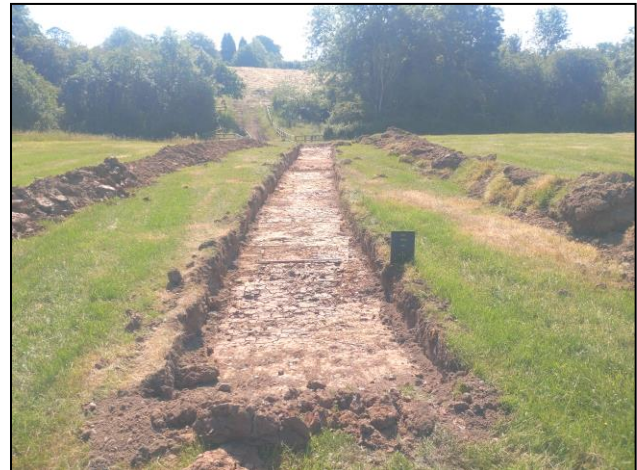
**Plate 5:** The eastern side of the site, looking east from the western end of Trench 8, showing the stream valley dividing the site from the fields to the east.

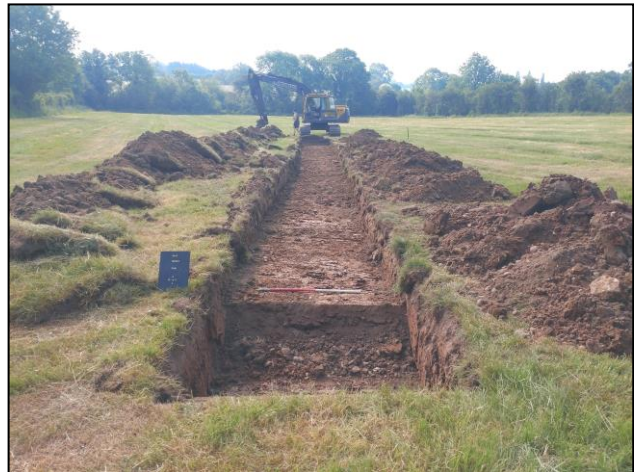
**Plate 6:** Working shot taken from the north-western corner of the northern field, looking east-south-east from near the western end of Trench 10. Earthwork ridge-and-furrow is visible to the south of the trench.
