# Preliminary Roost Assessment

21 Andrew Close, Nuneaton, Leicestershire, CV13 6EL

This report is prepared to inform a planning application with Hinckley and Bosworth Borough Council. This proposal can be described as a two storey extension to the rear of the dwelling

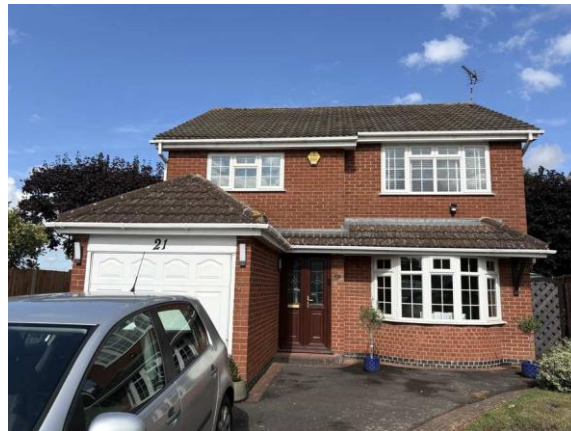
The building is a brick built residential dwelling with a gabled roof comprising interlocking concrete tiles and a single storey extension on the southern elevation comprising similar materials. The building appears in good condition, with no gaps across the roof, brickwork, eaves or windows that can provide opportunities for roosting bats. The building has negligible habitat value.

Building B1- southern (front) elevation

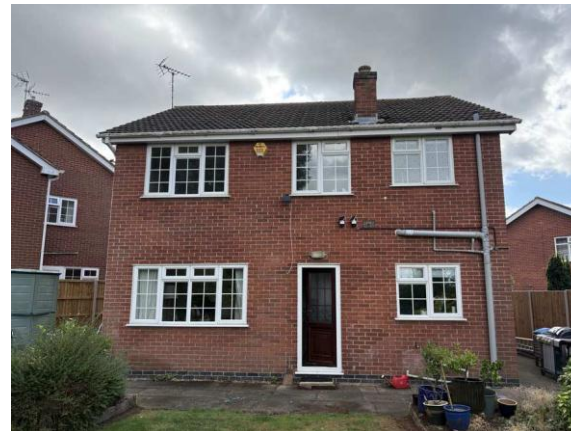
Building B1 – northern (rear) elevation

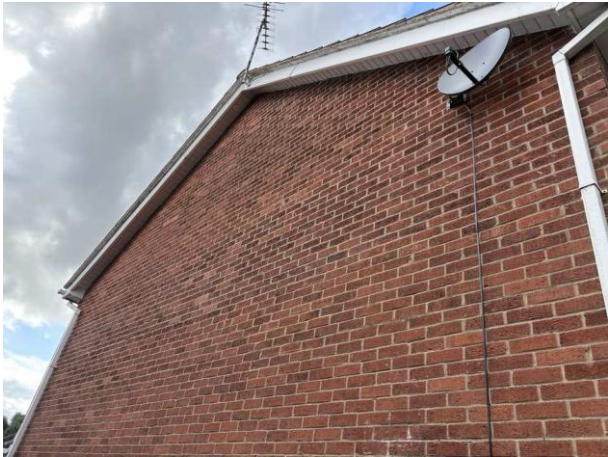
| Feature | Materials/Details | Condition / description / suitability | Photograph |
|---|---|---|---|
| Walls | Brick | <p><b>Condition/description</b><br/>Good condition</p> <p><b>Suitability/access/evidence of bats</b><br/>No roosting opportunities for bats.</p> | <p>B1 walls</p> |

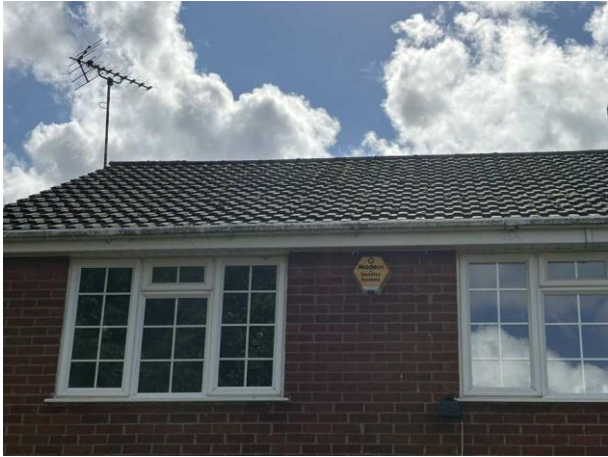
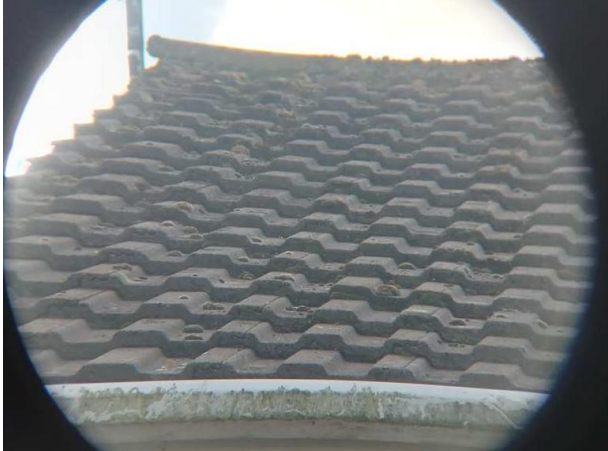
| Feature | Materials/Details | Condition / description / suitability | Photograph |
|---|---|---|---|
| Roof | Tiles | <p><b>Condition/description</b><br/>Good condition</p> <p><b>Suitability/access/evidence of bats</b><br/>No roosting opportunities for bats.</p> | <p>B1 roof</p> |

| | | | <p><i>B1 roof tiles close up</i></p> |

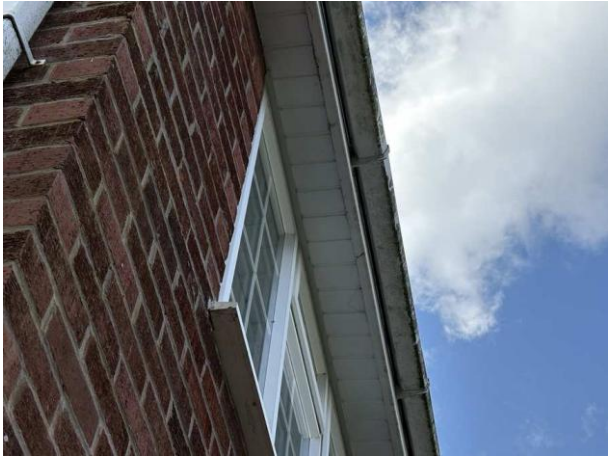
| Eaves | Overhanging | <p><b>Condition/description</b><br/>Good condition.</p> <p><b>Suitability/access/evidence of bats</b><br/>No roosting opportunities for bats.</p> | <p><i>B1 eaves</i></p> |

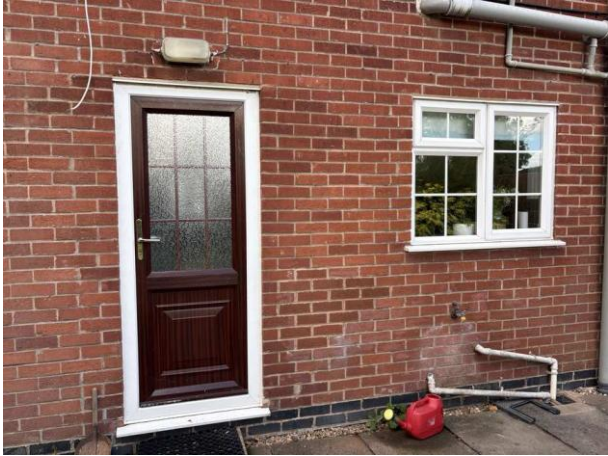
| Windows<br>/doors | uPVC | <p><b>Condition/description</b><br/>Good condition</p> <p><b>Suitability/access/evidence of bats</b><br/>No roosting opportunities for bats.</p> | <p><i>B1 window / doors frames and lintels</i></p> |

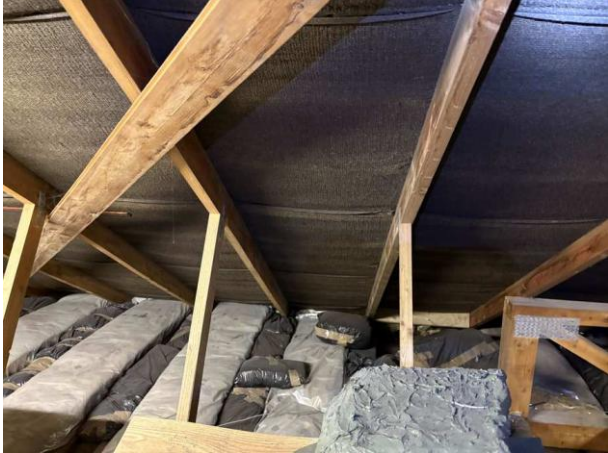
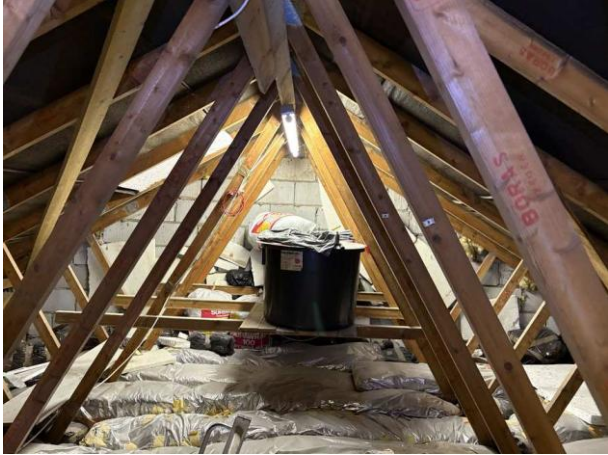
| Internal<br>void 1 | Timber rafters.<br>Bitumen felt lining | <p><b>Condition/description</b><br/>There is one loft space within B1, the materials within the loft appear in good condition, the bitumen is well sealed with no areas of daylight entering the loft. Timber rafters appear in good condition with no warping or cracking. Dimensions (approx): 8m length, 6m width, 2m height<br/>Temp: 24°C // Humidity: 51%</p> <p><b>Suitability/access/evidence of bats</b><br/>No evidence of bats was identified. In addition, no access points were identified, as such the presence of void dwelling bats is considered unlikely.</p> | <p><i>B1 internal void 1</i></p> |

| | | | <p>B1 internal void 1</p> |
