**39 Main Road, Ratcliffe Culey, Atherstone**

**Bat Surveys - Presence/Likely-Absence**

August 2025

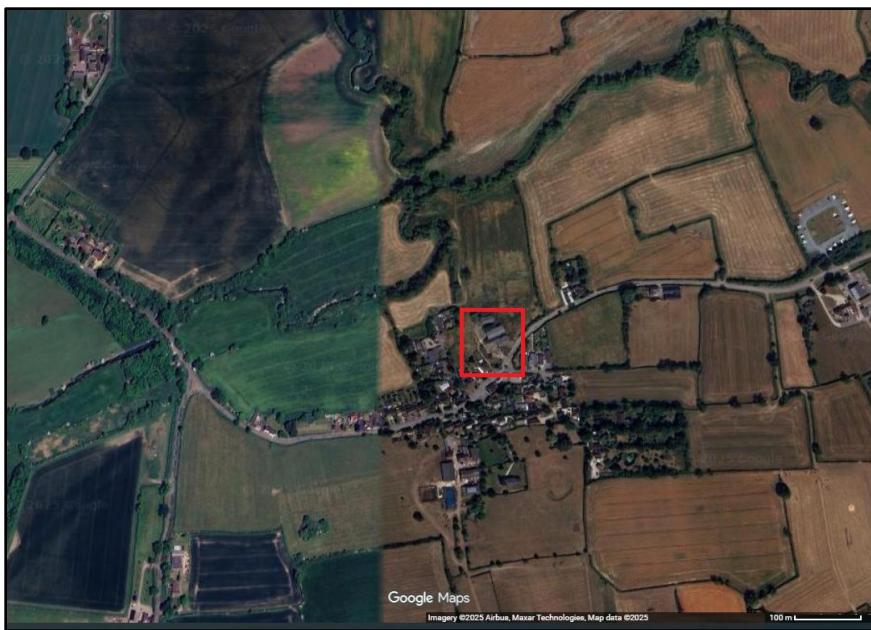
Figure 1: Aerial photo of site, showing landscape structure © Google 2025

A review of aerial photographs (Figure 1) and OS maps shows the site has only limited potential for importance in the context of the surrounding landscape; lacking boundary features connecting blocks of habitat through the wider hedgerow network or otherwise providing suitable habitat corridors for bats.

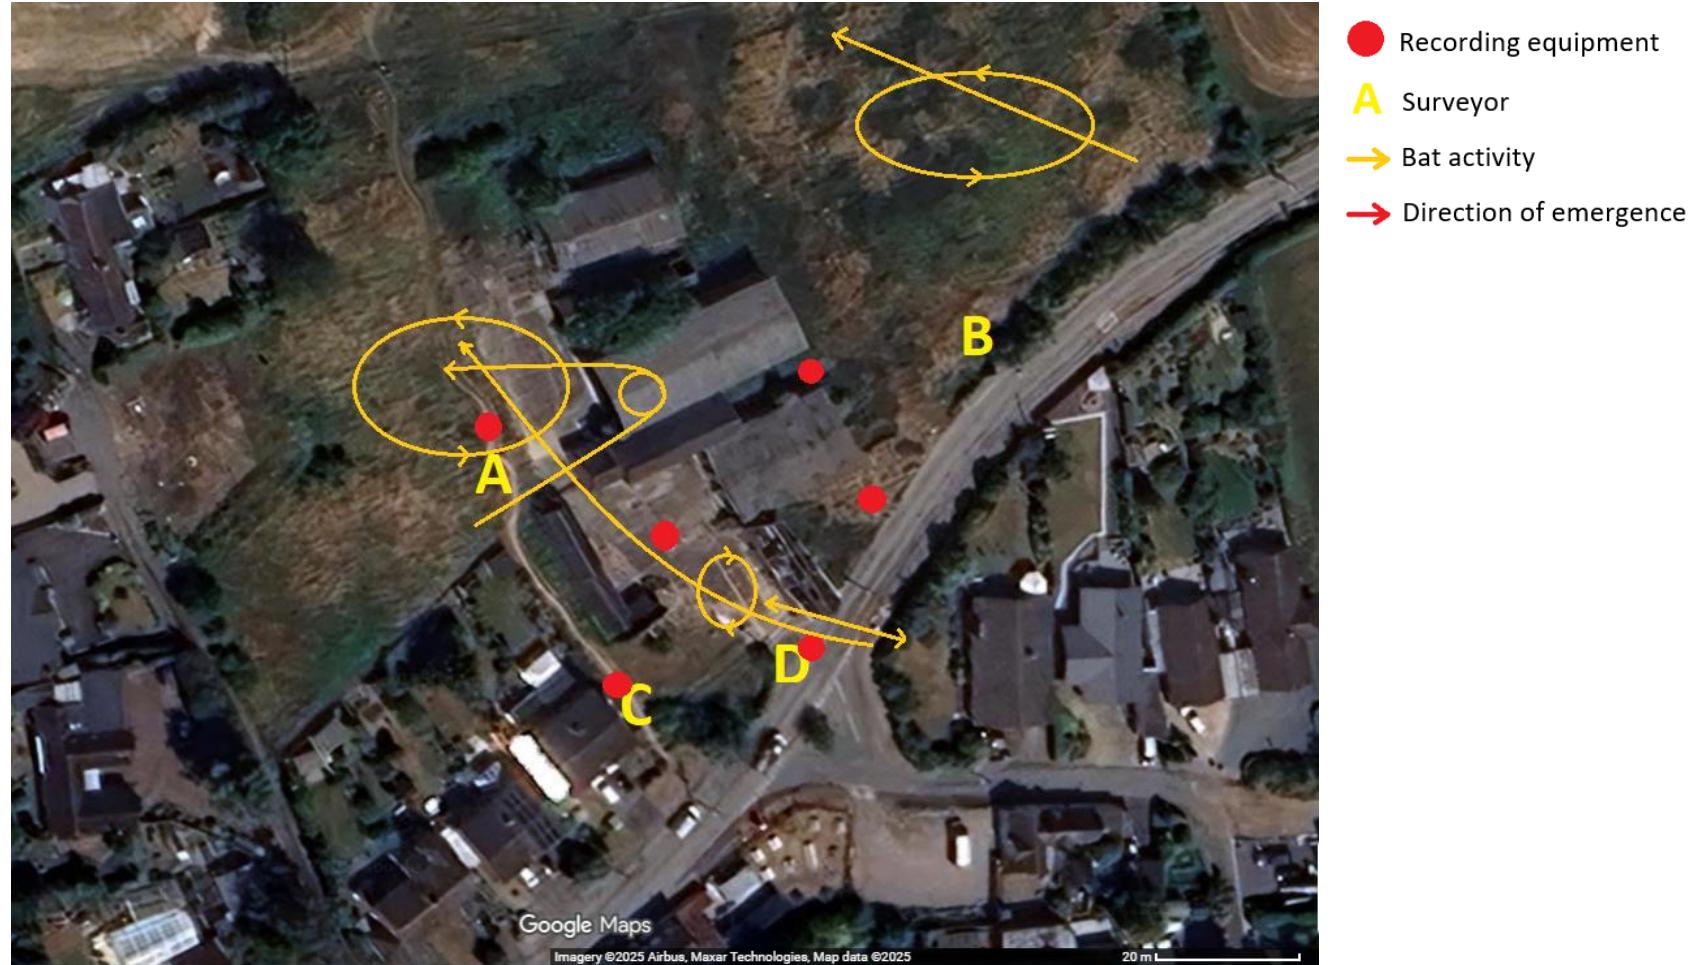
30/07/2025 - Dusk emergence

| Surveyor Location | Dates and Times | Bat Activity Observed |
|---|--|--|
| A | 30/07/2025<br>20:30 - 23:00<br>Sunset: 21:04 | A single common pipistrelle (CP) <i>Pipistrellus pipistrellus</i> was observed commuting across site at 21:21.<br><br>CP observed flying into B4 through the open doorway at 21:25, and foraging briefly before emerging again at 21:26.<br><br>Occasional CP foraging activity across site from 21:33 until 21:47 and from 22:09 until 22:52, by a minimum of two bats.<br><br>Noctule (Noc) <i>Nyctalus noctula</i> heard (not seen) at 21:46. |
| B | As above | Occasional CP foraging activity over the field to the East of site from 21:37 until 22:24, by a minimum of two bats.<br><br>A single brown long-eared bat (BLE) <i>Plecotus auritus</i> was observed commuting across the field at 22:31.<br><br>No observations associated with the buildings on site. |
| C | As above | Occasional CP foraging activity heard (not seen) from 21:26 until 21:34 and from 22:20 until 22:31.<br><br>N heard (not seen) at 21:46<br><br>No observations associated with the buildings on site. |
| D | As above | Occasional CP foraging activity in the courtyard in the centre of site from 21:14 until 21:34, by a minimum of one bat. Each time, the bat arrived from the Southeast, and departed in the same direction.<br><br>Individual CP seen commuting across site at 21:21.<br><br>Occasional CP foraging activity over the field to the East of site from 21:37 until 22:24, by a minimum of two bats.<br><br>No observations associated with the buildings on site. |

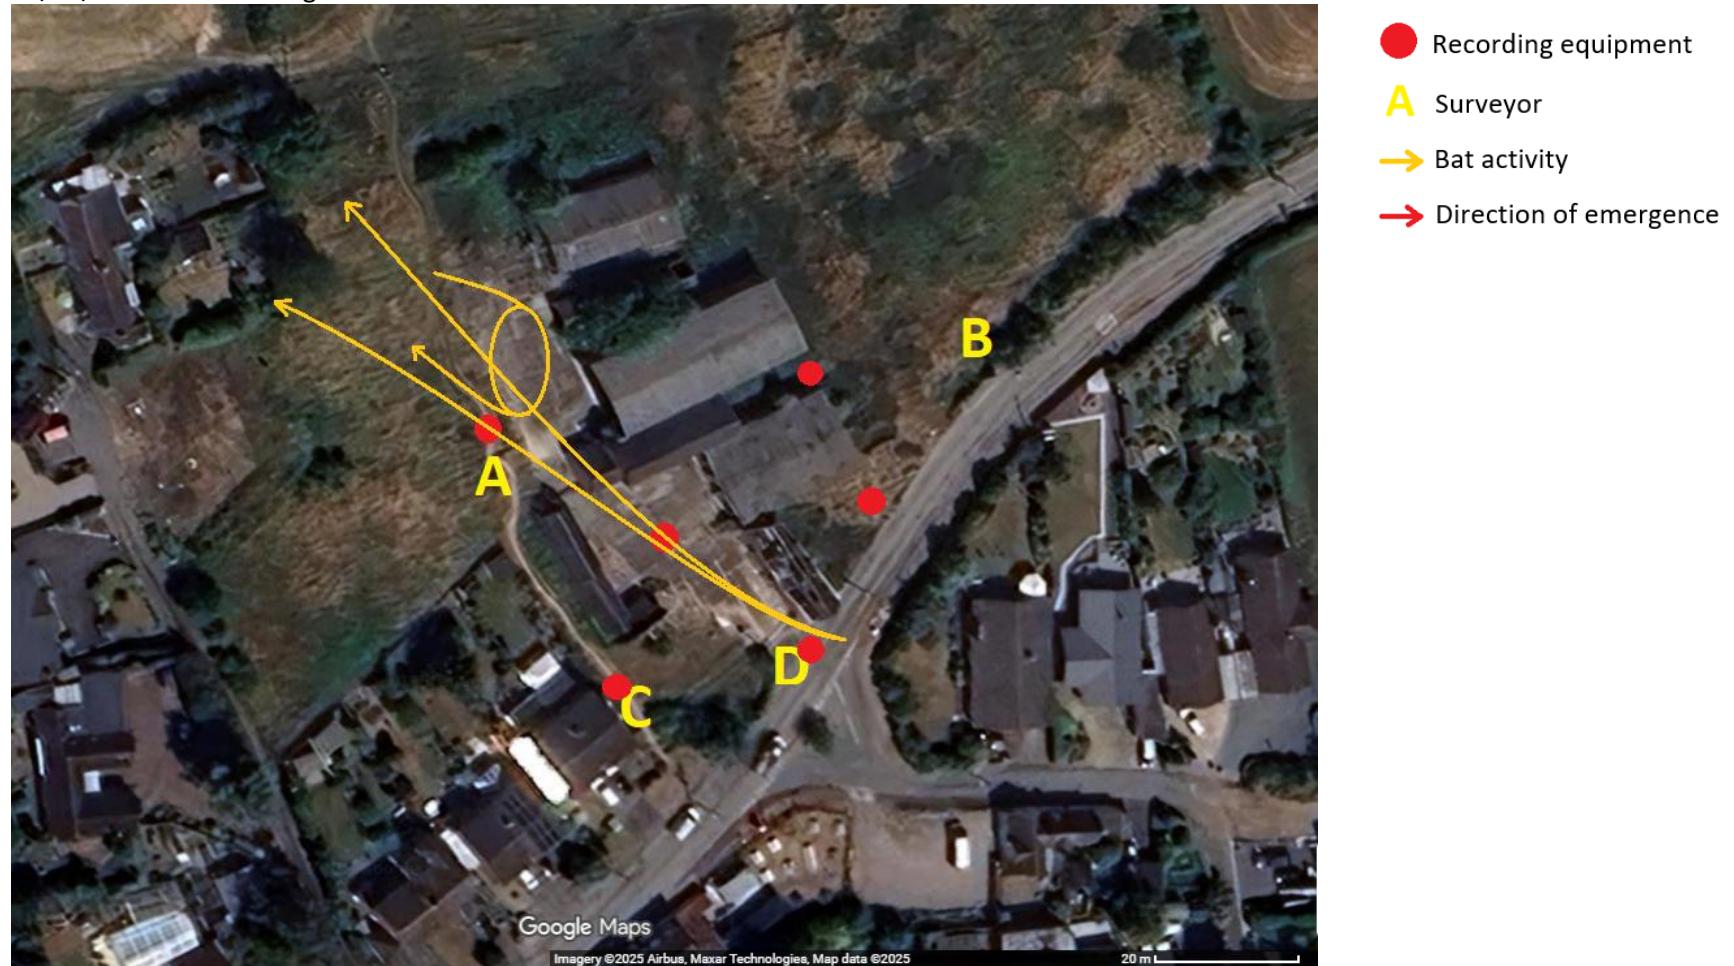
28/08/2025 - Dusk emergence

| Surveyor Location | Dates and Times | Bat Activity Observed |
|---|--|--|
| A | 28/08/2025<br>19:30 - 22:10<br>Sunset: 20:06 | Occasional individual CP commuting across site from 20:36 until 21:09.<br><br>Occasional CP foraging over hardstanding areas on site from 20:36 until 20:58.<br><br>Noctule (Noc) <i>Nyctalus noctula</i> heard (not seen) at 20:15 and 21:04.<br><br>No observations associated with the buildings on site. |

| B | As above | Occasional CP commuting and foraging activity heard (not seen) from 20:32 until 21:53.<br><br>No observations associated with the buildings on site. |
| C | As above | Occasional CP commuting and foraging activity heard (not seen) from 20:41 until 21:05.<br><br>N heard (not seen) at 21:04.<br><br>No observations associated with the buildings on site. |
| D | As above | Occasional individual CP commuting across site from 20:36 until 21:09.<br><br>Noctule (Noc) <i>Nyctalus noctula</i> heard (not seen) at 21:04.<br><br>No observations associated with the buildings on site. |
