# Bat Emergence and Re-Entry Survey

**2 Old Forge Road, Fenny Drayton,  
Nuneaton, Warwickshire  
CV13 6BD**

## Project

**This report is prepared to inform a planning application for the proposal described as: Demolition of the existing garage outbuilding and rear conservatory, construction of a new ground level garage, construction of a new ground level extension to replace conservatory, roof works to lift the ridgeline and facilitate new dormer windows and roof lights, and building extensions involving internal works.**

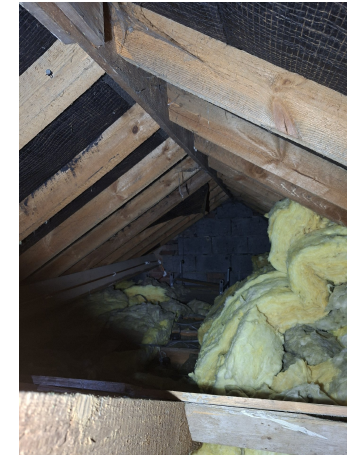
An updated loft inspection was undertaken by Assistant Ecologist Rabia Gull on 12/06/2026 as part of the BERS survey. The inspection identified no evidence of bats. The loft space was assessed for any material changes since the previous inspection, with no alterations to the structure, access points, or suitability for roosting bats identified. The conclusions of the original Preliminary Roost Assessment/ Ecological Appraisal (Arbtech, 06/06/2026) are therefore considered to remain valid.

**Figure 1a:** Internal loft space North West

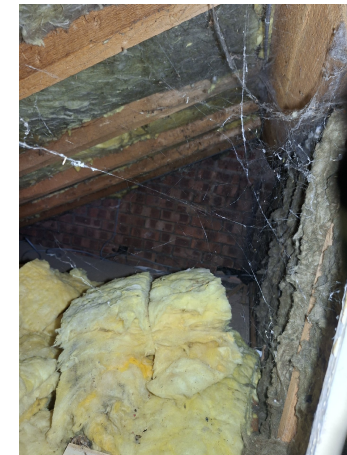
**Figure 1b:** Internal loft space South East

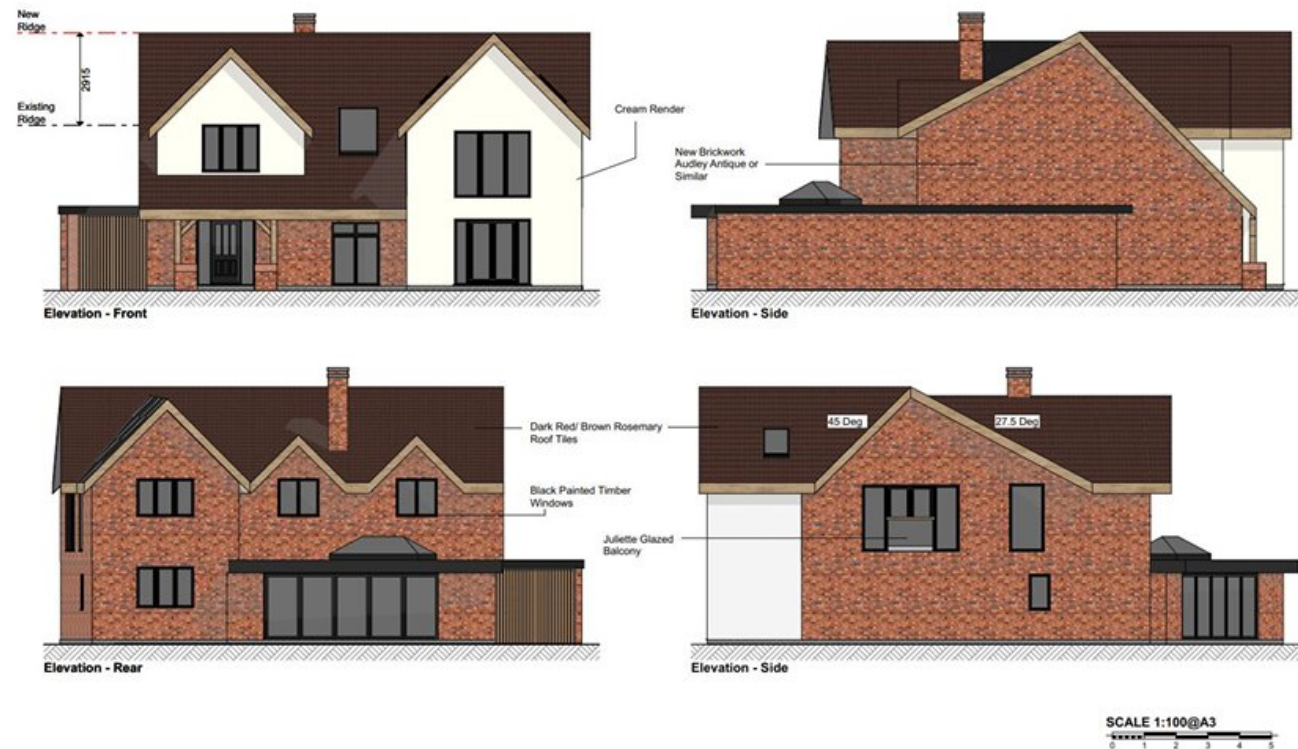
B1: Demolition of rear conservatory, construction of a new ground level extension to replace conservatory, roof works to lift the ridgeline and facilitate new dormer windows and roof lights, and building extensions involving internal works.  
B2: Demolition

Figure 2: The proposed plans

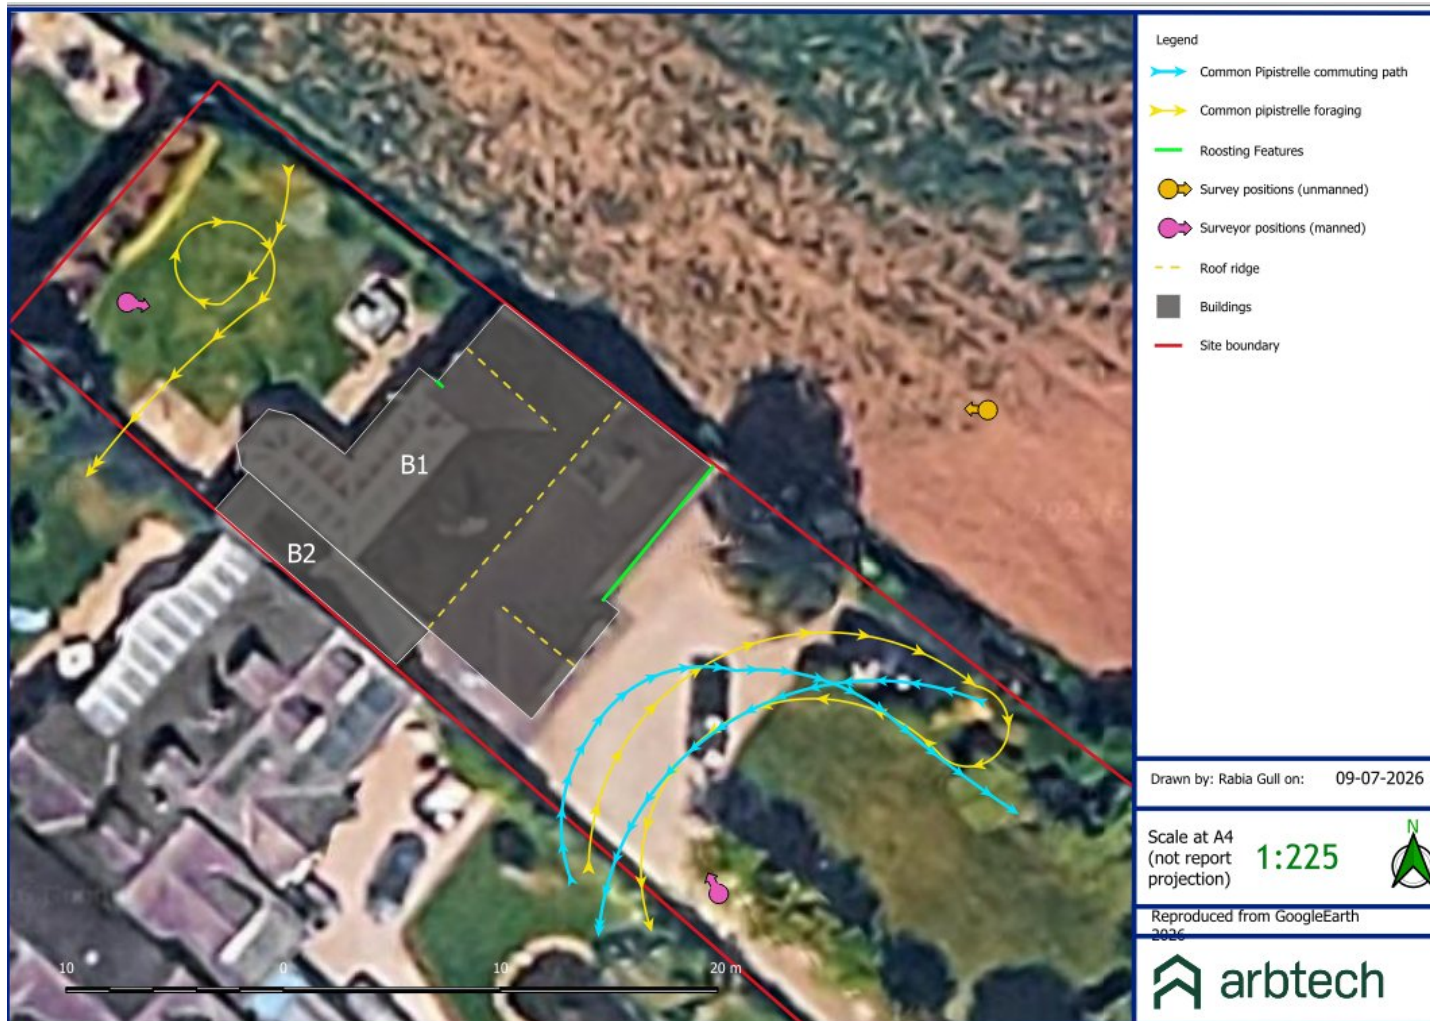
Foraging activity of Common Pipistrelles was observed at from South West to South East and back, passing in front of the South Eastern elevation of B1 and also in front of Western elevation in rear garden.

Commuting activity of Common Pipistrelles was observed From South West to South East in front of the South Eastern elevation of B1 and from South East to South West, passing in front of the South Eastern elevation of B1.

Plan 1: The site map including observed bat commuting and foraging paths.

Foraging and commuting bats could be impacted by additional lighting on site which can affect resources for the local population. Due to the presence of Liesler's bat's foraging/commuting on site, a wildlife sensitive lighting strategy will be adopted within the proposed development during and post-development. This should be designed in accordance with Guidance Note GN08/23 Bats and Artificial Lighting at Night (Institution of Lighting Professionals, 2023). Parameters include avoiding light spill onto key habitats or features used by bats for roosting, foraging, or commuting.

A low impact lighting strategy will be adopted for the site during and post-development, and this should be designed in accordance with Guidance Note GN08/23 Bats and Artificial Lighting at Night (Institution of Lighting Professionals, 2023). Parameters can be found on the Bat Conservation Trust website: <https://www.bats.org.uk/news/2023/08/bats-and-artificial-lighting-at-night-ilp-guidance-note-update-released>
