# **PRA of single storey extension IAW plan** **25.10.04B**

**67 Sapcote road**  
**Burbage**  
**LW10 2AS**

**Conducted By:**  
**C.Harrison - N.Dip Enviro, PTI**  
**License number: 2024-12336-CL17-BAT**

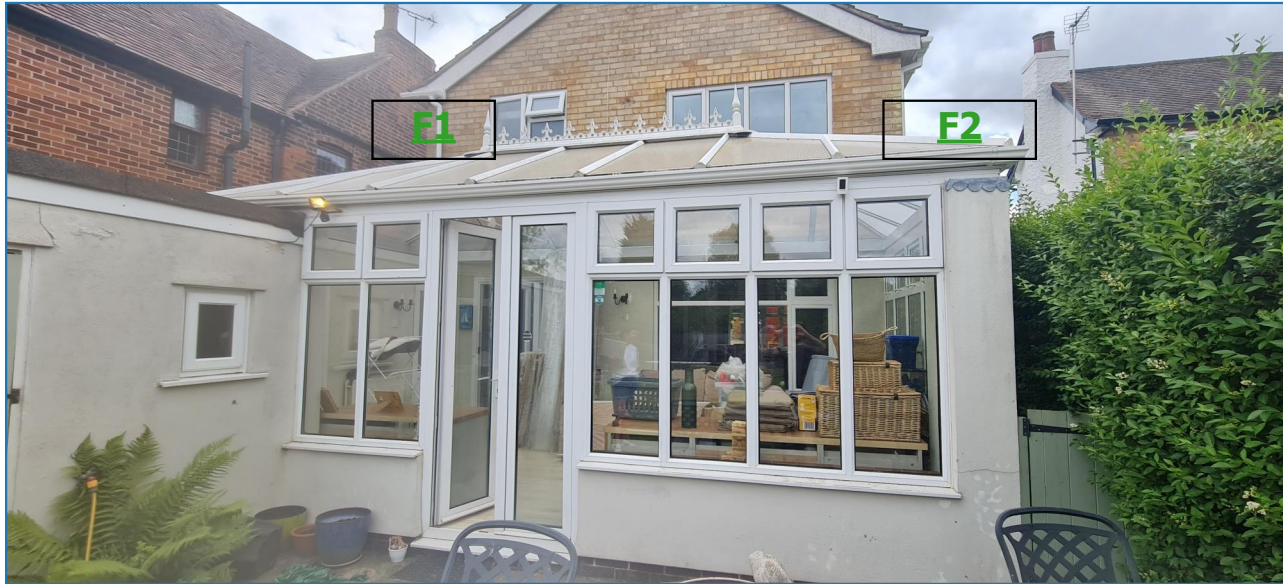
F1: UPVC Capping on apex

Does not extend or provide adequate shelter to support a roost.

**Negligible**

The conservatory is in constant use and would be subject to high levels of disturbance and light, no roost features present.

F2: UPVC trim and associated lead flashing.

No entrance point or space for shelter.

**Overall potential: Negligible**

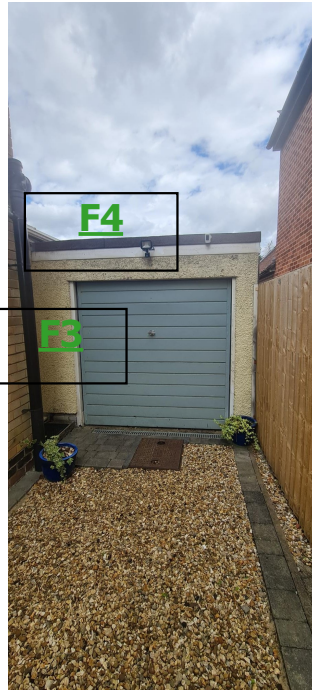
F4: Void between felt roof and fascia

Inadequate space for refuge.

**Negligible**

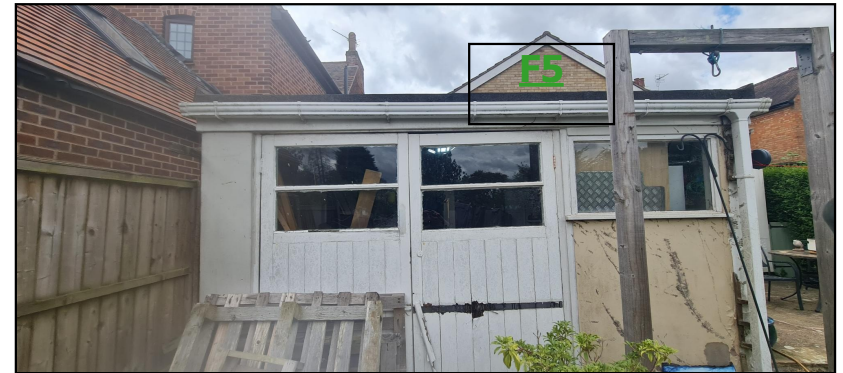
F5: Void between felt roof and fascia.

Inadequate space for refuge, extends in but not enough to provide shelter or access into structure.

**Negligible**

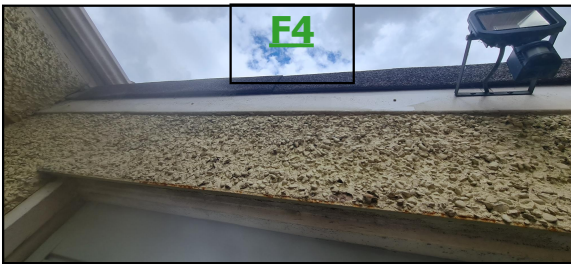
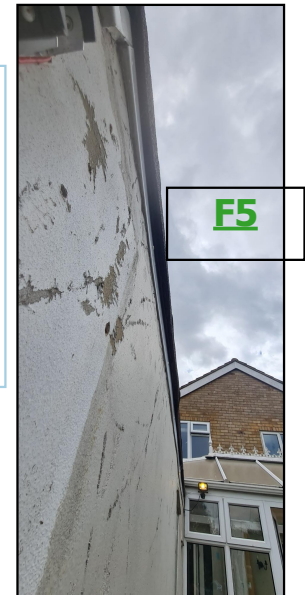
The external parts of the garage do have some wear which in some cases can provide suitable features to be used by bats, however in this case the features do not provide the space/extent required.

The frame around the wooden barn doors to the North side are degraded in some places but well set into frame which would prevent it being used as an access point.

**Overall potential: Negligible**

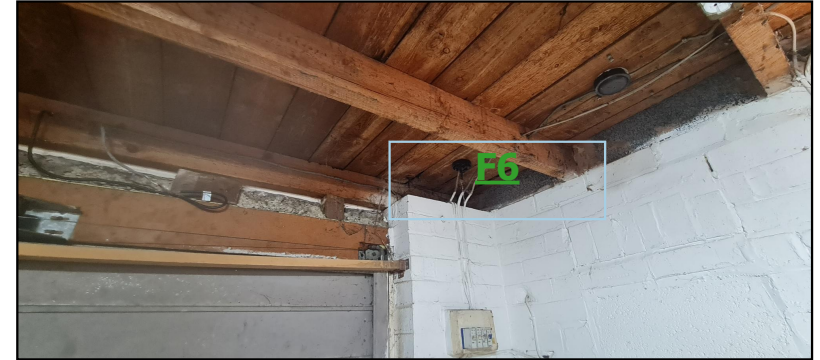
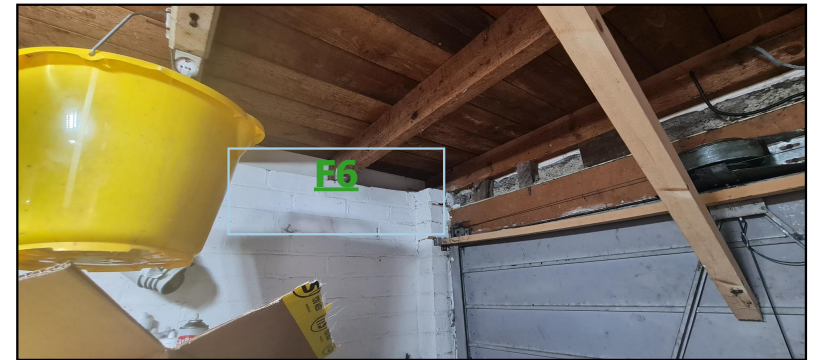
F6: Voids between roof boards, ceiling joists and rafters.

Tightly fitted with no spaces of suitable size.

**Negligible**

While no access points were identified from the outside the internal parts of the garage have been inspected. The roof is in direct contact with the felt above with no lining or insulation to allow a void space. No droppings or other evidence of use were found, some areas heavily webbed (old) which would indicate a lack of movement and increase the chance of identifying droppings.

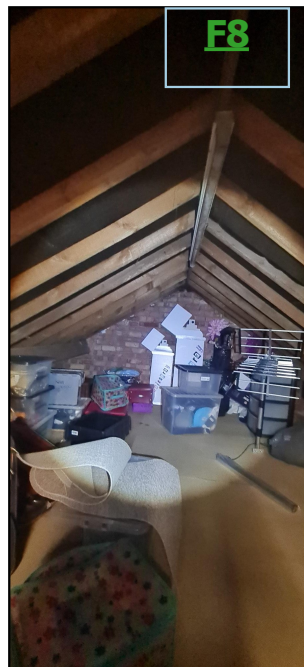
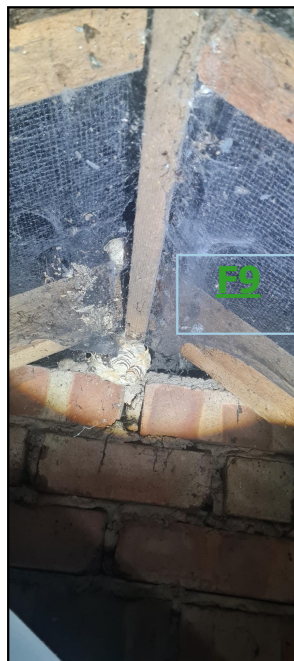
F9: Gable end

Evidence of use by Vespidae sp. and heavily webbed. Void behind not fully inspected however absence of any signs of use and active presence of vespidae would suggest absence.

**Negligible**
