PRESENCE / ABSENCE SURVEY (BATS)

1A RATBY LANE MARKFIELD
LEICESTERSHIRE LE67 9RJ

Report Reference: PRO120/05/25PAS

This report contains the results of a single Presence / Absence Survey (PAS) for bats at a hydrotherapy pool Building 1 (B1) and timber open fronted sheds (B2) scheduled for demolition at: Tomlinson's Kennels, 1 A Ratby Lane, Markfield Leicestershire LE67 9RJ. Central Grid reference: SK 49123 09129.

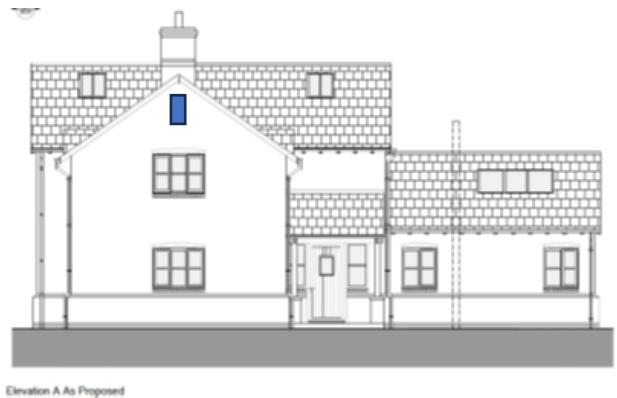
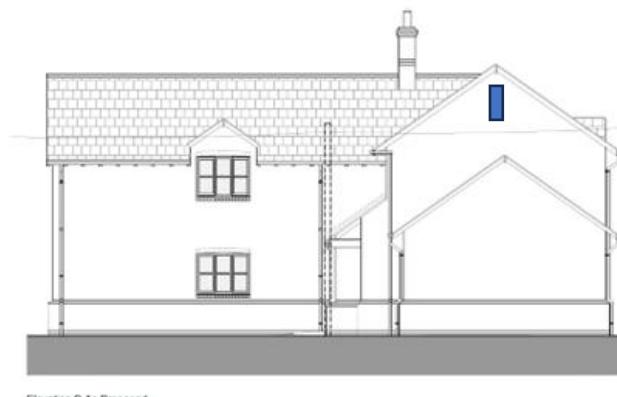
Figure 1. Southeast and southwest elevations of the proposed new dwelling showing the most suitable location of two integrated bat boxes or tubes, (blue rectangle). These can be built into the design of the building, see Habitat Enhancement below for product details.

B1 is graded as 'Low' potential to support roosting bats and this is based upon the roof covering of the building being tin and well-sealed, bright lighting to the façade and west gable, lack of suitable ingress points and the availability of two storey buildings nearer to better quality habitat. As a result, a single PAS was undertaken after the building inspection. The demolition of B1, means potential bat roost features will be lost to the development. See Figure 1 for recommended compensation.

As bats can still navigate to these trees and the wider area via existing hedgerows and trees, 'Low' impact due to light spillage from the proposed dwelling is predicted, Appendix C. This impact can be mitigated for by providing two integrated bat roost features into the new dwelling and facing southwest and southeast, Figure 1.

B1 and B2 are of 'Low' and very 'Low' roost potential respectively. The previous PEA Elite Ecology (2024) recommended three integrated bat boxes into the new building, however, given the roost potential of B1 and B2 and the poor quality of the existing ingress points available, two integrated bat boxes fitted to the new dwelling is more proportionate in this instance. The bat boxes should be fitted centrally near the apex of the gable facing a southerly direction to maximise warmth from the sun, see Figure 1 above and Appendix G.

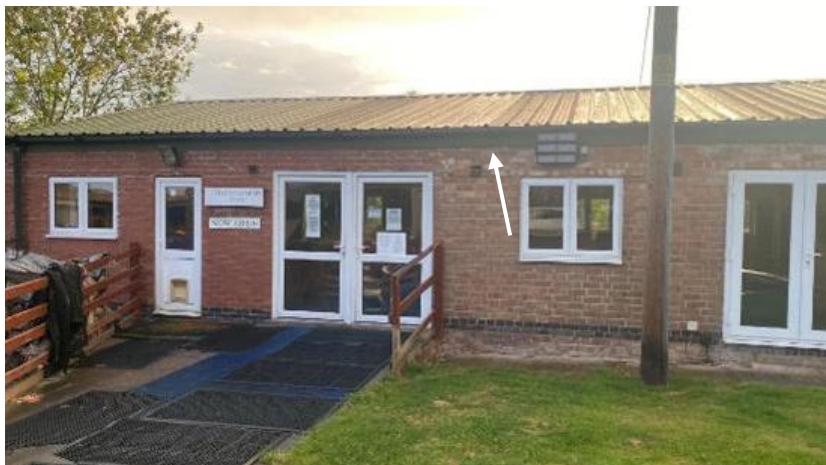
Photo 1. Facing northeast toward the hydrotherapy pool building showing the external lighting and area where the metal bargeboard is slightly lifted from the wall (arrowed).

The exterior building inspection showed B1 to be a single storey solid 9-inch brick construction measuring approximately 14m X 8m. The roof covering is constructed of metal cladding which was tight fitting apart from the east gable, the façade and rear of the building where gaps between the metal cladding bargeboard and brickwork could allow ingress to bats.

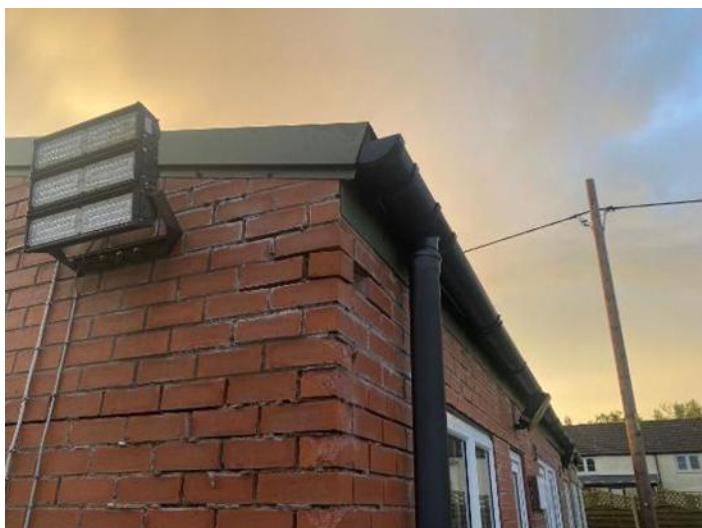
Photo 2. Loose half brick to the southeast corner with security lighting.

The gaps at the rear cladding had cobwebs so have not been subject to recent disturbance. A small gap is present due to missing mortar around a loose half-brick on the southwest corner of the building. No signs of bats were found throughout the external inspection, Appendix A Photographs 1 – 3. A small log storage area is present to the northeast end of B1 which could be used by roosting bats but is subject to disturbance regular disturbance, Photo 4.

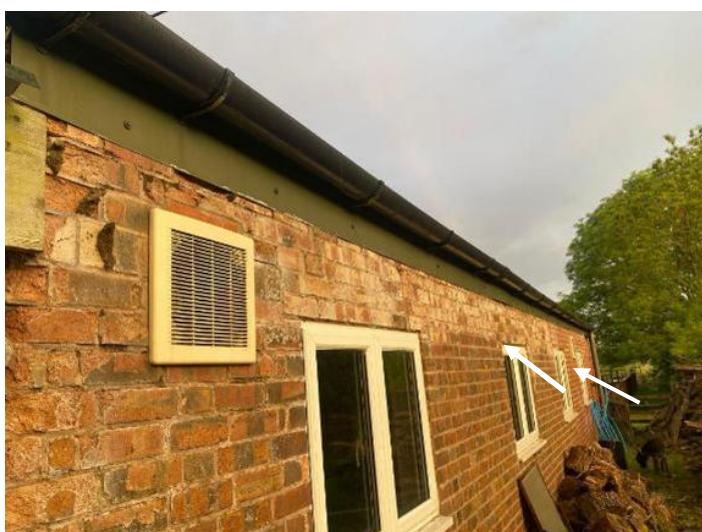
Photo 3. Facing northwest toward gaps above vent and under the bargeboard.

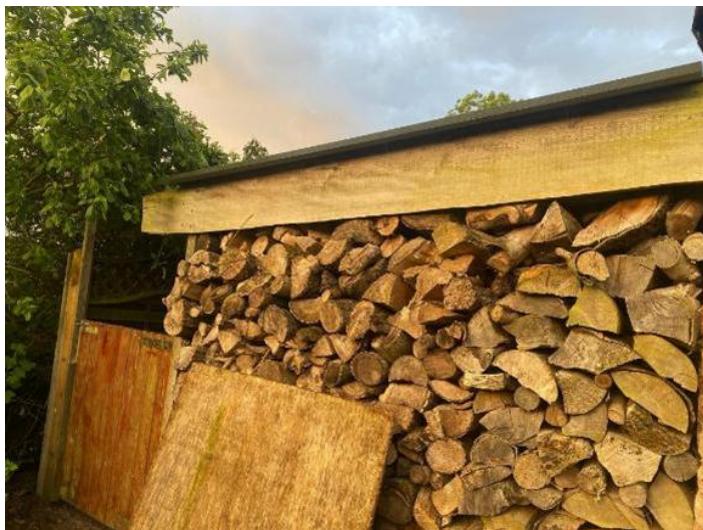
Photo 4. Log store to the northeast of B1 is subject to regular disturbance.

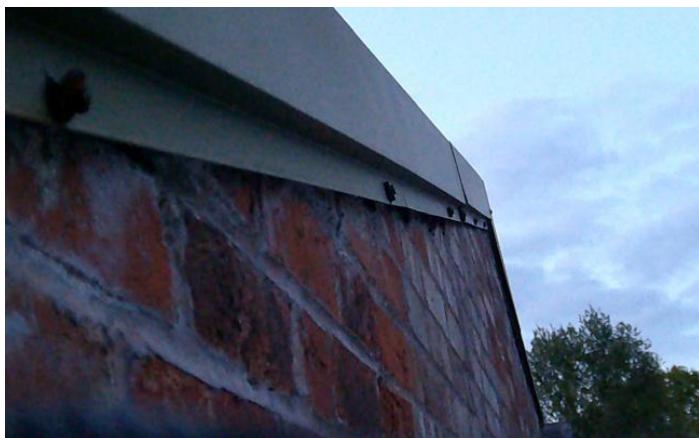
Photo 4. Facing northwest toward the upper east gable showing a gap between metal cladding and brickwork potentially providing access under the roof covering to bats. No signs of bats found during the inspection.

Camera 2 covered the east gable of B1 which also had gap between the bargeboard and brickwork. Camera 2 and IR lighting had to be raised onto the roof of a small glass conservatory attached to the east end of B1 to view the gable.

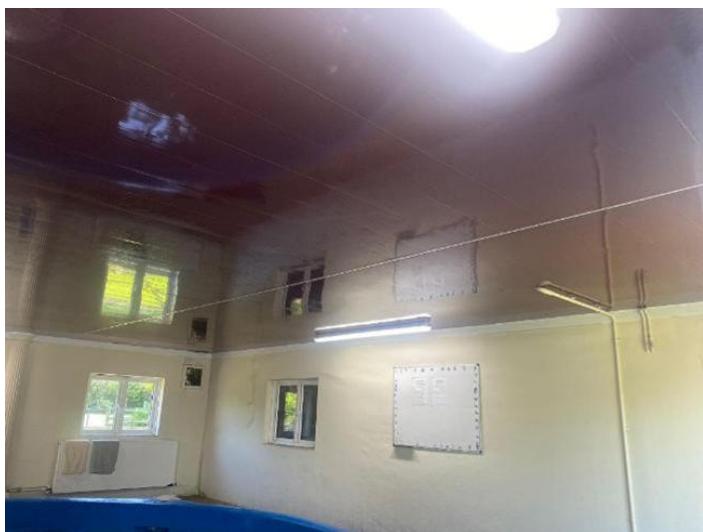
Photo 5. Hydrotherapy pool interior showing the building to be in use and plastic sheet ceiling is tightly fitted. No signs of bats throughout.

The internal inspection revealed a circular dog hydrotherapy pool which was full of water at the time of the survey. The air around the pool was humid and had a strong odour of chlorine. The ceiling above the pool room is constructed of plastic water-proof sheeting. No loft hatch is present so the small loft void could not be inspected, Photo 5. A small office and boiler room adjacent to the pool room are well-sealed throughout. No signs of bats were found throughout the internal inspection.

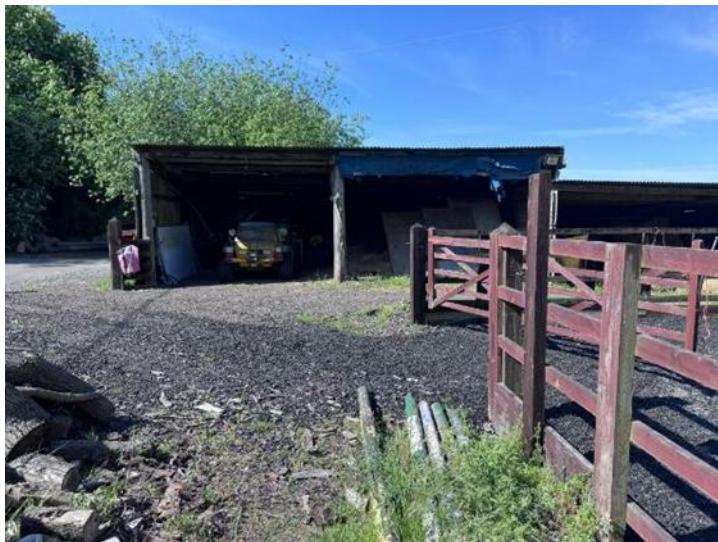
Photo 6. Facing southwest toward the eastern end of the open fronted sheds and part of the proposed dwelling footprint (foreground). See next photo showing the interior.

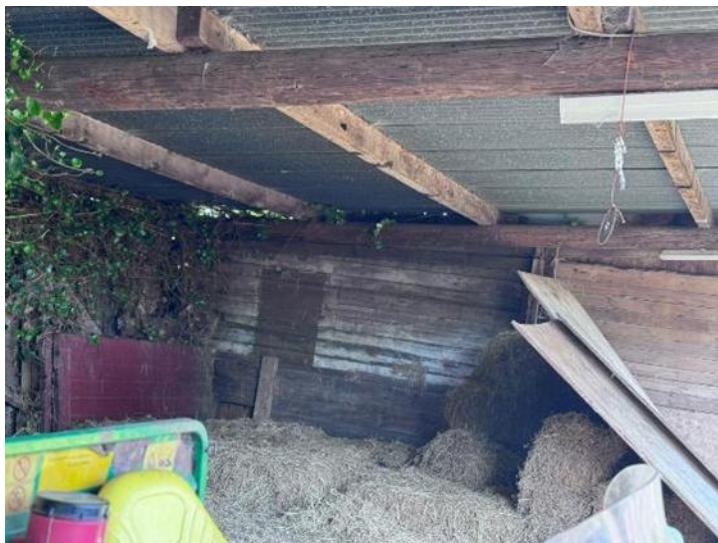
Photo 7. The roof is corrugated tin. There are no gaps in roof support timbers that can be used by crevice dwelling bats to roost in. The walls are single skin timber plank. Stored items were covered with dust indicating long term storage and had no evidence of bats such as droppings or urine staining. The remaining sections of the sheds are in this condition with no potential bat use apart from the northeast end wall, see next photo.

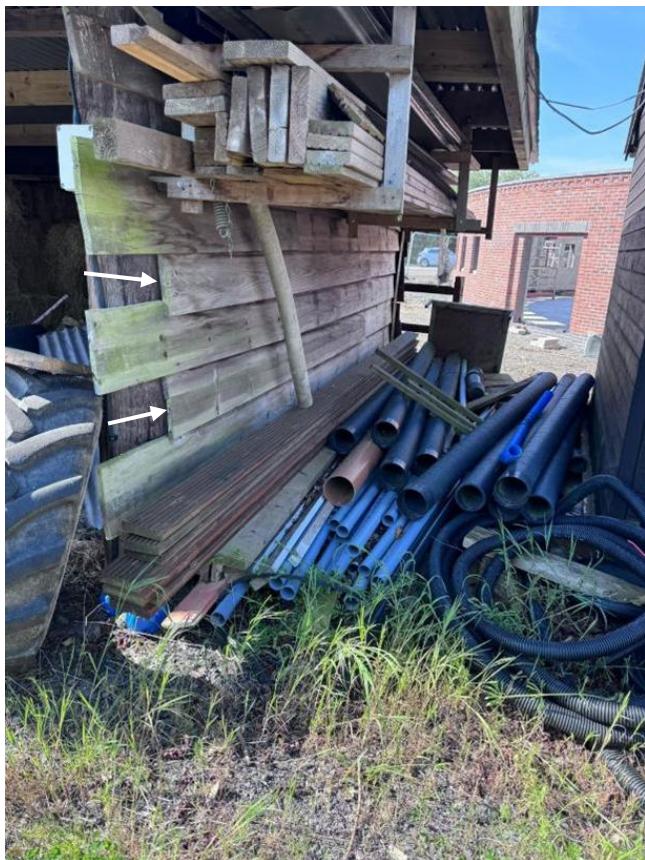
Photo 8. Facing south toward the northeast end of the of the sheds showing the wall is in poor condition and reinforced with plywood with small gaps (arrowed) providing a 'Low' potential roosting area. Bats will use these features as temporary roosting areas (Pers. Comm). Surveyor C was positioned near this feature during the PAS and could view along the open fronts of all sheds.

The PEA graded a series of connected open timber sheds as having 'negligible' bat roosting potential however, limited roosting potential was identified during an inspection so as a precaution B2 was upgraded to 'Low' potential.

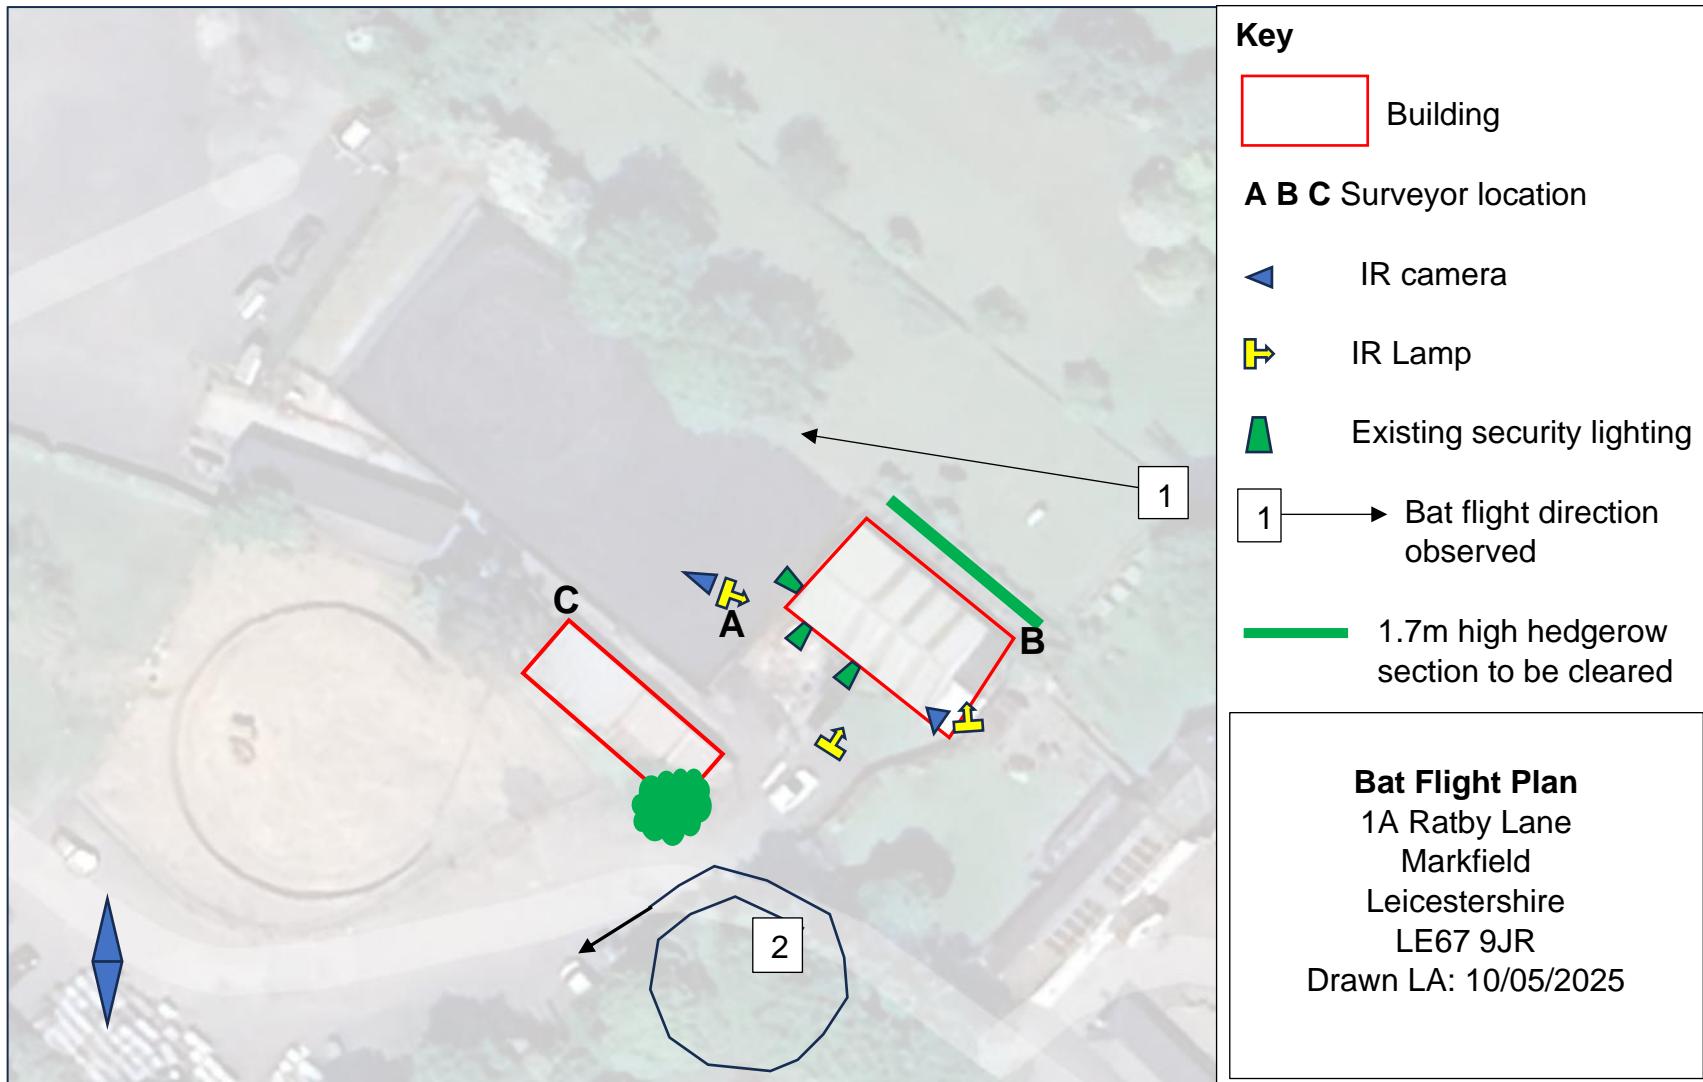
Appendix B Bat Flight Plan

A total of four bat call registrations were made during the survey. Three were recorded as *P. pipistrellus* and one Noctule (*Nyctalus noctula*). The first bat was the Noctule heard but not seen by all surveyors. The second bat was a (*P. pipistrellus*) at 21:14, 35 minutes after sunset. This species usually emerges around 20 minutes after sunset suggesting the bat may have emerged from further afield or was late emerging and was observed flying from the direction of neighbouring houses in the northeast as observed by Surveyor B, Appendix B.

The remaining two bats recorded were identified as (*P. pipistrellus*) recorded at 21:24 -21:26 and 21:38. The bat recorded at 21:24 was seen by Surveyor A flying around trees and foraging 50m to the south for two minutes. The bat at 21:38 was heard but not seen by Surveyor B.

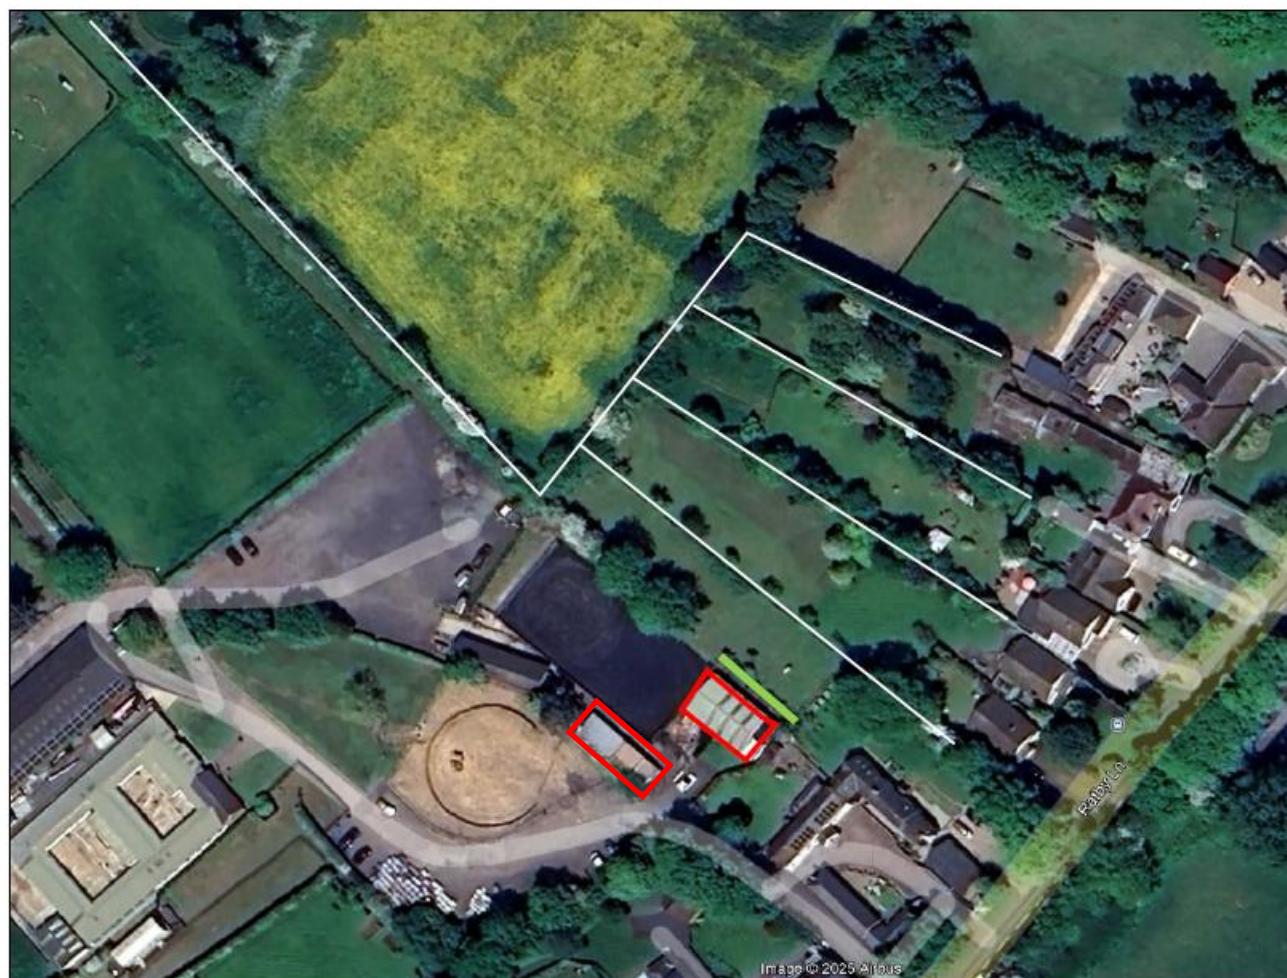
Bat Habitat Plan

1.5m high hedgerow section

The loss of the above hedgerow section if required, would not sever important bat flyways.

The white lines show suitable bat commuting routes from the immediate neighbouring properties to the northwest and wider area leading to moderate bat habitat.

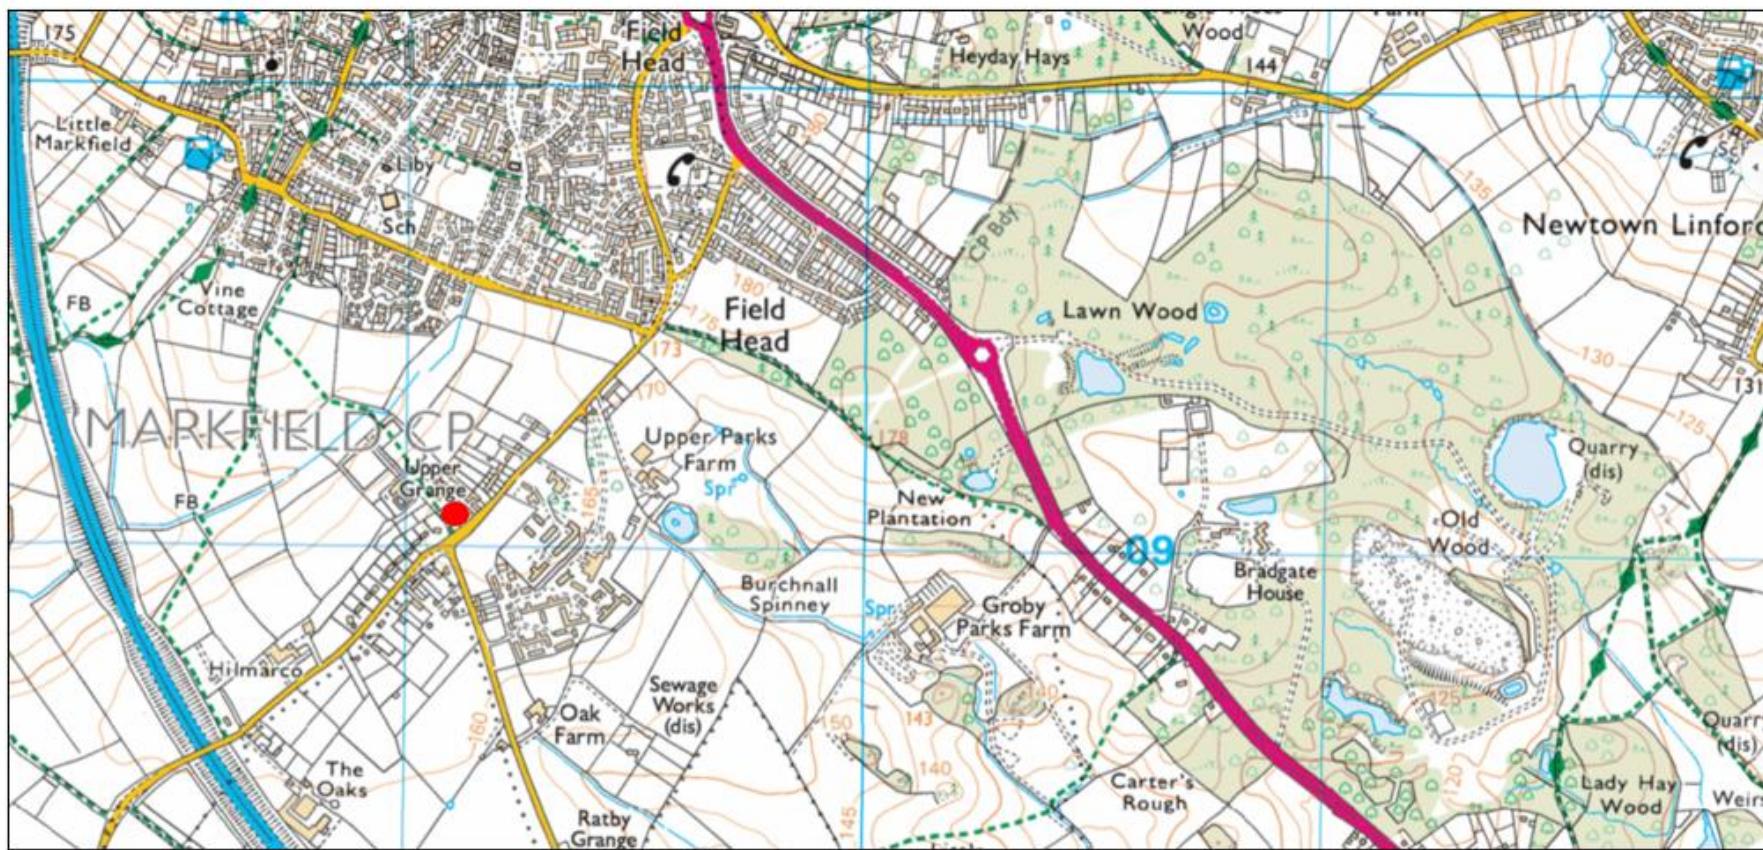
Bat Landscape Plan

Red dot shows the approximate location of the proposed development. The habitat to the east on the opposite of Ratby Lane, is of 'High' conservation value for bats with Lawn Wood and Old Wood supporting extensive woodland with a network of ponds. The immediate west is of 'Moderate' conservation value for bats being mainly agricultural and grazing pasture, with hedgerows and ditches which are bisected by the M1 Motorway to the west and the densely populated Markfield Village to the north.
