**Preliminary Bat Roost Assessment and Bird  
Survey for,  
Mr. and Mrs. M. Shorrocks.  
Building at,  
17 Orme Lane,  
Ratcliffe Culey,  
ATHERSTONE,  
CV9 3PB.**

**Map Ref SP 3285 9951  
8<sup>th</sup> August 2026.**

**S. Christopher Smith MRICS MSc CEnv.  
The Hayloft,  
Farm Lane,  
Grendon,  
ATHERSTONE,  
Warwickshire.  
CV9 3DR**

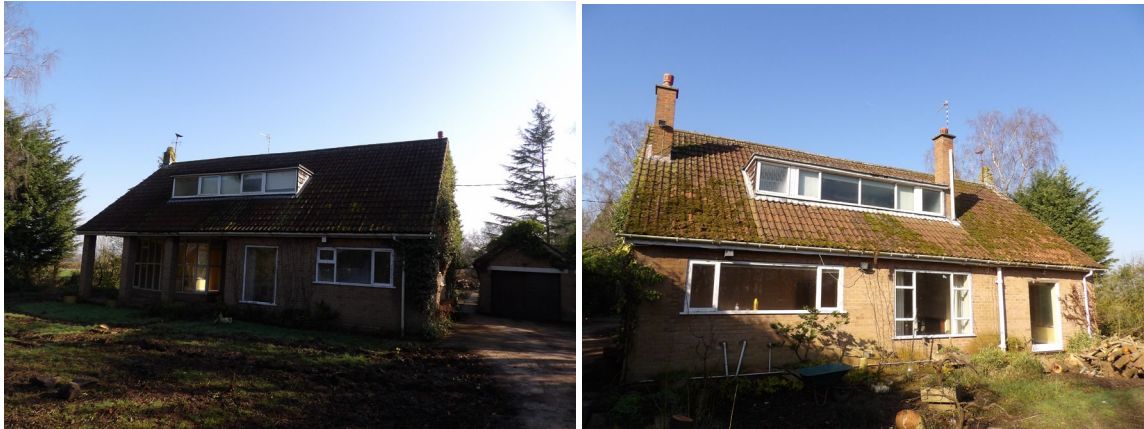
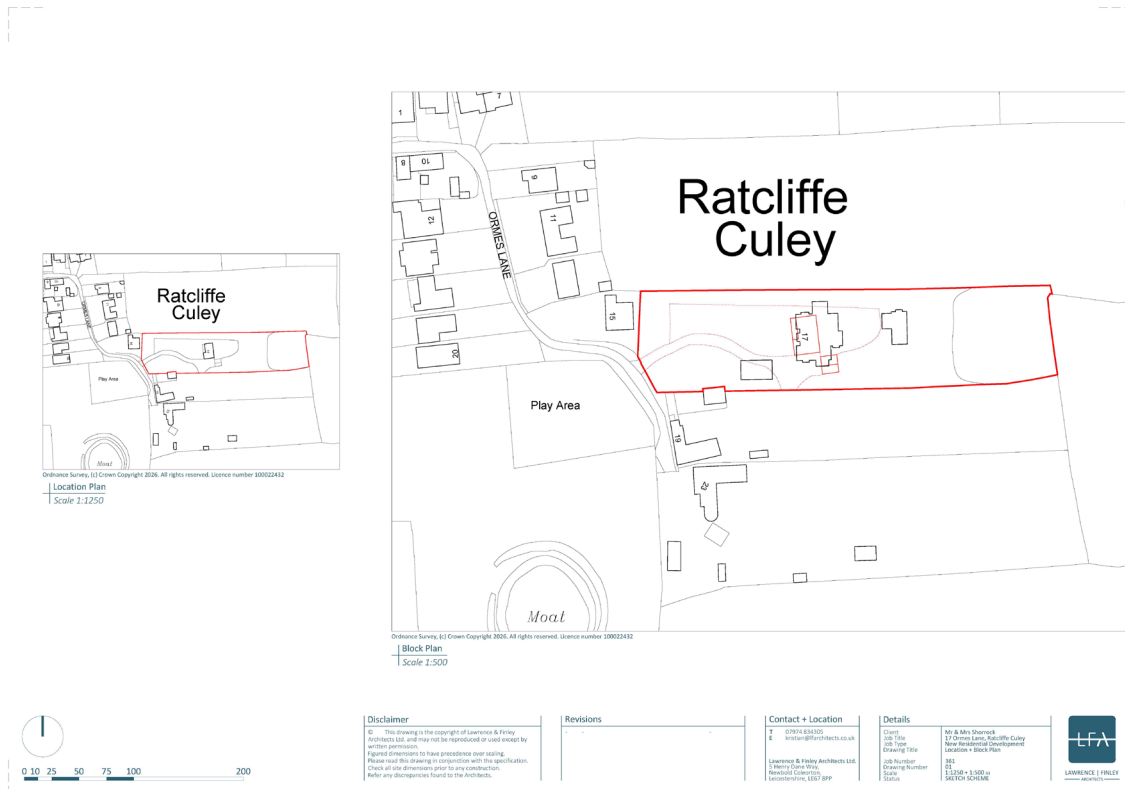
The buildings to be surveyed consisted of a two storey cavity brick dwelling with an interlocking pan tile pitched roof.

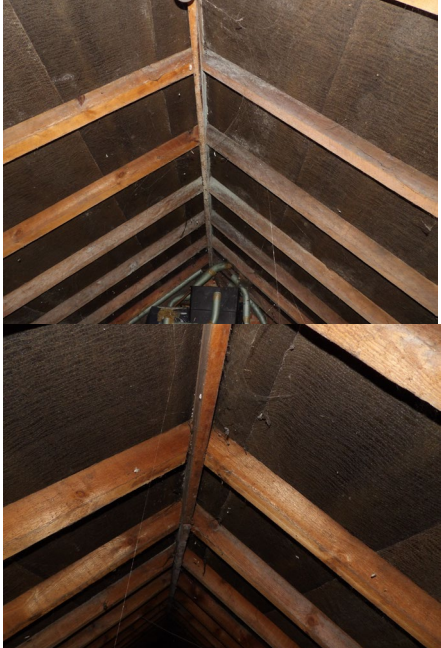
| Feature. | Bat roosting opportunities. | Photograph. |
|---|---|---|
| Against the ridge board | None. There is no access to the roof space for bats. | |

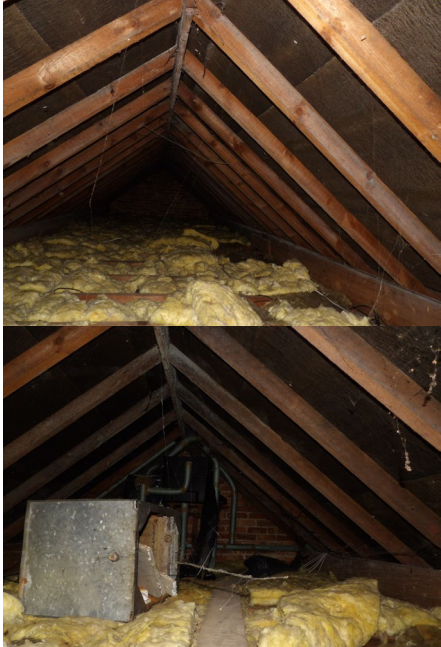
| Feature. | Bat roosting opportunities. | Photograph. |
|---|---|---|
| In splits in the timber. | None. Machine cut timber with no splits. | |

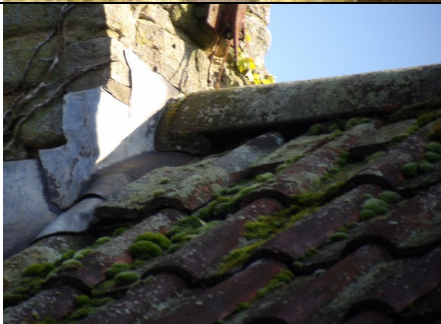
| Feature. | Bat roosting opportunities. | Photograph. |
|---|---|---|
| Under ridge tiles. | High. There is access for bats under the ridge tiles. | |

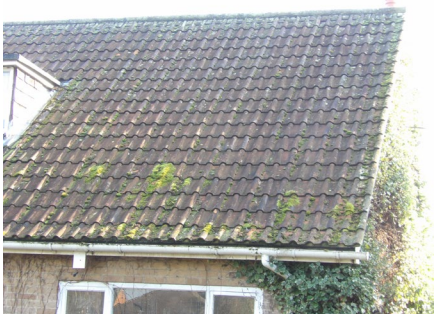
| | | |
|---|---|---|
| Under interlocking pan tiles. | None. There is no access for bats. | |

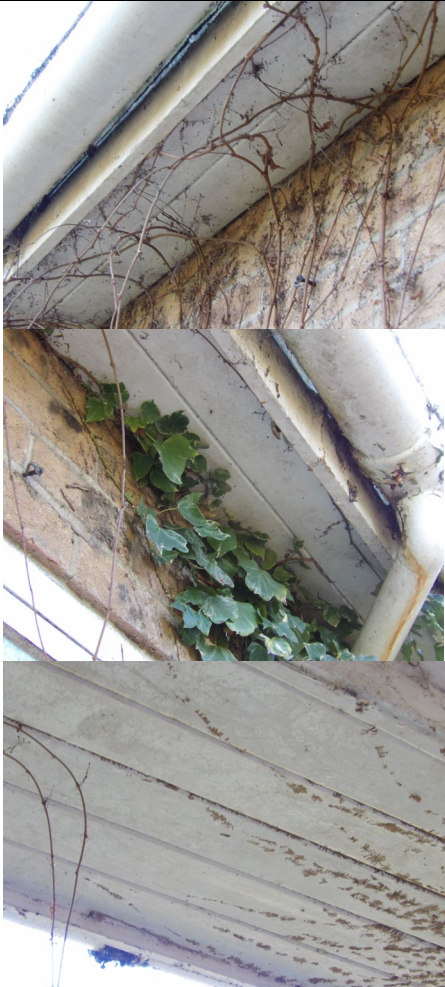
| Under timber fascia boards or behind soffits at eaves. | None. There is no access for bats. | |

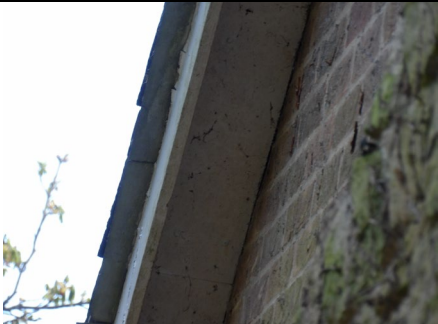
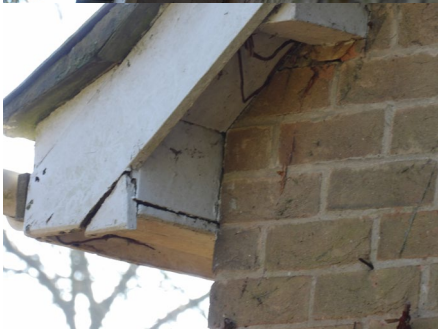
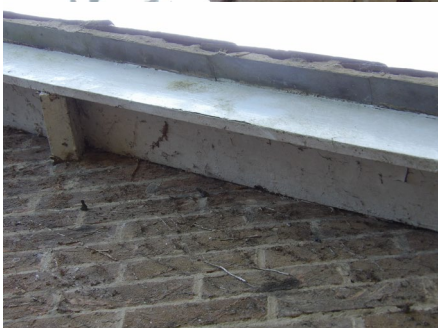
| Under barge boards and soffits at gables. | None. There is no access for bats. | |

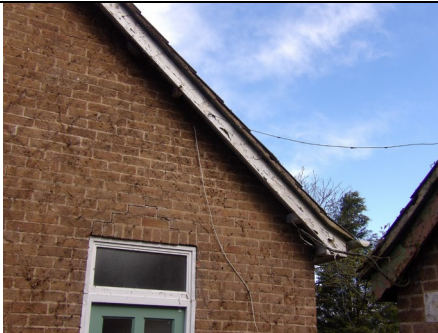
| In verge. | High. There is access for bats to the southern elevation verge in a number of places. | |

10 Common pipistrelle bats emerged from three gaps at the verge on the southern elevation on the 17<sup>th</sup> June 2026. The bats emerged from 3 gaps under the pan tiles on the verge.

A Bat Mitigation Class License will be needed from Natural England to demolish the dwelling, if planning permission is granted.

- A licensed Bat Worker is to be present when the roof tiles are removed because this will result in the destruction of three Day roosts of Common pipistrelle bats.
- Prior to the commencement of works a 'Toolbox' talk is to be given to contractors.
- When roof tiles or wooden shingles are removed they should be lifted away from the roof and not slid or twisted to avoid injuring any bats roosting beneath the tiles.
- Ridge tiles should be lifted without sliding so as to avoid injuring any bats roosting beneath them.

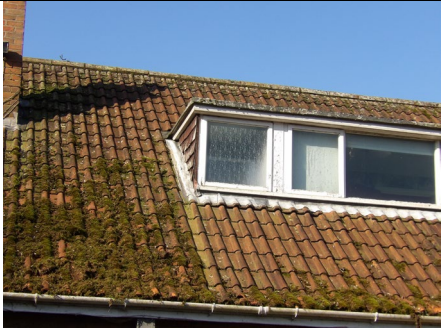
| | | |
|---|---|---|
| Under flat roof of dormer windows. | None. There is no access for bats. | |

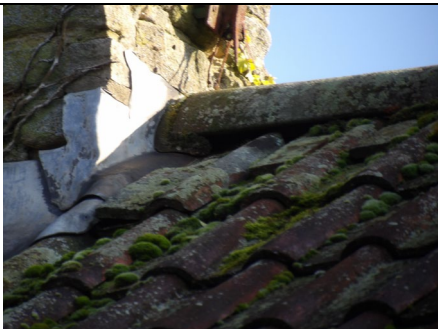
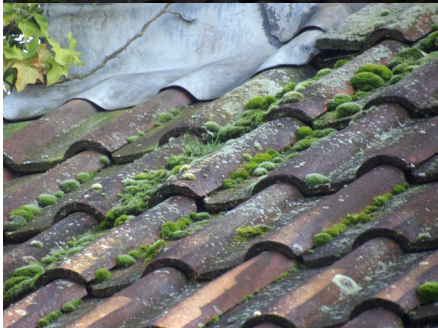
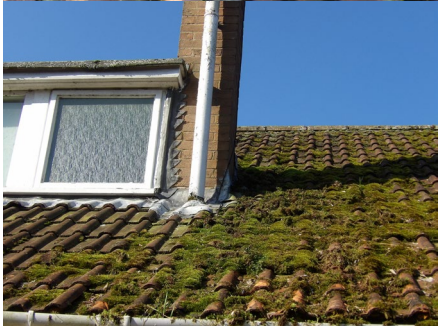
| | | |
|---|---|---|
| Under lead flashings. | None. There is no access for bats. | |

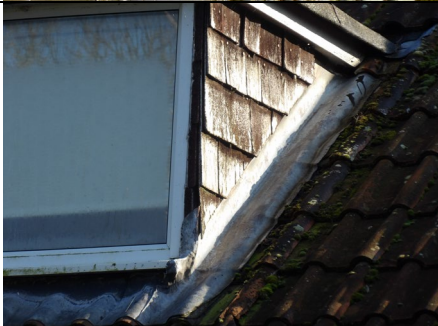
| | | |
|---|---|---|
| Under timber shingles of the dormer windows. | Moderate on front elevation dormer. There is access for bats under the shingles on the southern elevation. None on rear elevation dormer. | |

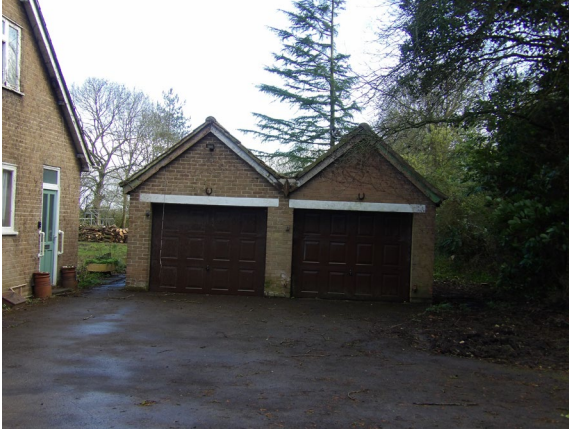
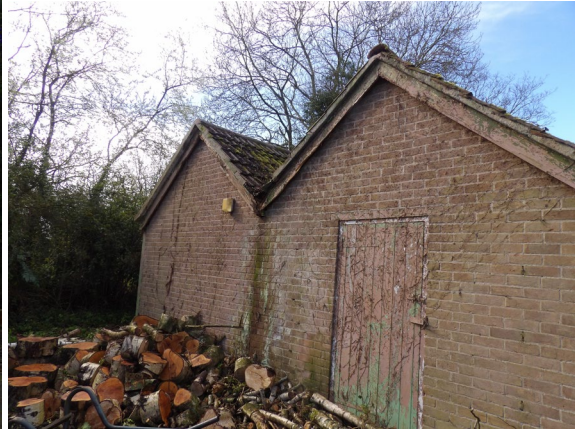
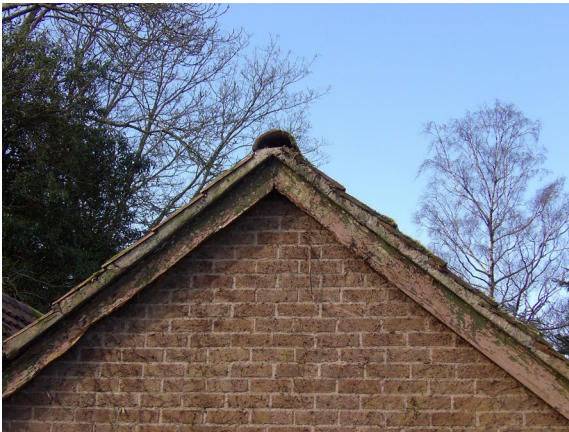
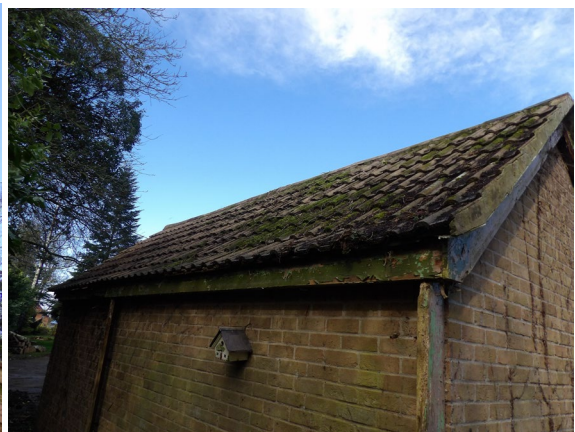
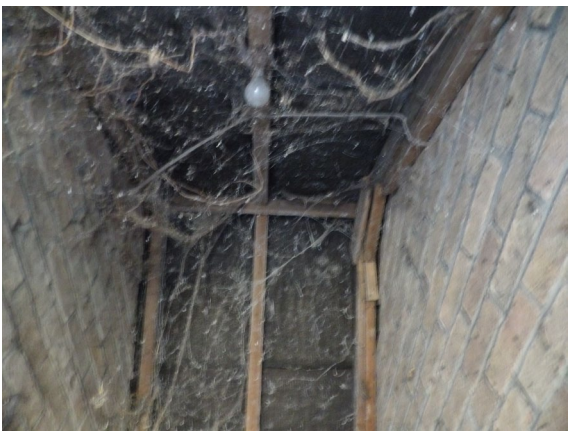
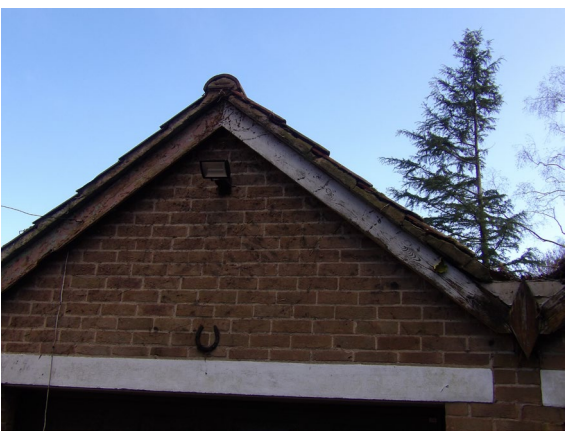
The garage is a cavity brick single storey building with two bays and a pitched roof covered with pan tiles. There is a bitumous underfelt on the roof. There is access to the underside of the ridge tiles on the rear elevation and the space between the rear of the pan tiles and the bitumous underfelt through gaps in the verge on the front elevation.

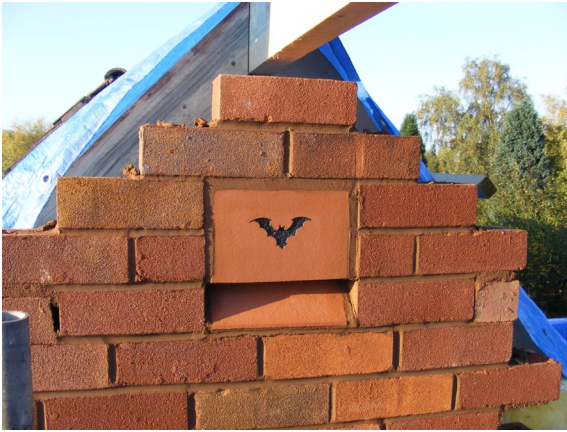
Three integrated bat boxes can be installed at the gable apex and at the eaves of one elevation of the new dwelling, should planning permission be granted. These are constructed from brick or concrete blocks and are built into the outer leaf of brickwork. They can have facing bricks or be rendered. They provide no access to the cavity wall.
