# NOCTURNAL BAT SURVEY REPORT

Moor Barns Farm,  
Pipe Lane,  
Orton-on-the-Hill,  
Atherstone,  
CV9 3NF

22<sup>nd</sup> May 2024

1631-NBS-V1-B

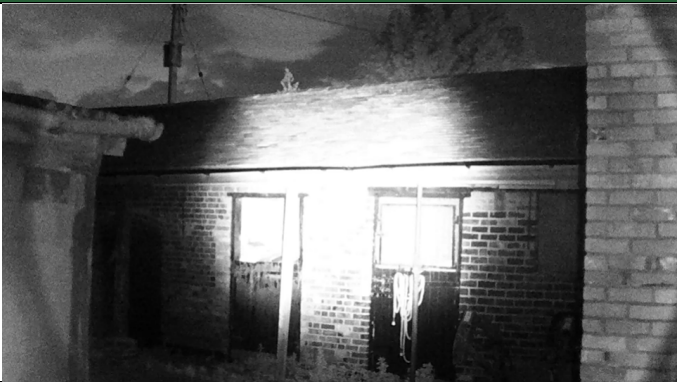
| Vantage Point | Camera screenshot |
|---|---|
| VP3 | |

- 3.1.3. A review of the IRC camera footage identified more activity but did not identify any bats emerging and/or re-entering from the buildings at the points of view. Please refer to Table 2 for the images of the cameras at the darkest point. However, no roost locations were recorded during the dusk survey.
