## HERITAGE STATEMENT

**Land east of Leicester Road,  
Earl Shilton**

**Manor Oak Homes**

**Date: April 2024**

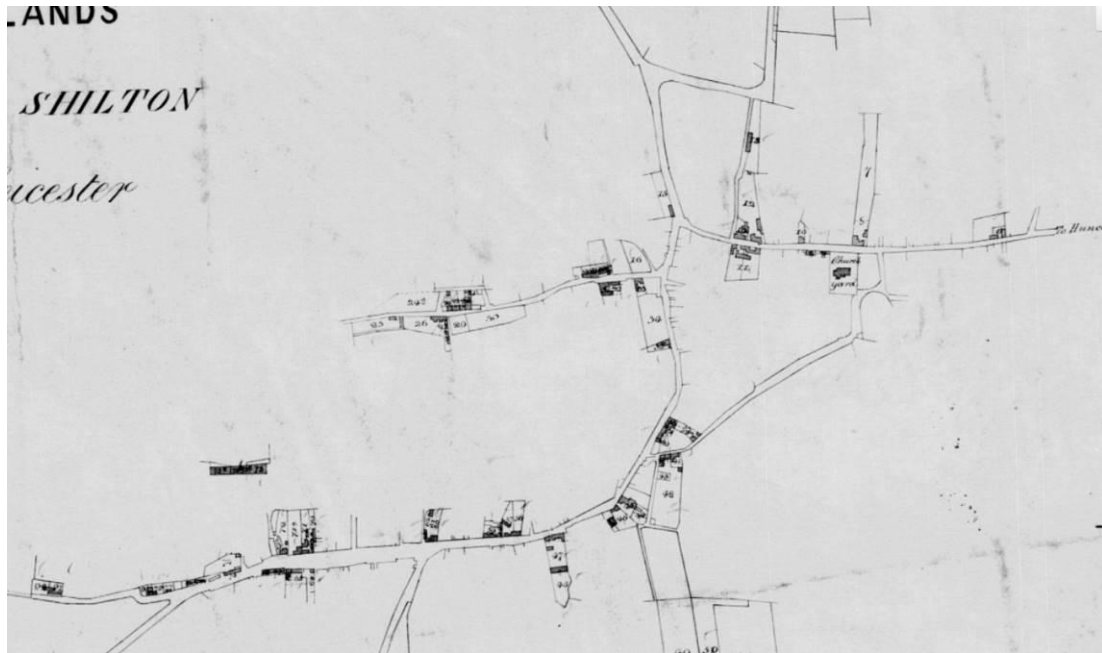
*Fig.1: 1856 tithe map of Earl Shilton*

- 2.12 The 1856 tithe map of Earl Shilton (**Fig.1**) shows a settlement of irregular form, comprising the north-south aligned High Street, with Keats Lane and Church Street branching off in long arms from either side of its northern end where it now becomes Leicester Road, and The Hollow and Wood Street turning west at its southern end. At that time, the north-eastern continuation of Leicester Road beyond the site did not exist; instead, the route to Leicester followed the

awkward dogleg created by the unnamed road along the site's northern boundary; the dogleg was later bypassed by the current A47 Leicester Road.

- 2.13 There is no record in the tithe apportionment of who owned or tenanted the parcel of land (it was possibly not tithable) that now contains the application site (and which at that time also included the land now occupied by the 1970s' Clearview Crescent development).

- 2.14 Various properties are shown on the east side of Spring Gardens, including a row of six houses and gardens at the northern end, along the lane frontage, and seven houses and gardens at the southern end, fronting onto the north side of Church Street. Opposite these, on the south side of Church Street were two houses, warehouses, other buildings and a garden. The castle site is not marked, but the church and churchyard are shown further east. Top House (No.18 Hill Top), listed at Grade II as a late 18<sup>th</sup>-/early 19<sup>th</sup>-century farmhouse, is not depicted on the map, but it is not certain whether all buildings then present have been included on the map.

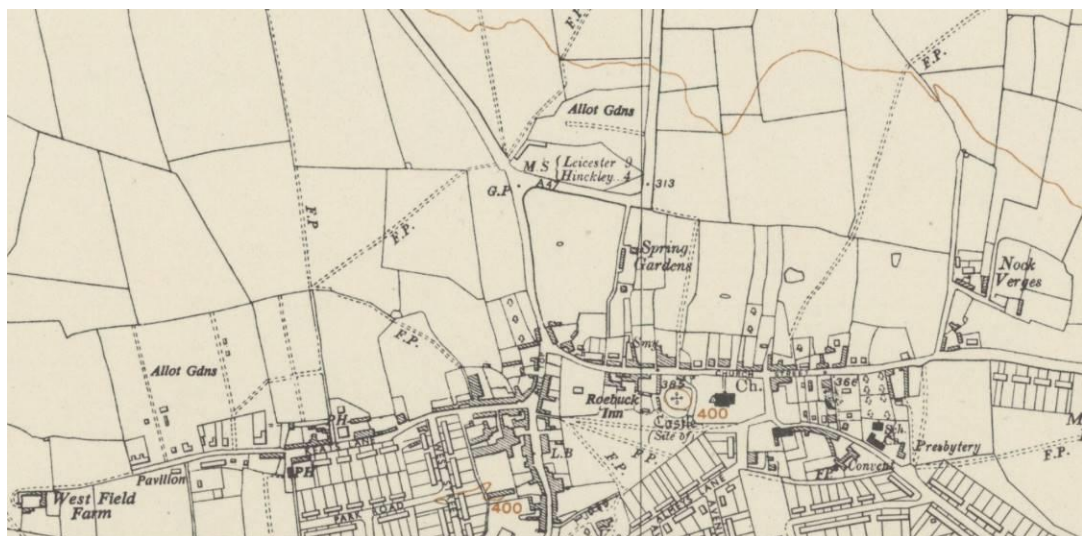
*Fig.4: 1955 Ordnance Survey map*

- 2.17 In the mid-20<sup>th</sup> century, there was much new residential development of the areas between the roads forming the 'skeleton' of the original settlement. This development can be seen in its early stages on the 1955 OS map (**Fig.4**) and more fully on the 1968 map (**Fig.5**). The redevelopment with Clearview Crescent of the land and buildings immediately south of the application site happened after this, in the 1970s.

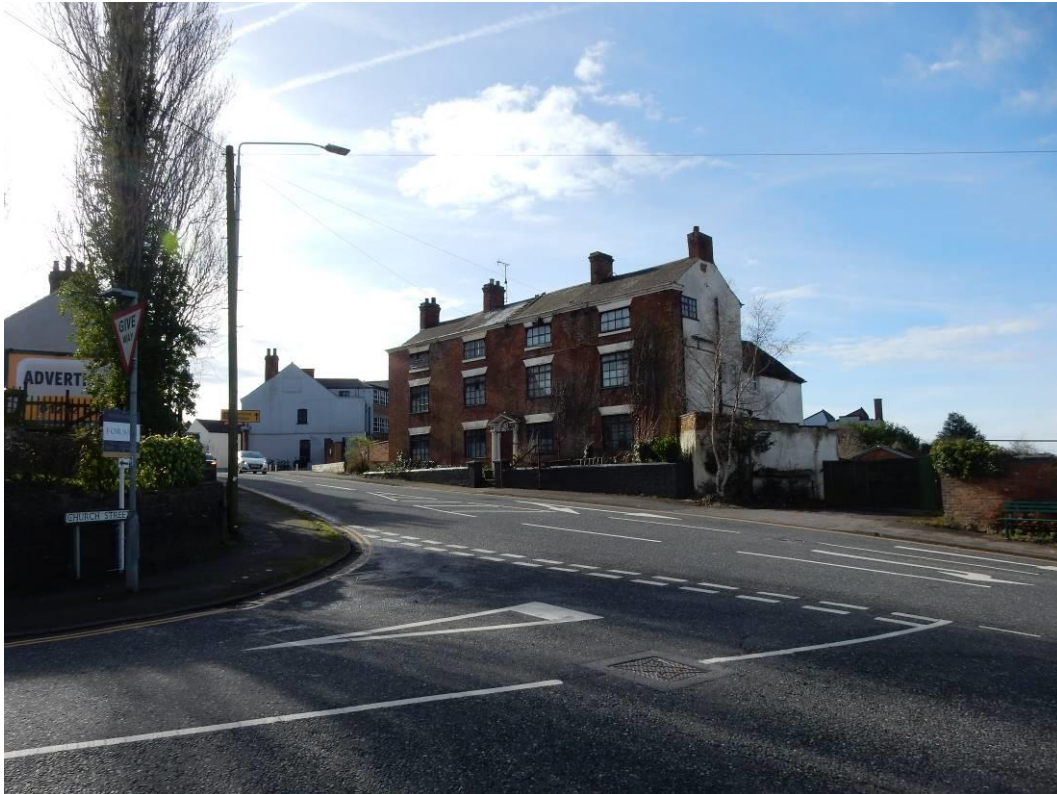
- 3.3.1 Top House (formerly known as Hill Top Farmhouse) was added to the statutory list at Grade II on 9<sup>th</sup> August 1989. Although it does not appear on the 1856 tithe map, its three-storey red brick façade (which appears to have been added to the front of an earlier building) is of late 18<sup>th</sup>-/early 19<sup>th</sup>-century appearance. It is a substantial building, with a wide four-bay façade and four chimneystacks with a short two-storey rear range at one end (**Plate 13**).

**Plate 13: Grade II listed Top House seen from junction of Leicester Road and Church Street**

- 3.3.3 The significance of this building derives from its date, from its substantial size and imposing façade, and what this tells us about the scale and status of the farm it was once associated with. It also serves as a reminder of the town's agricultural past before the 19<sup>th</sup>-century transformation into a primarily industrial town associated with hosiery and boot and shoe manufacture.

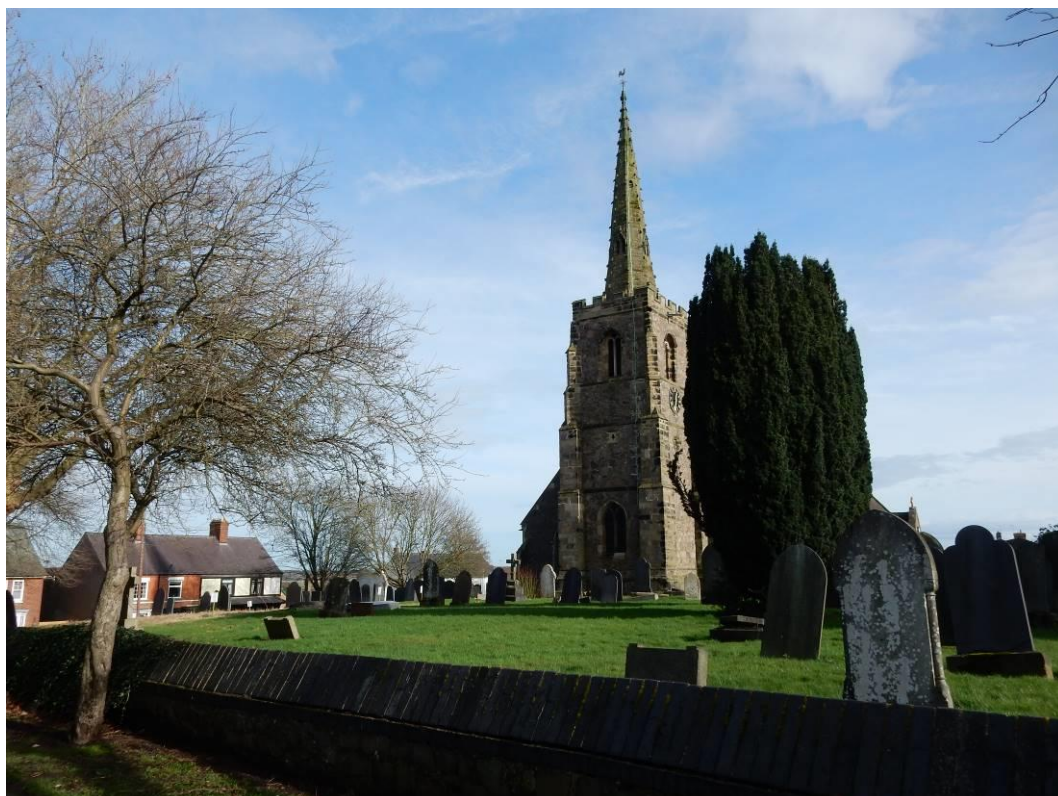
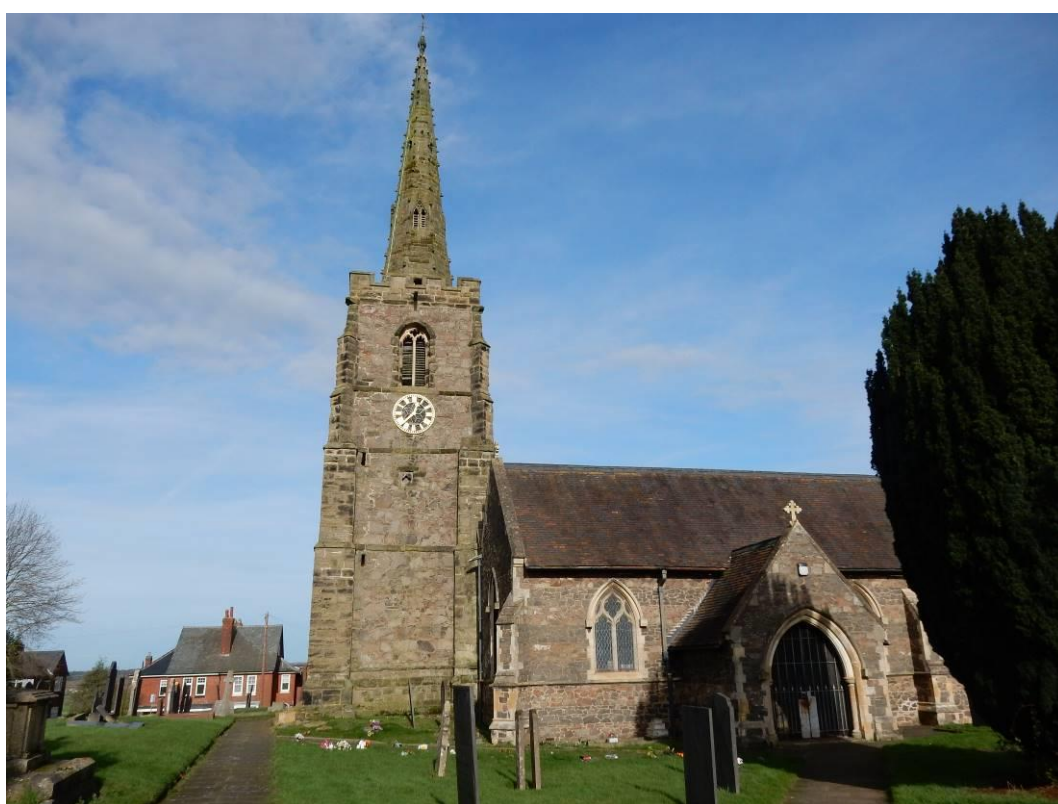
- 3.4.3 The church, a substantial building standing on high ground, is constructed of randomly coursed rubblestone with freestone dressings (**Plates 15 & 16**). It retains a 15<sup>th</sup>-century three-stage west tower with crenelated parapet and recessed spire of octagonal section. The rest (comprising a six-bay nave with aisles and north and south porches and a two-bay chancel with north vestry) was rebuilt in 1855-6 by Slater and Carpenter.

**Plate 15: West tower of Grade II\* listed Church of St Simon and Jude**

**Plate 16: Grade II\* listed church**

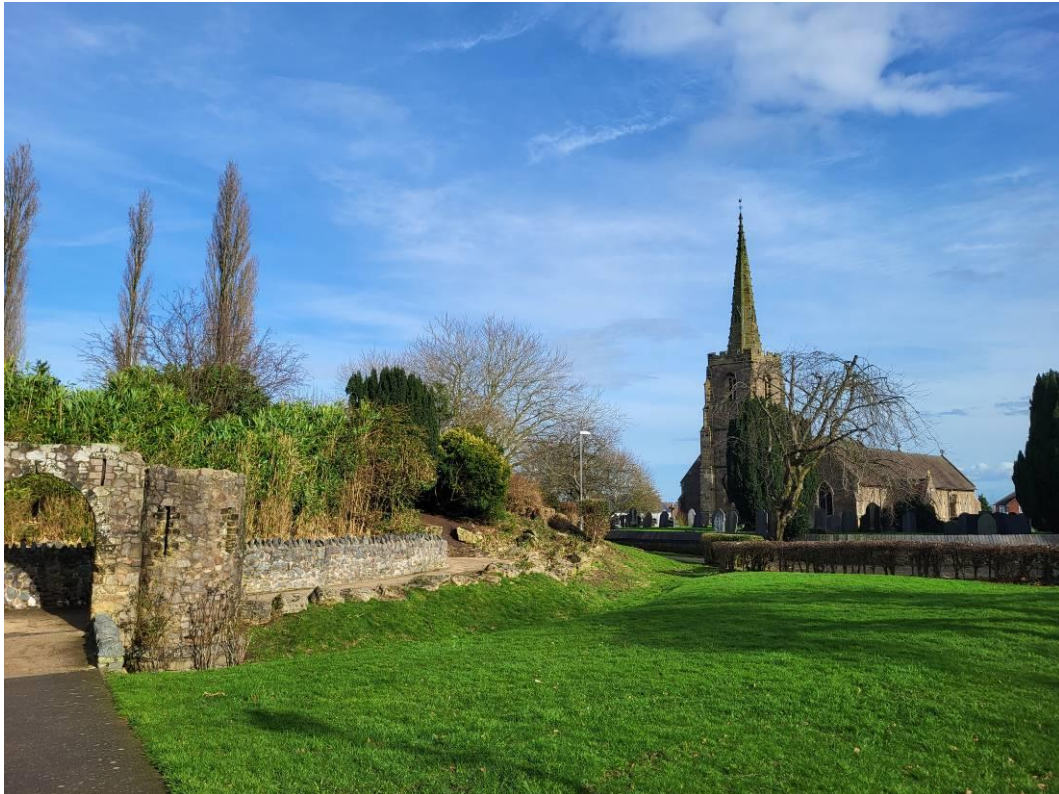
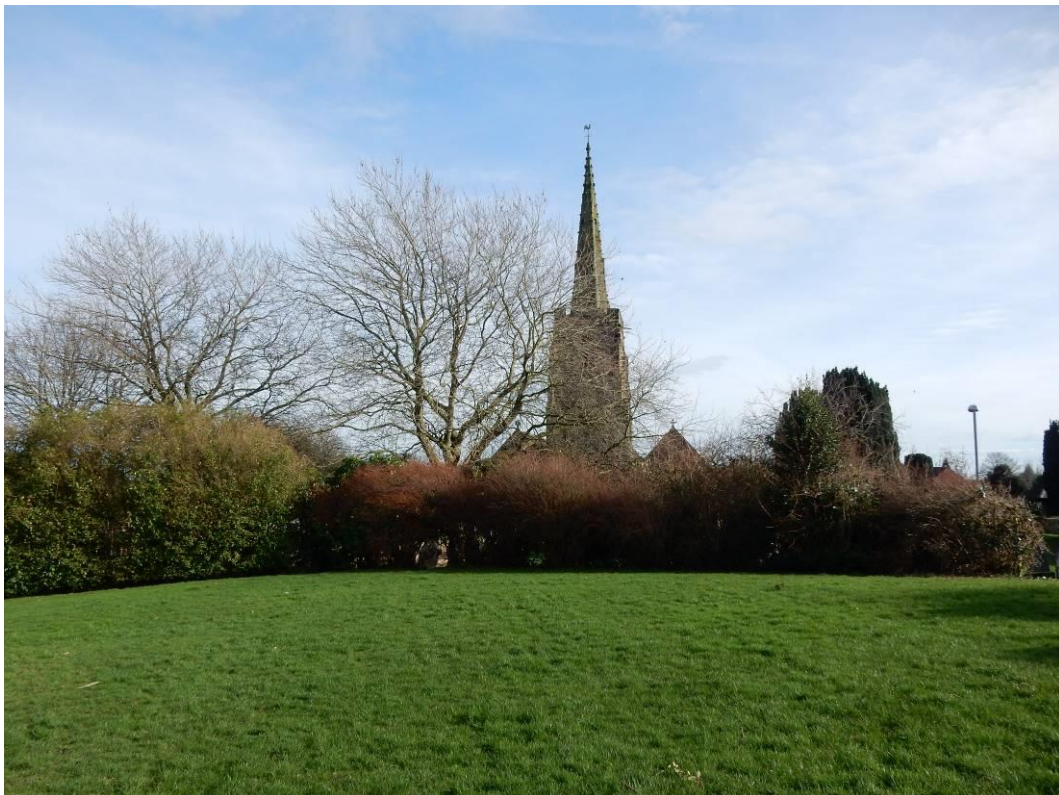
- 3.4.5 The key element of the building's setting is its churchyard. The adjoining Earl Shilton castle site is also an important element of its setting – there are good views towards the church from around the south and east sides of the Scheduled Monument and the tower and spire can be seen filtered by trees from the top of the castle mound (**Plates 17 & 18**).

**Plate 17: Looking north-east past the motte and bailey castle site towards the church**

**Plate 18: Looking east from the top of the motte towards the church**

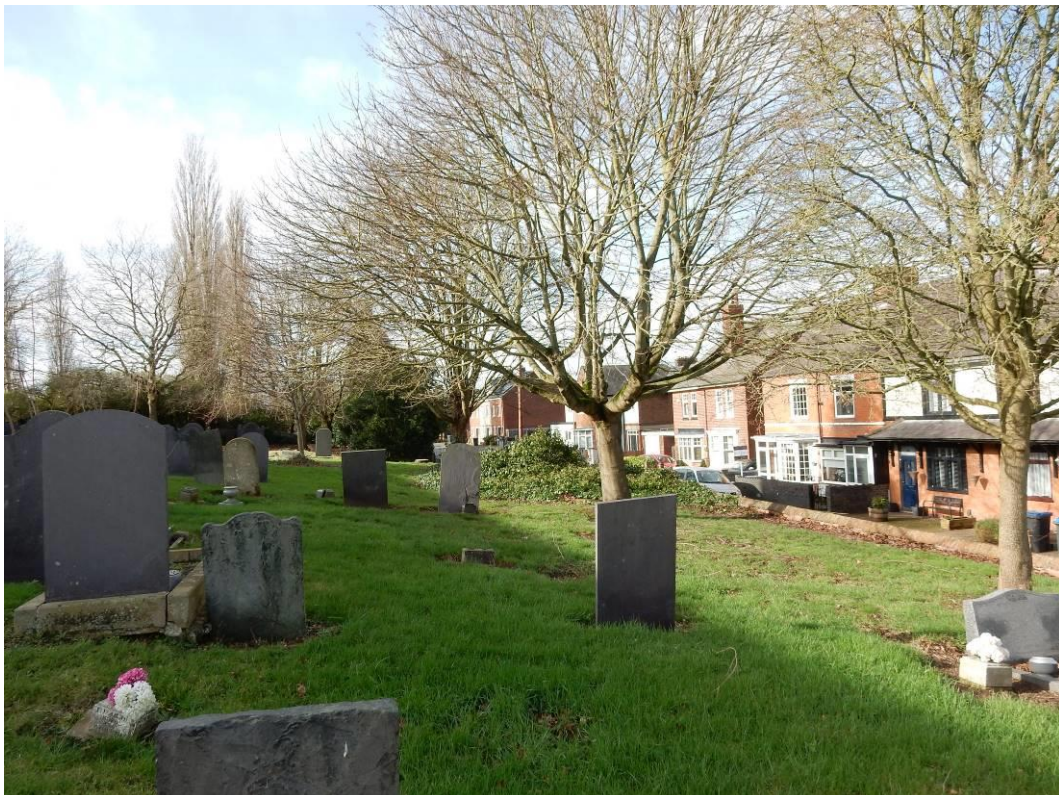
- 3.4.7 There are no views of the application site from the churchyard; views north-west in the direction of the site are obstructed the houses on the north side of Church Street and by trees in the churchyard (**Plate 20**).

**Plate 20: Looking north-west from the churchyard in the direction of the site (which is not visible)**

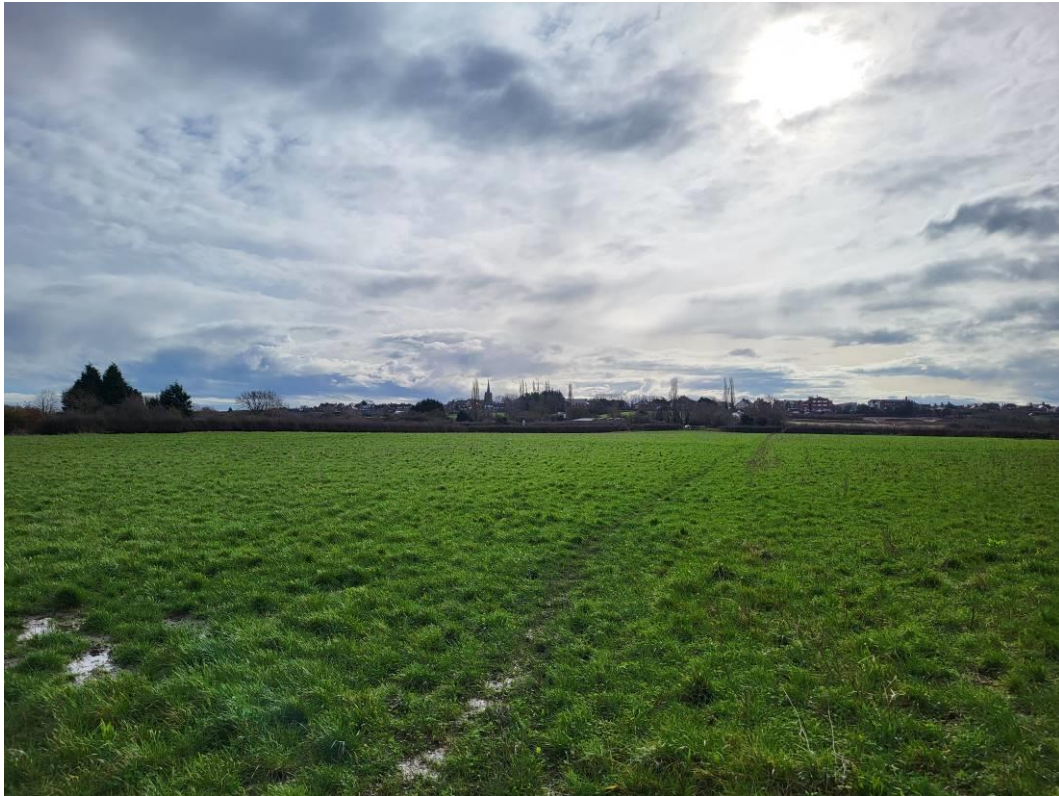
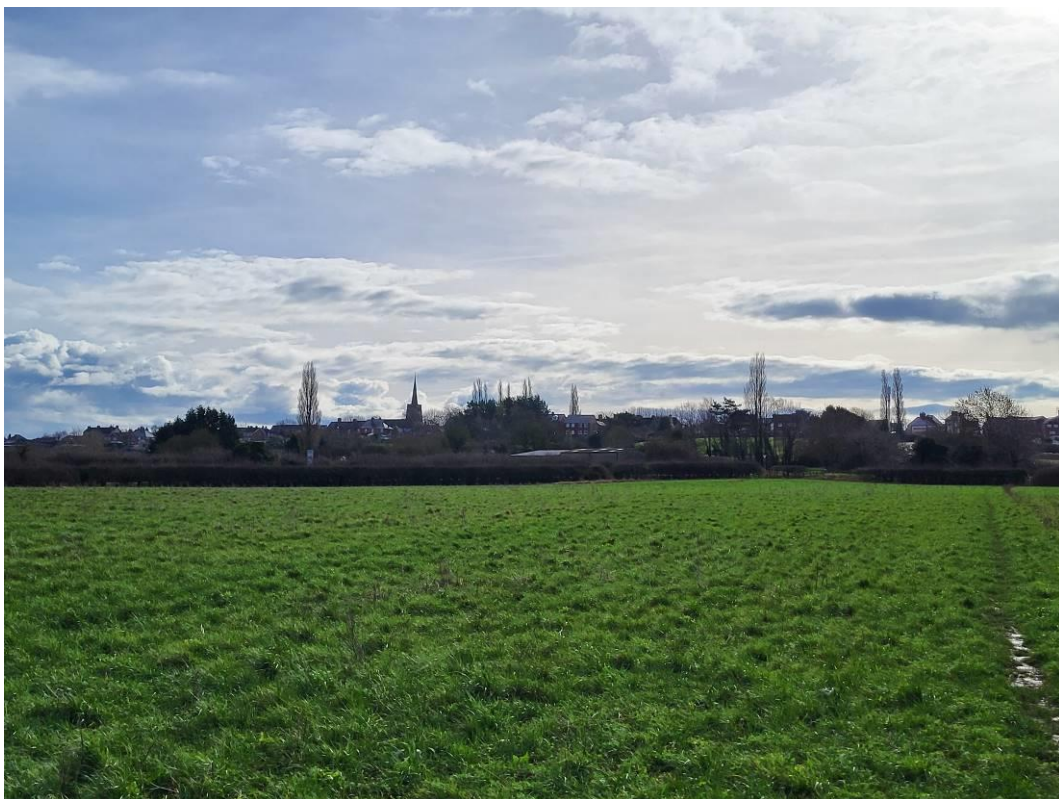
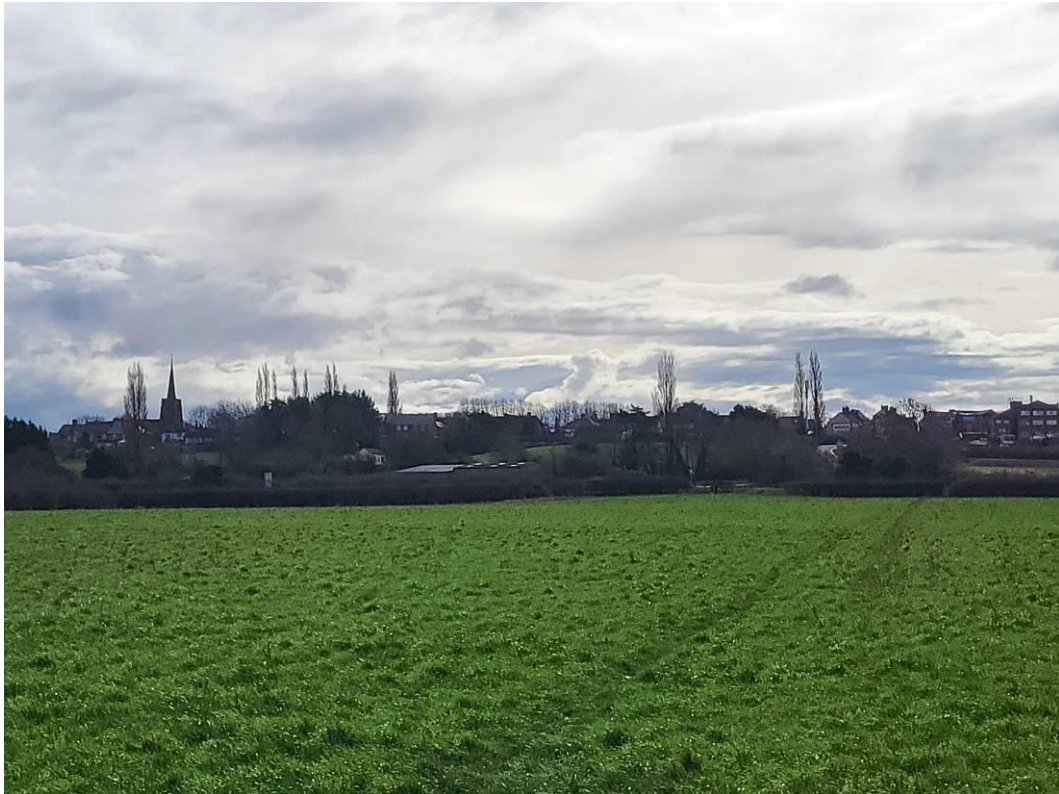
- 3.4.9 In these views (**Plates 21-23**), the substantial church tower and spire are a prominent feature of the skyline. The church is not, however, seen in isolation, but in context with the buildings on Church Street and Keats Lane (the buildings on the north side of Church Street are seen in front of the church), and generally as punctuating a long linear development of the town along the ridge, with the 'arms' of Keats Lane and Church Street extending out to either side of it. The open paddock land extending down the slope behind the properties north and north-west of the church, on Church Street, provides a patch of green in front of the church in these views, which indicates the position of the church close to the northern settlement edge.

**Plate 21: Looking south-east from PRoW towards Earl Shilton**

**Plate 22: Looking south-east from PRoW towards Earl Shilton (church to left, application site to right)**

**Plate 23: Looking south-east from PRow towards Earl Shilton (application site in centre)**

- 3.4.10 The position of the church within the settlement it serves is clearly apparent and legible. This is the essence of the contribution these views make to the ability to appreciate the significance of the church – that is, they facilitate an appreciation of the building as a parish church in its immediate urban setting, and also serving as a local landmark indicating the presence of the settlement in the wider landscape.

- 3.4.11 The application site forms a part of these wider views towards Earl Shilton which take in the church, but does not intervene within any of the direct sightlines

towards it from the PRoW. Instead, it is seen off to the right of the view, with the houses on Clearview Crescent visible on the higher ground of its southern boundary, along with properties on Church Street to the left (east). Further to the right of the view, the landscape is set to be transformed, with groundworks currently underway for the approved large residential developments north of Top House.

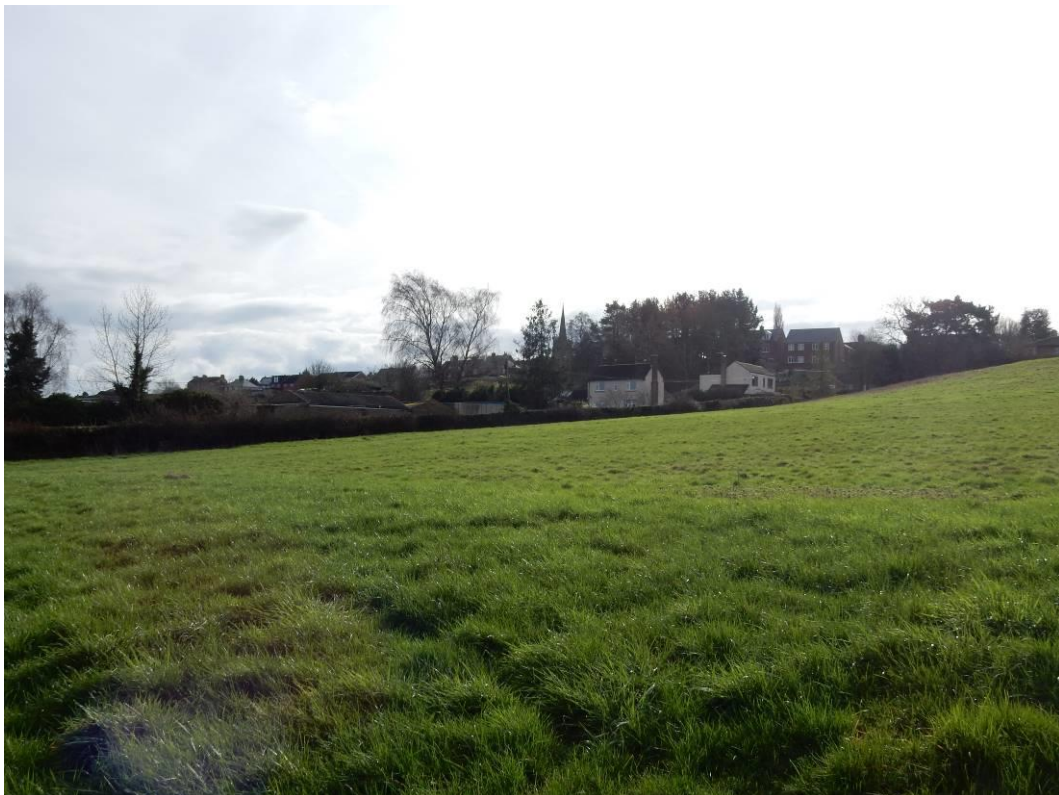
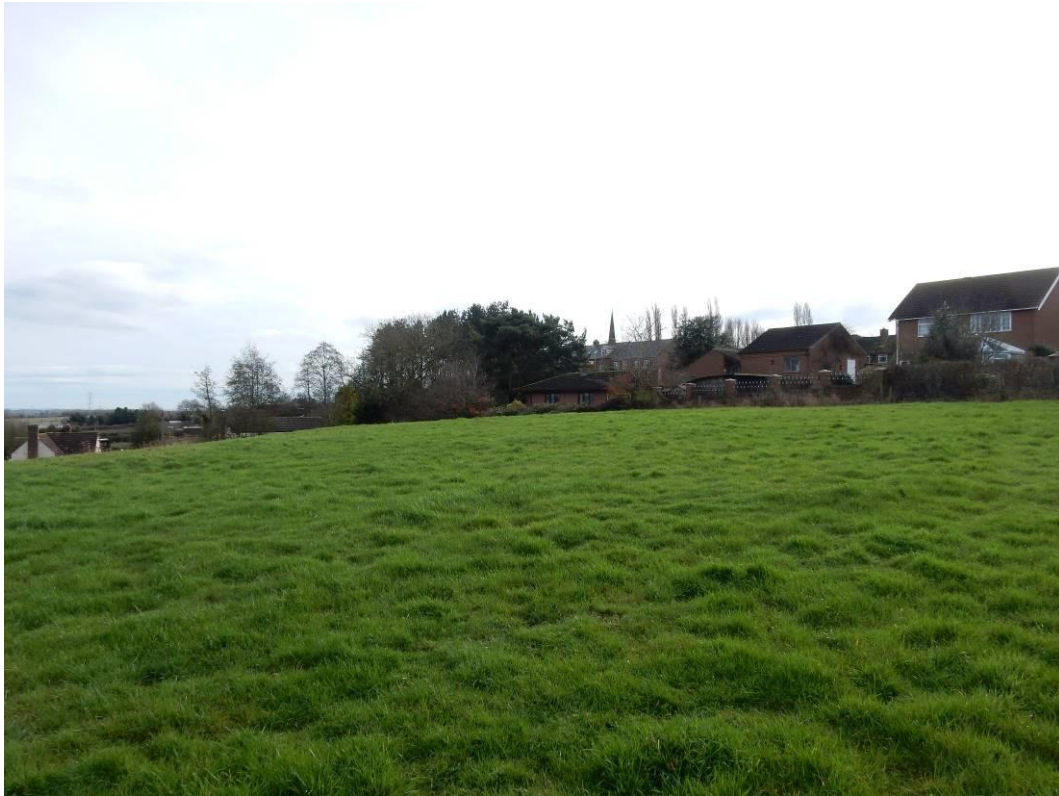
- 3.4.14 The church spire can be seen from various points within the site (noting that these are not public viewpoints), but these are generally insignificant and incidental views that do not contribute to the significance of the building, or the ability to appreciate it (**Plates 24 & 25**).

**Plate 24: Glimpsed winter view looking south-east towards church spire from north-western part of the site, heavily filtered by trees**

**Plate 25: Looking east from western part of site towards church spire (centre) rising above roofs on Church Street**
