**Historic Building  
Recording (L3)  
The Hollybush  
Restaurant  
Upper Bond  
Street  
Hinckley  
LE10 1RH**

**Type of Intervention:** Historic Building Survey Level 3

**Report No:** MAS/634/22

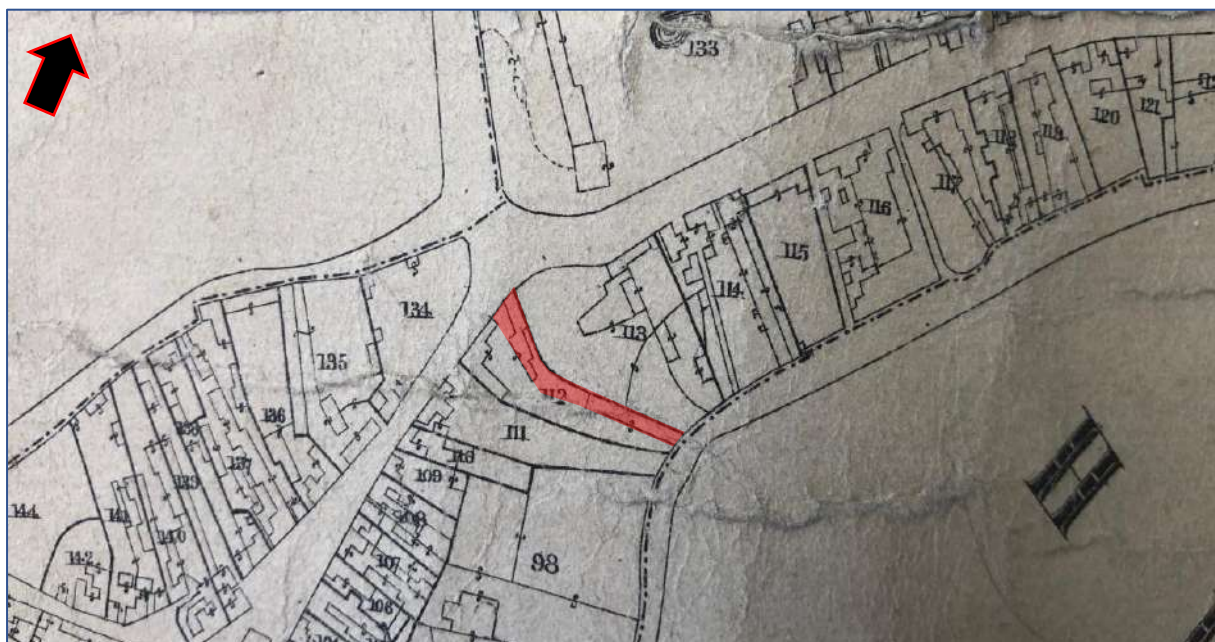
**Fig.15:** 1846 Tithe Map of Hinckley.

The next map, the 1846 Tithe Map shows the Site conforming to the same boundaries but with more detail, showing three distinct structures, two fronting Lower Bond Street, with a third linear building to the rear of the Site. One of the two buildings to the front, possibly that to the east may be the early incarnation of the Hollybush.

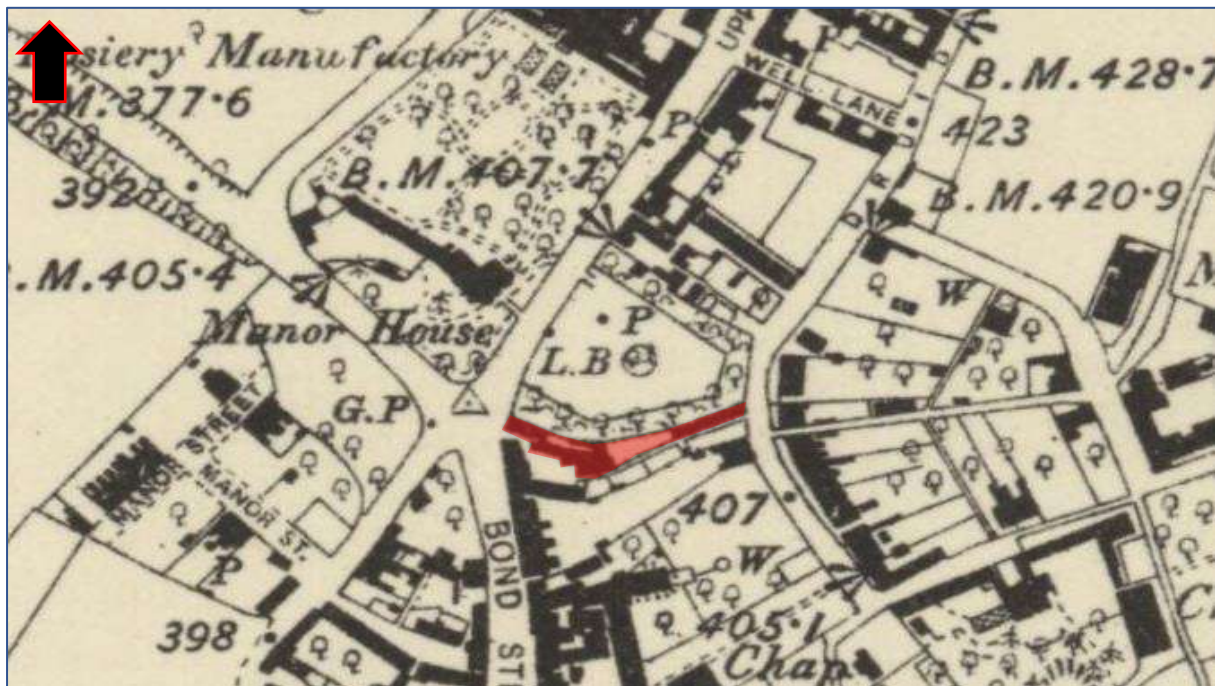
**Fig. 17:** 1904 Ordnance Survey.

By the time of the above 1904 Ordnance Survey the two structures are still present.

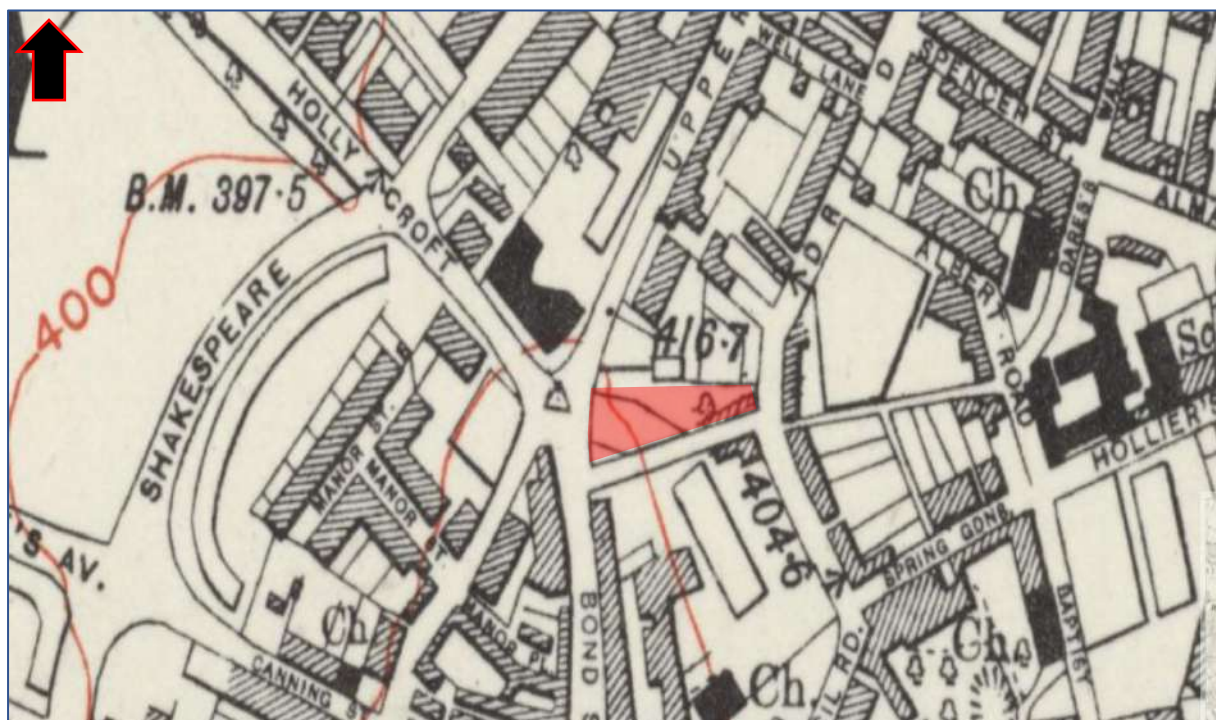
**Fig.19:** 1938 Ordnance Survey.

The final map above of 1938 shows the Site but there appears to be no building where one would expect the Hollybush to be, only some land boundary lines and a small linear building to the rear of the Site, the latter being visible on the 1924, 1904, 1887 and 1846 mapping. The above map is a revision of the 1923 Ordnance Survey so one would expect to see a building on the site which fronts the main road, as the edition of 1924 does show structures where one would expect to see them.

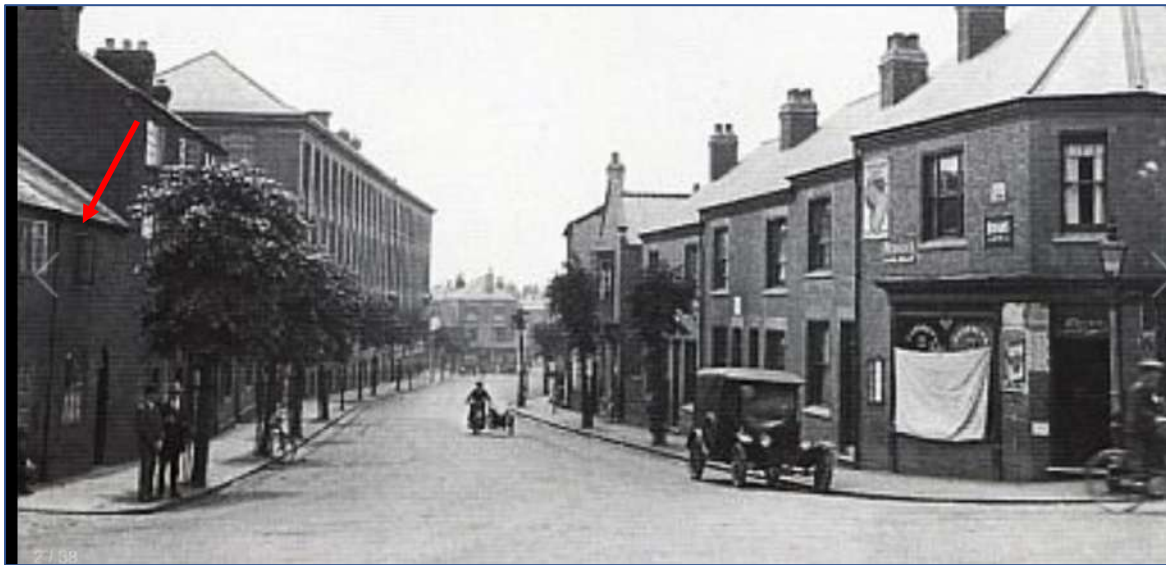
**Plate. 88:** Site prior to redevelopment in the 1920s-1930s.

The 1782 map shows that the Site as a curvilinear plot of land which is in-part occupied by a structure, the latter which appears to be part of a larger group to the southwest. The Hinckley Tithe Map of 1846 and its accompanying apportionment show the Site as plot (112) and belonging to a George Brocklehurst, tenanted by a Thomas Goadby and that the Site was occupied by house and garden. This group of buildings stays pretty much unchanged until 1938 when the plot is shown as an open plot, although the 1938 Ordnance Survey is questionable and conflicts with electoral registry records from 1936-1941. As well as map evidence, we also have a photograph, although undated but likely to be from the first quarter of the 20<sup>th</sup> century, going by the style of the motor vehicle which is in view. In this photograph a two-storey building located where the current Hollybush building is can just be seen (Plate. 88).

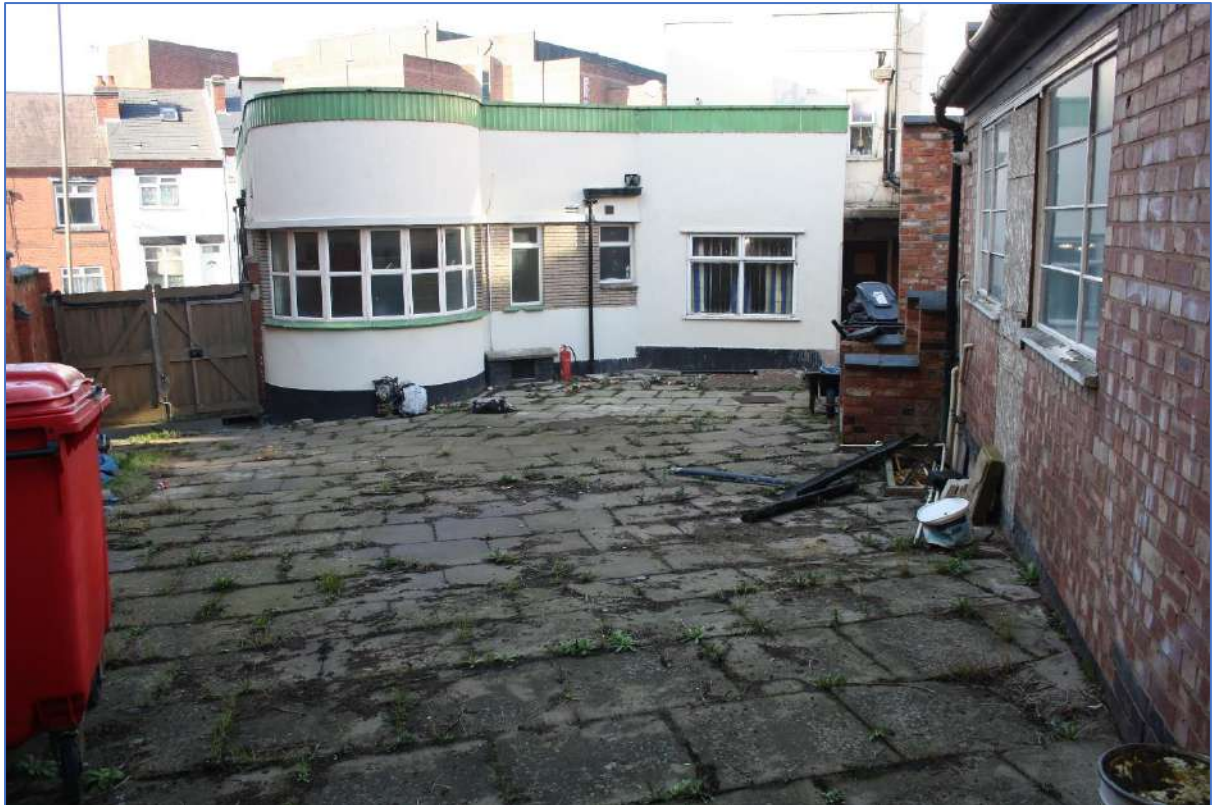
**Plate 4:** Elevation CC looking N/W.

Throughout this elevation are a series of nine UPVC windows, seven at ground floor level, the remaining two at first floor level. Starting to the left at ground level is a large square window comprising of three lights of nine panes, the central pane of each light being a bottom opener. The use of green tile is also evident as the sill and mullion detail. To the right of this is a wide rectangular window of ten panes, with three at the top opening. Again, green tile has been used as a sill detail. To the right of the entrance are a series of three small rectangular lights, each of two panes, the top pane in each opening, the sill of these comprises of plain terracotta tile. To the right of these is a single rectangular window of two panes, the top opening. Situated on the far-right corner of this elevation is a large curving window of sixteen lights, with four of the top lights opening. This window also displays a green glazed tile sill. At first floor level, to the left of the elevation is a rectangular window of eight lights, six fixed and two which are top opening. Green glazed tile has also been used for the sill and mullion detail. To the right of this window is a wide rectangular window of four fixed lights and two top openers, again the sill is of green glazed tile (plates 2, 4).

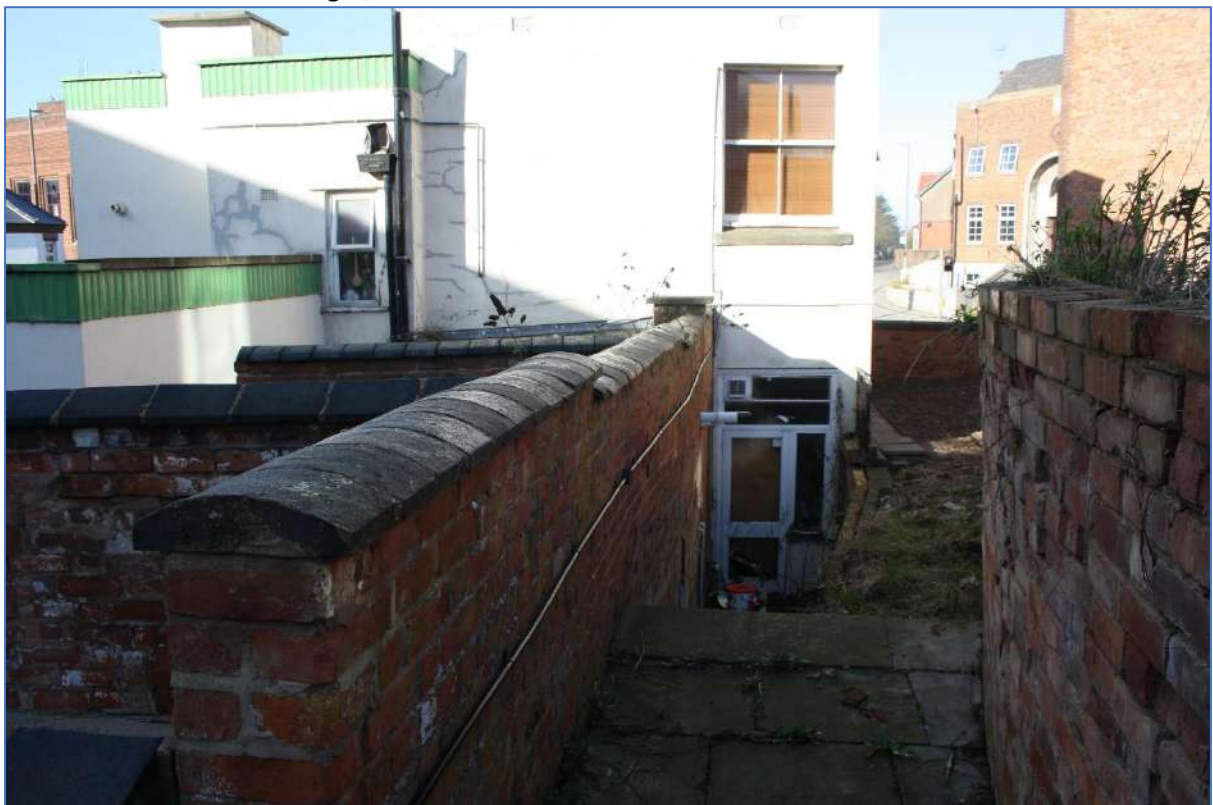
**Plate 5:** Rear entrance looking N.

This elevation is whitewashed cement render with a decorative fluted green glazed tile parapet and comprises of both one and two-storey heights. At ground floor level there is a rear entrance door of wood and contemporary design, with a UPVC rectangular fixed casement window of two lights, the top light opening. At first-storey height there is a rectangular window comprising of two panes, the top one which opens outwards. To the far right of this elevation at ground level is a rear entrance door comprising of two panes, the door is hung from a timber frame which displays a glazed side panel and fanlight of contemporary design. At first-storey level there is a traditional balanced sash set back from the masonry with a stone sill (plates 5 – 7).

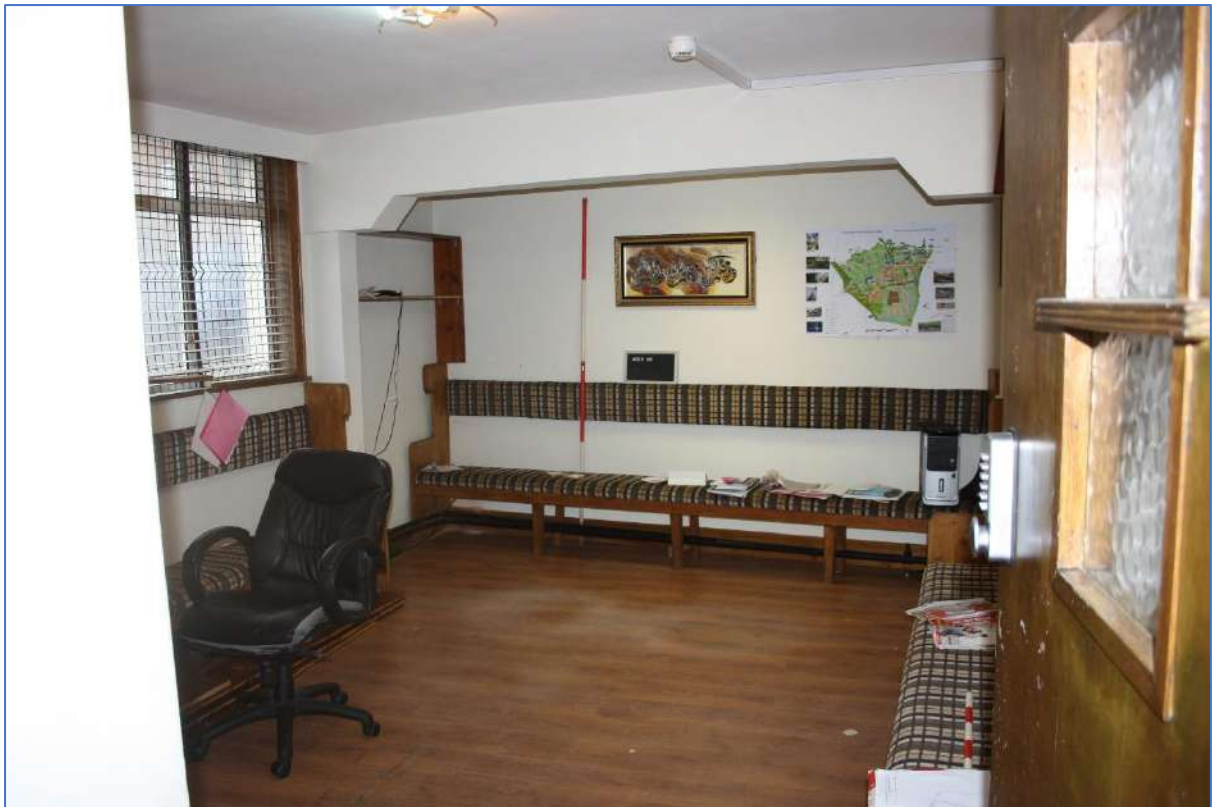
**Plate 9:** Room 2 looking N/E.

**Room 2 (Snug)** The entrance to this room leads off of the central hallway area 5 and is hung with an Art Deco style ply floor which is part-glazed with Art Deco style fixtures and fittings. This room is rectangular in plan, with a contemporary laminate floor with painted plaster walls and ceiling, with contemporary fixtures and fittings. Along three walls there are fixed high back benches, within the remaining wall is an Art Deco style ceramic open fireplace with tiled heart, although the former has been blocked up (plates 9–12).

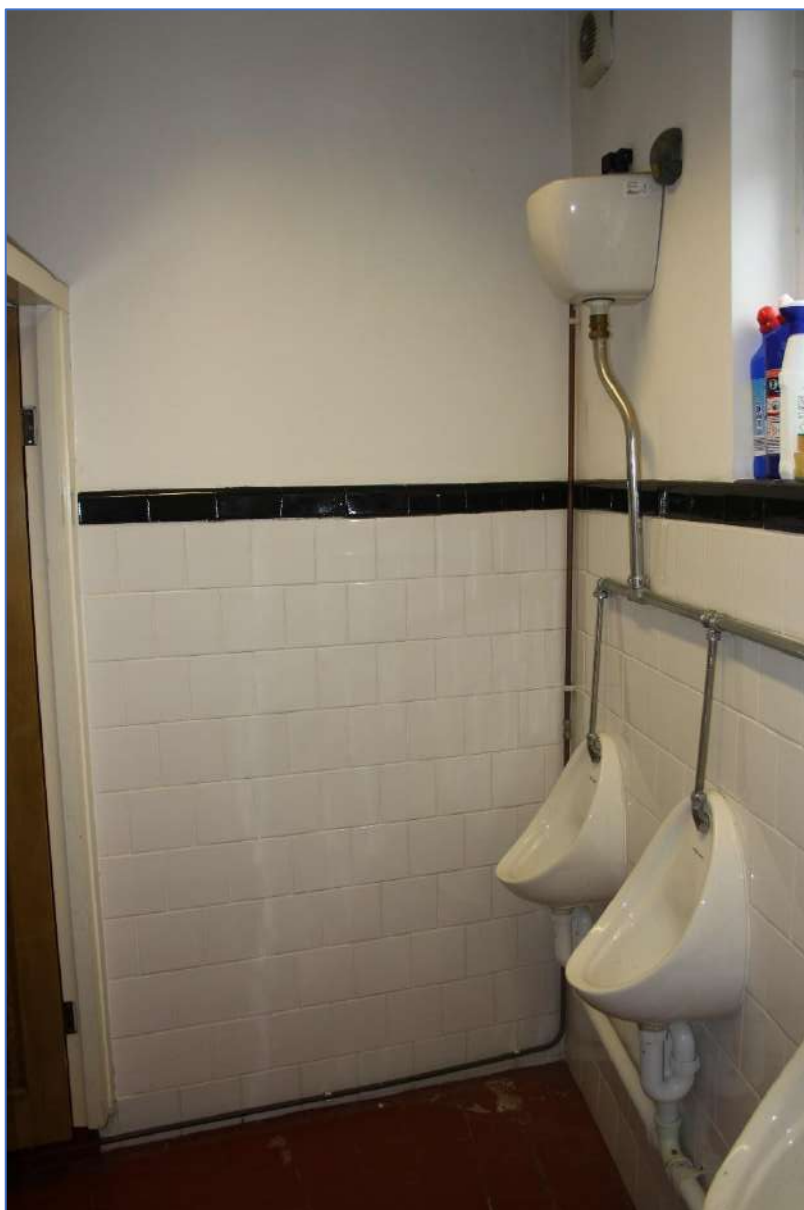
**Plate 13:** Room 20 looking S/W.

**Room 20 (Toilets Male)** Square in plan with a modern linoleum floor and half tiled walls, with painted ceiling and modern light fittings and fixtures. Modern sanitary ware (plate 13, 14).

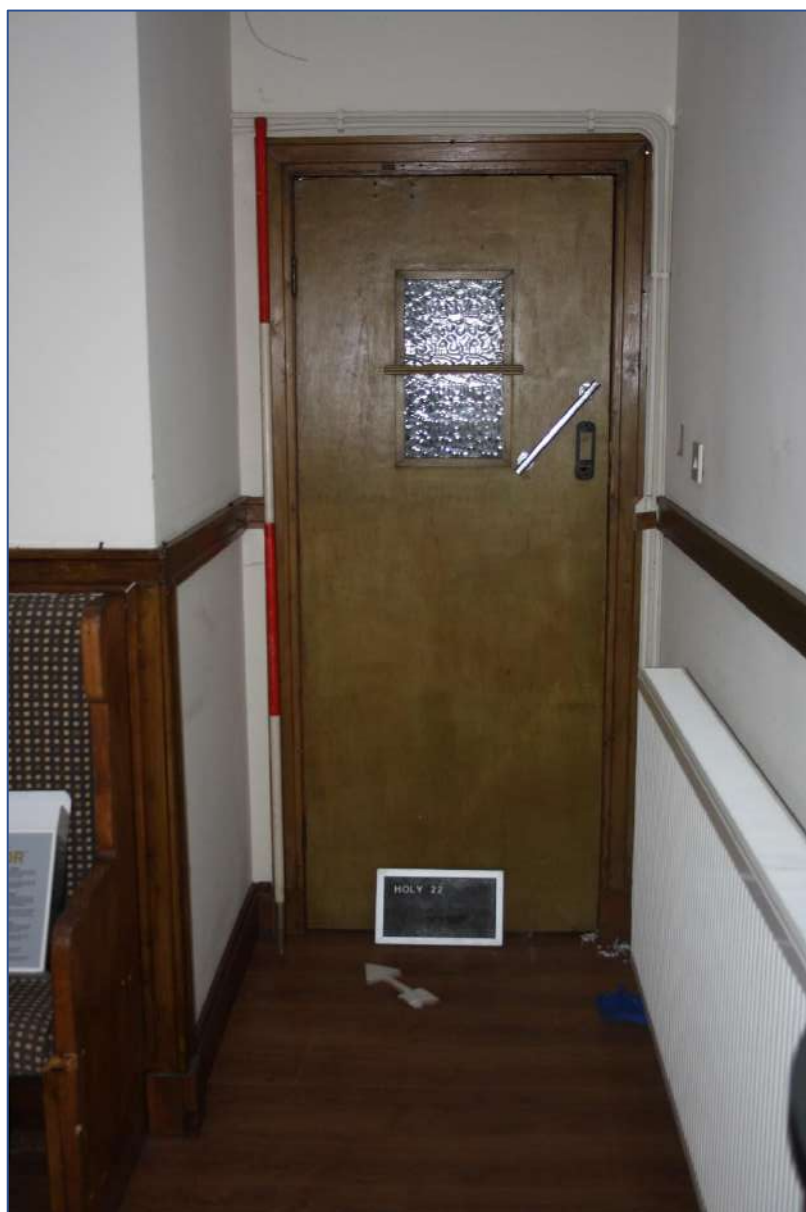
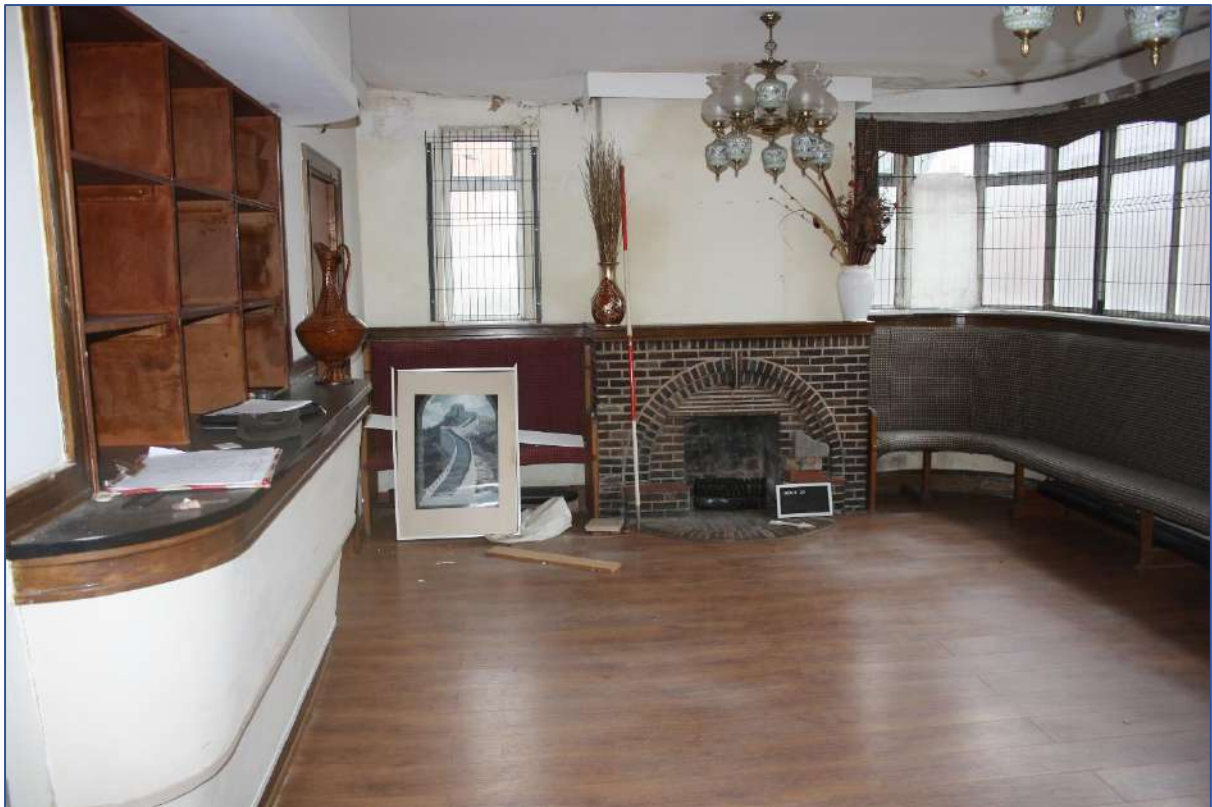
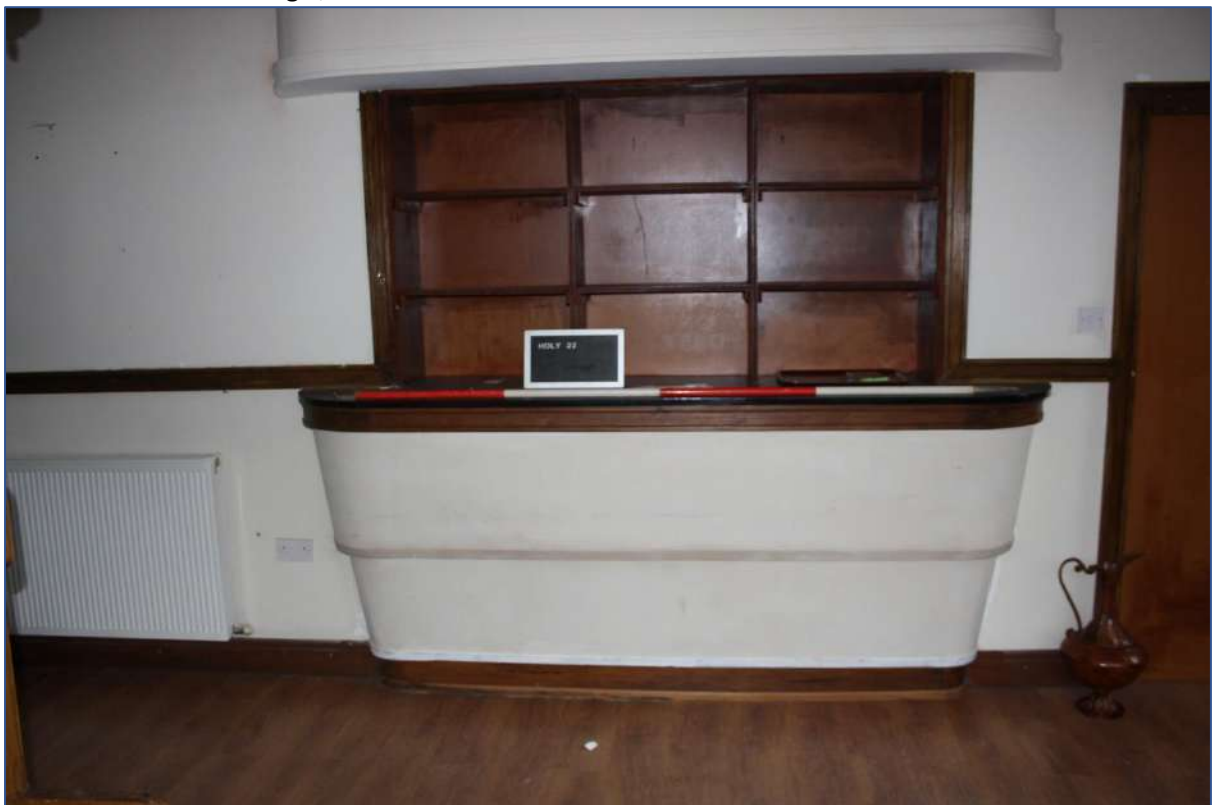
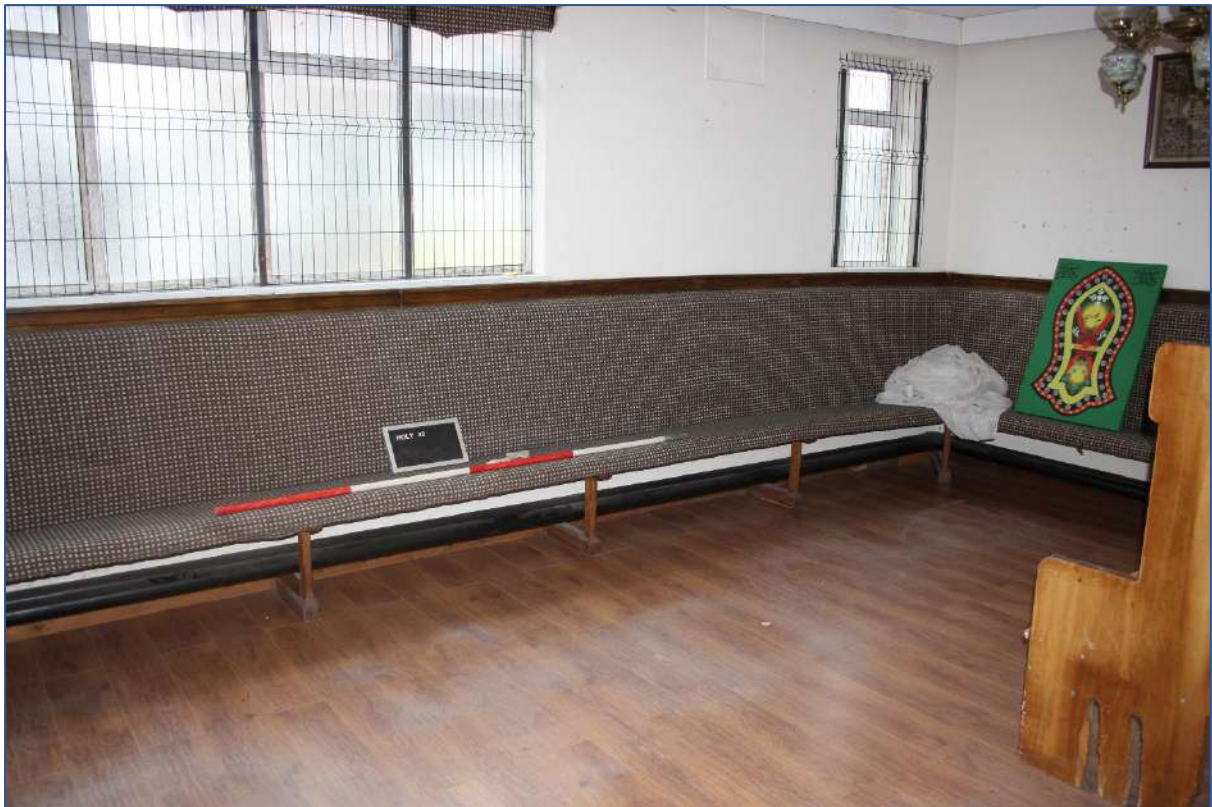
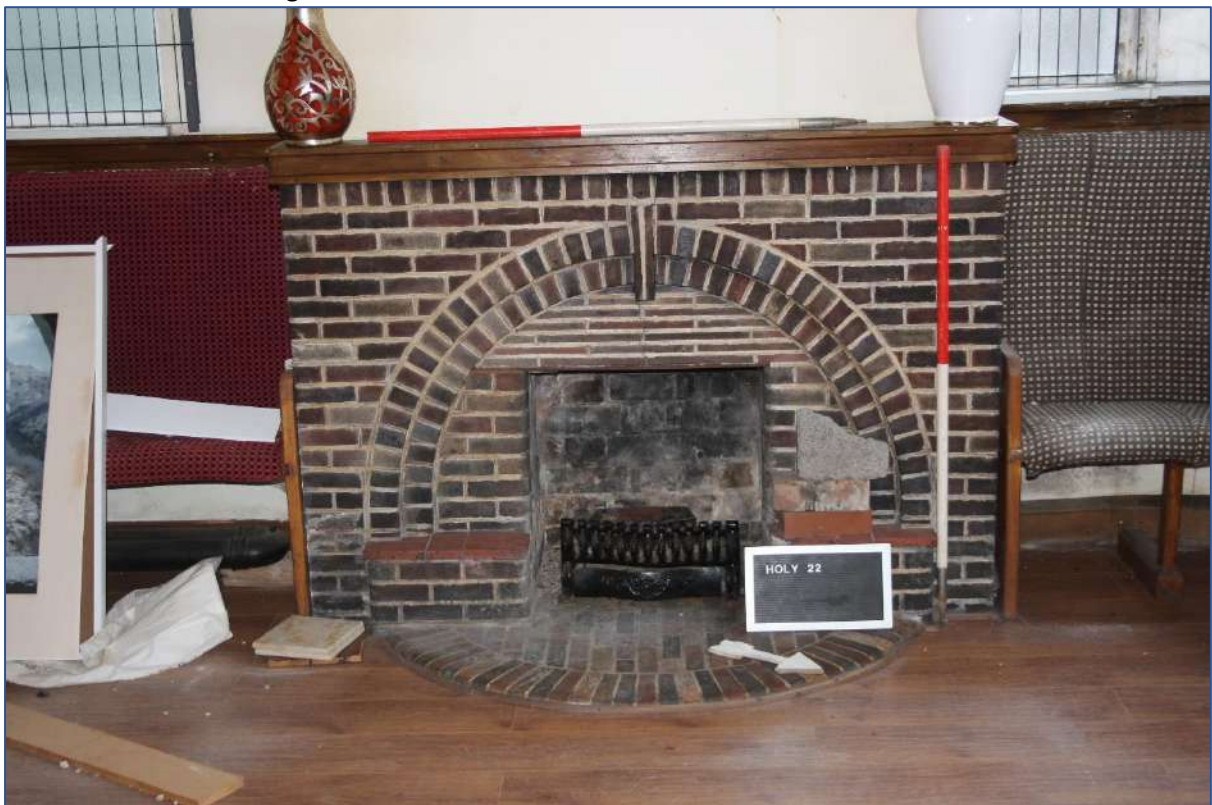
**Room 1 (Public Bar)** This room is L-shape in plan, with painted plaster walls and ceiling and a contemporary laminate floor, with a stepped style wooden skirting. The entrance door is of stained ply, part-glazed with Art Deco style fixtures and fittings and hung from an Art Deco style timber frame. Along two walls of this room are some high-backed bench seats which are fixed, while within the northwest wall is a brick open fireplace and hearth. Set within the southwest-northeast wall is an Art Deco style bar, to the right of this is a plain plywood door which connects this room with 9 and 12 (plates 15-21).

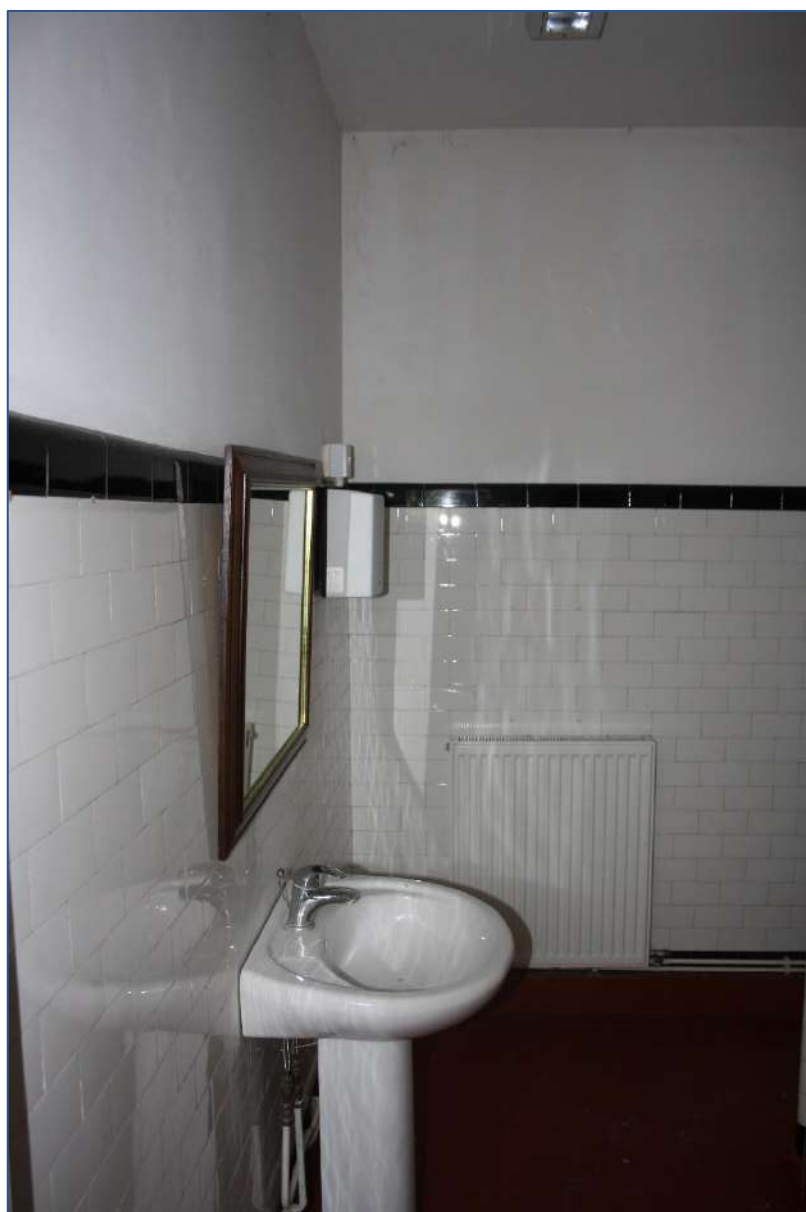
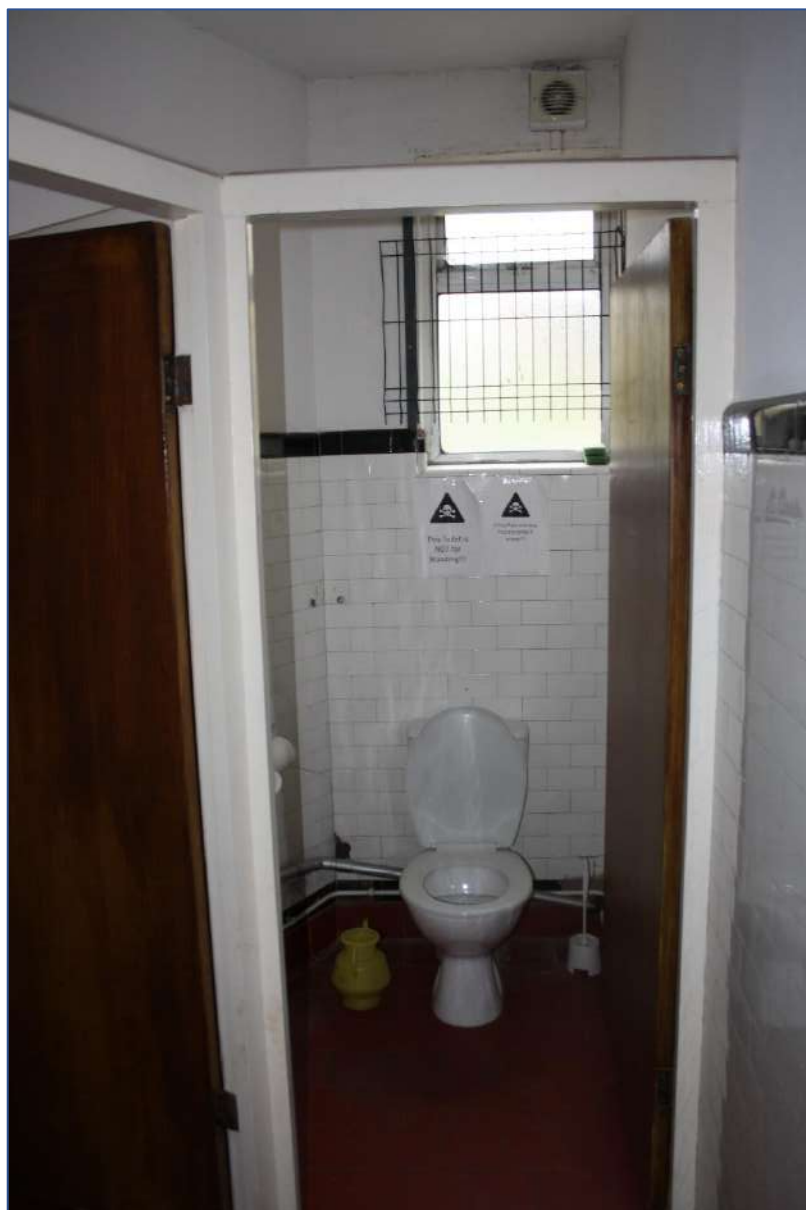
**Room 11 (Toilets Female)** This room is irregular in plan with a contemporary linoleum floor and is half-tiled, the upper areas of the wall and also the ceiling being painted. The internal doors are of modern type but the entrance door is Art Deco in style, being stained ply and half-glazed, hung from a matching timber frame. The sanitary ware modern (plates 32, 33).

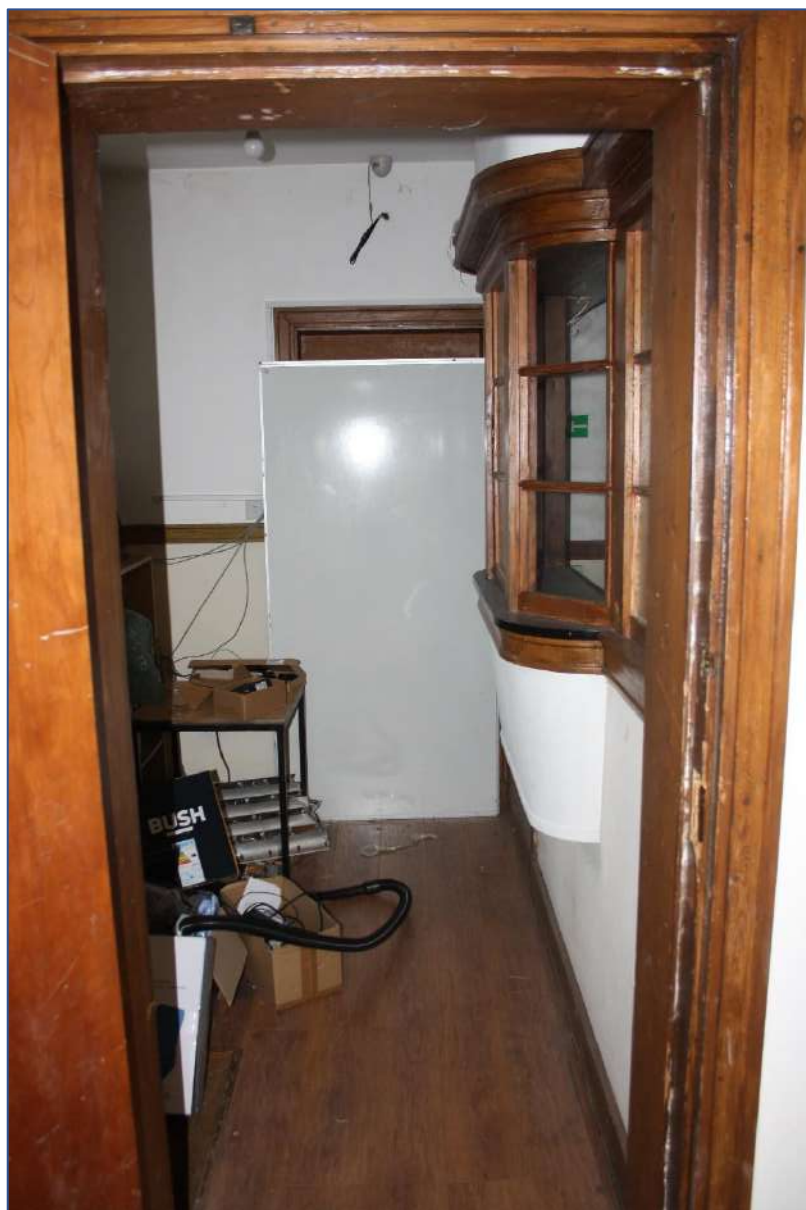
**Plate 40:** Room 9 looking N/W.

**Room 9 (Off-Sales Entrance)** Rectangular in plan and with an engineered oak floor, along with Art Deco features. The walls and ceiling are painted, and the lights and switches are contemporary. This room acts as a side entrance to the building, and a small bar area and connects Room 1 and 12 (plate 40).

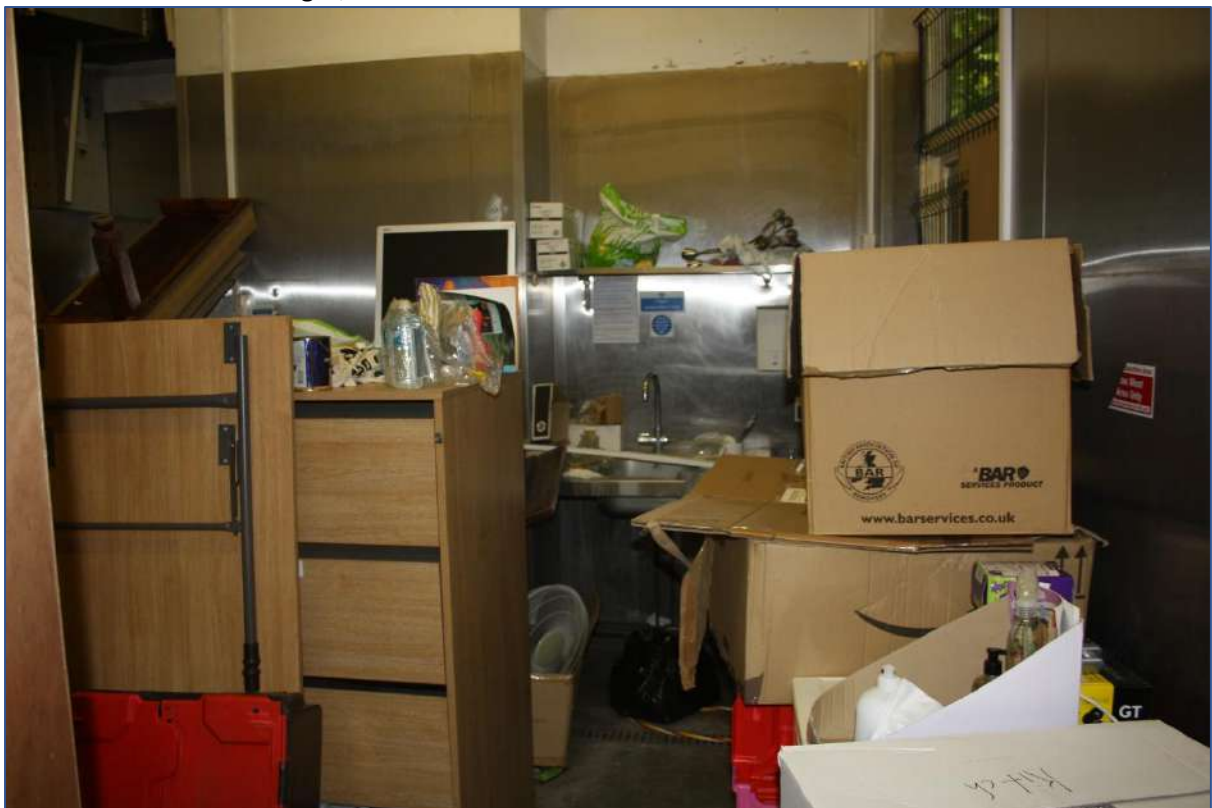
**Plate 46:** Room 4 looking N/E.

**Room 4 (Kitchen)** Not accessible due to stored materials (plate 46).

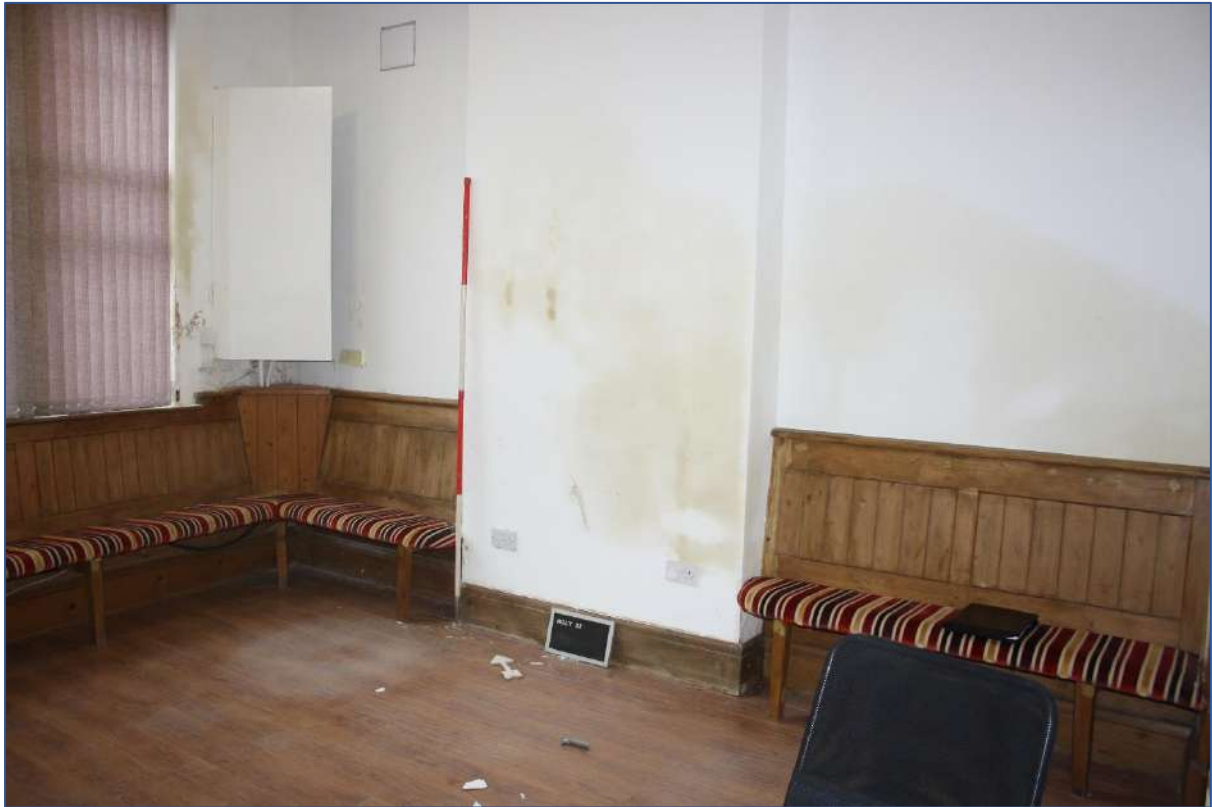
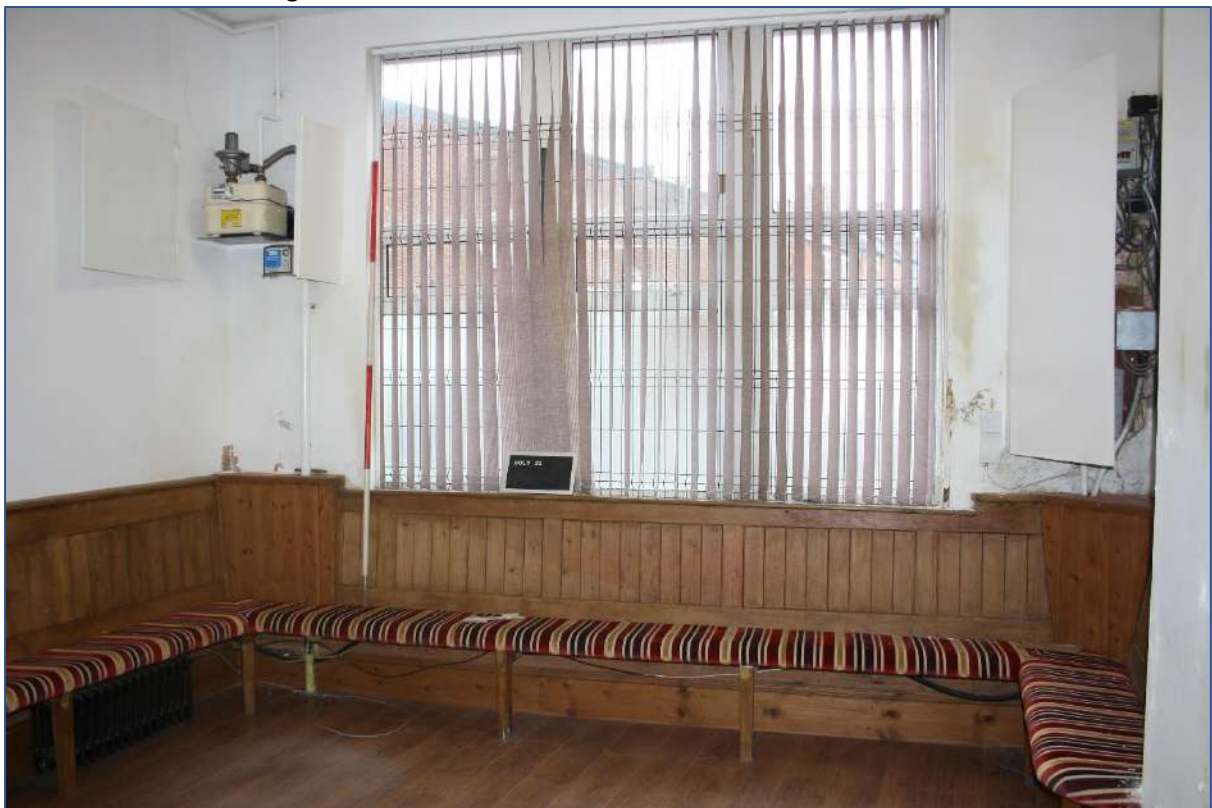
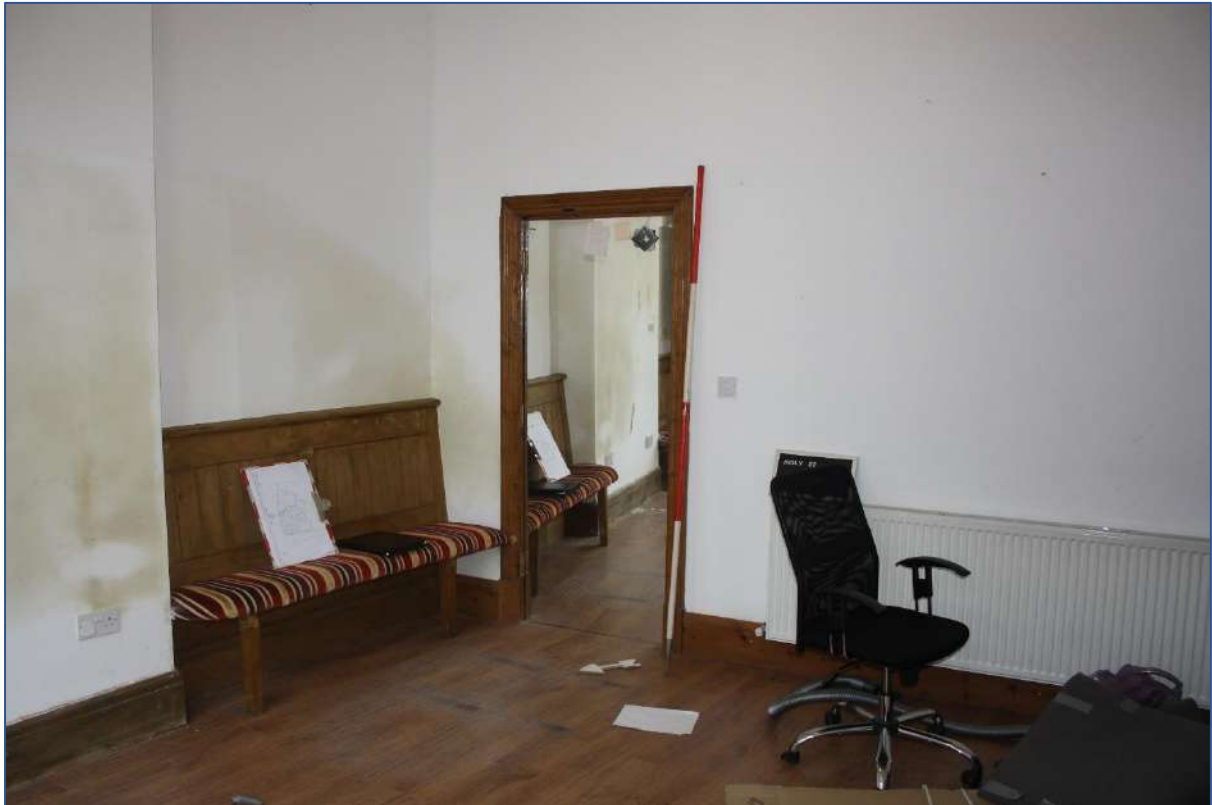
**Room 3 (Luncheon Room)** This room is entered via Room 6, is L-shape in plan with a contemporary laminate floor and painted plastered walls and ceiling, the entrance door being of stained ply, part-glazed with Art deco style fixtures and fittings and hung from an Art deco style frame.. Fixtures and fittings are of contemporary design, while the skirting is Torus profile. In the east wall is a large chimney breast which is blocked. Along three sides of the room there is some fixed benching, similar to those seen in both Rooms 1 and 2, although of somewhat more traditional design with a timbered back panel (plates 47-49).

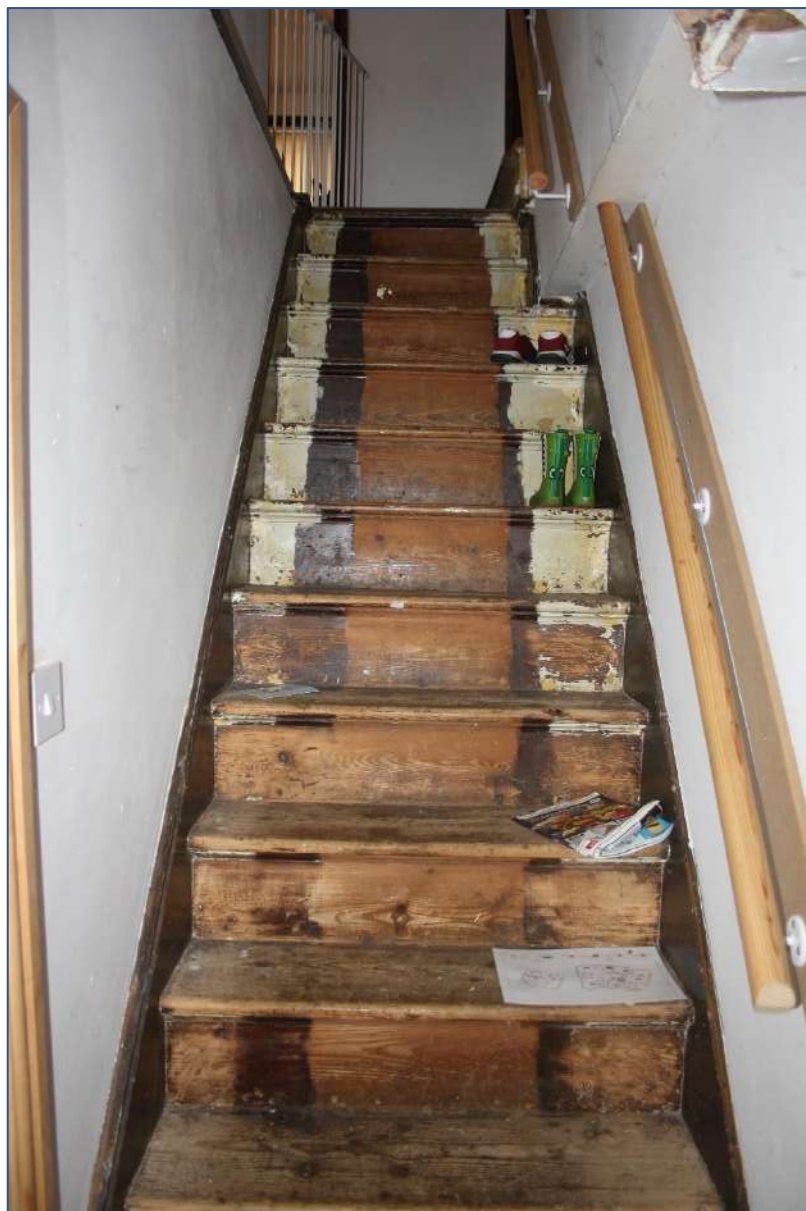
**Plate 53:** View N/W upstairs 17.

**Room 17 (Stairs)** Square in plan with painted walls and ceiling and plain wooden stairs (plate 53).

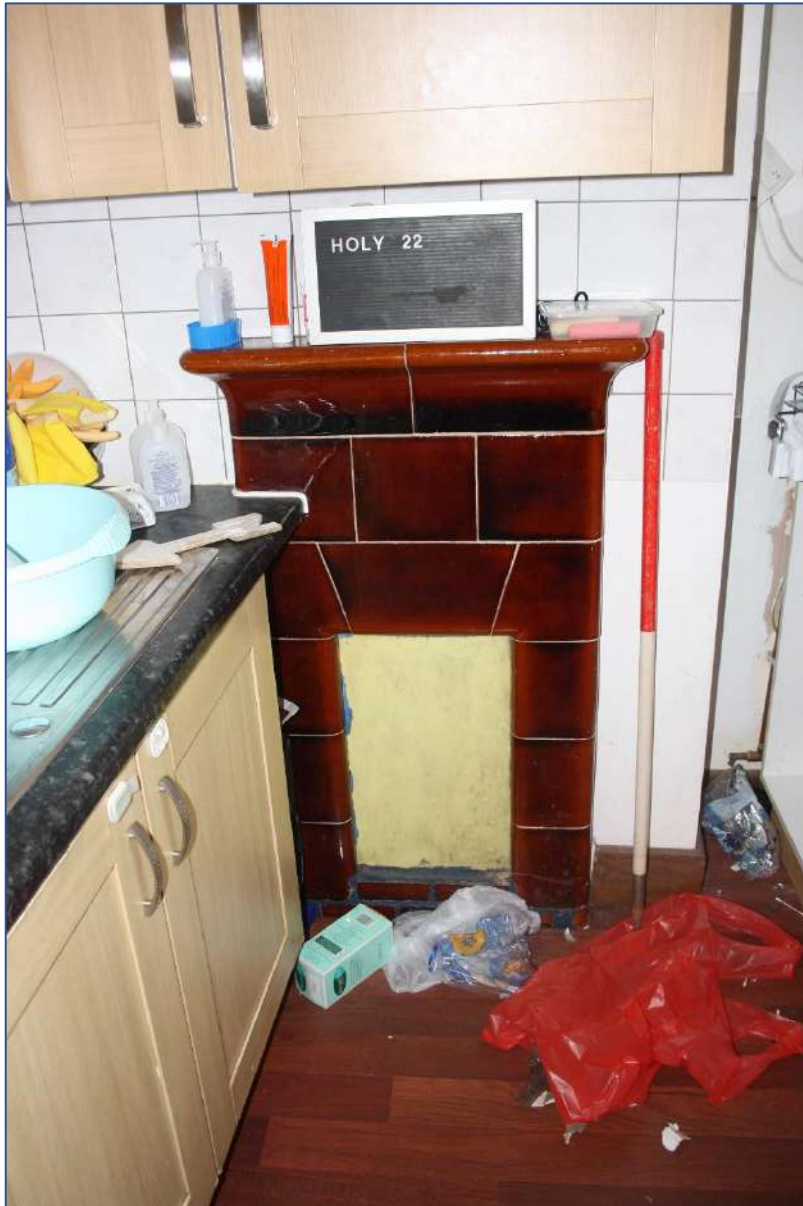
**Plate 54:** Fireplace in Room 22 looking N/W.

**Room 22 (Kitchen)** Square in plan with a laminate floor, part-tiled walls and painted plaster ceiling. This room retains a period tiled fire surround (plate 54). Kitchen.
