**Historic Building  
Recording (L3)  
The Hollybush  
Restaurant  
Upper Bond  
Street  
Hinckley  
LE10 1RH**

**Type of Intervention:** Historic Building Survey Level 3

**Report No:** MAS/634/22

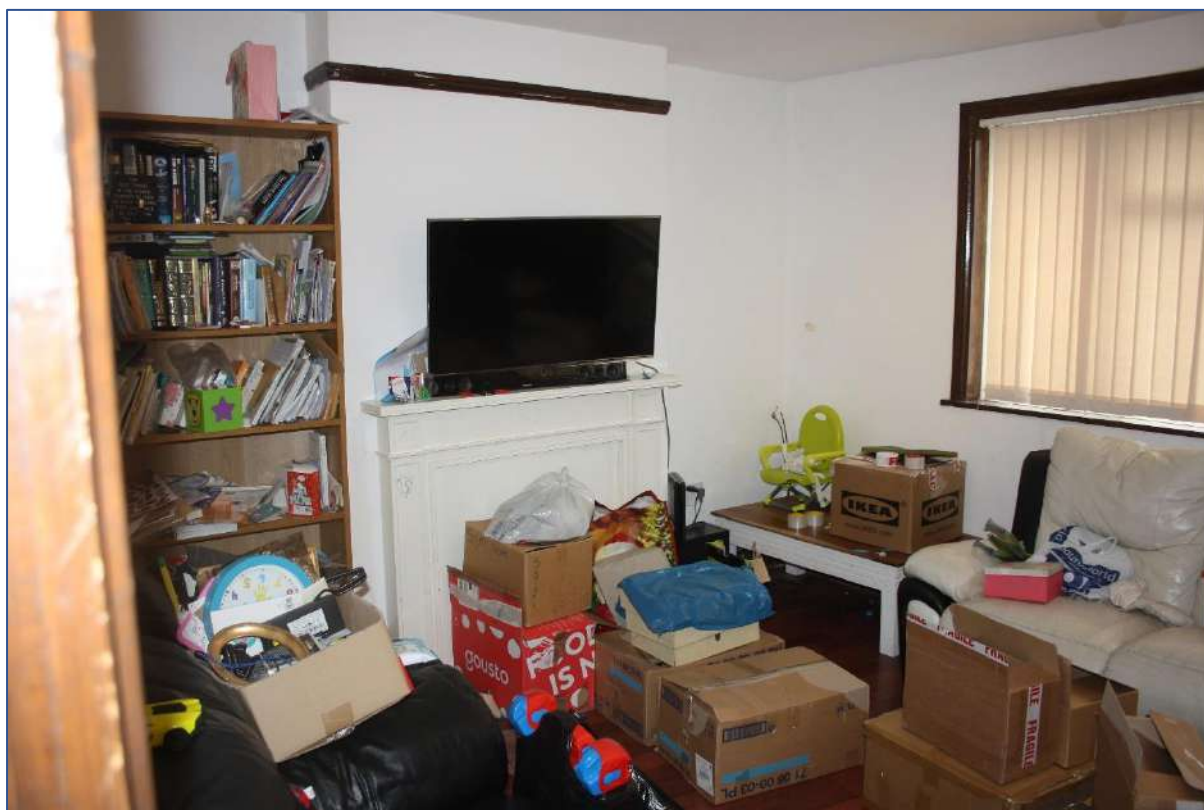
**Plate 56:** Room 26 looking W.

**Room 26 (Lounge)** square in plan with painted plaster ceiling and walls (plate 56, 57). Lounge.

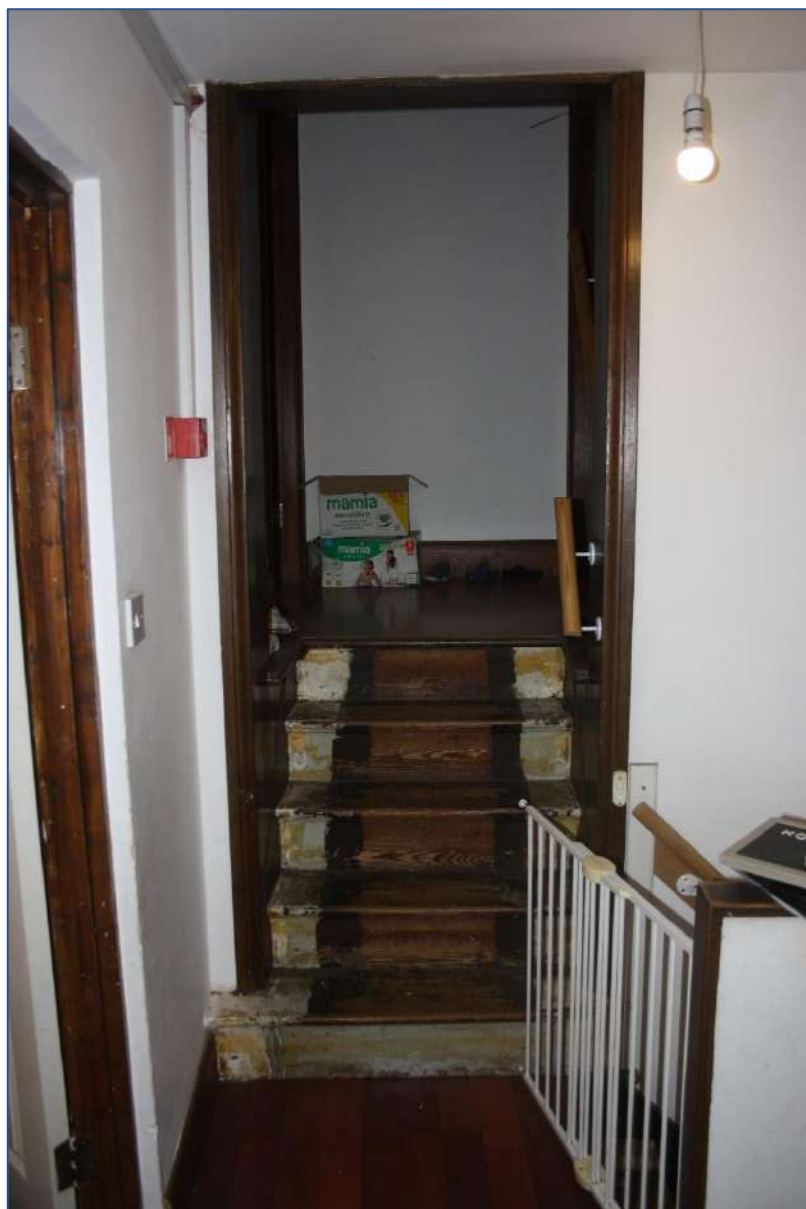
**Plate 58:** Room 24 looking N/E.

**Room 24 (Hall)** Linear in plan with exposed timber floorboards and a painted plaster ceiling and walls (plate 58).

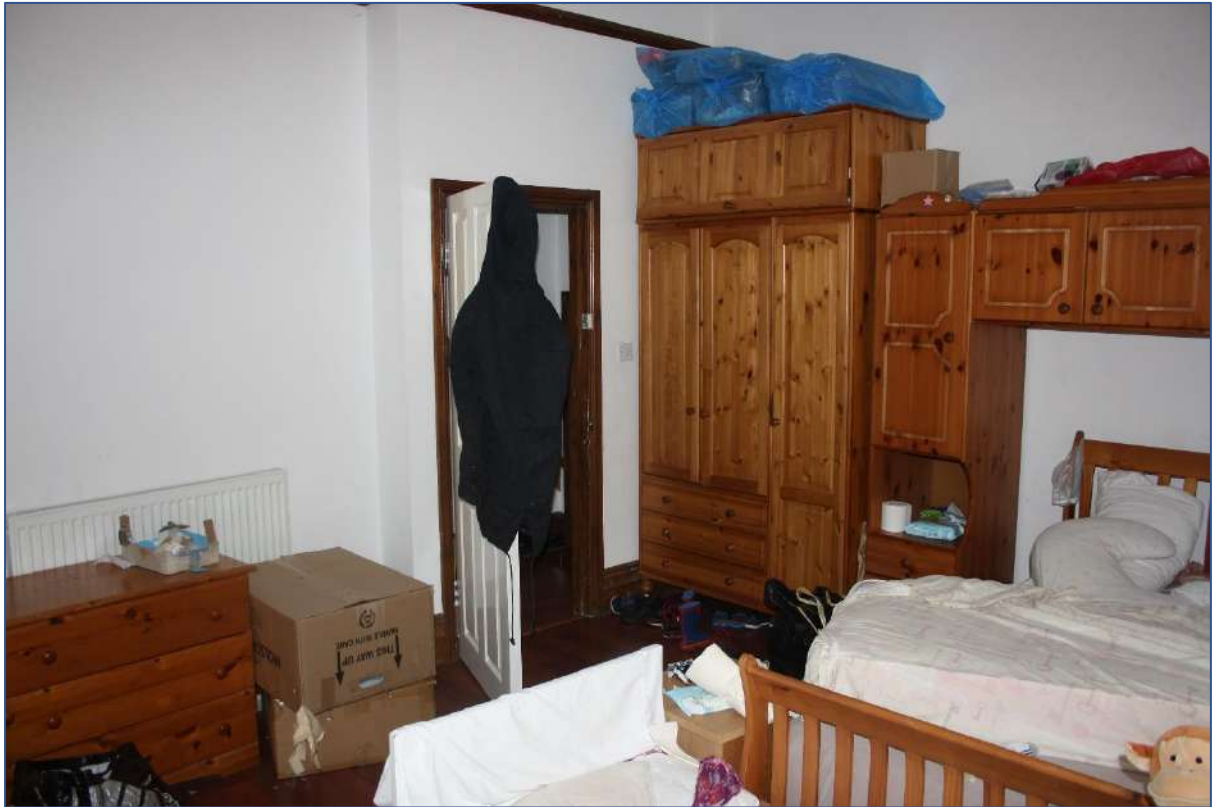
**Plate 61:** Room 25 looking S.

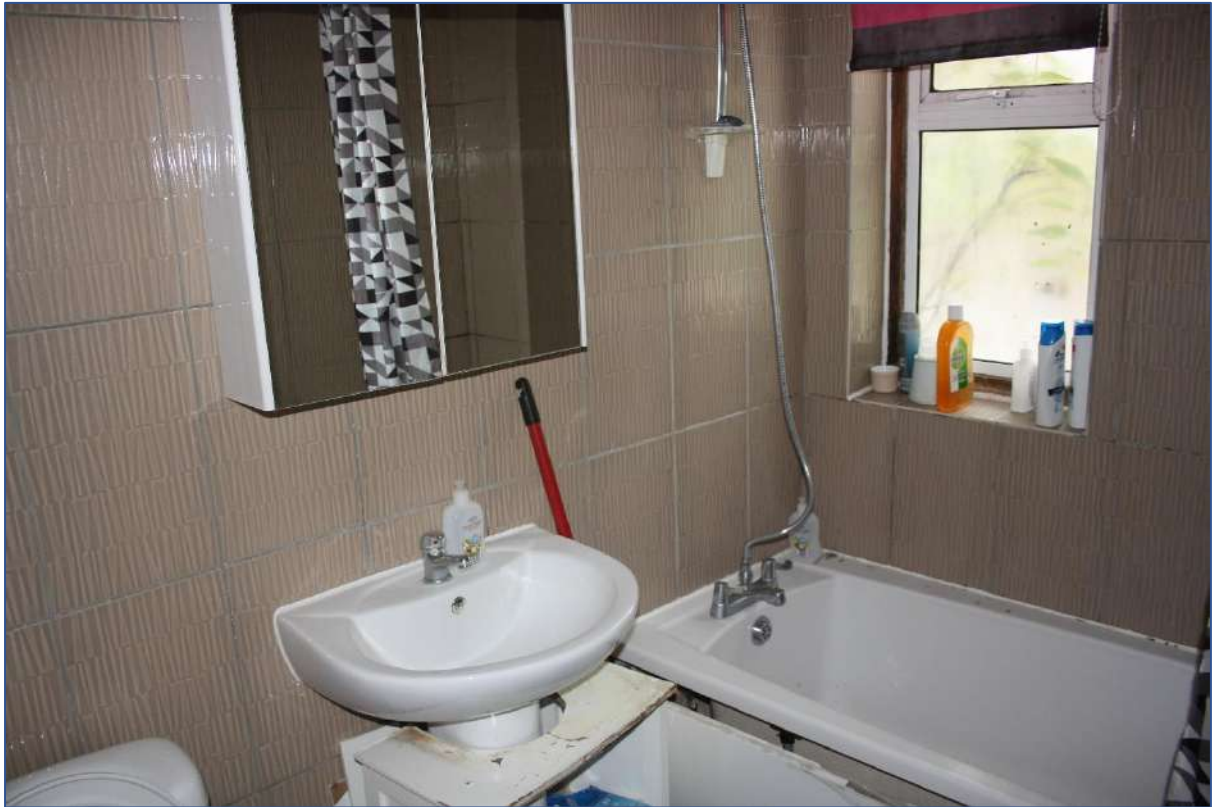
**Plate 66:** Room 21 looking E.

**Room 21 (Bathroom)** Square in plan with a linoleum floor, tiled walls and painted plaster ceiling and fitted throughout with modern sanitary ware (plates 65, 66). Bathroom.

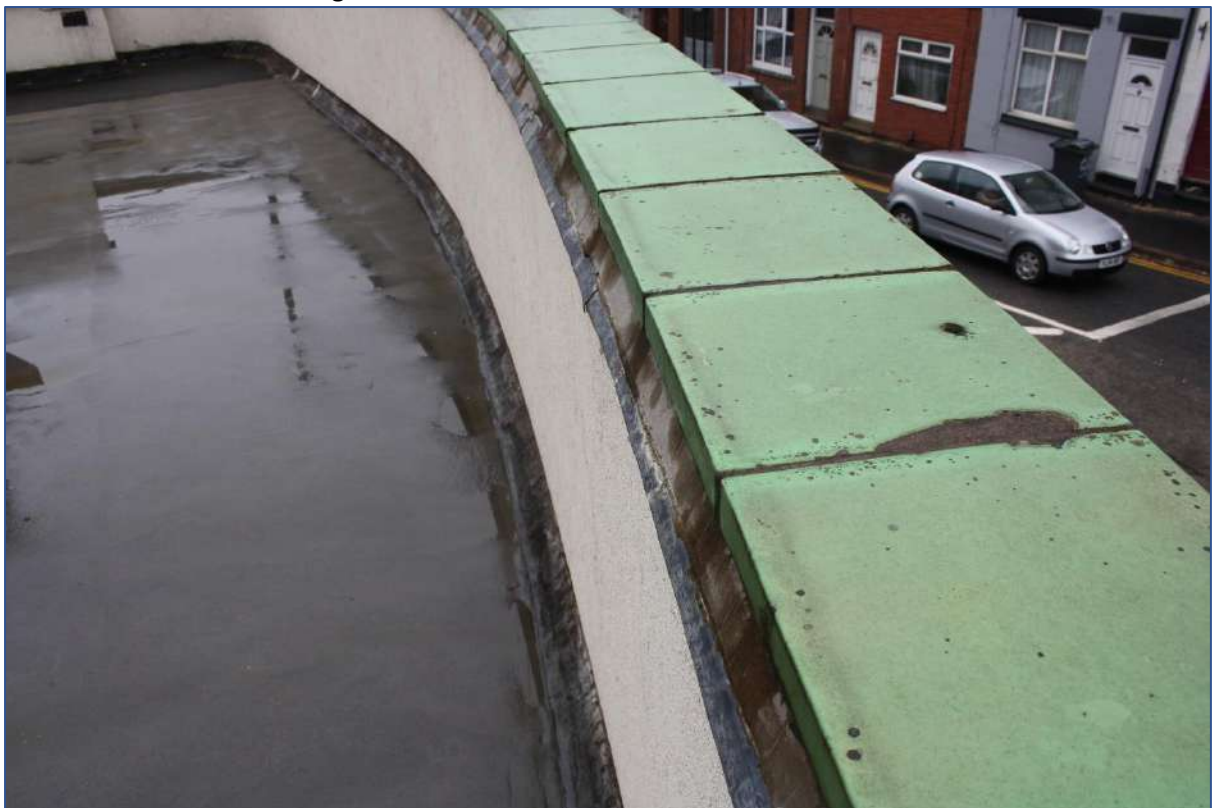
**Plate 69:** Roof area 27 looking at tile detail, looking W.

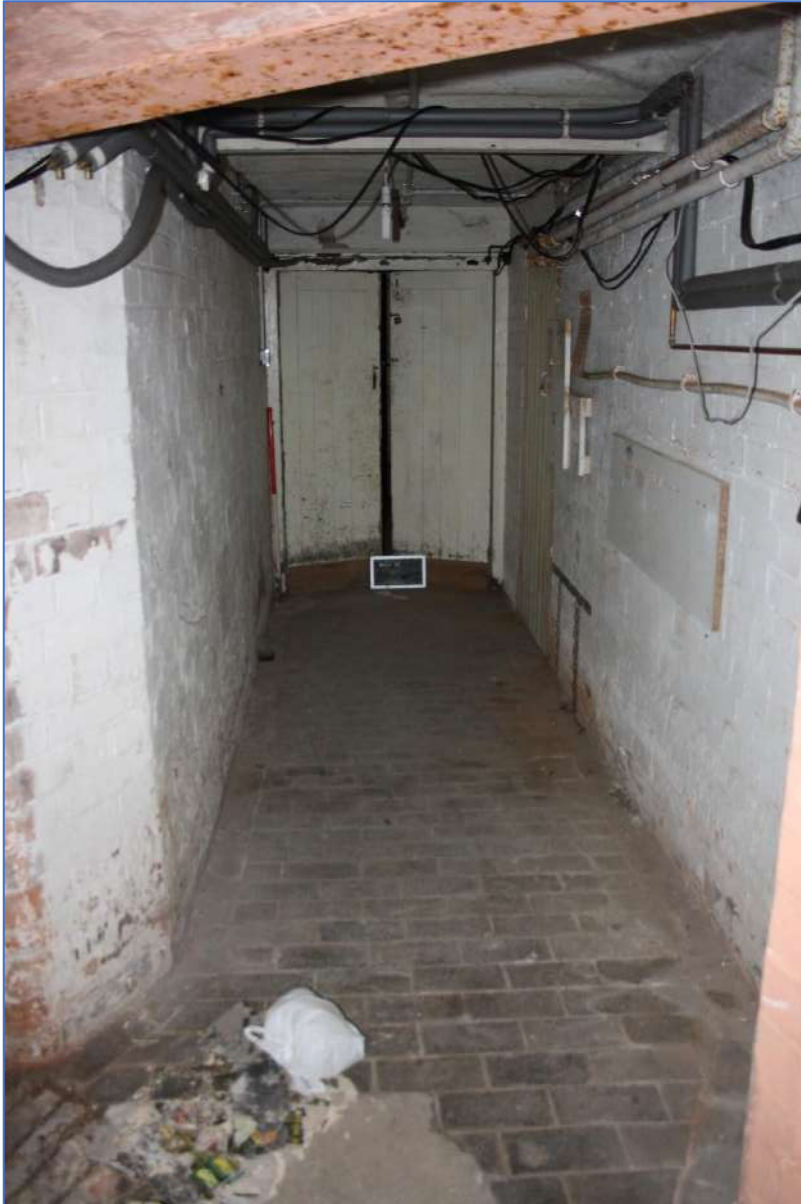
**Plate 78:** Cellar Corridor looking southwest.

**Cellar Corridor (Cellar Corridor)** This area is rectangular in plan and connects Cellar A, B and C. It has a Staffordshire Blue brick floor, with walls of painted brick in Stretcher Bond. The ceiling is block and beam concrete. At the southwest end of the corridor are a set of double doors in timber which give access to Cellar B, whilst to the northwest is a single access door to Cellar C (plate 78).

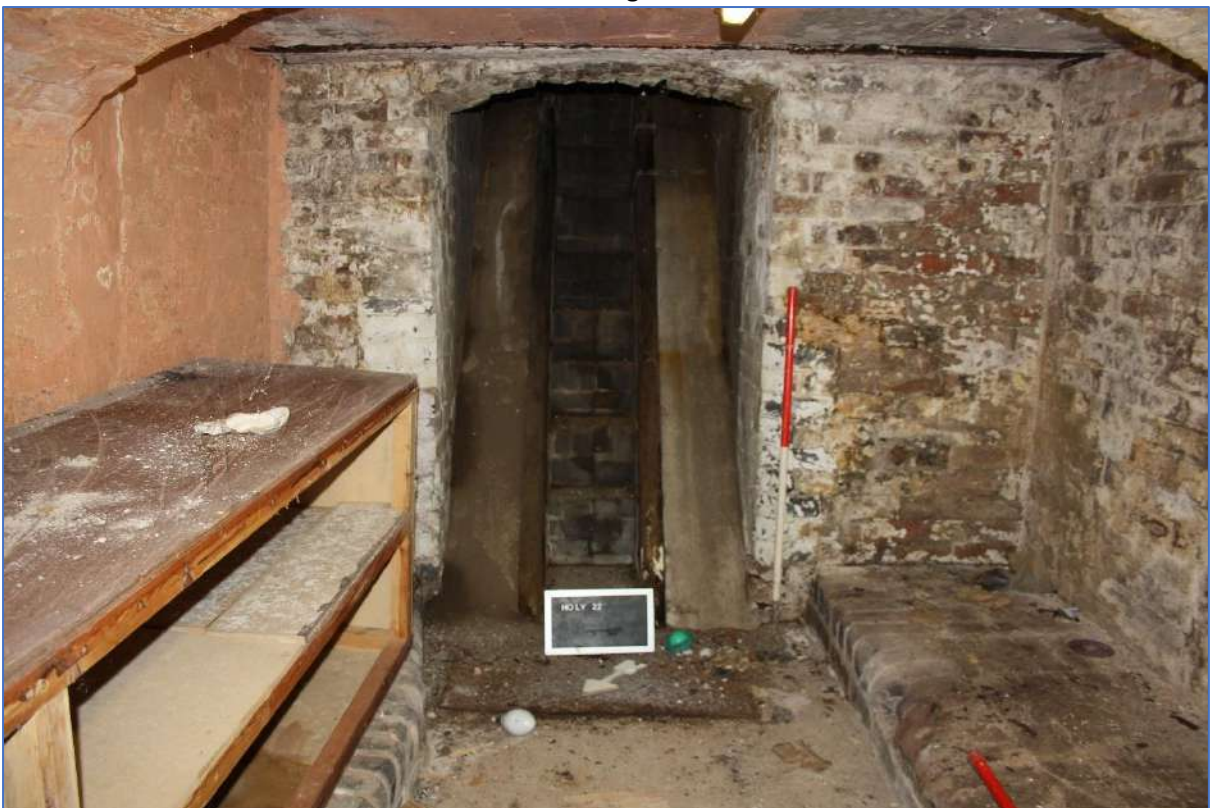
**Plate 80:** Barre Roll Roll looking south in Cellar A.

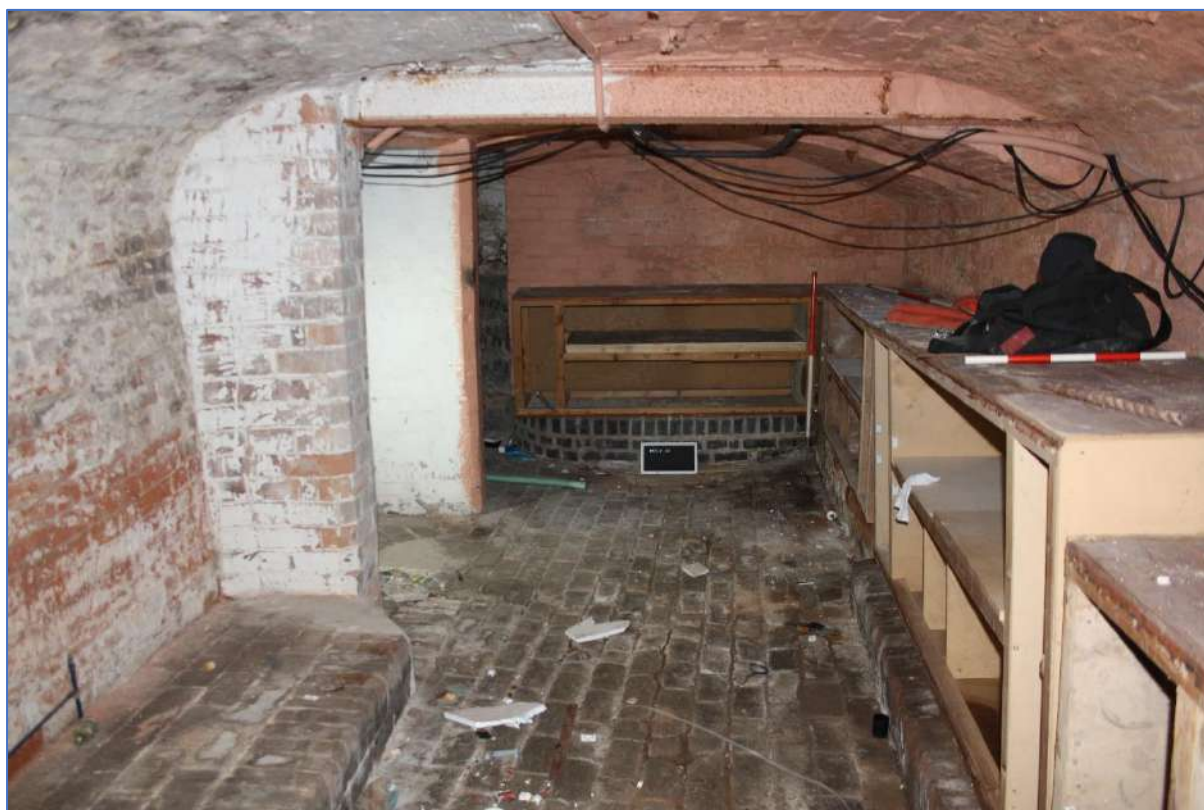
**Plate 81:** Brick vaulted Cellar A looking north.

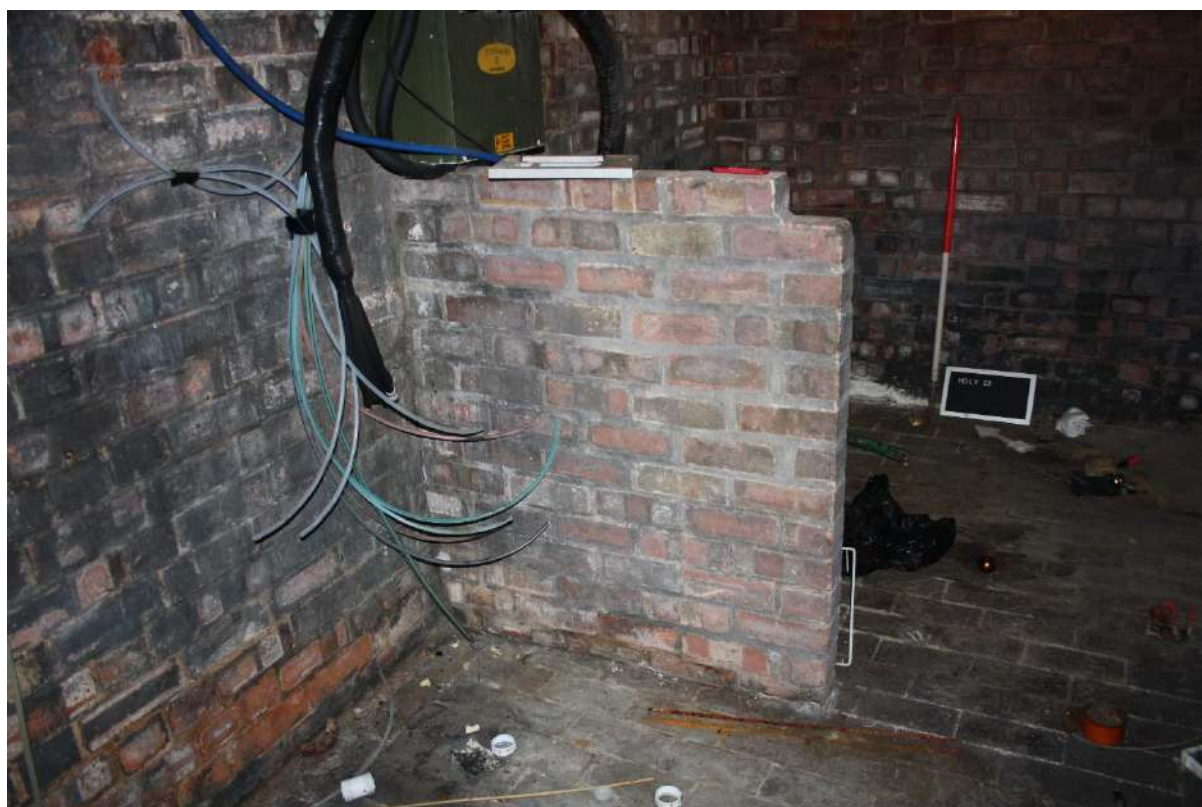
**Plate 83:** Brick partition in Cellar C looking north.

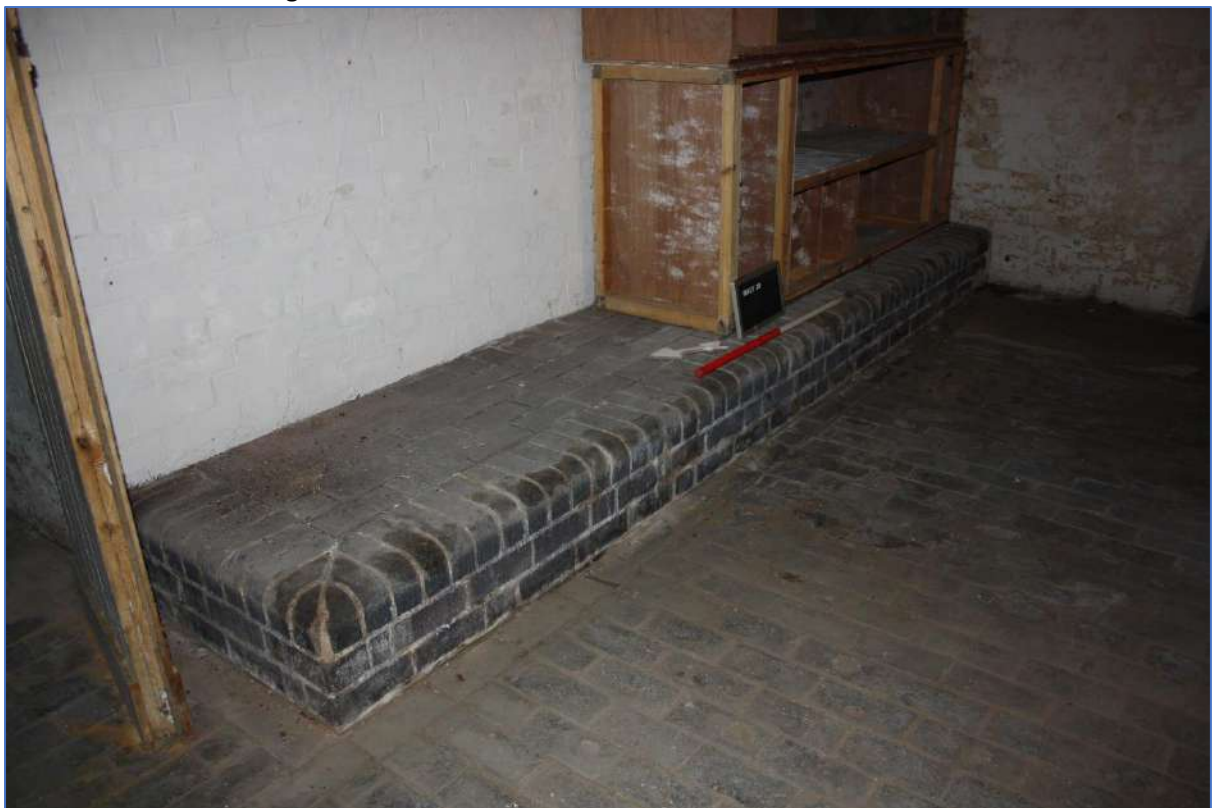
**Plate 86:** Brick Thrawl in Cellar B looking southeast.
