**HINCKLEY SCHOOL  
BUTT LANE, HINCKLEY**

**SPORTS PITCH SOIL AND DRAINAGE ASSESSMENT  
FOR  
REINSTATEMENT WORKS**

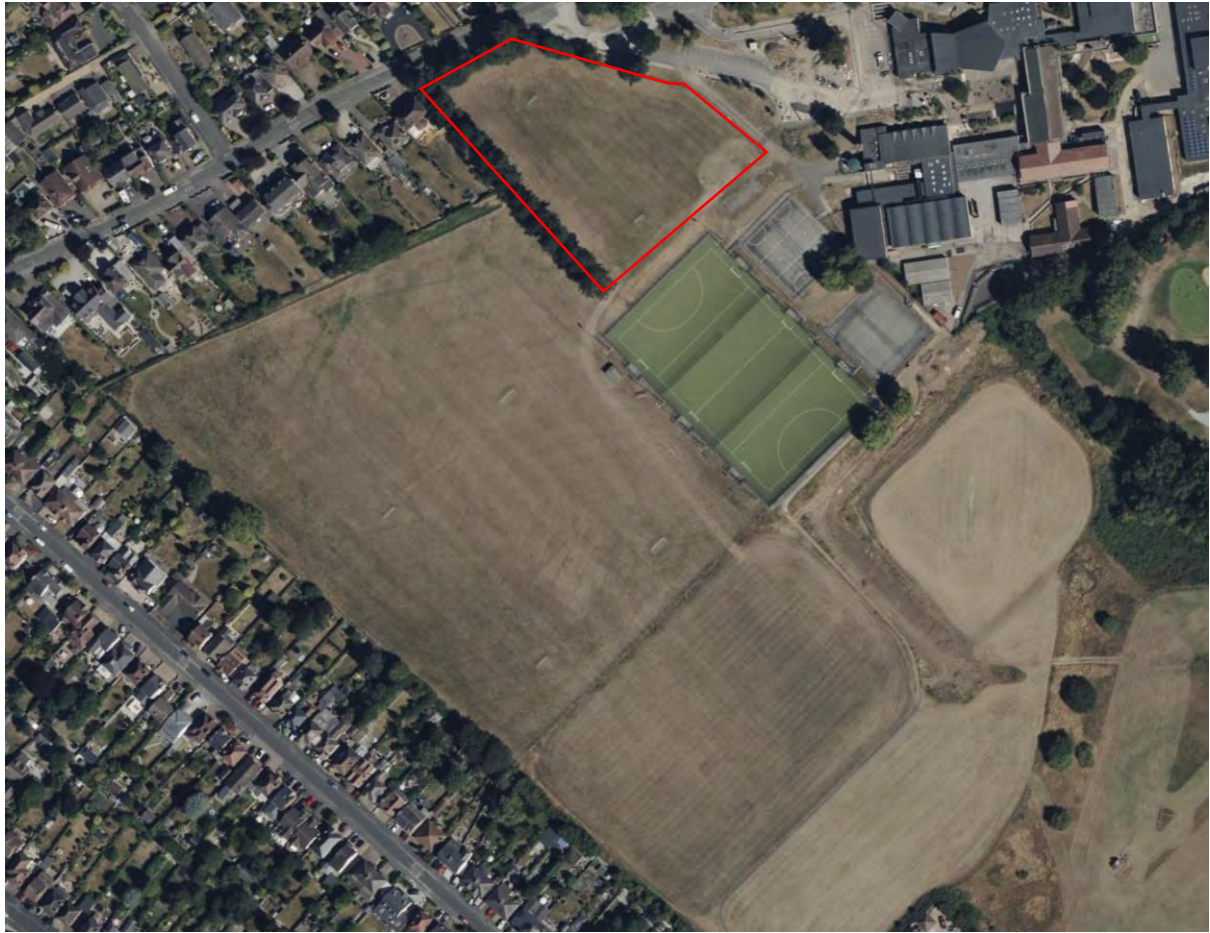
Figure 2: Aerial Image during drought conditions showing discoloured angled lines at the surface as evidence of herringbone field drainage to playing fields. The area of temporary accommodation exhibits no evidence of any existing field drains from records, anecdotal or aerial imagery.

No known drainage is thought to exist within the amenity grass area to be used for the proposed temporary accommodation. Aerial imagery suggests a herringbone system of old field drains is present in the playing field area to the west of the development site but there is no evidence of drains within the development site itself.

Given the 1:25 gradient along the longitudinal axis of the playing field it is likely that the area relies on the natural fall and permeability of the site soils to disperse surface water.

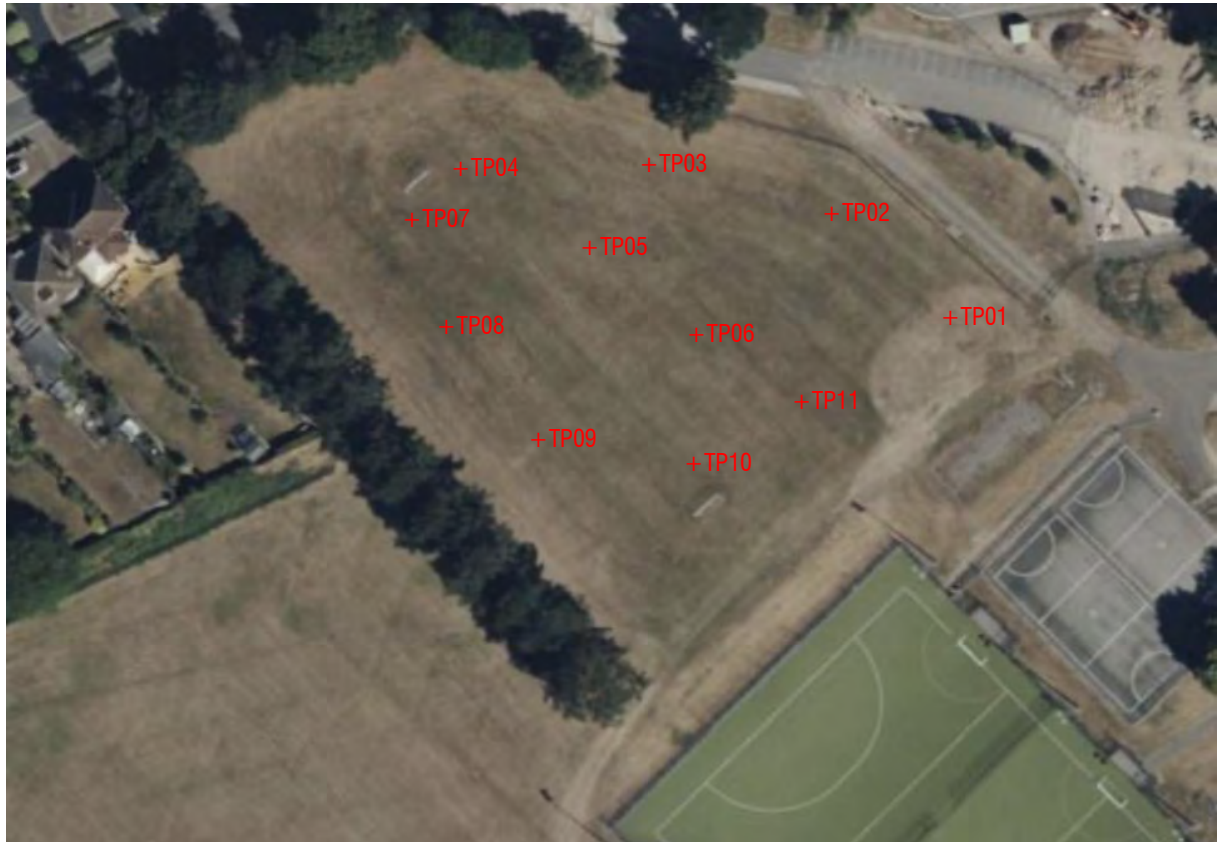
Figure 3: Sampling locations

11 hand pits were excavated across the playing field area in the locations shown in figure 5 above at depths between 0.20 and 0.65m. The purpose of the trial pits was to examine the upper layers of the soil profile and establish the presence of any underlying drainage.

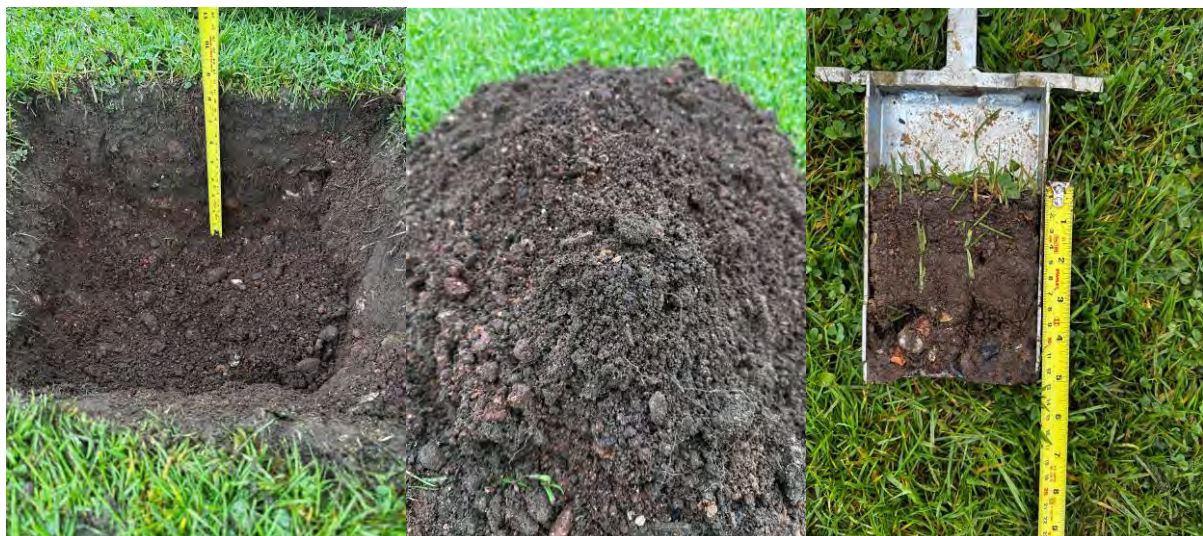
TP1 – 100mm Greyish Brown Sandy Clay Loam Topsoil; Compact overlying Red Ash, Flint, Coal with occasional glass fragments (previously disturbed ground). Trial pit dry, no worm activity. No evidence of drainage; End of Pit.

No existing site drainage is present within the area of the proposed temporary accommodation units or the wider sports pitch area. There is evidence of previously disturbed soils within the pitch area (trial pits 1, 3 and 9). Topsoil shall be removed, stockpiled and respread in accordance with the recommendations made in section 6.0 above.

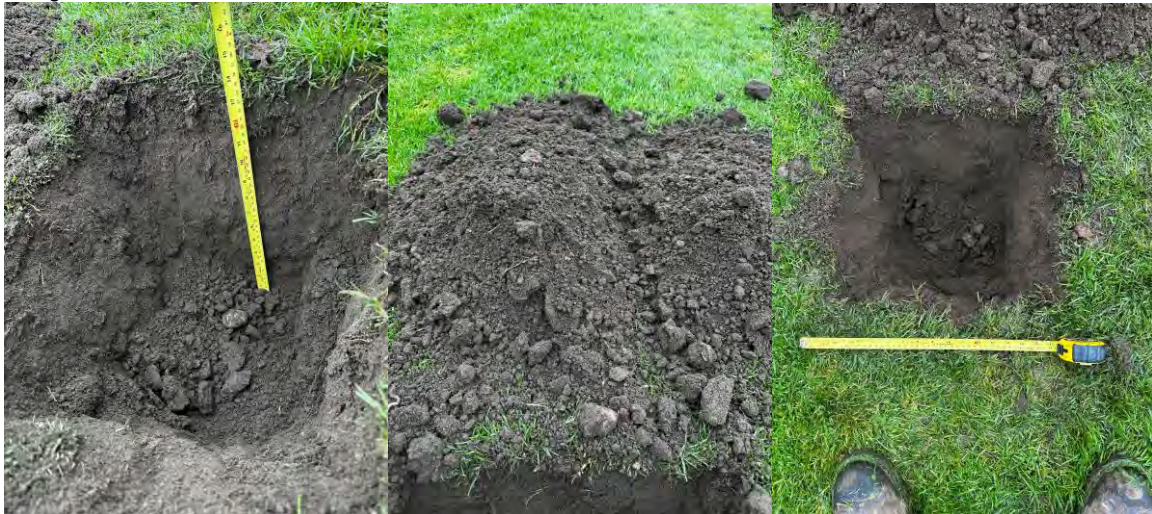
TP2 – 300mm Greyish Brown Sandy Loam Topsoil; Worm Activity; Frequent Stones 30-40mm; Shallow Rooting to 150mm; 300-500mm Silty Clay Loam Subsoil; Trial Pit Dry; No evidence of drainage; End of pit.

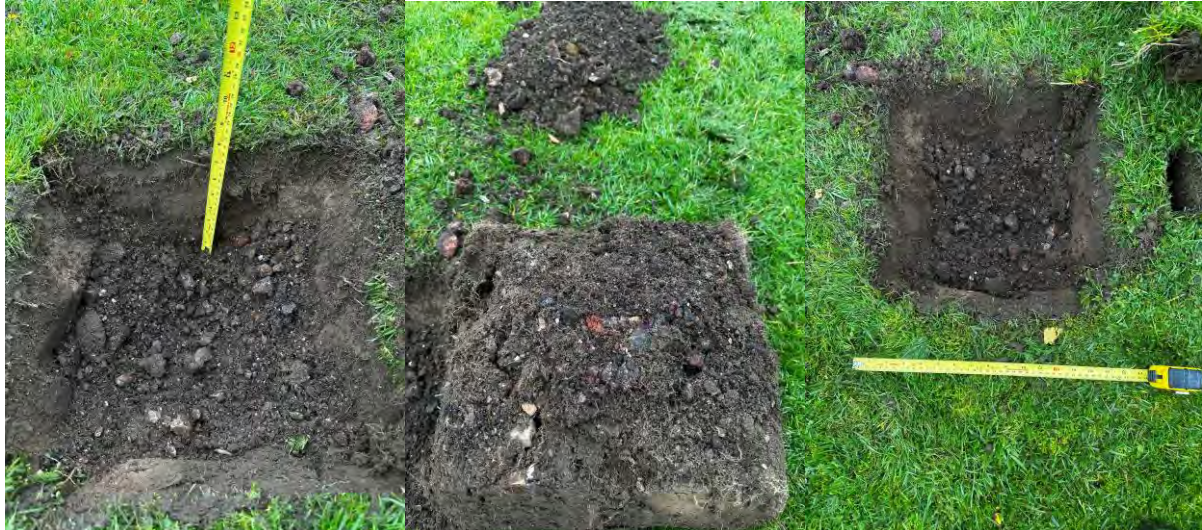
TP3 – 200mm Greyish Brown Sandy Loam Topsoil; Compact overlying Red Ash, Flint, Coal with occasional glass fragments (previously disturbed ground). Trial pit dry, worm activity. No evidence of drainage; End of pit

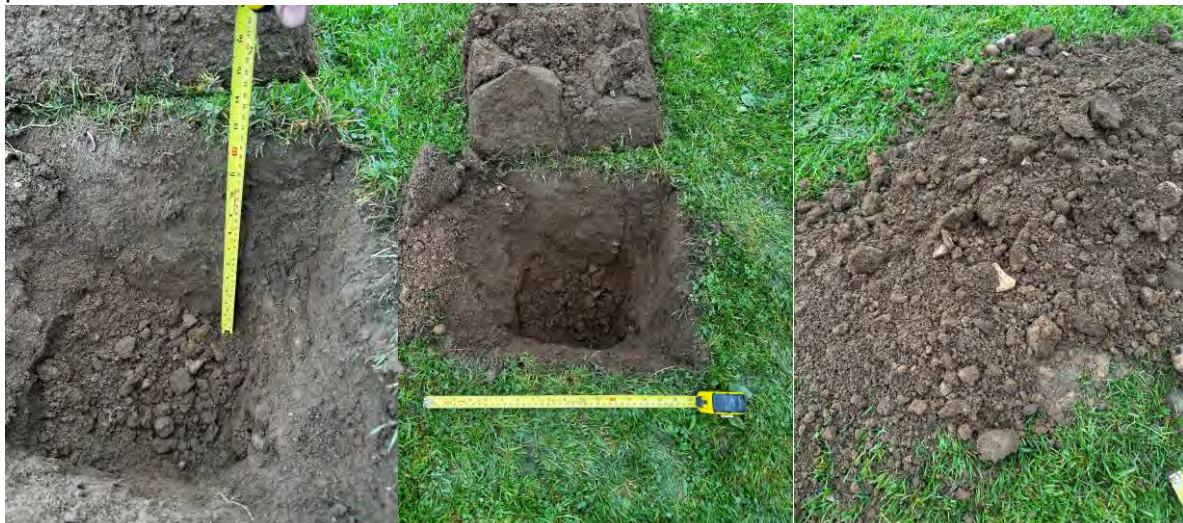
TP4 – 320mm Greyish Brown Sandy Clay Loam Topsoil; Compact; Frequent stones 30-50mm diameter; Worm activity; Dry; Brown Silty Clay Loam Subsoil 320-600mm; No evidence of drainage; End of pit

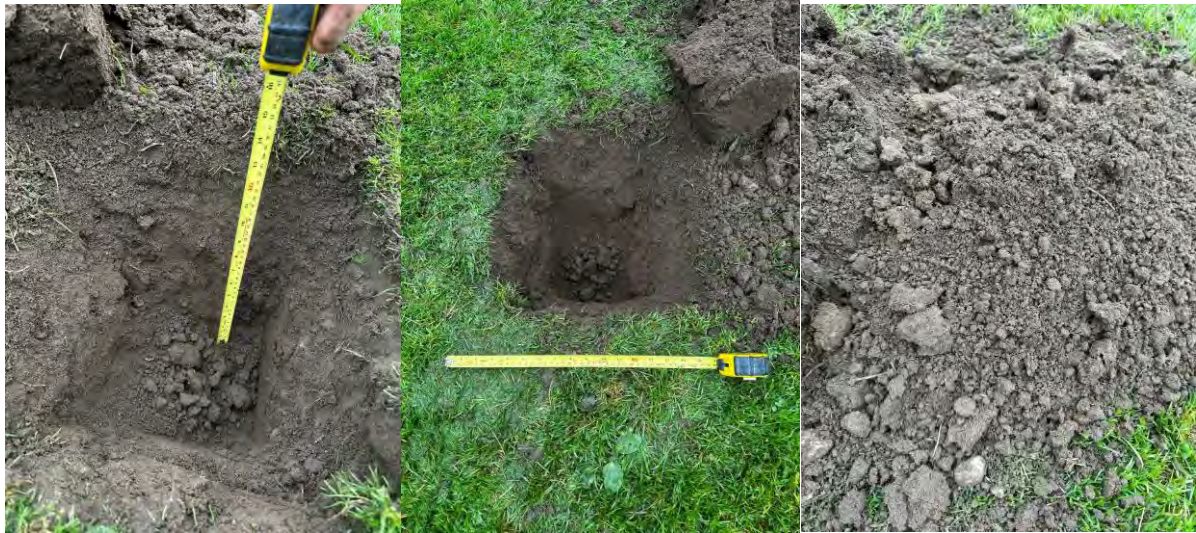
TP5 – 325mm Greyish Brown Sandy Loam Topsoil; Friable; Frequent stones 30mm diameter; Roots to 200mm; Worm activity; Dry; Silty Clay Loam Subsoil 320-550mm; No evidence of drainage; End of pit.

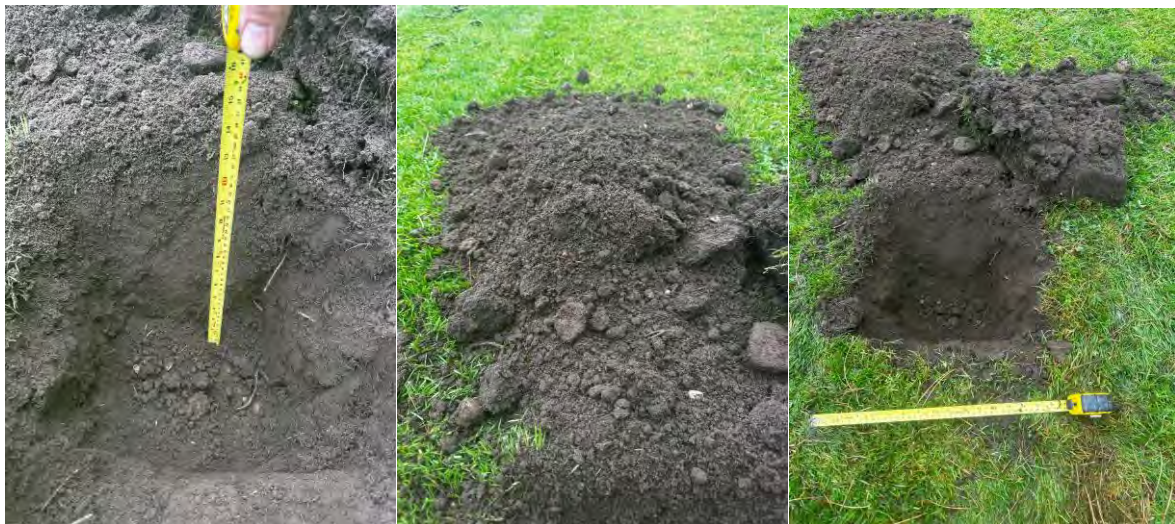
TP6 - 300mm Greyish Brown Sandy Clay Loam Topsoil; Friable; Frequent stones 30mm diameter; Roots to 200mm; Worm activity; Dry; Brown Silty Clay Loam Subsoil 300-500mm; No evidence of drainage; End of pit.

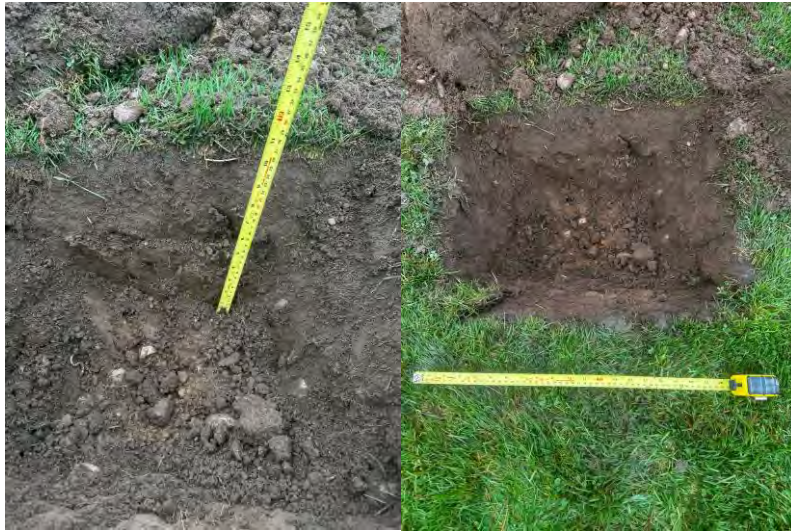
TP7 - 290mm Greyish Brown Sandy Clay Loam Topsoil; Compact; Tree Roots to 150mm; Frequent stones 30-40mm diameter; Worm activity; Dry; Brown Silty Clay Loam Subsoil 290-500mm; No evidence of drainage; End of pit.

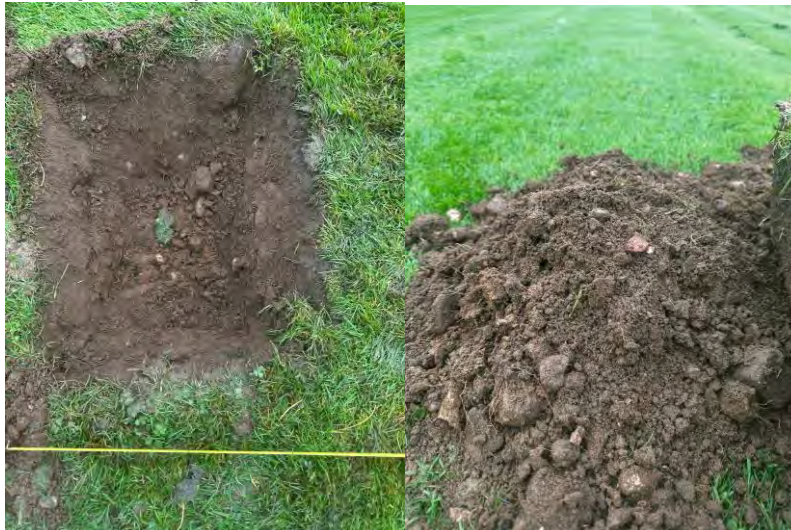
TP8- 290mm Greyish Brown Sandy Clay Loam Topsoil; Compact; Frequent stones 30-40mm diameter; Worm activity; Dry; Brown Silty Clay Loam Subsoil 290-500mm; No evidence of drainage; End of pit.

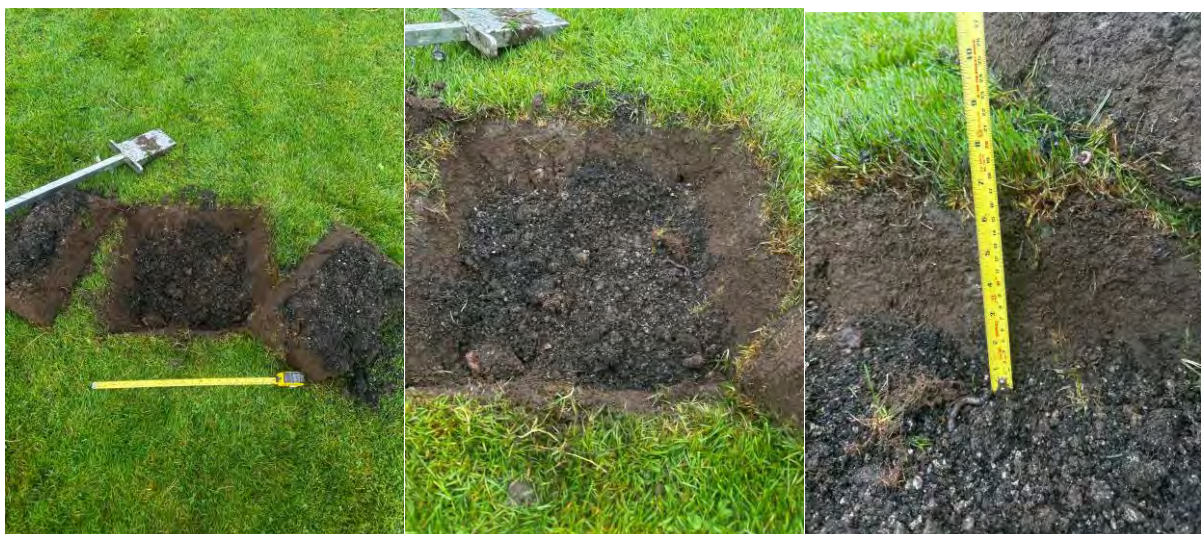
TP9 – 150mm Brown Sandy Clay Loam Topsoil; Compact overlying Ash, Flint, Coal with occasional glass fragments (previously disturbed ground). Trial pit dry, worm activity. No evidence of drainage; End of pit

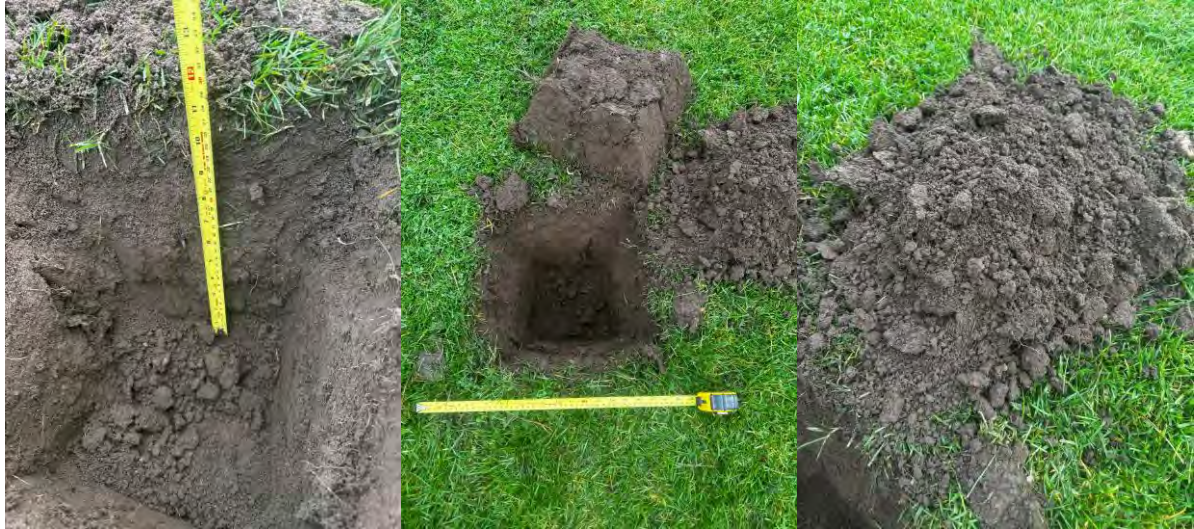
TP10 - 300mm Greyish Brown Sandy Clay Loam Topsoil; Compact; Occasional stones 25-50mm diameter; Worm activity; Dry; Brown Silty Clay Loam Subsoil 290-490mm; No evidence of drainage; End of pit.

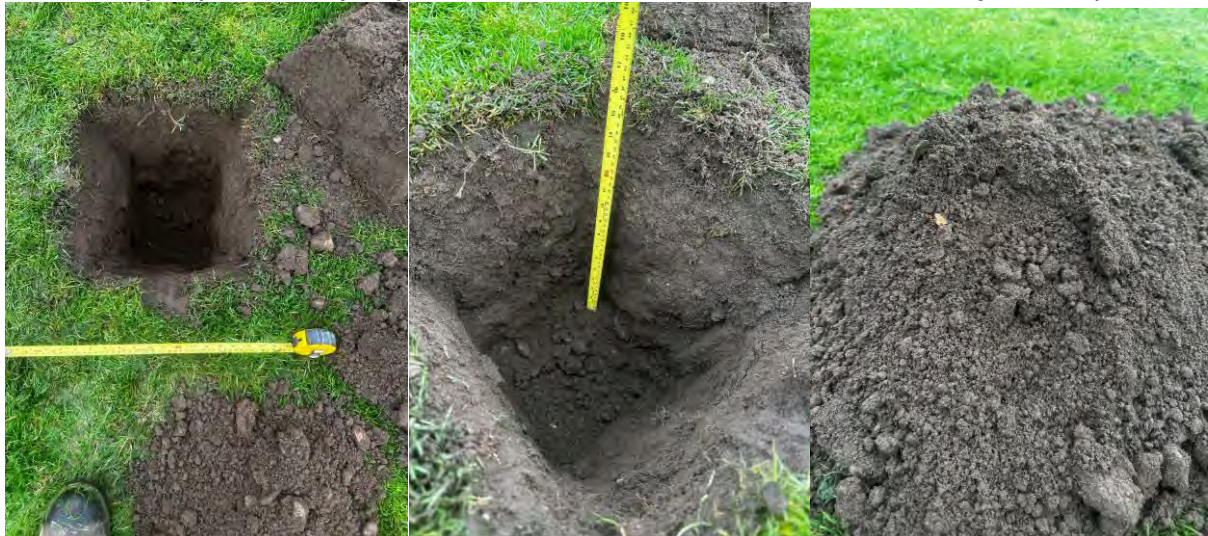
TP11 - 300mm Greyish Brown Sandy Clay Loam Topsoil; Compact; Occasional stones 25-50mm diameter; Worm activity; Dry; Brown Silty Clay Loam Subsoil 290-500mm; No evidence of drainage; End of pit.

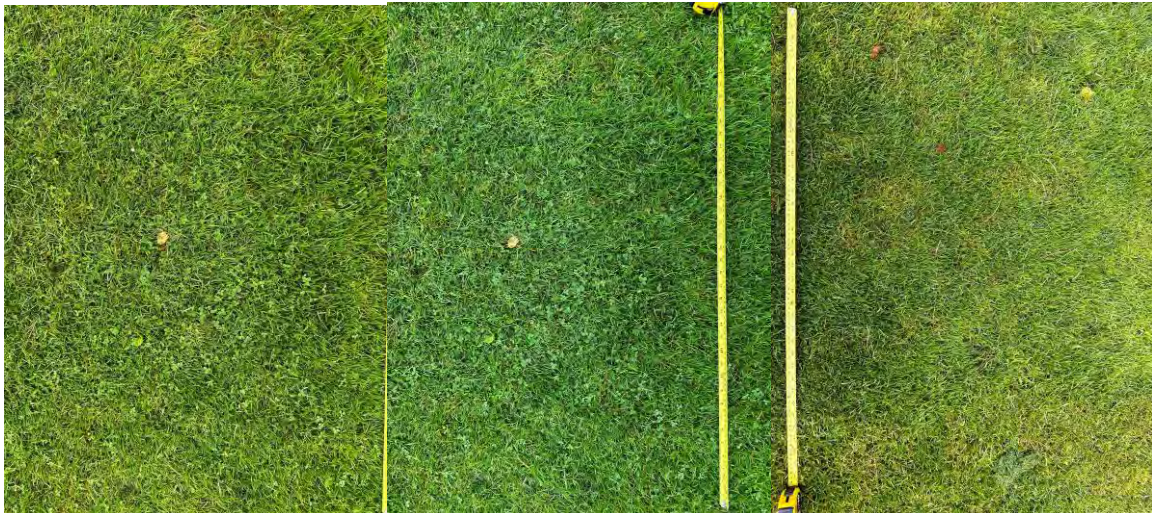
The playing field area is predominantly comprised of annual meadow grass with frequent moss and broadleaved weeds throughout.

- Aeration - The area of the pitch reinstatement should be verti-drained using 19 mm solid tines set to penetrate at least 200 mm. The amount of heave should be as great as possible to prevent surface disruption. The site should be in a suitable condition to accept the level of tine penetration as above but not too soft that the equipment causes surface disruption from wheel marks. The verti-drain should be used to reduce hardness of the playing surface which should be between 35 g and 200 g when measured by the STRI method of test using a 0.5 kg Clegg Impact Hammer from a drop height of 0.55 m.

- Sand Topdressing - The entire pitch area should be top-dressed on 2 occasions during establishment with approved salt free medium fine sports turf sand ideally with a particle size distribution within the central recommended range of the STRI Grading Curve for soil modification and top-dressing of winter games pitches. Following the application, the top-dressing sand it should be thoroughly brushed into the grass surface and levelled using a lute which will help to work the top-dressing into the verti-drain tine holes. The dressings should be applied following aeration in dry weather and ground conditions in a uniform layer of no more than 10.0mm deep from suitable top-dressing equipment.

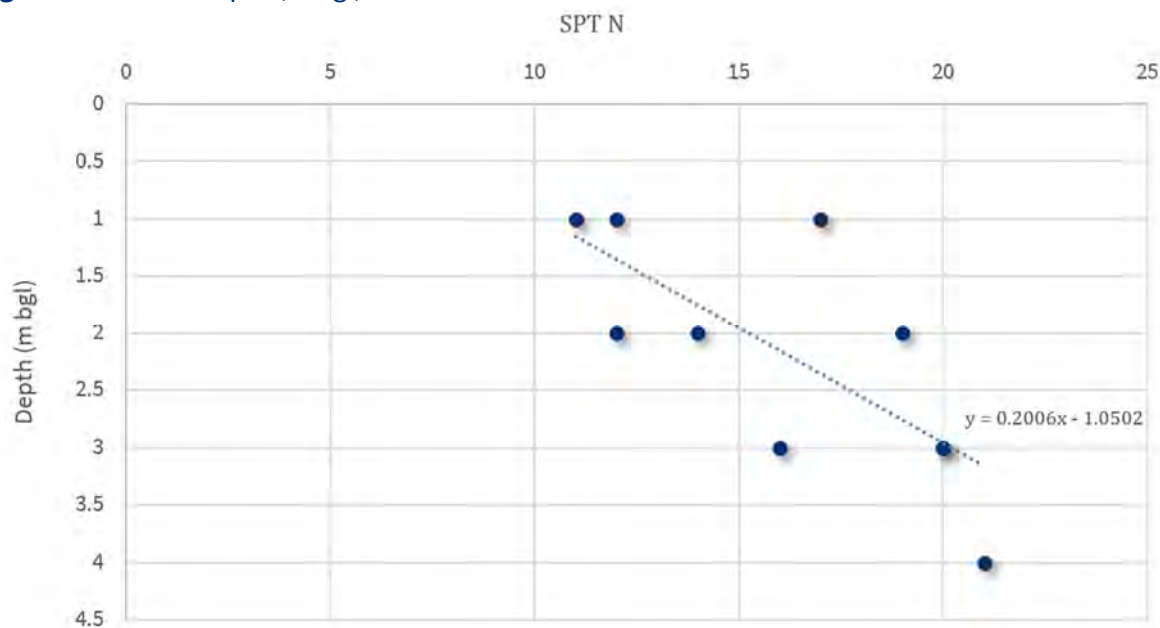
**Figure 1** SPT N vs Depth (m bgl): Made Ground

SPT N within MG generally ranged between 11 and 21 (a single outlier N of >50 recorded in WS03 at 4.00m bgl is possibly indicative of refusal in the underlying soils) and showed a gradual increase with depth (see Figure 1).

Using the relationship proposed by Stroud and Butler<sup>ref 8</sup>, where for SPT N <~25, the undrained shear strength ( $C_u$ ) = SPT N x 4.5, the  $C_u$  ranges between **49 and 94 kPa** (where N = <50).

N shows an increase in depth equivalent to the gradient: Depth (m bgl) = 0.2N-1.05. Although SPT N demonstrates relative consistency, due to the evidence of disturbance and limited data available, unless further assessment is undertaken, it is recommended that these indicative strength parameters are used with caution, and a worse case (**N=11**) is considered characteristic throughout this unit.

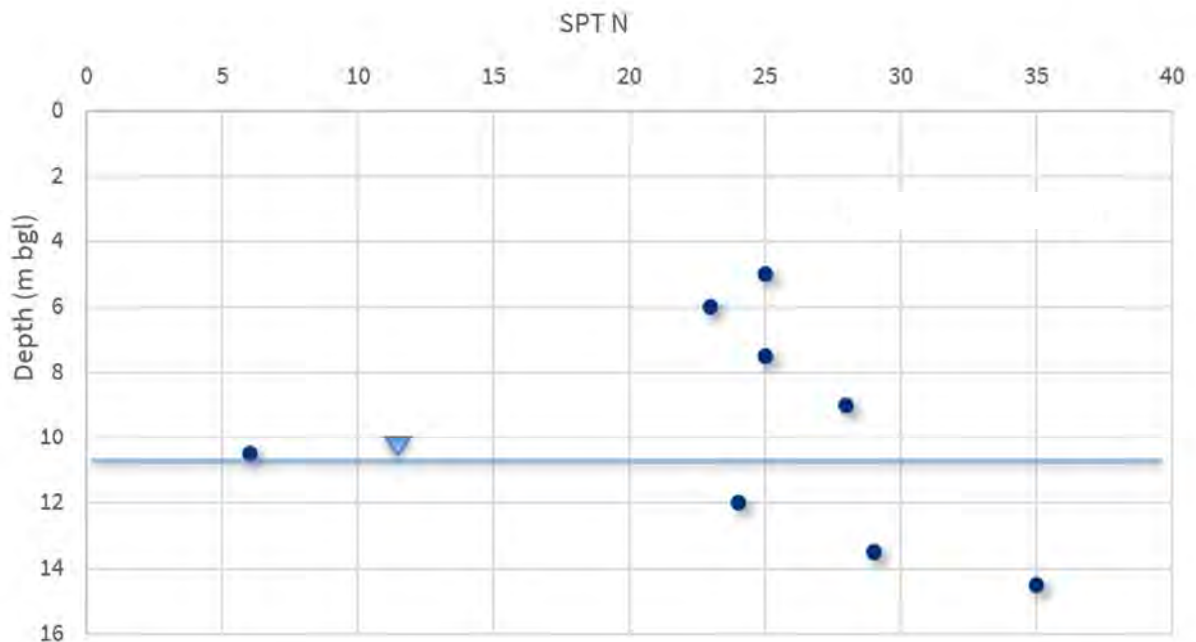
**Figure 2** SPT N vs Depth (m bgl): Wolston Sand and Gravel

SPT N within WOL generally ranged between 23 and 35. Although a generalised increase in N with depth was discernible within the limited data available, a single outlier from this range of 6 was recorded at a depth of 10.50m bgl. This test coincided with a groundwater strike and is likely to be indicative of loosening of the soils associated with vadose conditions (see Figure 2).
