## Preliminary bat roost assessment

| Site Location | New Hall Field House, High Street Earl Shilton,<br>Leicestershire LE9 7DG |
| Document<br>reference | CE4413 |
| Date of Site visit | 30 <sup>th</sup> November 2023 |

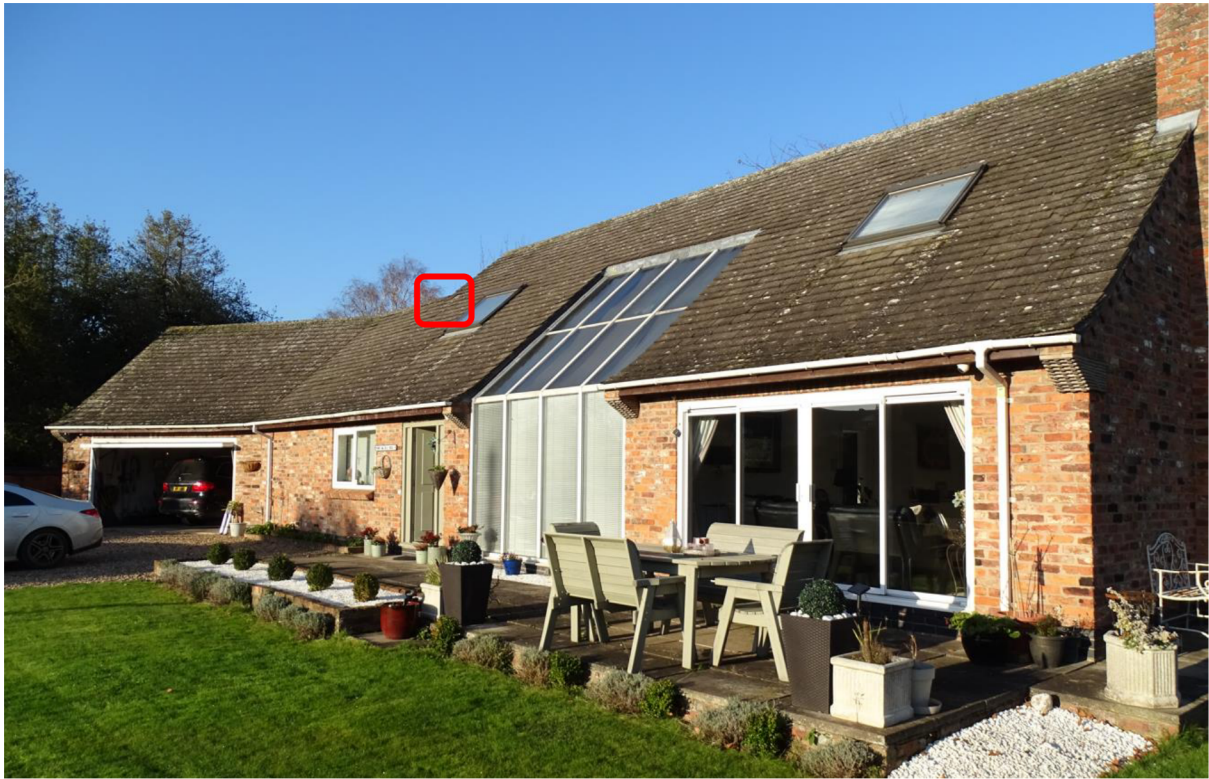
| External | Features of value to bats | Notes |
|---|---|---|
| Roof coverings | Yes | The property has demonstrated a number of broken/missing tiles which create gaps of adequate proportions to offer likely shelter/ access opportunities for bats. |

Image 1 – Front South facing elevation of the property offering a full missing tile of adequate proportions to offer likely shelter/access opportunities for bats

- 6.5** In line with best practice survey guidelines, a structure that offers low value features must have a further single emergence survey will be required to rule out or confirm activity from bats. This survey should be carried out within the recommended survey season from May to August.

- 6.7** It is advised that no further works take place to the identified areas of value to bats at this stage as this may cause disturbance to bats and their roosts. see section 2.0 of this report

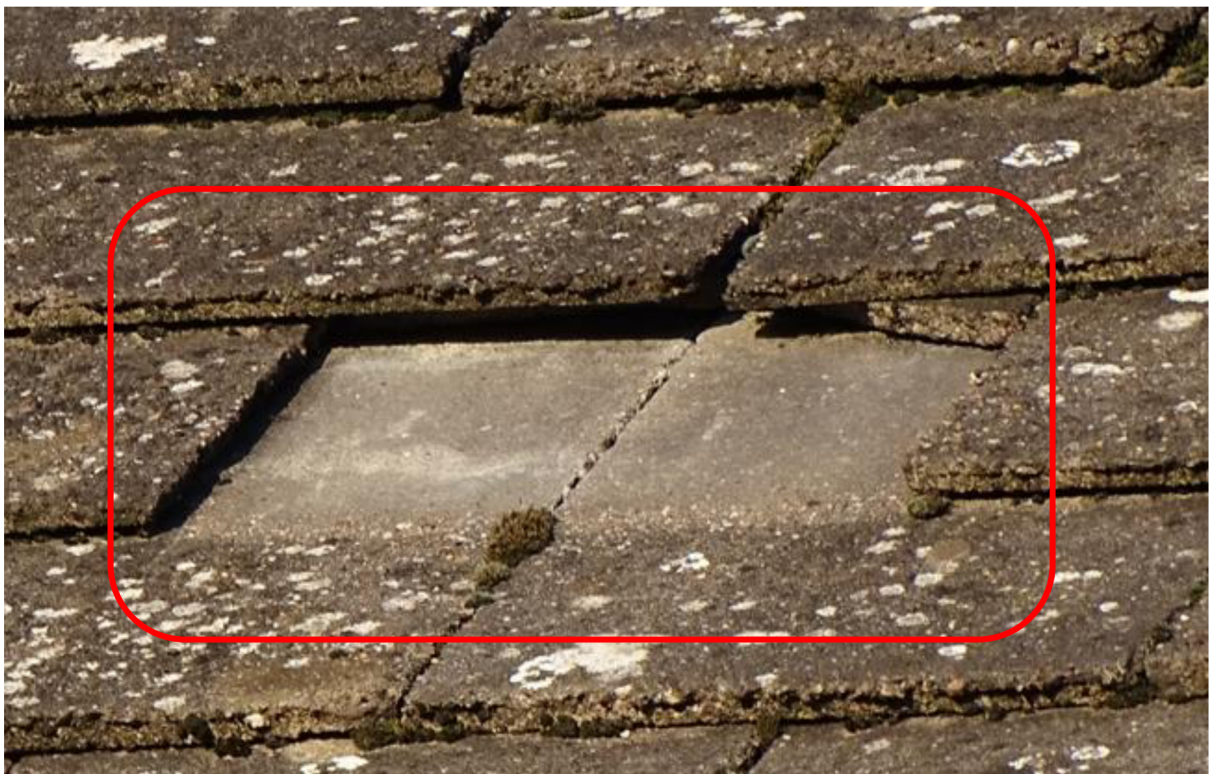
Image 2 – As per image one above

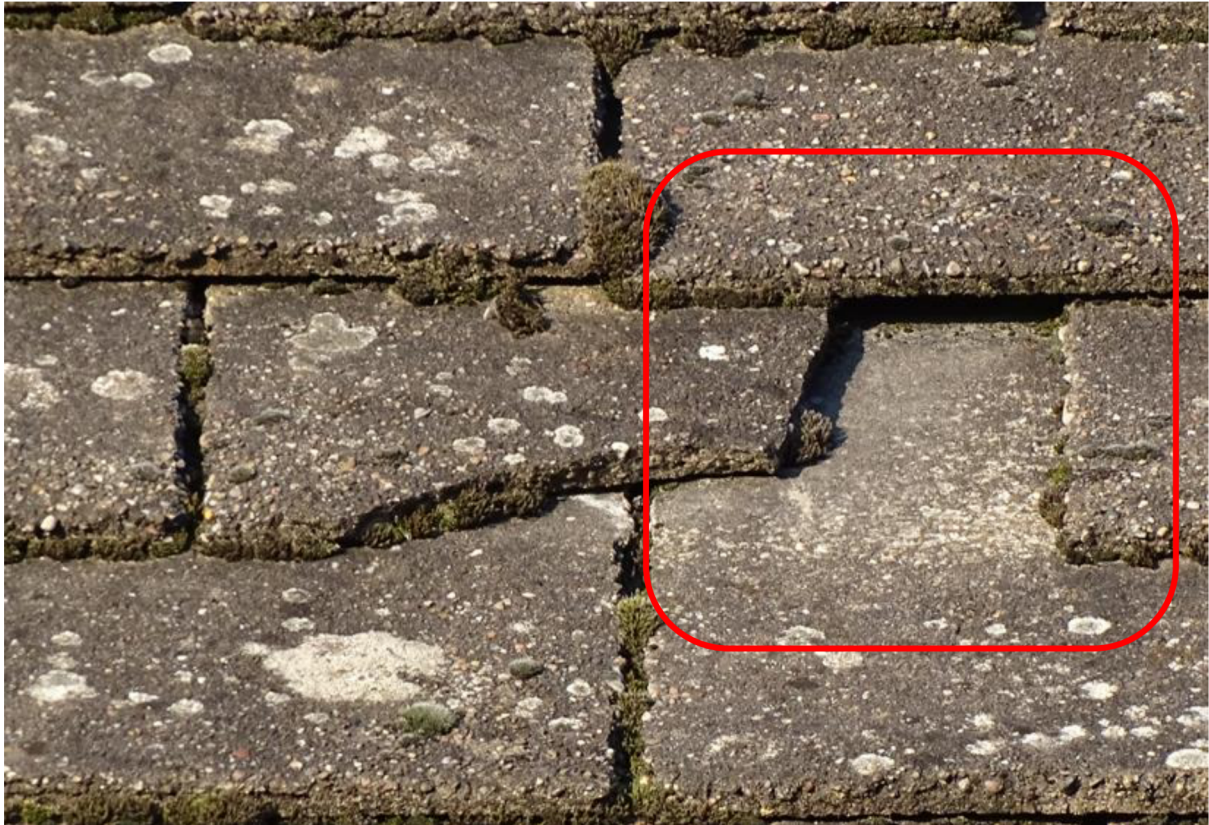
Image 2 – Further gaps of value to bats within the roof coverings above the garage section of the property, South facing elevation

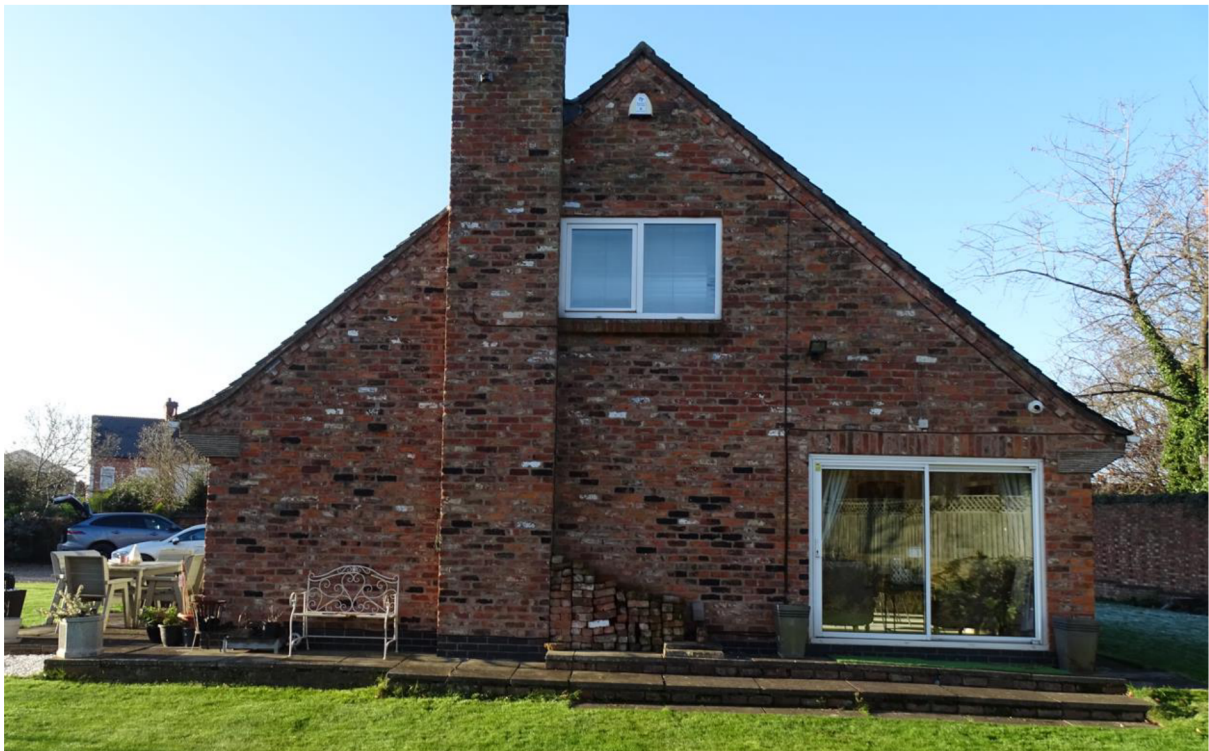
Image 3 – East facing elevation of the property

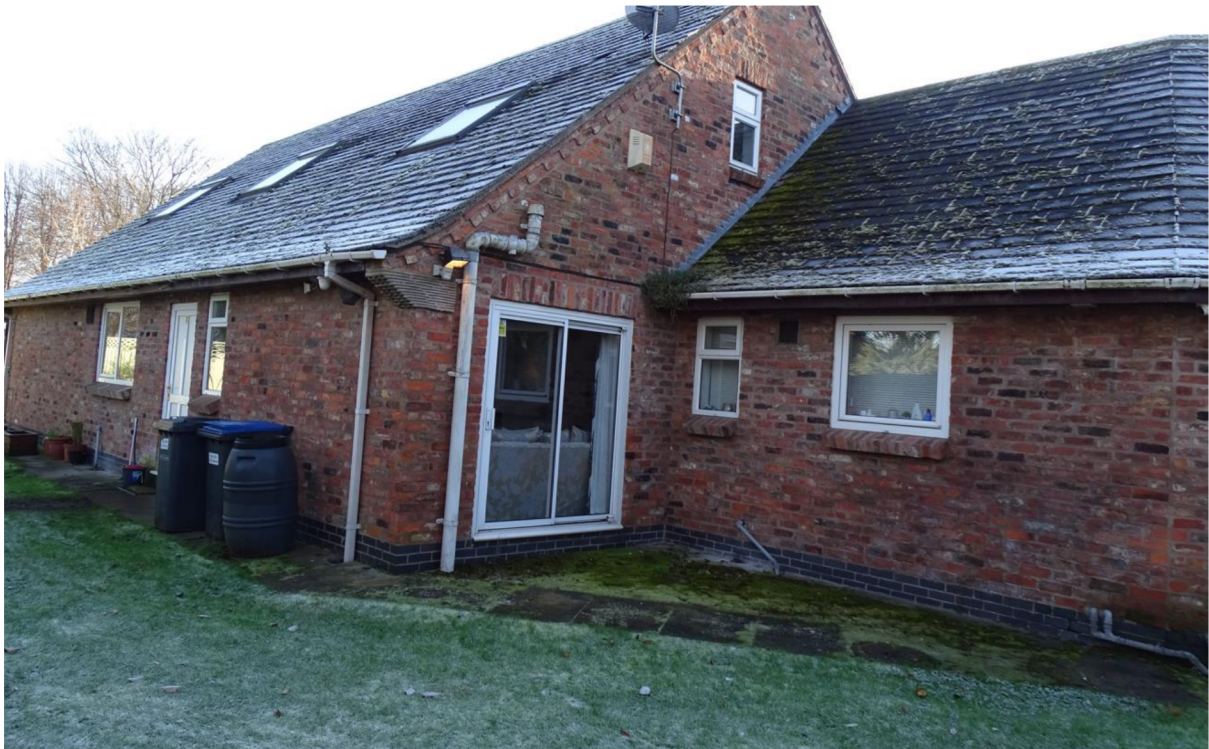
Image 5 – North facing elevation of the property

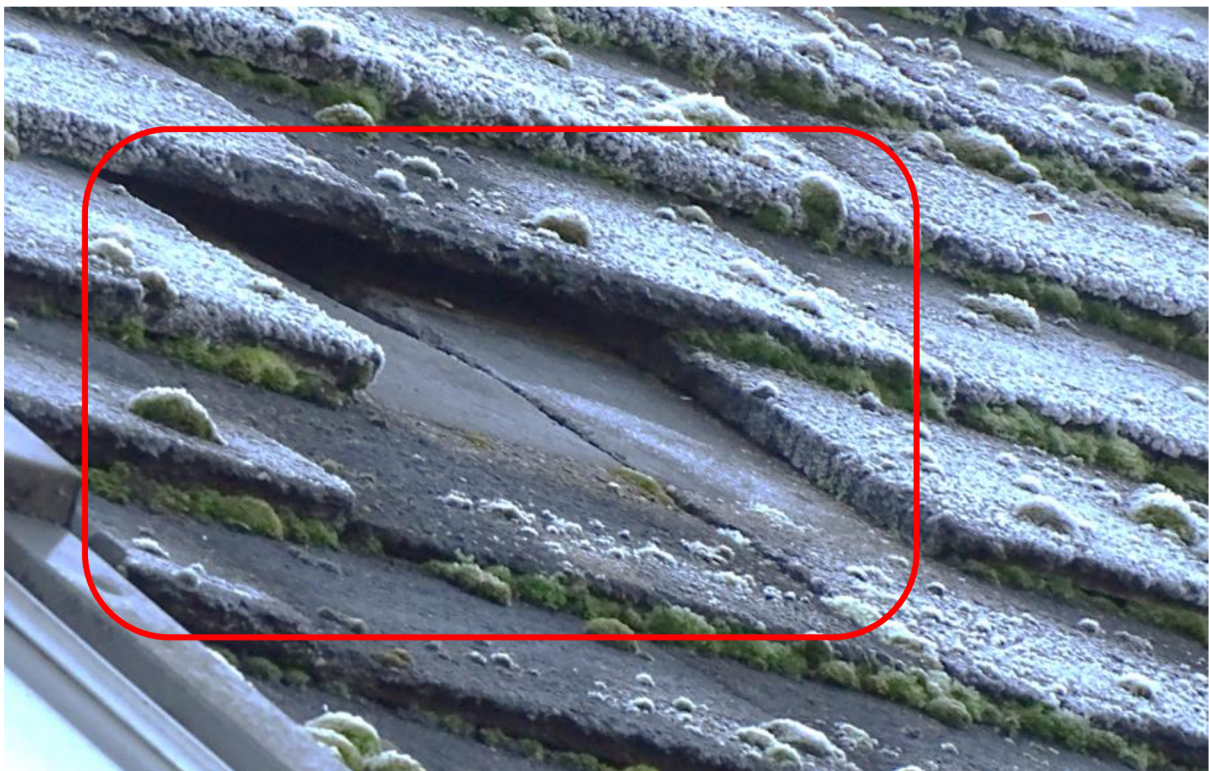
Image 6 – Further gaps of value to bats within the roof coverings to the rear North facing elevation

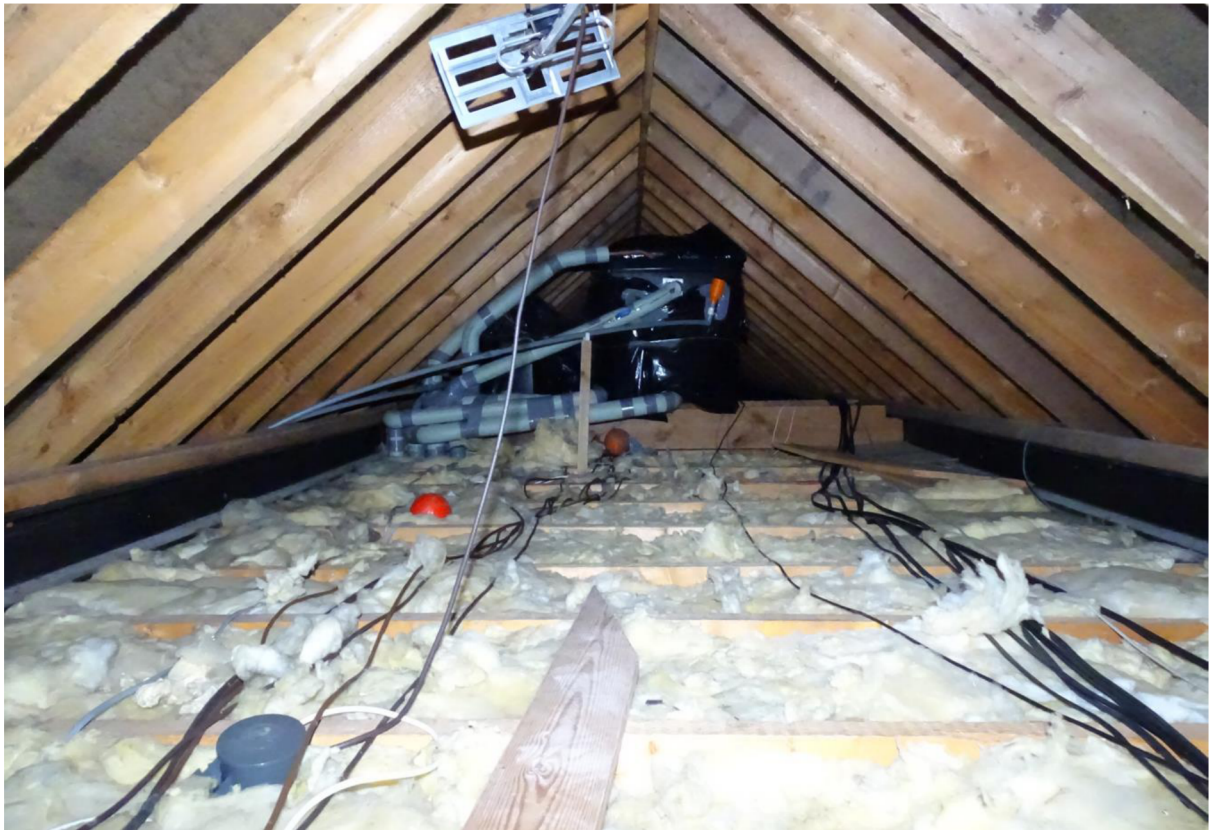
| Internal | Features of value to bats | Notes |
|---|---|---|
| Membrane coverings | Yes | Internally, a felt membrane covering was observed throughout the roof void spaces of the property.<br><br>Such coverings would offer further roosting habitats of value to bats between the membrane and roof tiles where external gaps look to provide access. |

Image 7 – Internal view from within the main roof void spaces of the property

- 6.4** No internal evidence of bat was identified within the roof void areas; however, we are unable to confirm any roosting evidence within the spaces between the roof coverings and felt membrane below where suitable roosting habitats of value to crevice dwelling bats area offered.

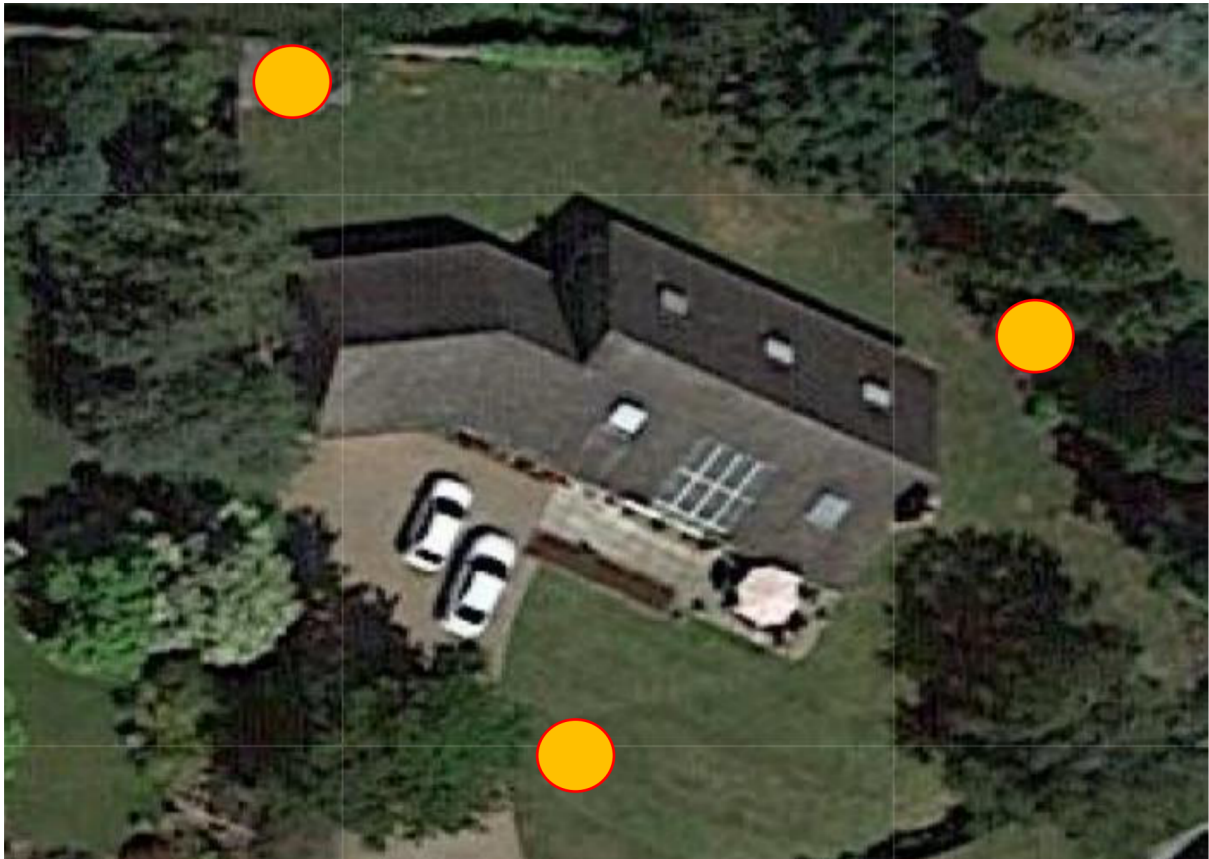
#### Appendix 4: Emergence Survey Location Points

Below site view to show suitable surveyor location points during each emergence survey to maintain visibility of the property.

In line with best practice survey guidelines, a total of three surveyors will be required to visually cover all elevations of the structure during each emergence survey.
