**Taylor Wimpey UK Ltd**

**Land South of Jacqueline Road, Markfield**

**Geo-environmental site assessment**

**Project no. 301538**

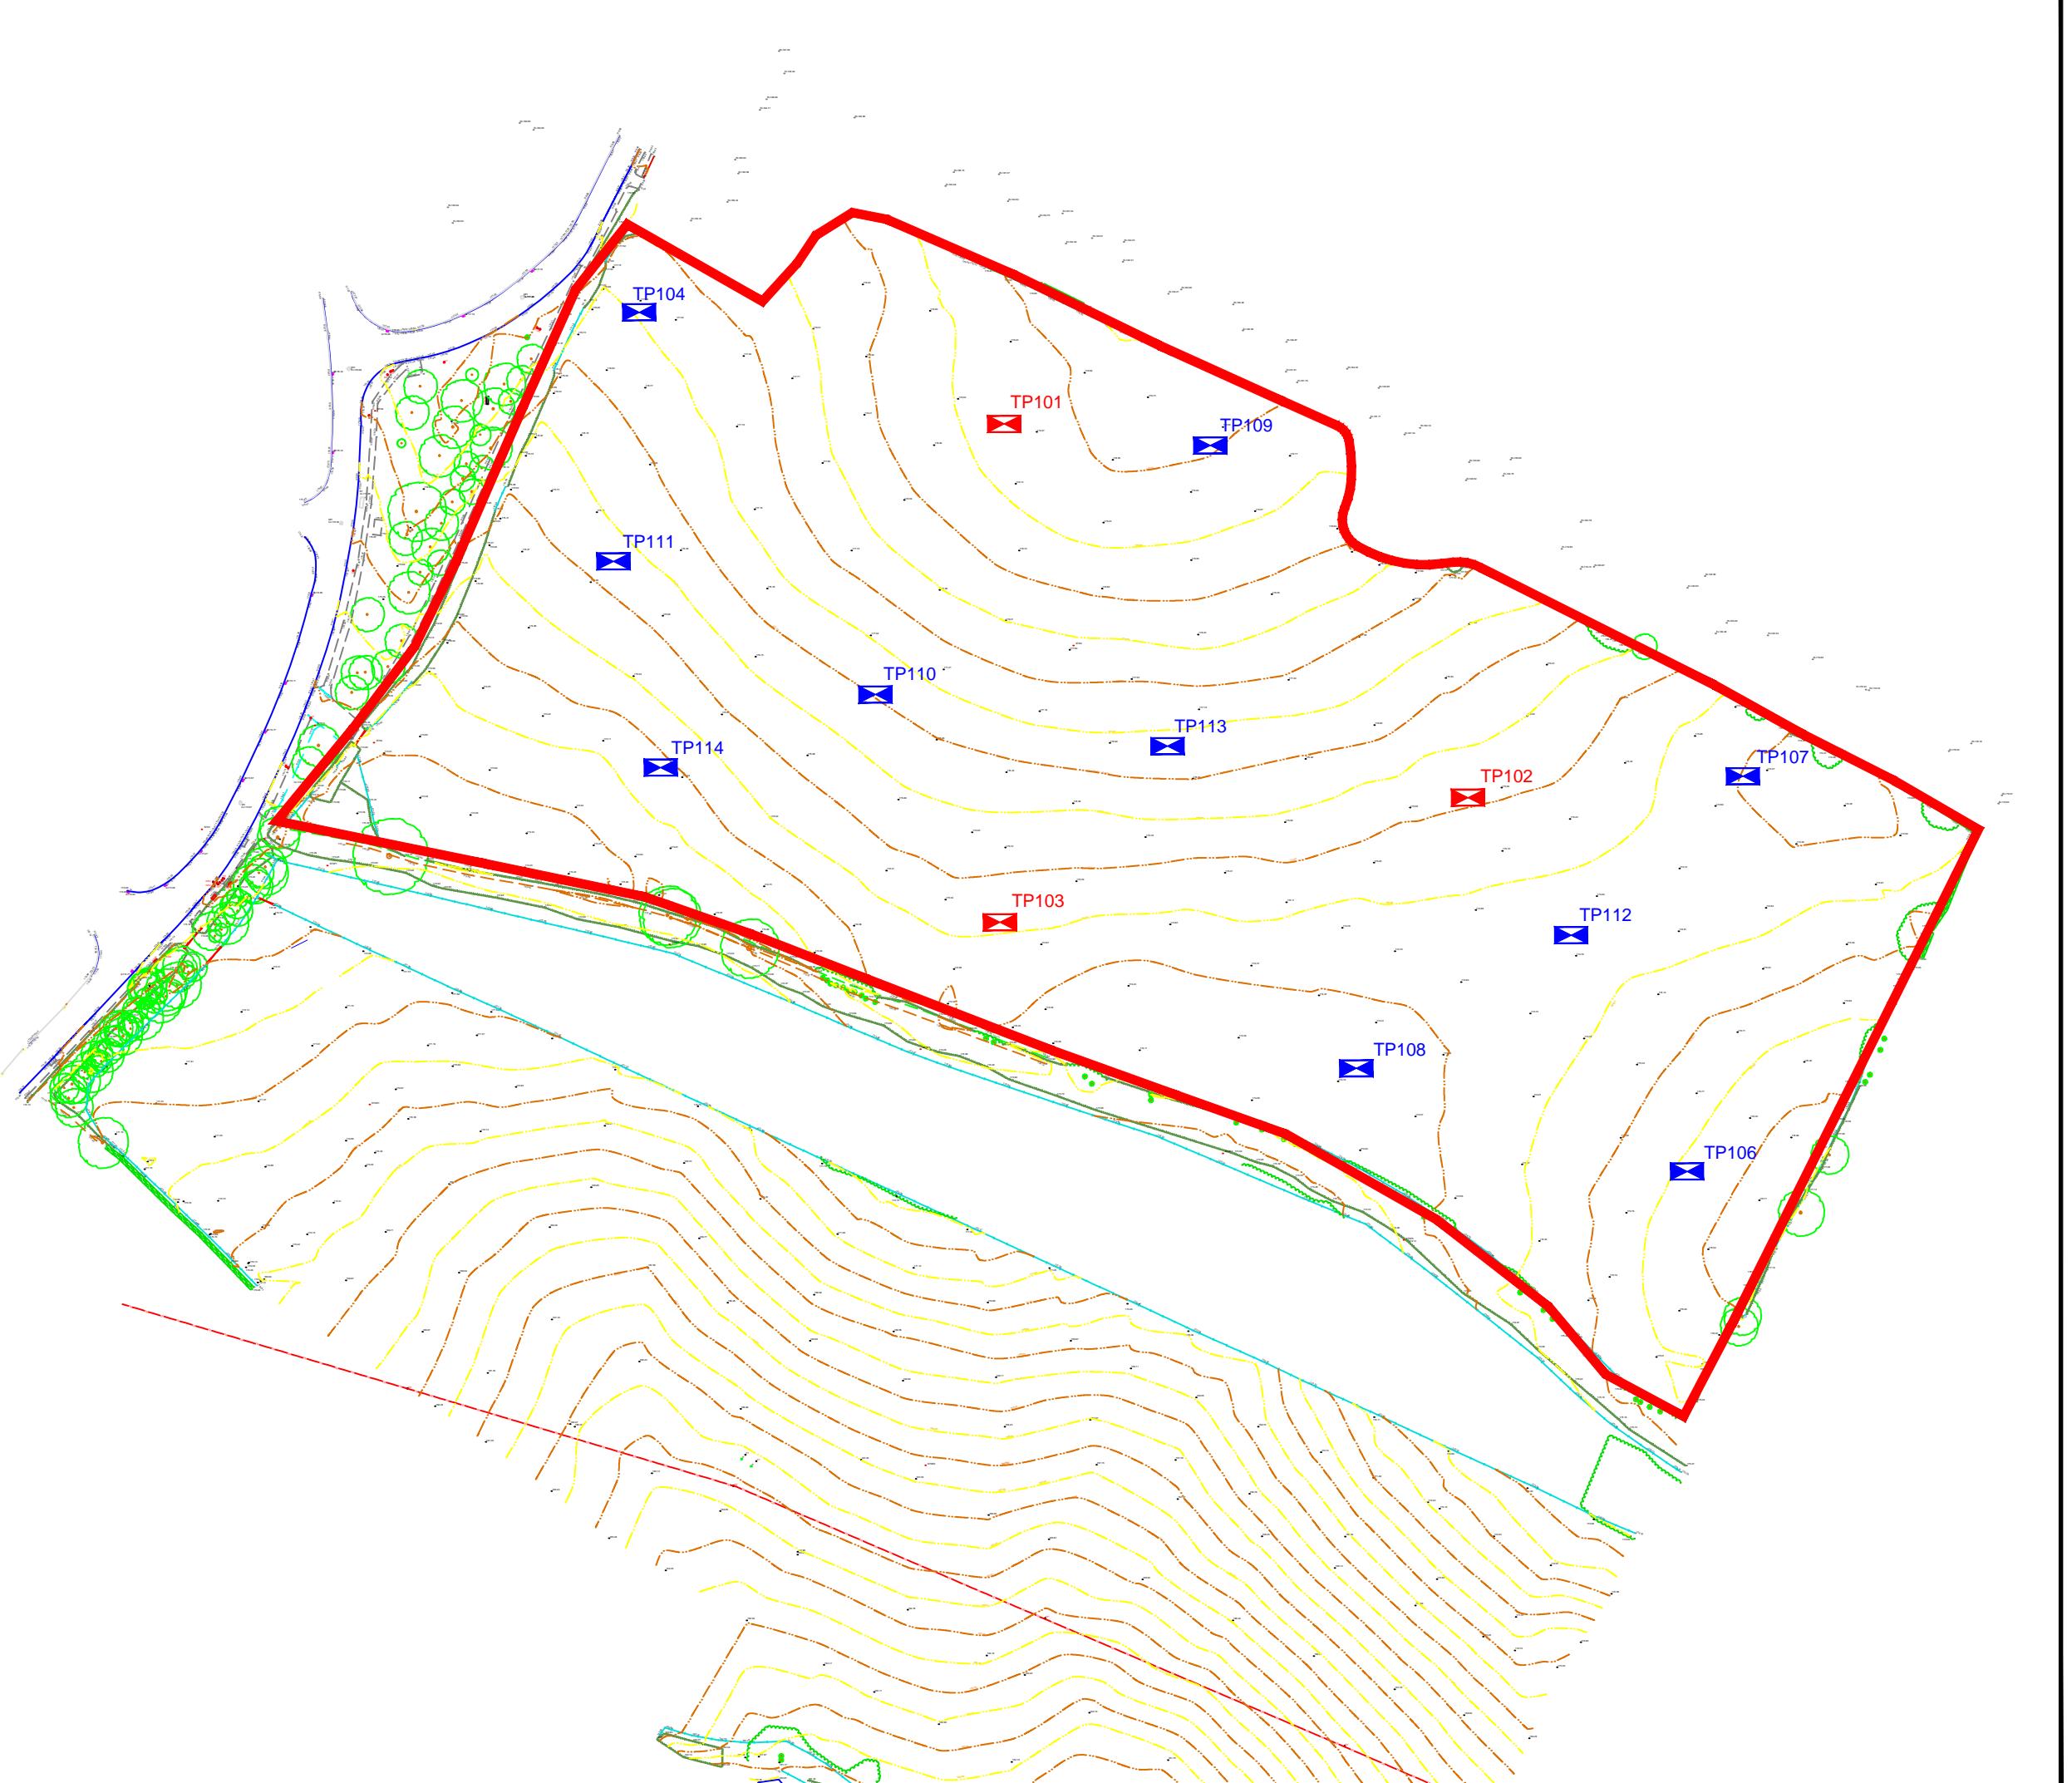
LEGEND:																											
<span style="color:red">—</span>	Site boundary																										
<span style="color:red">■</span>	Soakaway trial pit locations																										
<span style="color:blue">■</span>	Trial pit locations

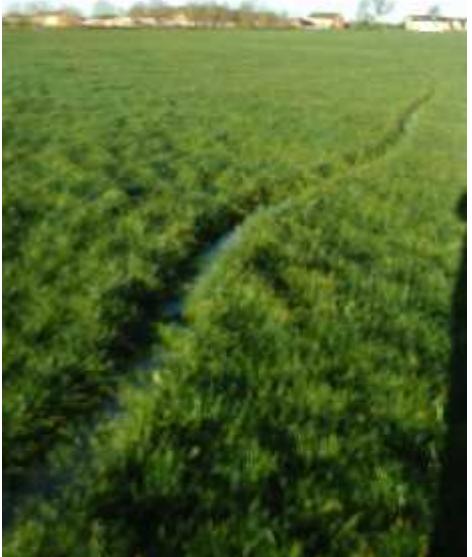
<b>Photo No.</b> 2	<b>Date:</b> 13/01/15	
<b>Direction photo taken:</b> NE

<b>Description:</b> Water filled animal track

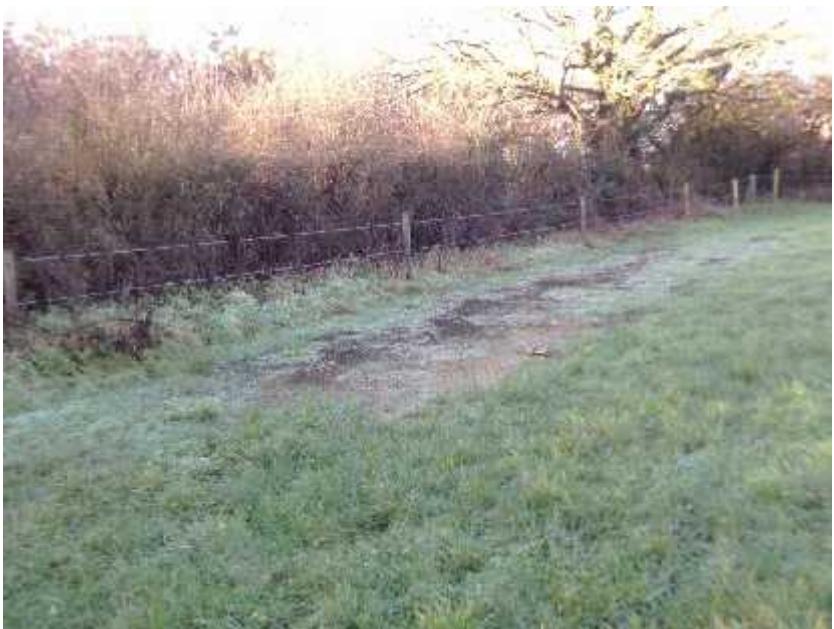
<b>Photo No.</b> 3	<b>Date:</b> 13/01/15

<b>Direction Photo Taken:</b> SW		
<b>Description:</b> Waterlogged area in the south west corner of the site

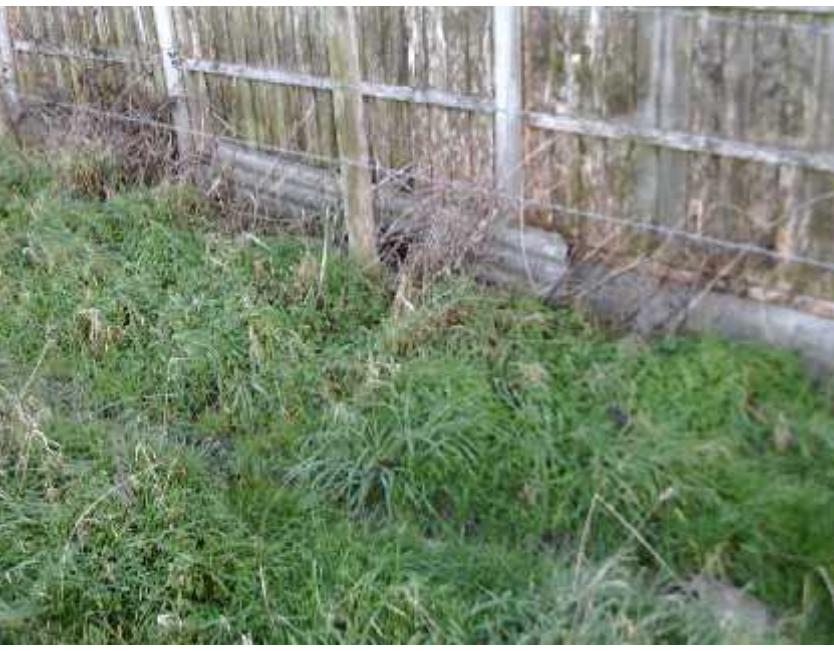
<b>Photo No.</b> 4	<b>Date:</b> 13/01/15

Suspected asbestos containing materials (ACM) were noted in the form of cement board on the northern boundary between the residential rear garden fence and the dual barbed wire fence surrounding the site. There is no evidence of ACM further into the field although its absence elsewhere cannot be discounted.

<b>Direction Photo Taken:</b> N/A		
<b>Description:</b> Suspected asbestos containing material on northern boundary

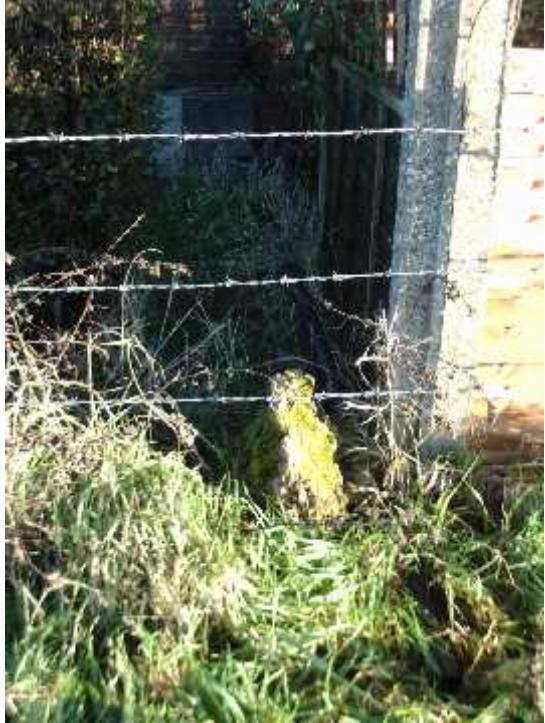
<b>Photo No.</b> 5	<b>Date:</b> 13/01/15	
<b>Direction Photo Taken:</b> N		
<b>Description:</b> Surface runoff pipe from residential property on the northern boundary extends onto the site

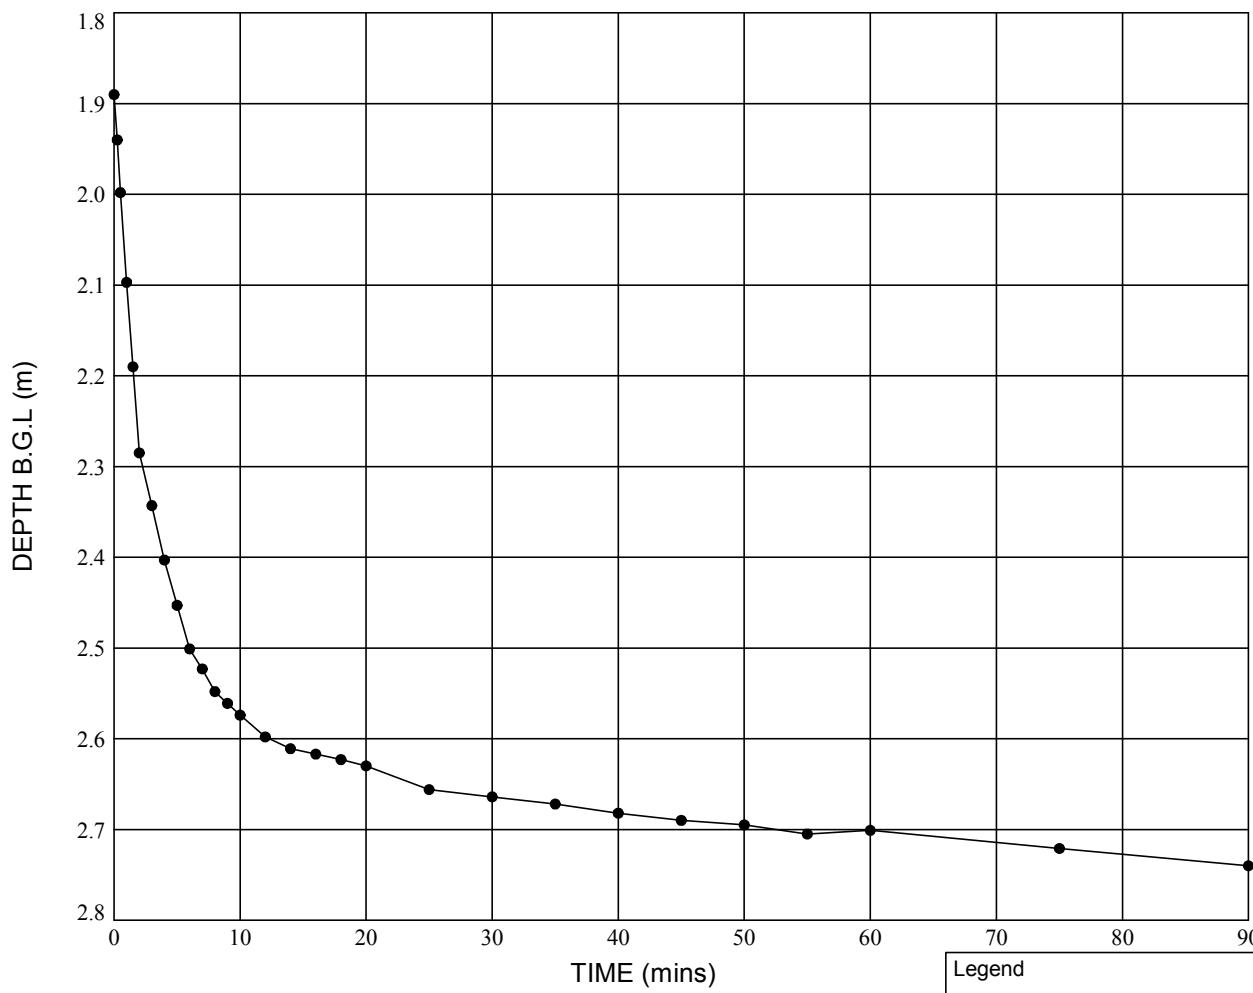
## PLOT OF DEPTH OF WATER BELOW GROUND LEVEL AGAINST TIME

Pit start depth = 2.95 m  
 Pit final depth = 2.95 m  
 Effective depth,  $D_e$  = 1.06 m  
 Effective storage volume,  $V_{p75-25}$  = 1.5370  $m^3$   
 Surface area,  $a_{p50}$  = 7.0340  $m^2$   
 Time,  $t_{p75-25}$  = 2433 secs  
 Infiltration rate,  $f$  =  $8.98 \times 10^{-5} m/s$

Soakaway tests were carried out trial pits, TP101 – 103 to establish the infiltration characteristics of the strata encountered. The tests were carried out generally in accordance with the method described in BRE Digest 365 (BRE, 2007). This involved filling the pits with water from a tanker and recording the drop in water level with time as the water soaked into the ground. The tests were carried out three times within TP101 and TP103. TP102 recorded a rise in water level, possibly due to groundwater infiltration that was not noted during the excavation of the pit. The test was therefore aborted. The data are presented in Appendix H including the calculations in accordance with BS 5930 (BSI, 1999).

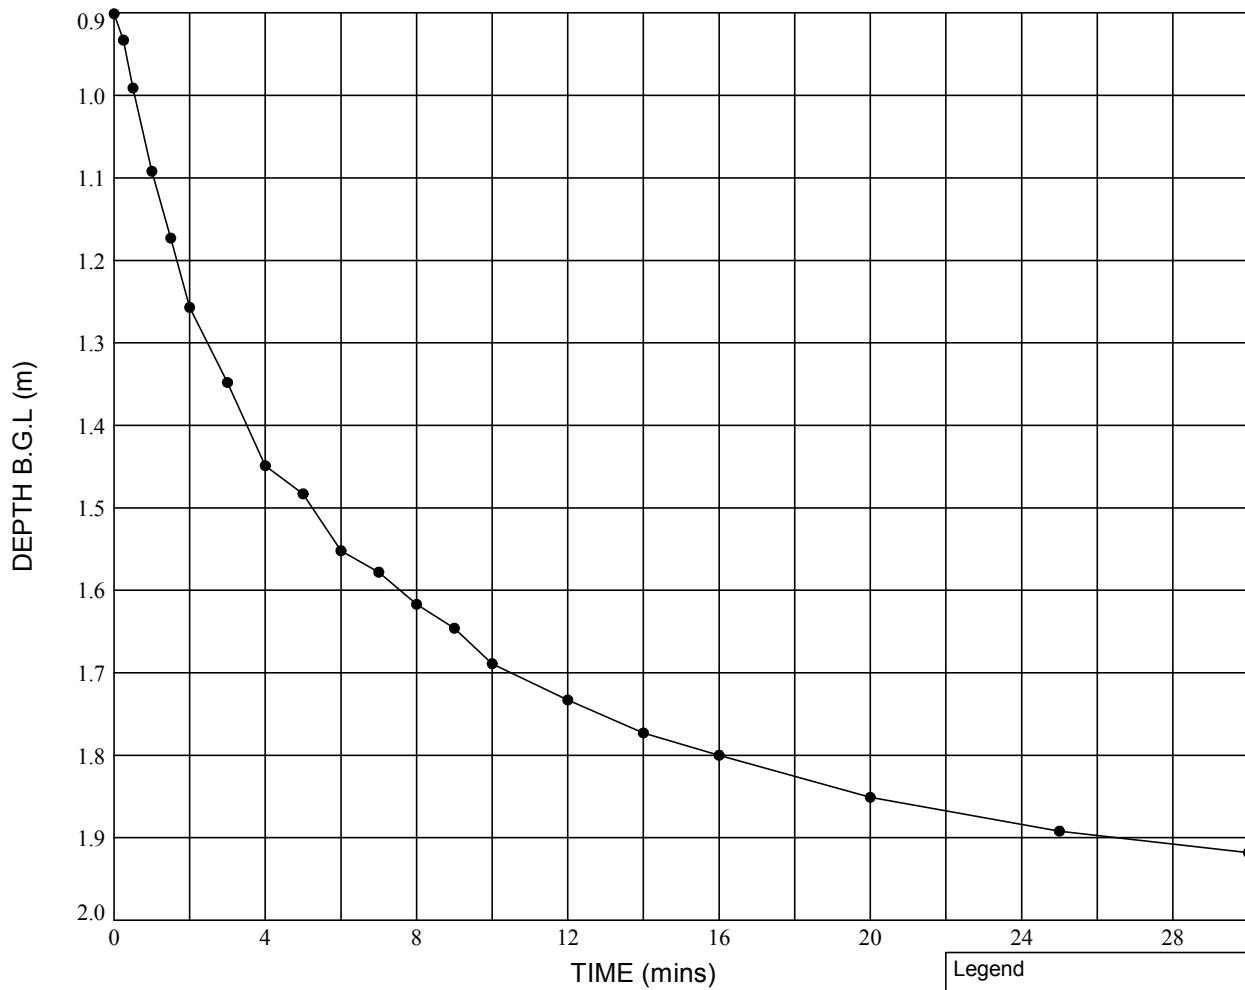
## PLOT OF DEPTH OF WATER BELOW GROUND LEVEL AGAINST TIME

Pit start depth = 2.01 m  
 Pit final depth = 2.01 m  
 Effective depth,  $D_e$  = 1.11 m  
 Effective storage volume,  $V_{p75-25}$  = 0.8151  $m^3$   
 Surface area,  $a_{p50}$  = 4.8525  $m^2$   
 Time,  $t_{p75-25}$  = 627 secs  
 Infiltration rate,  $f$  =  $2.68 \times 10^{-4}$  m/s

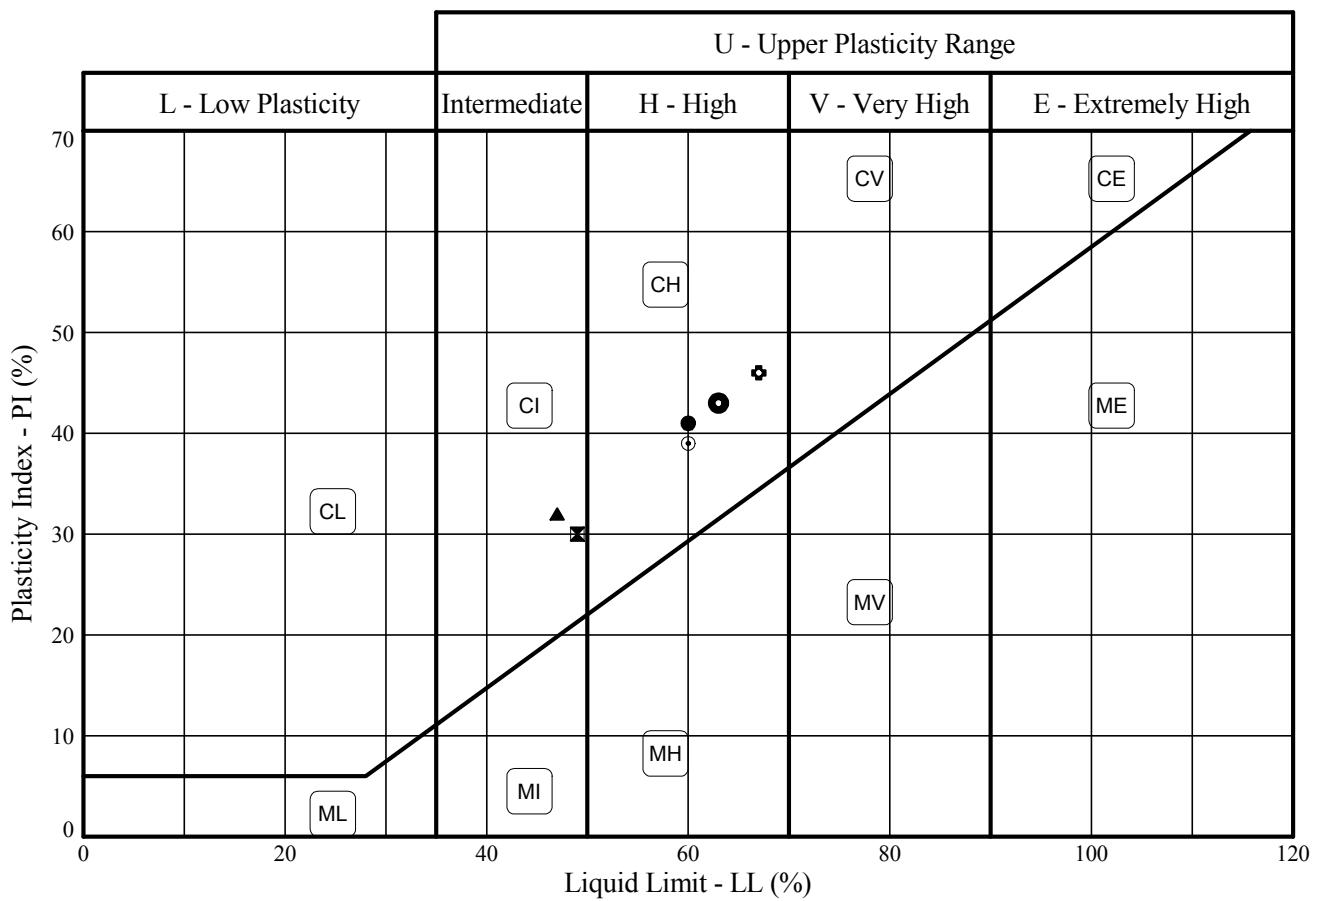
## PLASTICITY CHART - PI Vs LL

Soil parameters	Range	Reference
Liquid limit (%)	47-67%	Appendix I
Plastic limit (%)	15-21%	
Plasticity index (%)	30-46%	
Plasticity term	Intermediate to high	
Moisture content (%)	21-33%	
Undrained shear strength (kN/m <sup>2</sup> ) from shear vane	32-108	Appendix F
Stiffness term	Firm to stiff

In accordance with clause 42.3 of BS5930:1999  
Testing in accordance with BS1377-2:1990

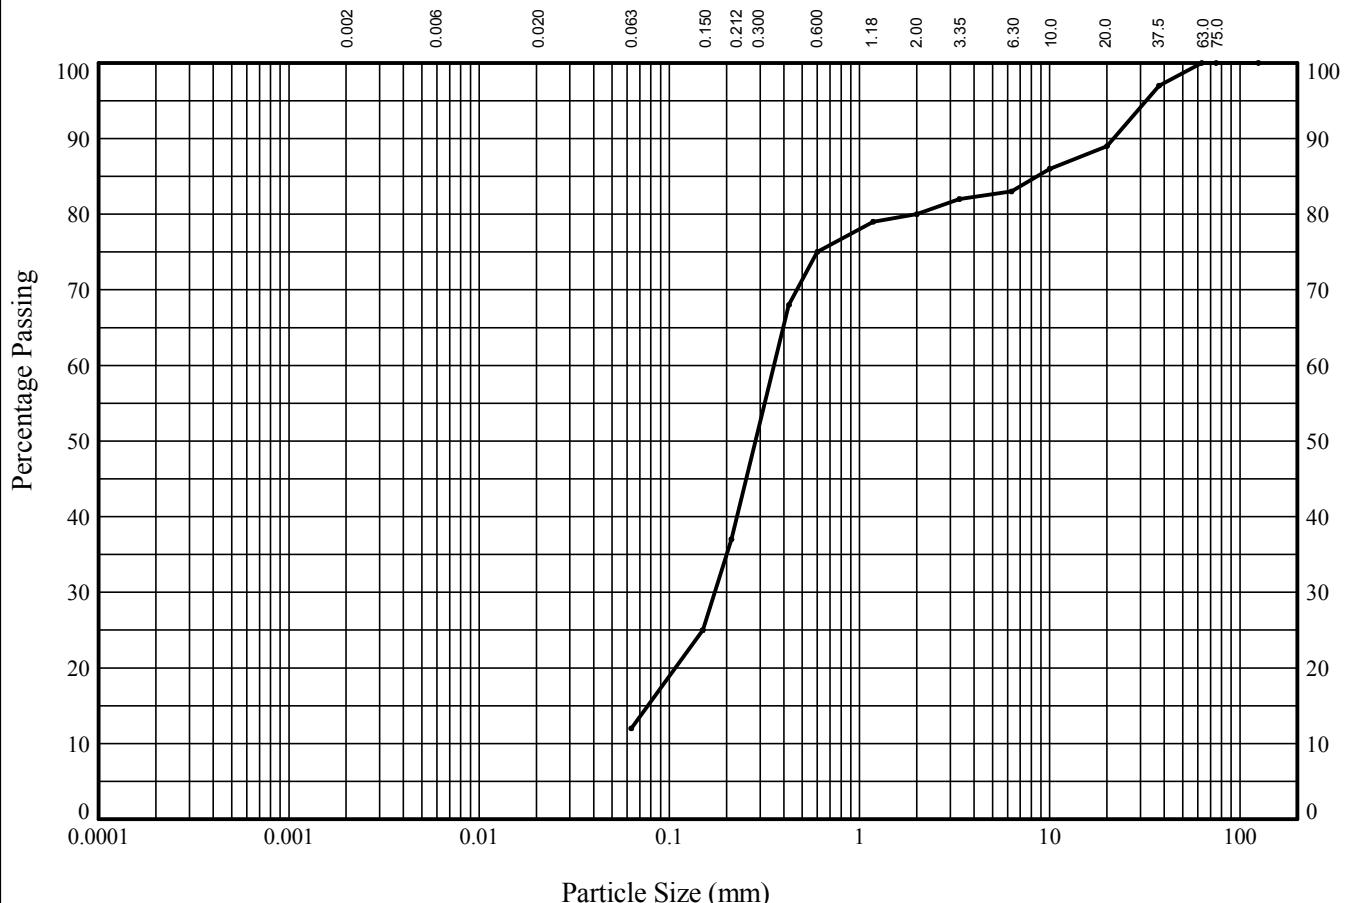
Trial Pit : **TP102**      Sample Ref: **1**      Sample Type: **B**      Depth (m): **1.70**

CLAY		fine	medium	coarse	fine	medium	coarse	fine	medium	coarse	COBBLES
		SILT			SAND			GRAVEL			
BS Test	Sieve (mm)	Percentage			Particle	Percentage		Soil		Sieve	
		Passing			Diameter	Passing		Fraction		Percentage	
	125.0	100						GRAVEL		20	
	75.0	100						SAND		68	
	63.0	100						SILT/CLAY		12	
	37.5	97									
	20.0	89									
	10.0	86									
	6.30	83									
	3.35	82									
	2.00	80									
	1.18	79									
	0.600	75									
	0.425	68									
	0.212	37									
	0.150	25									
	0.063	12

Soil Description:  
**Brown clayey very gravelly SAND**

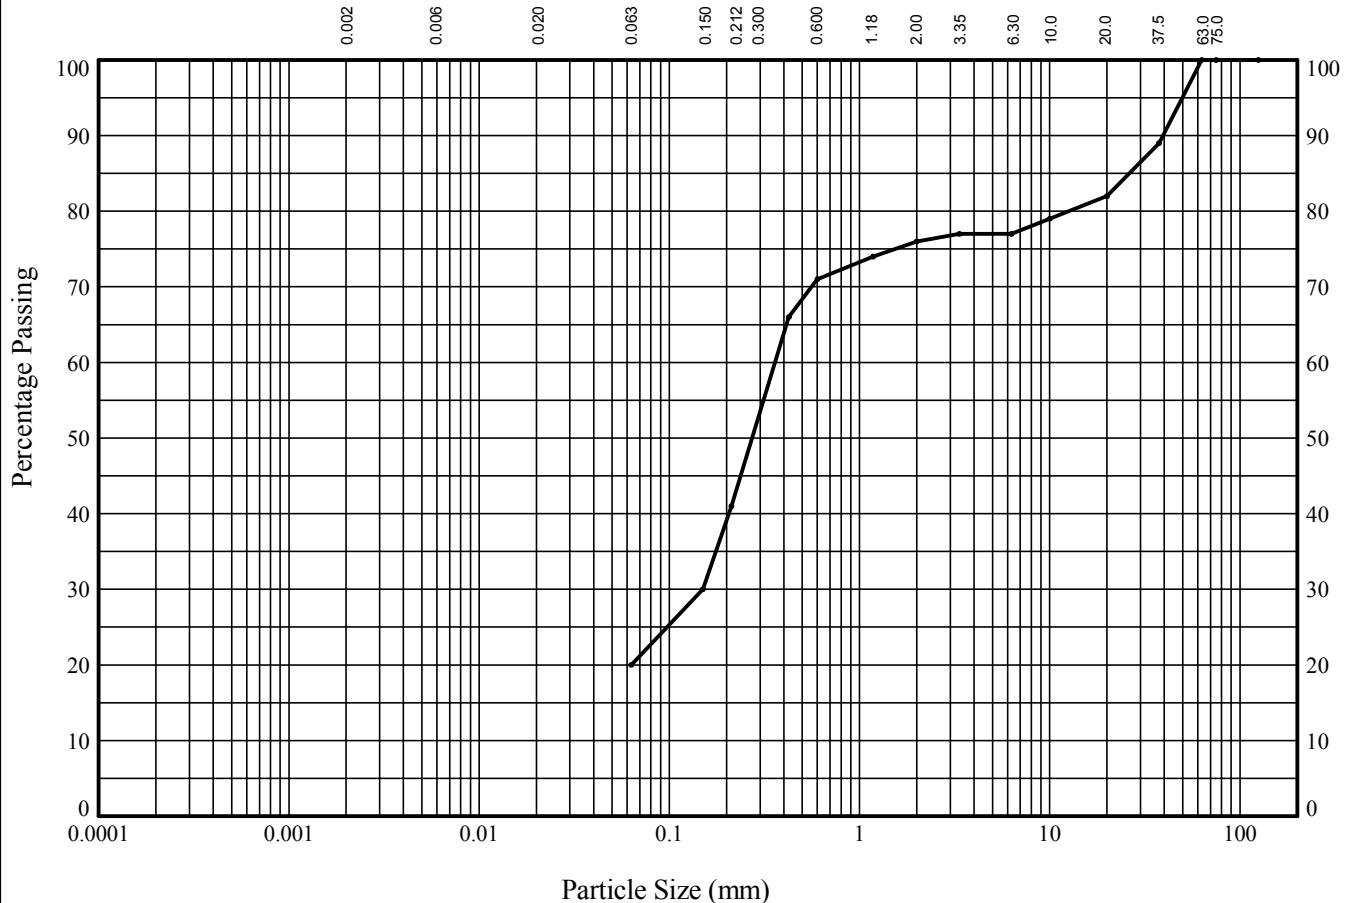
Trial Pit : **TP104**      Sample Ref: **2**      Sample Type: **B**      Depth (m): **1.90**

CLAY		fine	medium	coarse	fine	medium	coarse	fine	medium	coarse	COBBLES
		SILT			SAND			GRAVEL			
BS Test	Sieve (mm)	Percentage			Particle	Percentage		Soil		Sieve	
		Passing			Diameter	Passing		Fraction		Percentage	
	125.0	100						GRAVEL		24	
	75.0	100						SAND		56	
	63.0	100						SILT/CLAY		20	
	37.5	89									
	20.0	82									
	10.0	79									
	6.30	77									
	3.35	77									
	2.00	76									
	1.18	74									
	0.600	71									
	0.425	66									
	0.212	41									
	0.150	30									
	0.063	20

Soil Description:  
**Brown very clayey very gravelly SAND**

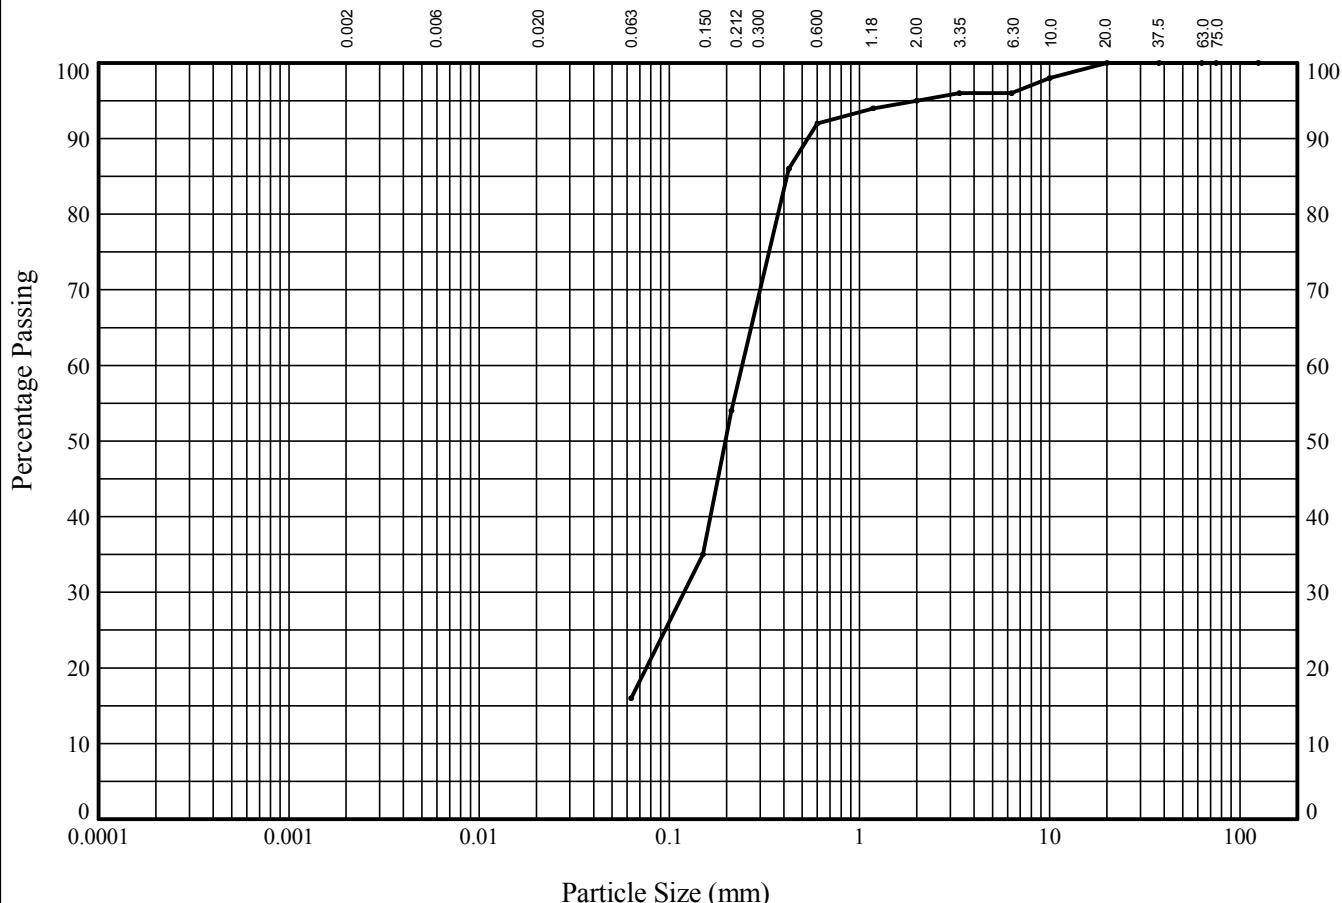
Trial Pit : **TP111**      Sample Ref: **3**      Sample Type: **B**      Depth (m): **1.90**

CLAY		fine	medium	coarse	fine	medium	coarse	fine	medium	coarse	COBBLES
		SILT			SAND			GRAVEL			
BS Test	Sieve (mm)	Percentage			Particle	Percentage		Soil		Sieve	
		Passing			Diameter	Passing		Fraction		Percentage	
125.0		100						GRAVEL		5	
75.0		100						SAND		79	
63.0		100						SILT/CLAY		16	
37.5		100									
20.0		100									
10.0		98									
6.30		96									
3.35		96									
2.00		95									
1.18		94									
0.600		92									
0.425		86									
0.212		54									
0.150		35									
0.063		16

Soil Description:  
**Brown clayey gravelly SAND**

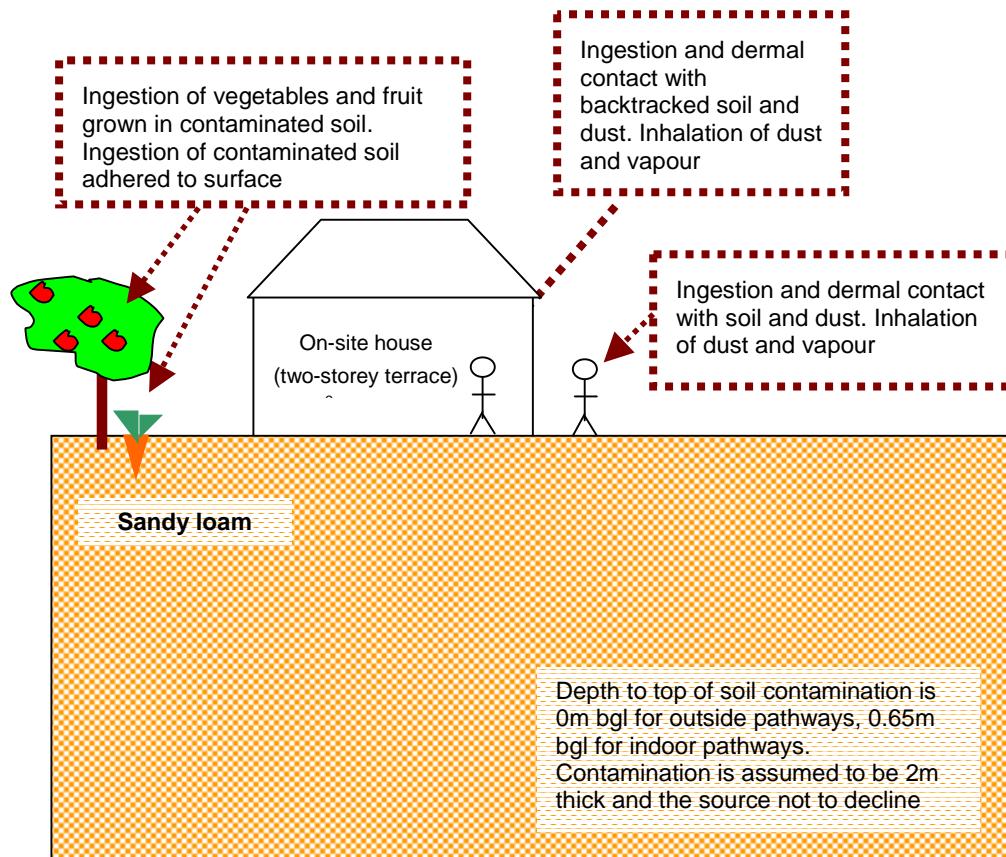
**Figure 1: Conceptual model for CLEA residential scenario – private gardens**

The SAC were produced using the input parameters in Tables 1 to 5 and the GrAC using input parameters in Table 6. The final selected GAC are presented by pathway in Table 7 and the combined GAC in Table 8.
