## *Class Q Structural Inspection*

Project: Former Agriculture Barn, Lutterworth Road, Burbage

Project No: 26-22876

Document No: 0-030

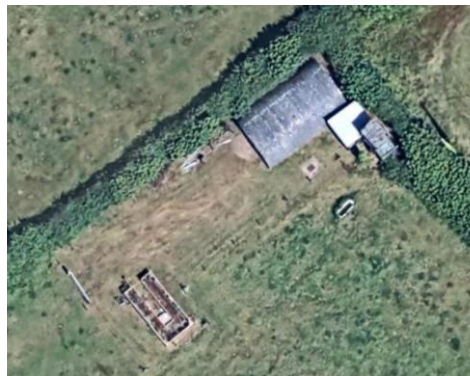
- 3.1. The buildings are of mixed construction as indicated on the accompanying plan.

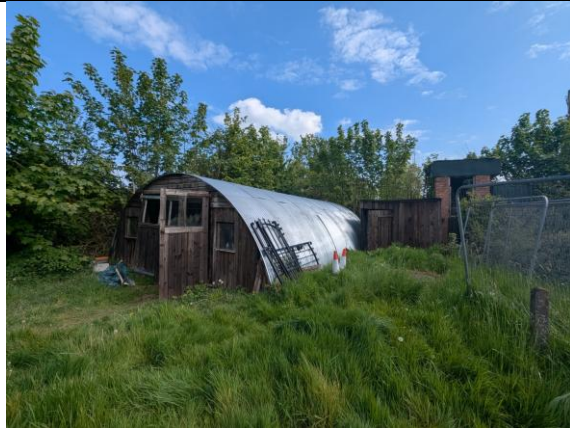
Photo 1 – Front Elevation

3.2.2. The front and rear walls are formed in timber frame

construction that is generally performing well, albeit is currently uninsulated.

These elements are considered suitable for retention and upgrading.

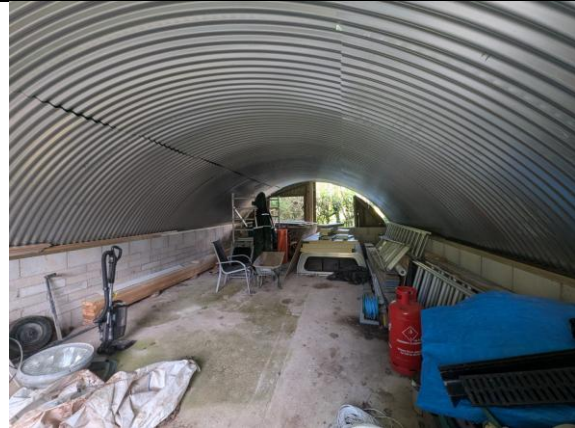
Photo 2 – Internal view

- 3.2. The principal structure comprises a steel-framed Nissen hut of agricultural origin, historically utilised for storage. The building is formed from semi-circular steel ribs, enclosed in corrugated metal sheeting forming both the roof and wall envelope.
- 3.2.1. The building is generally watertight and enclosed, with the corrugated metal sheeting forming a continuous external envelope. The roof operates as an enclosed and weather-resistant structure in its current form. It is anticipated that thermal upgrading measures, including internal insulation and lining, will be required as part of the proposed conversion.

3.2.3. The concrete ground floor slab is in excellent condition, free from cracking, movement and is suitable for re-use. Any upgrade works required will relate to thermal and damp performance, rather than structural integrity.

3.2.4. The primary steel frame exhibits no signs of distortion, instability or buckling typically associated with a failing corroded frame. The frame geometry remains true and stable in its present form. The structure represents a sound and serviceable loadbearing system, capable of supporting conversion works without structural rebuilding.

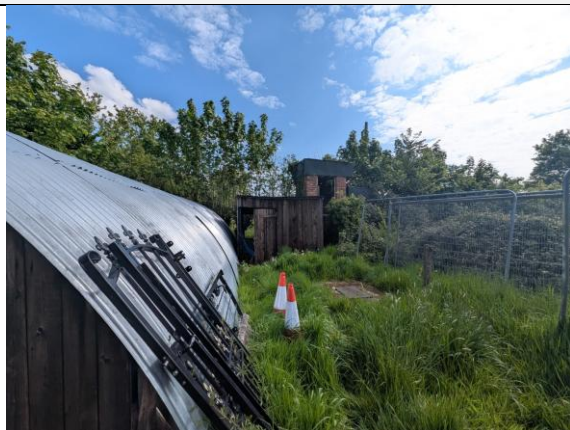
Photo 3 – Water Tower

3.3. Adjacent to the hut is a detached structure comprising of a 1.5 storey loadbearing brick structure, consistent with a former water tower. The brickwork is in good condition and is suitable for re-use. The building is generally dry inside indicating a level of weather-tightness suitable for conversion.

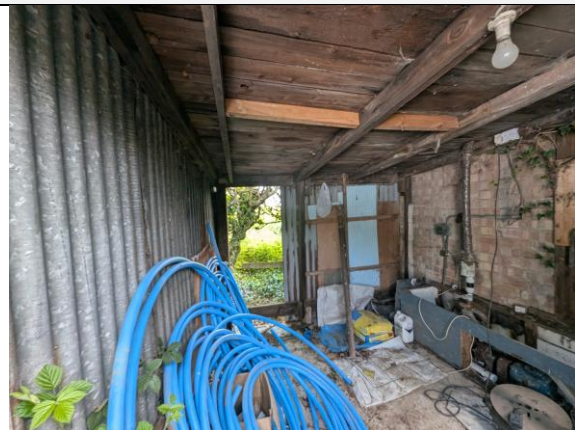
Photo 4 – Pump house

3.3.1. A lightweight timber pumphouse, of later construction has been built between the brick tower and the Nissen Hut. This building is dry inside and appears to be performing well. This is likely to be built off the concrete slab which is in good condition and is suitable for re-use.

3.3.2. The timber walls and roof are currently uninsulated and require thermal upgrading as part of the conversion works.
