# Preliminary Bat Roost Assessment

Horiba MIRA, Watling Street, Nuneaton

A Report To: Horiba Mira Ltd  
Report Number: RT-MME-159786-03  
Date: March 2023

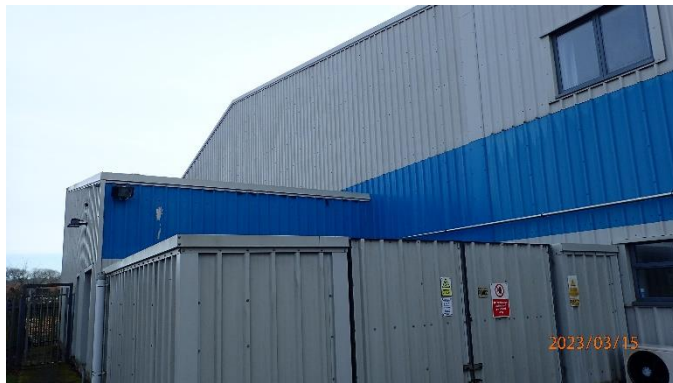
**Plate 3.1: External view - western elevation**

Building B1 comprised a large, steel-framed building, approximately 9 m tall and constructed from sheet metal with a plastic spray coating (Plate 3.1). The walls were double panelled with two skins of metal, and insulation material between the two. Due to the corrugated nature of the metal sheeting small gaps were present in some locations, however, these were blocked by foam inserts and did not lead into any suitable crevices or cavities. The roof was gabled with a low gradient and comprised metal panels all of which appeared tightly sealed. To the rear was a single-storey blockwork extension, the walls and roof of which also appeared tightly sealed with no suitable bat roosting features or ingress points.

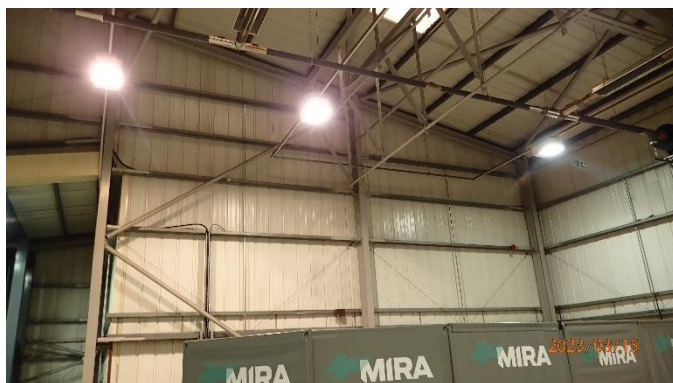
**Plate 3.2: Internal space**

Internally the building was open to the roof and no lofts or voids were present. The internal room is in frequent use and brightly illuminated. No suitable roosting features were present.
