IV.124.23  
Date: 6<sup>th</sup> February 2024

**RE: Land off Lindridge Lane, Desford, Leicestershire**

As per your instruction, Ivy House Environmental (IHE) attended the site known as land of Lindridge Lane, Desford, Leicestershire on the 24<sup>th</sup> October 2023 in order to undertake geotechnical investigation at the site. Soakaway testing was also undertaken to determine a soil infiltration rate at the site.

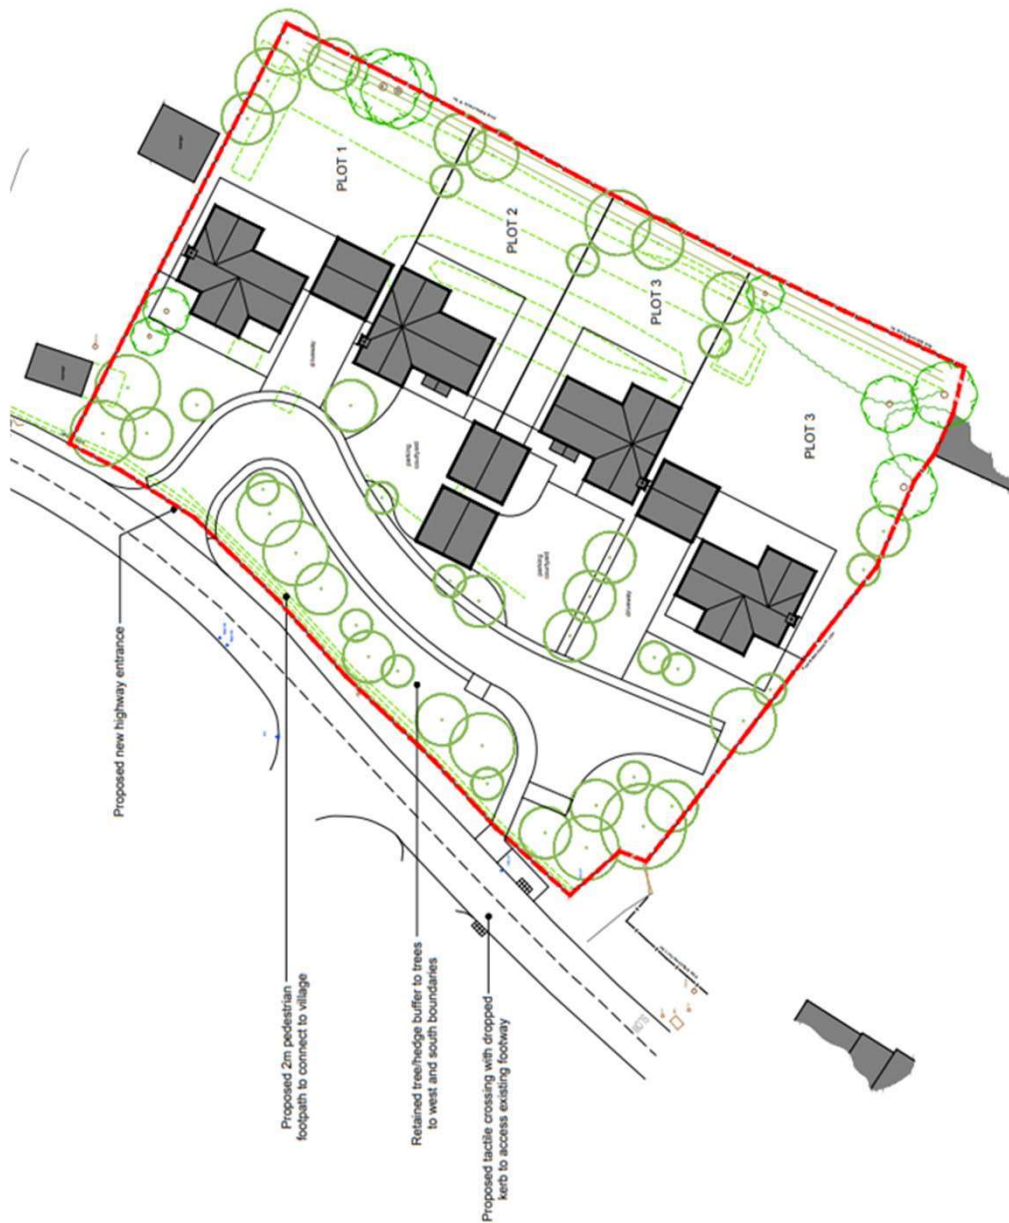
| | | DWG No:<br>Figure 4 | |

| TITLE:<br>Development Proposal | | | |

The development proposal for the site is for the development of four residential properties with associated access road and private gardens.
