LAND AT CRABTREE FARM, BARWELL (PARCEL 1)

PHASE II GEO-ENVIRONMENTAL ASSESSMENT  
FOR  
JAMES MADISON HOMES LIMITED

**Project Ref:**  
EAL.02.20

**Date:**  
September 2020

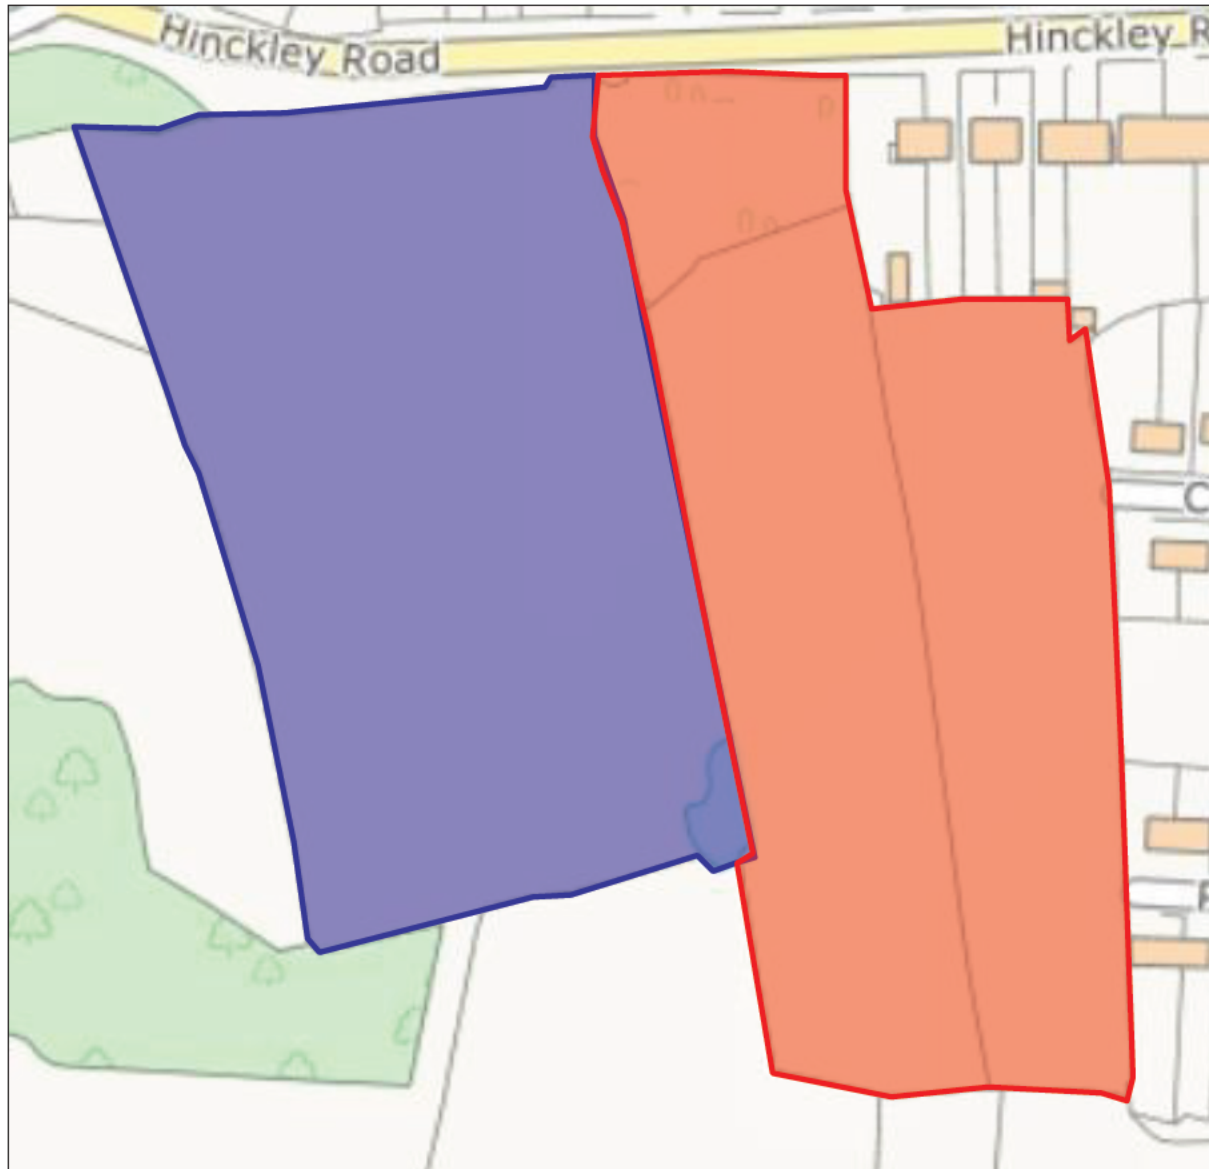
Proposed End Use Plan

Parcel 2 - area of proposed burial ground (not included in Phase II Report)

The intrusive investigation incorporated both the area of the proposed residential (Parcel 1) and the area of the proposed burial ground (Parcel 2). This report will focus solely on the proposed residential development area (Parcel 1). A separate report will be issued for the burial ground (Parcel 2). A site plan showing the extents of Parcel 1 and 2 is included in **Appendix A** for clarity.

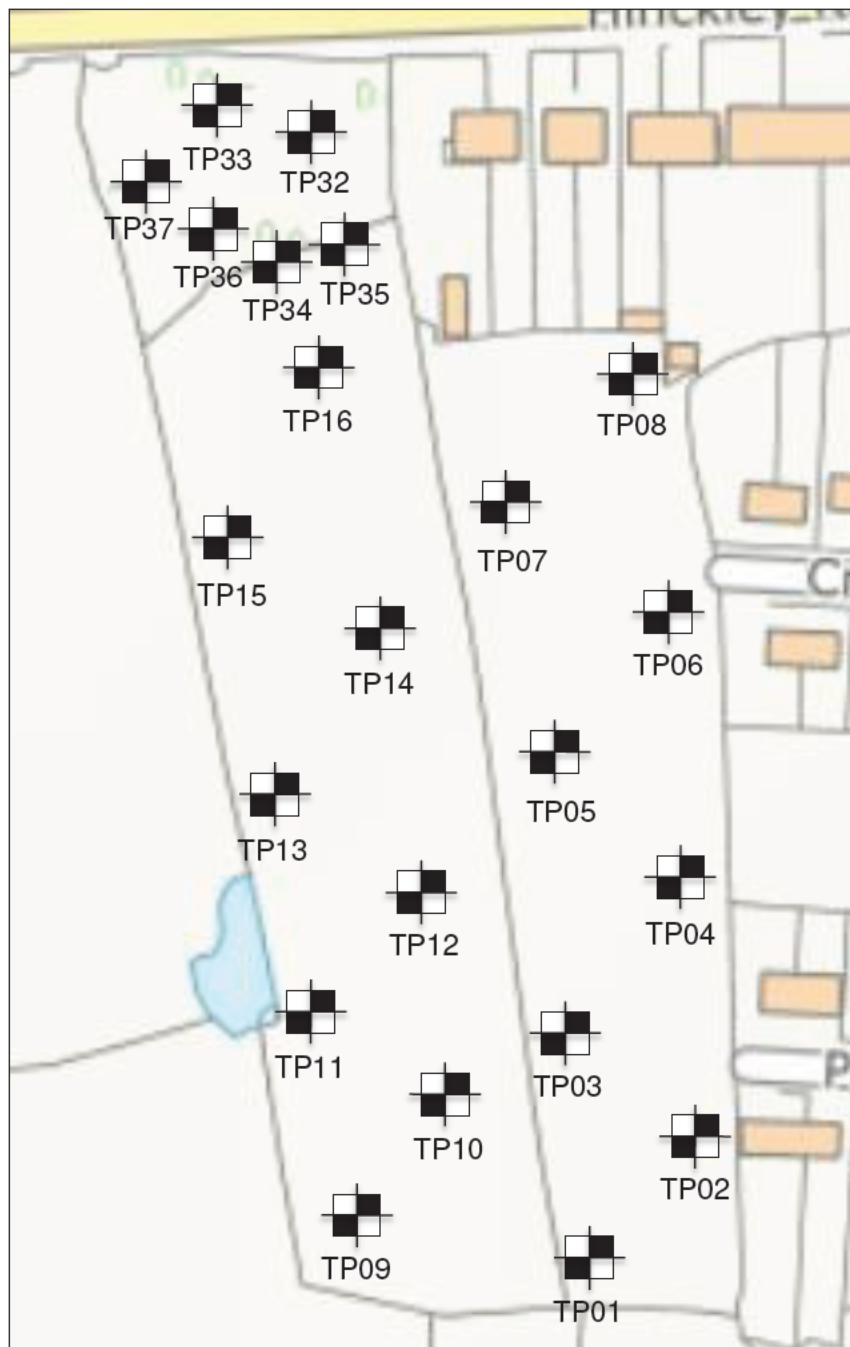
Exploratory Hole Location Plan

Trial Pit

- The advancing of 22 mechanically excavated trial pits to a maximum depth of 3.00mbgl,
- The analysis of 15 soil samples for a standard 'CLEA' screening suite and selected site specific determinands,
- The analysis of 5 samples for geotechnical design criteria including Plasticity Index (PI), Water Soluble Sulphate and pH,

The exploratory hole location plan along with all exploratory hole records are contained in **Appendix B**.

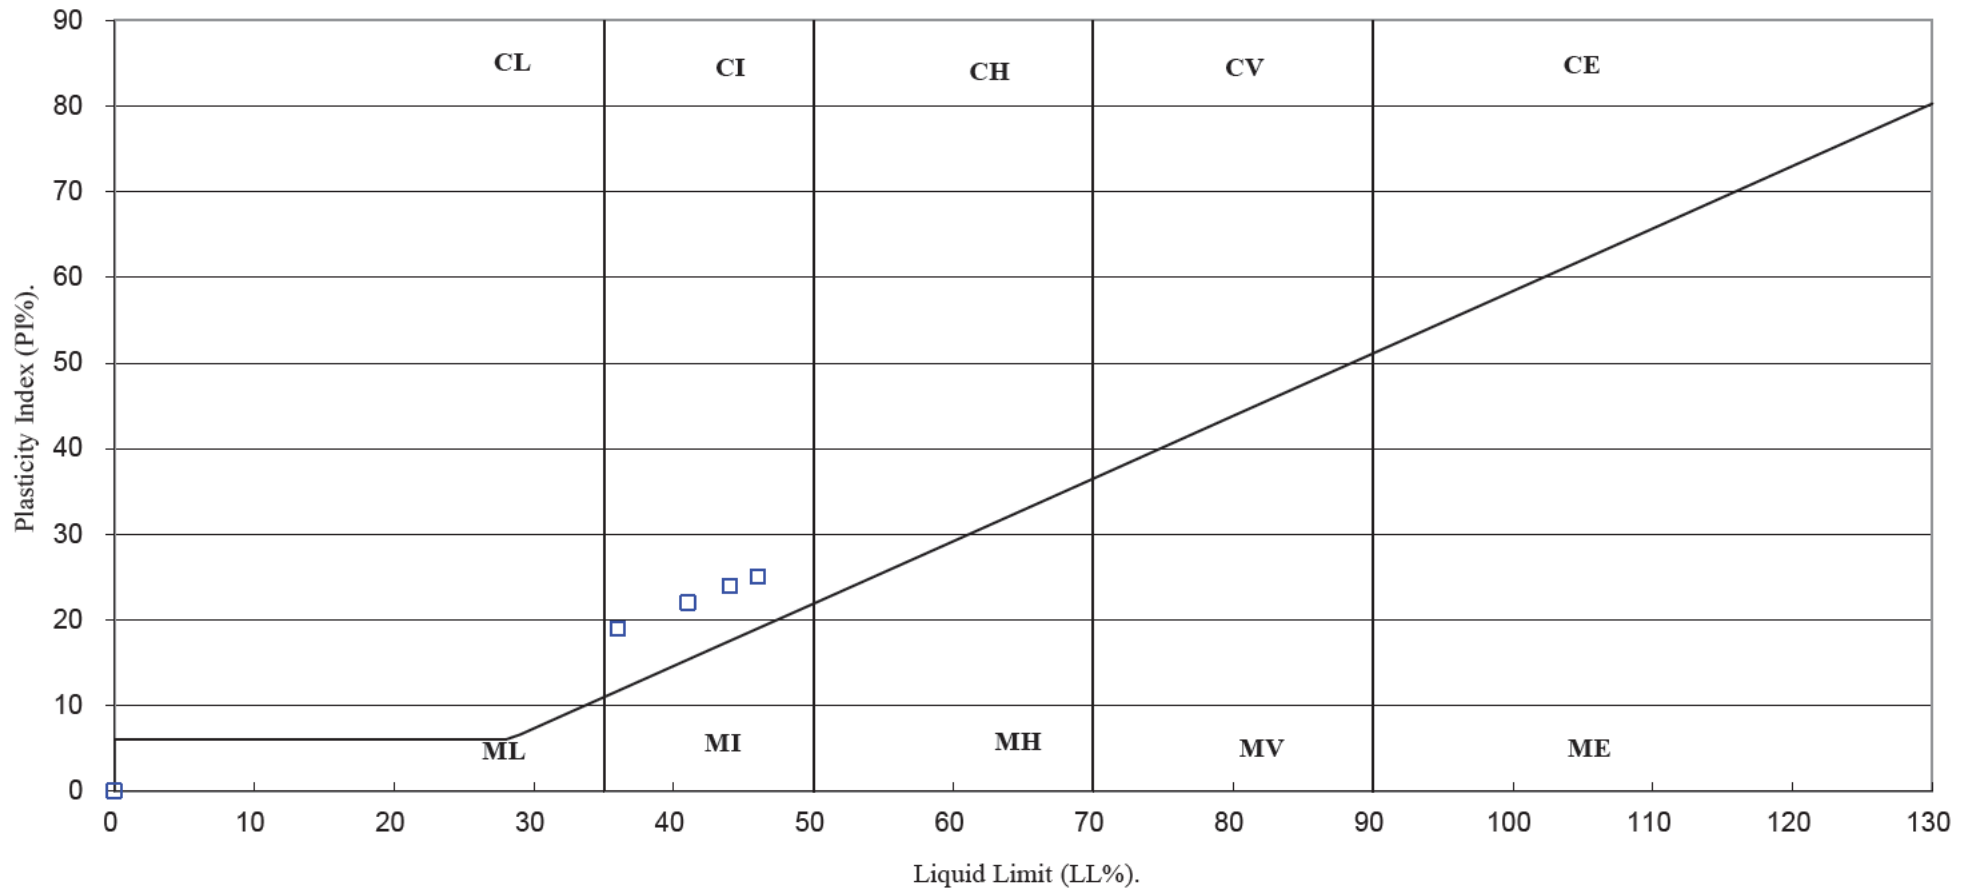
# PLASTICITY CHART FOR CASAGRANDE CLASSIFICATION.

The results contained in **Appendix C** illustrate PI values of between 19% and 25% and moisture contents between 17% and 19%, indicating the cohesive deposits to be of medium volume change potential as a maximum classification which should be used across the site.
