## Preliminary Ecological Appraisal & Preliminary Roost Assessment

36 Barton Road, Market Bosworth, Nuneaton, Leicestershire CV130LQ

This report is prepared to inform a planning application with Hinckley and Bosworth Borough Council. This proposal can be described as Extension and alterations to dwelling

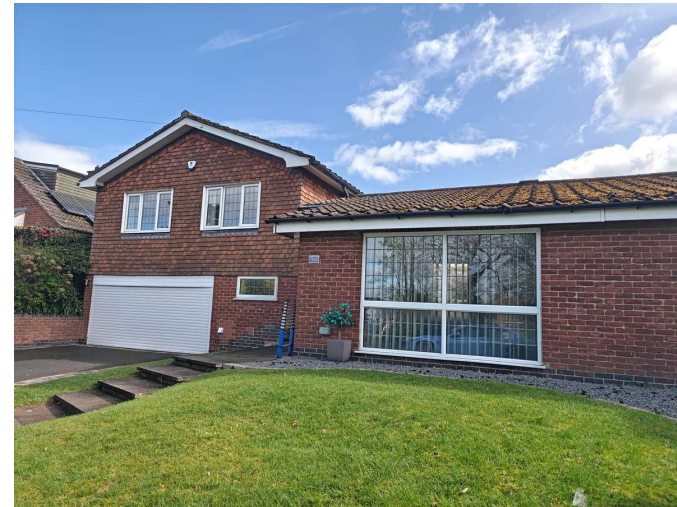
B1 is a two-storey, detached, brick-built dwelling. The main roof is of gabled structure with concrete tiles. Internal voids were recorded within the building. No bat evidence was found during the survey.

In line with Good Practice Guidelines (Collins, J (Ed) 2023), B1 is assessed to have low habitat value for roosting bats due to the only feature present being the hanging tiles.

One bat emergence survey is required on B1 during the active bat season (May- September) to confirm presence /likely absence of abts roosting in or on the building. 2 Surveyors and 2 unmanned IR cameras are required to provide full coverage of the buildings' elevation to look for emerging/re-entering bats.

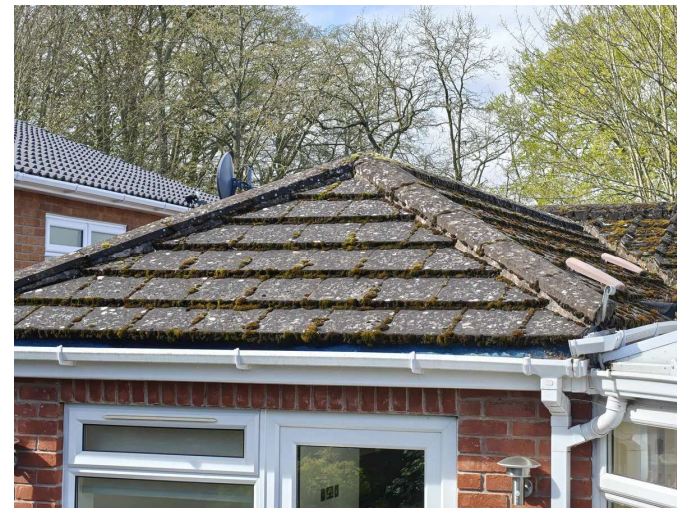
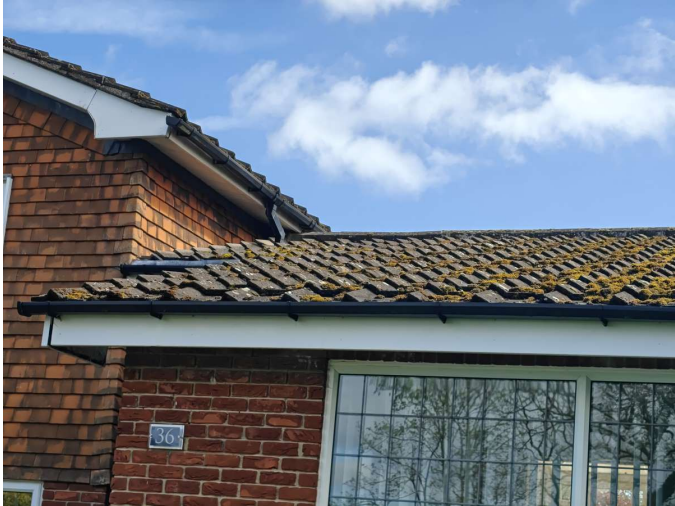
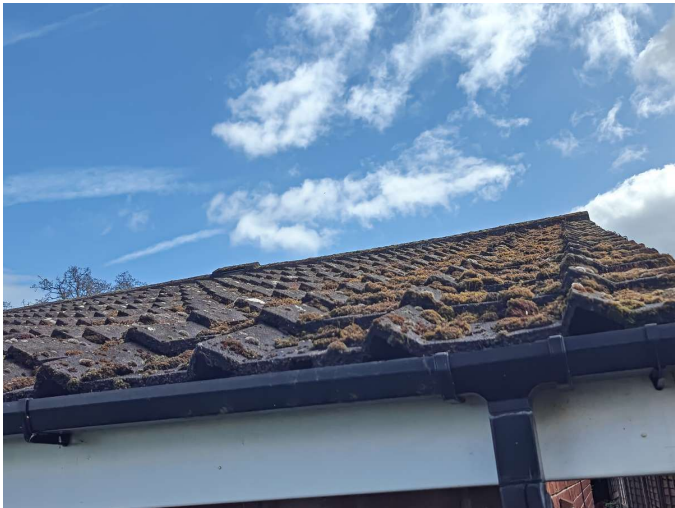
The roof is in good condition with an intact covering and no substantial gaps. There are a small number of small gaps (<8mm) between concrete tiles, however, these are unlikely to support bats due to their size and the presence of spray foam insulation underneath. The majority of these gaps are filled with moss. The size of the gaps are too small for bats to access.

| | | | | <p><i>South east ground storey hipped roof</i></p> <p><i>Ground storey west elevation</i></p> <p><i>Small gaps &lt;8mm</i></p> | |

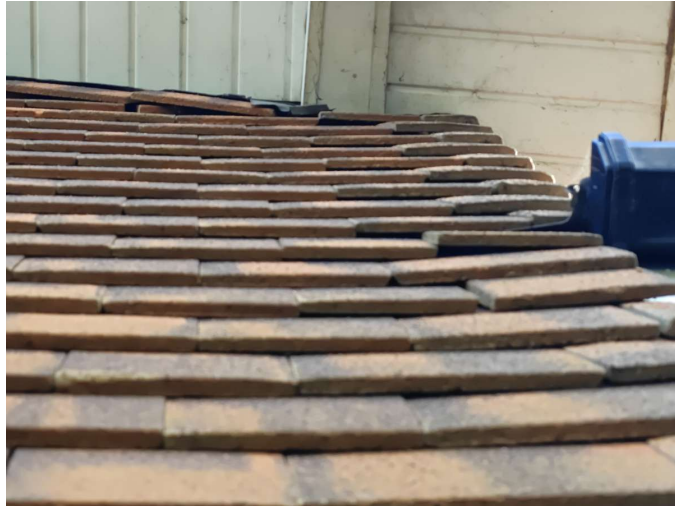
| | Walls | Brick-built + Hanging tiles (sections) | The walls exhibit gaps under hanging tiles. Specifically, on the west elevation of the two-storey aspect, there is an area of hanging tiles containing several gaps large enough for individual bats, potentially leading to further roosting habitat behind the tiles or within a wall cavity. | <p><i>Gaps under hanging tiles</i></p> | |

The proposed development will result in major works to both elevations and roof, including removal of hanging tiles, this could result in the destruction of any bat roosts present and could cause disturbance, death or injury to bats.

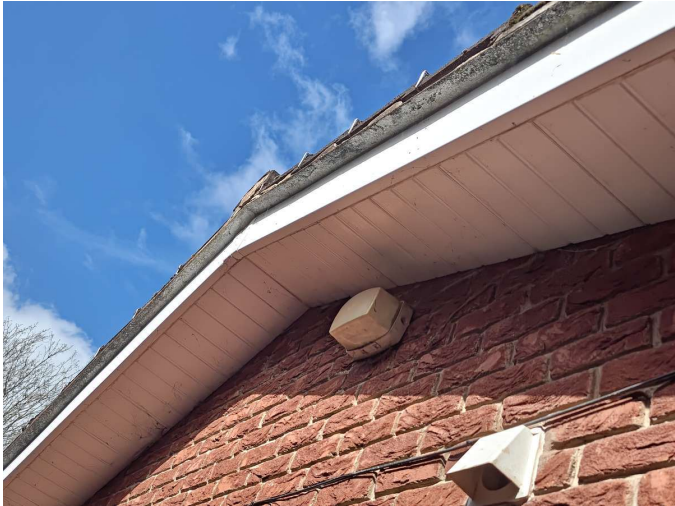
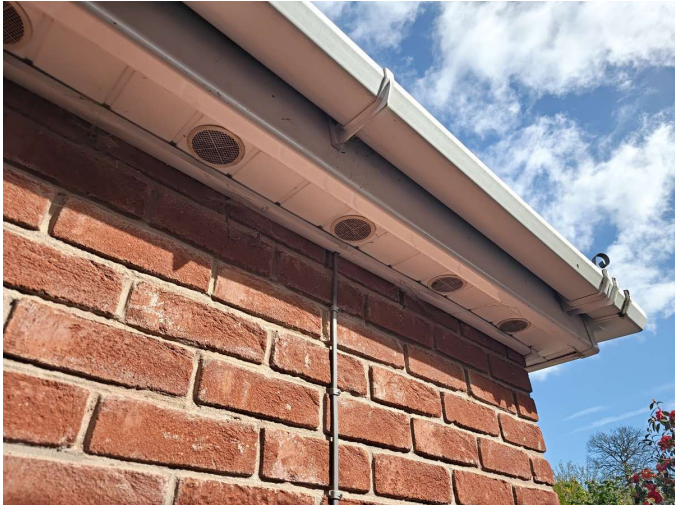
| | Eaves | PVC | <p>The eaves and soffits are in good condition, appearing intact and well-sealed. There are no observed gaps under the soffits, which are flush to the brickwork.</p> | <div><p><i>Gable end soffit</i></p><p><i>Ground story soffit</i></p></div> | |

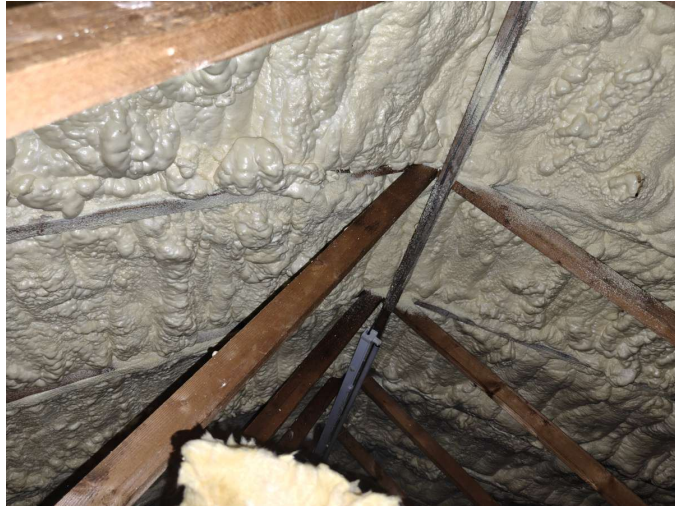
| | Voids | Spray insulation | <p>A loft space void was recorded within B1. This void is accessible and measures approximately 12 sq m with dimensions of 6m length, 2m width, and 1m height. The void contains spray insulation. The temperature was recorded at 17°C and humidity at 75%. No specific roosting features or bat evidence were noted within this void.</p> | <p><i>Spray foam</i></p> | |

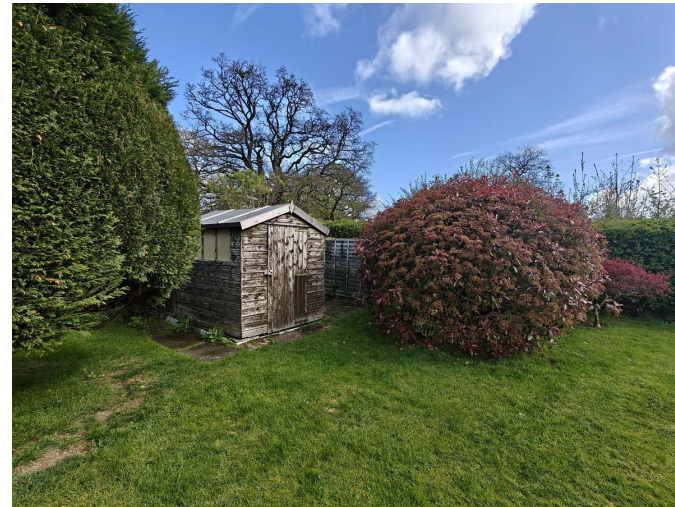
B2 is a detached, single-storey, timber-framed out-building. The main roof is gabled and clad in bitumen felt. No bat evidence was recorded during the survey.

In line with Good Practice Guidelines (Collins, J (Ed) 2023), B2 is assessed to have negligible habitat value for roosting bats due to the timber shed is well sealed and not suitable for roosting bats.

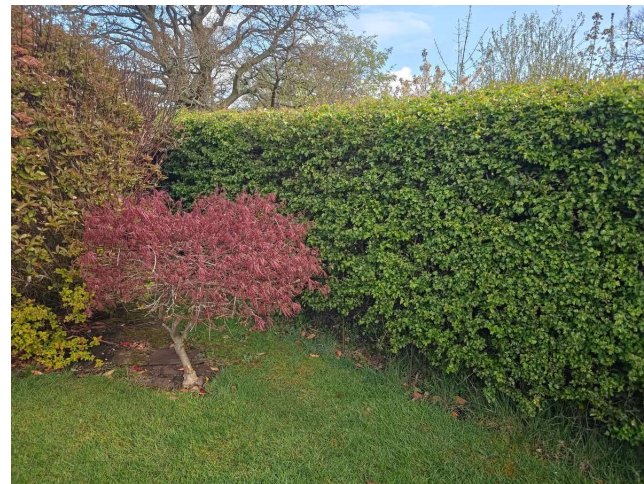
*Photo 4: Native hedgerow*

There is a hawthorn hedgerow bordering the northeast boundary that comprises entirely hawthorn. The hedgerow is well maintained through annual trimming, and is approximately 2m high and 1.5m wide.

In accordance with the Statutory Biodiversity Metric Condition Assessment Matrix, the native hedgerow was assessed to have a good condition value.
