**Historic Building  
Recording (L3)  
The Hollybush  
Restaurant  
Upper Bond  
Street  
Hinckley  
LE10 1RH**

**Type of Intervention:** Historic Building Survey Level 3

**Report No:** MAS/634/22

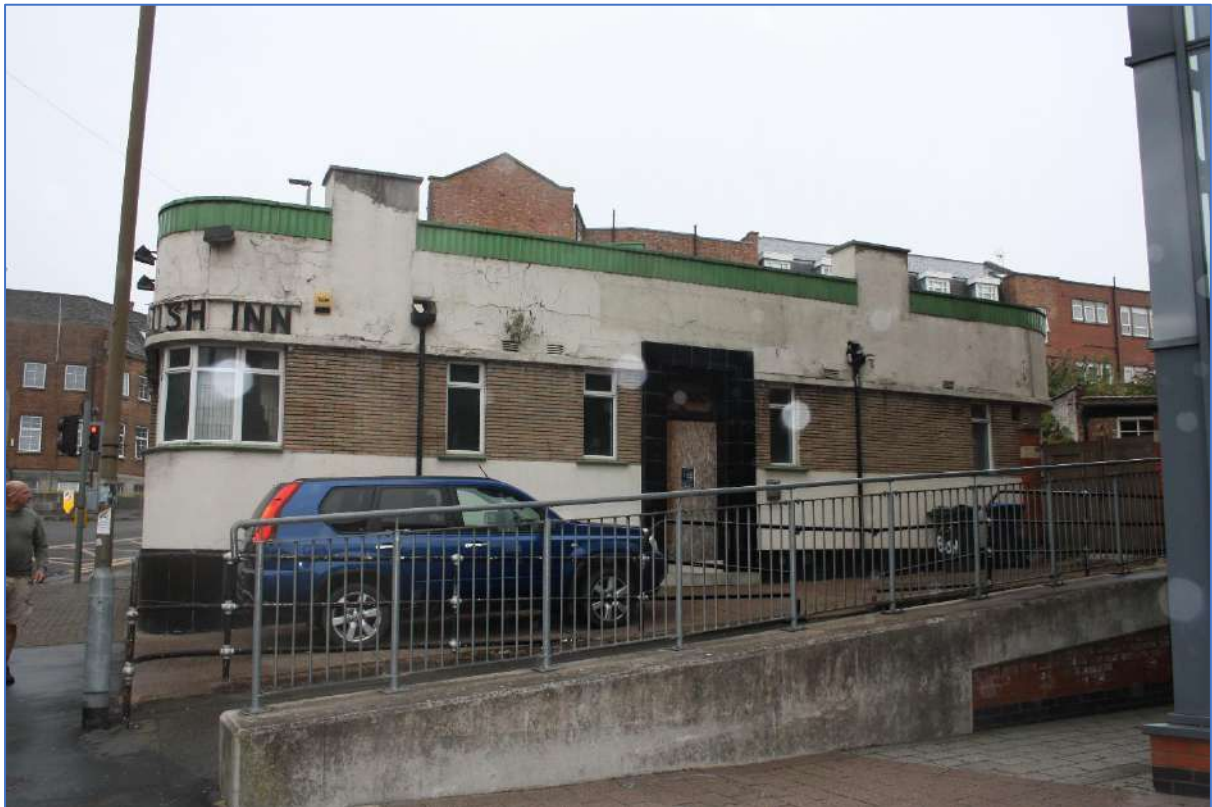
**Plate 2:** Elevation BB looking E.

This elevation is not too dissimilar to that of AA, being of whitewashed cement render, although the central brick banding is consistent throughout. There is a wide central entrance with a contemporary door of Stirling board, the latter is hung from a stout wooden frame, whilst like that of AA, the jambs are of glazed black tile. This door leads to the Off—Sales area. Either side of this entrance are a series of two UPVC rectangular windows, each comprising of a bottom fixed light and a top opening. The sills are of glazed green tile. At roof height are two cement rendered stacks which feed to the public and lounge bars (plate 2).

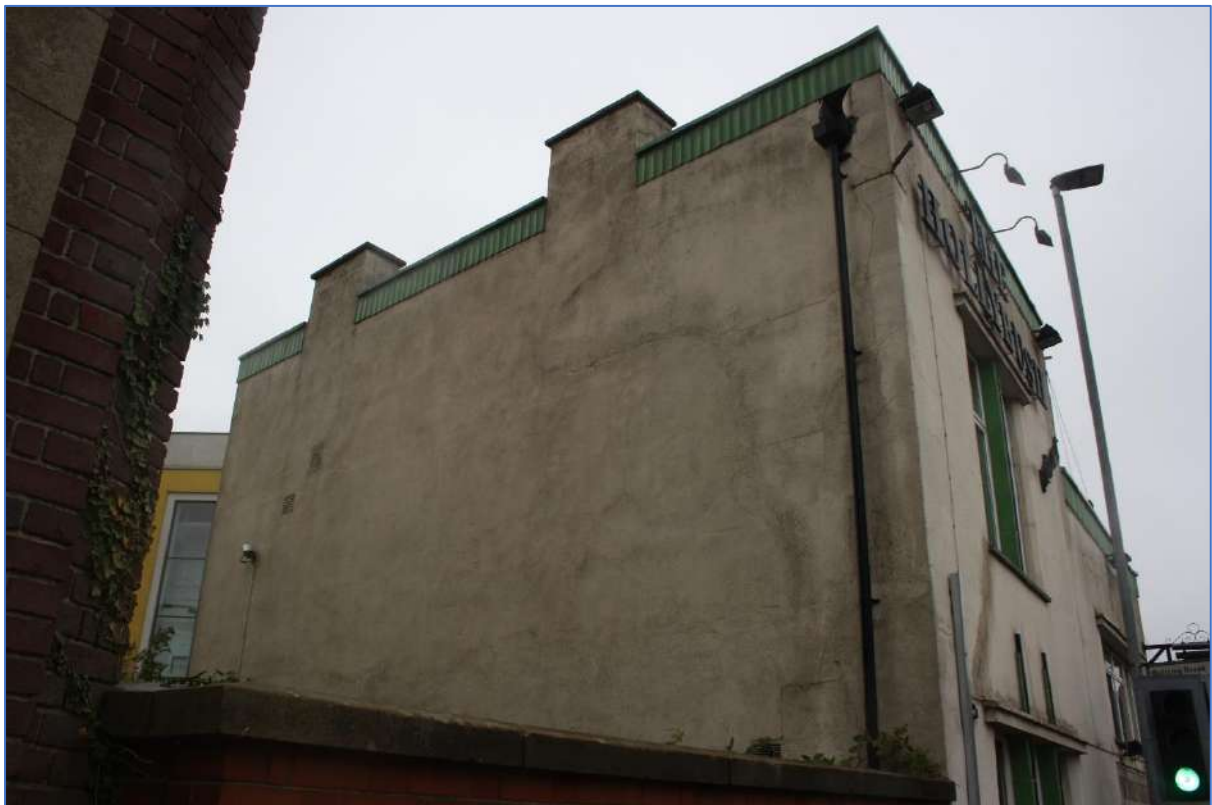
**Plate 3:** Elevation DD looking S.

This elevation is of whitewashed cement render with a green glazed fluted tile parapet and two cement rendered stacks at roof level (plates 3, 6).

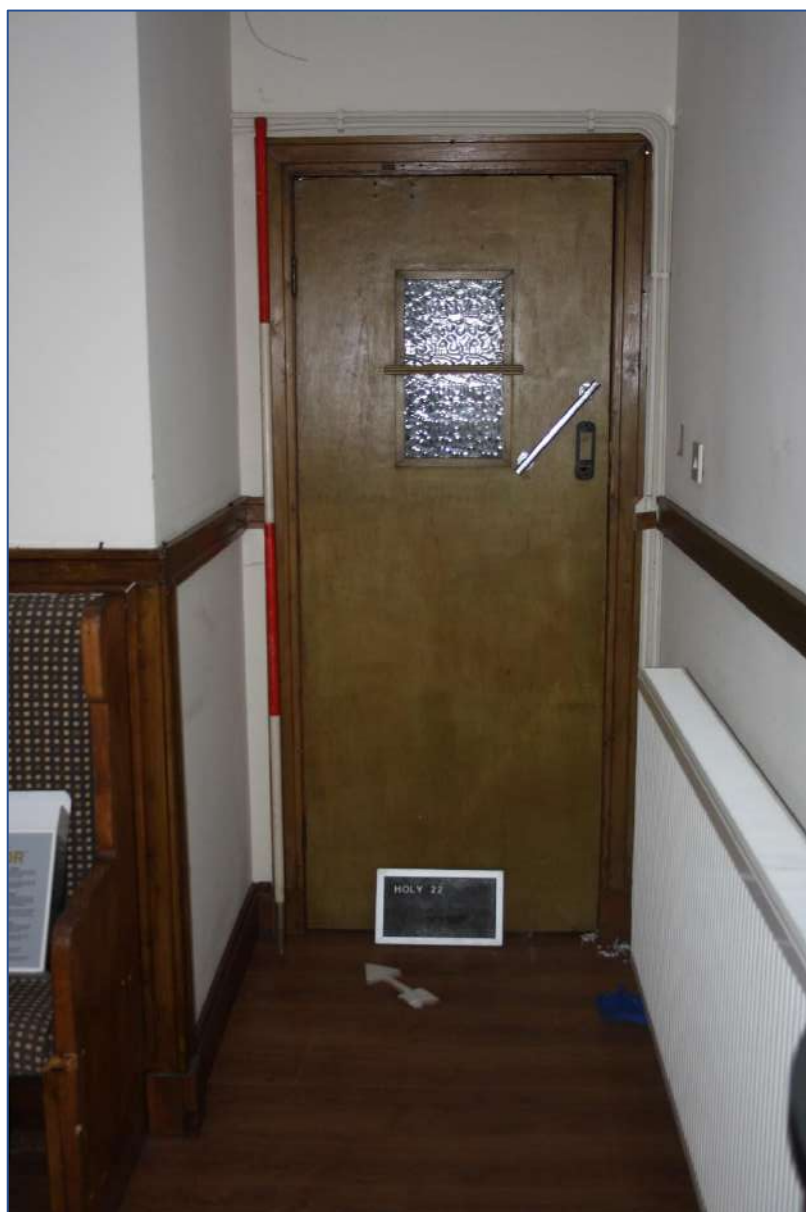
**Plate 15:** Room 1 looking N/E to entrance door.

**Room 1 (Public Bar)** This room is L-shape in plan, with painted plaster walls and ceiling and a contemporary laminate floor, with a stepped style wooden skirting. The entrance door is of stained ply, part-glazed with Art Deco style fixtures and fittings and hung from an Art Deco style timber frame. Along two walls of this room are some high-backed bench seats which are fixed, while within the northwest wall is a brick open fireplace and hearth. Set within the southwest-northeast wall is an Art Deco style bar, to the right of this is a plain plywood door which connects this room with 9 and 12 (plates 15-21).

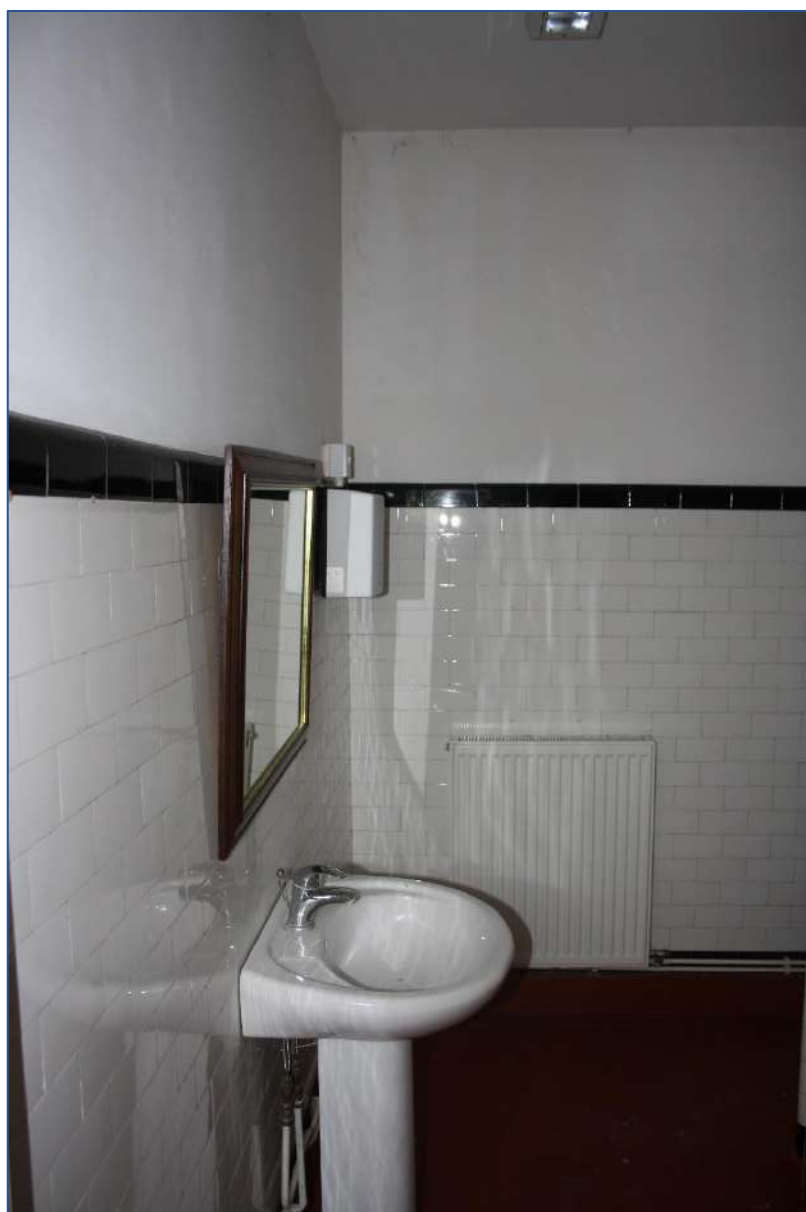
**Plate 32:** Room 11 looking N/W.

**Room 11 (Toilets Female)** This room is irregular in plan with a contemporary linoleum floor and is half-tiled, the upper areas of the wall and also the ceiling being painted. The internal doors are of modern type but the entrance door is Art Deco in style, being stained ply and half-glazed, hung from a matching timber frame. The sanitary ware modern (plates 32, 33).

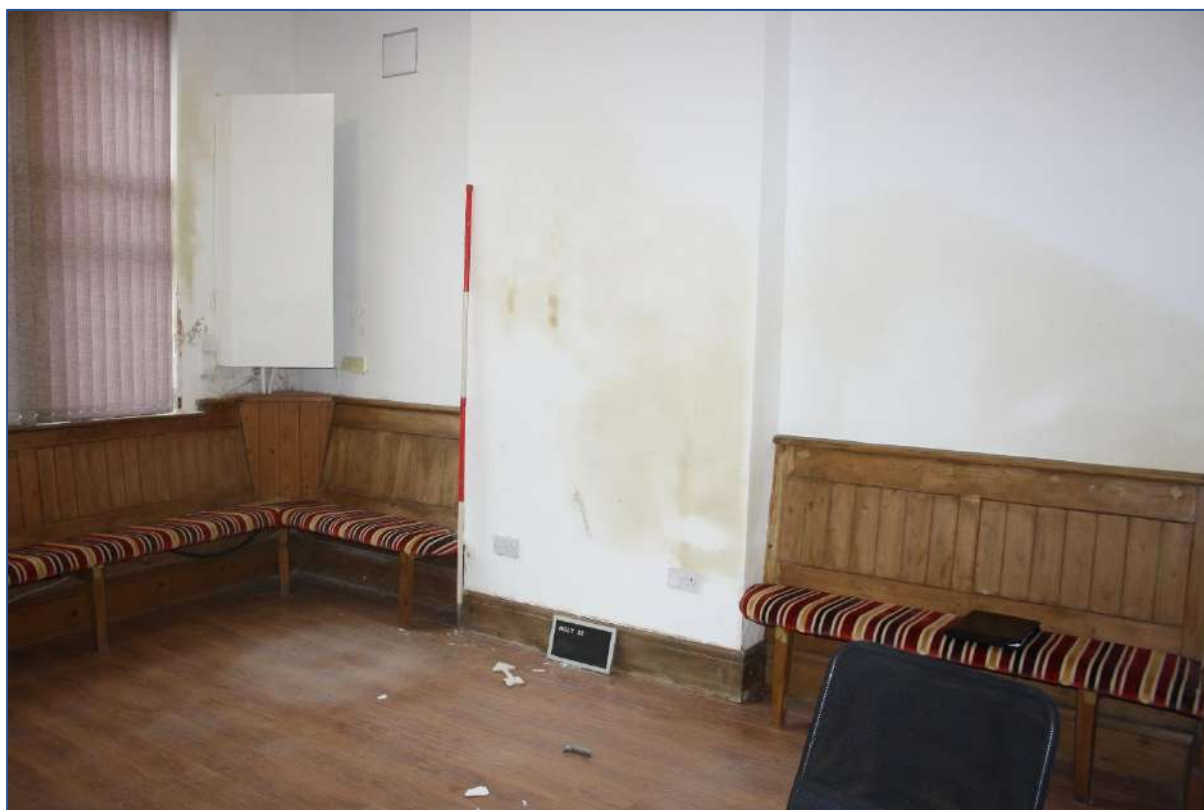
**Plate 47:** Room 3 looking E.

**Room 3 (Luncheon Room)** This room is entered via Room 9, is L-shape in plan with a contemporary laminate floor and painted plastered walls and ceiling, the entrance door being of stained ply, part-glazed with Art deco style fixtures and fittings and hung from an Art deco style frame.. Fixtures and fittings are of contemporary design, while the skirting is Torus profile. In the east wall is a large chimney breast which is blocked. Along three sides of the room there is some fixed benching, similar to those seen in both Rooms 1 and 2, although of somewhat more traditional design with a timbered back panel (plates 47-49).
