## **An Archaeological Standing Building Survey The Greyhound Inn Main Street Botcheston Leicestershire**

ABRS Report No 2023-GHBL

# **An Archaeological Standing Building Survey**

**Planning Permission 21/01377/FUL**

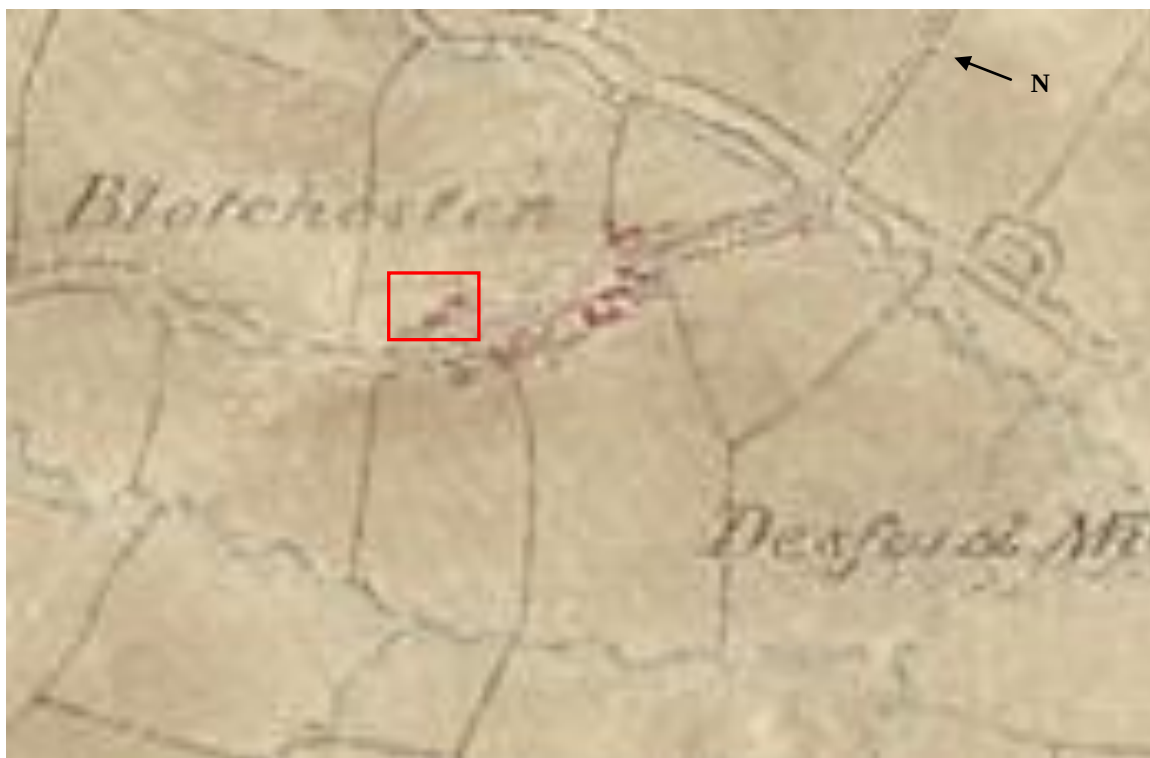
**Figure 2**  
Ordnance Survey Drawings: Leicester, City of Leicester (1815).  
(OSD 263)

The earliest, currently available map of the proposed development area is the Ordnance Survey Drawing Leicester, City of Leicester (*Figure 2*) drawn in 1815. The map was published at a small scale, 2 inches to the mile, the equivalent of 1:31,680; nevertheless it is possible to accurately locate the proposed development area and identify a rectangular building fronting the highway which could potentially be identified as the Greyhound Inn. The hamlet never expanded greatly and in 1846 the population was just 37 people. By the middle of the 19th century the Earl of Stamford was lord of the manor.

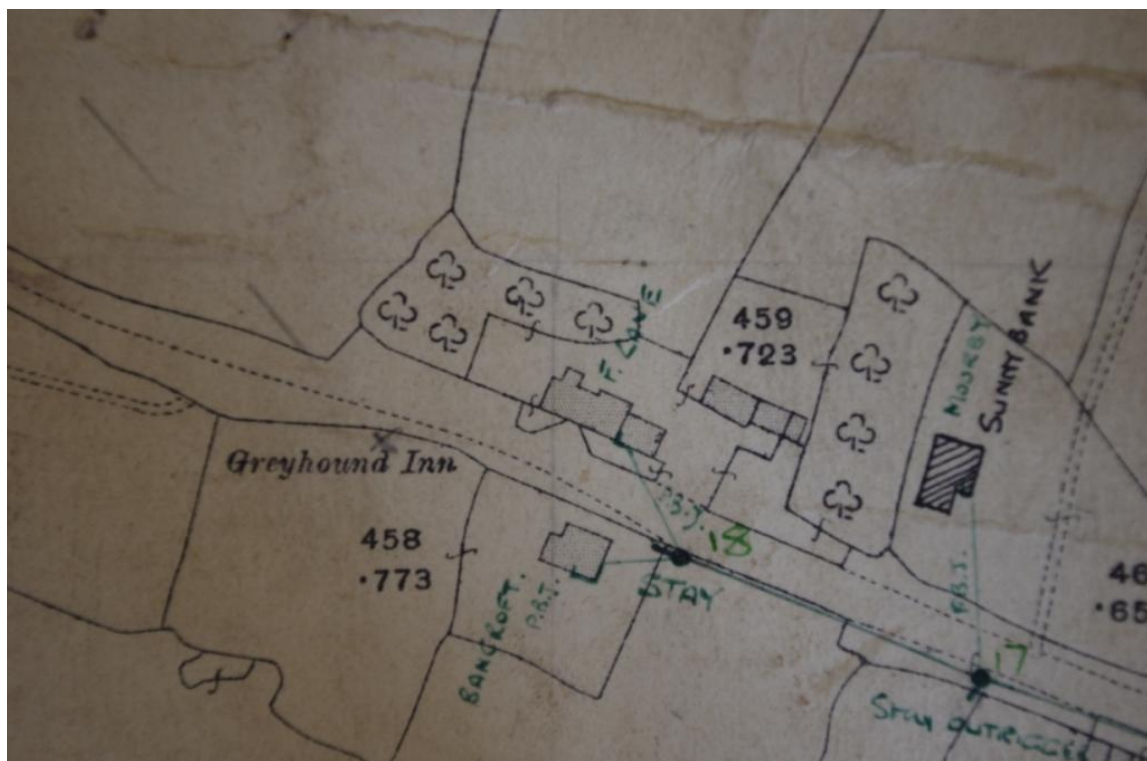
**Figure 5**  
1916 Edition Ordnance Survey.

A "Map Showing Provision Of Electricity Supply To The Ratby, Groby, Desford, Botcheston, Kirby Muxloe And Leicester Forest East Area" (ROLLR Ref DE5877 (Figure 5)) drawn sometime in the 1930s, but based on the 1916 Ordnance Survey records the Greyhound similarly to the first edition, but shows the building as consisting of two unequal bays, the easternmost being the smaller of the two. The map records the Greyhound as being owned/occupied by F. Cave, this is confirmed by Kelly's Directory of 1928 which lists Fredrick Albert Cave at the Greyhound.

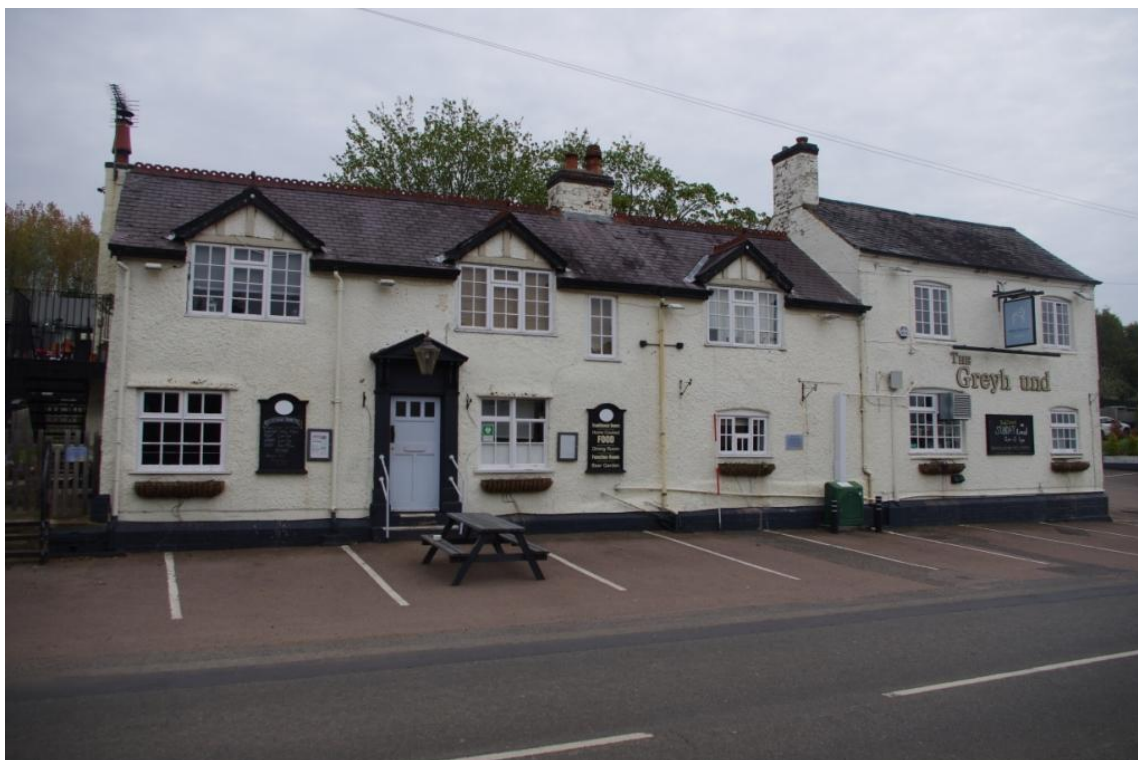
**Figure 10**  
Building A, Principal Elevation (Looking North – North East).

There is a clear and significant change in height visible on the principal elevation, with the easternmost bay being higher; this supports cartographic sources which indicated this easternmost bay was later. This easternmost bay is clearly 19th century in dimensions and appearance.

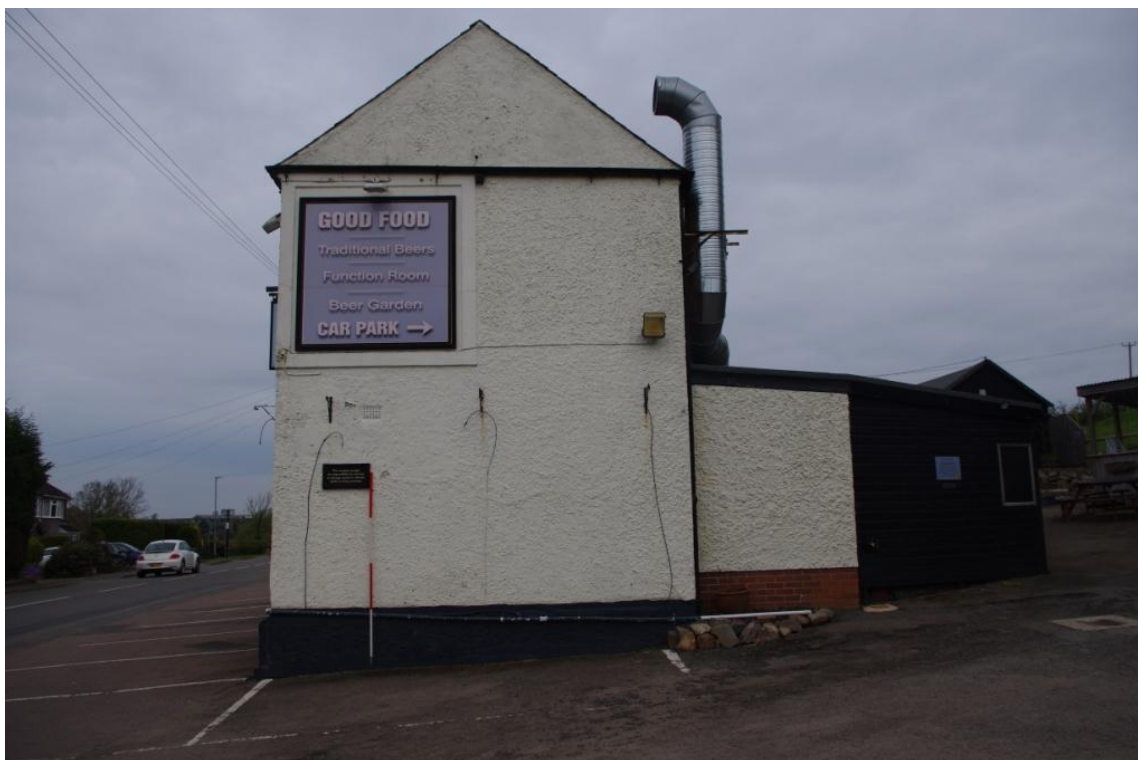
**Figure 11**  
Building A, East – South East Facing Elevation (Looking West – North West).

Both gables are largely empty (*Figure 11*). However, the western gable (*Figure 12*) shows evidence of a change to the roofline and changes in the render which may again, like the principal elevation suggest concealed framing, in the north west corner there is even a hint of a cruck blade (*Figure 13*). This is, however is far from certain.

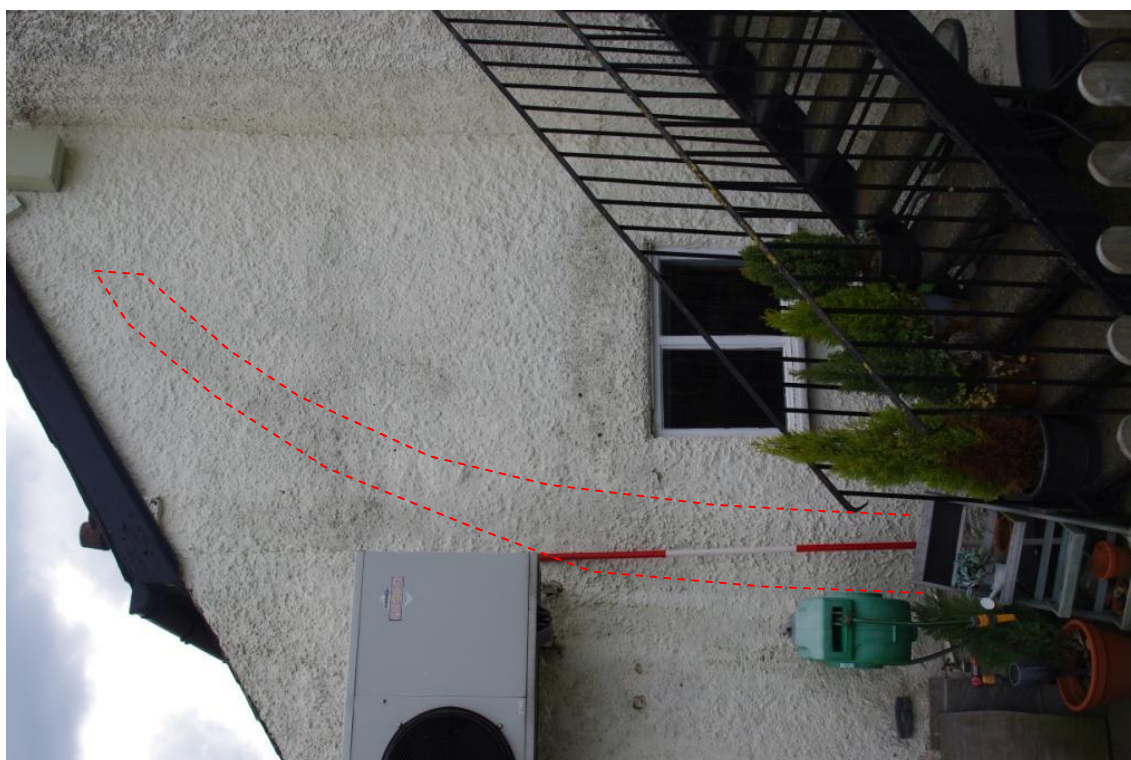
**Figure 13**  
Building A, West – North West Facing  
Gable, Possible Crack (Enhanced) in  
North West Corner  
(Looking South East).

There is also evidence to indicate that the westernmost bay is timber framed and includes very tentative evidence, in the form of discolouration to the render of a possible cruck blade in the north west corner. The easternmost bay is a 19th century extension.

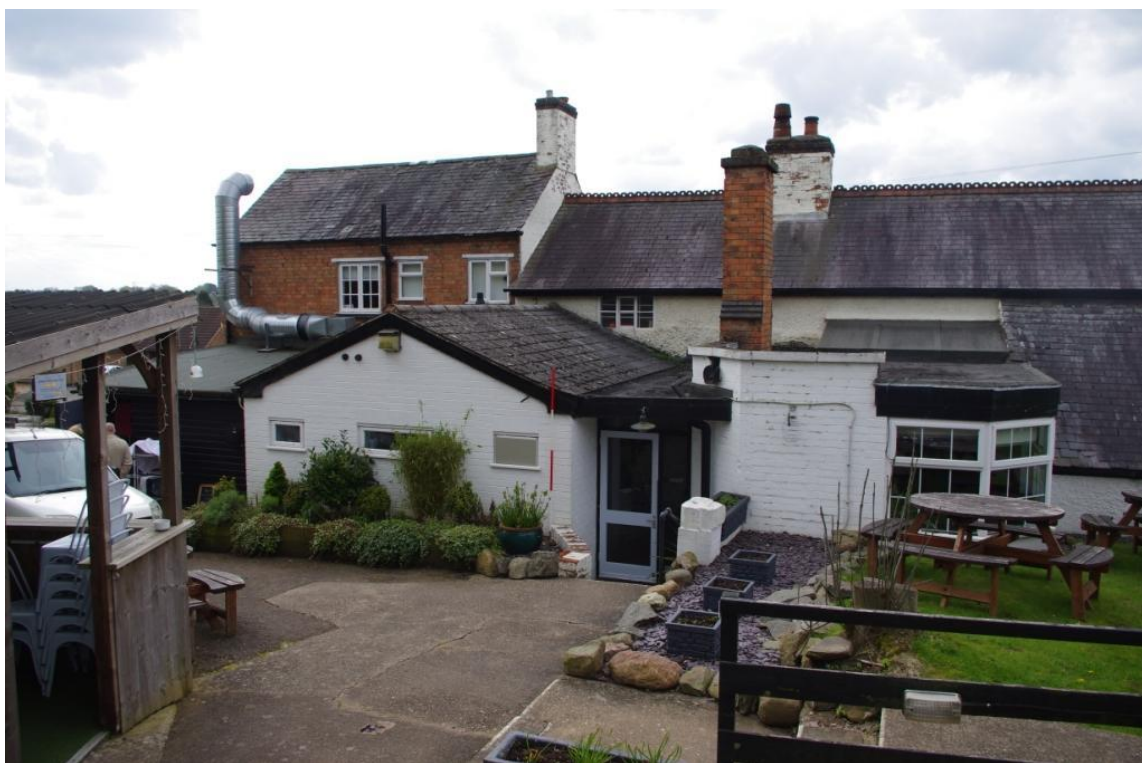
**Figure 14**  
Building A, Rear Elevation (Looking South).

The rear elevation is a confused collection of later extensions (*Figure 14*). The use of metric bricks for the two principal extensions indicates that these are post 1965 in date. To the west is a clearly earlier extension under a catslide roof and towards the centre is a large chimney. The chimney bricks are clearly 19th century in date which suggest another earlier extension here, which has been largely subsumed by the post 1965 flat roofed extension (*Figure 15*).

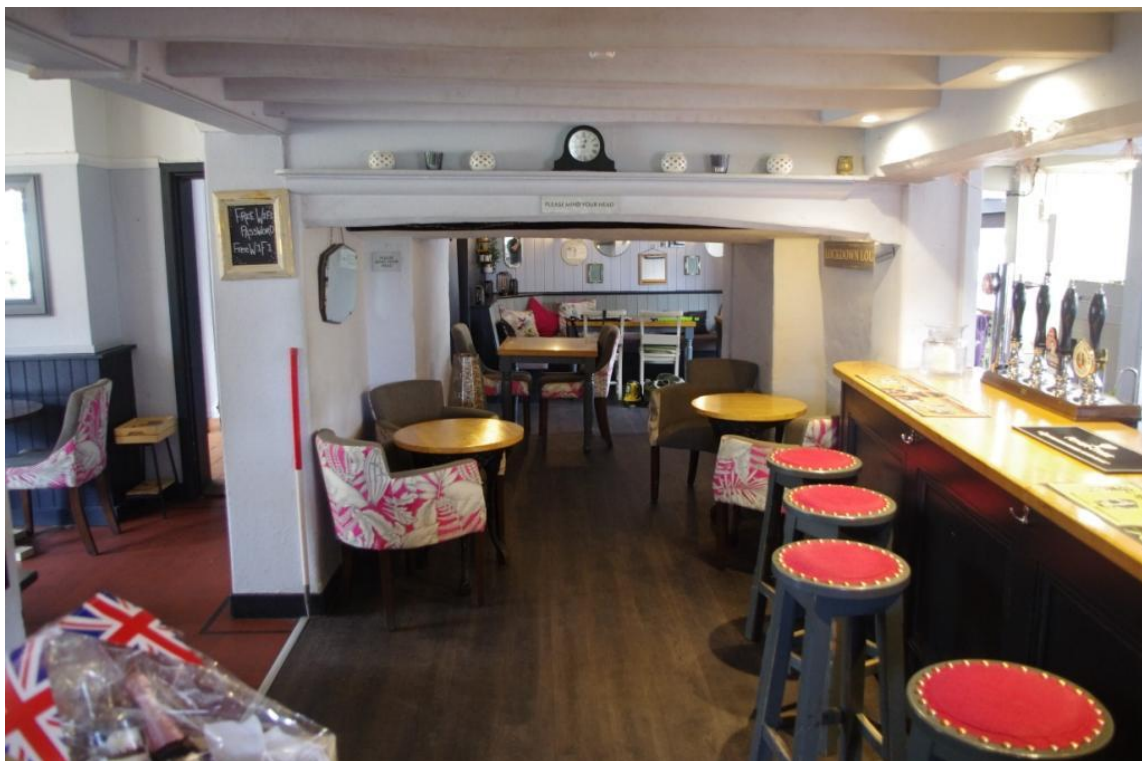
**Figure 16**  
A(2), Fireplace (Looking East – South East).

The westernmost bay is largely a single bay which now houses the servery against the front wall, but was clearly originally two separate bays. Against the rear wall at the centre of the bay is a large, much altered chimney breast (*Figure 16*) which confirms the building originated as a lobby entrance house, clearly a two unit plan with back to back fireplaces. The westernmost fireplace is finished with a chamfered and stopped timber overmantle. The scroll stop (*Figure 17*) is potentially early 17th century in date. The moulded mantlesheaf could, potentially be original as there are dated 17th century examples recorded, but modern paint prevents detailed examination. The easternmost fireplace has much rougher bressummer with open mortice, which is again chamfered and stopped, however, later damage has removed the stop (*Figure 18*). This may reflect the different status of the rooms, the westernmost being the parlour and the easternmost being the living kitchen.

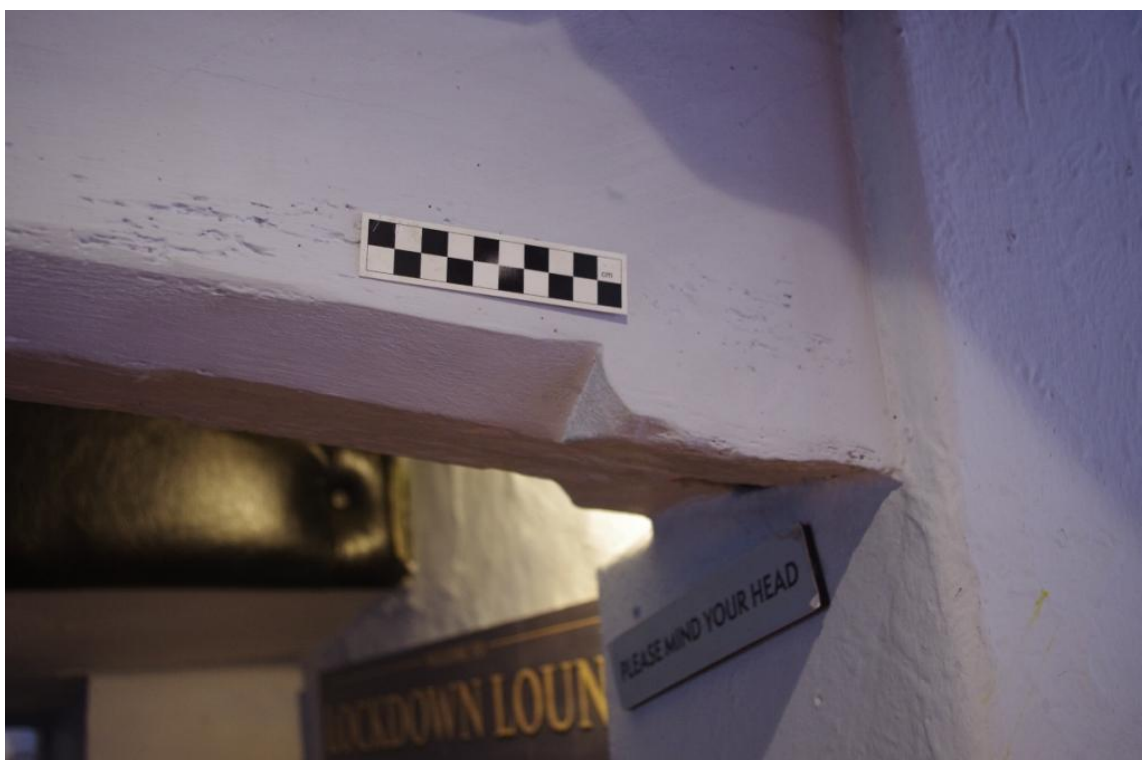
**Figure 17**  
A(2), Scroll Stopped Overmantle (Looking South – South East).

The ceiling in (2) is carried on a heavy chamfered and stopped bridging beam; the beam has an almost identical scroll stop to the overmantle indicating the two are contemporary. The joists are hand finished and are also likely to be contemporary and some have evidence of reuse.

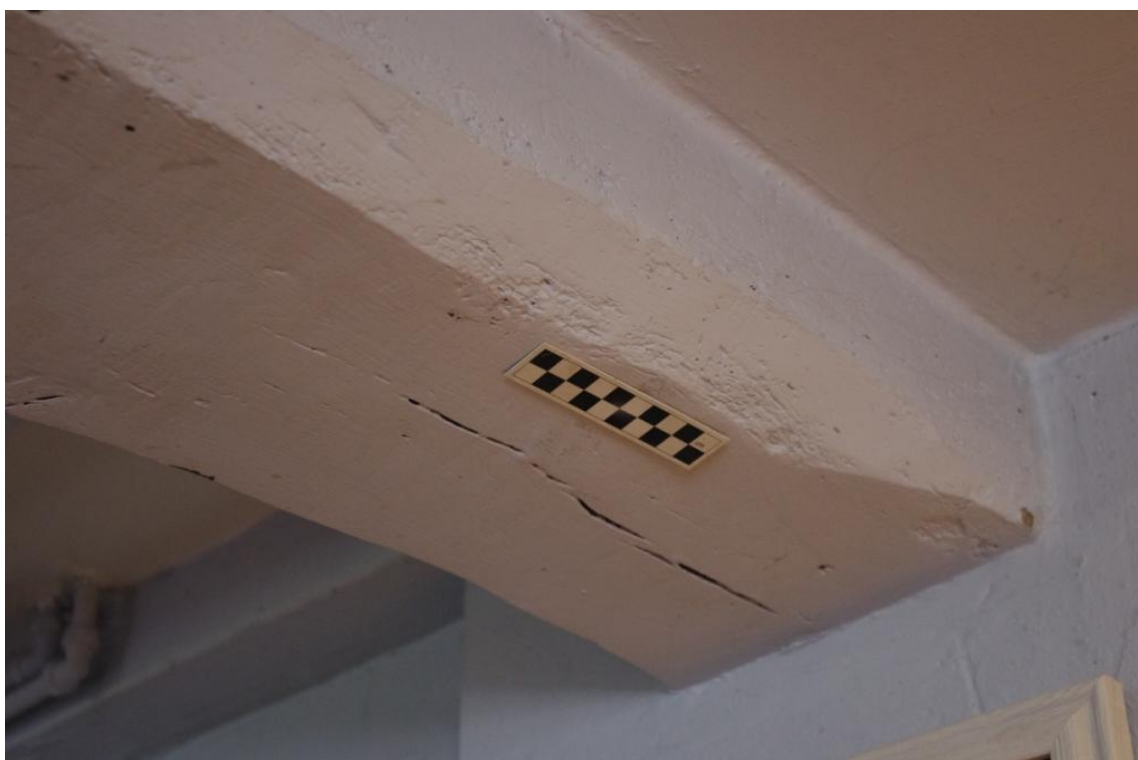
**Figure 19**  
A(1), Chamfered & Stopped Bridging Beam (Looking North East).

Interestingly, the beam in (1) is chamfered and stopped at its eastern end (*Figure 19*), this would suggest that the short section of wall between (1) and (2) could potentially be original. If so it may indicate that this western bay was originally two bays.

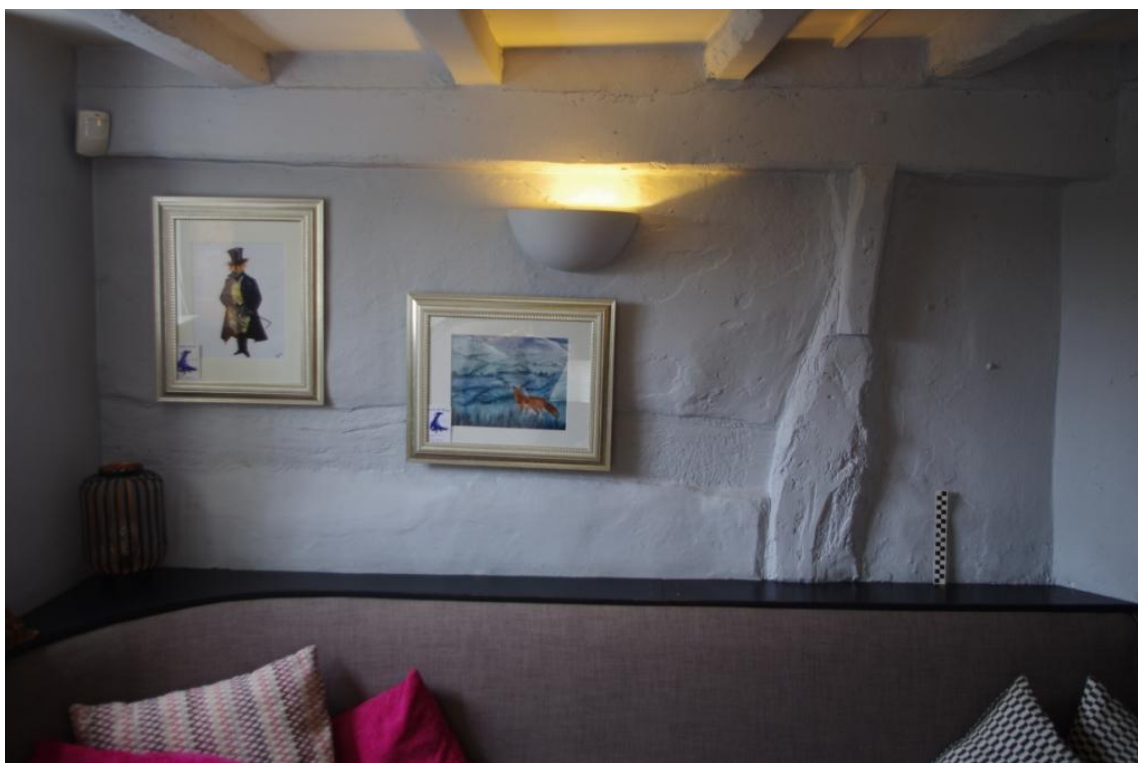
**Figure 20**  
**B(1), Framing Visible in Rear Wall (Looking North – North East).**

There is clear evidence of timber framing in the rear wall of (1) consisting of a post and rail (*Figure 20*). To the east is an angled projection in the wall which may again be remnant

framing. Both the gable and the front wall are unevenly finished suggesting further timber framing maybe concealed here also. The gable fireplace is modern brick.

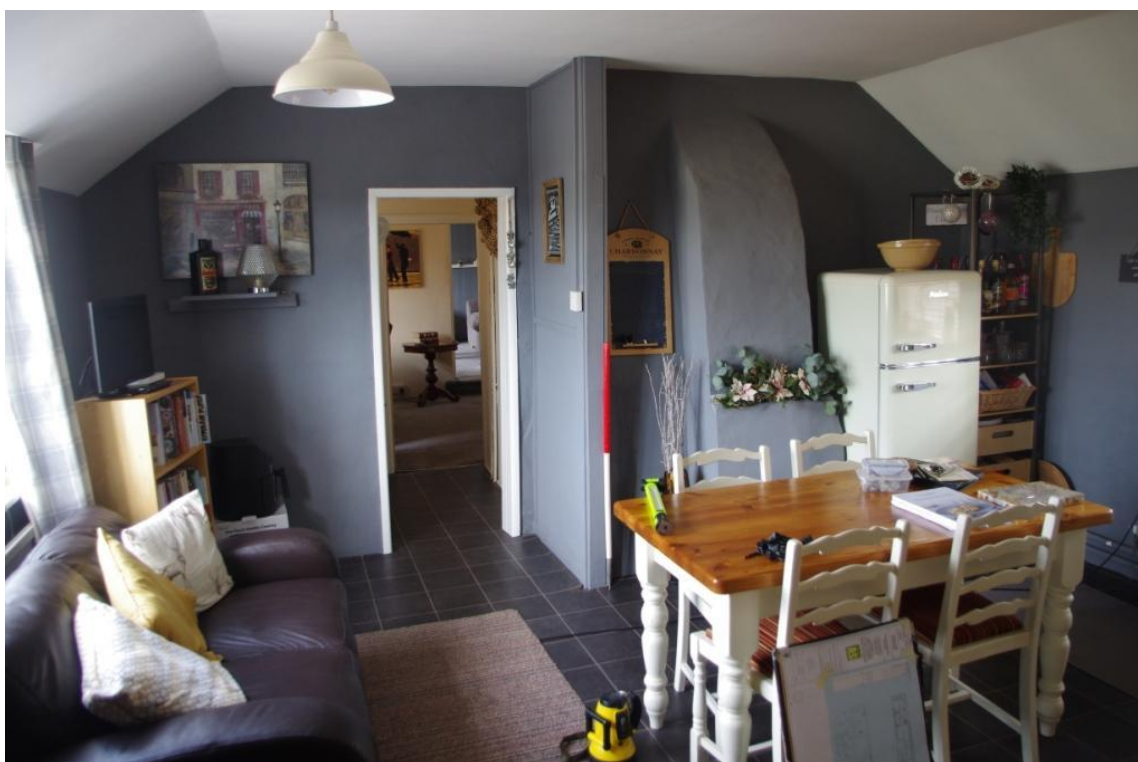
**Figure 21**  
**B(8), Chimney Breast (Looking West – North West).**

Access to the first floor is via a straight flight stair against the east gable, there is also an external, steel stair on the west gable. The first floor consists of the three principal bays (*Figure 25*), the easternmost being the 19th century extension. The first floor retains very little of historic or architectural significance beyond the historic plan-form. There is a large chimney breast between (7) and (8) (*Figure 21*).

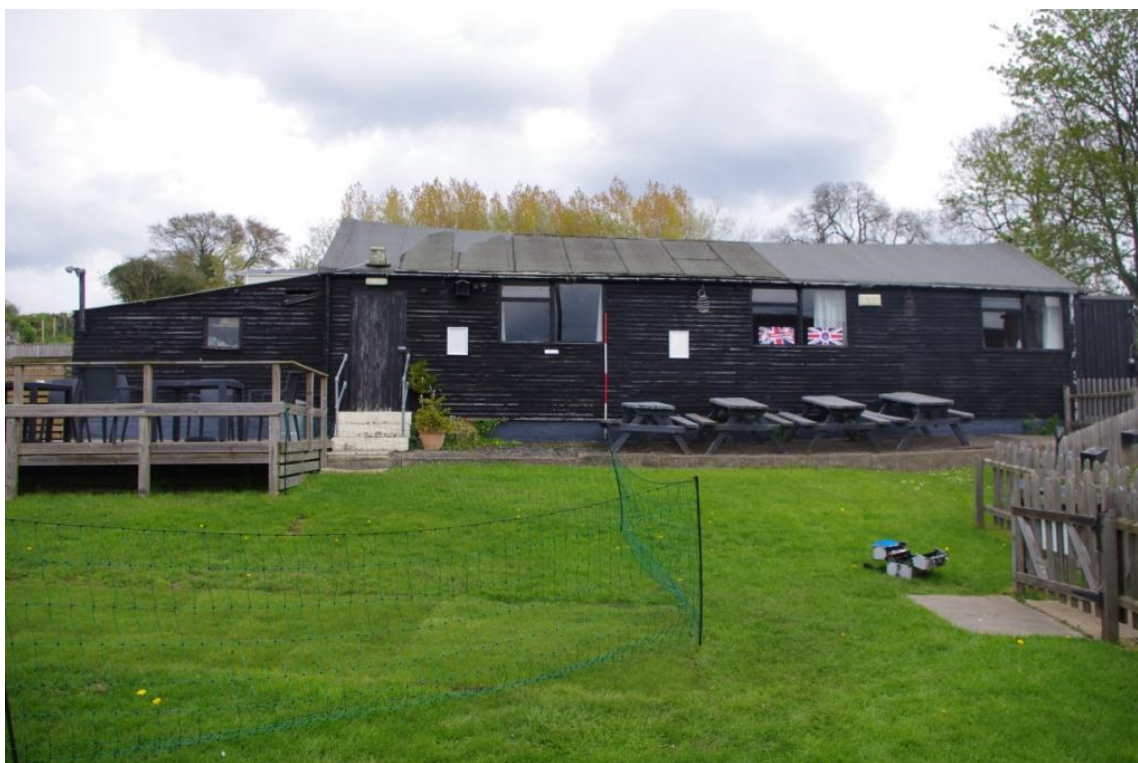
**Figure 22**  
Building B, South – South East Facing Elevation (Looking North – North East).

The Games Room is located some 8 metres north of the Greyhound. The timber built building is linear in plan under a pitched felt clad roof (*Figure 22*). Abutting the west gable is a lean to extension. There are modern windows on the south facing elevation, along with a single door to the west. On the east facing gable is a double door, the rear elevation is blank.

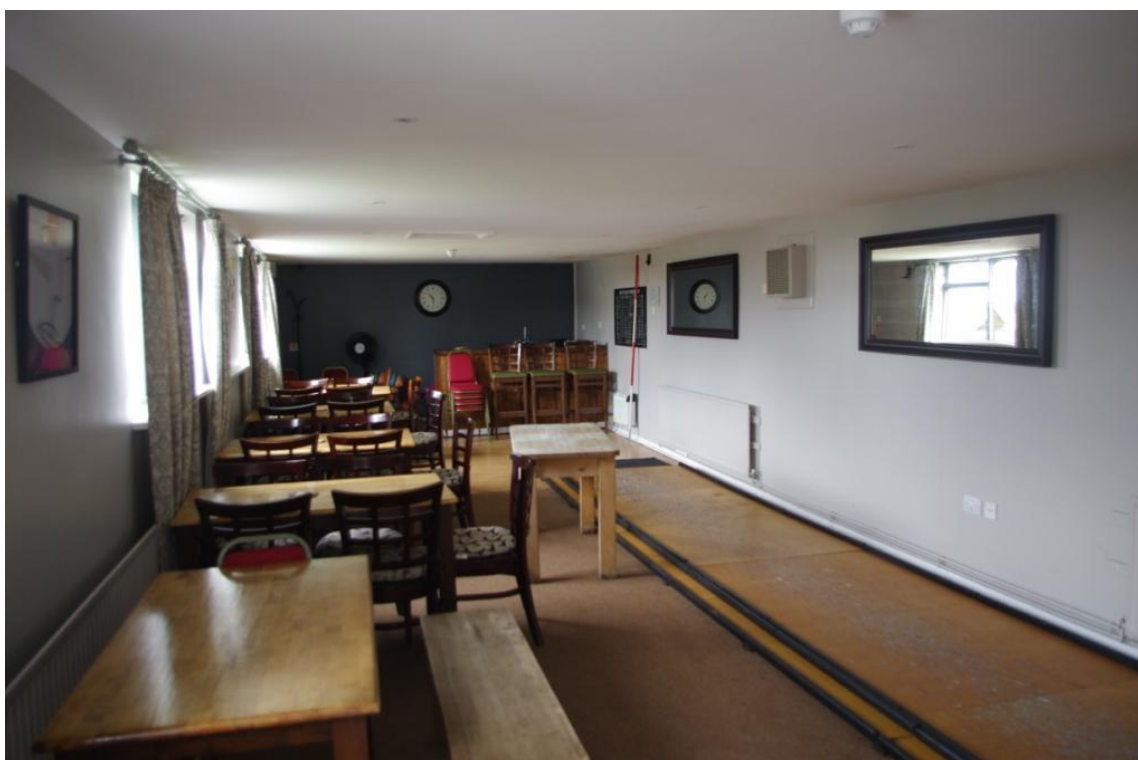
**Figure 23**  
Building B, General View, Internal (Looking West – North West).

Internally the building consists of a single bay (*Figure 24*) with a servery in the north west corner and a skittle alley against the rear wall. The interior is all modern with no visible evidence to indicate a construction date (*Figure 23*). Cartographic sources suggest the building could be as early as the 1920s; there was no visible evidence to confirm or refute this.
