## **PHASE 1 BAT & NESTING BIRD SURVEY**

**Coalbourn Cottage, Whitwick Road,  
Copt Oak, Markfield, Leicestershire,  
LE67 9QB**

**31<sup>st</sup> March 2025**

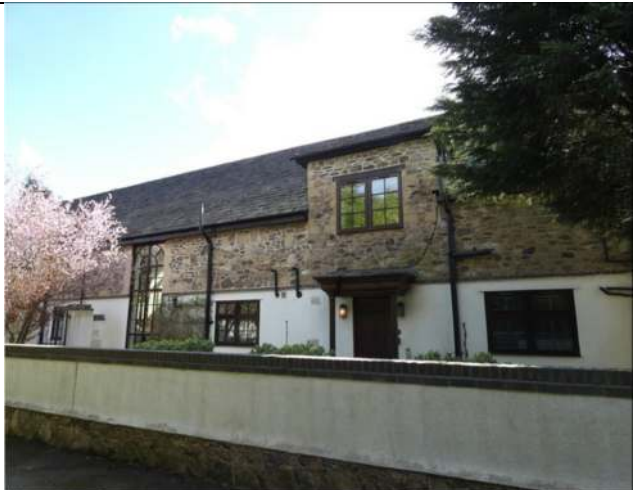
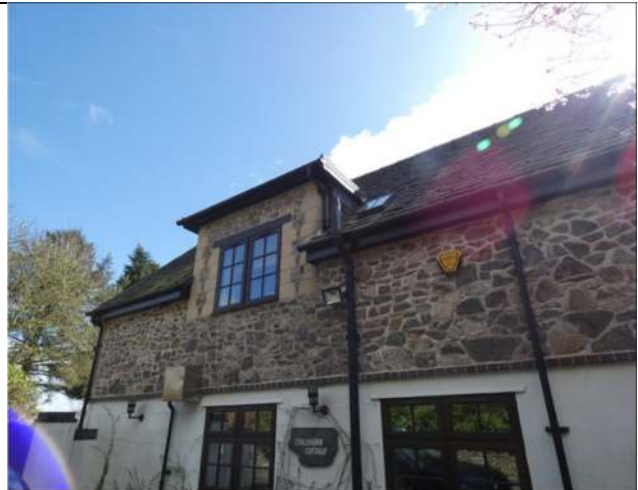
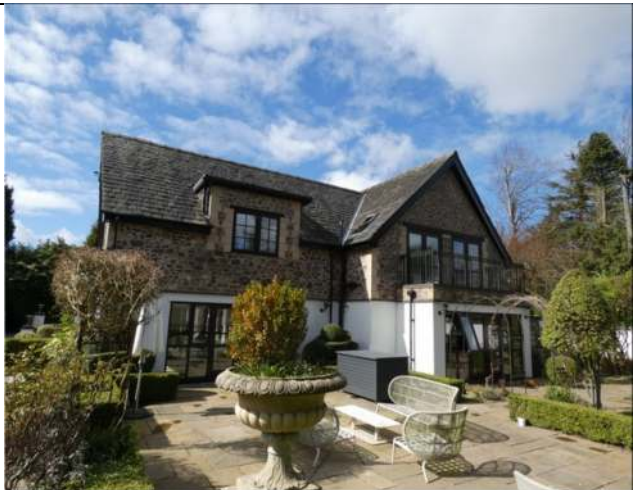
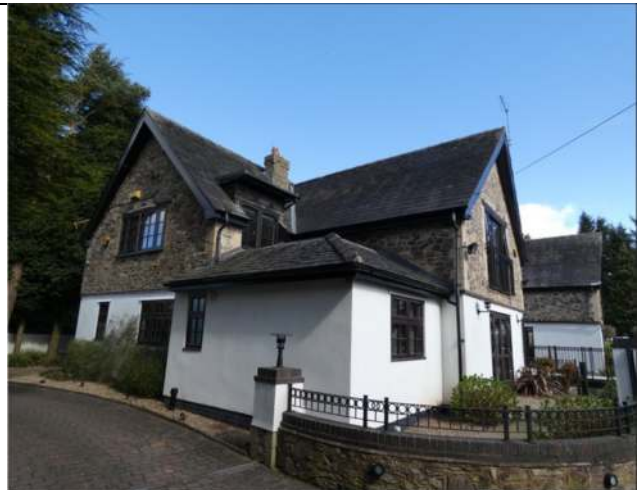
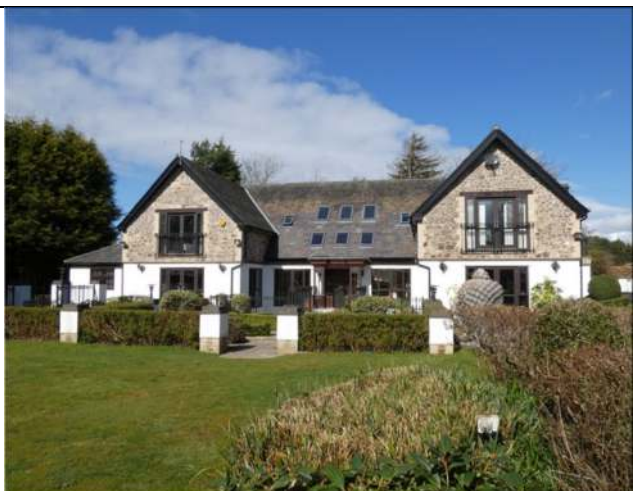
Large two-storey stone house comprising a main section, orientated east-west, with 2 two-storey gabled projections to the south and a single-storey extension at the south-west corner. The gable roofs are covered with slates and are lined with a traditional bitumen lining except for the mansard roof of the single-storey extension which is lined with a breathable roofing membrane.

Photograph 1. The western end of the north elevation of the house

Photograph 2. The eastern end of the north elevation of the house

Photograph 3. The east elevation of the house

Photograph 4. The west elevation of the house

Photograph 5. The south elevation of the house

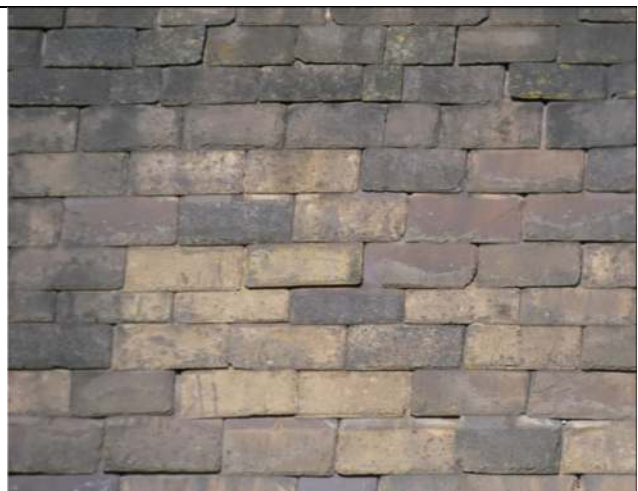
The lower parts of the roof in the main part of the house are relatively well sealed but higher up the main roof, on the gable projections to the south, and on the single-storey extension there are numerous openings under slates and ridge tiles (e.g. Photographs 7-10). These openings lead to the cavities between slates, battens and lining which are suitable for crevice-dwelling species such as those of the genus *Pipistrellus*. In addition, they may lead into the enclosed roof voids.

Photograph 6. Example of the slates on the lower part of the roof of the house

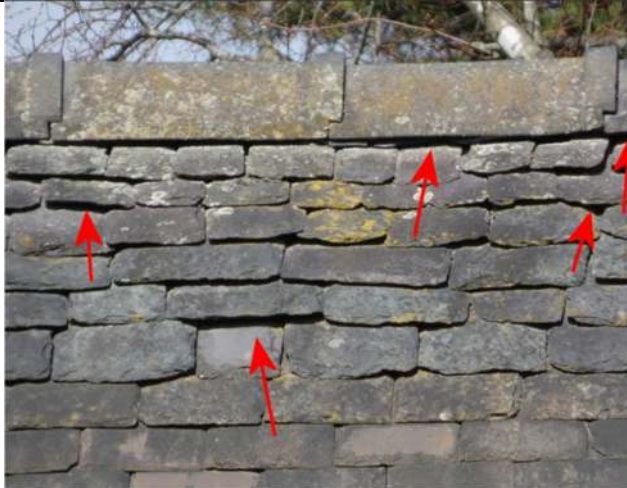
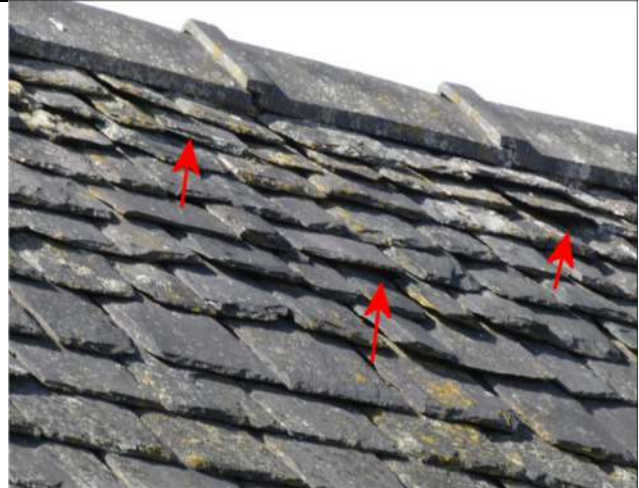
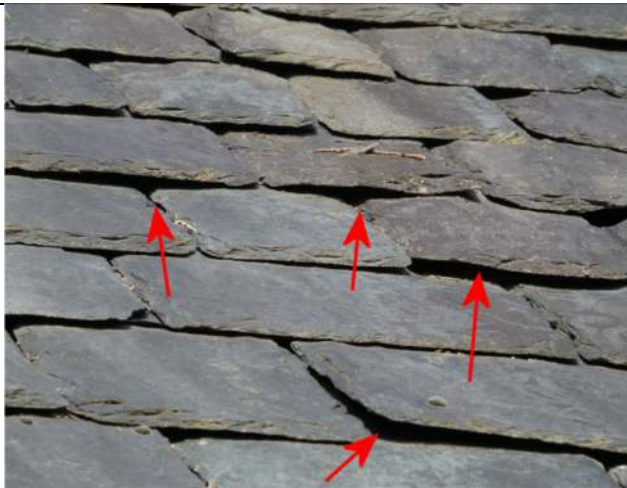
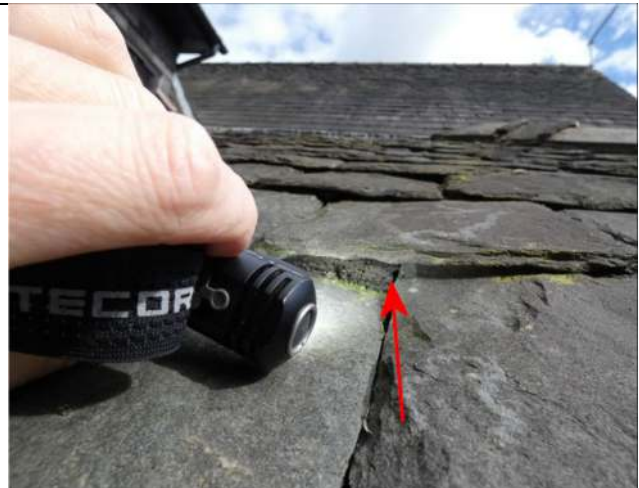
Photograph 7. Example of openings under slates on the main roof of the house

Photograph 8. Further example of openings under slates on the main roof of the house

Photograph 9. Example of openings under slates on the roof of the single-storey extension at the south-west corner of the house

Photograph 10. Further example of an opening under slates on the roof of the single-storey extension of the south-west corner of the house

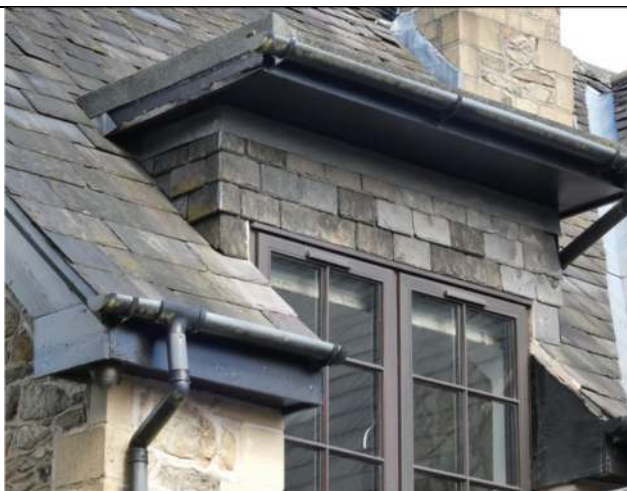
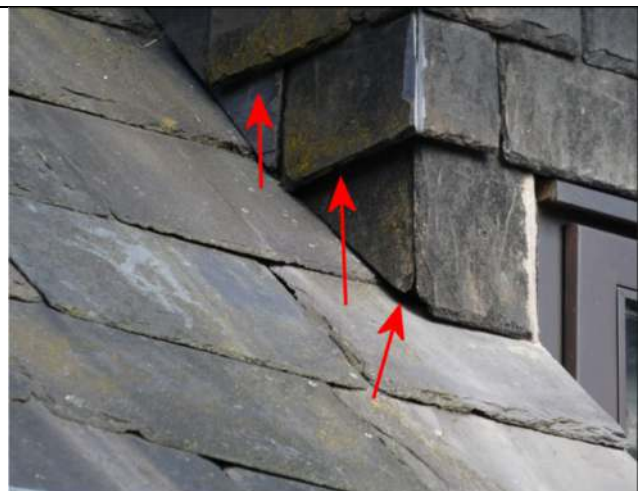
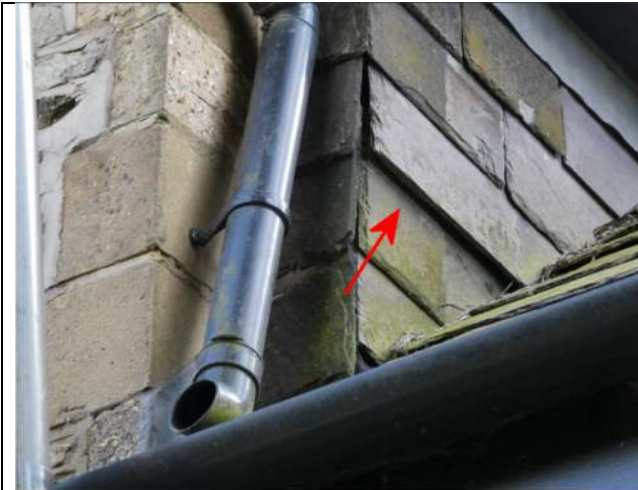
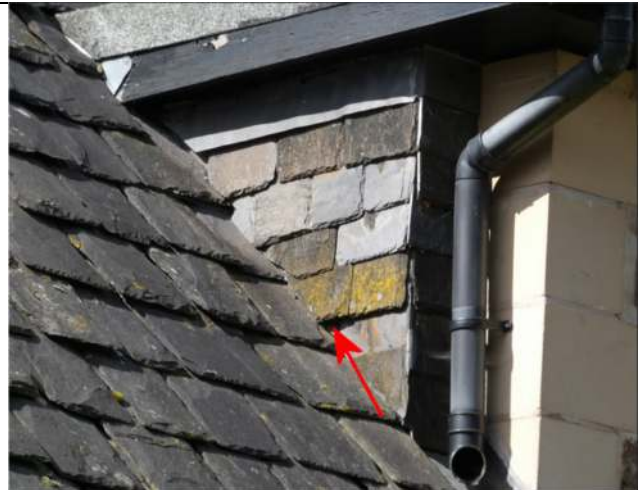
The dormer windows are covered with hanging slates (e.g. Photograph 11). There are many openings under these leading to the cavity underneath (e.g. Photograph 12-14).

Photograph 11. Example of a dormer window

Photograph 12. Example of openings under hanging slates on the north-facing dormer window

Photograph 13. Example of openings under hanging slates on the south-facing dormer window

Photograph 14. Example of openings under hanging slates on the westernmost north-facing dormer window

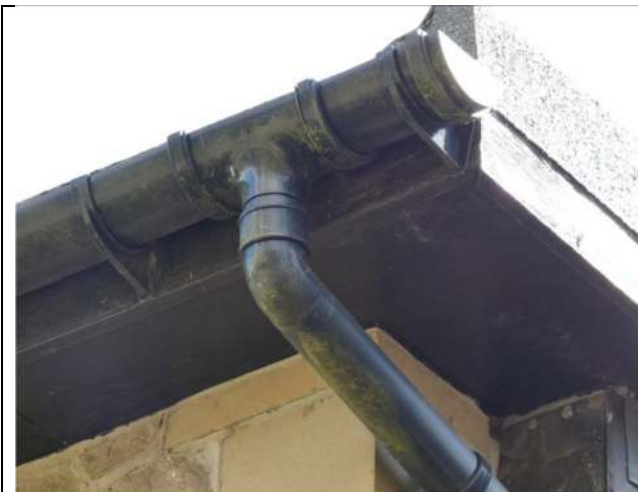
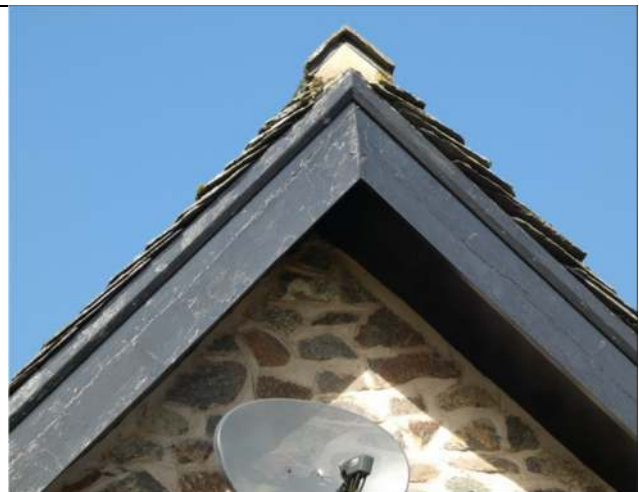
The soffits and fascias appear to be completely sealed (e.g. Photographs 15 and 16) except for an opening between the wall and the soffit to the east of the westernmost north-facing dormer window which has previously been filled with expanding foam but is currently partly open (Photograph 17). The cavity beyond was inspected using an endoscope and although there were no obvious signs of bats near the entrance (Photograph 18) it was not possible to inspect further into the cavity. Below this opening is the boiler room and within this part of the building, there was a large quantity of bat droppings, probably produced by pipistrelle bats, caught in wire mesh above the boilers (Photograph 19) as well as some droppings underneath this (e.g. Photograph 20). The bats are clearly roosting

Photograph 15. Example of the soffit and fascia

Photograph 16. Example of the soffit and fascia above a gable wall

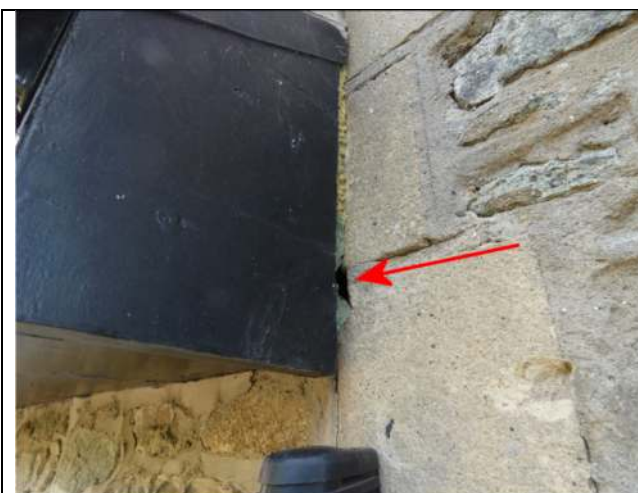
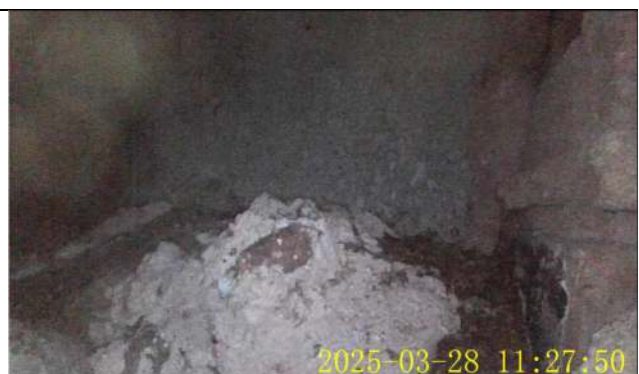
Photograph 17. Gap between the wall and the soffit to the east of the westernmost north-facing dormer window

Photograph 18. Endoscopic view of the cavity behind the soffit to the east of the westernmost north-facing dormer window

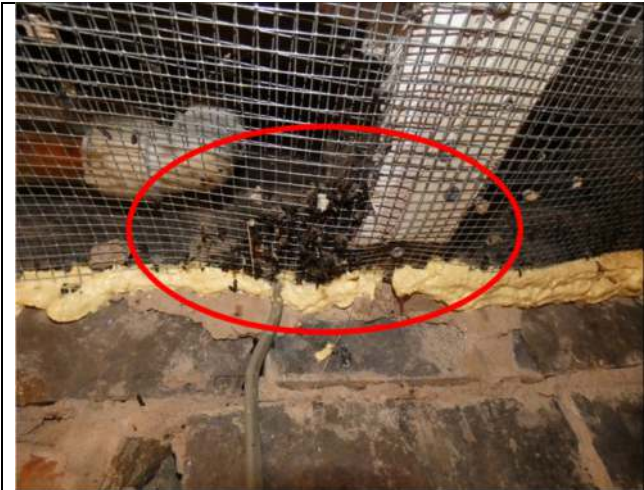
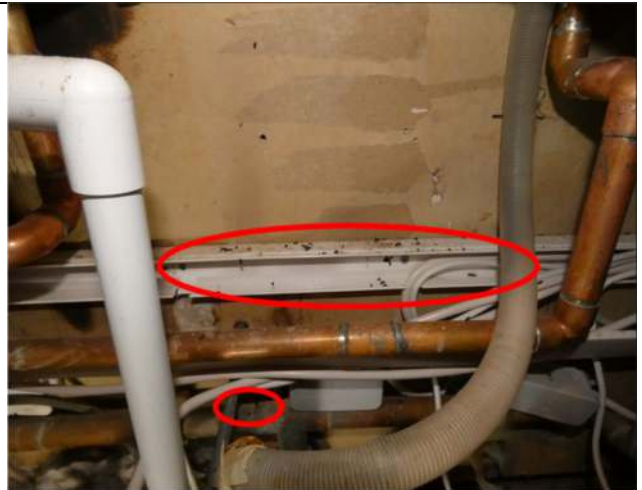
above this area but further investigation is needed to determine the exact location and to confirm where the access point is.

Photograph 19. Large accumulation of bat droppings in the boiler room to the east of the westernmost north facing dormer window

Photograph 20. Further example of bat droppings in the boiler room to the east of the westernmost north facing dormer window

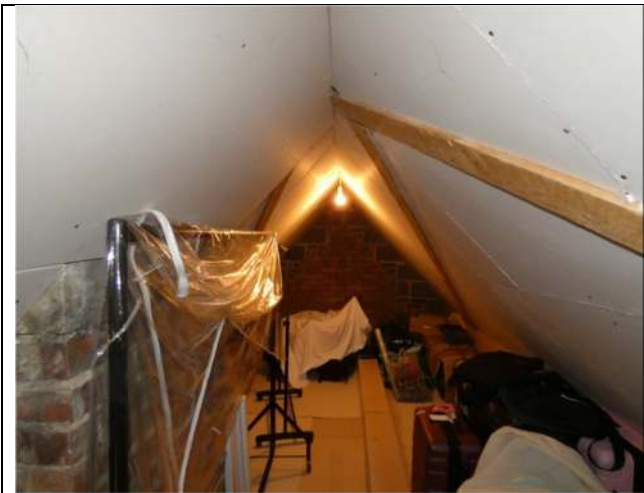
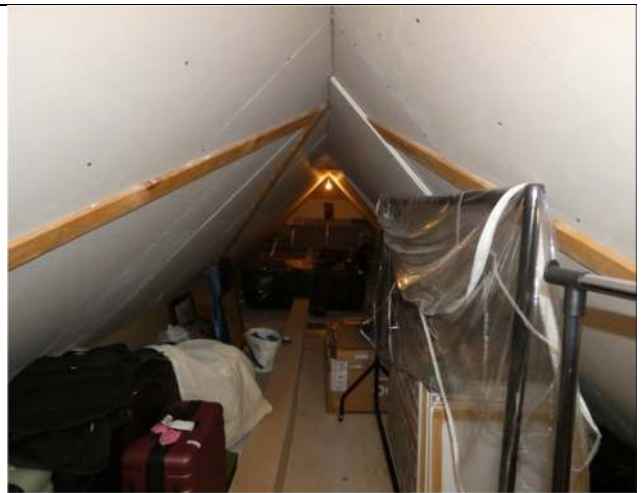
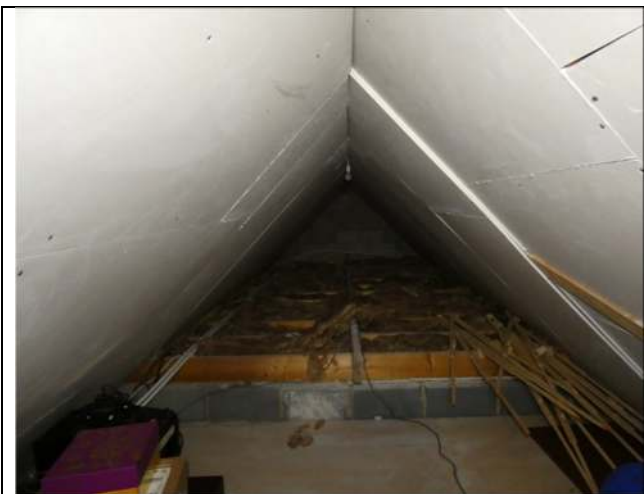
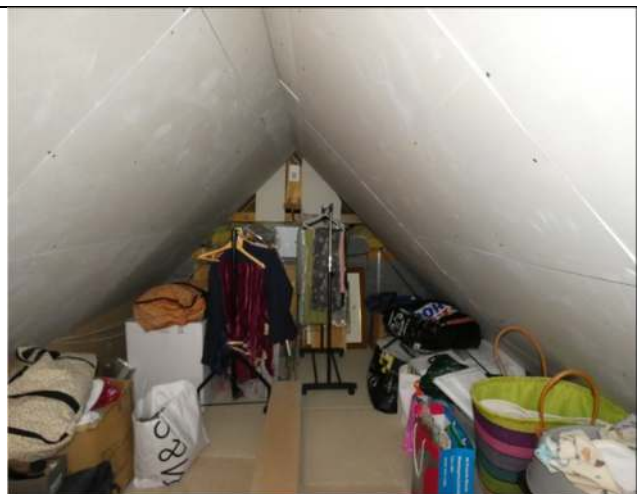
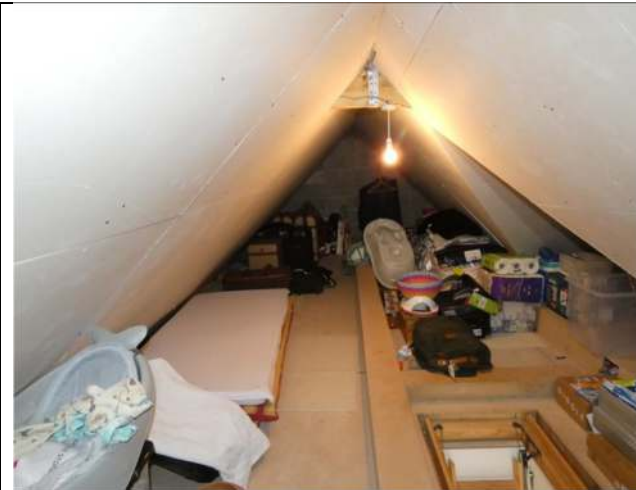
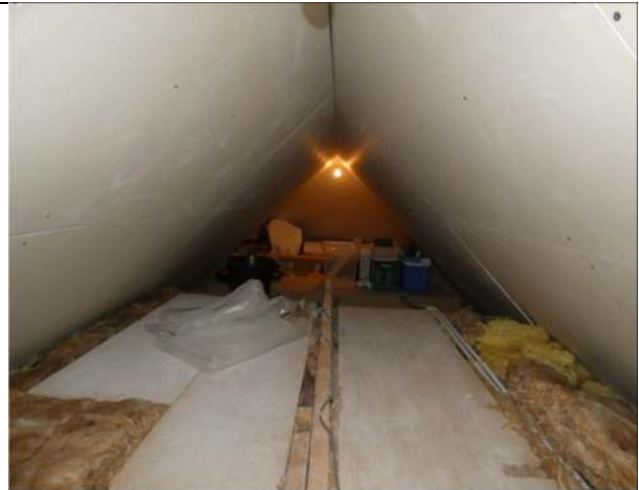
There are two separate sections of enclosed roof void within the main part of the house which lead into the gabled projections to the south (Photographs 21-26). Within both these sections, plasterboard has been attached to the underside of the rafters to create a ceiling. There was no evidence of bats within the eastern section or the easternmost gabled projection to the south but within the western section there were several small-sized droppings underneath and caught in an opening by the chimney (Photographs 27 and 28). It is likely that bats are getting into this area via openings under slates near the base of the chimney (e.g. Photograph 29).

Photograph 21. The western section of enclosed roof void (view to west)

Photograph 22. The western section of enclosed roof void (view to east)

Photograph 23. The section of enclosed roof void within the westernmost gabled projection to the south

Photograph 24. The eastern section of enclosed roof void within the house (view to west)

Photograph 25. The eastern section of enclosed roof void within the house (view to east)

Photograph 26. The section of enclosed roof void within the easternmost gabled projection to the south

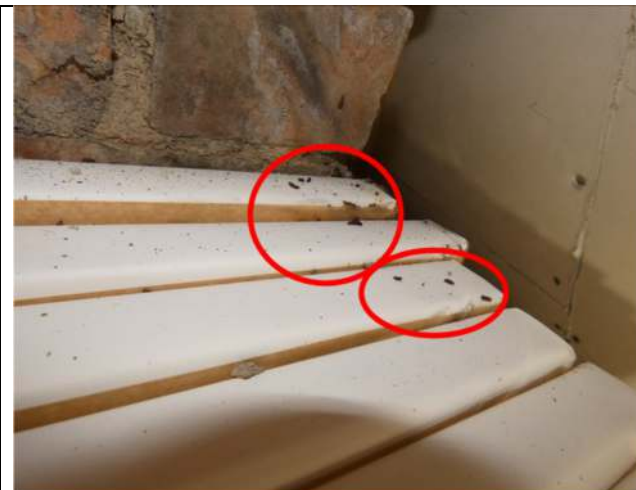
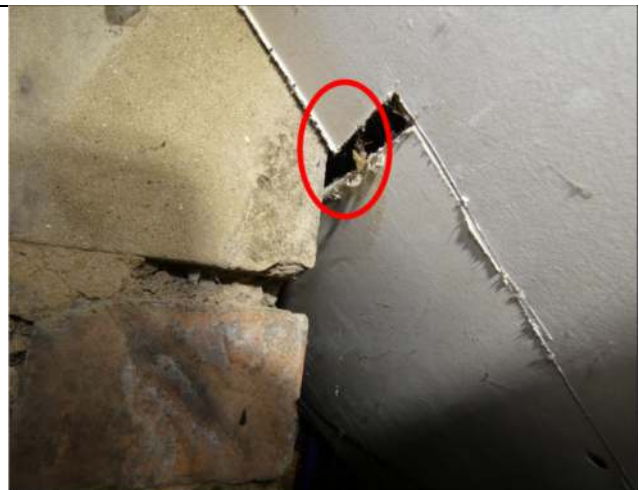
Photograph 27. Bat droppings within the western section of enclosed roof void under the chimney

Photograph 28. Bat droppings caught in an opening within the western section of enclosed roof void under the chimney

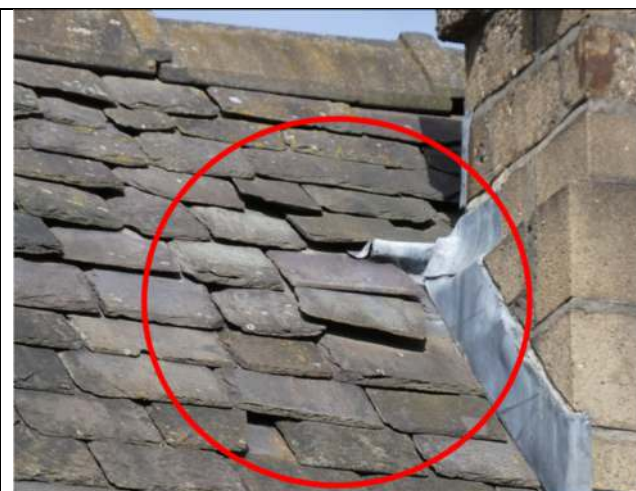
Photograph 29. Openings under slates near the base of the chimney

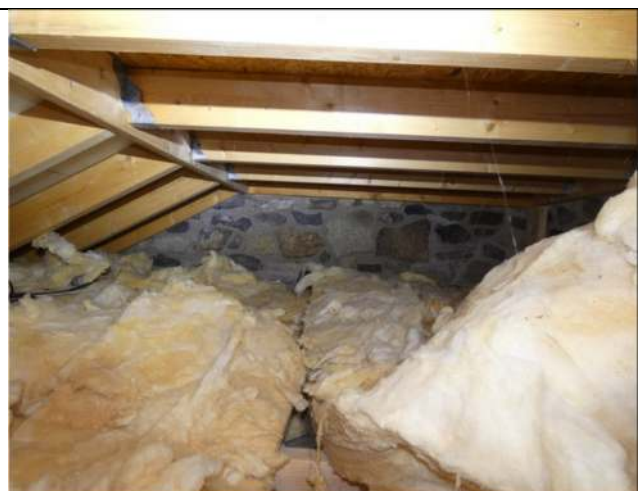
Within the single-storey extension at the south-west corner of the house, there is a very small enclosed roof void (Photograph 30). There was no evidence of bats within the space.

Photograph 30. The enclosed roof void within the single-storey extension at the south-west corner of the house

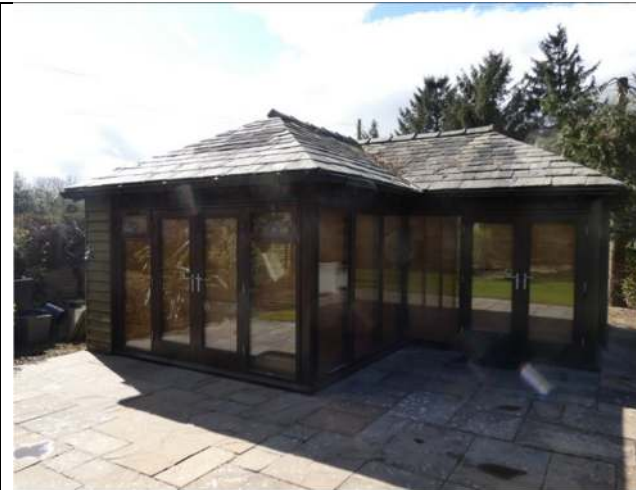
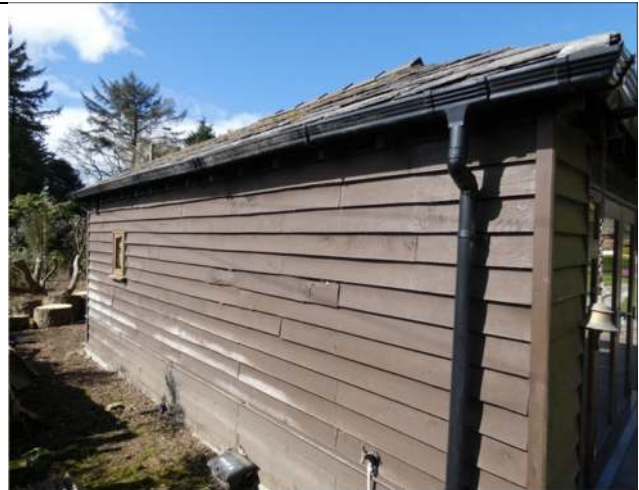
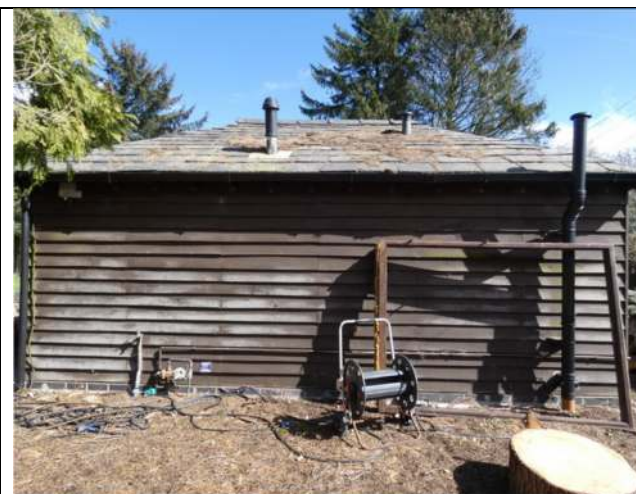
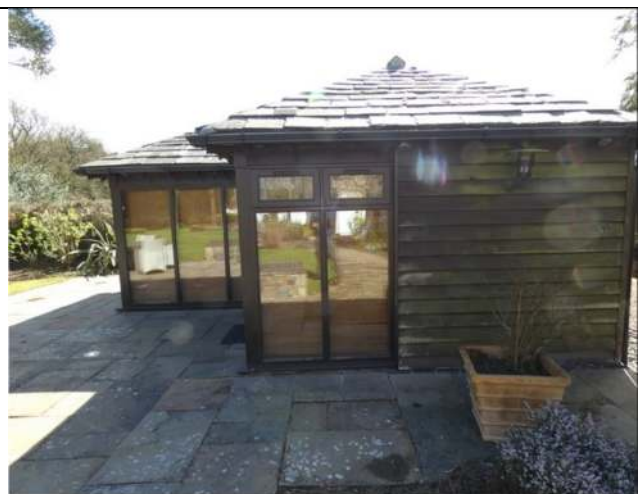
L-shaped timber-clad building. The hipped roof is covered with slates and is lined but it was not possible to determine with what material.

Photograph 31. The east elevation of the outbuilding

Photograph 32. The south elevation of the outbuilding

Photograph 33. The west elevation of the outbuilding

Photograph 34. The north elevation of the outbuilding

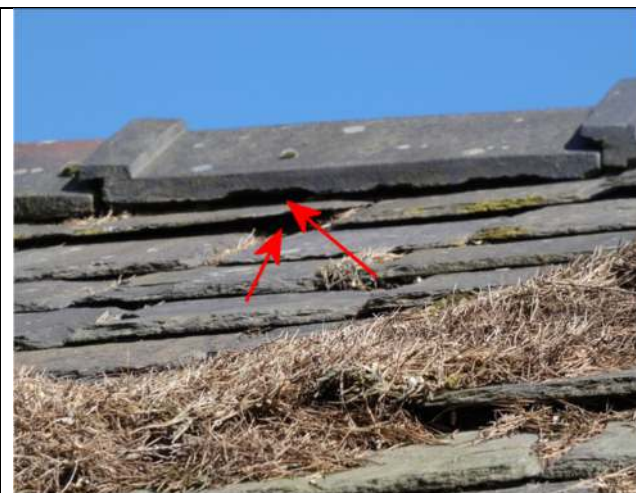
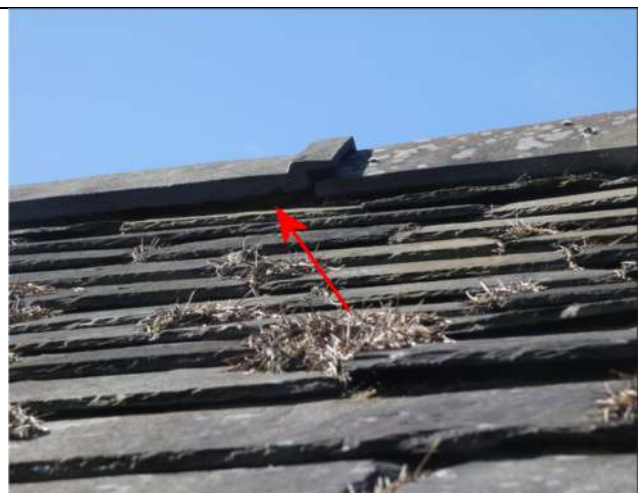
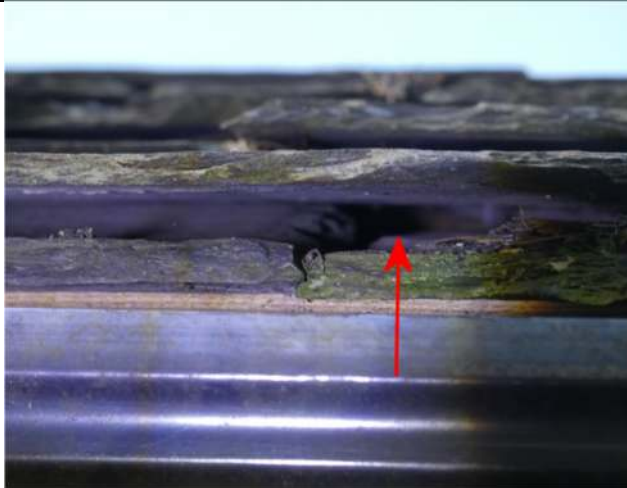
There are numerous openings under the slates and ridge tiles leading to the cavity between slates/tiles, battens and lining (e.g. Photographs 35-37). Such cavities are suitable for crevice-dwelling species.

Photograph 35. Example of openings under ridge tiles and slates on the roof of the outbuilding

Photograph 36. Further example of an opening under a ridge tile on the roof of the outbuilding

Photograph 37. Further example of an opening under a slate on the roof of the outbuilding

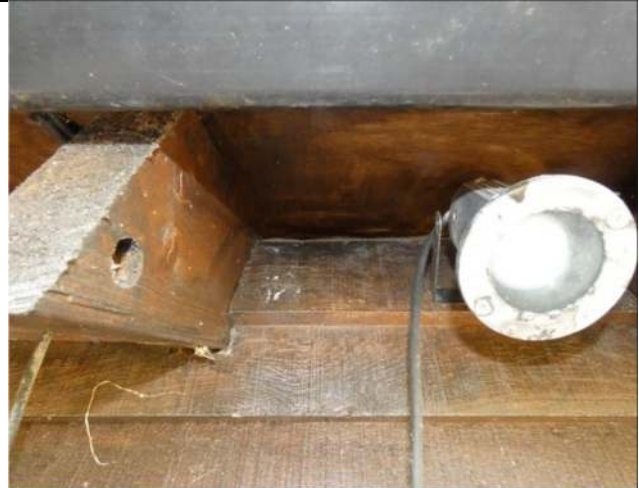
There were no openings under the eaves of the building (e.g. Photograph 38).

Photograph 38. Example of the sealed eaves on the outbuilding

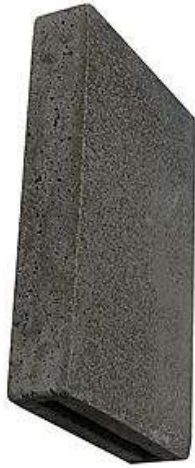
Photograph 39. Greenwood's EcoHabitats single cavity bat box
