# Detailed Unexploded Ordnance Risk Assessment

Cliffe Hall Farm, Markfield

10621 RA

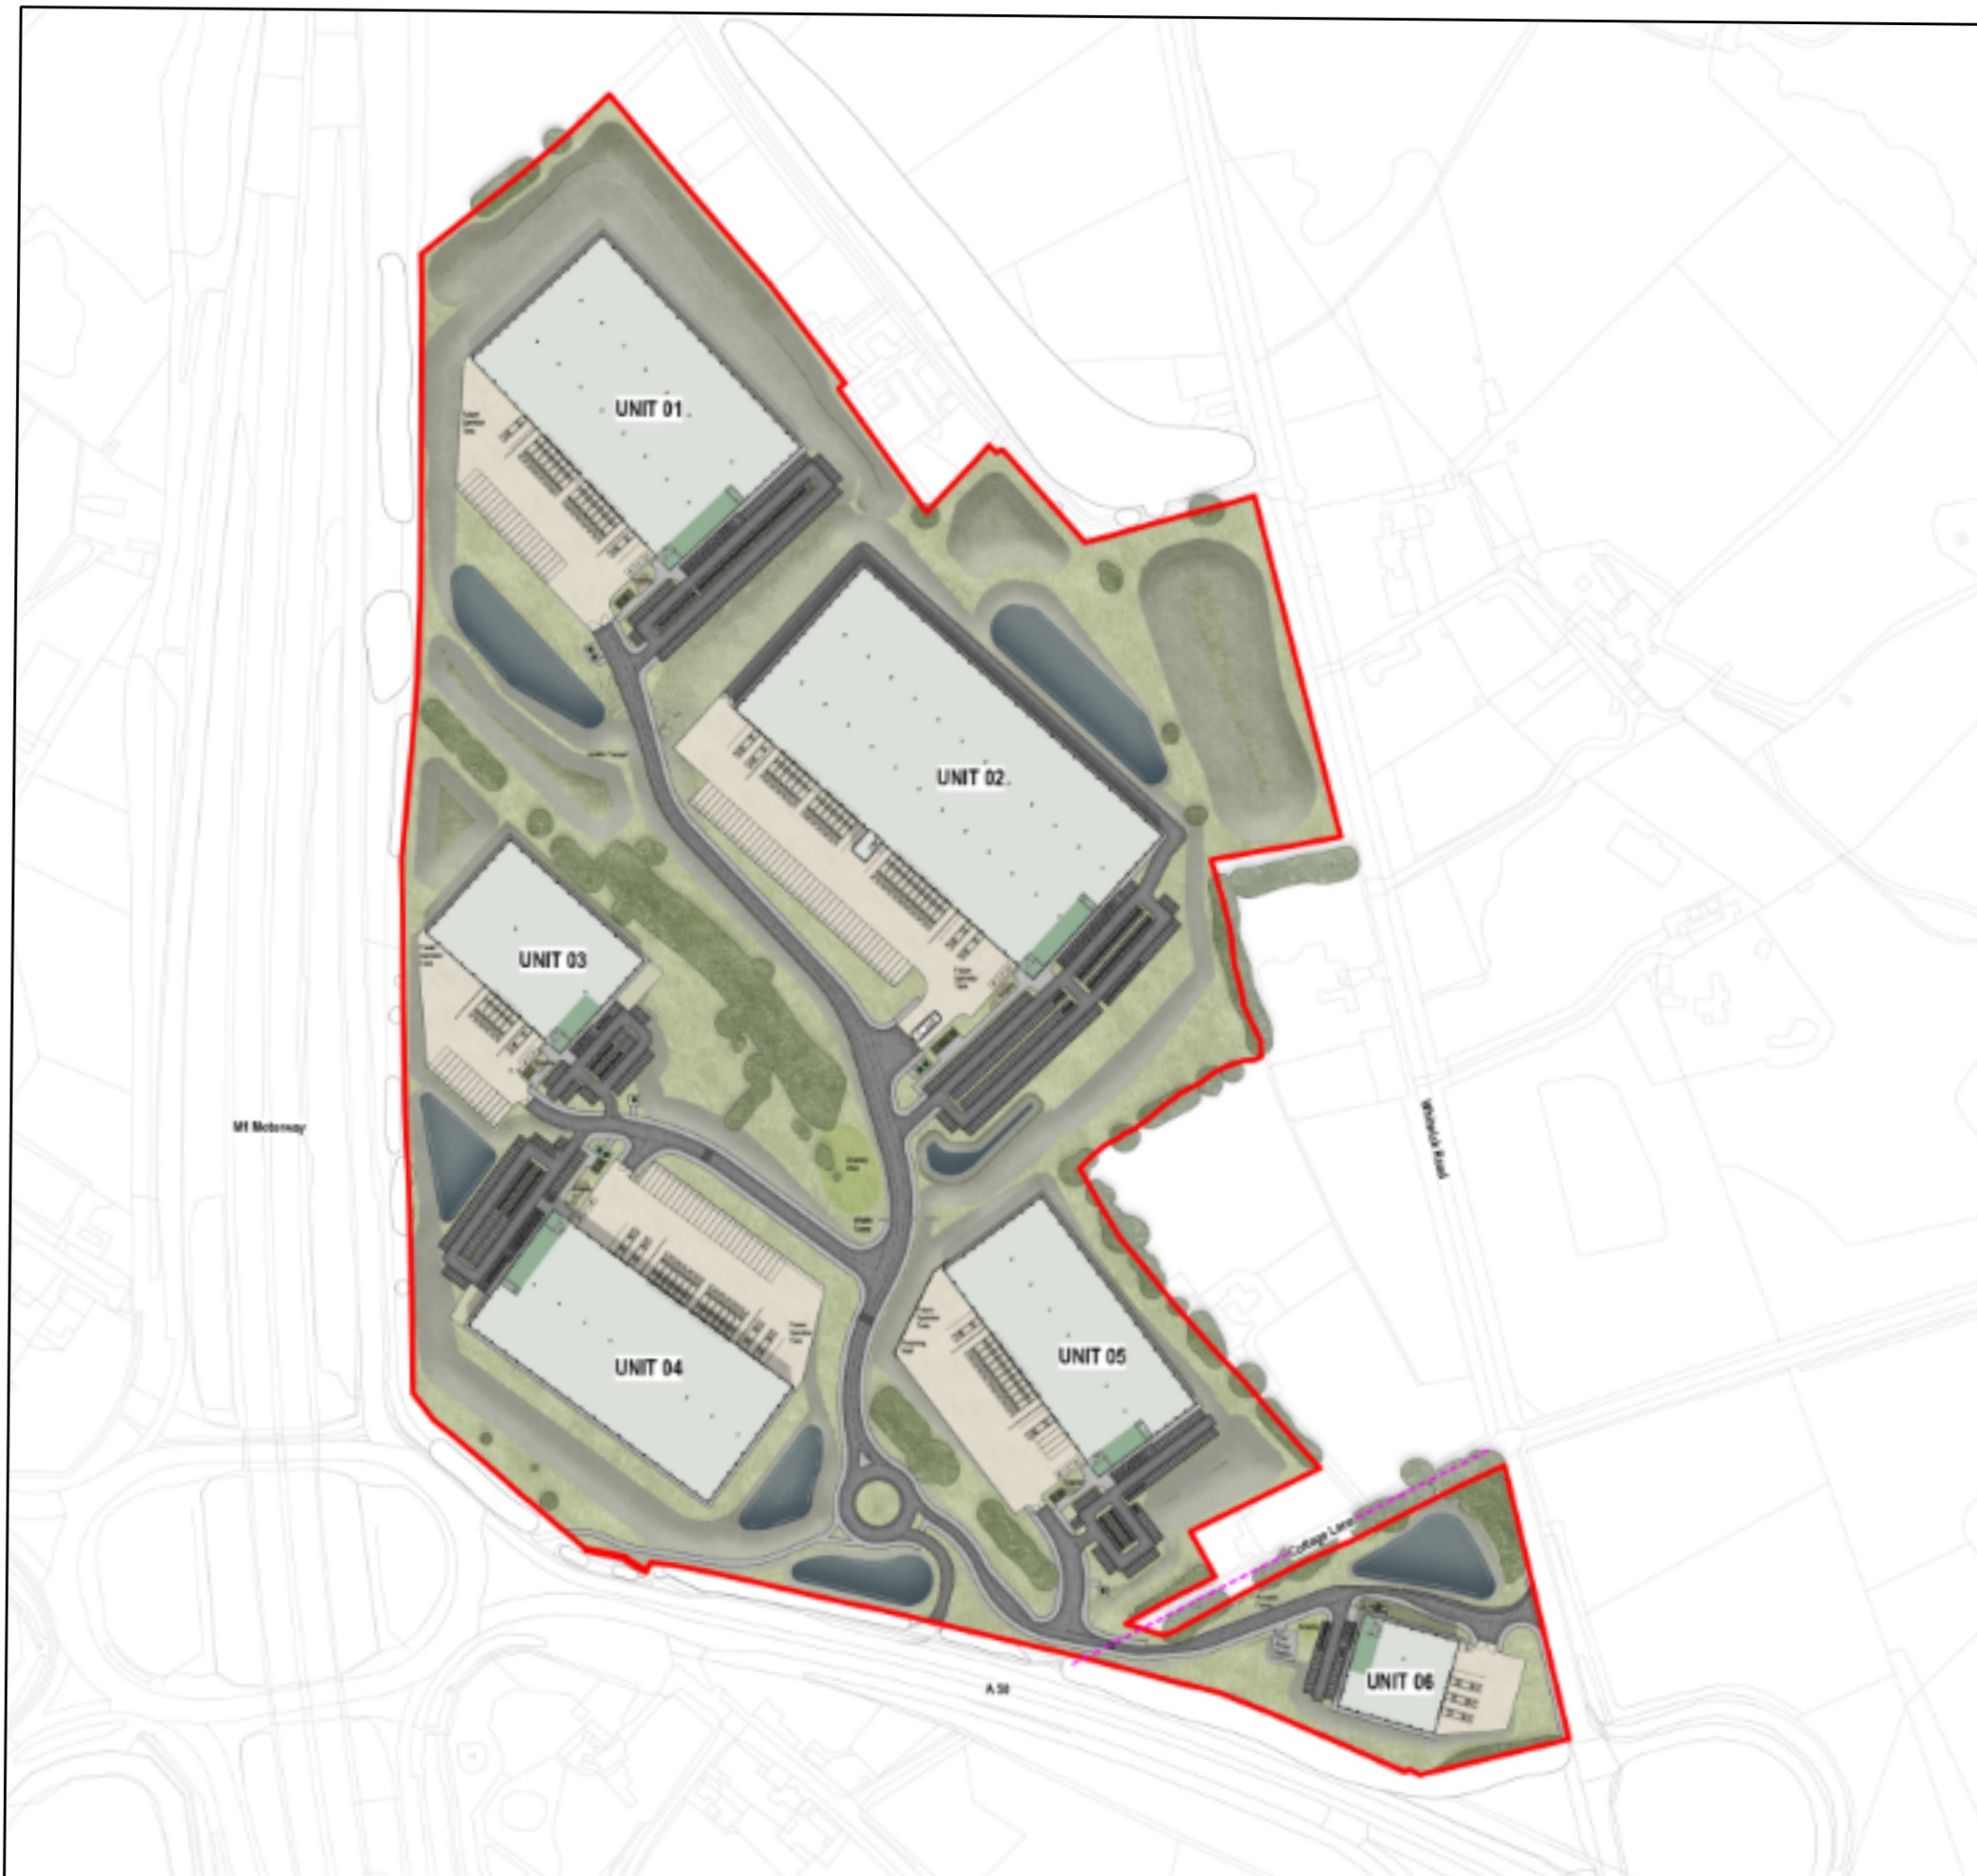
# Figure 4.1

| | Date | Observations | Reference | Source |
|---|---|---|---|---|
| <b>Pre-WWII</b> | 1929 | <ul style="list-style-type: none"> <li>The site encompasses rural fields related to <i>White Hill</i>.</li> <li>A road encroached into the southern extent of the site.</li> <li>A <i>F.P</i> (footpath) crosses the site from south to the eastern boundary.</li> </ul> | Figure 4.1 | Landmark Maps |

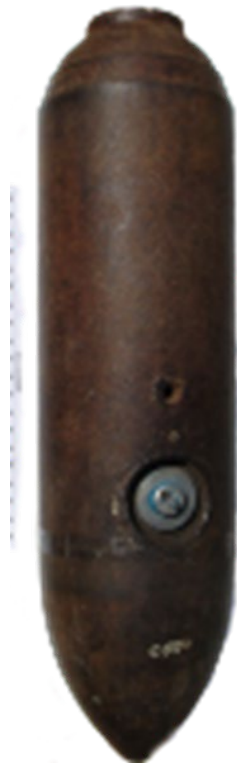
# Sprengbombe Cylindrisch 50 (SC50)

**Bomb weight:** 40-54kg

**Fuze Type:** Impact fuze / electro-mechanical time delay fuze

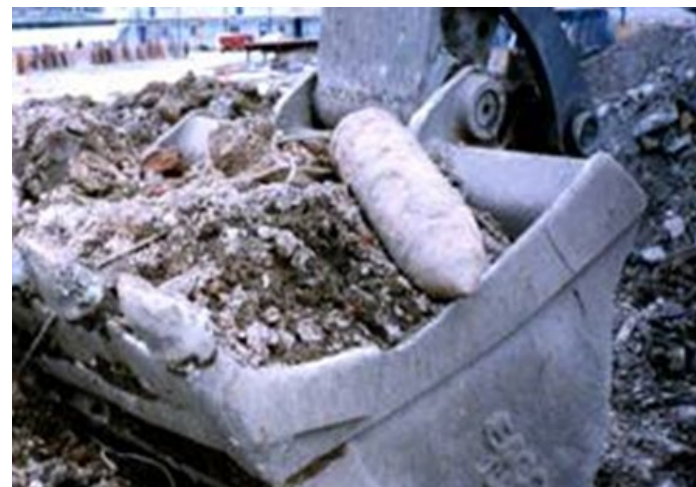
In May 2015, an SC50 was found at a building site on Empire Way, Wembley, London. (Image source: *The Guardian*)

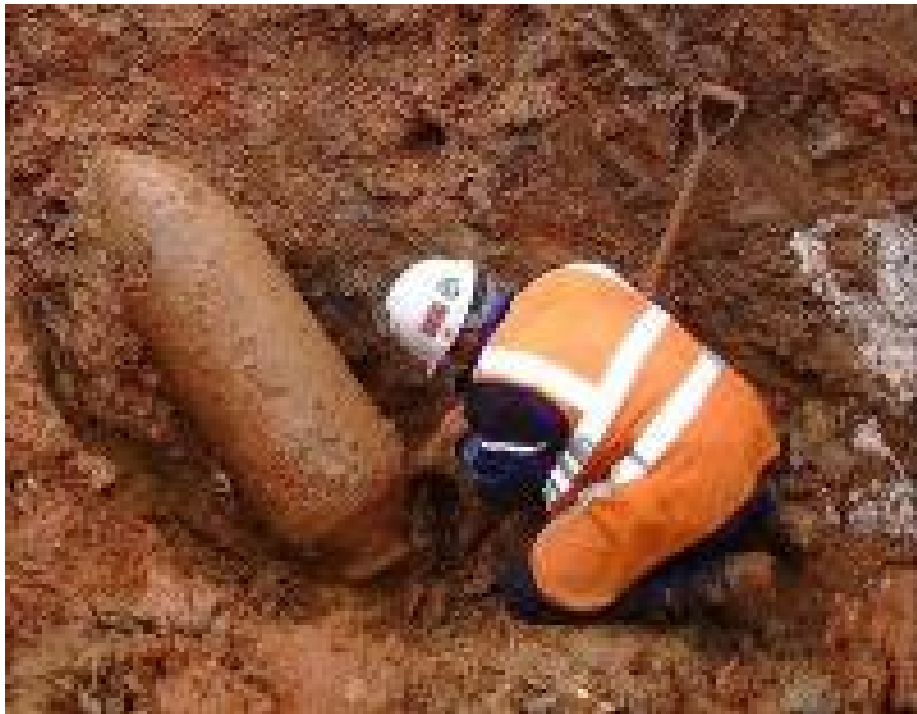
**SC250 found on site**  
In 2000, Igne discovered an SC250 whilst supervising construction work at Hawkinge, Kent.

Additional Notes:  
The images show SC250 bombs facing upwards in the ground, illustrating the J-Curve Effect.

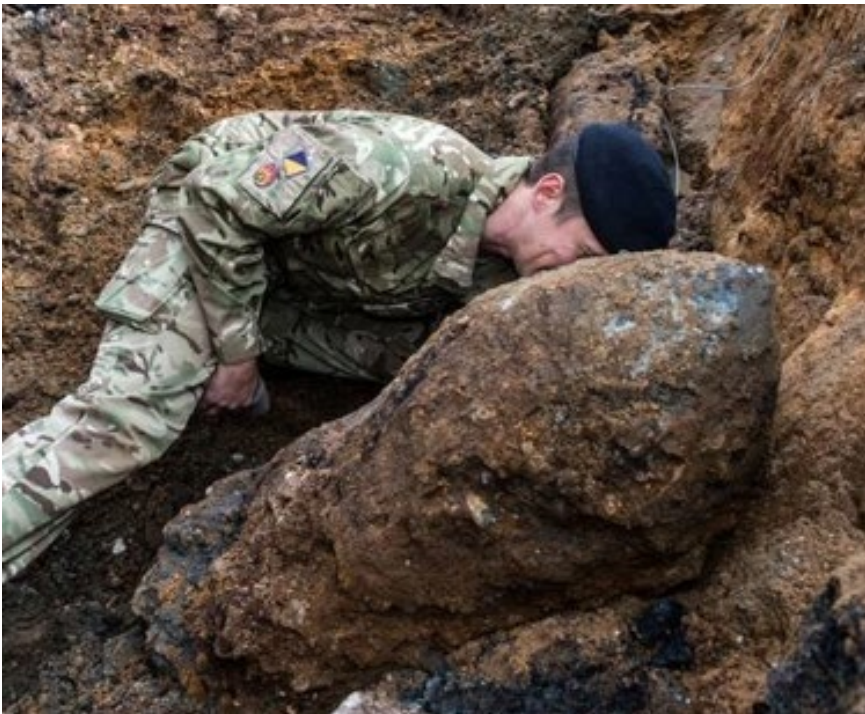
**SC250 found on site**  
In 2015, a 250kg HE bomb was found on a construction site in Bermondsey, London.

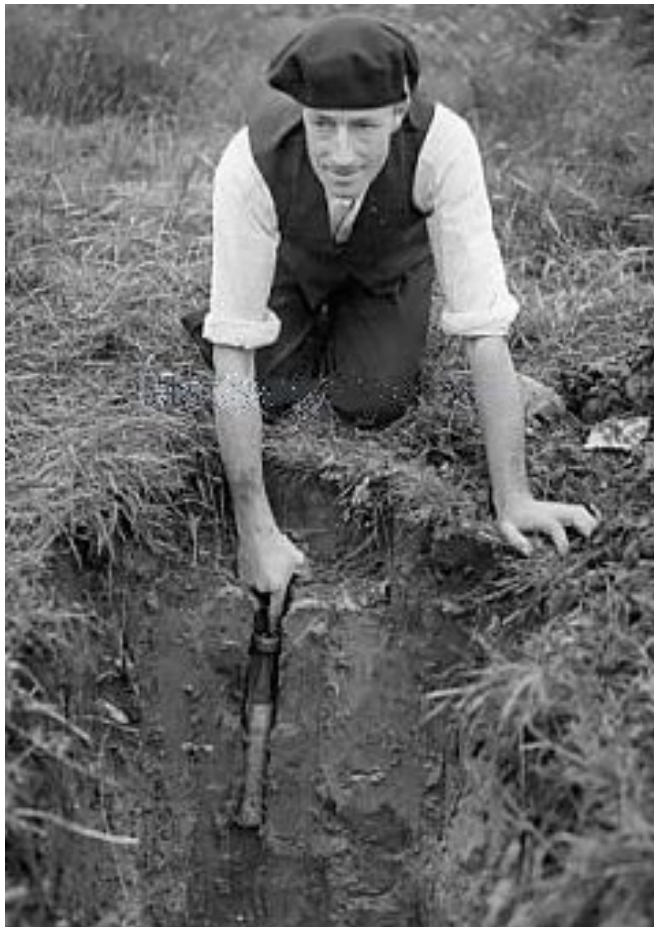
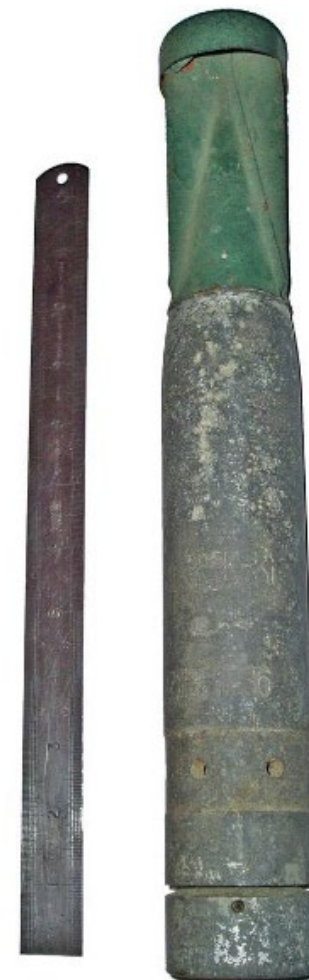
# 1kg Incendiary Bomb (IB)

**Bomb weight:** 1.0 & 1.3kg  
**Filling:** 680g Thermite  
**Fuze Type:** Impact fuze  
**Body Dimensions:** 350 x 50mm  
**Body Diameter:** 50mm  
**Use:** As incendiary – dropped in clusters against towns and industrial complexes  
**Remarks:** Jettisoned from air-dropped containers. Magnesium alloy case. Sometimes filled with high explosive charge.

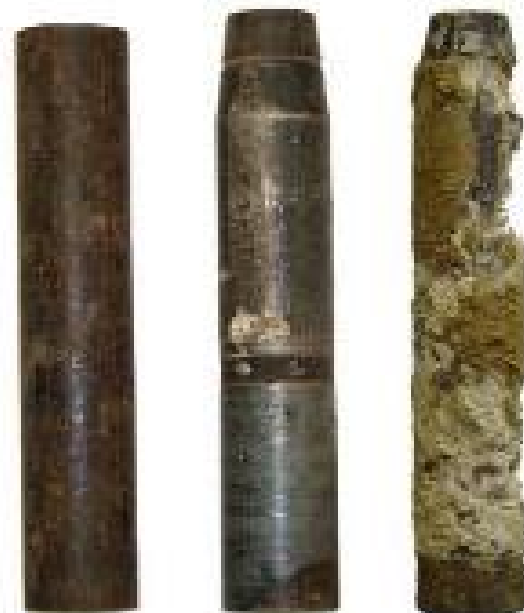
Left: ordinary scaffold pipe  
Centre: 1kg incendiary bomb  
Right: incendiary bomb found on site in UK

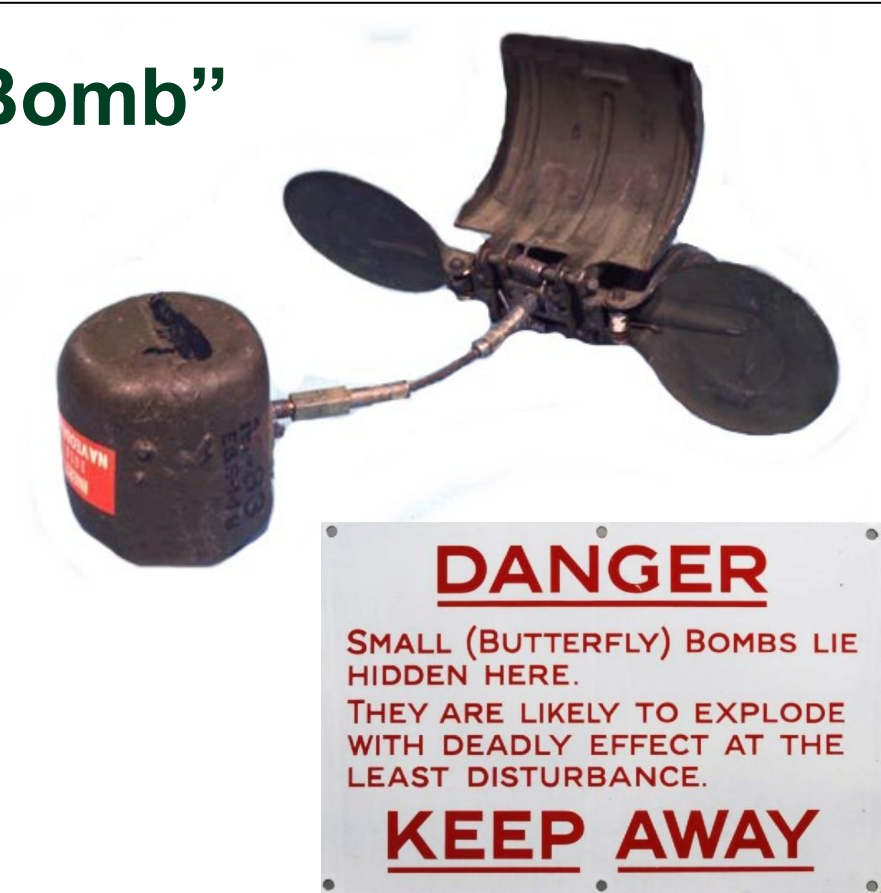
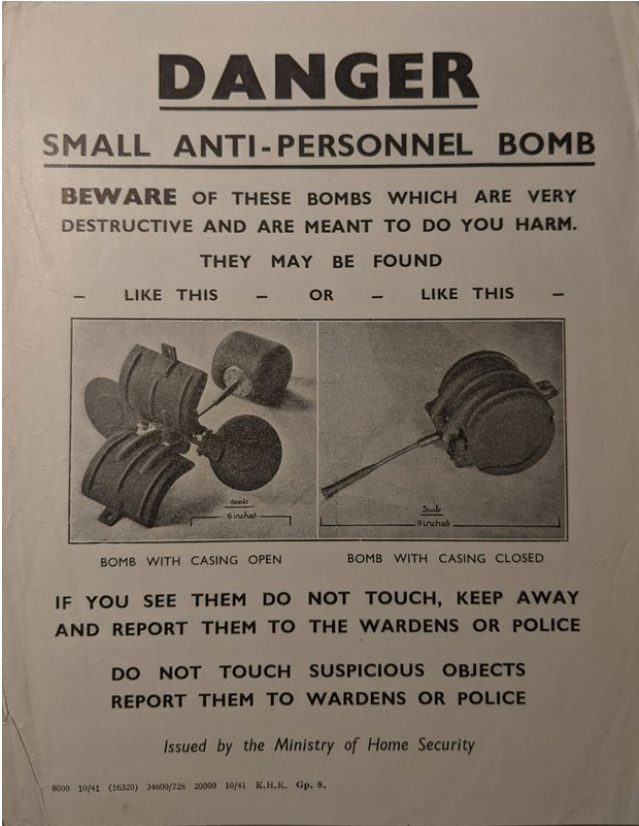
# SD-2 & SD-2 B “Butterfly Bomb”

**Bomb Weight:** 2.0kg  
**Explosive Weight:** 0.225kg  
**Explosive Filling:** 225g of TNT  
**Fuze Type:** Mechanical (41) clockwork fuze only in SD-2  
**Bomb Dimensions:** 200x76mm with cable attachment but without brake airscrews  
**Bomb Diameter:** 76mm  
**Use:** Against living targets and with Störzänder (deterrent fuze) as mine  
**Remarks:** Jettisoned from air-dropped containers. Generally lethal to anyone within a radius of 25m and could injure people as far away as 150m.

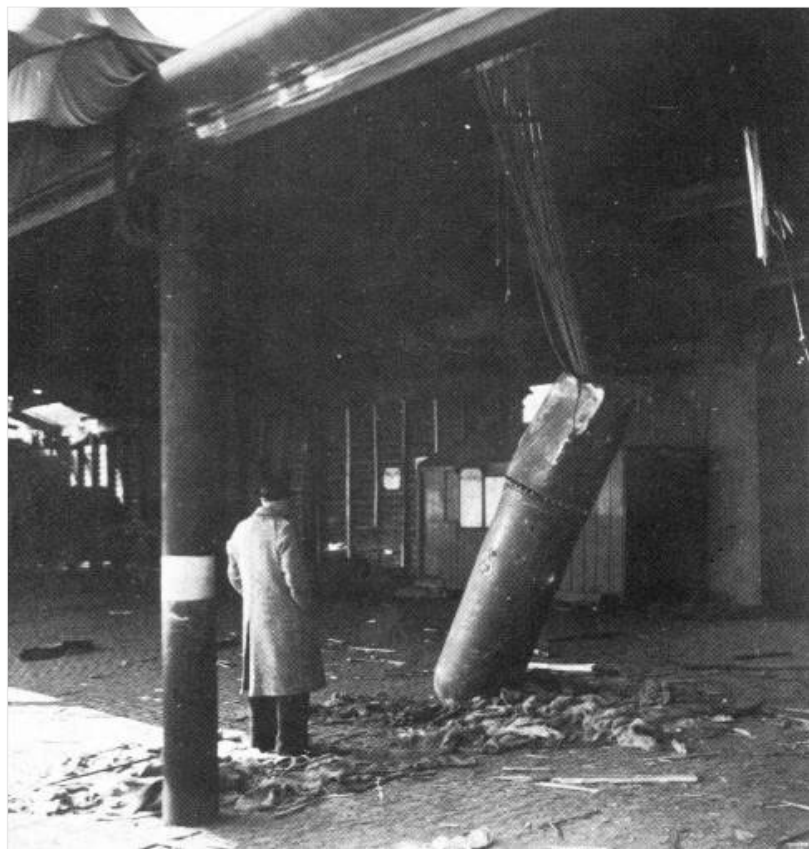
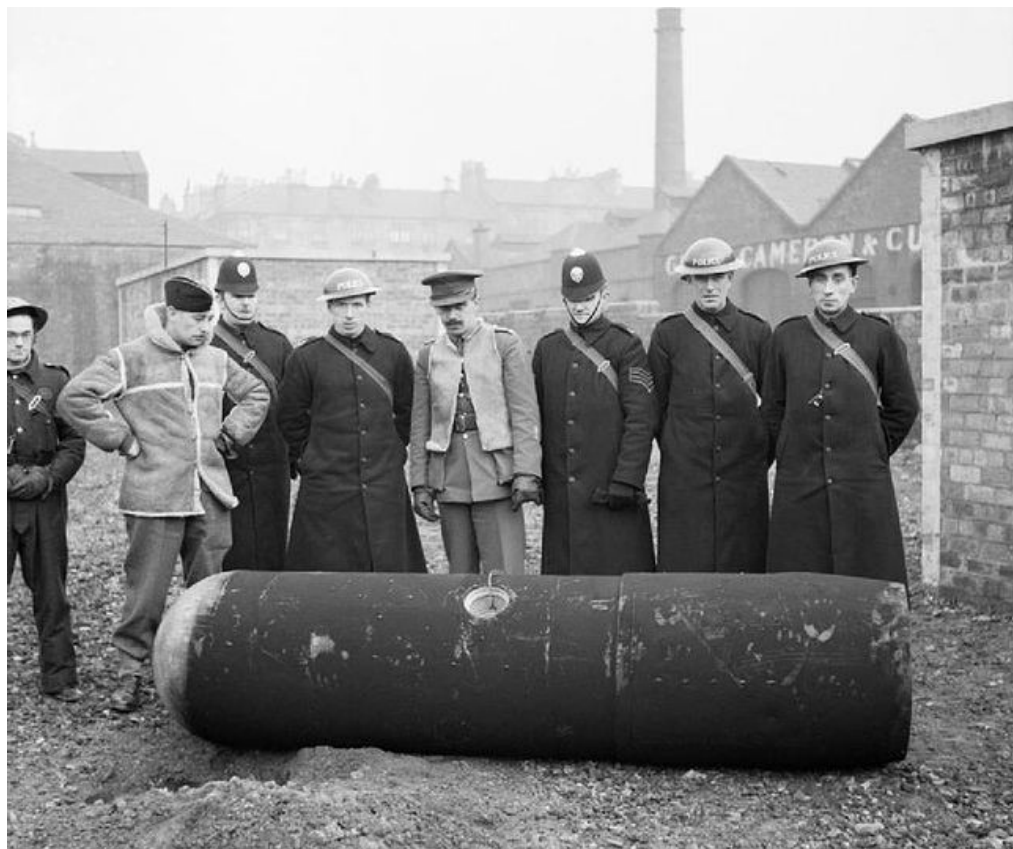
# Luftmine A/B “Parachute Mine”

**Bomb Weight:** A- 500kg, B – 1000kg  
**Fuze Type:** Mechanical clockwork fuze  
**Bomb Dimensions:** A – 1768mm, B – 2682mm  
**Use:** Capable of creating severe blast damage in built-up areas  
**Remarks:** Parachute mines were standard German sea mines fitted with a suitable detonator. They were widely used against British cities.

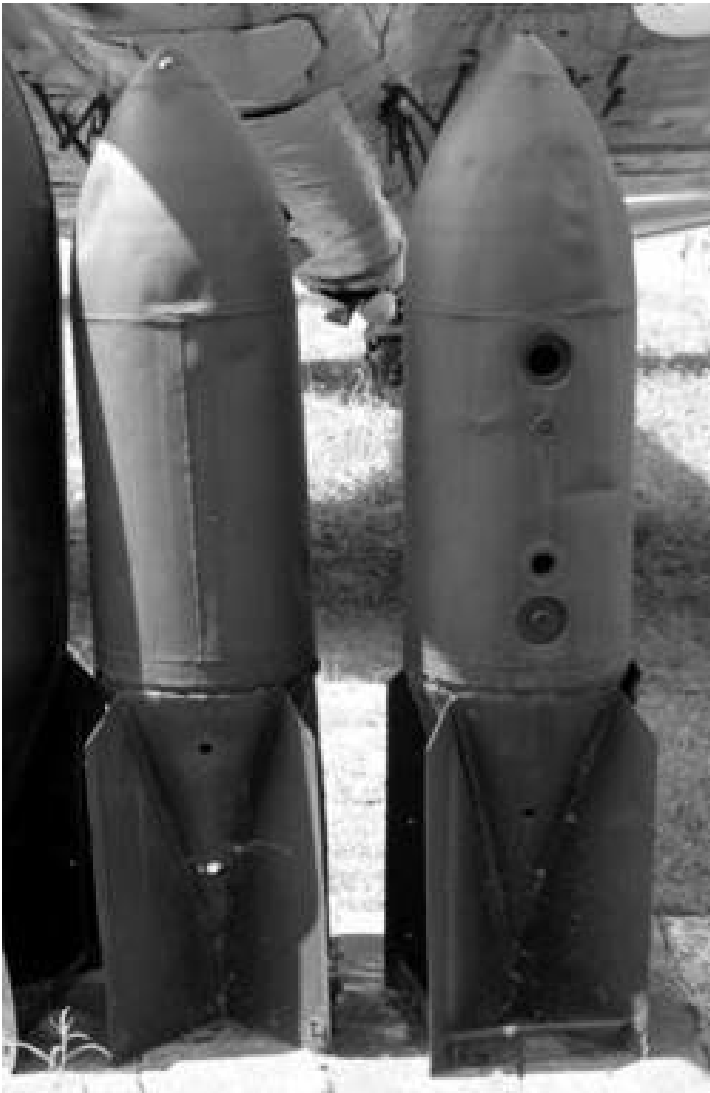
# Flam C-250 “Oil Bomb”

**Bomb Weight:** 125kg  
**Explosive Weight:** 1kg  
**Flammable Weight:** 74kg  
**Filling:** Mixture of 30% petrol and 70% crude oil  
**Fuze Type:** Super-fast electrical impact fuze  
**Bomb Dimensions:** 1650 x 512.2mm  
**Body Diameter:** 368mm  
**Use:** Often used for surprise attacks on living targets, against troop barracks and industrial installations  
**Remarks:** Thin casing – not designed for ground penetration

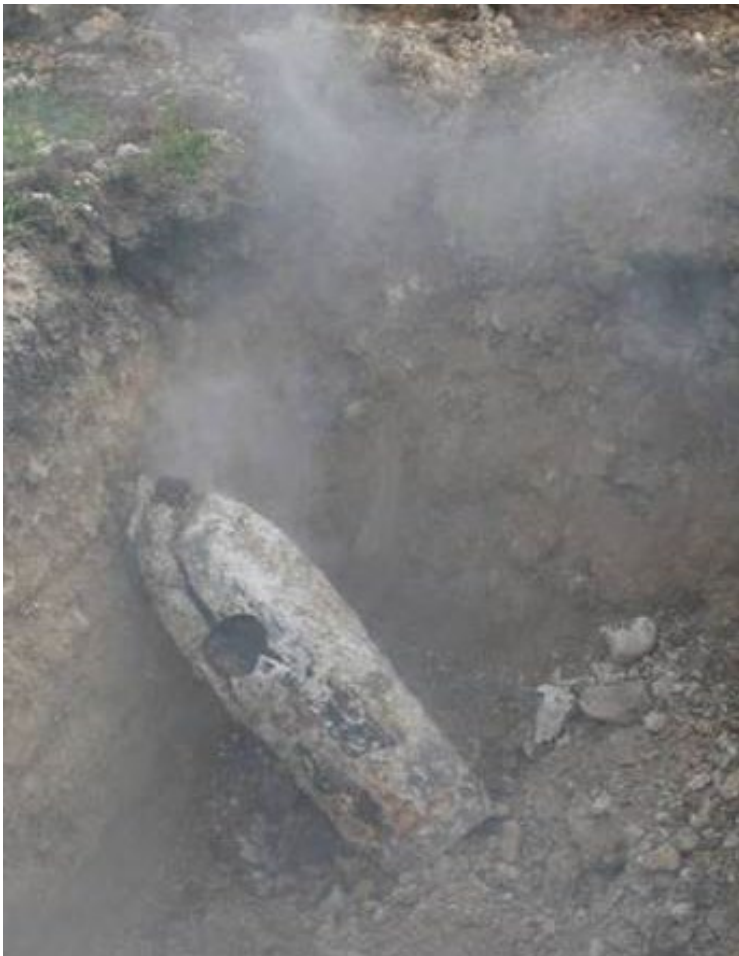
# C-50 A Phosphorous Bomb

**Bomb Weight:** c.41kg  
**Explosive Weight:** 0.03kg  
**Incendiary Filling:** 12kg liquid filling with phosphor igniters in glass phials  
**Fuze Type:** Electrical impact fuze  
**Bomb Dimensions:** 1100 x 2800mm  
**Body Diameter:** 200mm  
**Use:** Against all targets where an incendiary effect is to be expected  
**Remarks:** Early fill was a phosphorus / carbon disulphide incendiary mixture

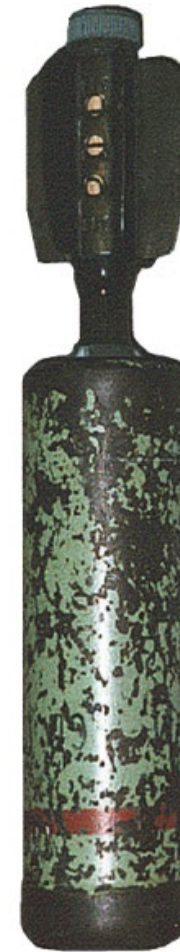
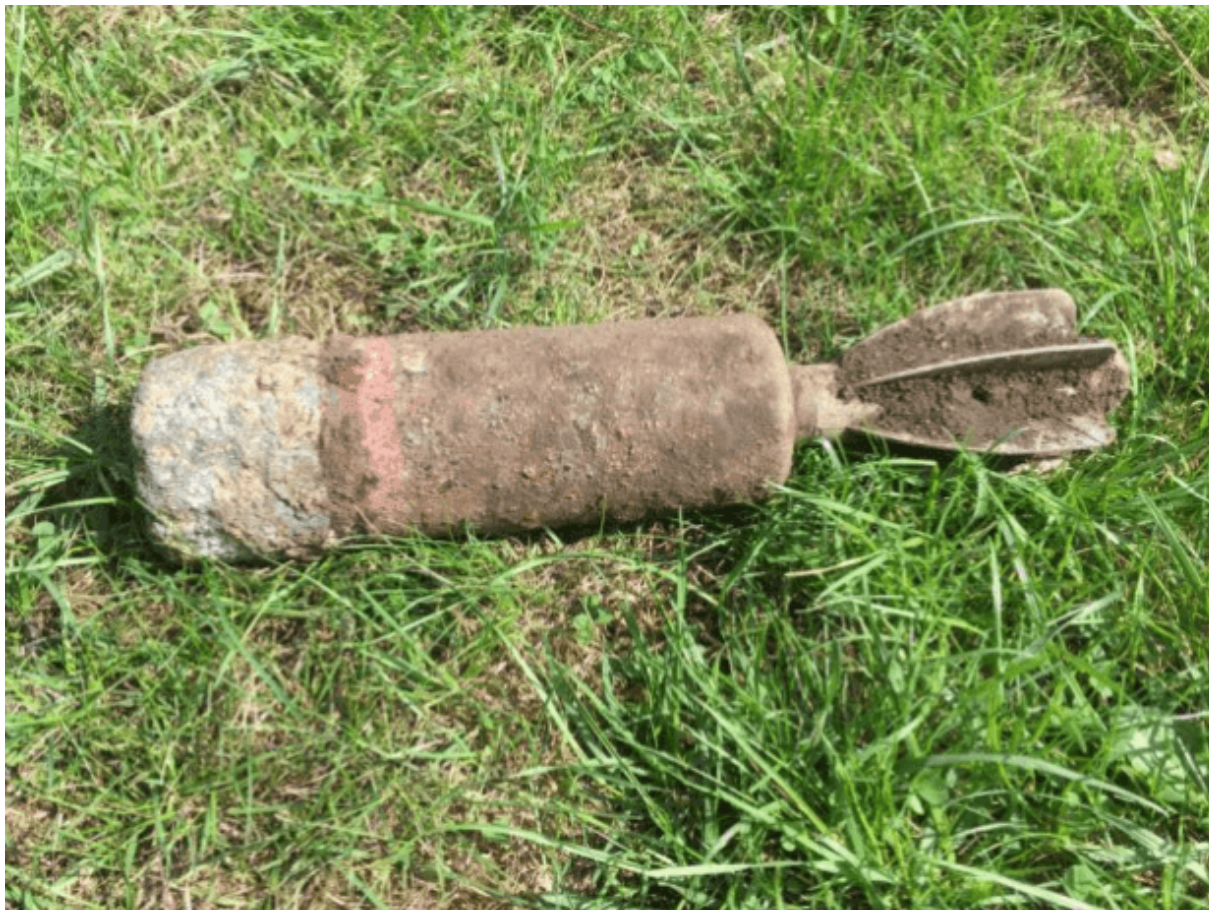
**Bomb Dimensions:** 51 x 290mm **Filling:** 200g RDX/TNT

**Remarks:** Fitted with an impact fuze which detonates the fuze booster charge (exploder) and, in turn, the high explosive charge. The main charge shatters the mortar bomb body, producing near optimum fragmentation and blast effect at the target.

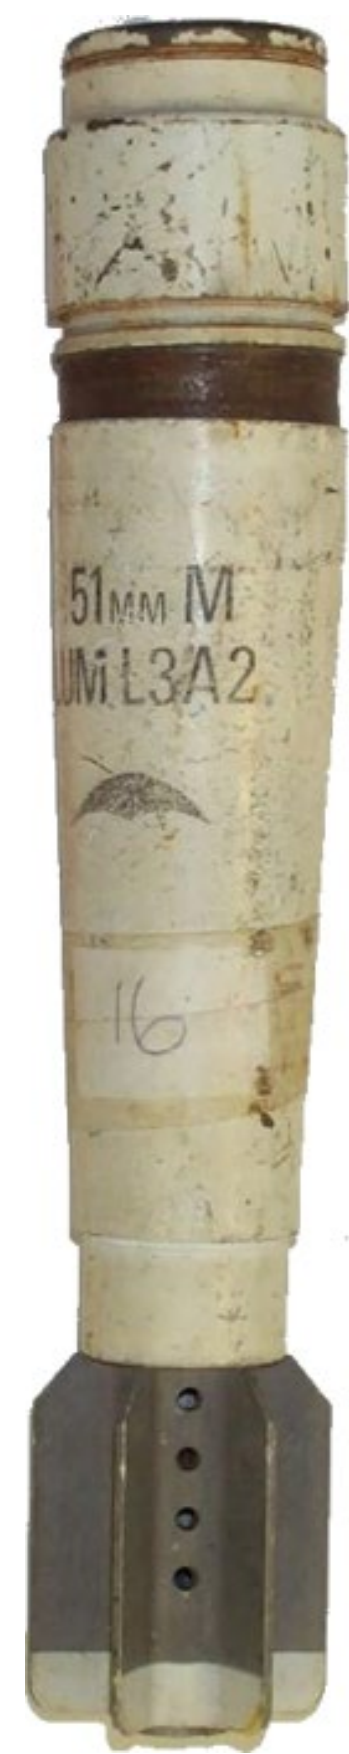
# Typical 2” Illuminating Mortar

**Fuze Type:**  
Illuminating  
**Bomb**  
**Dimensions:** 51  
x 290mm  
**Filling:** Various  
**Remarks:** The  
expulsion  
charge ignites  
and ejects the  
candle  
assembly. A  
spring ejects the  
parachute from  
the tail cone.  
The parachute  
opens, slowing  
the descent of  
the burning  
candle which  
illuminates the  
target.

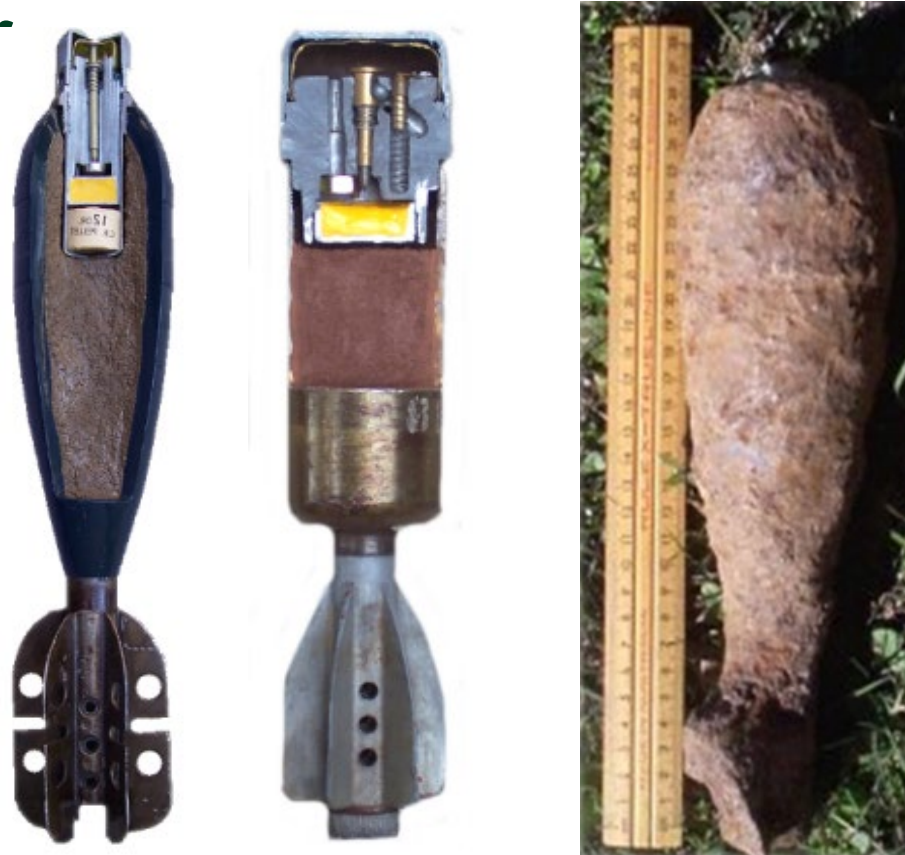
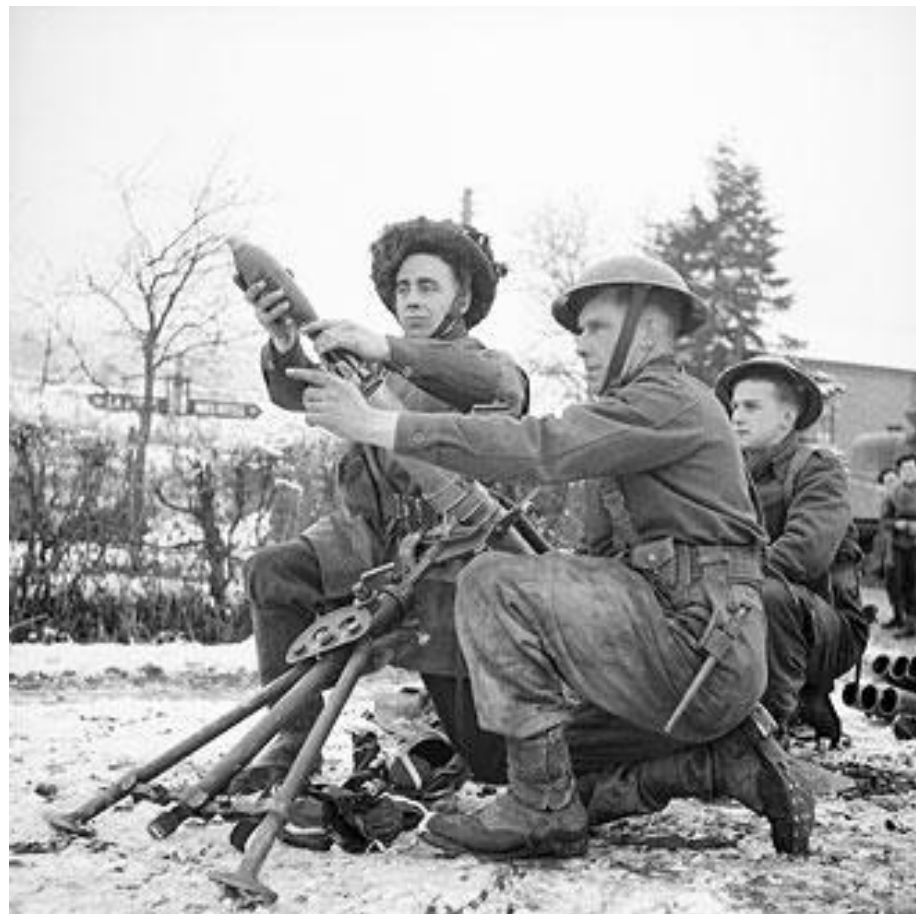
**Filling:** Typically, white phosphorus

**Remarks:** On impact, the fuze functions and initiates the bursting charge. The bursting charge ruptures the mortar bomb body and disperses the white phosphorous filler. The white phosphorous produces smoke upon exposure to the air.

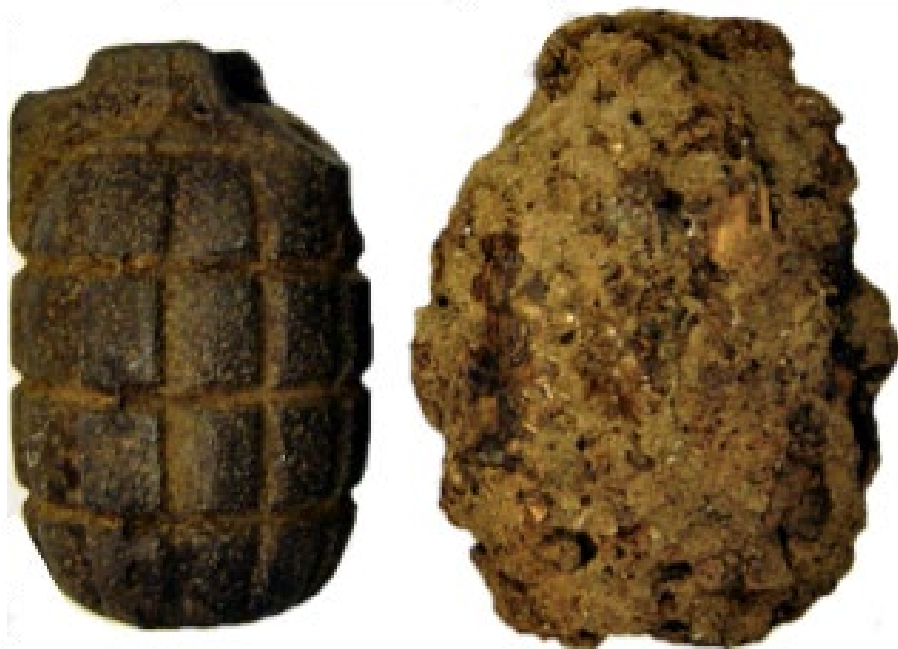
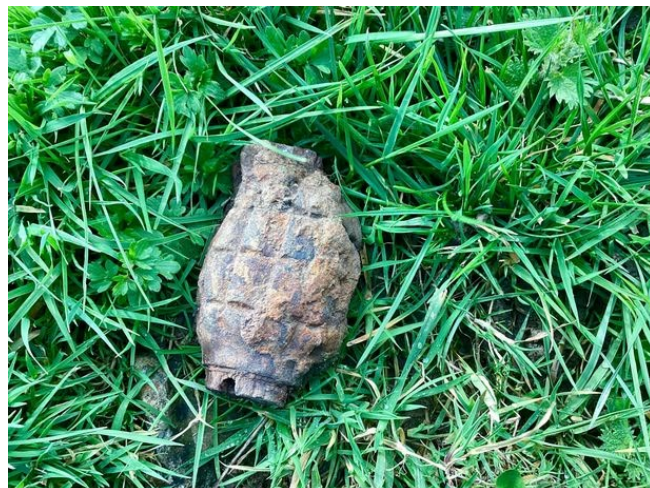
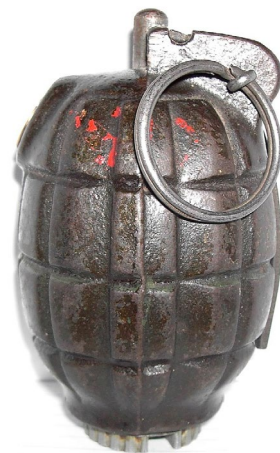
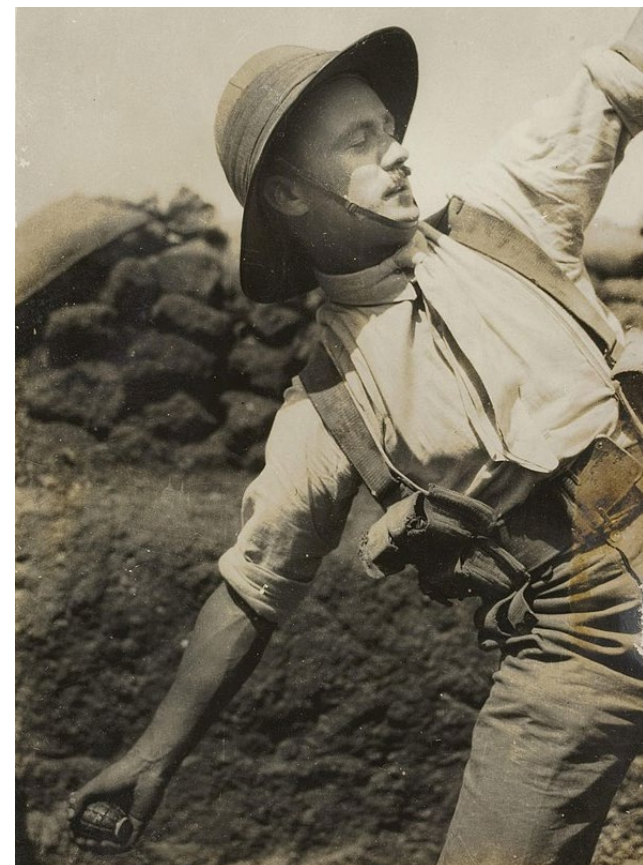
# No. 36 “Mills” Grenade

Grenade, .303 inch rifle, No. 36M, Mark I.

**Weight:** 0.7kg filled  
**Type:** Hand or discharger, fragmentation  
**Dimensions:** 95 x 61mm  
**Filling:** Alumatol, Amatol 2 or TNT  
**Remarks:** 4 second hand-throwing fuze with approximate range of 30m. First introduced May 1918.

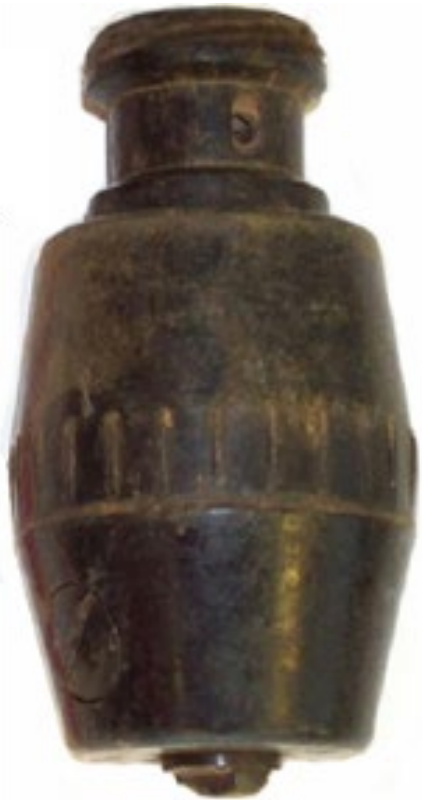
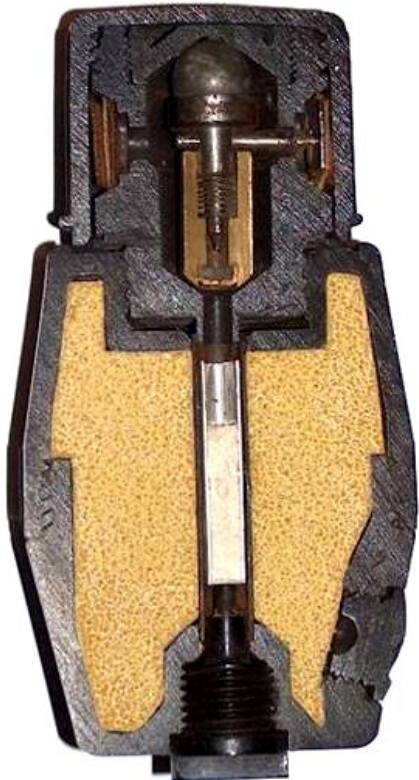
# No. 69 Grenade

**Weight:** 038kg filled  
**Type:** Percussion / Blast  
**Date Introduced:** December 1940  
**Remarks:** Black Bakelite body. Blast rather than fragmentation type. After unscrewing the safety cap, a tape is held when throwing the grenade releasing the safety bolt in the throwing motion. Detection is problematic due to its very low metal content.

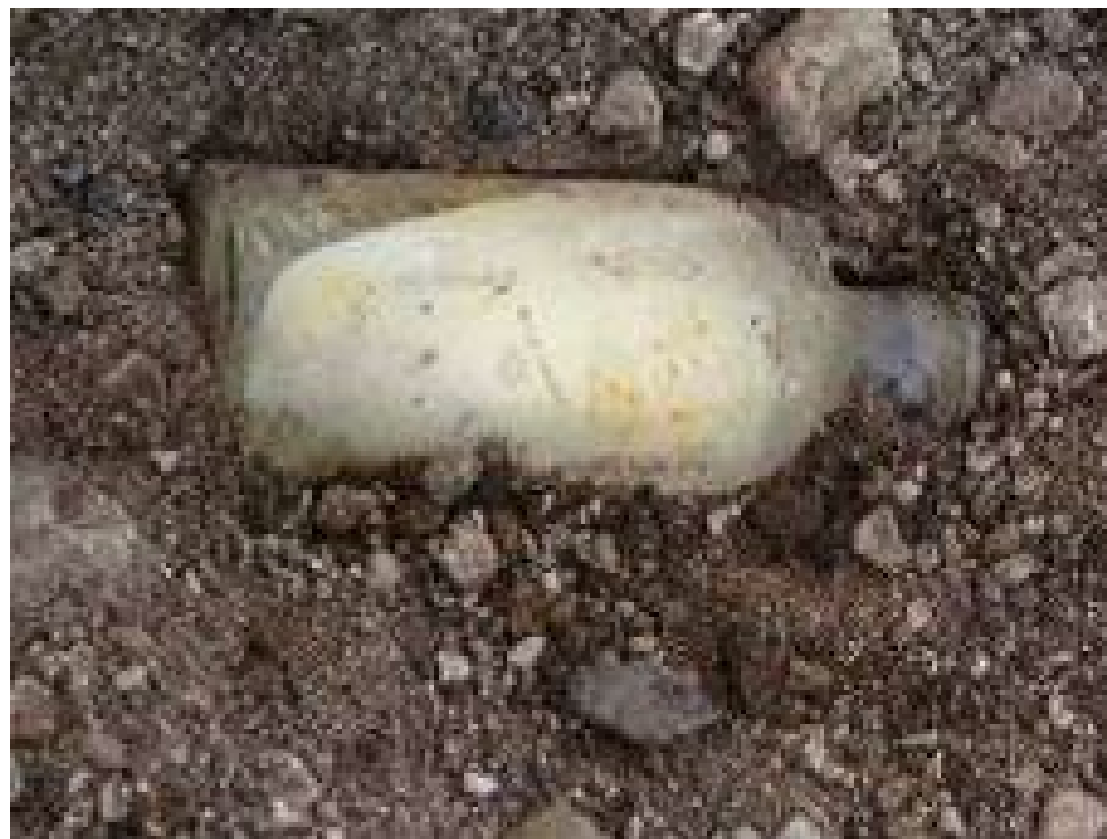
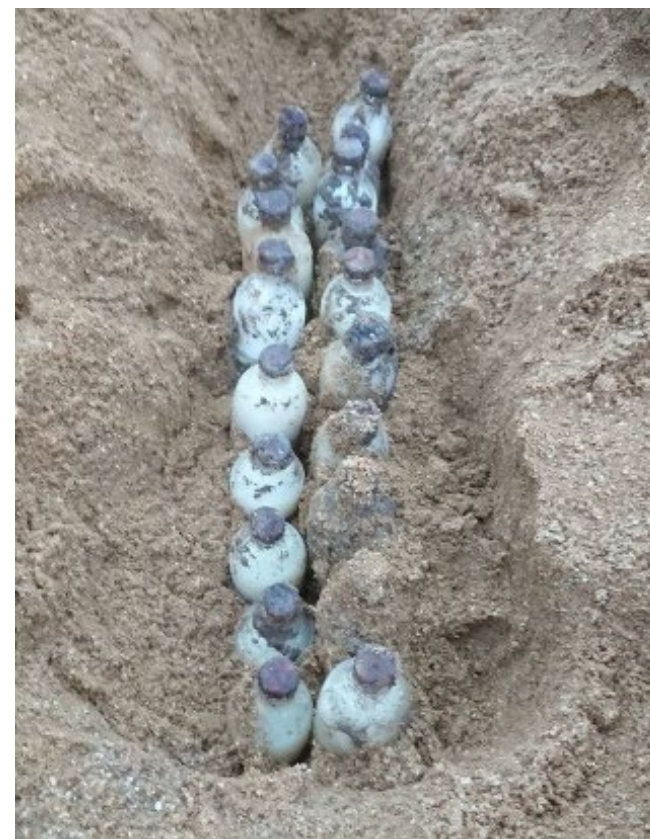
The grenade comprised a glass bottle with a total volume of approximately 1 pint. It was filled with white phosphorous, benzene, a piece of rubber and water. Over time, the rubber dissolved to create a sticky fluid which would self-ignite when the bottle broke.

Fired by hand or Northover Projector.

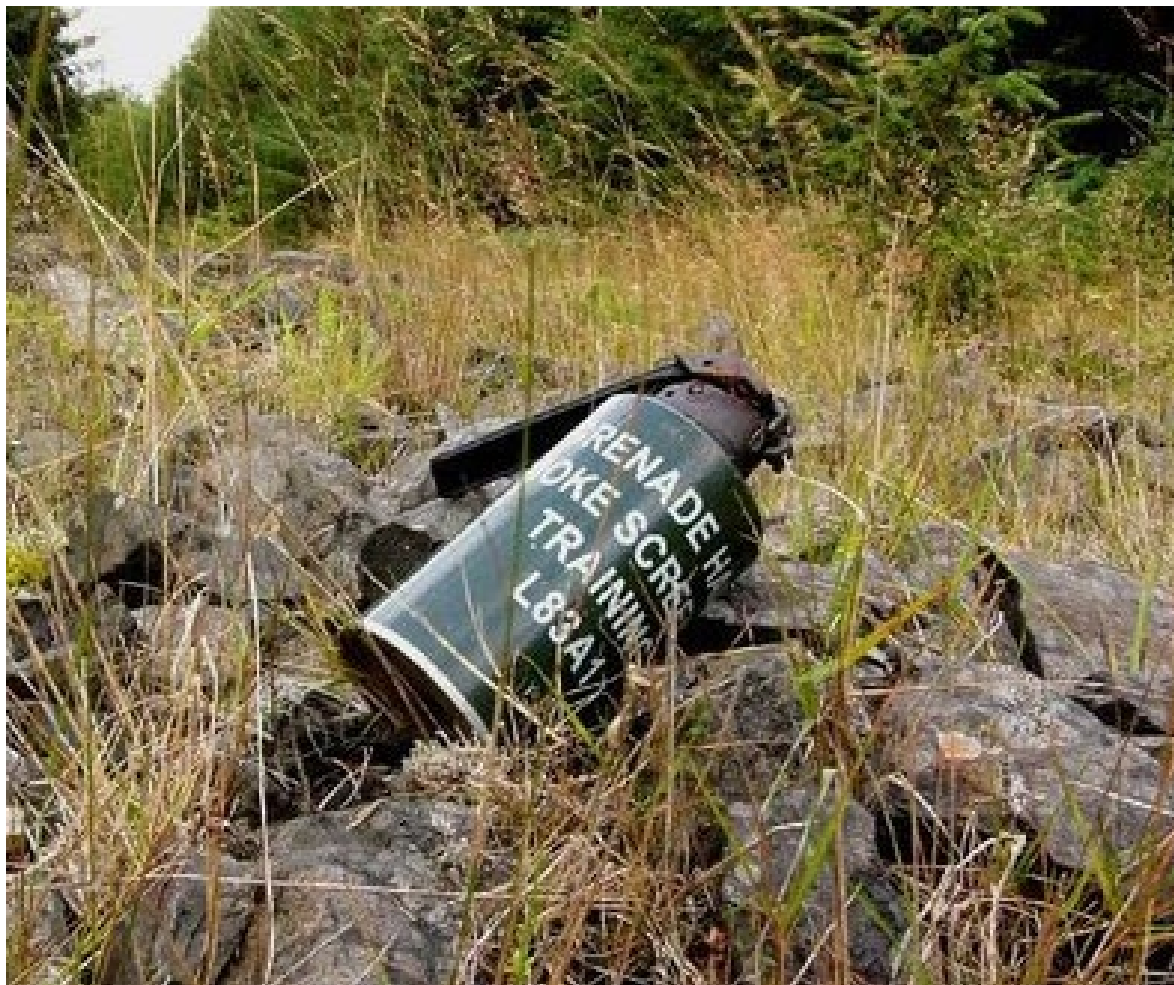
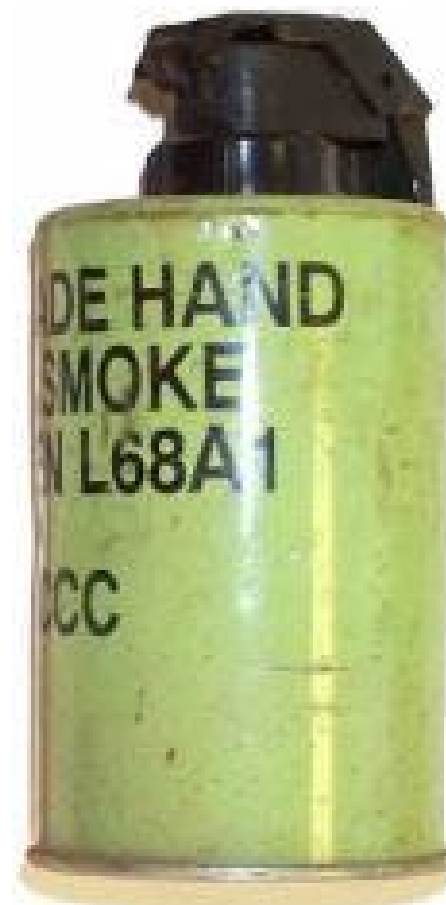
**Date Introduced:** Current MoD issue

**Remarks:** Smoke grenades are used as ground-to-ground or ground-to-air signalling devices, target or landing zone marking devices, and screening devices for unit movement.

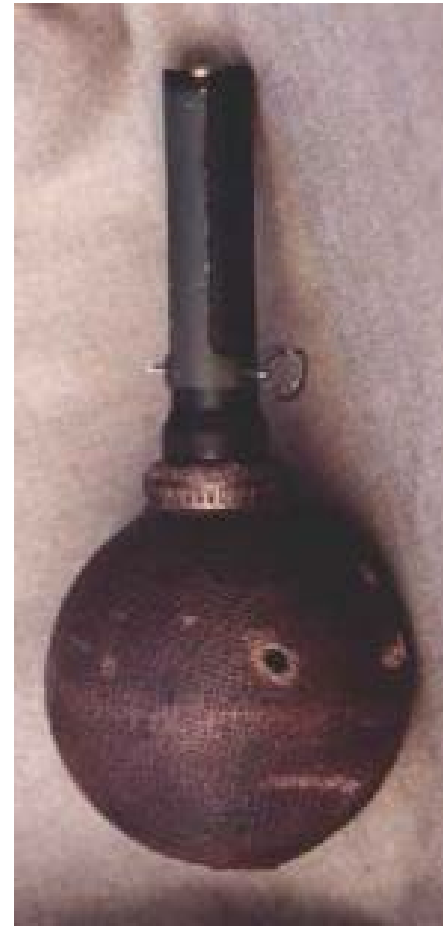
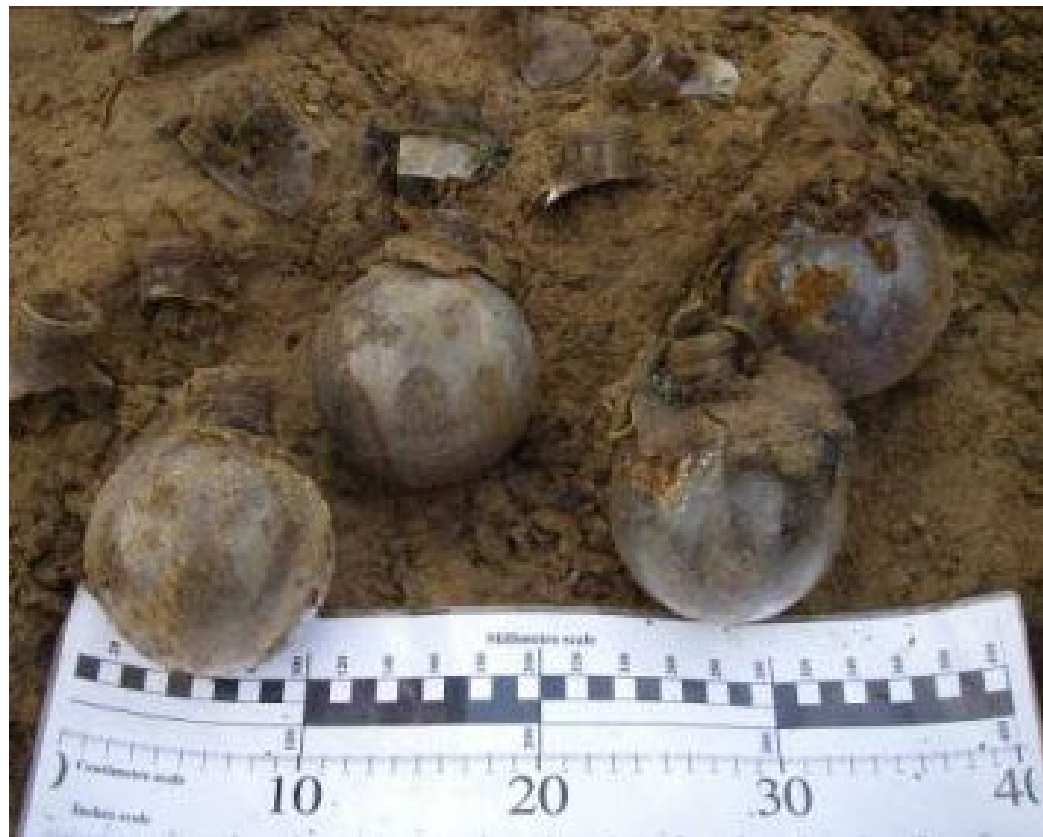
# No. 74 Grenade (“Sticky Bomb”)

Designed as an anti-tank grenade and used by the Home Guard. The grenade consisted of a glass ball on the end of a Bakelite (plastic) handle. Inside the glass ball was an explosive filling whilst on the outside was a very sticky adhesive covering. Until used, this adhesive covering was encased in a metal outer casing.
