# Detailed Unexploded Ordnance Risk Assessment

Cliffe Hall Farm, Markfield

10621 RA

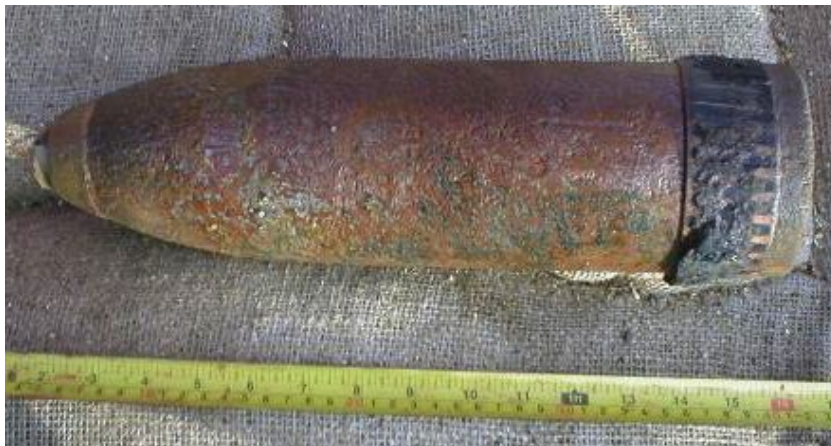
4in HE Projectile

- a) Long, pointed ogival nose and streamlined body.
- b) Square or tapered base. Boat tailed/streamlined.
- c) One-piece body construction.
- d) Base plate screwed or welded to the base, occasionally of one piece construction.
- e) Copper driving band near the base of the projectile.
- f) Body construction normally thin.
- g) Low charge to weight ratio.
- h) Fuzed with point-initiating and/or base-detonating fuze.
- i) If no driving band is present, it may use two bourrelets.

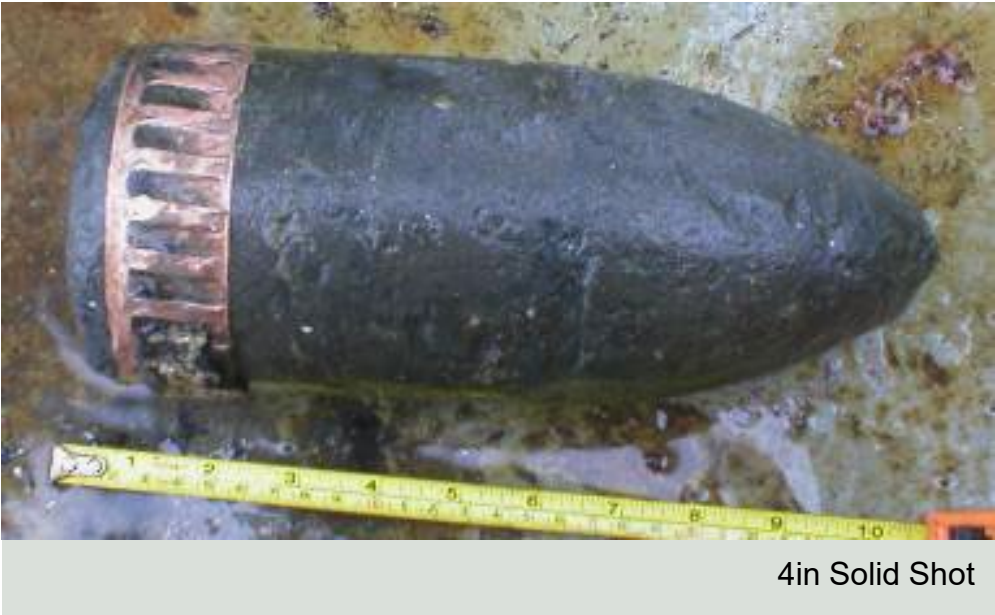
4in Solid Shot

- a) Driving bands (early designs) or obturators (current designs).
- b) Tracer pockets common.
- c) Ballistic caps and piercing caps (current designs).
- d) Early shot projectiles were made of hard high grade steel. Current designs use tungsten carbide or Depleted Uranium (DU) cores or penetrators.
- e) Most current shot projectiles now use discarding sabots, either of the post or petal type
- f) Proof shot projectiles have flat heads and are used to test guns.
- g) No fuzes are present.

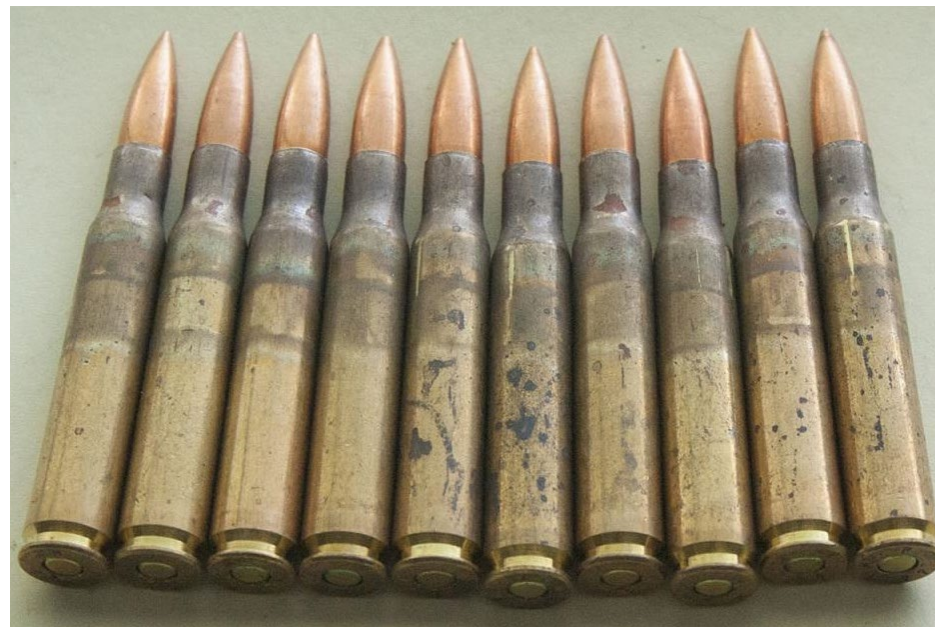
**Type:** Rifle / machine gun round

**Markings:** Regular round – none. Tracer round – red primer

**Remarks:** Cartridges are belted or supplied loose in cartons
