11 Sapcote Road,
Burbage

**PRELIMINARY ROOST
ASSESSMENT &
BAT EMERGENCE SURVEY
REPORT**

Report No. 250717.PRA.BES.V1

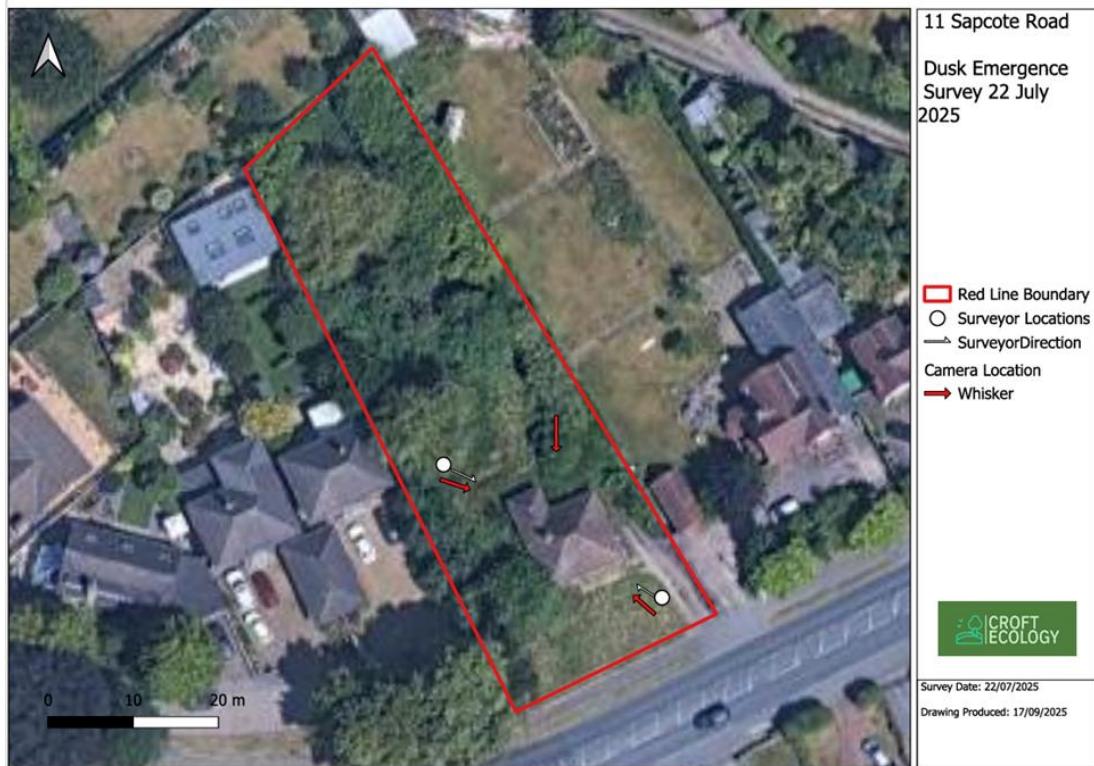
Two surveyors, equipped with EMT2 Pro bat detectors and infra-red cameras (Nightfox Whisker2), made observations of any bat activity or bat emergence both from and around the building, focusing on areas with potential roosting features, identified in the Preliminary Roost Assessment. Surveyor and camera locations (paired, with one additional camera) are illustrated in Figure 2 below.

Figure 2. Surveyor locations (white dots) and camera locations with direction of view (red arrows are infra-red cameras) during the two bat emergence surveys.)

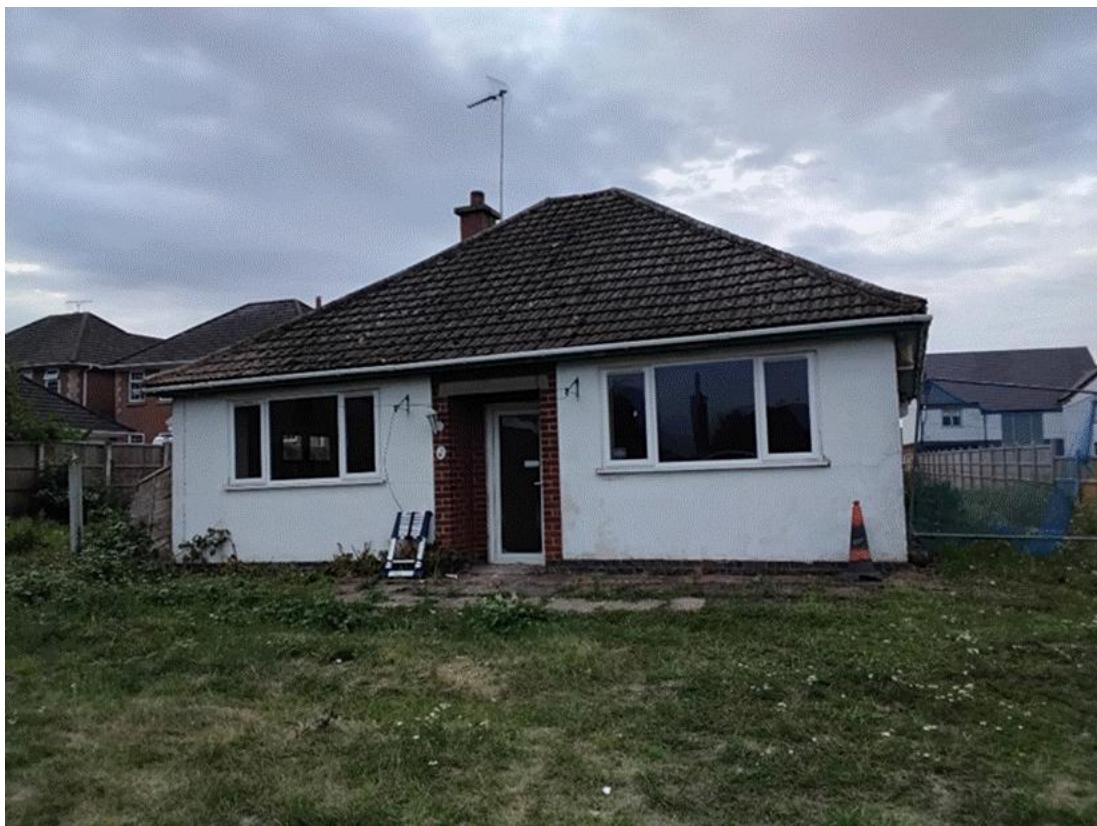
The bungalow comprised a brick structure with rendered walls and a tiled pyramidal roof with a small hipped rear extension (Photo 1). Numerous potential roosting features were noted across the building, with slipped, broken and missing tiles across the roof slope, missing mortar on the hipped tiles and gaps below the ridge tiles (Photo 2). Gaps at the hips and ridges provided access points to the tunnel below. A wooden soffit was present, with occasional gaps noted between the boards providing access to the soffit (Photo 3) – though the majority were found to be cobwebbed. The valley of the roof was lined with lead flashing, though this was tightly sealed with no potential roosting features noted around the valley.

Photo 1. Southern elevation of 11 Sapcote Road

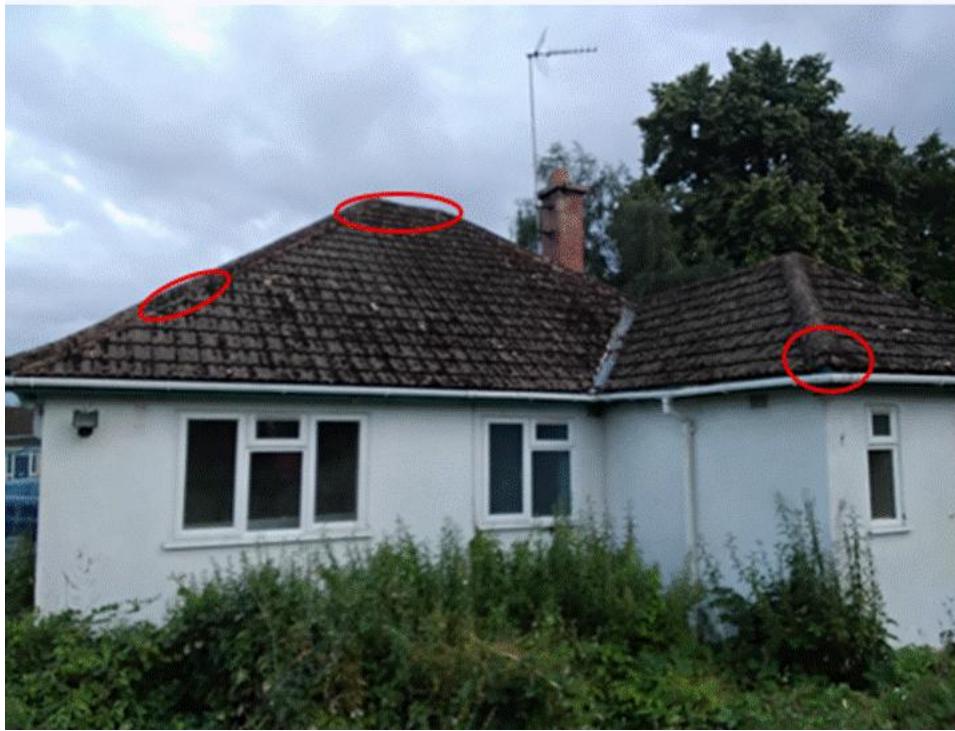
Photo 2. Northern elevation of 11 Sapcote Road, with gaps noted at the ridge, hips eaves and roof slope.

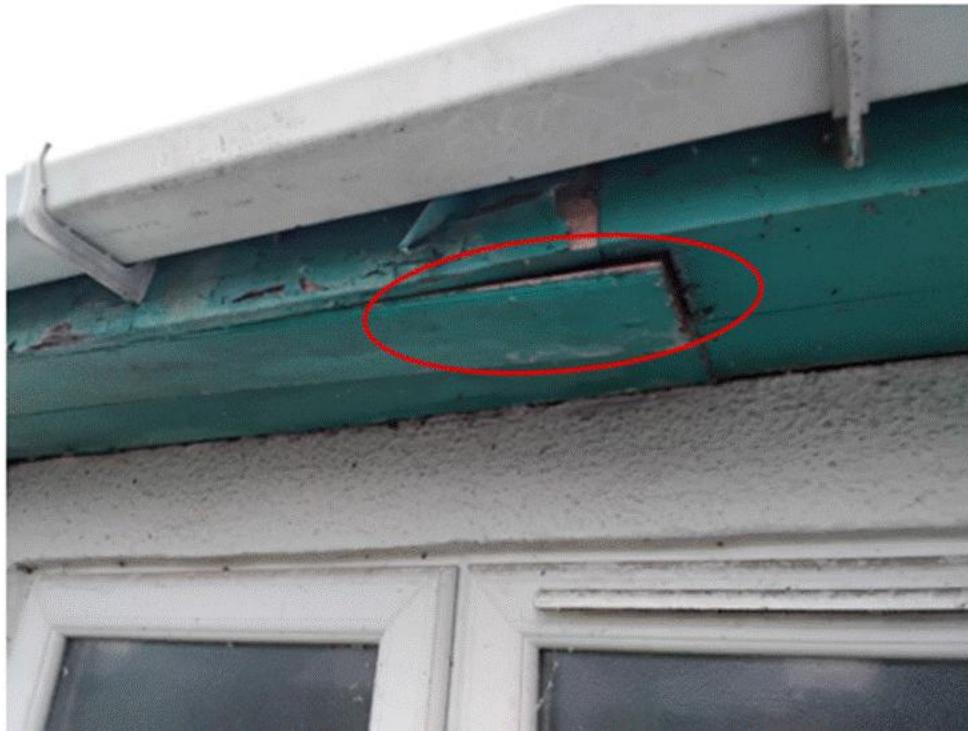
Photo 3: Access point into the soffit

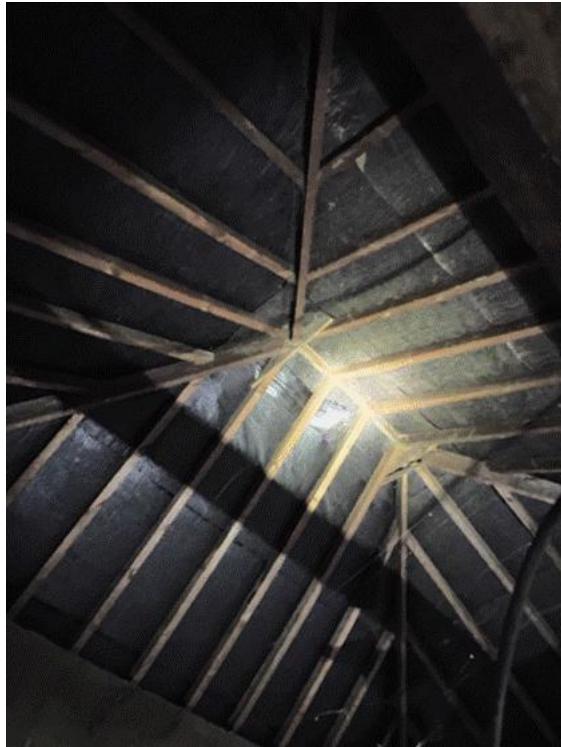
Internally, renovation works to the building had been undertaken and the ceiling was no longer present, allowing an inspection of the interior of the roof void. A bituminous roofing membrane was present below the tiles, with wooden rafters and a wooden ridge beam supporting the roof

(Photo 5). The presence of lining created a crevice between the tiles and sarking which could be used by crevice dwelling species such as pipistrelles. The ridge beam was cobwebbed. While the removal of the ceiling limited the ability to identify any bat droppings which may have accumulated under key features such as the timber joints and ridge beam, no evidence of bats in the form of droppings or feeding remains was noted on the top of the ceiling joists, walls or ground floor of the building. Due to the removal of the ceiling the loft space would be lit by the windows of the bungalow, creating a lighter environment throughout the day than if the ceiling was retained. A brick chimney extended through the roof void. The mortar of this was in good condition, with no potential roosting features for bats.

Photo 4: interior of the roof void

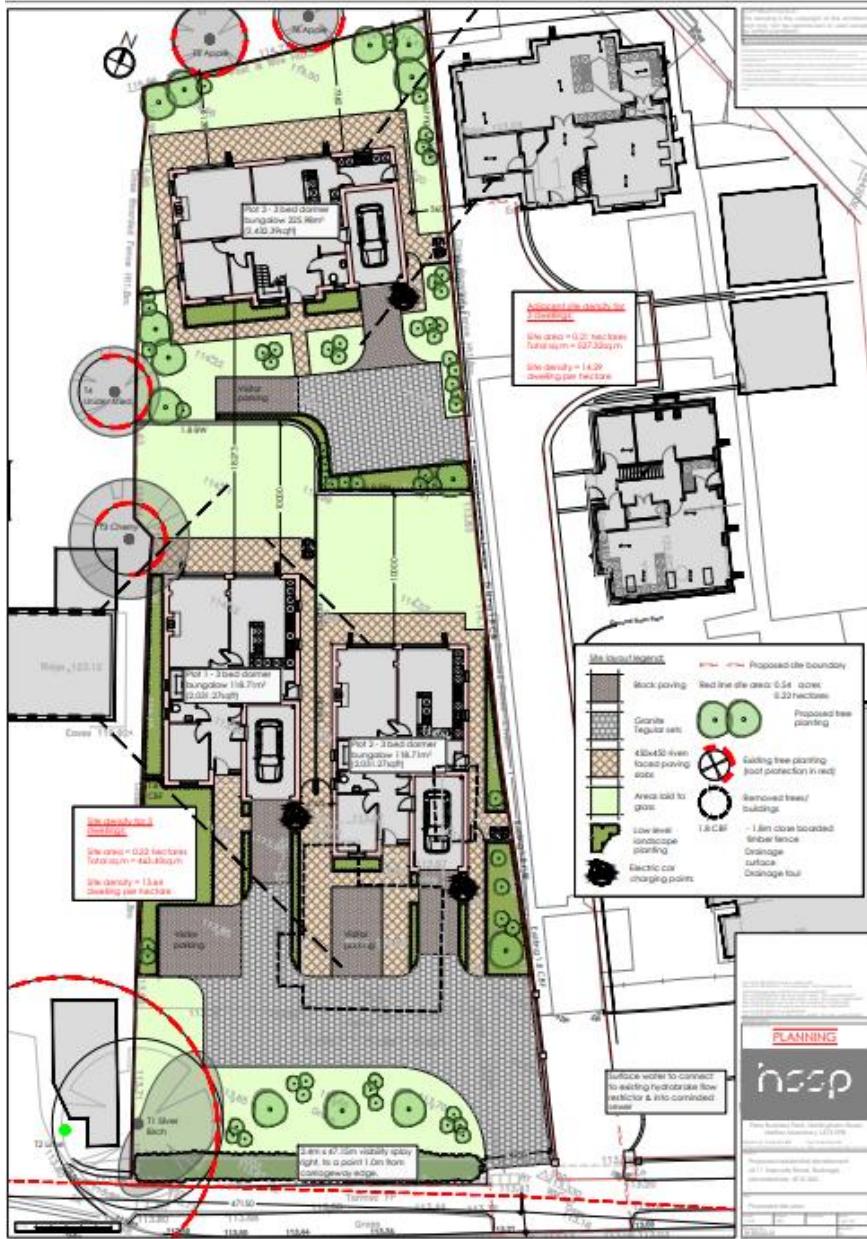
The proposed development is for the demolition of the existing building, followed by the construction of 3 new dwellings with residential gardens, as shown in Figure 3.

Figure 3: Proposed development map for 11, Sapcote Road (Source: HSSP Architects drawing 9169-03-01 dated January 2025)

- Integrated bat boxes should be incorporated within the new dwellings, to provide enhanced roosting opportunities for bats. The boxes should be installed between the southwest and southeast aspect, at least at eaves height, away from artificial light sources. Further details on box type and location should be discussed and agreed with the architect and ecologist.
- Enhancements for foraging bats could include planting of night-scented flowers including evening primrose *Oenothera biennis* and honeysuckle *Lonicera periclymenum*.

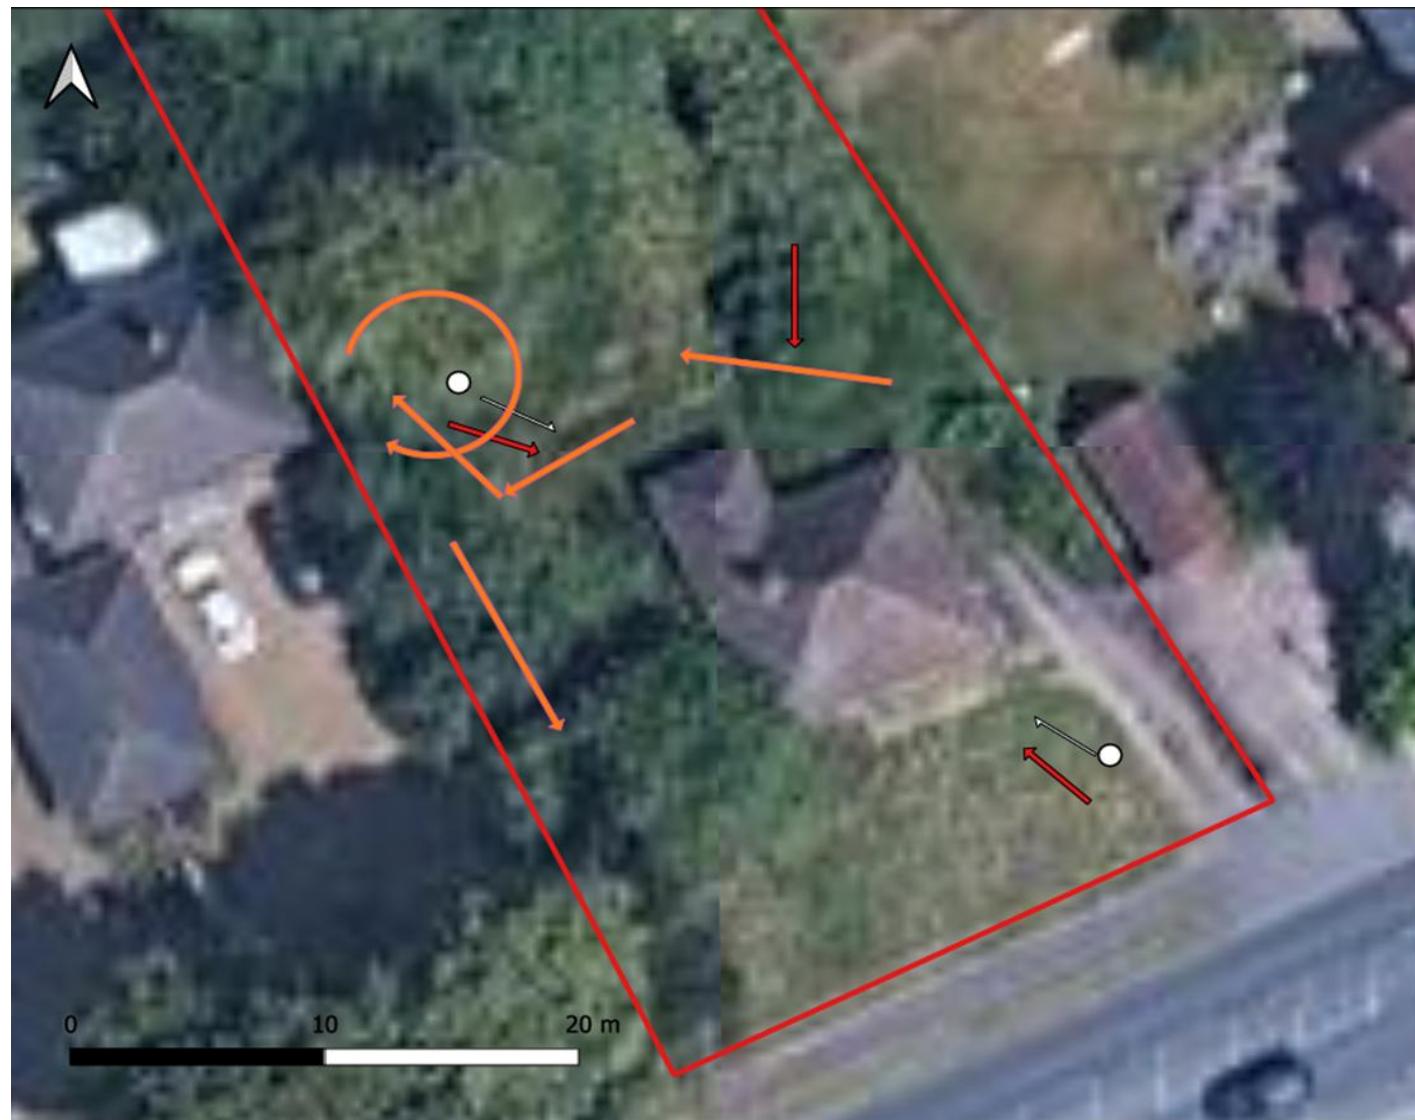
Dusk Emergence
Survey 22 July
2025

The dusk emergence survey saw no bats emerge from the building. Low levels of activity were recorded, with 18 bat passes across the survey. The first bats recorded were two common pipistrelle *Pipistrellus pipistrellus* passes at 21:32, around 18 minutes after sunset. Whilst this is the typical emergence time for the species the bat was not seen emerging from the building and therefore is likely roosting in an alternative off site location.

Throughout the rest of the survey common pipistrelle passes were regular, with sightings of foraging behaviour along the west boundary fence. Two noctule *Nyctalus noctula* calls and one brown long-eared *Plecotus auritus* call were also recorded.

Red Line Boundary
Surveyor Locations
Surveyor Direction
Camera Location
Whisker
Flight Paths
P. pip

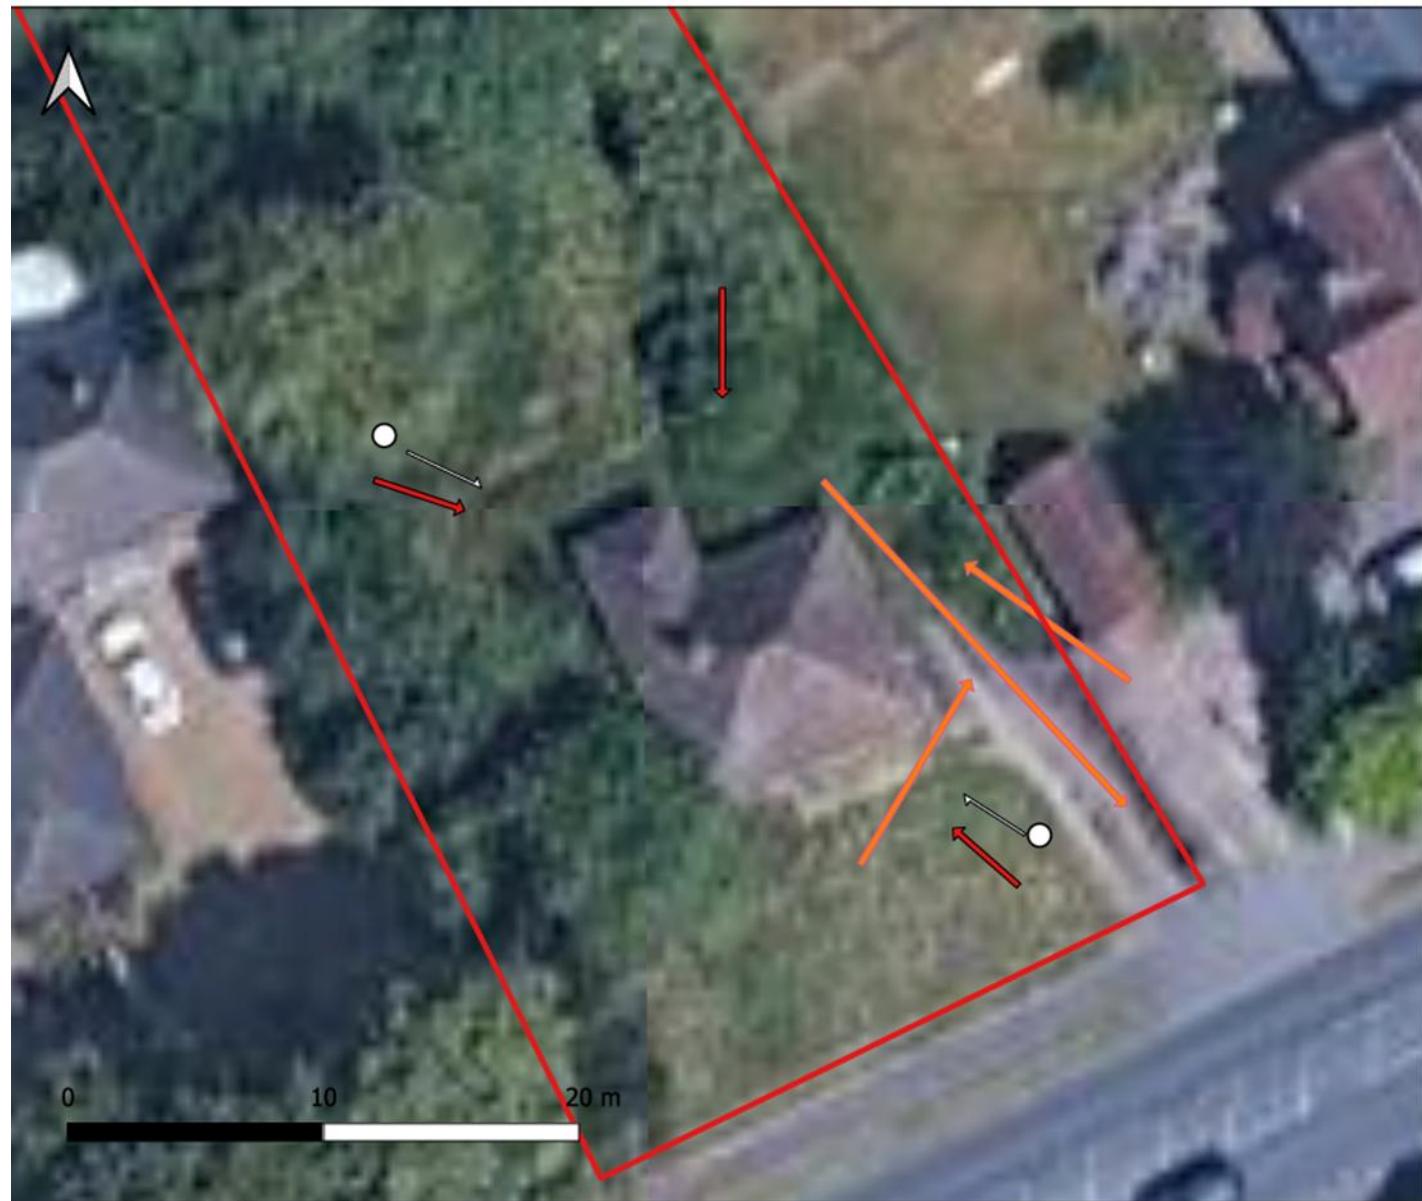
Dusk Emergence
Survey 12 August
2025

No bats emerged from the building during the survey.

Bat activity was less than the initial survey. The first bat recorded was a noctule pass 10 minutes after sunset. While this is a typical emergence time for this species no emergence was observed, and because the species typically roost in trees it was considered likely the bat emerged from an alternative roost off site location.

Occasional common pipistrelle were recorded, foraging above the roof of the building at 21:15, and passing from east to west at 21:17. A serotine *Eptesicus serotinus* was also noted at the Site, recorded passing at 21:30.

- Red Line Boundary
- Surveyor Locations
- Surveyor Direction
- Camera Location
- Whisker
- Flight Paths
- P. pip*
