## **Hinckley Academy, Leicestershire**

### **Flood Risk Assessment and Drainage Strategy**

**SPL0001-DID-XX-XX-RP-C-1010**

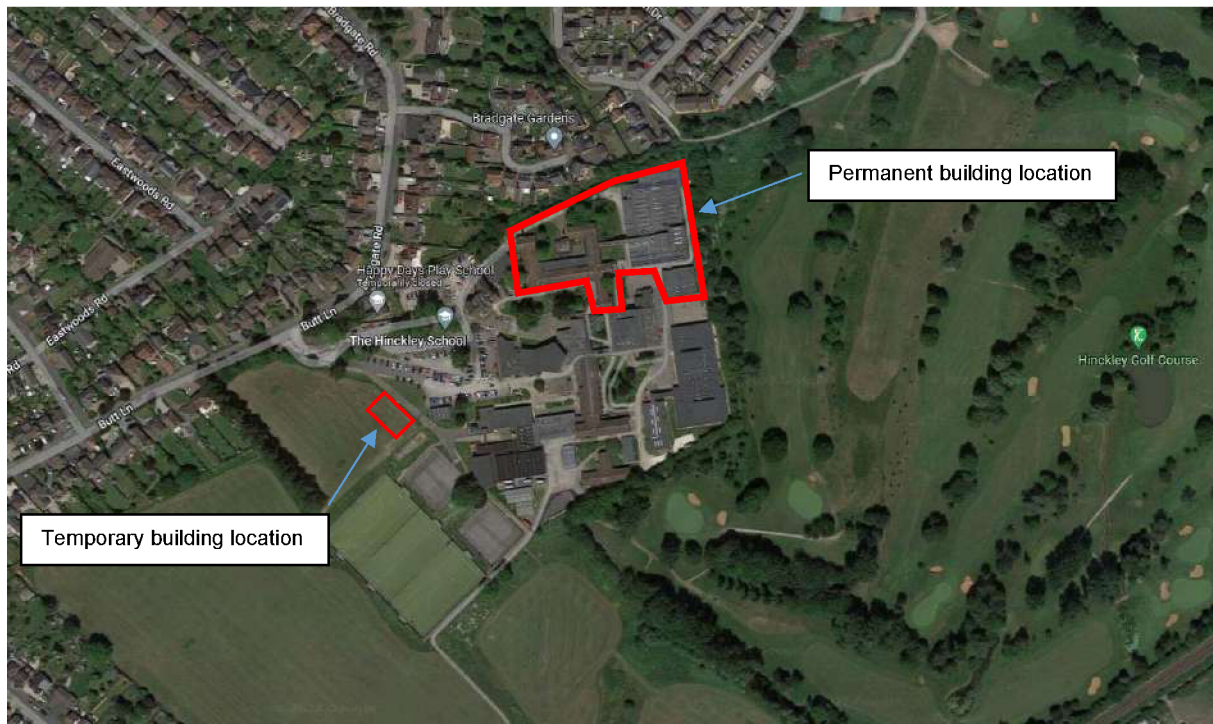
**Figure 1 – Proposed Site Location (See Appendix A)**

The proposed site is within the existing Hinkley School campus and is accessed off Butt Lane in Hinkley, Leicestershire. The site is bounded to the north by the housing off Bradgate Road and Bradgate Gardens. To the east of the site is Hinkley Golf Course. Housing off Woodland Road bounds the south of the site, adjacent to the school playing fields. A site location plan can be found in Figure 1 below.

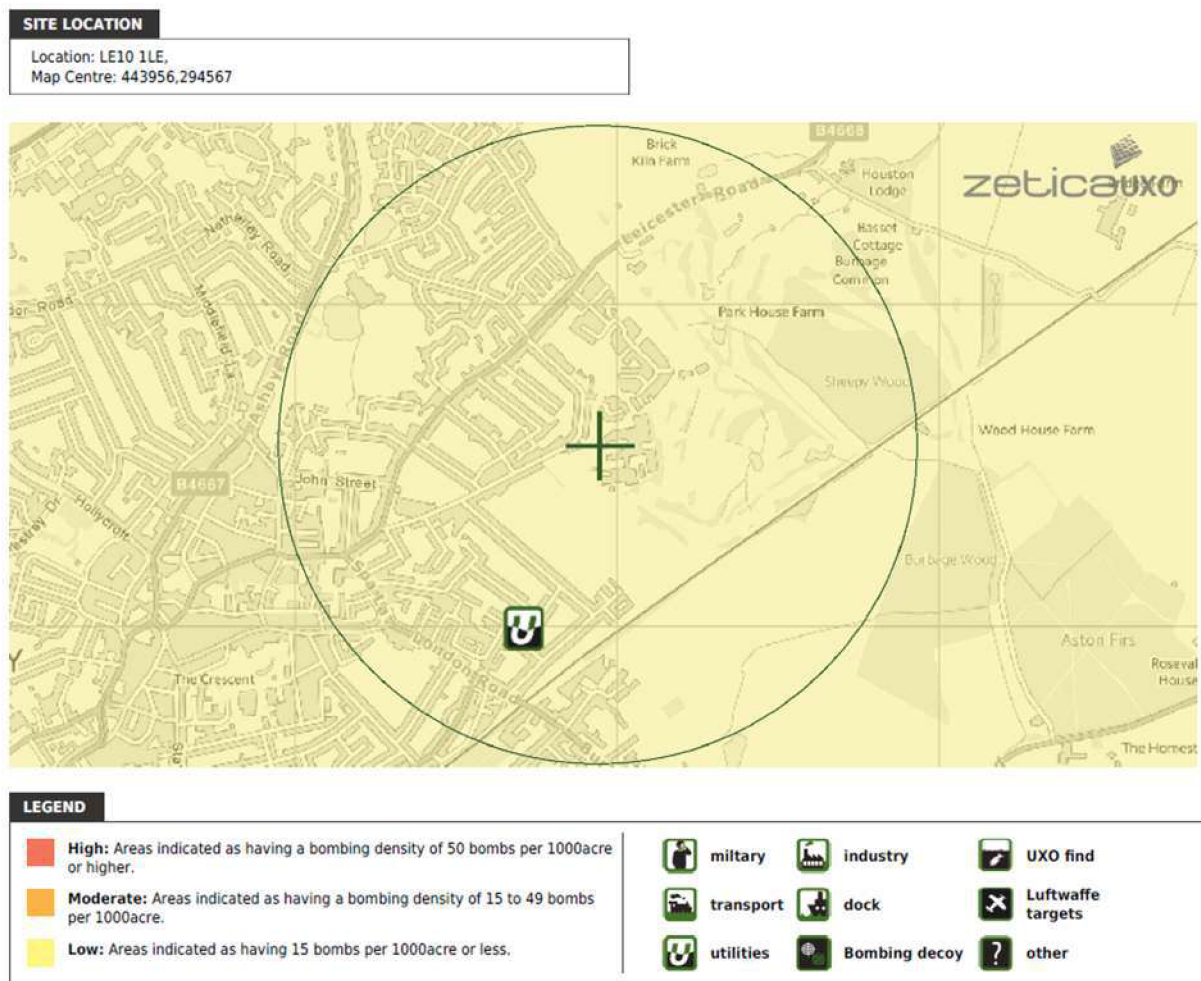
**Figure 2: Unexploded Ordnance Risk Map (zeticauxo.com)**

An online risk assessment was carried out on Zetica.com to assess the risk of unexploded ordnance on the proposed site. As can be seen below in Figure 2, there is a very low risk of encountering any unexploded bombs on the site with the map indicating the possibility of 15 bombs or less per 1000 acres. If any suspect items are found during construction the following mitigation measures are advised:

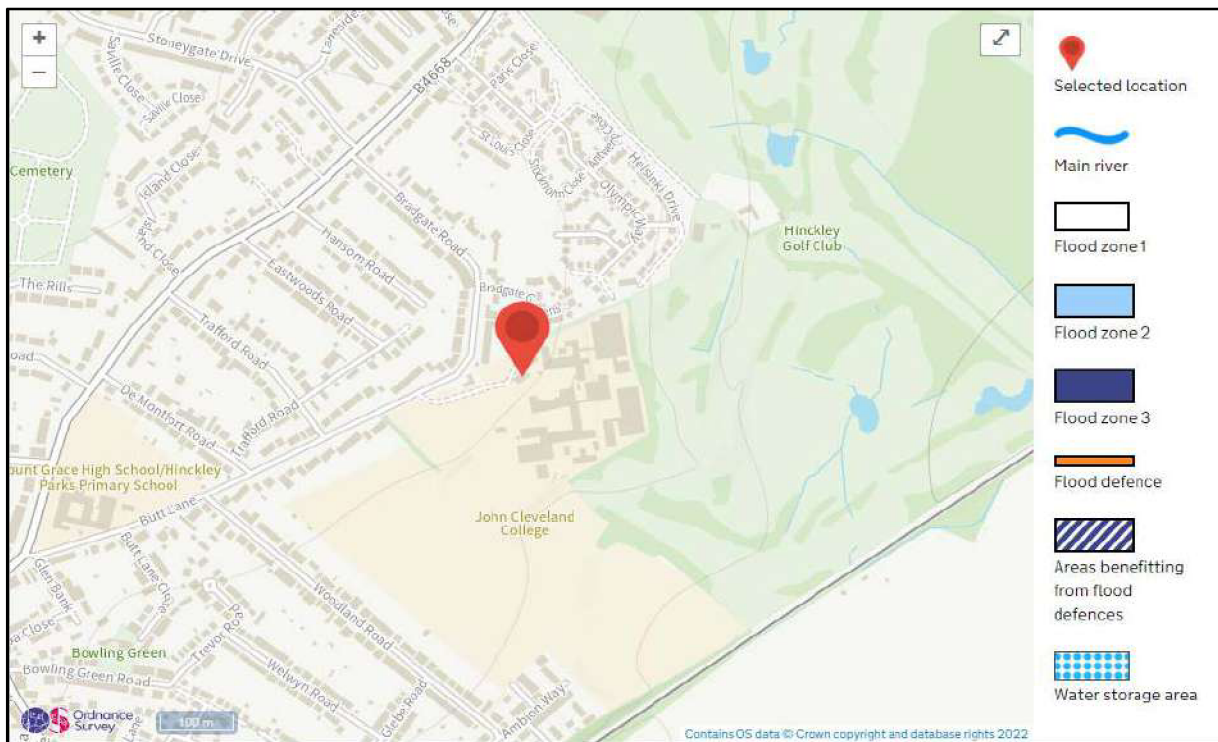
**Figure 3: Fluvial and tidal flood map extent, taken from Flood Maps for Planning (gov.uk), accessed 29/11/2022**

The entirety of the development site is located within the Environment Agency's (EA) Flood Zone 1, as shown in Figure 3, and Appendix B. NPPF Technical Guidance described Flood Zone 1 as having a less than 1 in 1000 annual probability of river or sea flooding (<0.1%). As aforementioned, all uses of land are appropriate in this zone.

The development site is not located within a Critical Drainage Area, which implies that there is a low flood risk from fluvial, tidal, surface or groundwater sources generally. Regardless, this Flood Risk Assessment will provide a detailed analysis of the flood risk both to and as a result of the development.

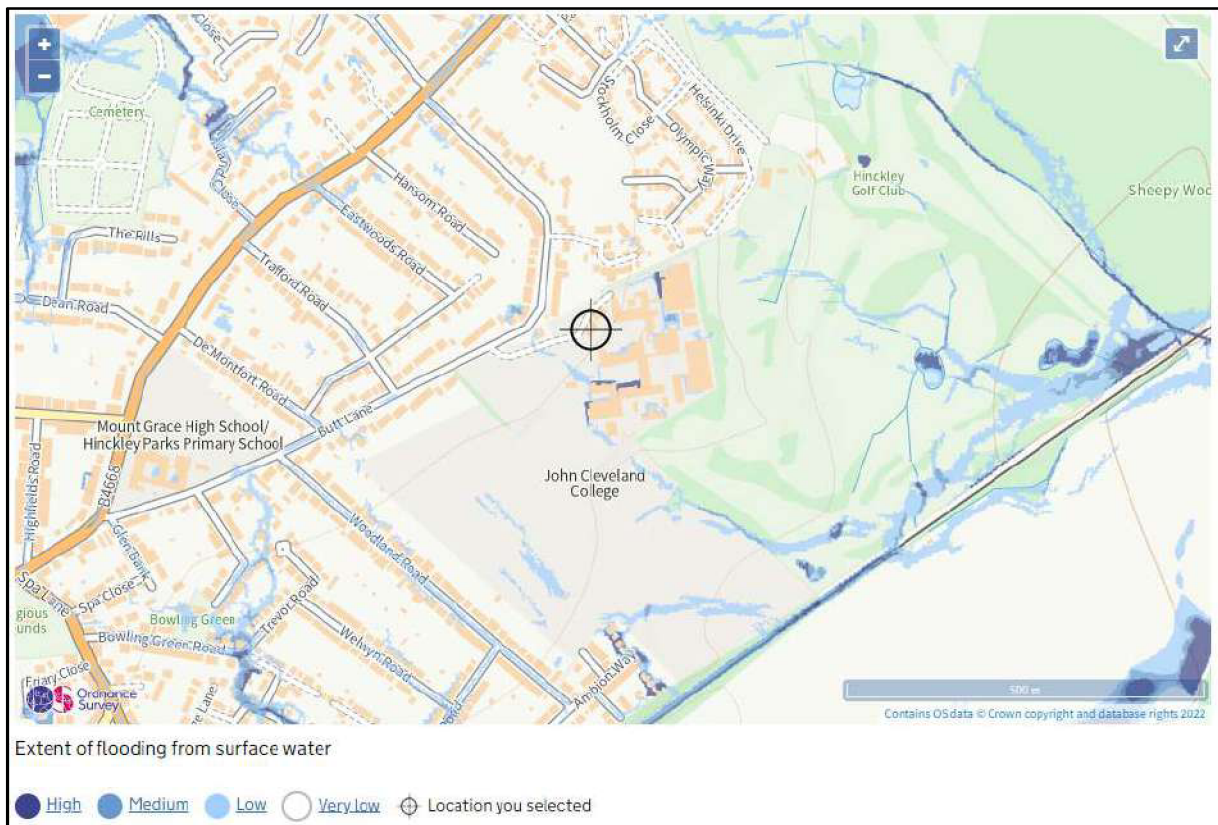
**Figure 4: Surface water flood map (accessed from gov.uk, on 29/11/2022)**

The southern half of the site falls within the Humber River basin district which is classed as a Flood Risk Area (FRA). Incidents of fluvial flooding, sewer flooding and overtopping have been recorded in this area. The main school does not fall within this area, but the temporary building does. Whilst the temporary building lies within this boundary, analysis of surface water flood maps shows that there very low risk of surface water flooding at the temporary building location therefore this report considers the surface water flood risk to be low across the site. (Please see Figures 4 below).

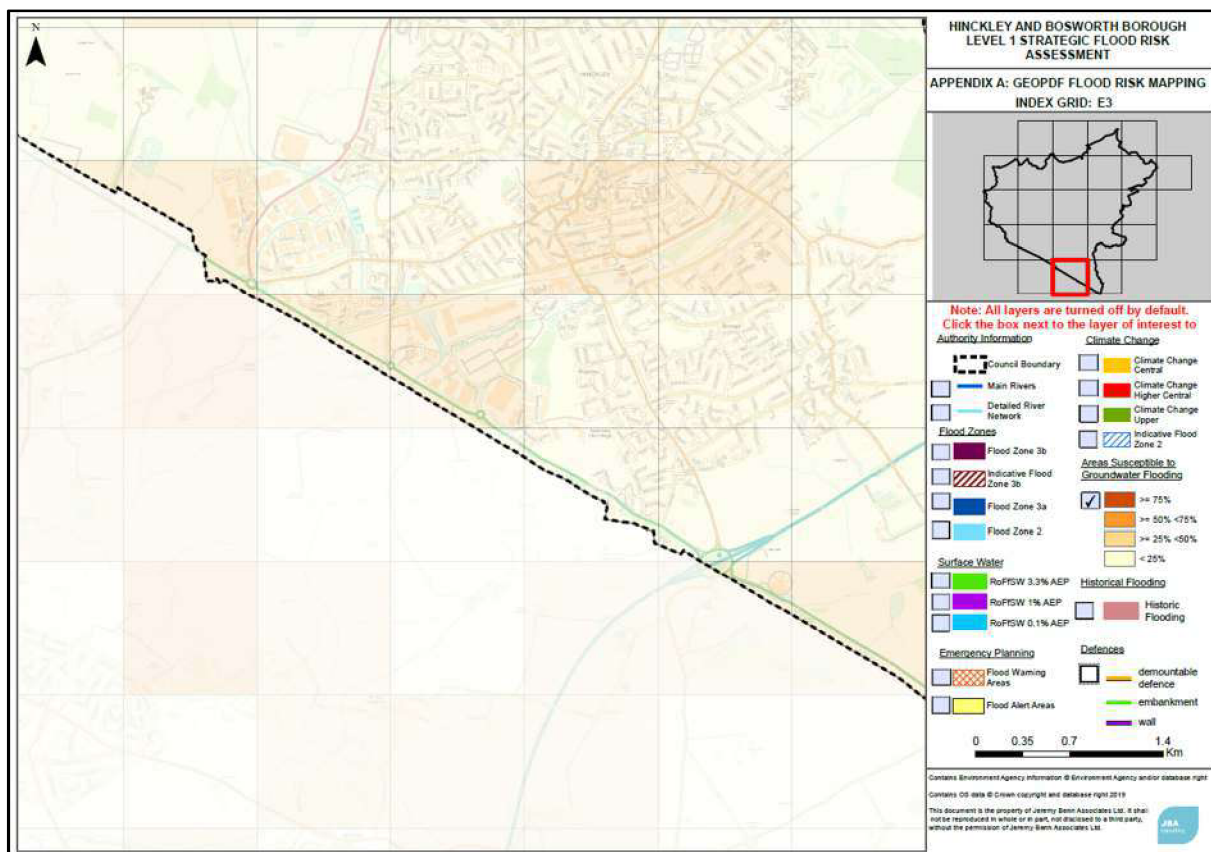
**Figure 5: Areas Susceptible to Groundwater Flooding, Hinckley & Bosworth Borough Council  
Local Flood Risk Management Strategy report, Appendix C**

Groundwater flooding occurs when groundwater emerges at the surface under conditions where the 'normal' range of groundwater levels and groundwater flows is exceeded. There is limited data available on groundwater flood risk in the Hinckley area. The available flood maps show that, in general the majority of the Hinckley area is within the <25% susceptible classification (See Figure 5 below), therefore it is at a lower risk of groundwater flooding. Only areas along the River Sence channel fall within the higher susceptibility classifications and are therefore at higher risk from groundwater flooding. The proposed site does not fall into this category.

This Flood Risk Assessment considers the groundwater flood risk for the development to be low. As infiltration is not proposed for the site, the development is also not likely to be contributing to a groundwater flood risk to itself or any other development.

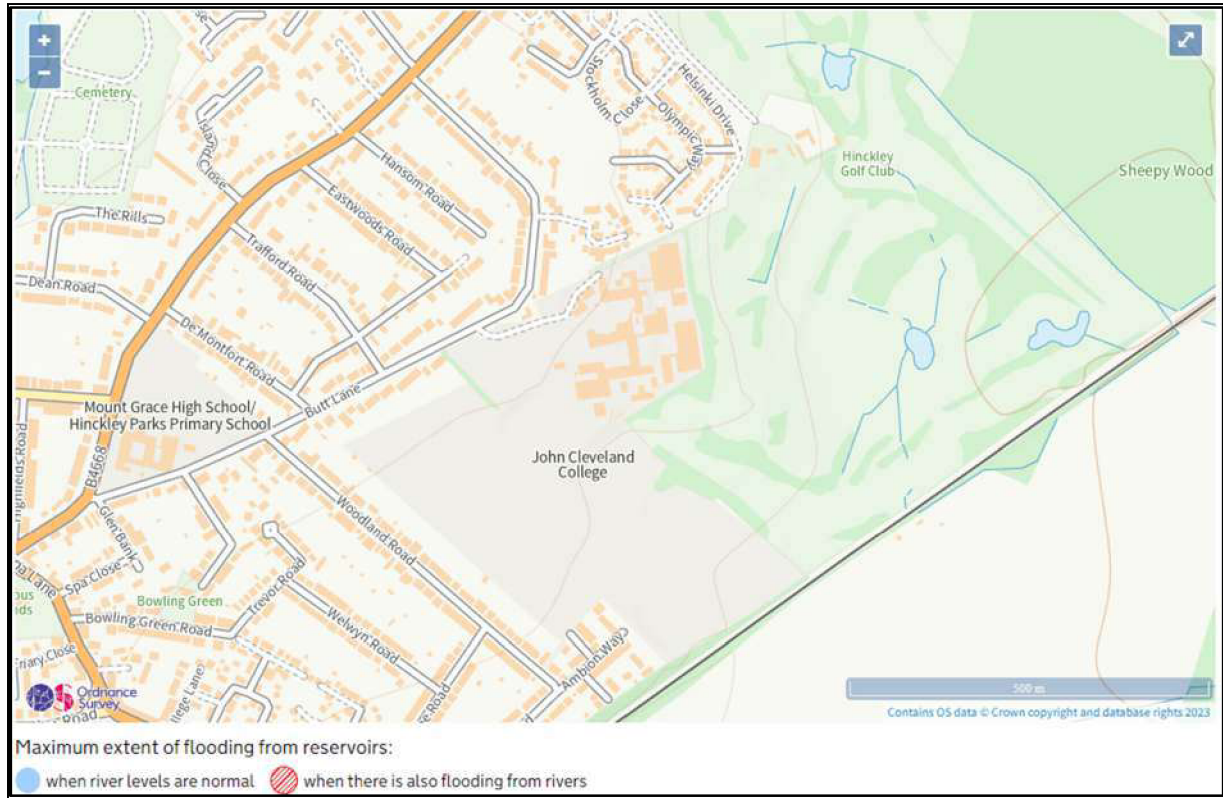
**Figure 6: Artificial Water Bodies Flooding Map (EA, gov.uk website, accessed 16/01/2023)**

The entirety of the development is located outside any extent of flooding from reservoirs (see Figure 6). The site will therefore have a 0% flood risk from artificial water bodies and is acceptable for all forms of development.

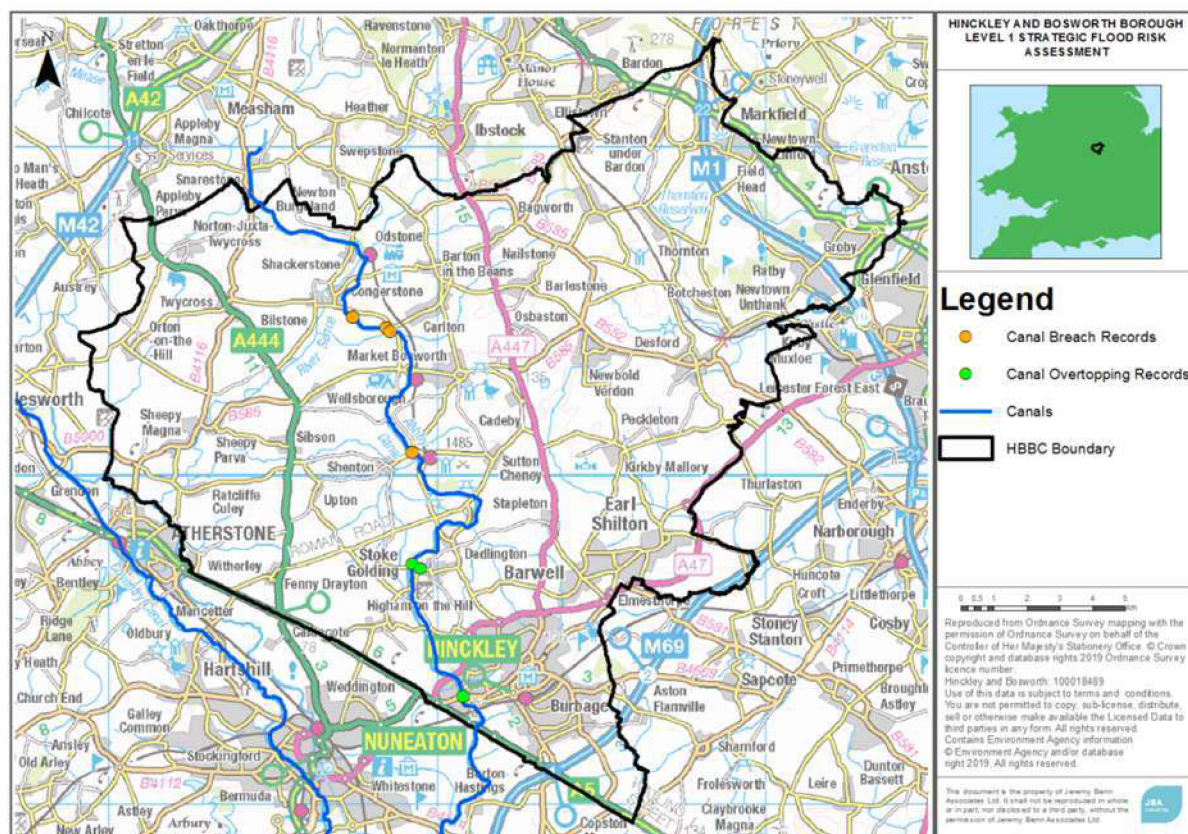
**Figure 7: Map Showing the Location of all recorded incidents of canal breaches and overtopping in the study area (dated 2019)**

There is one canal in the Hinckley borough, the Ashby canal. It has the potential to interact with other watercourses and become flow paths during flood events or breach scenarios. There have been 8 recorded incidents of canal breach from 1981 – 1996 but only in rural locations and only three recorded incidents of canal overtopping which occurred in the Stoke Golding & Hinckley area. Therefore, the risk of flooding from canals is considered low. Figure 7 below shows the location of canal breach and overtopping incidents in the Hinckley area.

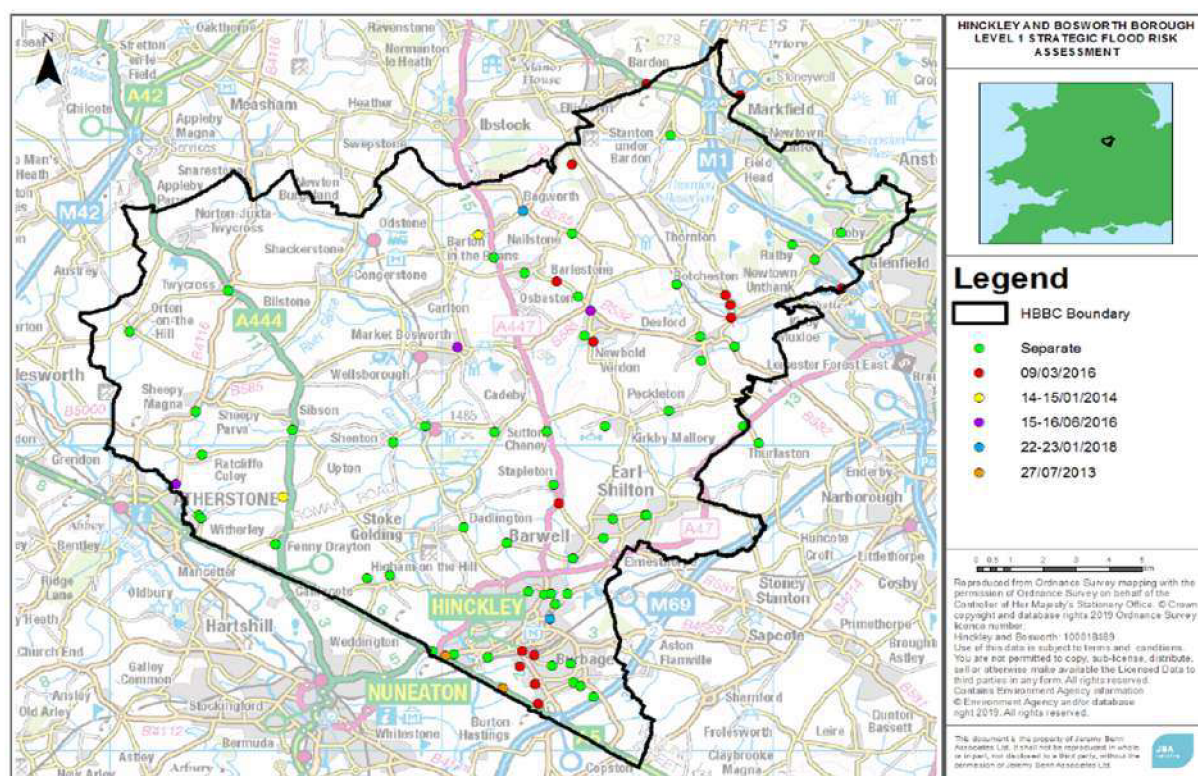
**Figure 8: Historical Flooding Extent Map, Data extracted from 2019 Strategic Flood Risk Assessment for Hinckley & Bosworth Borough Council.**

A review of the historical flooding data indicates that there have been no recorded flood events within the boundary of the proposed development site or the associated access road as can be seen in Figure 8 below.

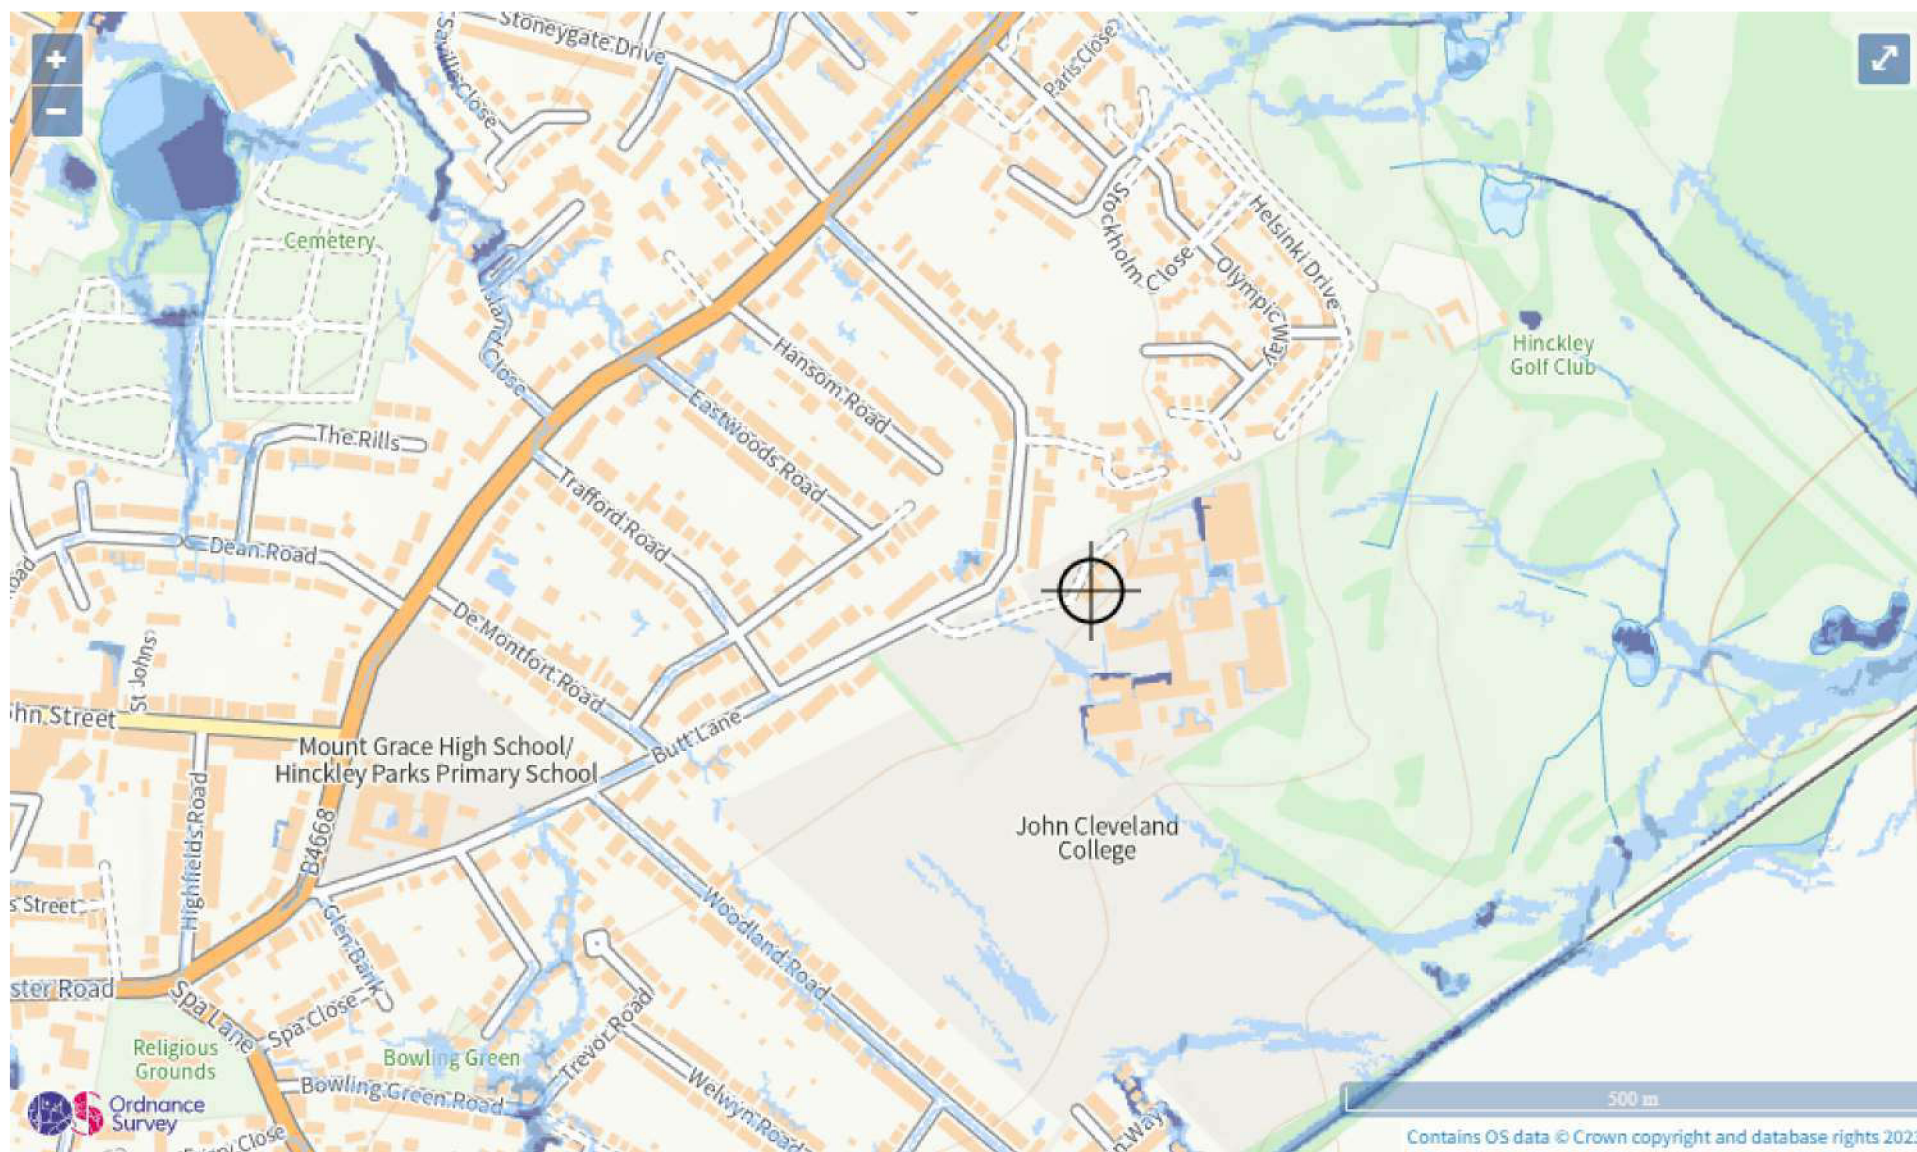
## **Appendix C – Flood Maps for Planning**

Extent of flooding from surface water

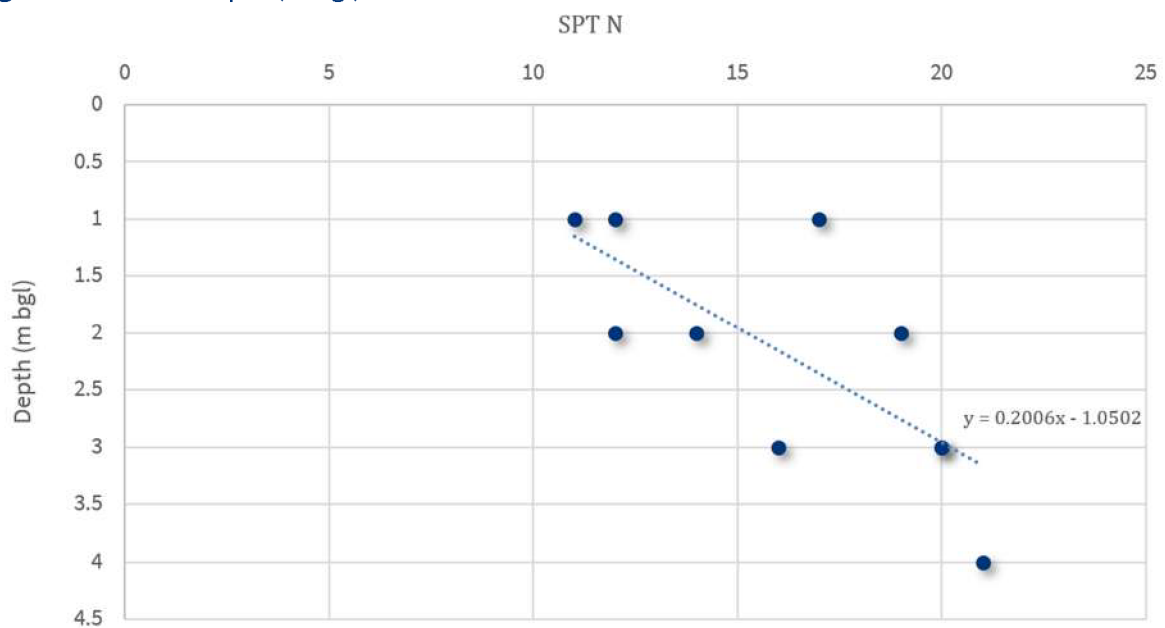
**Figure 1** SPT N vs Depth (m bgl): Made Ground

SPT N within MG generally ranged between 11 and 21 (a single outlier N of >50 recorded in WS03 at 4.00m bgl is possibly indicative of refusal in the underlying soils) and showed a gradual increase with depth (see Figure 1).

Using the relationship proposed by Stroud and Butler <sup>ref 8</sup>, where for SPT N <~25, the undrained shear strength ( $C_u$ ) = SPT N x 4.5, the  $C_u$  ranges between **49 and 94 kPa** (where N = <50).

N shows an increase in depth equivalent to the gradient: Depth (m bgl) = 0.2N-1.05. Although SPT N demonstrates relative consistency, due to the evidence of disturbance and limited data available, unless further assessment is undertaken, it is recommended that these indicative strength parameters are used with caution, and a worse case (**N=11**) is considered characteristic throughout this unit.

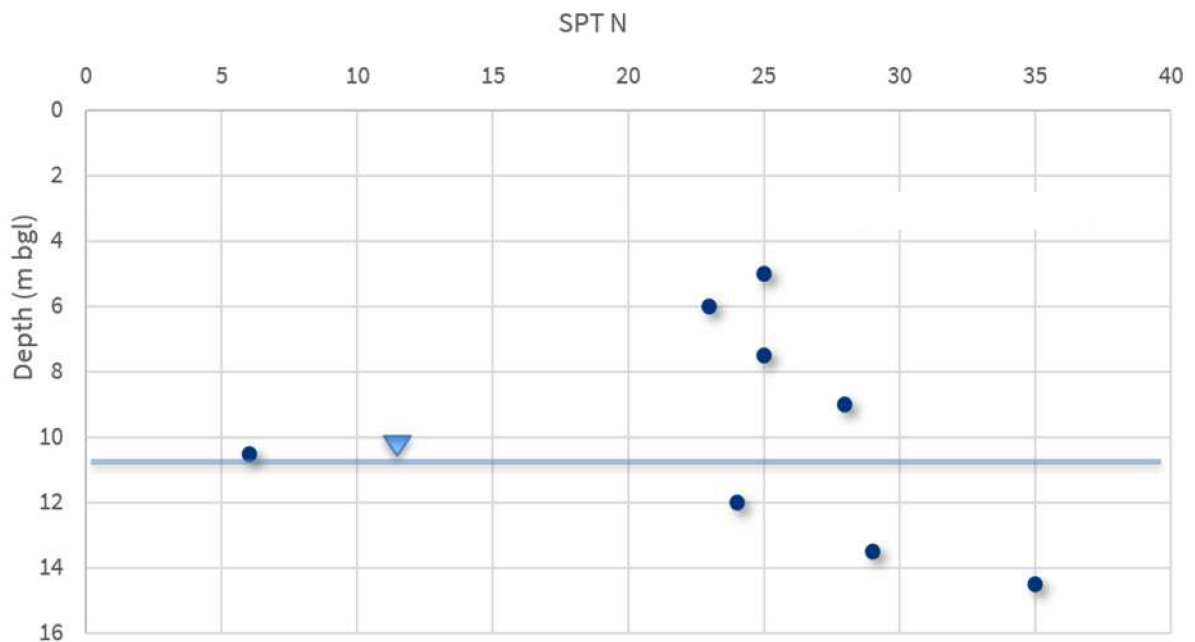
**Figure 2** SPT N vs Depth (m bgl): Wolston Sand and Gravel

SPT N within WOL generally ranged between 23 and 35. Although a generalised increase in N with depth was discernible within the limited data available, a single outlier from this range of 6 was recorded at a depth of 10.50m bgl. This test coincided with a groundwater strike and is likely to be indicative of loosening of the soils associated with vadose conditions (see Figure 2).

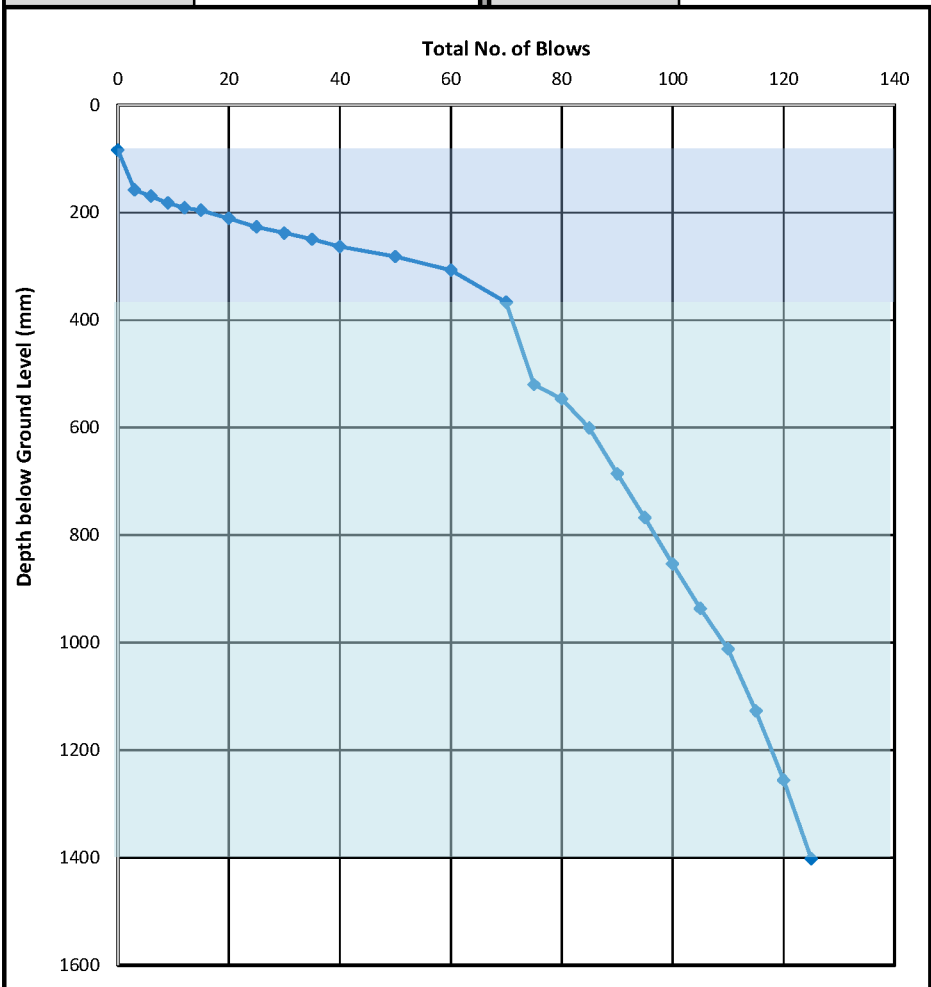
## DCP w. In Situ CBR v1.1 (03/09/2018)

CBR values derived from DCP by Highways specification:  $\text{Log}_{10}(\text{CBR}) = 2.48 - 1.057 (\text{Log}_{10}(\text{mm/blow}))$

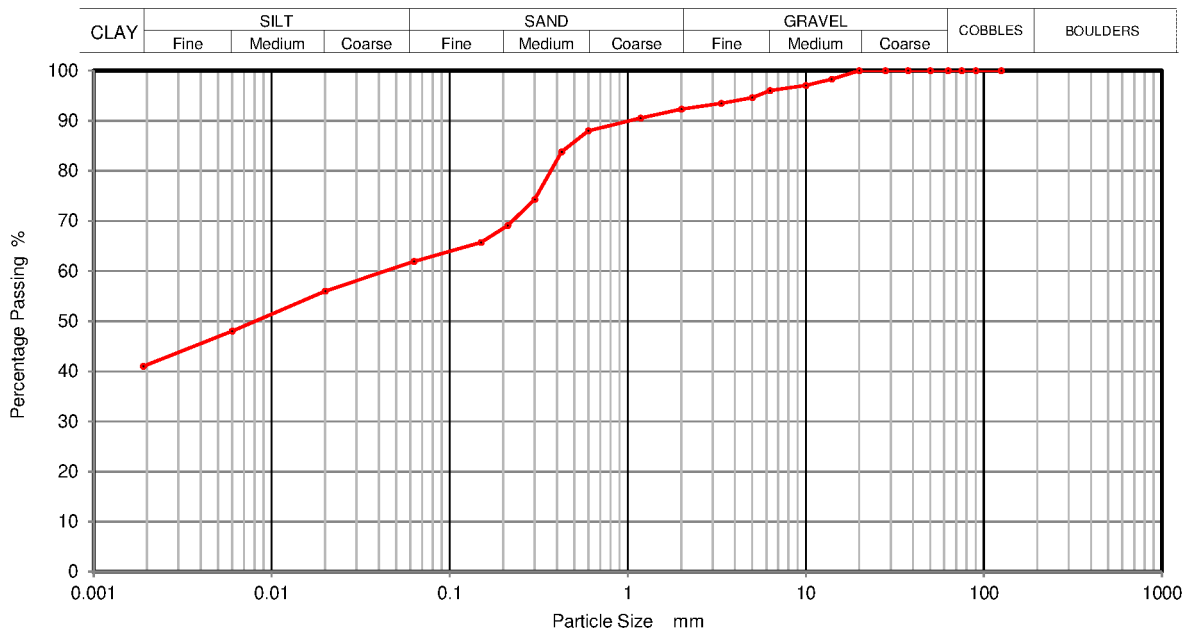
**PARTICLE SIZE DISTRIBUTION**  
**BS 1377 Part 2:1990**  
**Wet Sieve & Pipette Analysis, Clause 9.2 & 9.4**

| Soil Description | Brown slightly fine to medium gravelly silty fine to coarse sandy CLAY |
