**Hinckley Day Case**

**Phase 1 Ground Investigation Report**  
**(March 2025)**

**Prepared for Darwin Group**

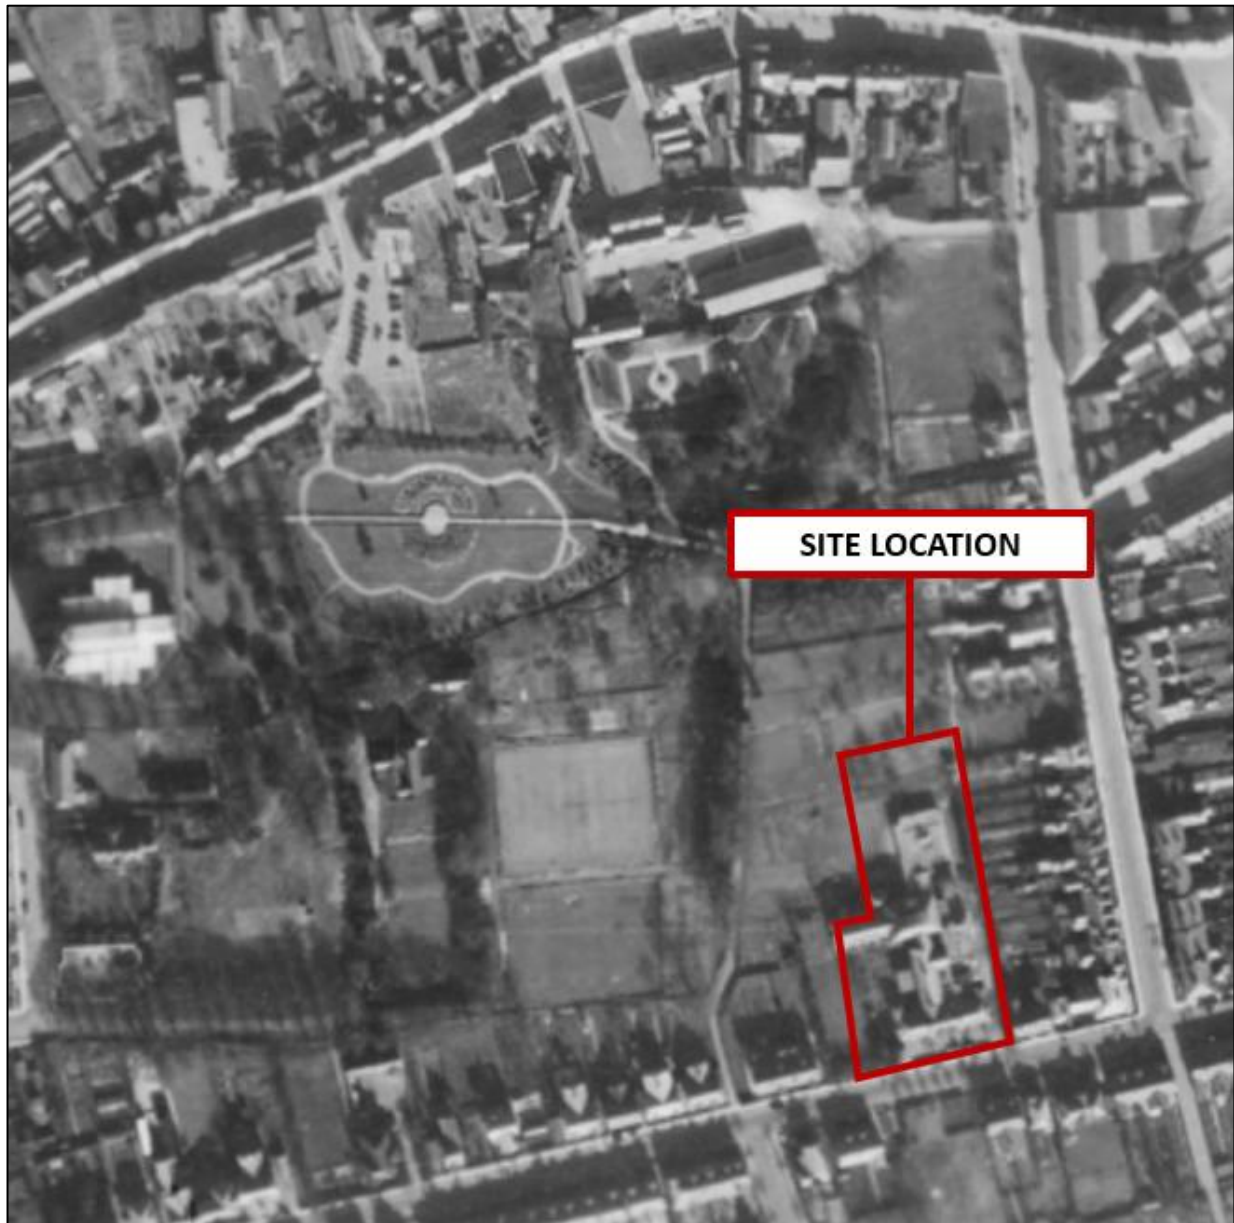
**Figure 3.2-1: Aerial View of the Site July 1948**

A review of the historic maps for the site shows that a number of substantial changes to the site have occurred. The 1889 map shows the site and the surrounding land being agricultural land. By 1903 a building called Cottage Hospital had been constructed on the site. This is the existing building that forms the frontage of the site. By 1924, the Cottage Hospital building had been extended to the north. By 1961, the cottage hospital building was further extended to the north and the Hinckley Health Centre Surgery, which is currently located to the north of the site had been constructed. On the 1968 map an electrical sub-station is present to the north-east of the site. On the 1986 map, additional hospital buildings had been constructed on land to the east of the site and the electrical sub-station has been removed.
