## Preliminary Roost Assessment

16, Tower Road, Earl Shilton, Leicestershire LE9 7EG

This report is prepared to inform a planning application with the Hinckley and Bosworth Borough Council. The proposal is described as:  
Erection of a rear single and two storey extension (Application reference: 25/00626/HOU)

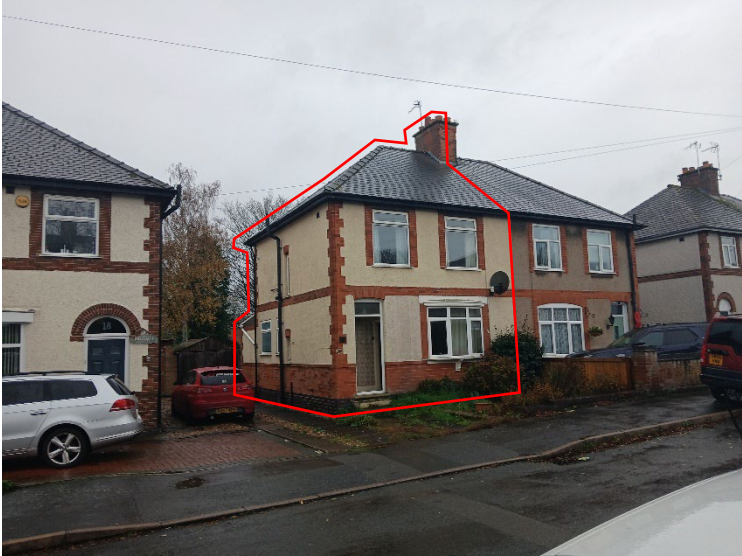
| | Figure 1. Onsite habitat (rear vegetated garden and scattered trees) | |
|---|---|--|
| <p><i>Summary</i></p> <p>B1 is a two-storey, semi-detached dwelling with a single storey flat roof rear extension. It is located within a residential area in the town of Earl Shilton, Leicestershire.</p> <p>The proposed works comprises the demolition of the existing single storey extension to facilitate the construction of a new rear single and two storey extension to the rear.</p> <p>No evidence of bats was identified on or within B1, however evidence may be concealed within the identified roosting features.</p> <p>Due to the presence of a low number of external roosting features suitable for crevice dwelling bats, access points into the void spaces suitable for void dwelling bats, and surrounding habitat, B1 is assessed as <b>low habitat value</b>.</p> | | |

Figure 2. Eastern (front) elevation of B1

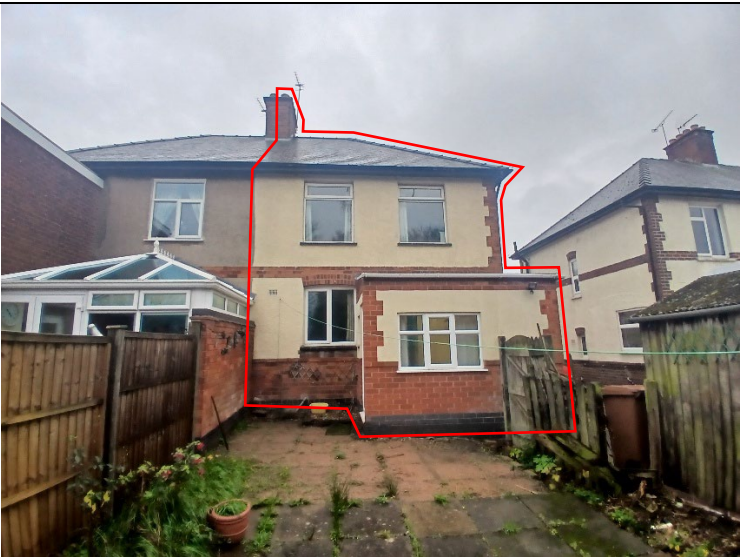
| | | | |
|---|---|---|---|
| | | | Figure 3. Western (rear) elevation of B1 |

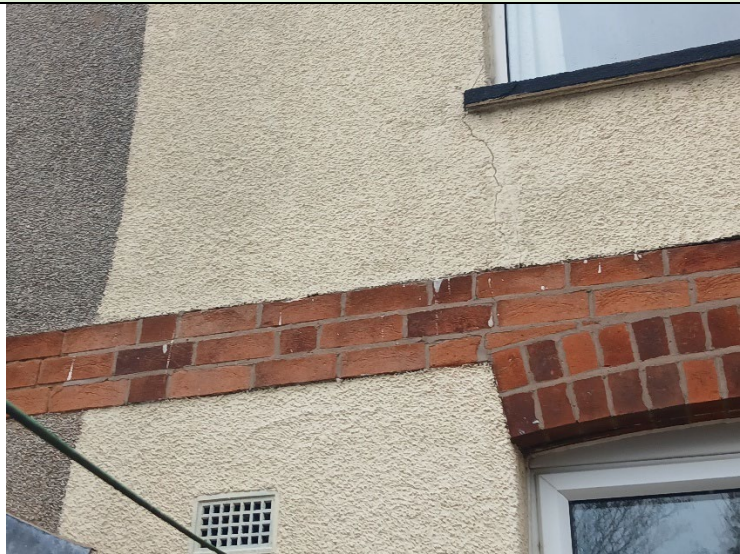
| | | | |
|---|---|---|---|
| Walls | Brick and mortar, rendering | <p><b>Condition/description</b></p> <p>The walls appear in good structural condition throughout B1. They appear intact with no significant gaps in the mortar or rendering.</p> <p><b>Suitability/access/evidence of bats</b></p> <p>No suitable roosting features or evidence of bats were identified on or within the walls of B1. No areas were identified where evidence could be concealed.</p> | |
| | | | Figure 4. Sealed walls on the western (rear) elevation of B1 |

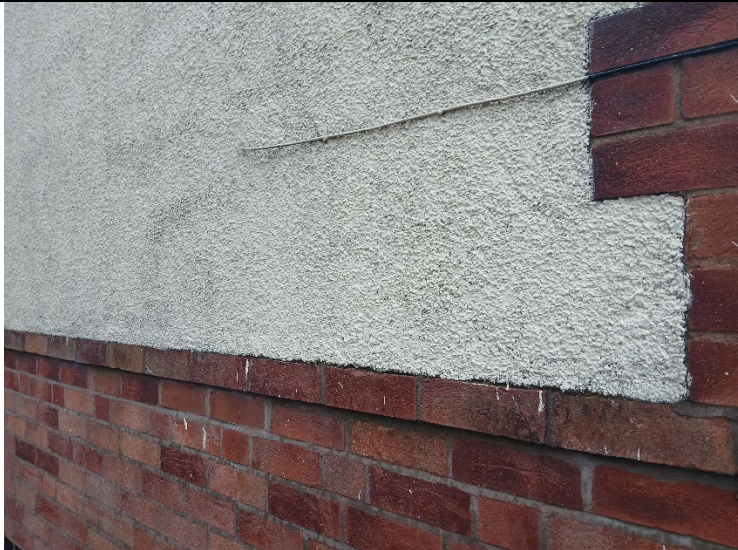
| | | | Figure 5. Sealed walls on the southern (side) elevation of B1 |

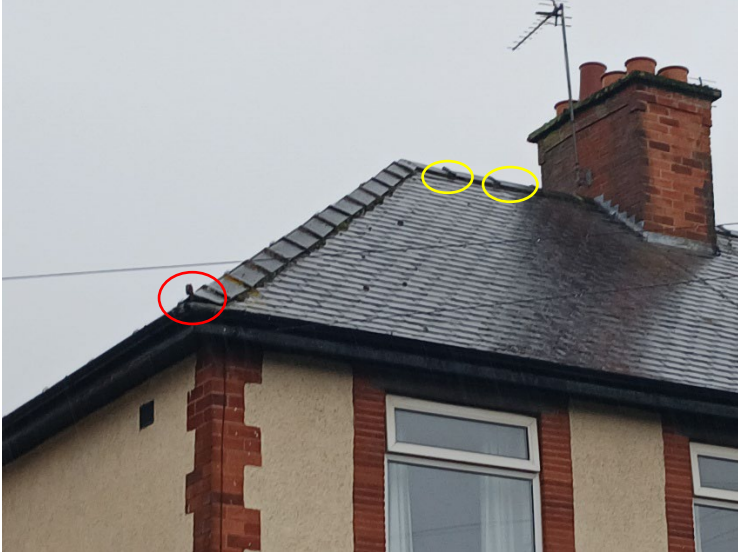
| Roof | Clay | <p><b>Condition/description</b></p> <p>B1 comprises a hipped roof and is attached to an offsite dwelling to the north. Under an inspection from ground level using binoculars, the roof tiles largely appear in good condition and lay flat, however areas of light ingress are visible internally toward the eaves, although these appear minor. The hip tiles appear in moderate condition. There is a significant gap located under the end hip tile at the southeastern corner of the building, as well as on the southwestern hip line on the southern elevation. A significant area of light ingress is visible internally from within the loft space associated with each gap. Additional gaps under the hip tiles were noted externally, however no light ingress was visible internally within the loft space following a close inspection of the hip and ridge lines.</p> <p>The roof of the single storey rear extension appears in good structural condition and well-sealed.</p> | |
| | | | Figure 6. Gap at end hip tile on the southeastern corner of B1 (red), additional gaps under ridge tiles (yellow) |

| <i>Recommendations</i> | <p><b>Roosting habitat [Buildings]</b><br/>A total of <b>one</b> bat emergence survey is required during the active bat season (May – September) to assess the presence/absence of roosting bats within B1. These survey visits should be completed during the optimal survey period <b>mid-May to August inclusive</b>. The survey visits should be at least three weeks apart.</p> <p>A total of <b>two</b> surveyors are required to provide full coverage of the buildings. Infrared cameras should be used as an aid.</p> <p>If any bat roosts are confirmed from this survey schedule, a bat licence would be required. This is applied for with the help of a class 2 licensed bat ecologist after planning permission is granted, but before commencement of works.</p> <p><b>No works to the property that may block or remove potential roosting features should be carried out until the required surveys have been completed. Undertaking such work beforehand could unlawfully affect bats if present and may compromise the validity of the surveys and hinder the planning application process.</b></p> <p><b>Foraging and commuting habitat</b><br/>No further surveys are required.</p> <p><b>Artificial lighting</b><br/>A low impact lighting strategy will be adopted for the site during post-development which outlines the areas of the site that will be retained as dark corridors. Parameters can be found on the Bat Conservation Trust website:<br/><a href="https://www.bats.org.uk/our-work/buildings-planning-and-development/lighting">https://www.bats.org.uk/our-work/buildings-planning-and-development/lighting</a></p> |

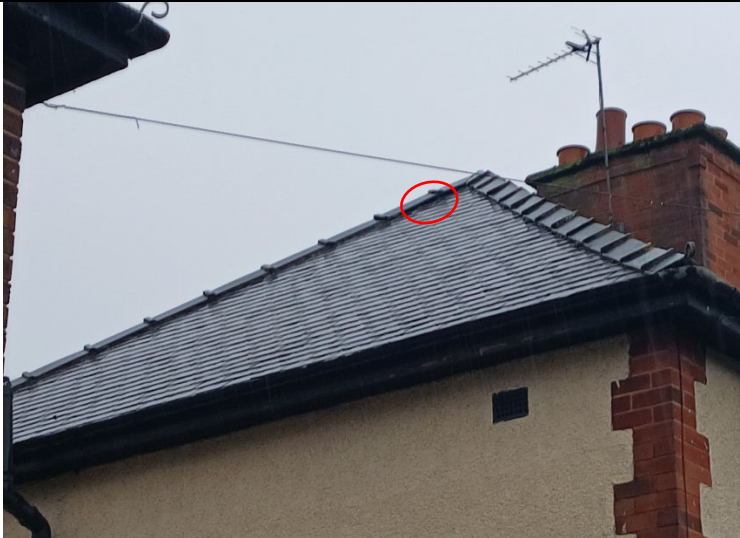
| | | <p><b>Suitability/access/evidence of bats</b></p> <p>Space under tiles could accommodate low numbers of crevices dwelling bat species due to the absence of roof lining and as such limiting a high volume of habitat available. Furthermore, these features could provide suitable access into the loft space where light ingress was identified internally as there is no roof lining/membrane to obstruct access. No evidence was identified externally or internally; however, evidence may be concealed between the roof tiles although in low levels due to the limited space these features provide for crevice dwelling bats. Due to the lack of roof lining, higher numbers of droppings would likely fall through within the loft space, and none were identified.</p> | |

Figure 7. Gap under hip tile on the southern (side) elevation of B1 (associated with light ingress internally)

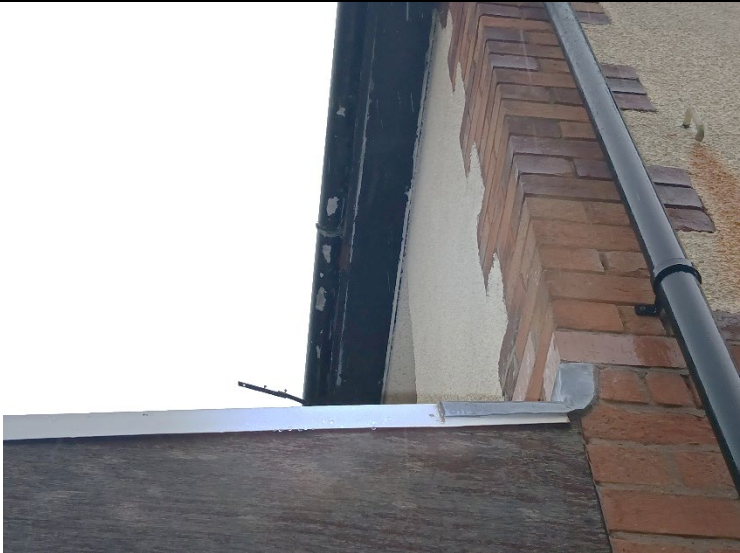
| Soffits/fascia | Timber | <p><b>Condition/description</b></p> <p>The timber soffits and fascia appear in good structural condition throughout, sealed and flush to the wall tops despite some cosmetic deterioration.</p> <p><b>Suitability/access/evidence of bats</b></p> <p>No suitable roosting features, access points or evidence of bats were identified on or within the soffits/fascia throughout B1.</p> | |

Figure 8. Sealed soffits on the western (rear) elevation of B1

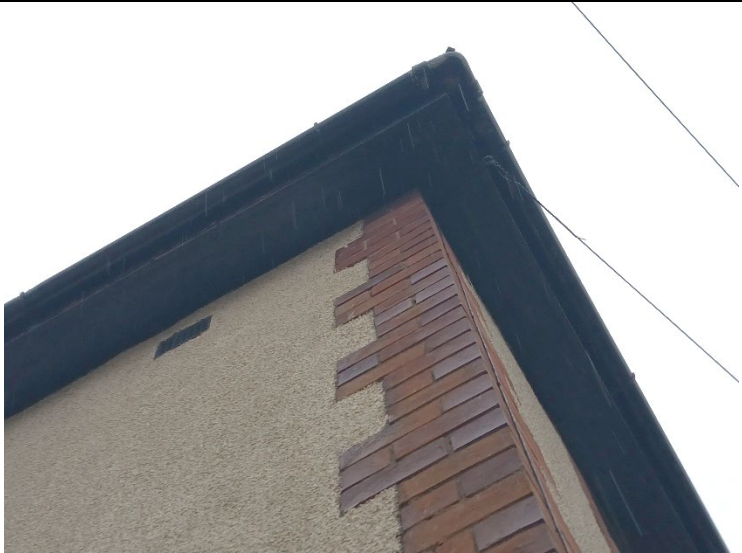
Figure 9. Sealed soffits on the southeastern elevation of B1

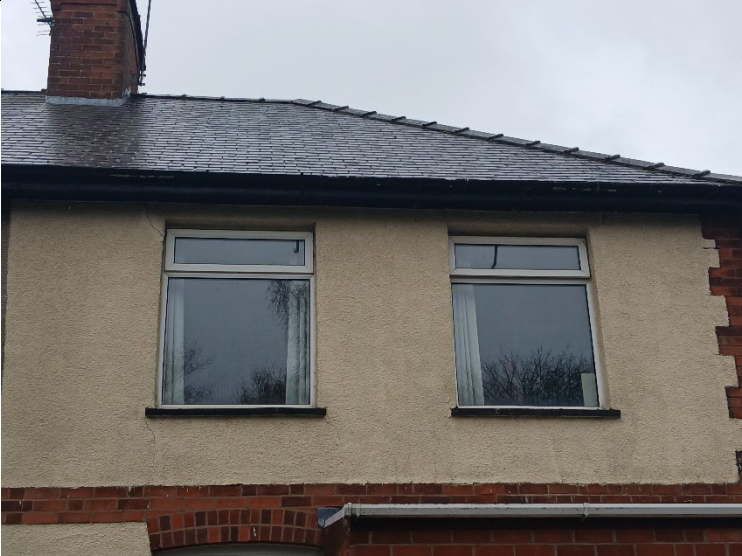
| Window/doors frames and lintels | uPVC | <p><b>Condition/description</b></p> <p>The window, doors and on all elevations appear in good condition. They appear tight fitting, and surrounding sealant intact.</p> <p><b>Suitability/access/evidence of bats</b></p> <p>No suitable roosting features, access points or evidence of bats were identified on or within the windows and doors throughout B1.</p> | |

Figure 10. Sealed windows/lintels on the western (rear) elevation of B1

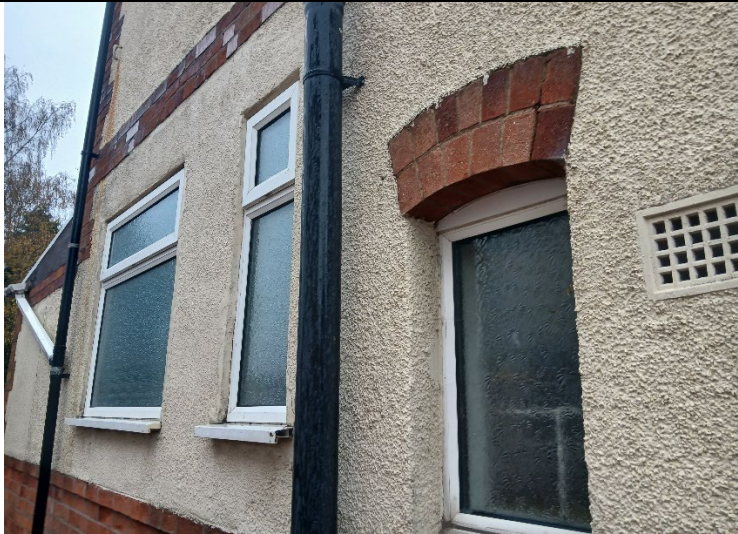
| | | | Figure 11. Sealed windows/lintels on the southern (side) elevation of B1 |

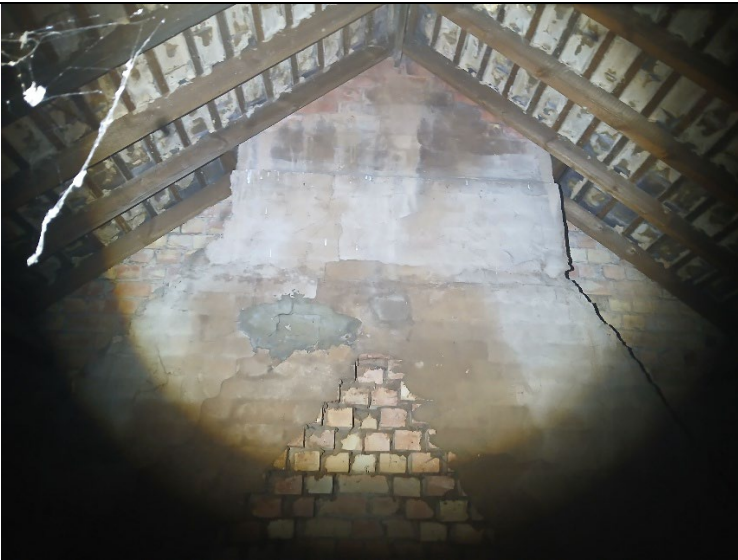
| Internal voids | Timber rafters and ridge beam. Open floor to ridge. | <p><b>Condition/description</b></p> <p>Internal space measures approx. 5.5m long, 6m wide, floor to ridge height approx. 2.5m.</p> <p>The roof timbers appear in good condition. There is no roof lining. Following a close inspection using torch, the majority of the tiles appear sealed with mortar. There are minor areas of light ingress towards the eaves on the western roof plane however the gaps do not appear of a significant size. There is a significant area of light ingress at the end hip tile on the southwestern corner of the building as well as the gap under the hip tile on the southwestern hip. Both features are associated with gaps identified externally. The loft space is free of obstructions and as such appears unused.</p> <p><b>Suitability/access/evidence of bats</b></p> <p>No evidence of bats was identified within the loft space.</p> | |
| | | | Figure 12. B1 loft space (looking north) |

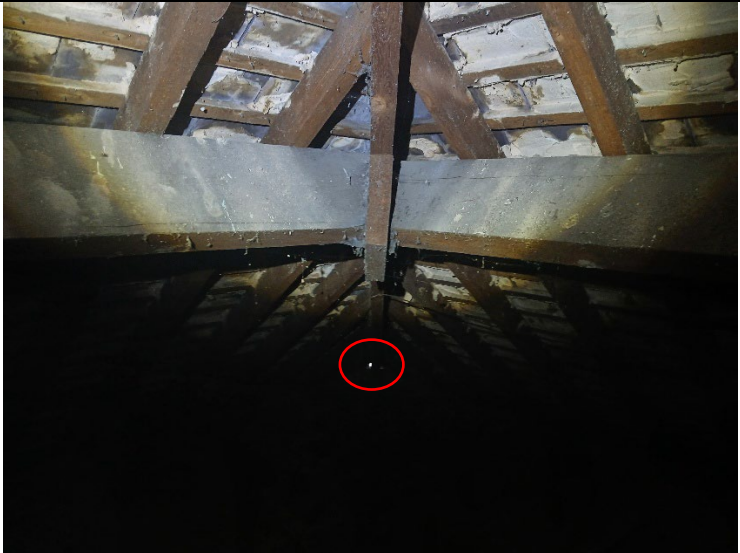
| | | <p>The gap at the end hip tile on the southwestern corner of the building as well as the gap under the hip tile on the southwestern hip of the building could allow access for entering and entering void dwelling bats. This is due to the size and lack of lining to obstruct entering and exiting bats, although its absence may result in unstable internal temperatures. The loft provides suitable space for pre-emergence warm up flights, due to the lack of obstructions.</p> |

Figure 13. Light ingress (gap at end hip tile) within B1 loft space

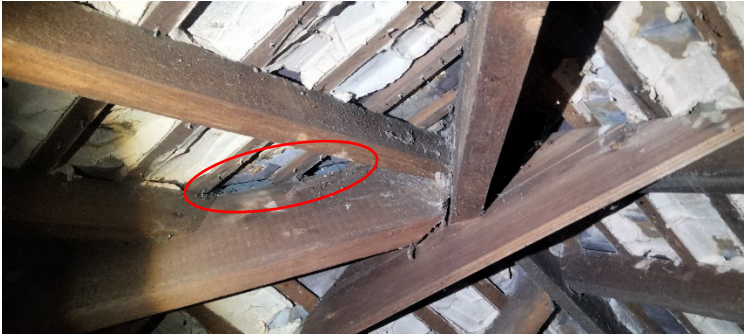
Figure 14. Light ingress (gap under hip tile) on the southwestern hip line

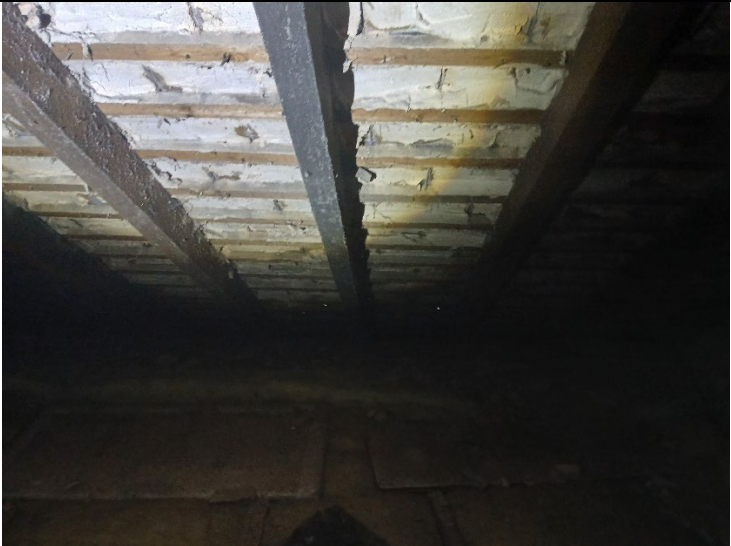
| | | | <div data-bbox="1299 167 2027 715"></div> <div data-bbox="1310 719 2016 782"><p>Figure 15. Minor areas of light ingress noted toward eaves on the western (rear) roof plane</p></div> |

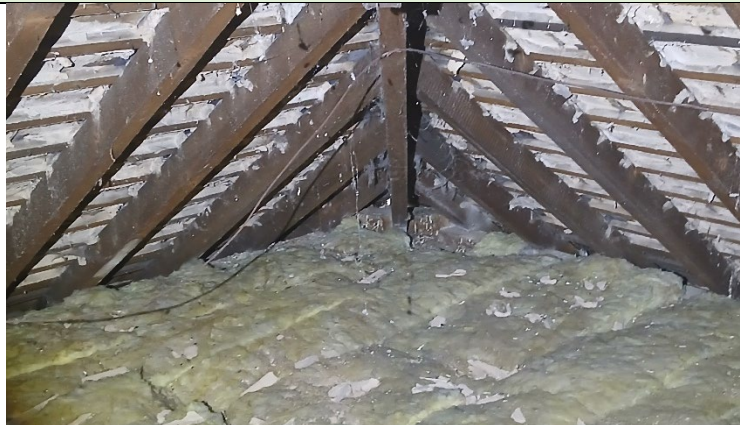
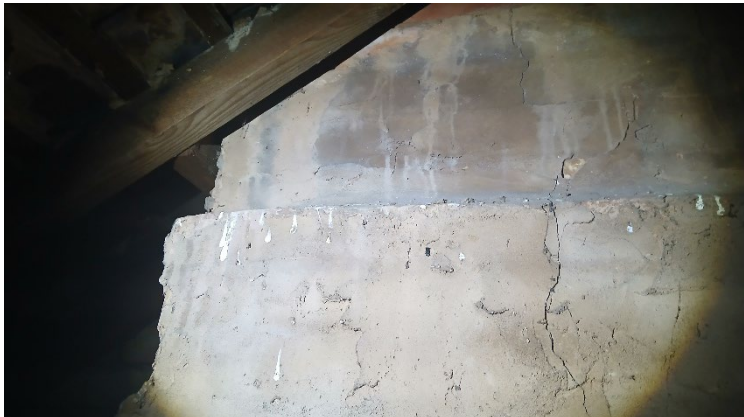
| Summary of Survey Findings | <b>Buildings</b><br>Bird droppings we identified within the southwestern corner of the loft space (location of gap at end hip tile), as well as scattered along chimney at the northern supporting wall. The building is considered suitable for nesting passerine species such as robin, wren, and house sparrow. | <div><p>Figure 16. Bird droppings located at the southeastern corner of B1 loft space</p></div> <div><p>Figure 17. Bird droppings scattered along chimney at the northern supporting wall</p></div> |

| <i>Recommendations</i> | <p><b>Buildings/trees</b><br/>The Wildlife &amp; Countryside Act 1981 (as amended) makes it an offence to obstruct or prevent any wild bird from using its nest, or to intentionally take, damage or destroy a wild bird's nest while the nest is being used or built. Contractors should remain vigilant during construction works, with precautionary checks for nesting birds carried out throughout the extended nesting season (February through to September, inclusive). If an active nest is found, it must be protected. All works that could disturb nesting birds, including noise from construction activities, should cease. A buffer zone of approximately 10m (minimum) is recommended for common species until the young have fledged. However, buffer zone requirements vary depending on species and the location of the nest relative to the works. A suitably qualified ecologist should be consulted for further advice where necessary.</p> <p>Precautions should be taken with machinery and noise levels when working close to any retained nests so as not to disturb any nearby nesting birds during construction works. At least a 5m buffer should be created between any machinery and active nests. However, buffer zone requirements vary depending on species, and a suitably qualified ecologist should be consulted for further advice. Further information can be found here: RSPB Guidance on Birds in Roofs. <a href="https://www.rspb.org.uk/birds-and-wildlife/helping-birds-and-wildlife/birds-in-the-roof">https://www.rspb.org.uk/birds-and-wildlife/helping-birds-and-wildlife/birds-in-the-roof</a></p> |

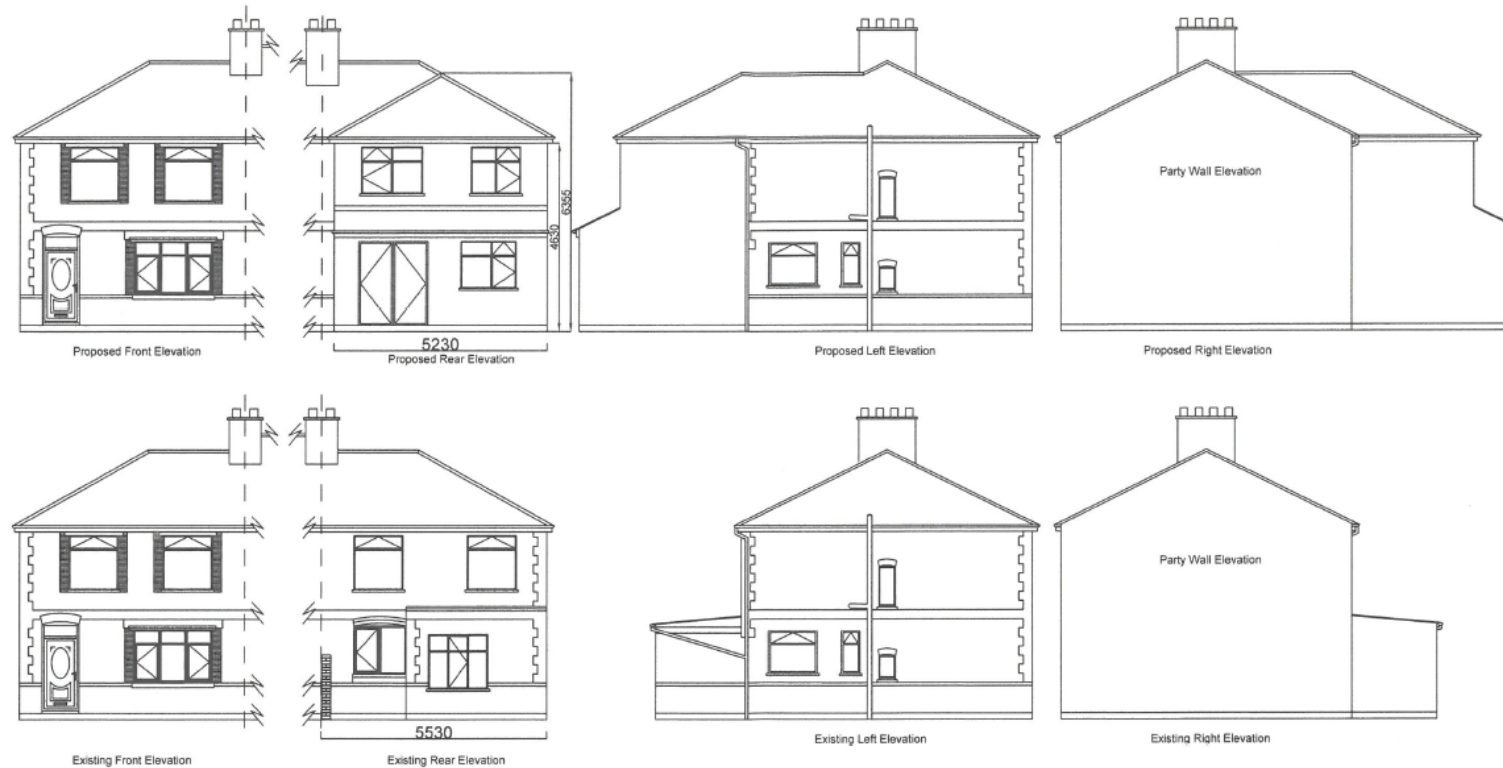
**Appendix 3: Proposed plan**

Proposed Rear Extension  
16 Tower Road,  
Earl Shilton  
LE9 7EG
