## PRELIMINARY BAT ROOST ASSESSMENT

**104-106 Station Road, Earl Shilton  
Leicestershire**

**Report  
2<sup>nd</sup> December 2024**

**Report reference:**  
**C4261-1**

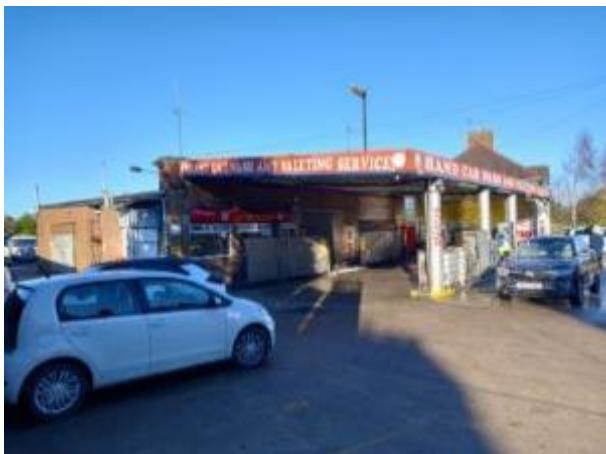
Plate 3.1: Eastern and southern elevations of main building

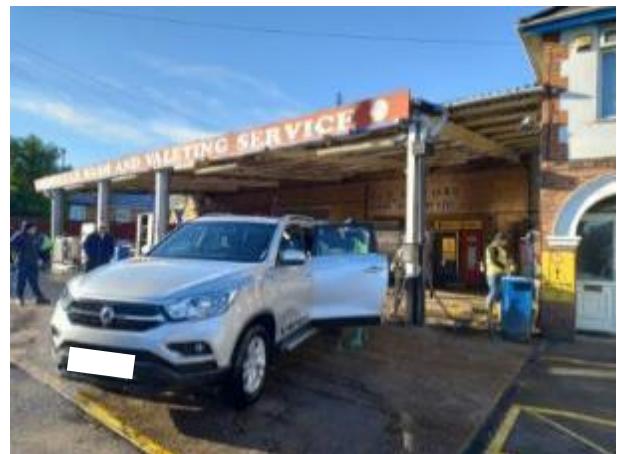
There is a brick parapet wall on the eastern elevation, onto which joins the canopy over the garage forecourt. It is constructed from single-skin corrugated sheeting (resembling asbestos), with metal horizontal and vertical support beams. For additional support, the horizontal beams extend into the walls of the garage to the west, and the adjacent house to the north.

Plate 3.2: Garage forecourt and canopy, and adjacent house

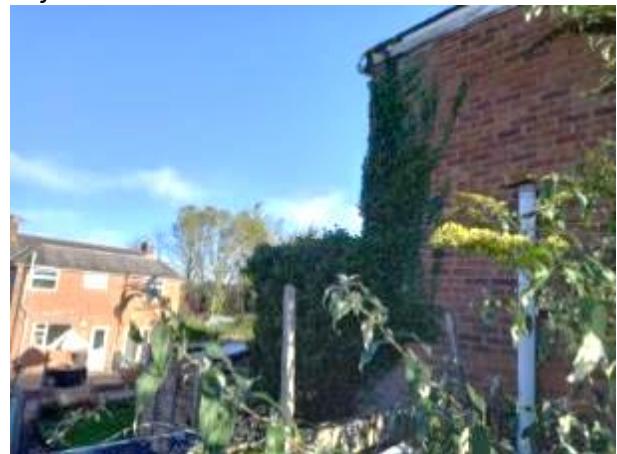
Plate 3.4: Dense ivy on the western elevation

An old nest, constructed from twigs, was noted on a metal support beam for the forecourt canopy where a small piece of chicken wire is visible either side of the beam (Plate 3.24). The construction, size and location of the nest suggests it was built by a pigeon species *Columba* sp. A further possible nest was noted inside a cavity created by corrugated asbestos-type material panels on the south-eastern corner of the main building (Plates 3.25-3.26). Twigs were visible in the gaps between the corrugations and the horizontal board that would provide a base for the nest, suggestive of a nest. Dense ivy growth on the north-western corner of the building may provide nesting opportunities for small songbirds, such as robin *Erithacus rubecula* (Plate 3.4).

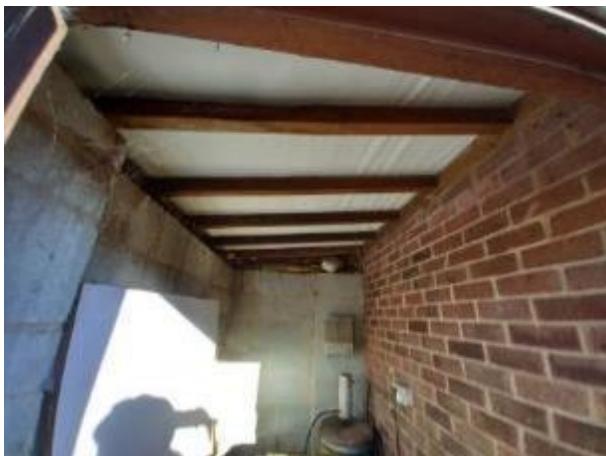
There are further low extensions on the west and north elevations of the large extension. The larger northern extension is used as a storeroom for the workshop, is accessible from inside the building, but also has external doors that provide an emergency exit for the workshop (Plates 3.4-3.6). This has a single-skin, slightly sloping, metal corrugated roof, with a mix of wood and uPVC bargeboard, and walls constructed from brick (Plate 3.12). The smaller, western extension (Plates 3.3 and 3.7) is only accessible from outside, and is constructed from single-skin blockwork. The slightly sloping roof on this section is clad with corrugated metal sheeting, supported by wooden beams, and is lined internally with a breathable roofing membrane (Plate 3.13). It is used for storage of equipment.

*Plate 3.13: Internal view of small western extension*

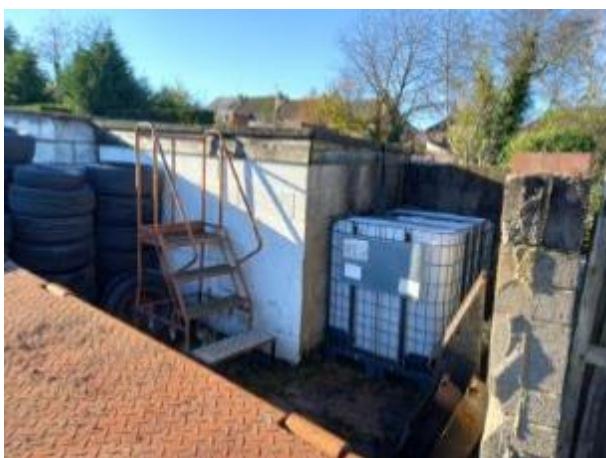
The small outbuilding at the western end of the site has blockwork walls and a slightly sloping roof covered with felt (Plate 3.14). Around the roof there is wooden bargeboard. The building is small, being roughly 1.8 m high, by 2 m wide and 3 m long. There are no windows or access points visible within the walls, and it is likely it can only be accessed via the hatch in the roof (Plate 3.15).

*Plate 3.14: Storage building*

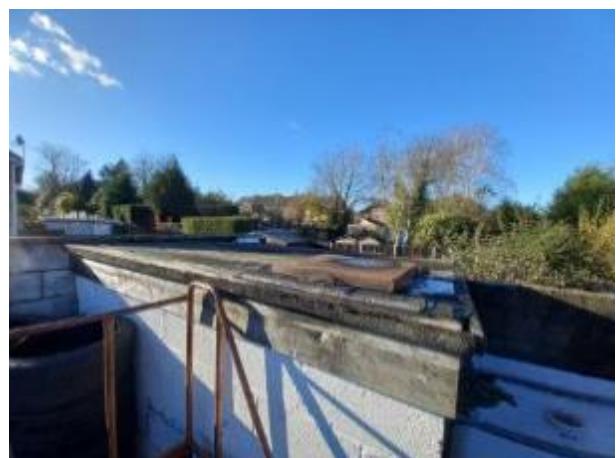
*Plate 3.15: Roof of storage building, showing probable access hatch in roof*

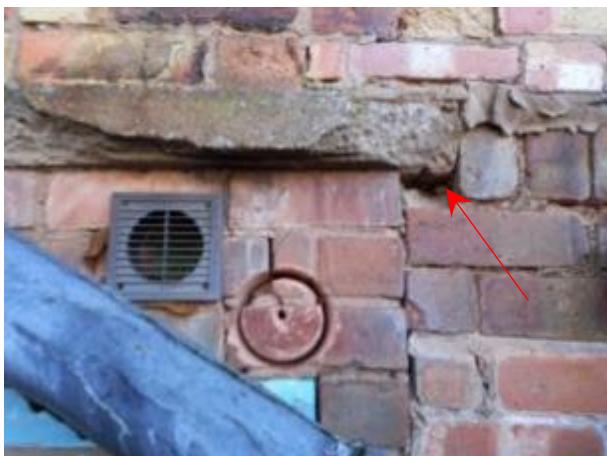
The brickwork on the original building is in moderate to good condition, with occasional areas of missing mortar, especially on the northern and eastern elevations (Plate 3.16-3.17). There are some holes in the brickwork, possibly from missing vents (Plates 3.19-3.20). There are further gaps on the eastern elevation around the folding door, where wooden inserts (possibly associated with a previous door) have rotted away, and where the metal beams of the forecourt canopy extend into the parapet wall, and also where the canopy's beams extend into the wall of the adjacent house (Plate 3.21). These features may provide crevices large enough for use by individual bats opportunistically. There is a gap between the wooden lintel and metal folding door on the east elevation; whilst possibly just large enough for bats to access, it is not considered a

Where these gaps were safely accessible for a detailed inspection, most were found to be shallow and do not provide sufficient shelter for roosting bats. Where gaps led into deeper cavities, large enough for one or two bats at most, most were filled with cobwebs, indicating no recent use by bats. No bats or evidence of bat use (e.g. bat droppings) were found within any of these cavities.

Plate 3.16: Missing mortar on northern elevation (main section) that leads into a small crevice in the wall (indicated with arrow)

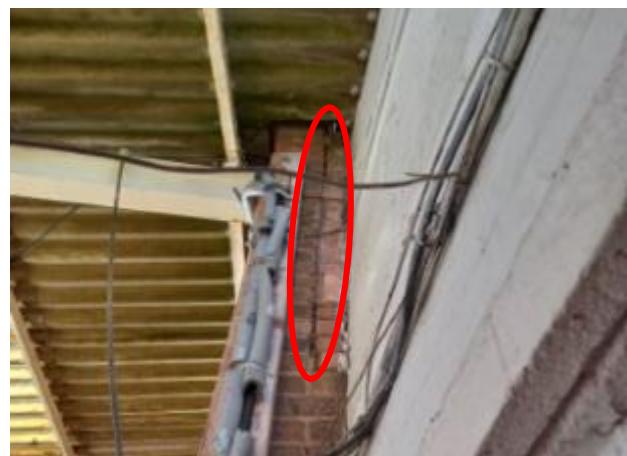
Plate 3.17: Possible crevice in between the two skins of the wall at the northern end of the parapet wall

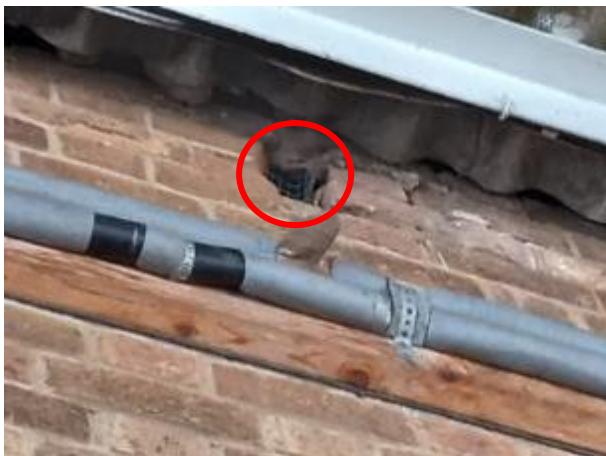
Plate 3.18: Possible gap between mesh and brickwork that may provide bats with access into the original building

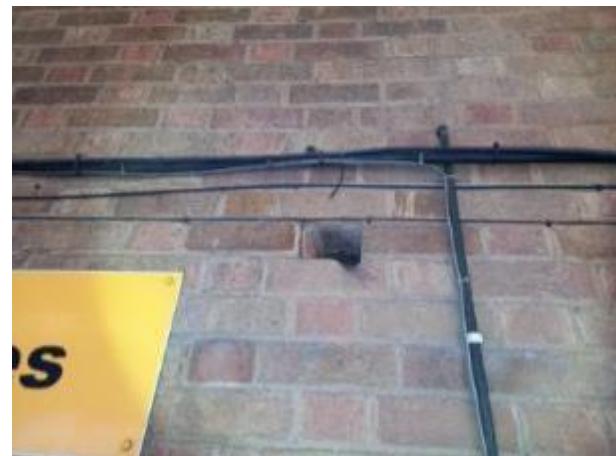
Plate 3.19: Hole into wall on eastern elevation of original section

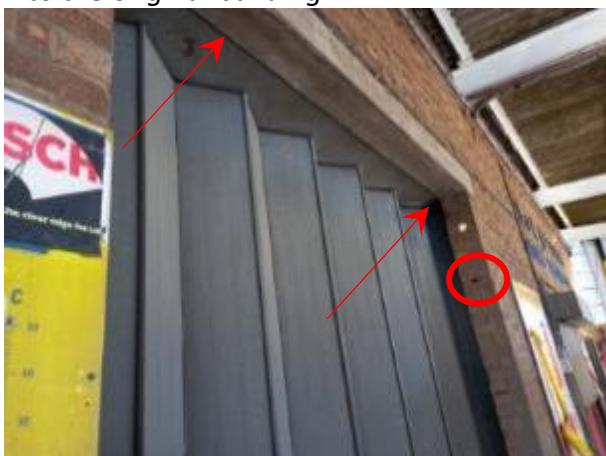
Plate 3.20: Gaps at top of folding doors and between lintel and door frame (indicated by arrows), and where rotten wood has created gap into a small cavity between brick skins (circled)

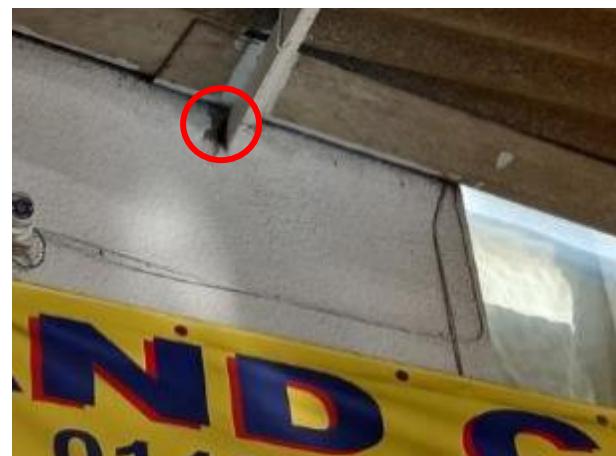
Plate 3.21: Example of gap between canopy beam and the brickwork of the adjoining house

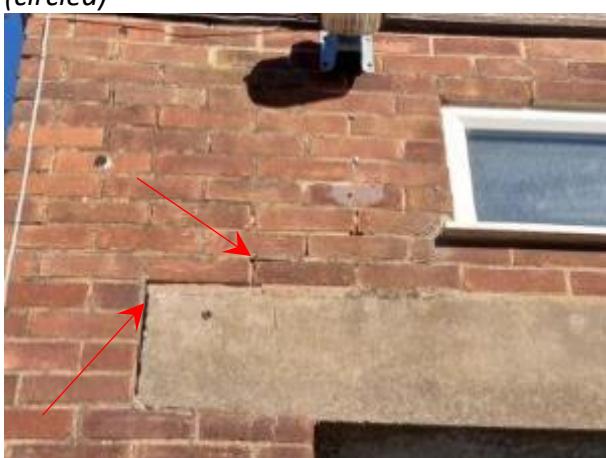
The brickwork is in better condition on the large extension, although there is gap next to the lintel over the western-most folding door, which extends into a crack in the brickwork (Plate 3.22). The gap by the lintel may be large enough to provide space for an individual bat, but the crack appears too small to be accessible by a bat. There are also further potential gaps where the wooden bargeboards are coming away from the walls; inspection of these gaps with a torch and binoculars found most gaps are filled with thick cobwebs, suggesting no recent use by roosting bats. There are also some gaps where the roofing felt is lifted, although these gaps are quite open and thus unlikely to provide a suitable sheltered roosting location for bats.

Plate 3.22: Gap around lintel on main extension, leading to shallow crack in brickwork (indicated with arrows)

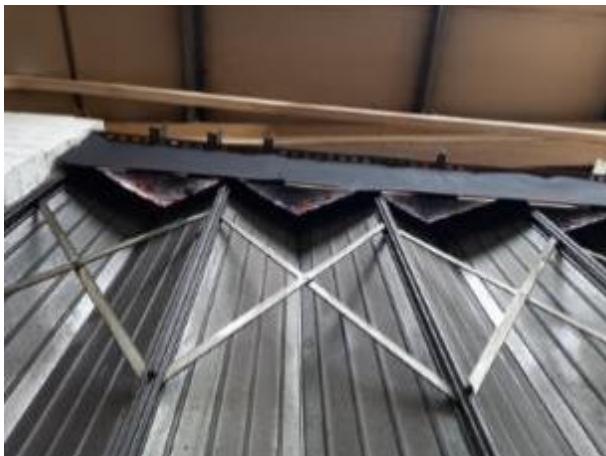
Gaps at the top of the folding garage doors may provide bats with access into the building (Plate 3.23). However, the construction of the building means there are few or no potential roosting crevices inside. The workshop area has high levels of ambient light from the windows and skylights, which further reduces the likelihood of these parts of the building being used by roosting bats. Much of the building is in regular use by the staff, but the infrequently used storage areas on the first floor have cobwebs on the roof beams and ceiling, suggesting no recent disturbance of these areas by people, bats or other fauna.

Plate 3.23: Daylight visible at top of folding doors

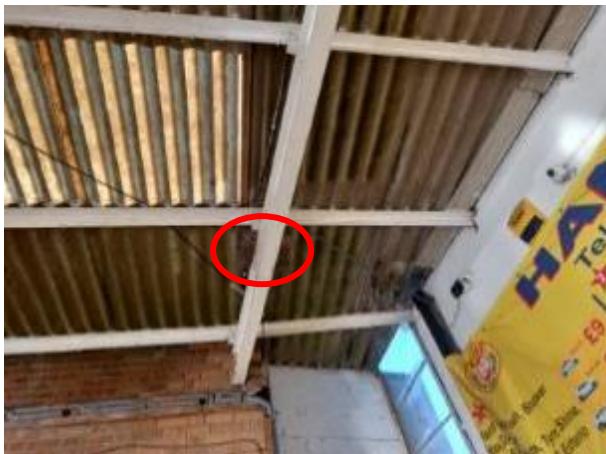
Plate 3.24: Location of old, probable pigeon, nest (circled)

At least one old bird nest was noted during the survey, and it is therefore likely that birds will nest in the main building in the future. In the absence of mitigation, if nesting birds are present at the time of demolition this would result in breaches of the legislation which protects nesting birds. Precautionary measures during demolition are provided in Section 6.2. The nesting opportunities present are relatively limited and it is considered that their loss will not result in a significant loss of nesting opportunities in the local area.

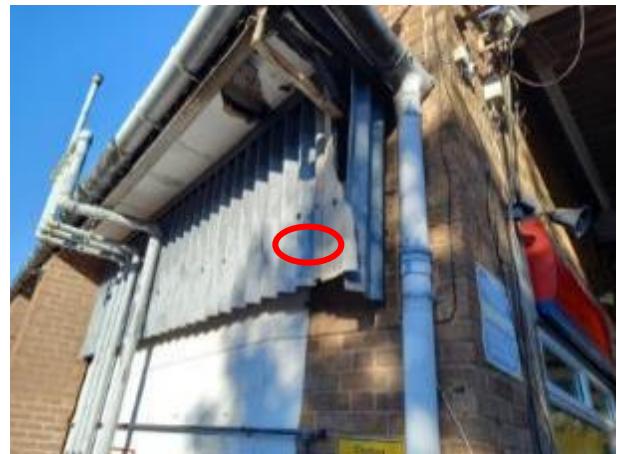
Plate 3.25: Location of twigs (circled) inside corrugated panels, that may represent an old nest – see also Plate 3.26

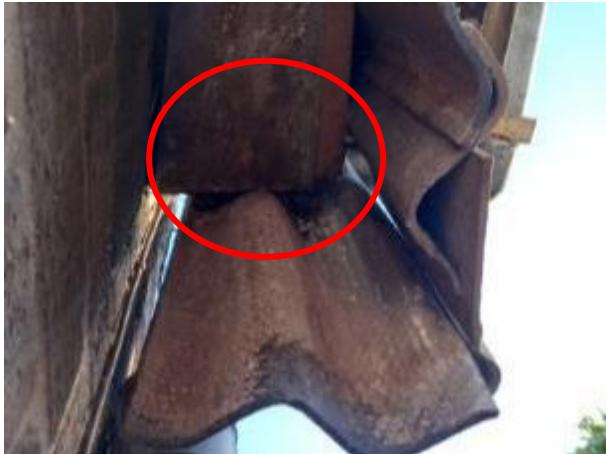
Plate 3.26: Location of twigs, possibly suggestive of an old nest location
