Redrow Homes Ltd (Harrow Estates Division)

Land East of the Common

Barwell

Sustainable Drainage Statement

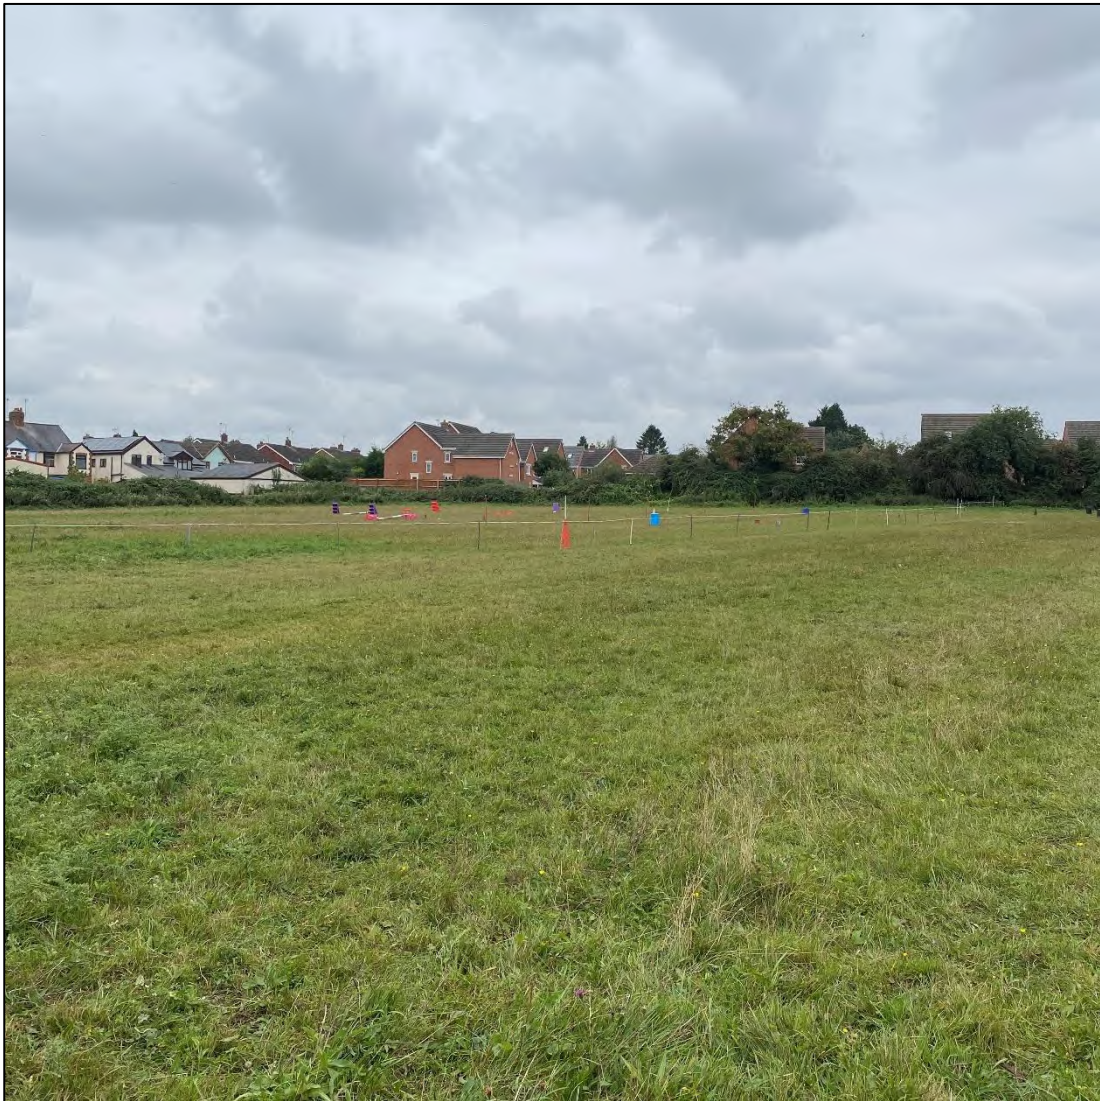
**Figure 2.1: Existing Site Conditions (taken from within the western area of the site facing Northwest to The Common and Gardner Close)**

- 2.1 The existing site is greenfield, comprising of agricultural land. The site is bound to the north by Dawson's Lane, to the east by existing fields, to the south by the A47 and to the west by The Common.
- 2.2 The site is made up of various different parcels of greenfield land, separated by hedgerows and trees. The current use of the site is agriculture and paddocks with a series of outbuildings located in the northern parcel. A typical image of the current condition of the site, as observed by BWB Consulting in 2021, is shown in **Figure 2.1**.

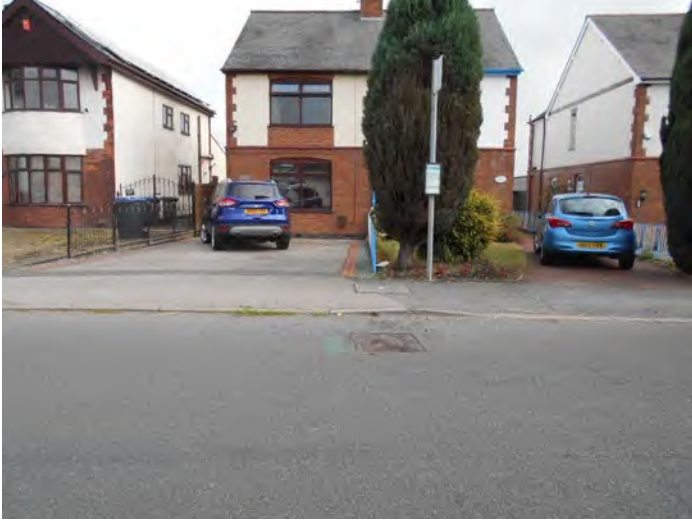
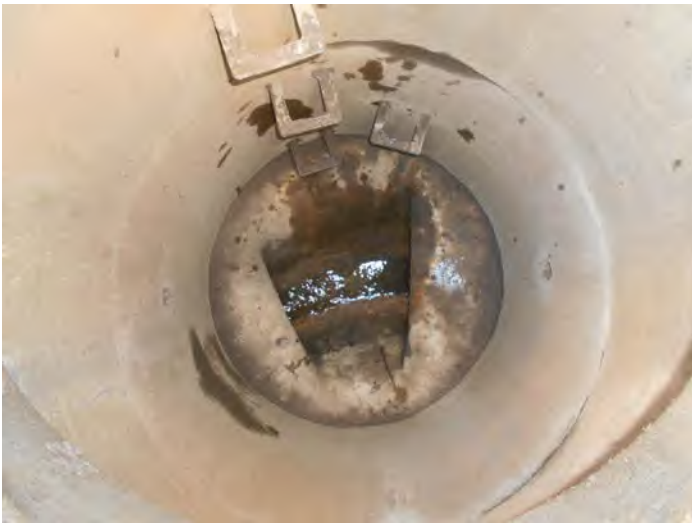
**MH SP44968402**

Cover ☒ Steps/Lad ☒ Shaft ☒ Chamber ☒ Benching ☒ Channel ☒Remarks - **CCTV UPSTREAM AND DYE TESTING REVEALED NO INCOMING CONNECTION WITH PIPE FROM FIELD THAT RUNS UNDERNEATH No.63 THE COMMON**

**LOCATION**

**CHAMBER**

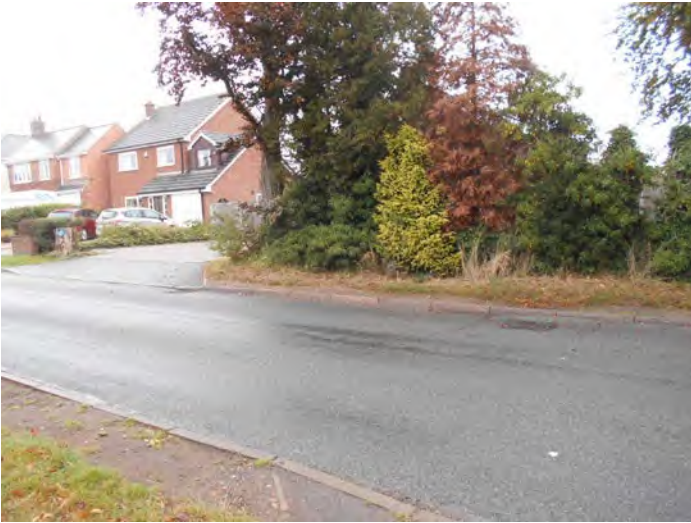
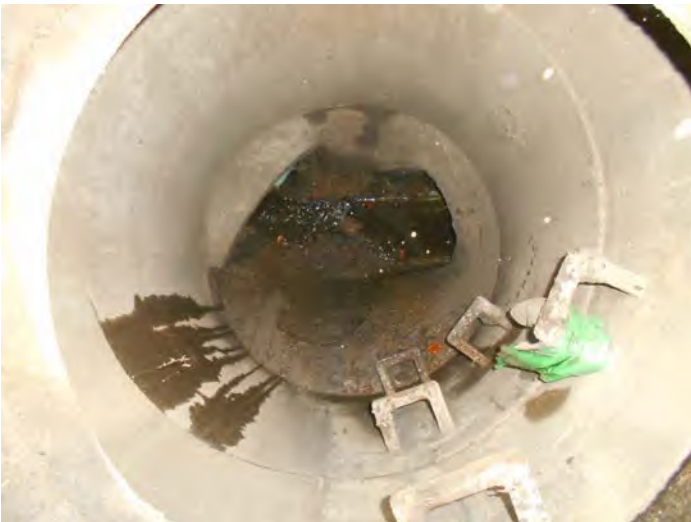
**MH SP44969301**

**LOCATION**

**CHAMBER**

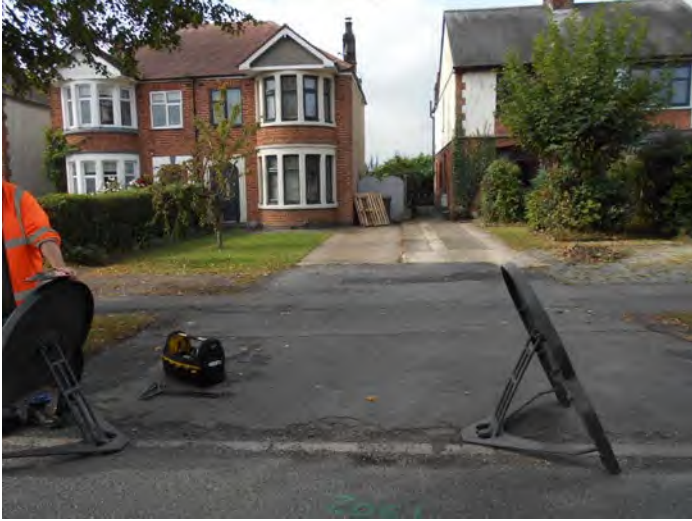
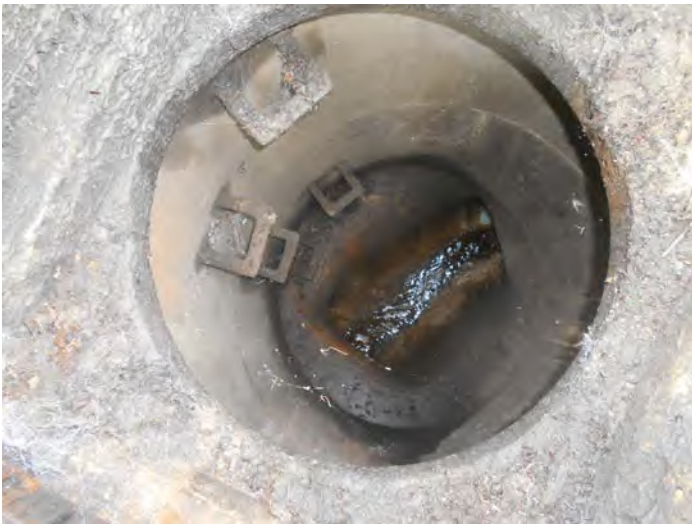
**MH SP44969302**

**LOCATION**

**CHAMBER**

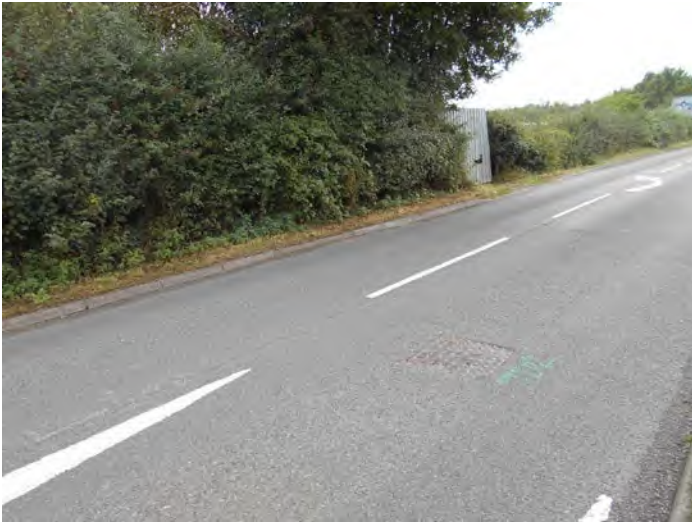
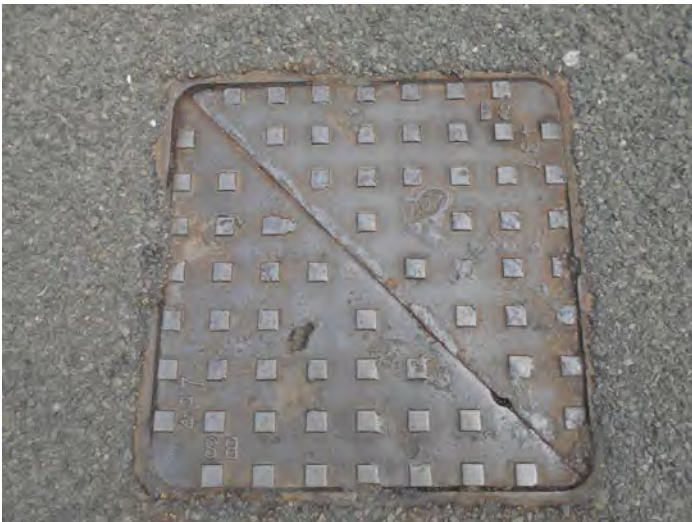
**MH SP44969202**

Remarks - **MANHOLE IS STUCK IN FRAME UNABLE TO RAISE. CCTV THROUGH MANHOLE UNTIL 40m  
BEYOND MANHOLE FROM UPSTREAM MANHOLE REVEALS NO CONNECTION TO WATERCOURSE IN FIELDS.**

**LOCATION**

**COVER UNABLE TO RAISE  
COMPACTED IN FRAME**

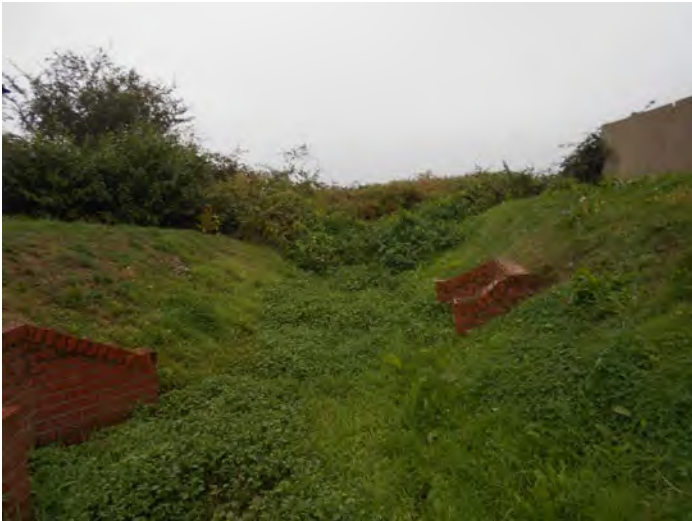
**OPEN DRAINAGE DITCH  
LOOKING TOWARDS  
NORTHERN SITE  
FENCE/HEDGE**

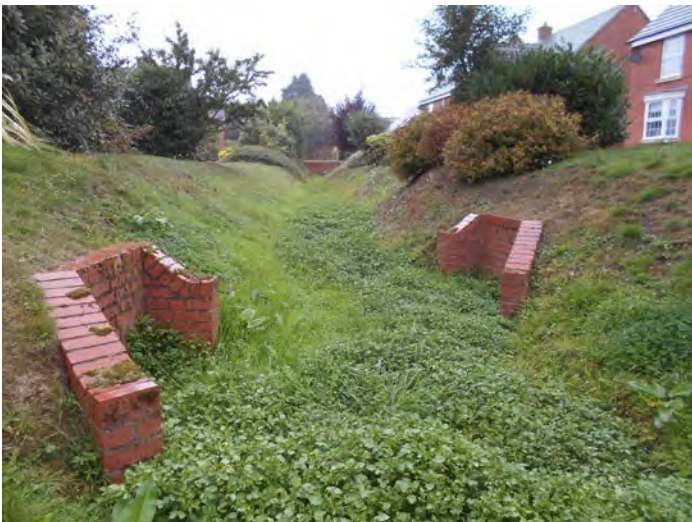
**OPEN DRAINAGE DITCH  
LOOKING TOWARDS  
GARNER CLOSE**

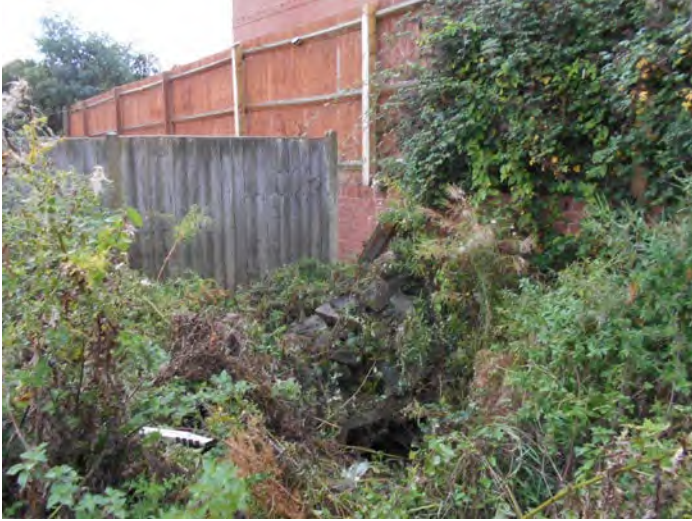
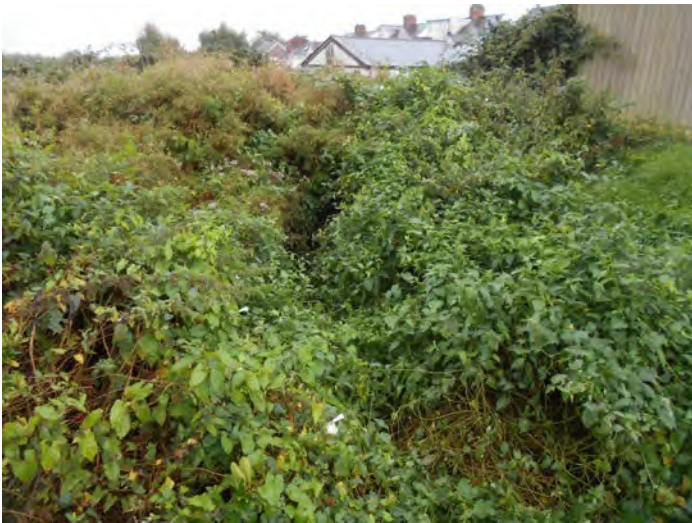
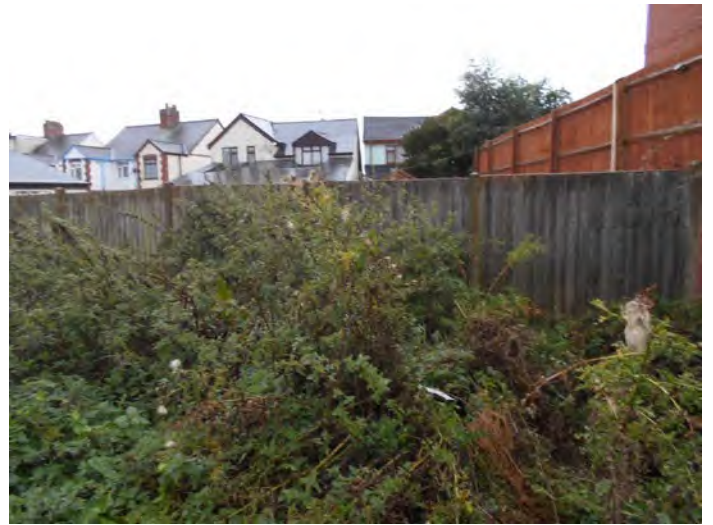
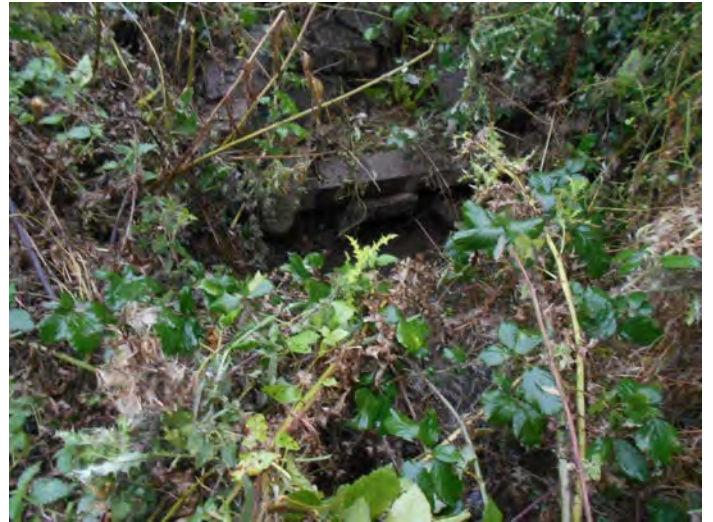
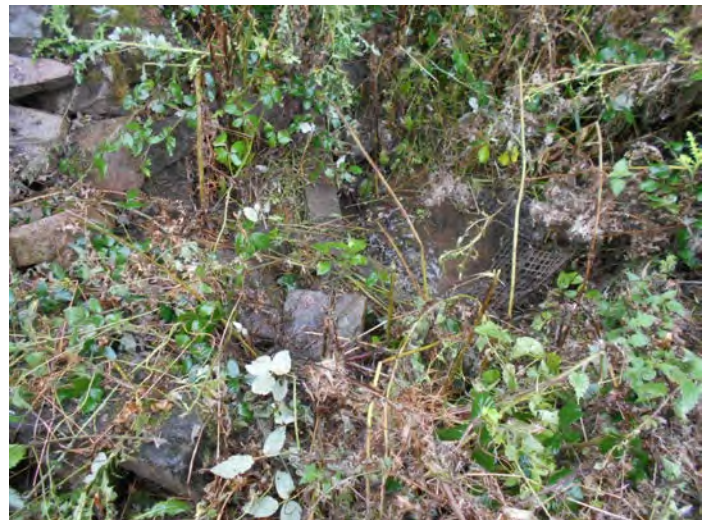
Remarks - INFALL HEADWALL COLLECTS WATER FROM THE GENERAL AREA AT THE END OF THE OPEN DRAINAGE DITCH ON GARNER CLOSE. THE PIPE GOES UNDERGROUND AT THIS POINT AND INTO THE GARDEN OF "63 THE COMMON" AND ACCORDING TO THE PROPERTY OWNER HAS BEEN BUILT OVER. THE PIPE CHANGES MATERIAL AND IS IN BAD CONDITION PREVENTING CCTV GOING VERY FAR. THE PIPE THEN CONTINUES OUT TO THE FRONT OF THE PROPERTY AND DOWN THE VERGE TO MH SP44969304

LOCATION

INFALL

WATER AT IFHW1

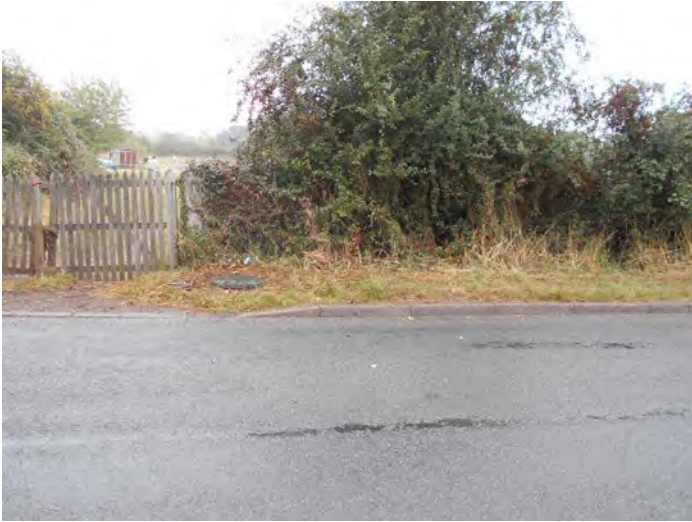
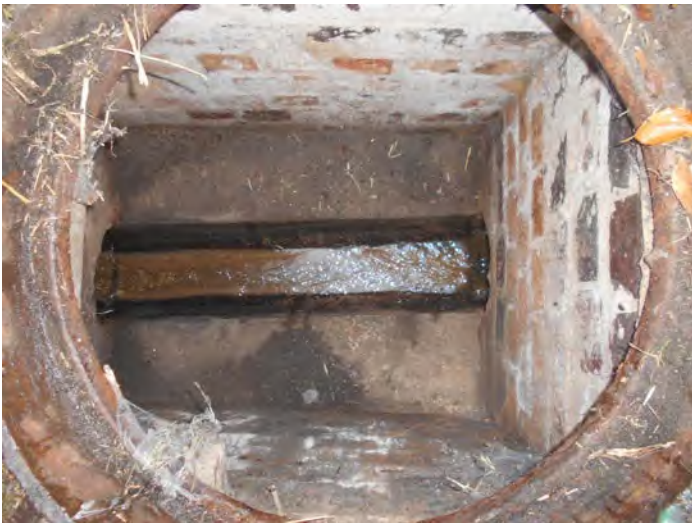
**MH SP44969304**

Remarks - **UNABLE TO CCTV VERY FAR UPSTREAM FROM MANHOLE DUE TO ROOTS IN PIPE SO NO OTHER UPSTREAM MANHOLES FOUND ON RUN BETWEEN CHAMBER AND HW1 IN FIELD. CONNECTIVITY BETWEEN HW1 AND MANHOLE VERIFIED BY DYE TESTING. SIMILAR DOWN STREAM TO HW2(DYE TESTED)**

**LOCATION**

**CHAMBER**

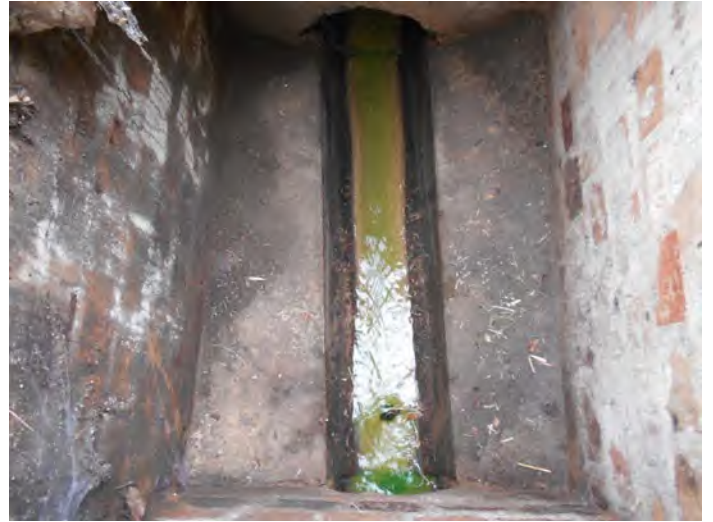
**DYE TEST FROM IFHW1  
IN CHAMBER TO PROVE  
CONNECTION**

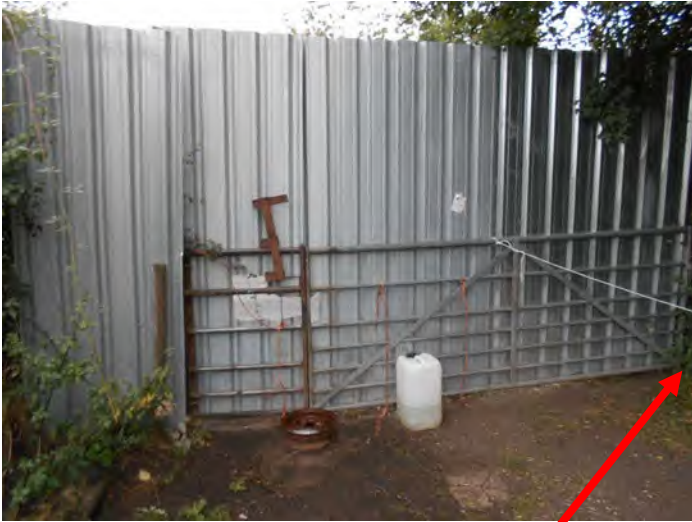
**HWOFF2**

Remarks - HEADWALL CONTAINS THE PIPE RUNNING FROM MH SP44969304 AND IT DISCHARGES INTO AN OPEN DITCH RUNNING AROUND A FIELD BOUNDARY ULTIMATELY LINKING UP TO AN INFALL HEADWALL IFHW3 AT THE NORTH SIDE OF THE A47.

**LOCATION**

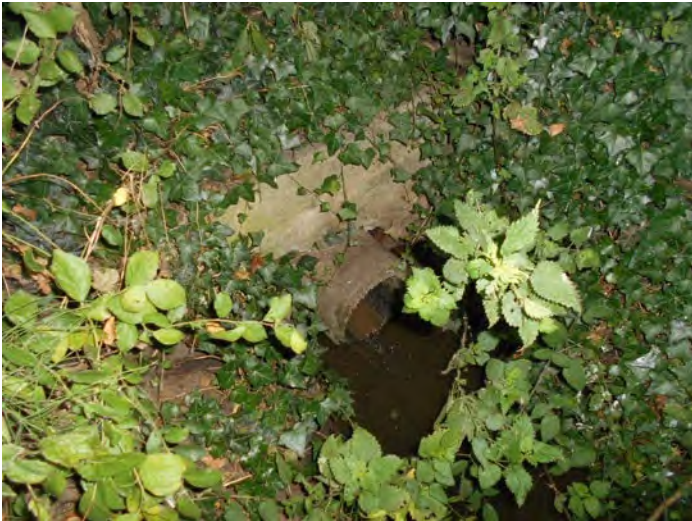
**OUTFALL HEADWALL  
TO DITCH**

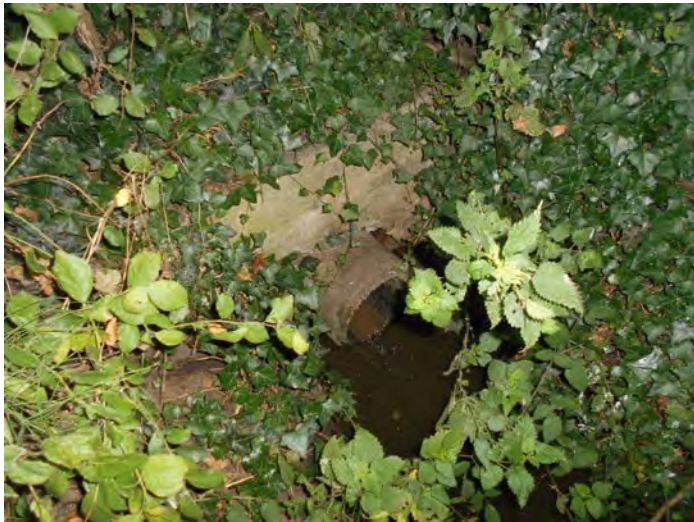
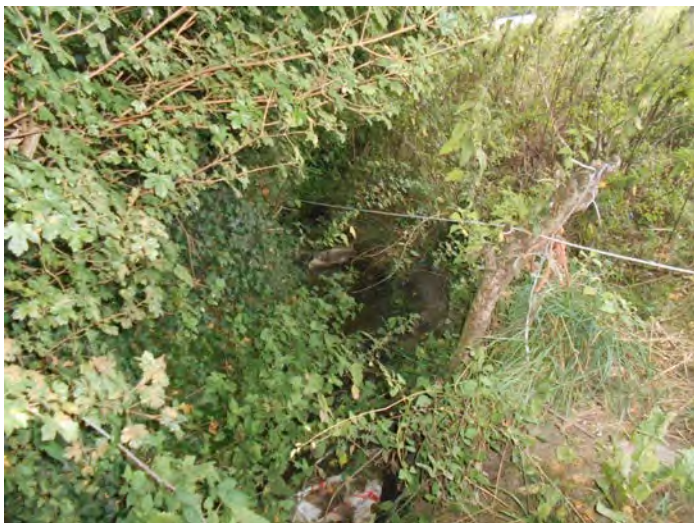
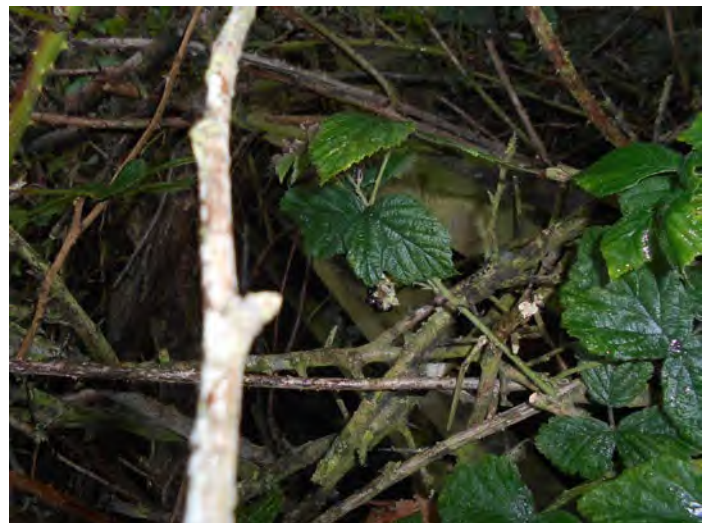
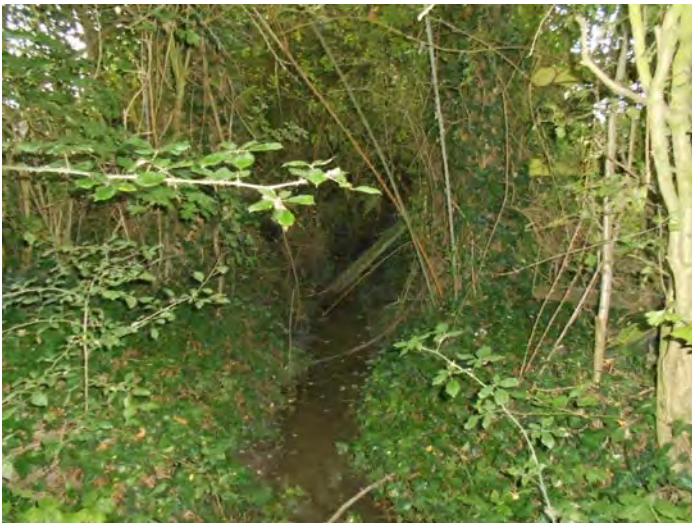
## **FIELD BOUNDARY DITCH**

**START AT OFHW2**

**DITCH**

**DITCH(OVERGROWN)**

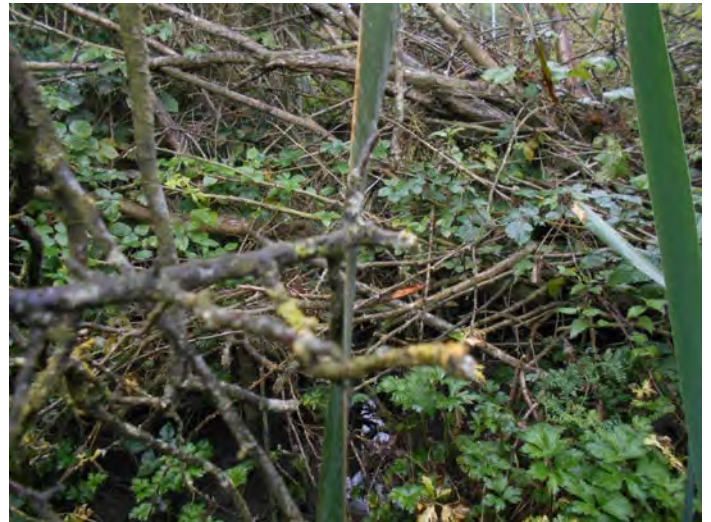
**DITCH(OVERGROWN)**

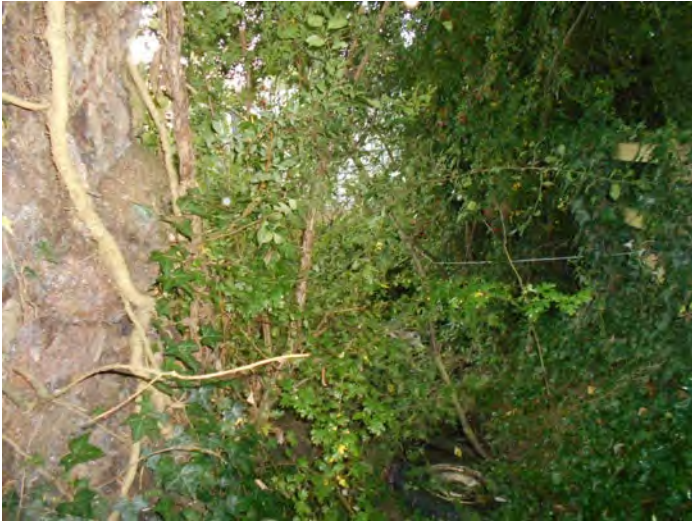
**DITCH(EVIDENCE OF  
DUMPING)**

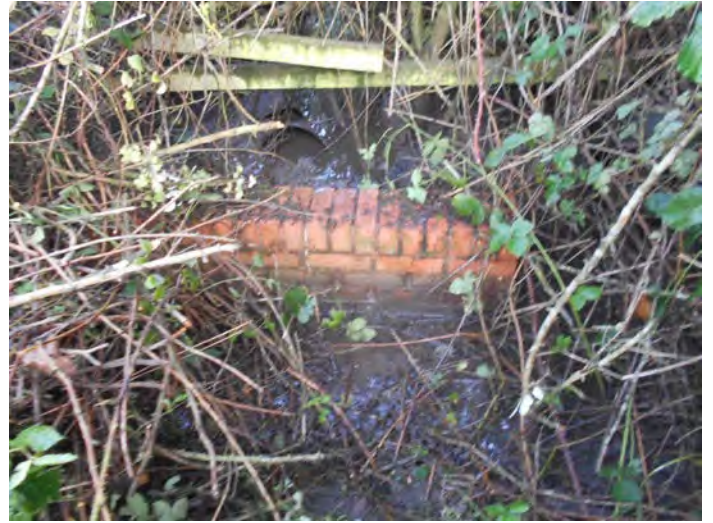
**END OF FIELD DITCH AT  
IFHW3  
NOTE FIELD DITCH SILTED  
U/S OF HW & D/S OF HW  
HIGHWAY DRAINAGE DITCH**

- 3.6 The downstream headwall noted within **Appendix 4**(reference IFHW3)) is recorded as being heavily silted both upstream and downstream therefore, maintenance work is recommended prior to connection being made.

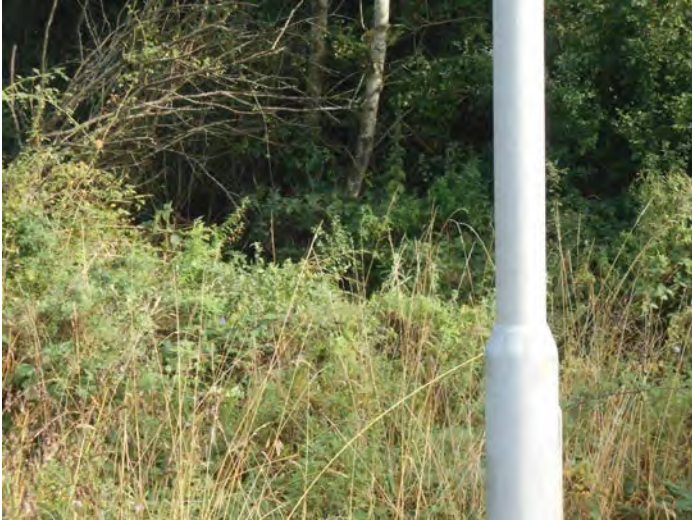
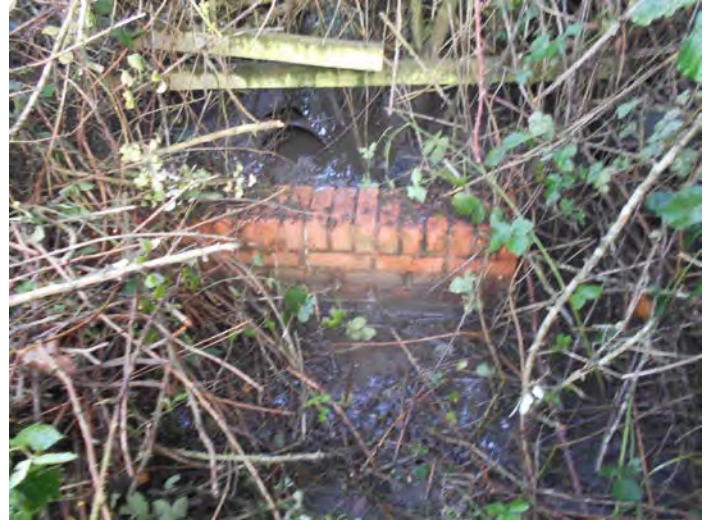
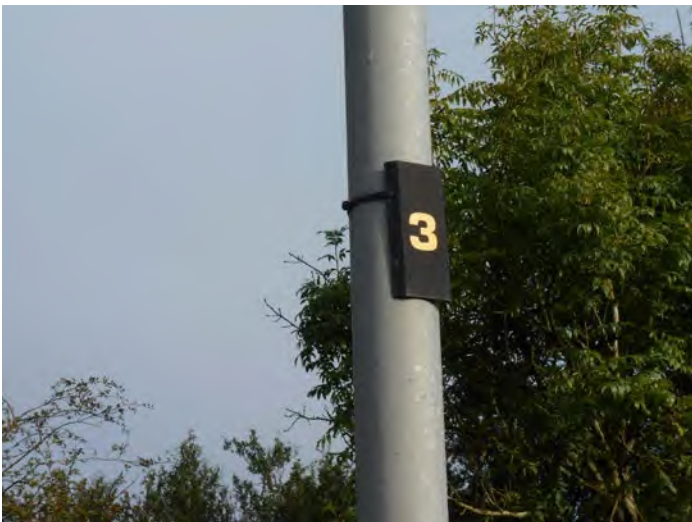
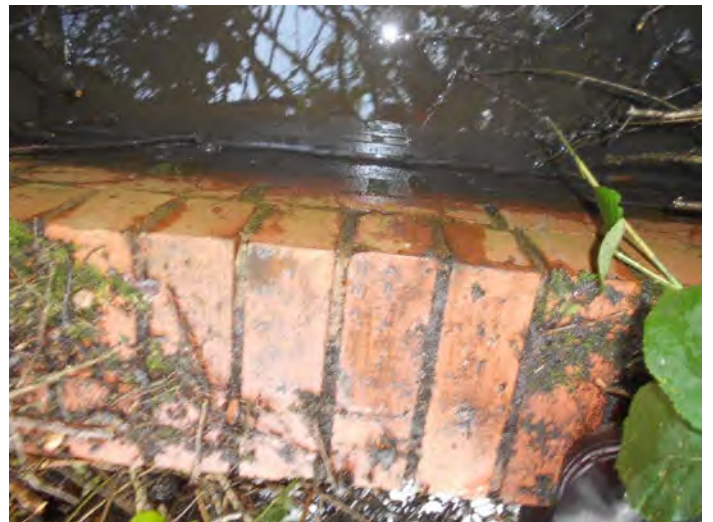
### **IFHW3**

Remarks - INFALL HEADWALL IS AT END OF THE OPEN DRAINAGE DITCH RUNNING AROUND FIELD. AT THE A47 BOUNDARY FENCE THE HEADWALL SHOULD COLLECT THE WATER FROM THE FIELD DITCH AND ALLOW IT TO PASS THROUGH TO INFALL INTO A HIGHWAY DITCH(POSSIBLY HEAVILY SILTED) OR CULVERT(AGAIN BURIED). BOTH PIPES ON EITHER SIDE ARE BURIED SO INVERT LEVELS AND PIPE SIZES AT THE HEADWALL ARE UNOBTAINABLE.

**LOCATION IN A47 VERGE**

**VIEW FROM D/S**

**LAMP POST IS NO.3**

**VIEW ON U/S FACE**

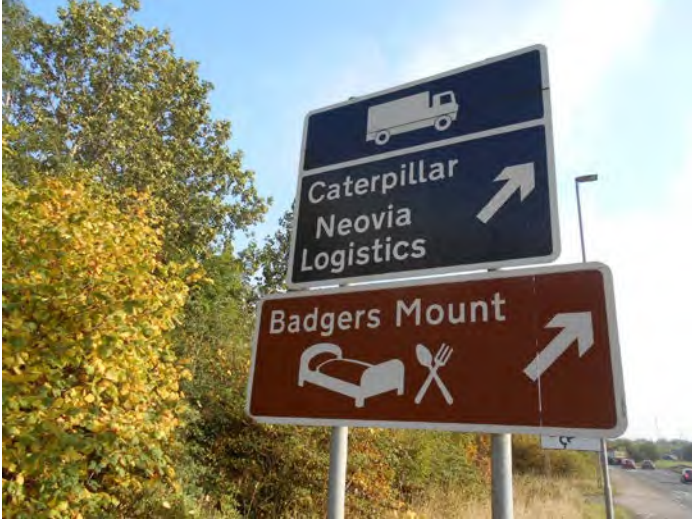
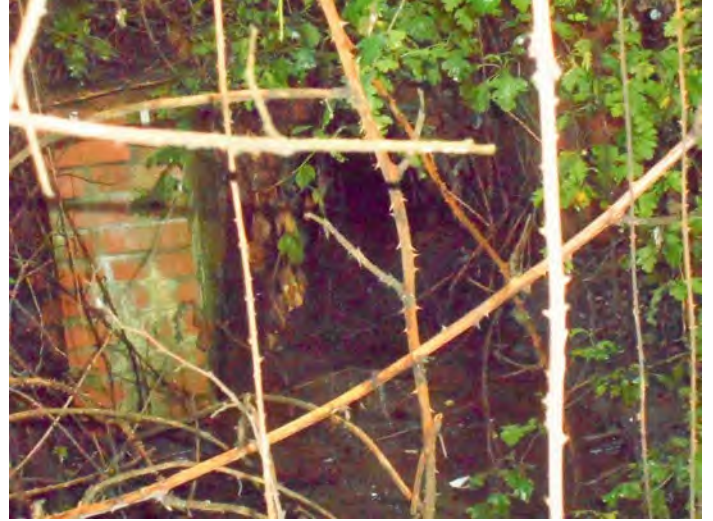
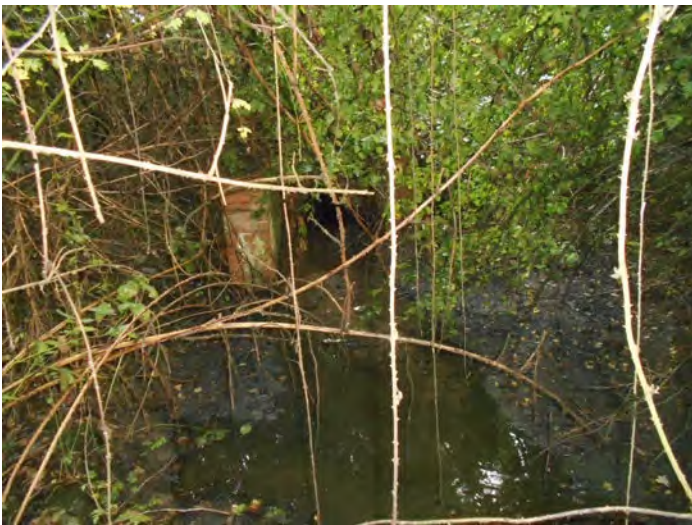
## **A47 HW4**

**LOCATION (IN HEDGE NEAR  
THIS SIGN ON A47)**

**HEADWALL**

**HEADWALL INTO HIGHWAY  
DRAINAGE DITCH**

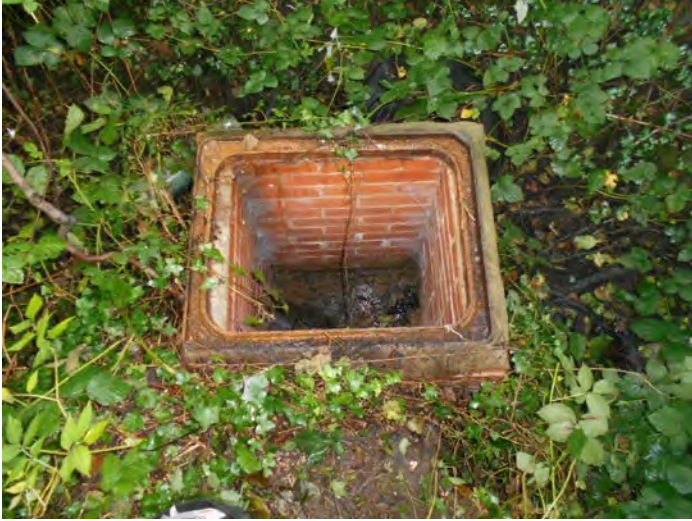
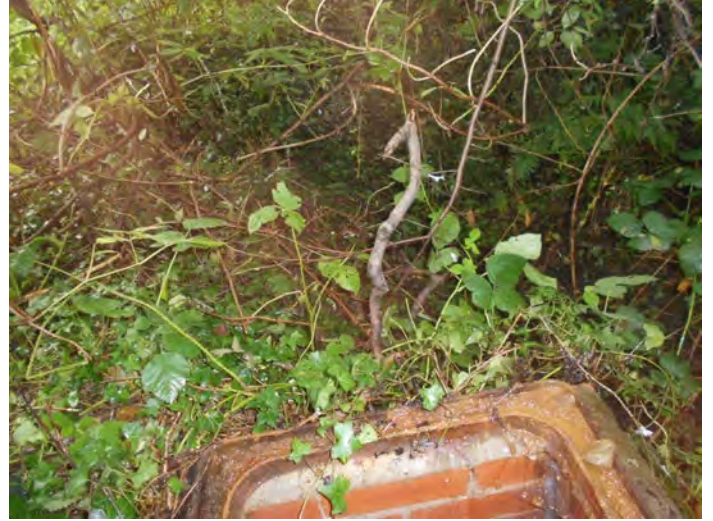
**A47 MH1**

**LOCATION REAR OF  
FOOTPATH ON OLD A47**

**HIGHWAY DITCH INCOMING**

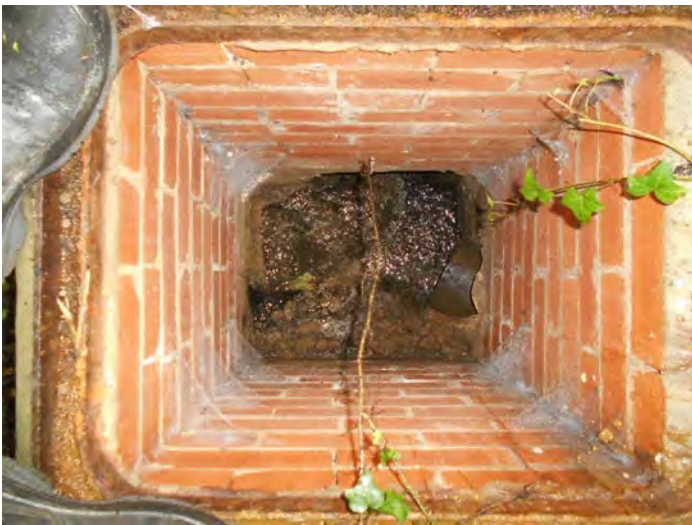
**CHAMBER**

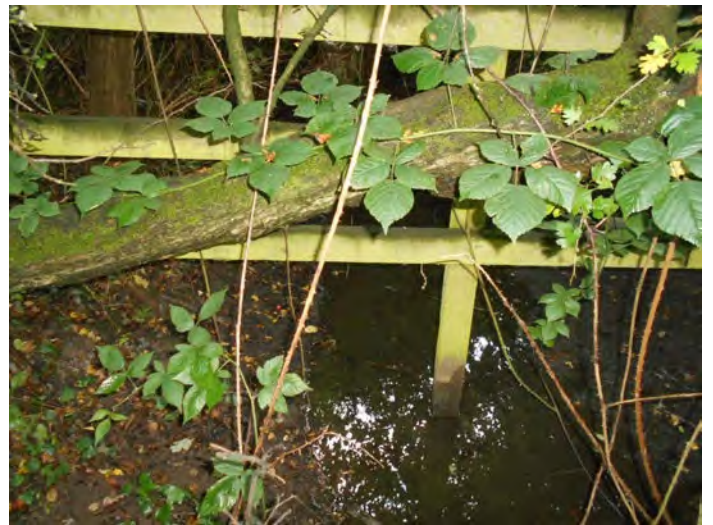
**WATERCOURSE INCOMING**

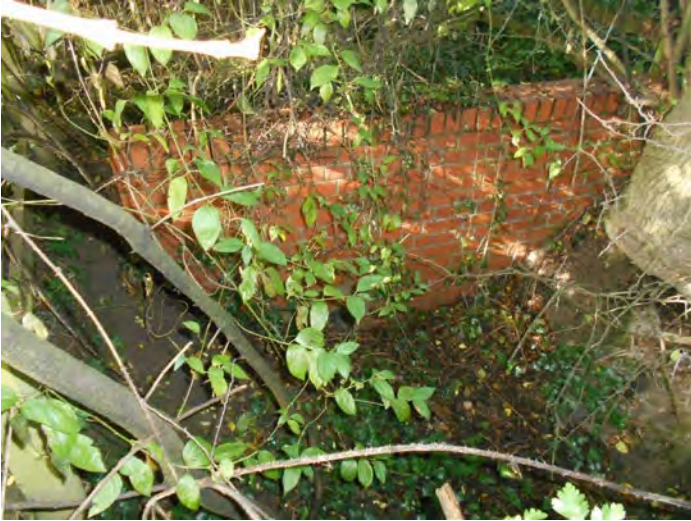
**HEADWALL ON  
WATERCOURSE**

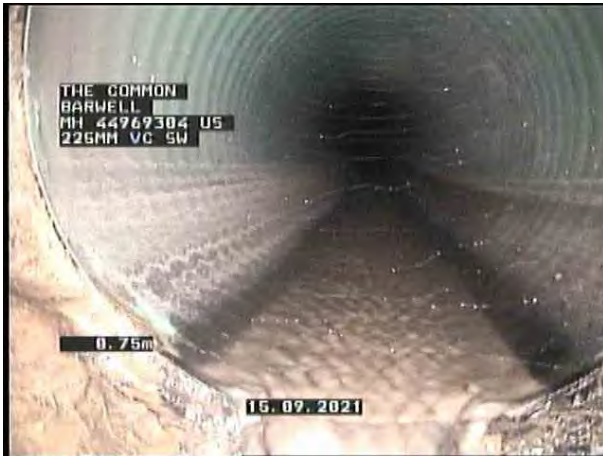
\_X\_af490d8f-1502-4e2d-b38c-858b3ffb67ac\_20210915\_09210  
0\_473.jpg, 00:00:22, 0.70 m  
Material changes to asbestos cement

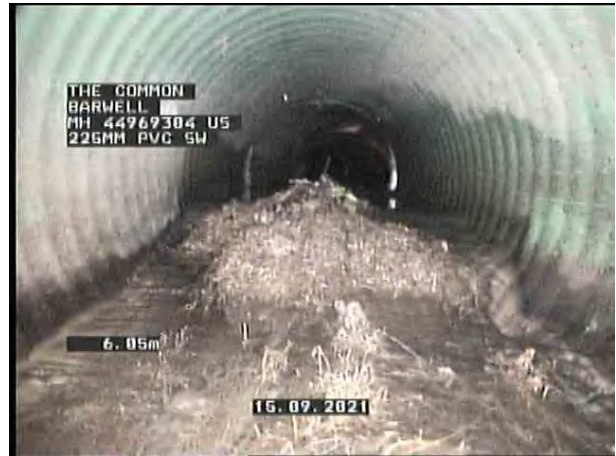
\_X\_5f304ae7-a971-4180-bdd8-d945b1fa45b4\_20210915\_0922  
46\_352.jpg, 00:01:37, 6.00 m  
Roots, mass, 60% cross-sectional area loss

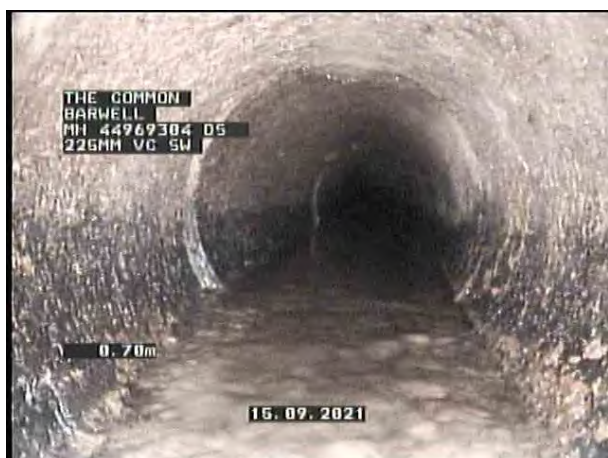
44969304X\_0493e192-3ae8-4370-aaab-ff8b2572b6a9\_202109  
15\_092716\_830.jpg, 00:02:38, 0.00 m  
Water level, 30% of the vertical dimension

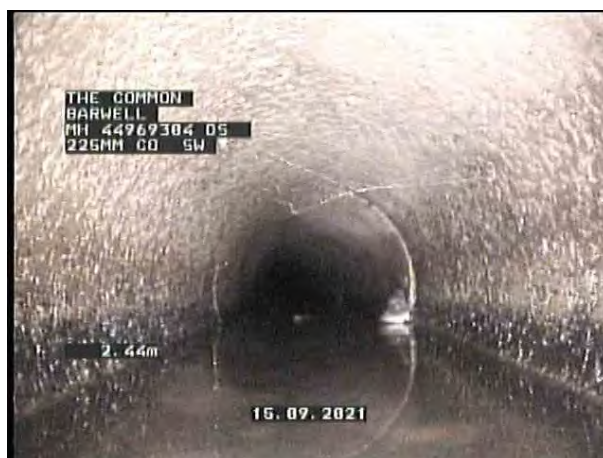
44969304X\_96954ea0-1821-42f3-95ef-5b383f259c3a\_2021091  
5\_092753\_942.jpg, 00:02:38, 0.00 m  
Water level, 30% of the vertical dimension

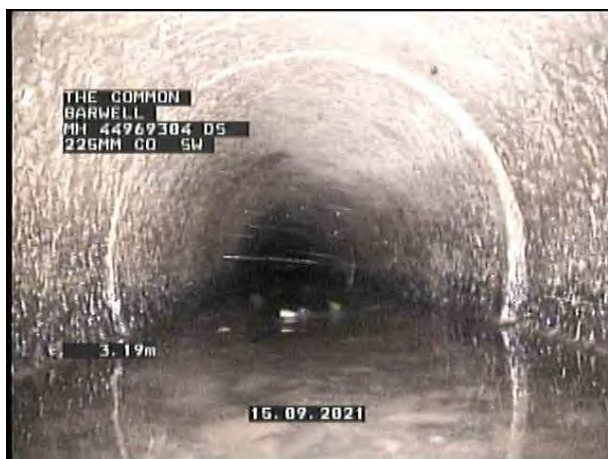
44969304X\_c8b9277b-d51e-4de4-a6bf-7dcb52b176a3\_202109  
15\_092856\_250.jpg, 00:02:38, 3.10 m  
Settled deposits, other, 30% cross-sectional area loss, start,  
Stones

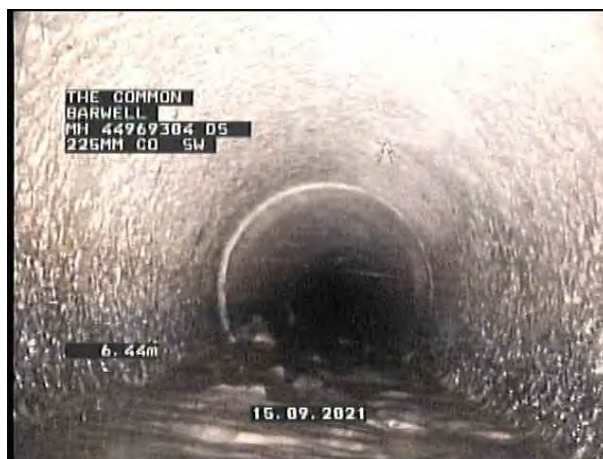
44969304X\_06e2cca7-0eec-41b9-af30-9e0b6f651069\_202109  
15\_093645\_844.jpg, 00:02:05, 6.40 m  
General photograph taken at this point

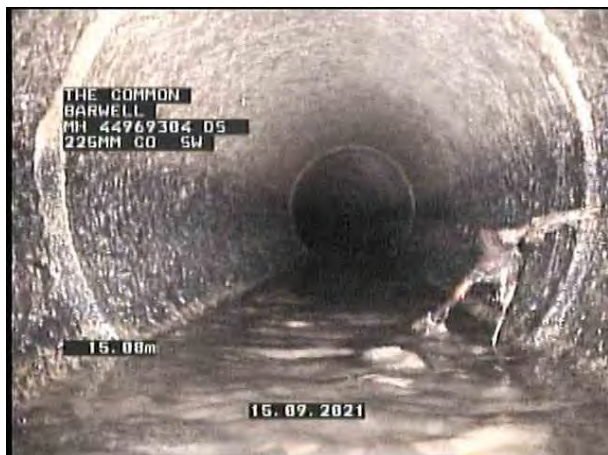
44969304X\_222e1a04-1bbc-4be9-b13a-ef4936e4c40c\_20210915\_093917\_271.jpg, 00:04:15, 15.00 m  
Roots, tap at joint

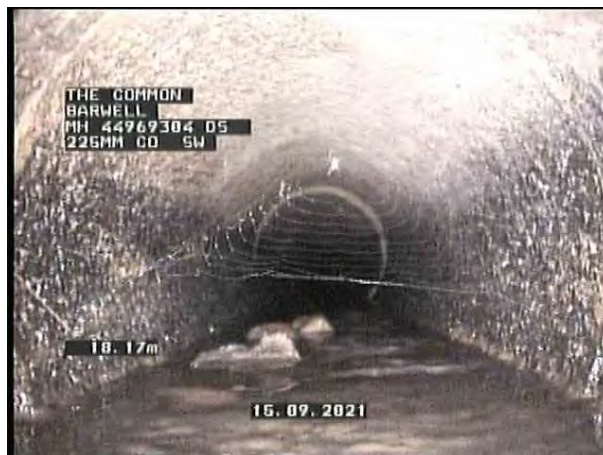
44969304X\_af71568a-4de3-480d-9f97-5f19523ae225\_20210915\_093957\_014.jpg, 00:04:39, 18.10 m  
Settled deposits, other, 35% cross-sectional area loss, Stones

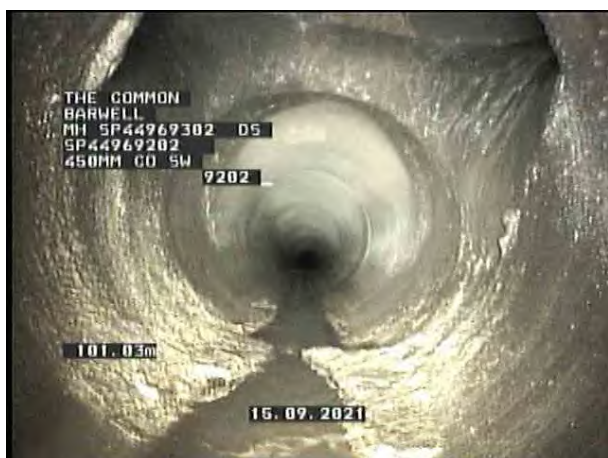
SP44969302X\_a736604f-dcfb-4293-942f-097d95082289\_2021  
0915\_103538\_060.jpg, 00:07:46, 101.00m  
Finish node type, manhole, reference number: SP44969202

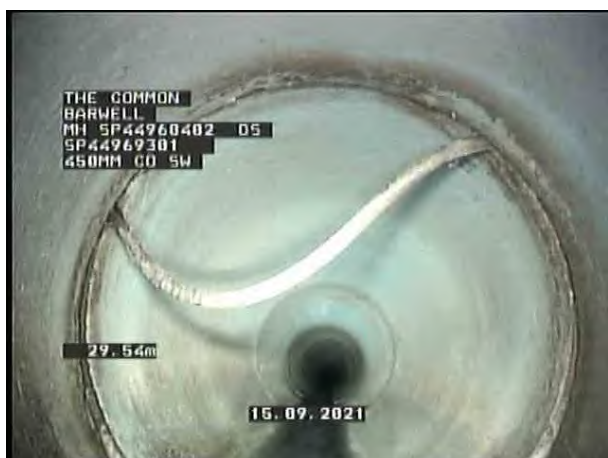
SP44968402X\_213e87f8-b81c-473a-867b-c9baa1e2c6bd\_20210915\_114137\_685.jpg, 00:03:28, 29.50m  
Other obstacles in invert from 10 o'clock to 2 o'clock, 5% cross-sectional area loss, joint seal

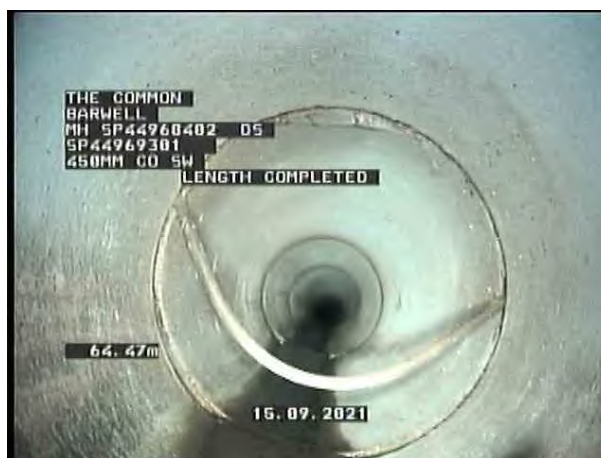
SP44968402X\_b2db40e0-8525-4b68-9019-65fe188b795c\_20210915\_114625\_508.jpg, 00:07:17, 64.40m  
Survey abandoned, Length completed

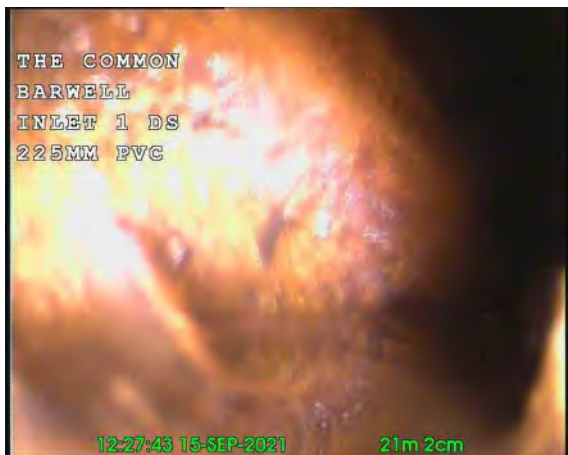
\_84de2ae9-5e38-46cd-aa6d-ae625238febe\_20210916\_101054.  
jpg, 21.20 m

Survey abandoned, Camera unable to pass
