# East Lodge

*163 The Park, Market Bosworth, Leicestershire, CV13 0LP.*

Historic Building Recording (level 3).

*26th May 2023*

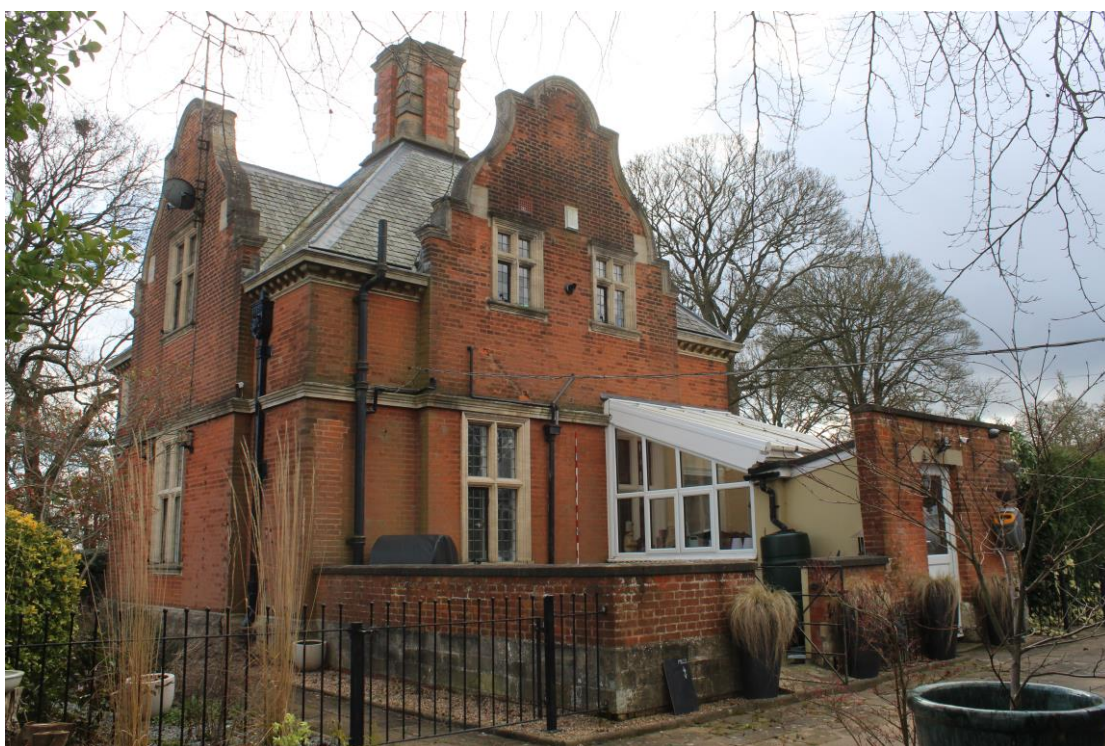
*Plate 3: View from northeast, note the repaired brickwork following the removal of kitchen-yard wall around northeast corner. The rendered wall is the surviving west wall of the coal-shed.*

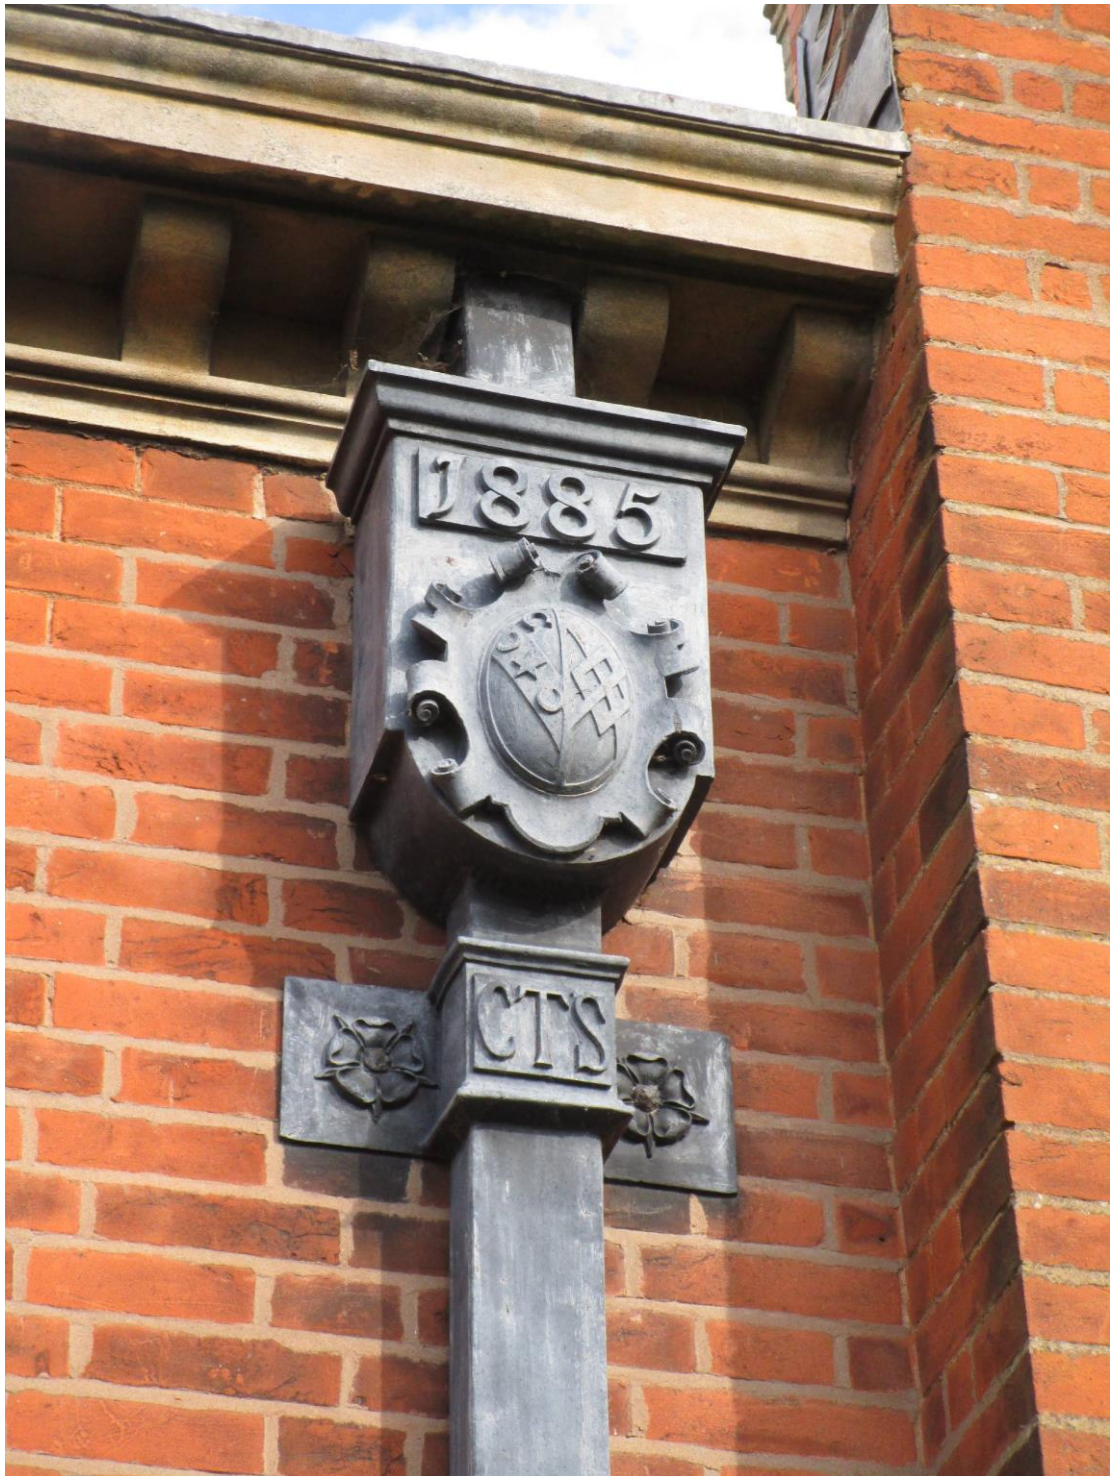
*Plate 6: View of hopper and rainwater pipe detail.*

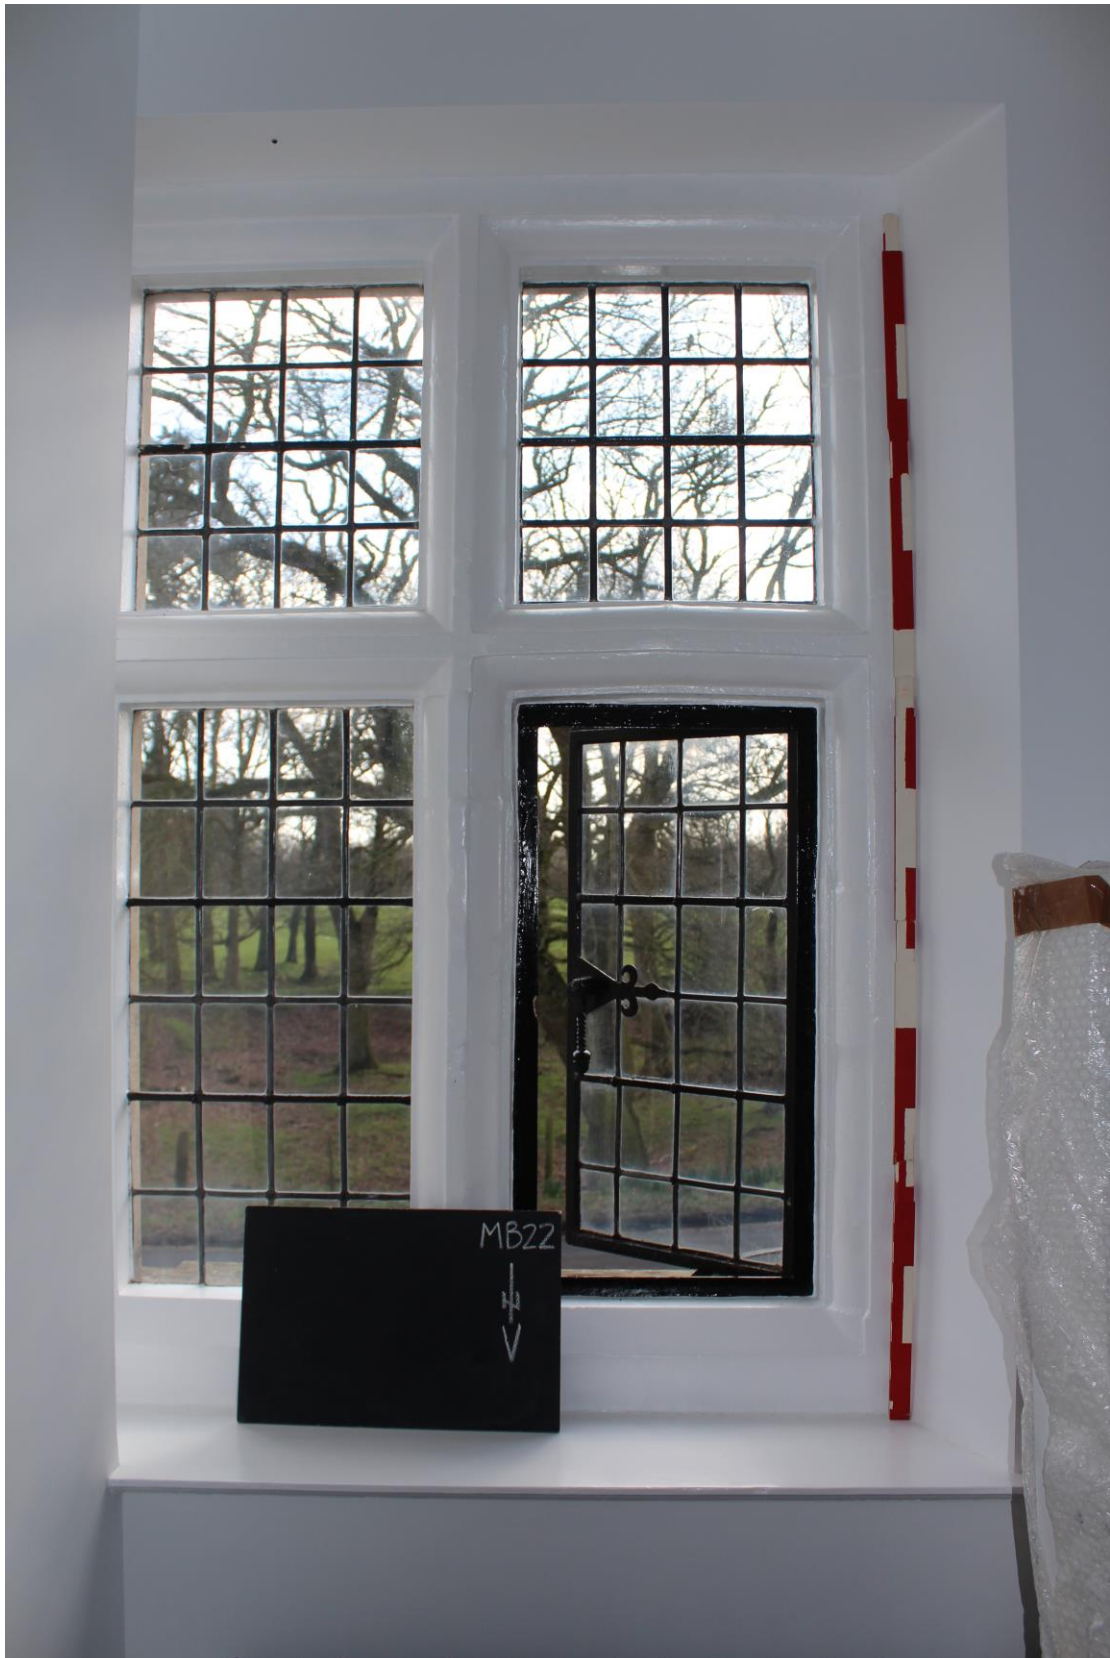
*Plate 8: A 1st floor at the front partially blocked by an internal wall but preserving the symmetry of the front elevation.*

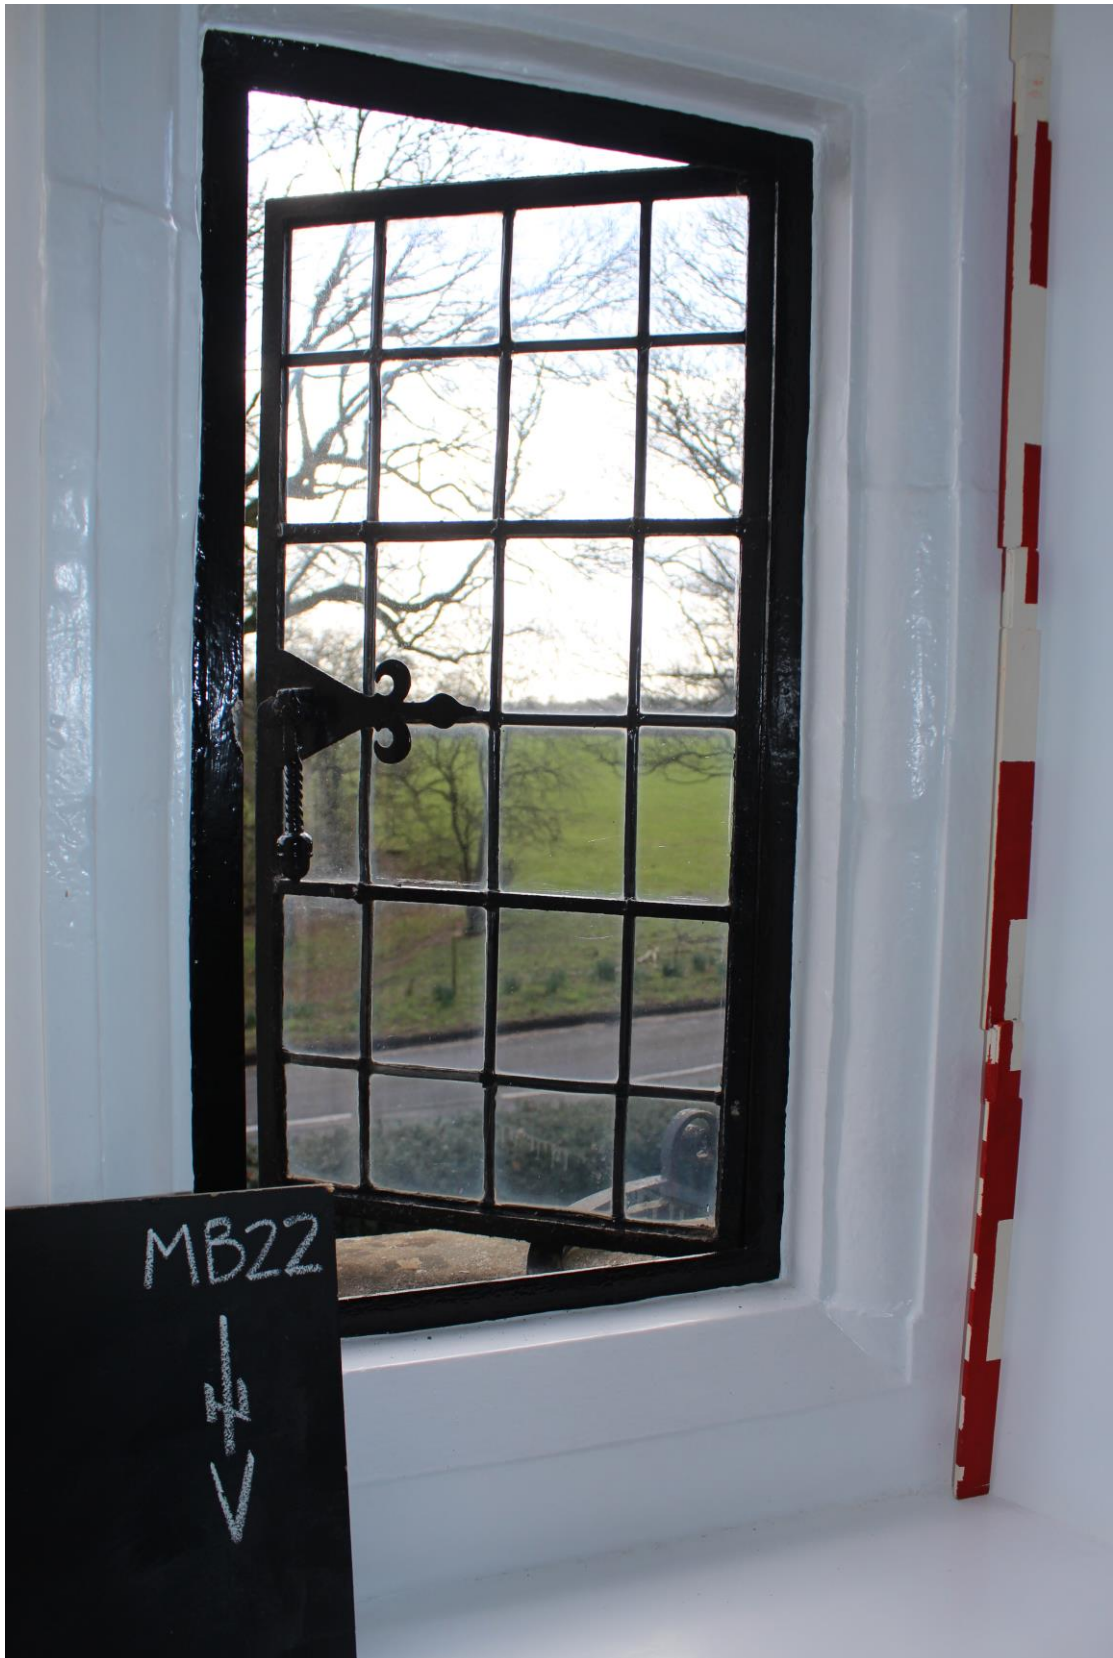
*Plate 9: Detail of window's iron fittings and furnishings.*

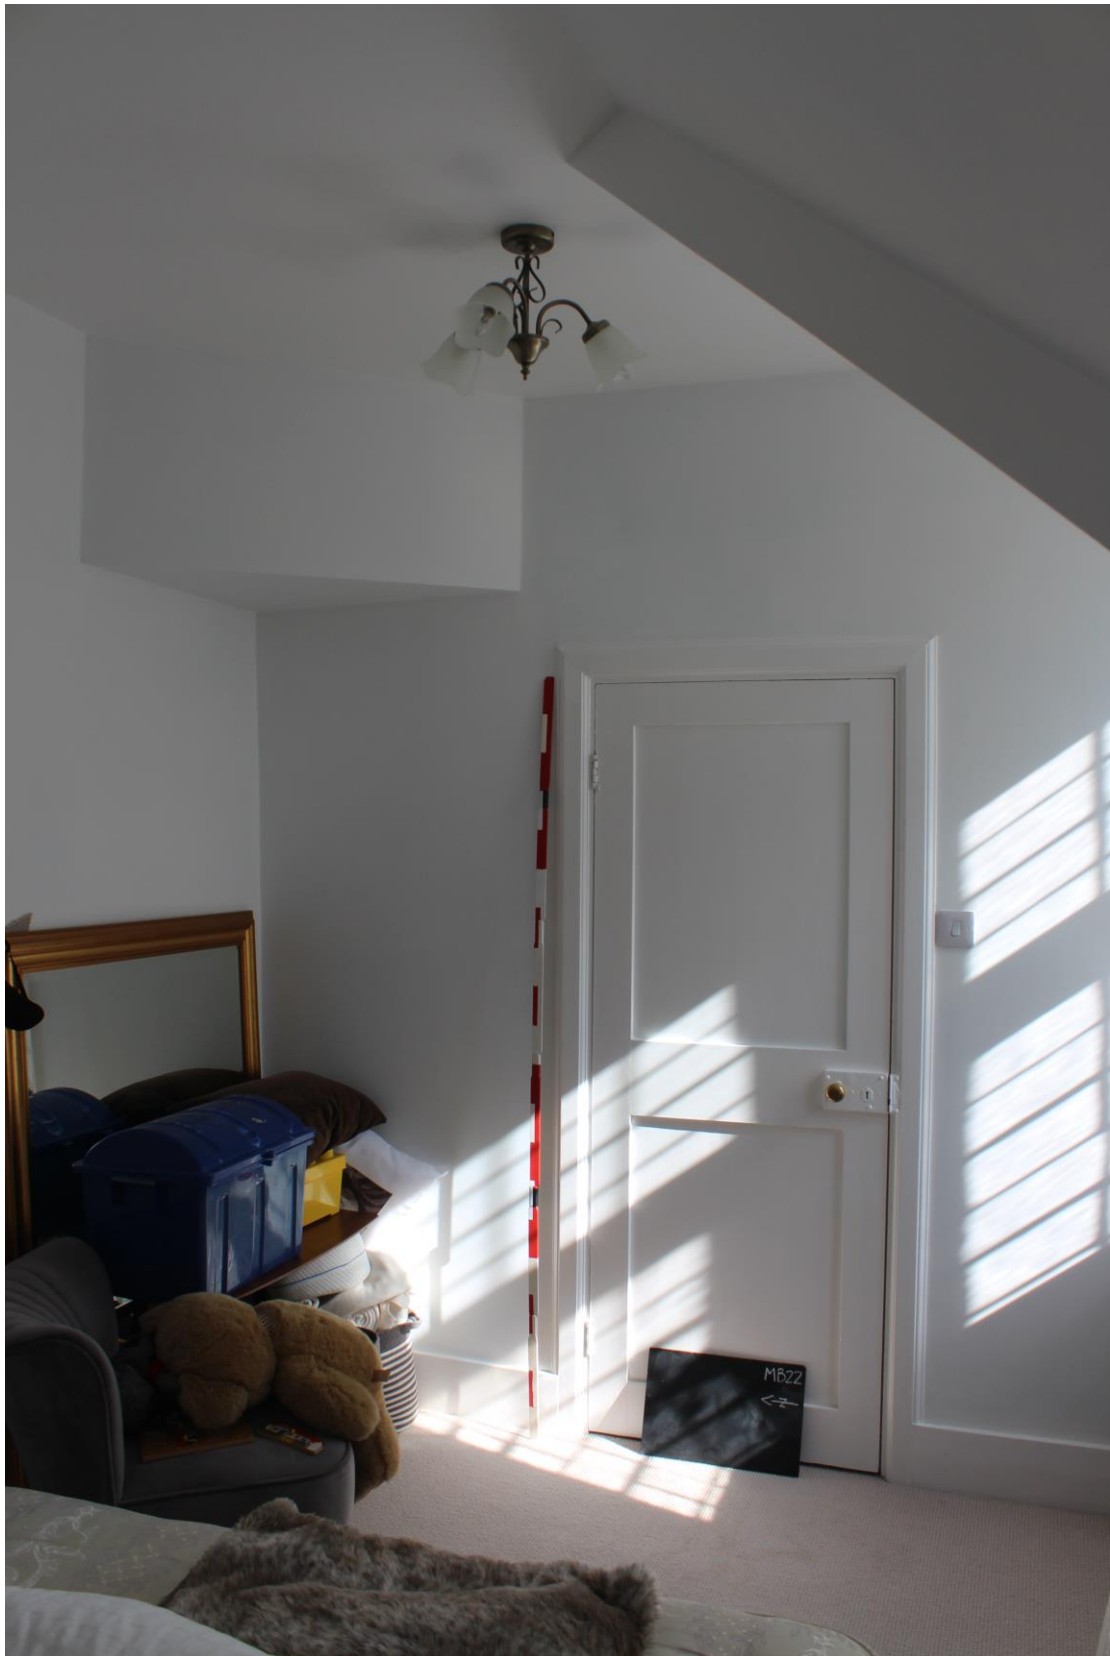
*Plate 10: Possible evidence for a small corner fireplace removed during modernisation.*

Fireplaces are replaced often to reflect changes in domestic comfort and there are no original fireplaces on the ground floor, in the dining-room there is a modern reproduction and in the former parlour the fireplace has been panelled over, replacing another modern reproduction. The site of the kitchen chimney can be seen with part of the flue in the corner boxed in well above head-height. On the first floor there are two small fireplaces; simple stone piers and lintel, ovolo-moulded with sloping flat-stops on the inner and outer arises, terminating in flat stops. One retains its original iron grate and the other, in the bathroom, has been converted for storage. In the front bedroom a triangular boxing-in above head-height suggests the former presence of a small corner fireplace.

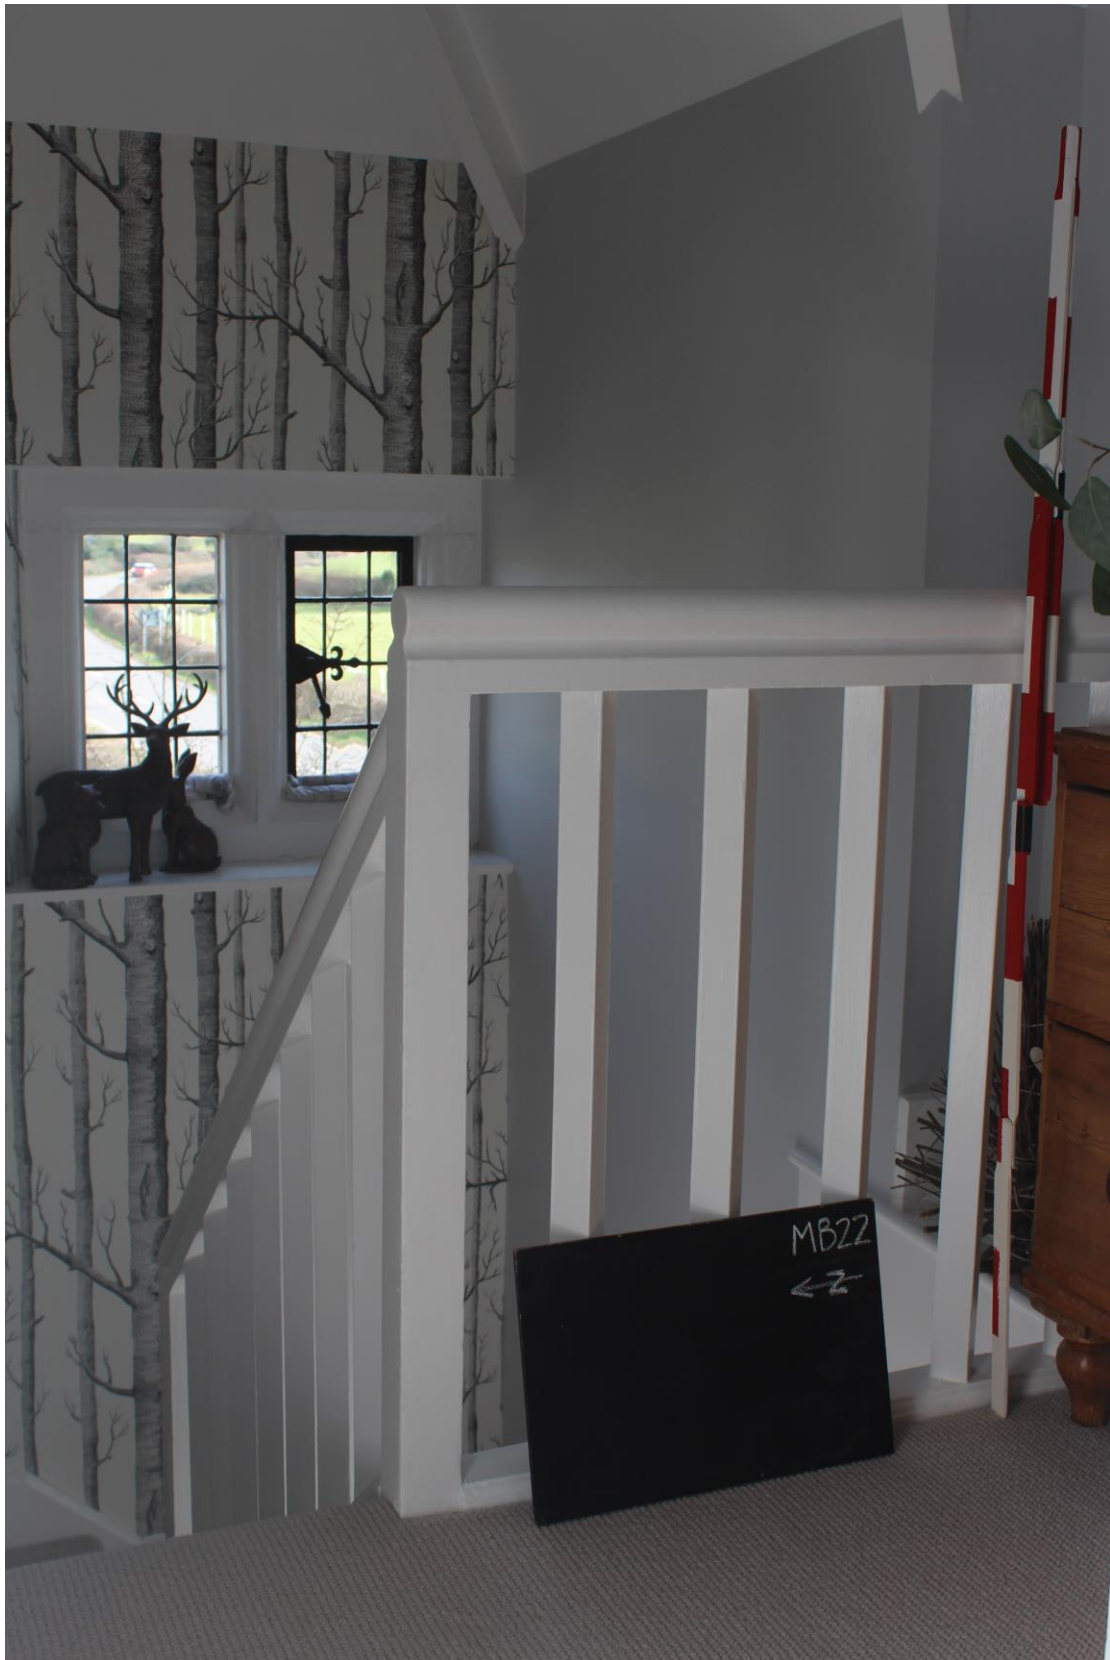
*Plate 11: A view to the southeast at the landing, showing the simple balustrade and the small window which from the outside is the only compromise to the building's symmetry.*

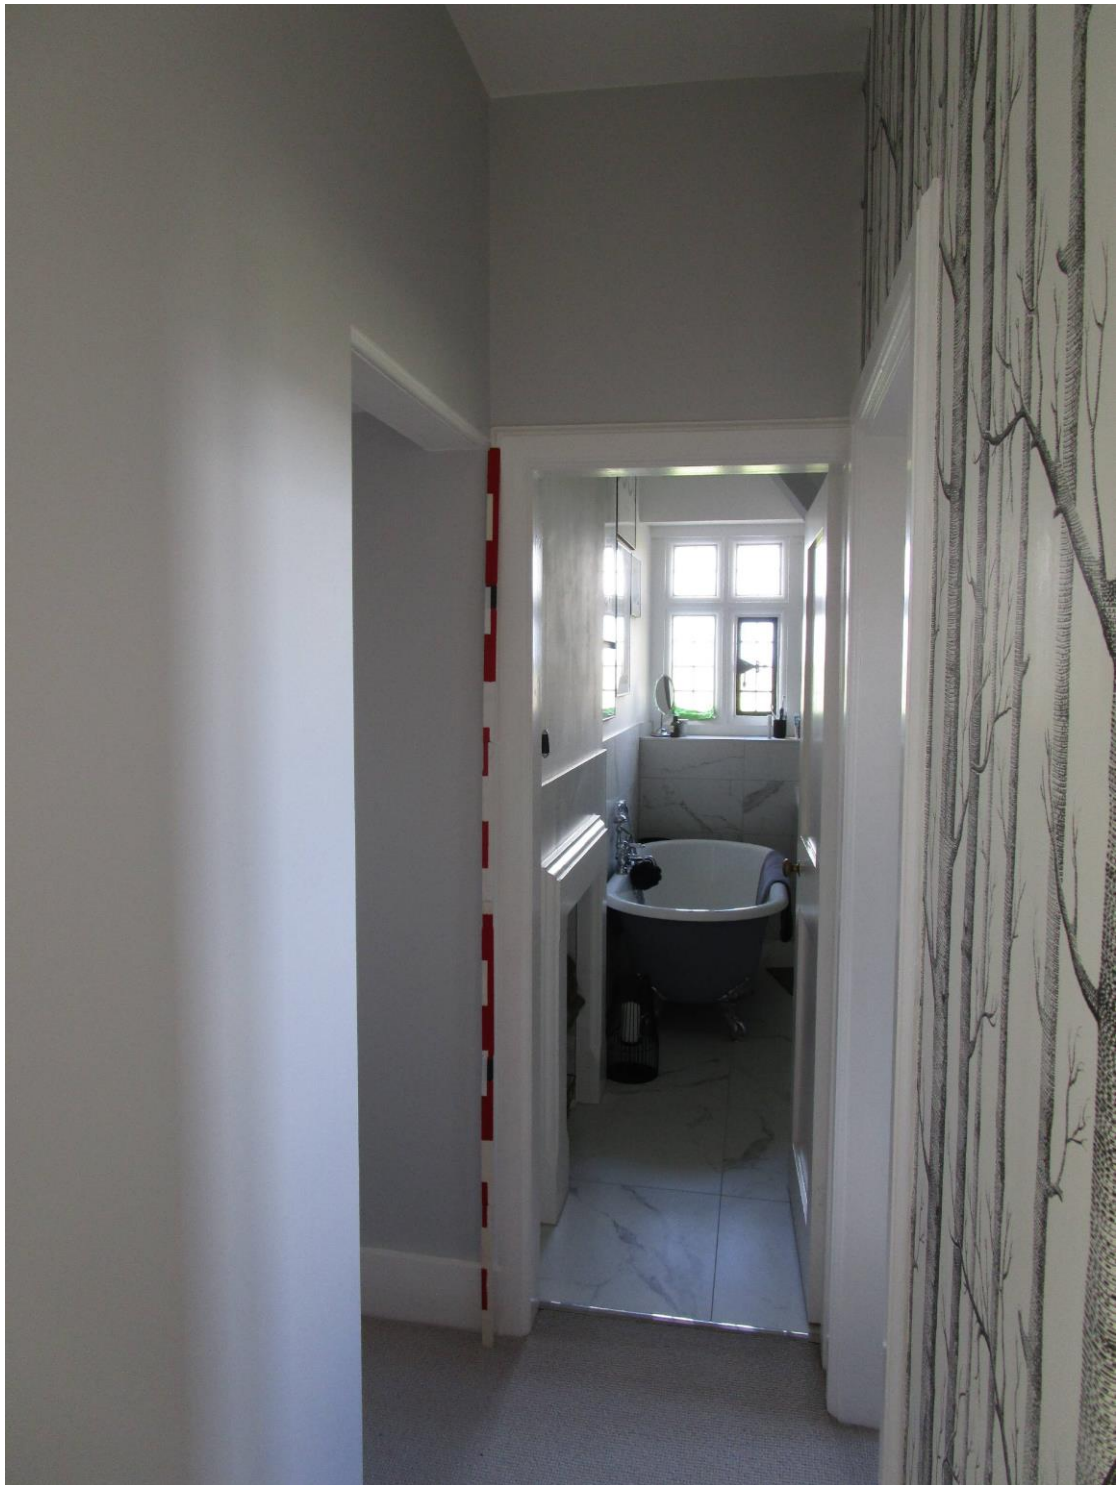
*Plate 12: View along 1st floor corridor to the bathroom and the remains of an original fireplace.*

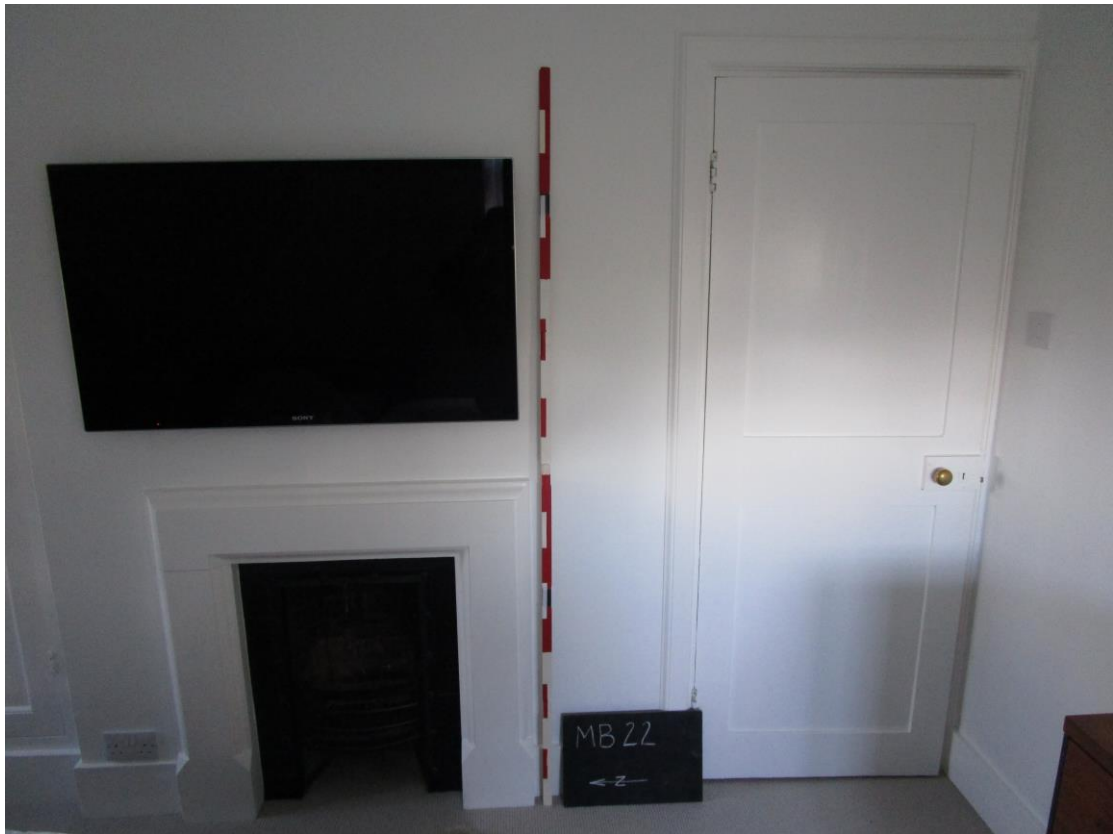
*Plate 13: 1st floor fireplace and door; both original features.*

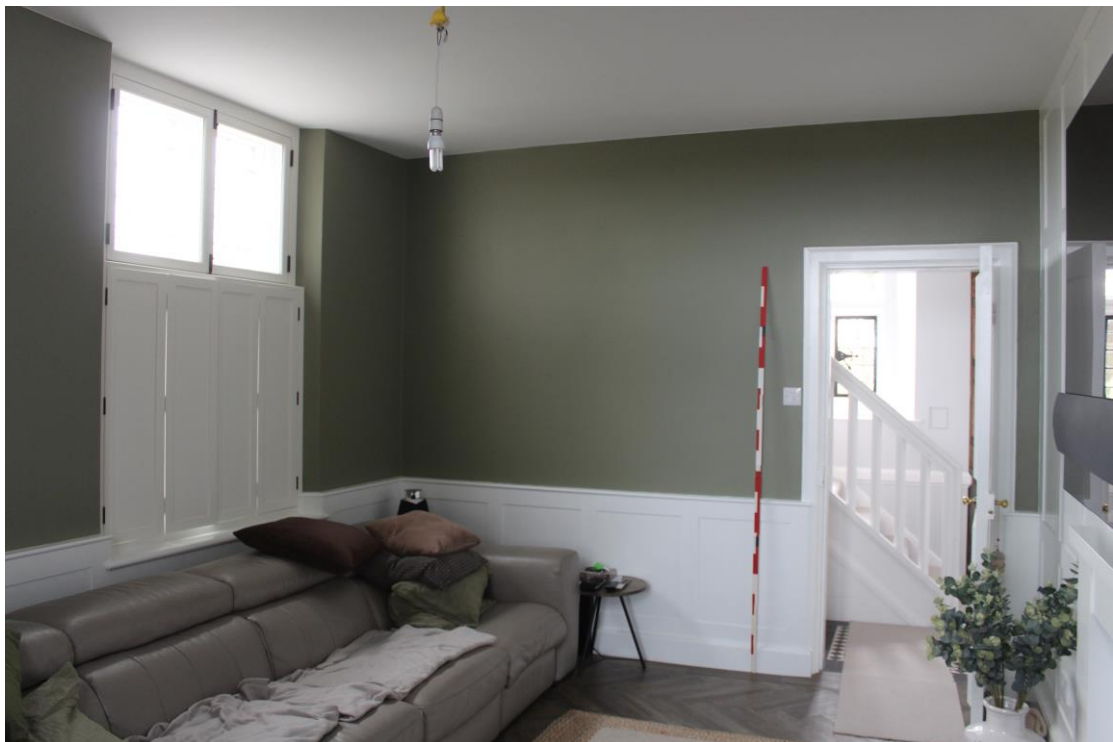
*Plate 14: The former parlour, the dado-panelling and window shutters are modern features, and the fireplace which replaced the original, on the right, has been panelled over.*

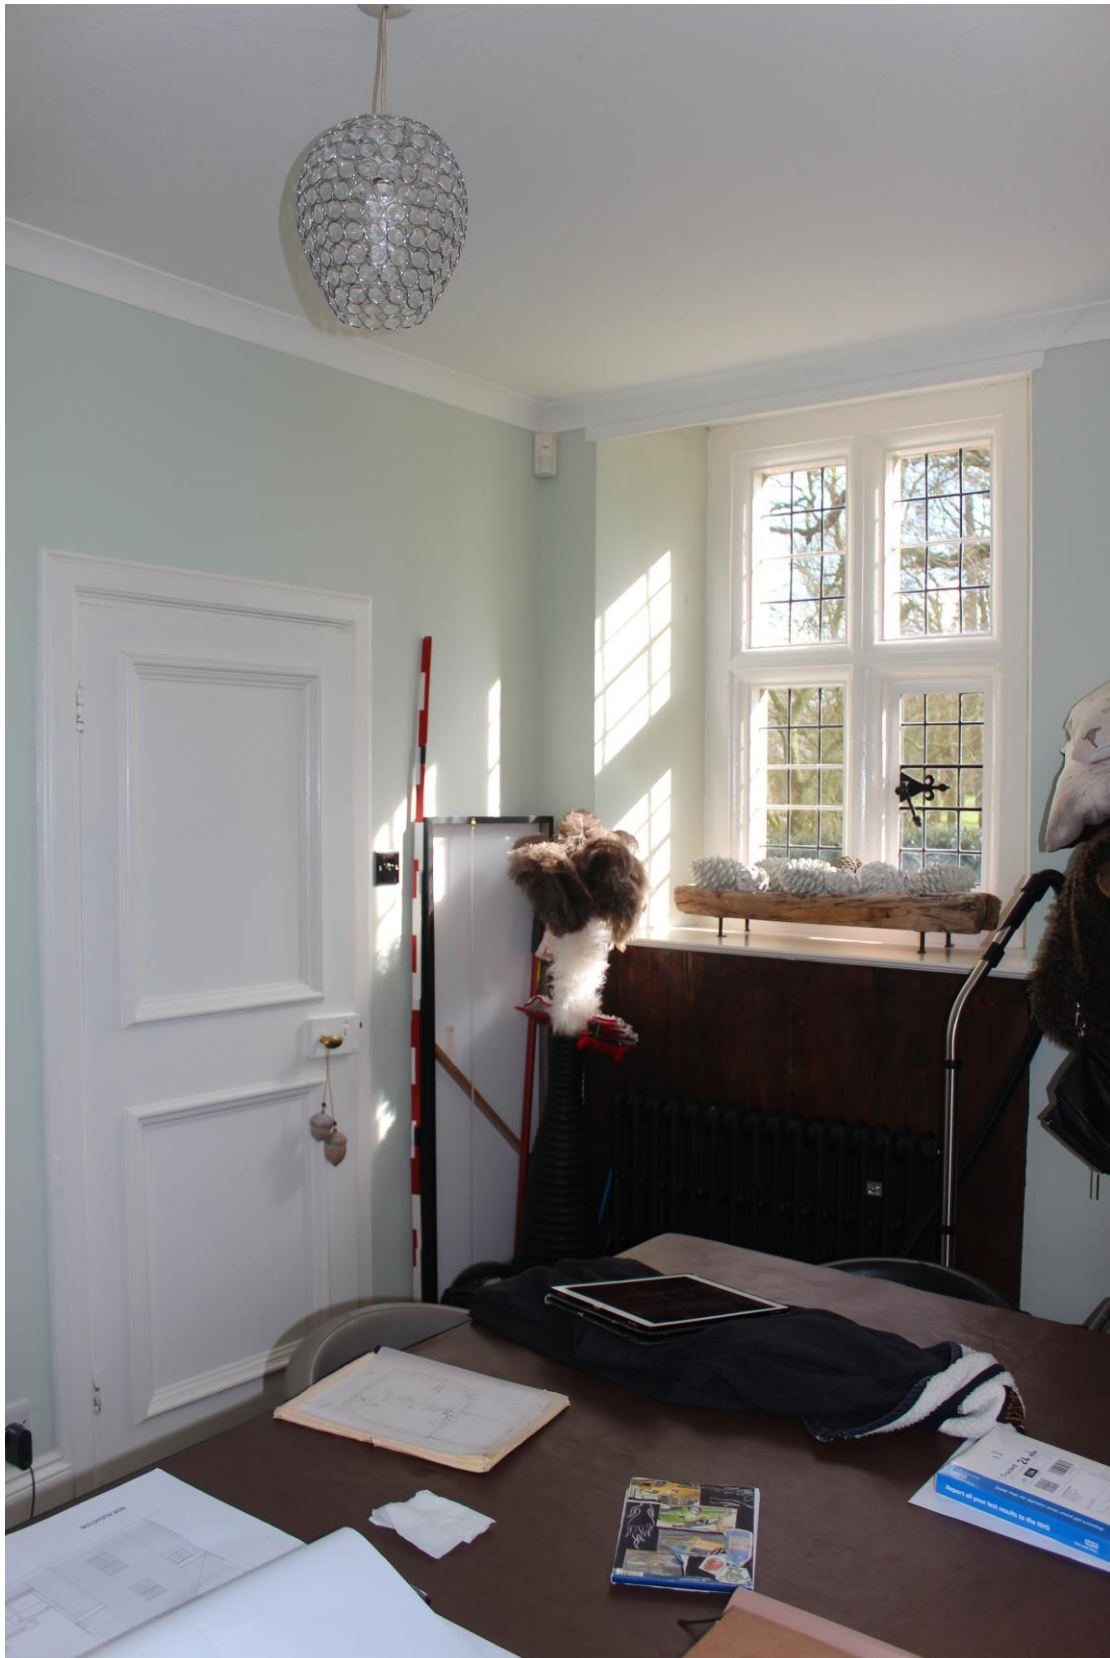
*Plate 15: The dining room, showing a heavily moulded two-panel door, contrasting with the utilitarian doors on the 1st floor.*

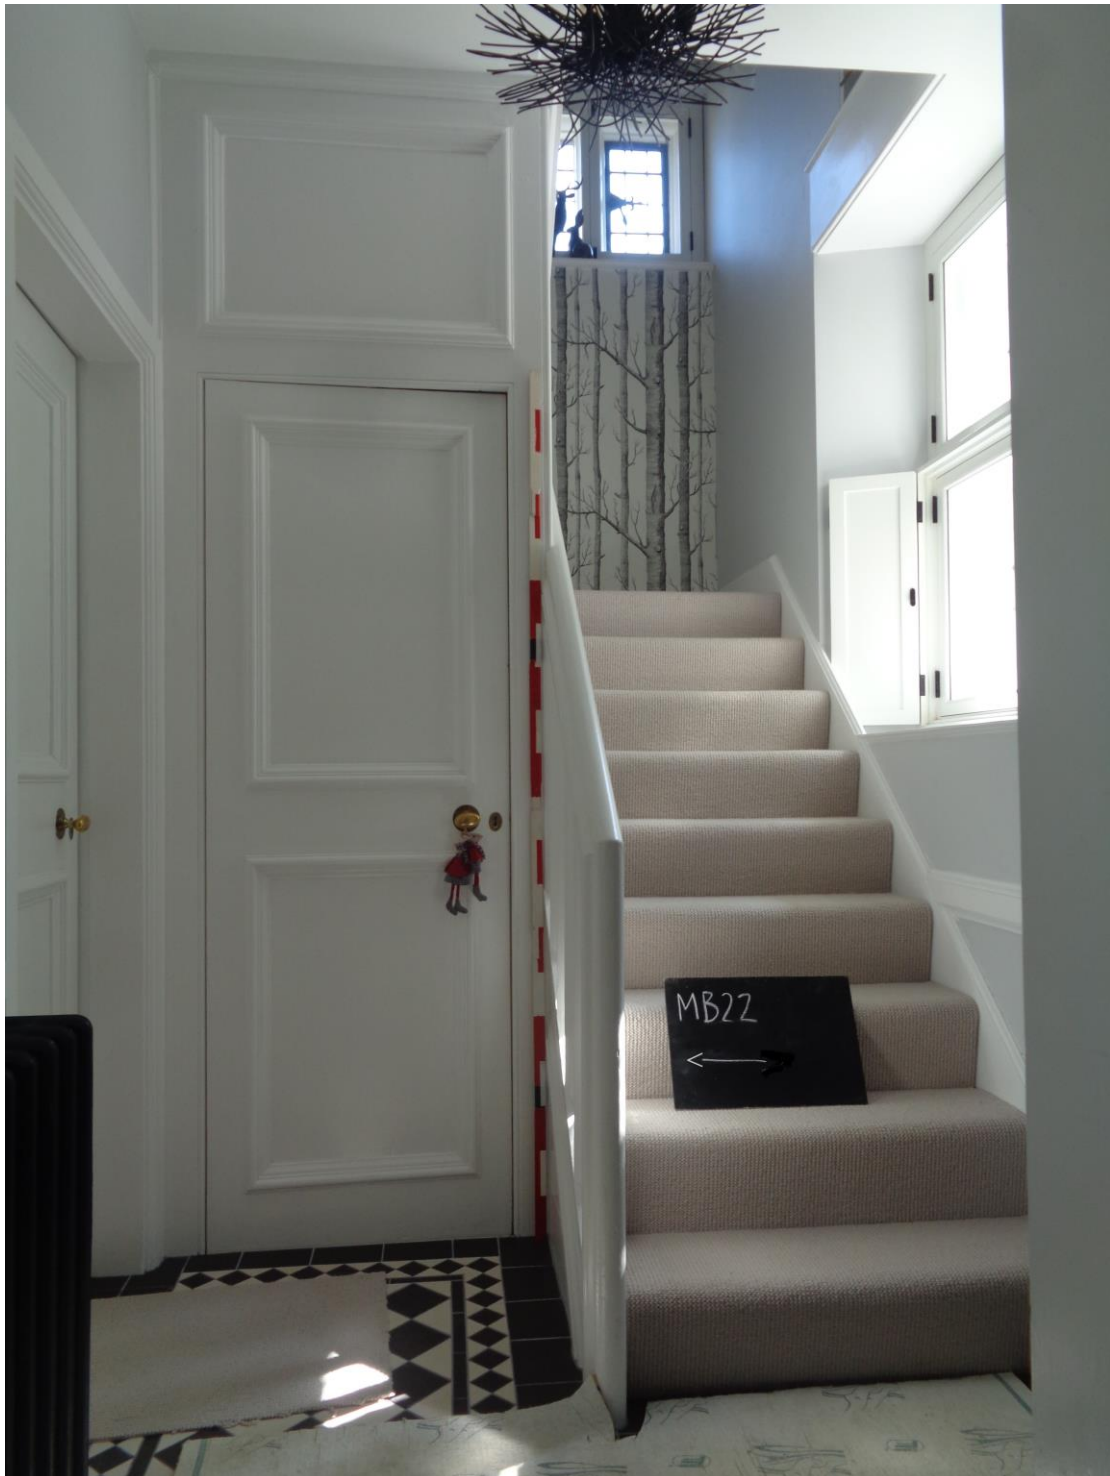
*Plate 16: The entrance hall showing original doors and fittings, and stair-rail, the tiled floor however is modern as are the C19 style radiators throughout.*

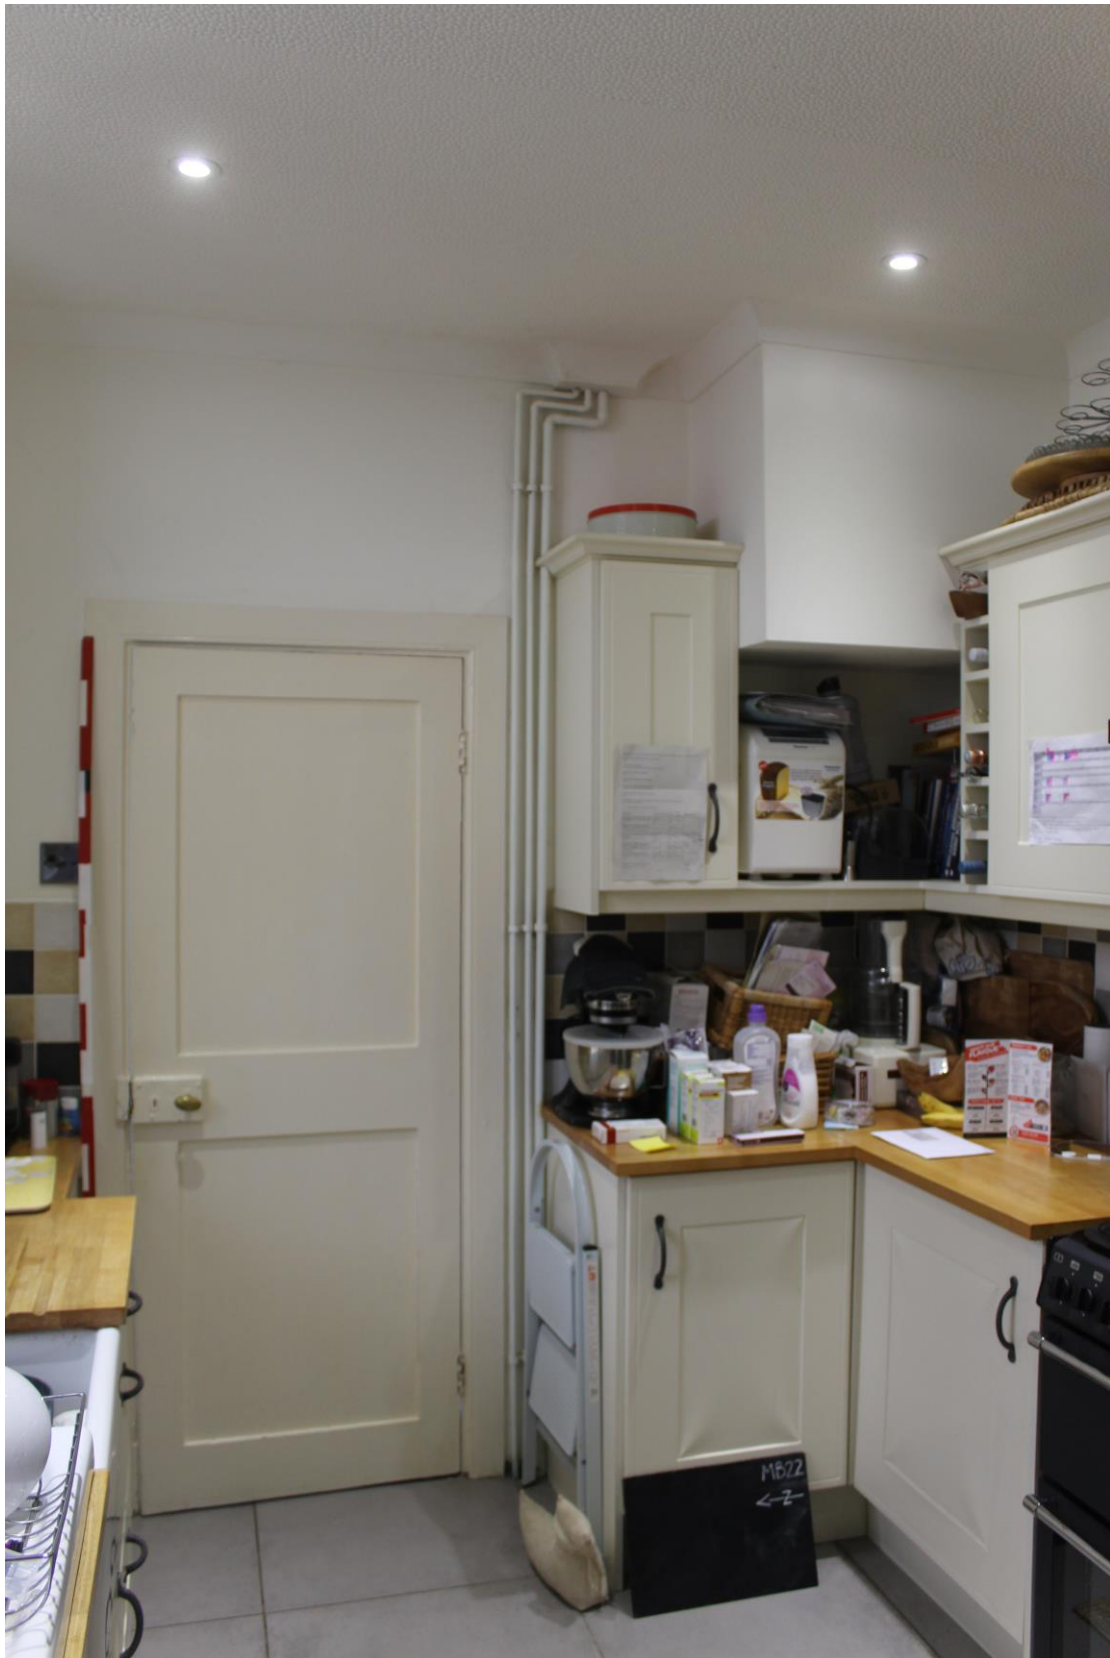
*Plate 17: The kitchen showing an original utilitarian door and what appears to be the remains of a chimney flue over the site of a probable range.*

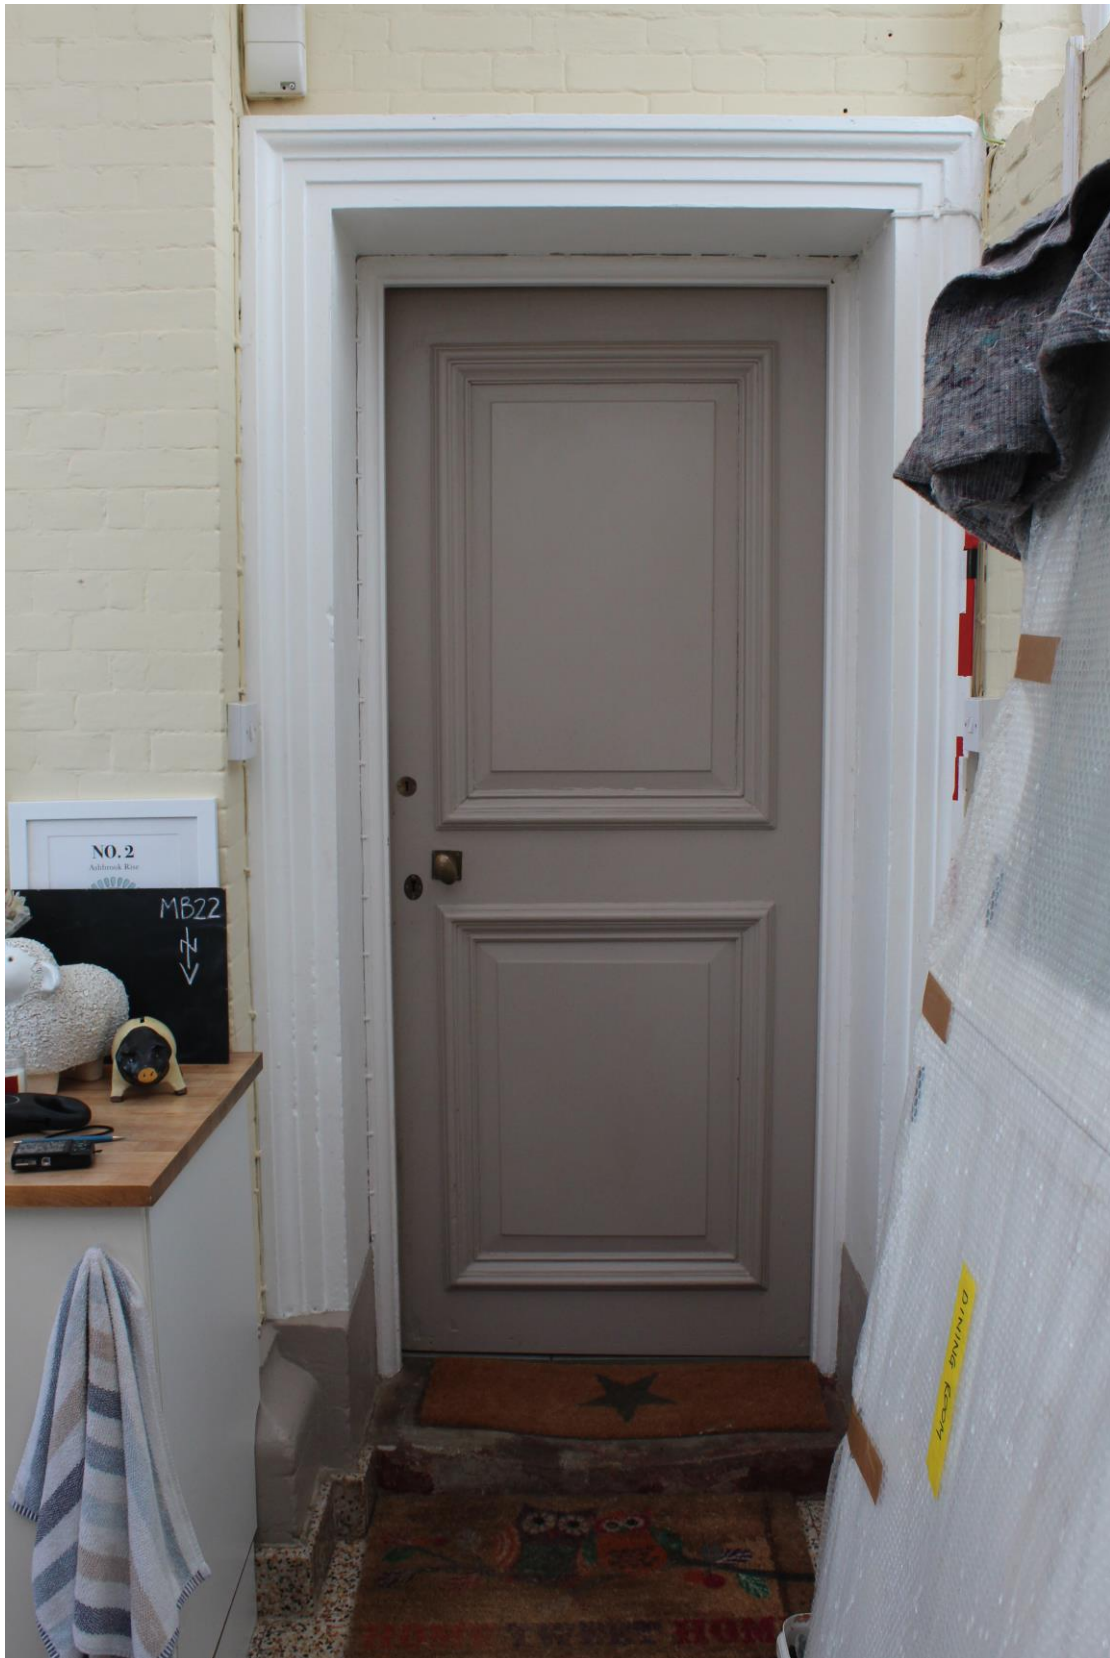
*Plate 18: The former backdoor, note the worn step. The part of the original kitchen-yard here was roofed over and incorporated the old WC in modern times to provide a laundry and utility room. The doorway from the yard to the garden beyond was retained in the scheme as the existing backdoor.*

When the utility room was added, the old WC was incorporated into the scheme and refitted completely, and the old back-gate was replaced by a new door, the lower parts and footings here were uncovered during excavation. The coalhouse/woodshed was demolished but the enclosing wall was just reduced, opening this prospect of the house, with a new entry being cut through the north wall for access. Both outhouses were under pent roofs, and concealed from view, presumably so as not to mar the splendour of the lodge with service buildings. There is no evidence for the site of the pump that was located on the east side of the yard, however, the brick well that served the pump via a lead-pipe was uncovered during excavation of the area to the west of the kitchen -yard.

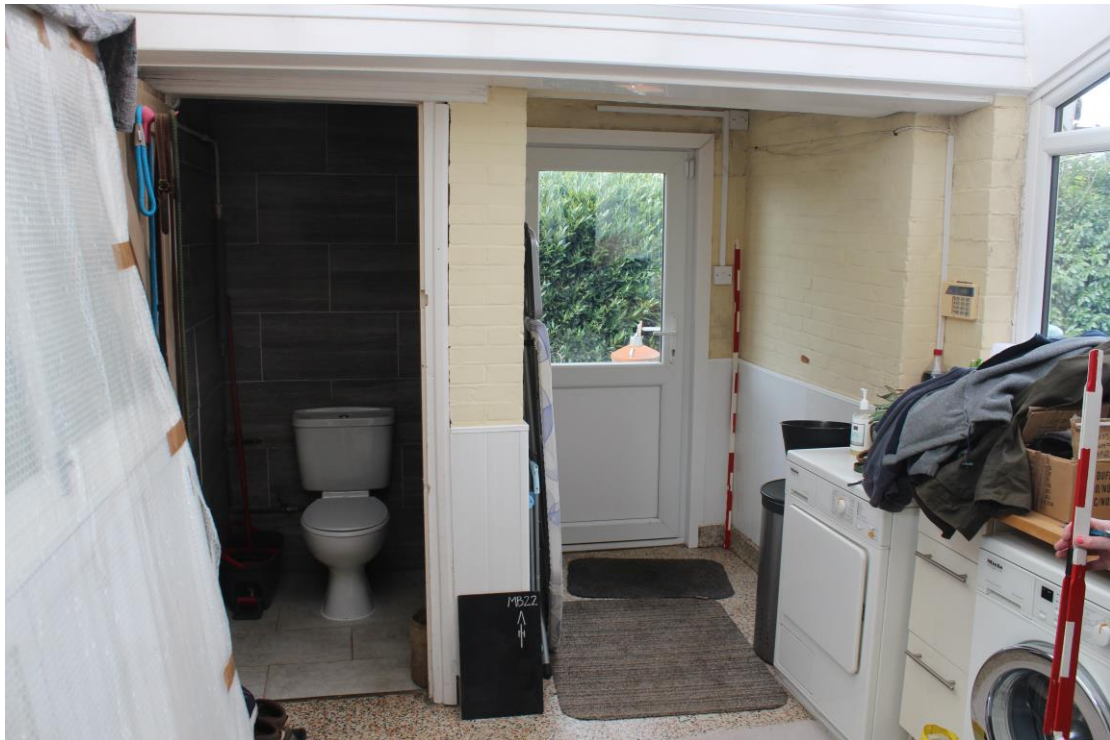
*Plate 19: The utility room showing the modernised WC, the wall to the right of the backdoor is the west wall of the lost woodshed/coalhouse.*

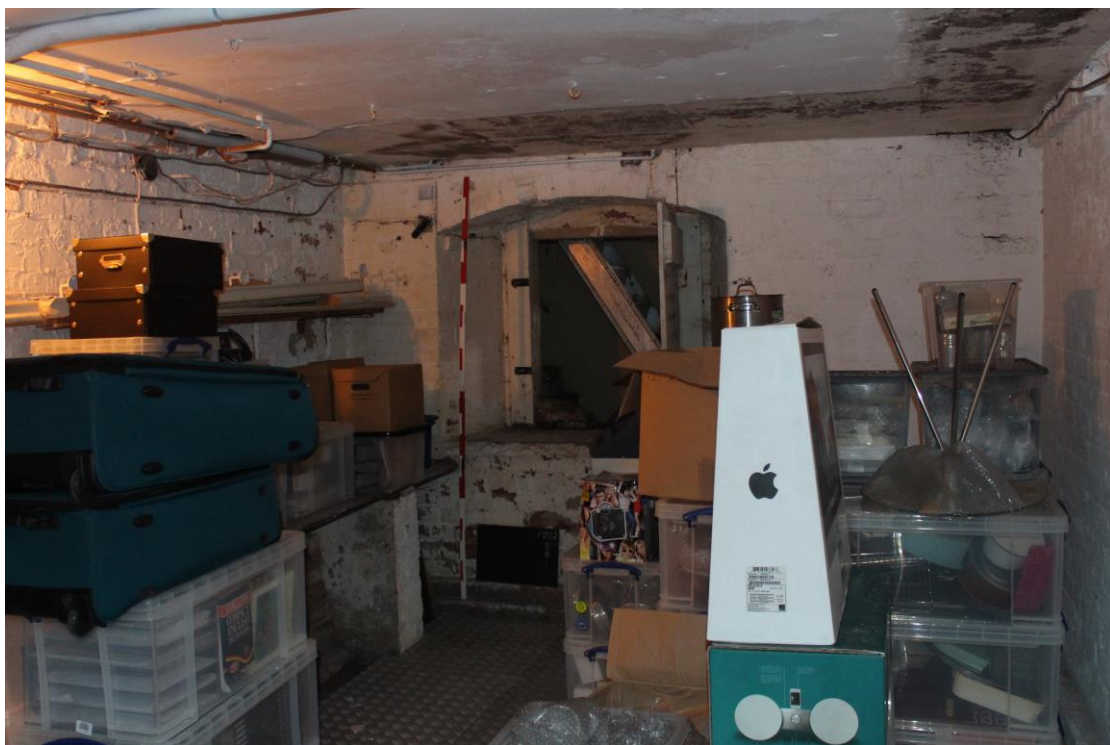
*Plate 20: The cellar, showing the slate cold-shelf and the masonry of the casement window. The mullion was removed, a simple doorway added, and a short ladder inserted into the lightwell to provide external access.*

The cellar is accessed from the front hallway through a heavily moulded door like the others here, to the parlour and to the dining-room, and there is a matching moulded panel above it. The stone casement-window at the far end, looking out to a light-well, has had its mullion removed to provide external access and a rude boarded door has been inserted. The central slab of slate-shelf, supported on brick walls, has been removed to provide access to the modern boiler set into an original recess. Both heads of recess and window rere-arch have segmental-heads.
