# East Lodge

*163 The Park, Market Bosworth, Leicestershire, CV13 0LP.*

Historic Building Recording (level 3).

*26th May 2023*

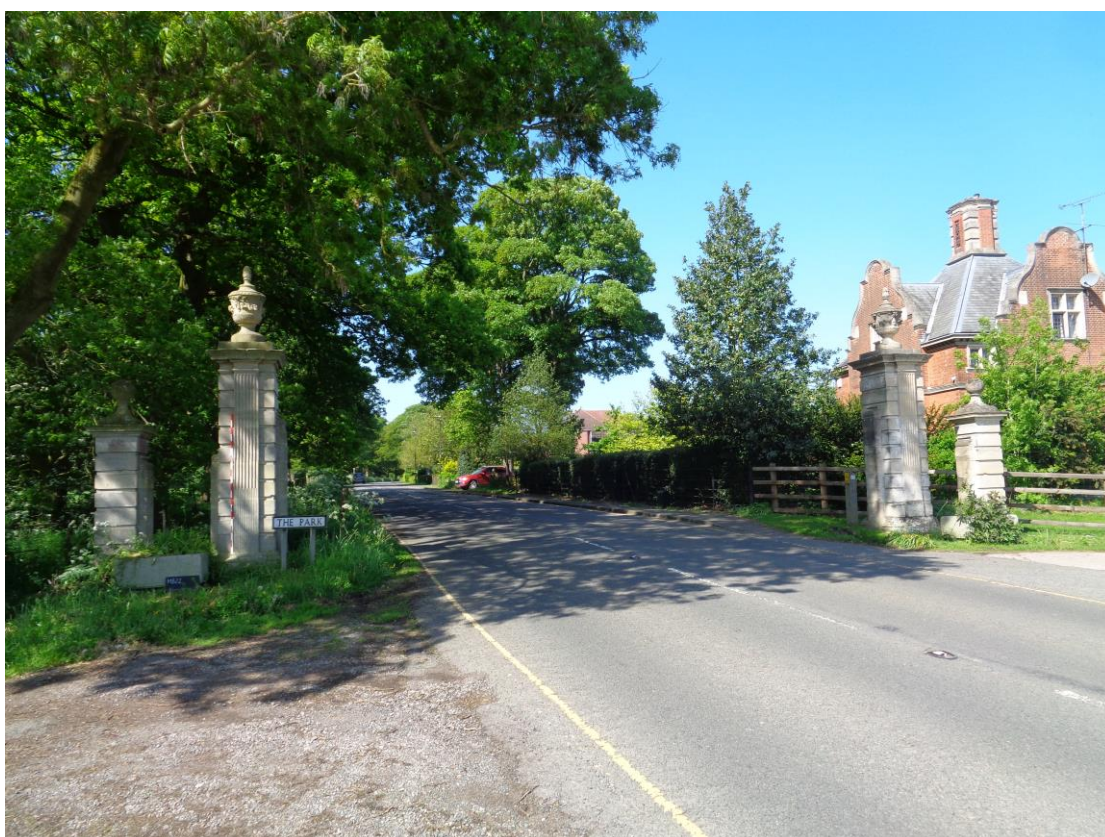
*Plate 22: view from east showing present location of gate-piers. Compare this with fig. 11 view.*

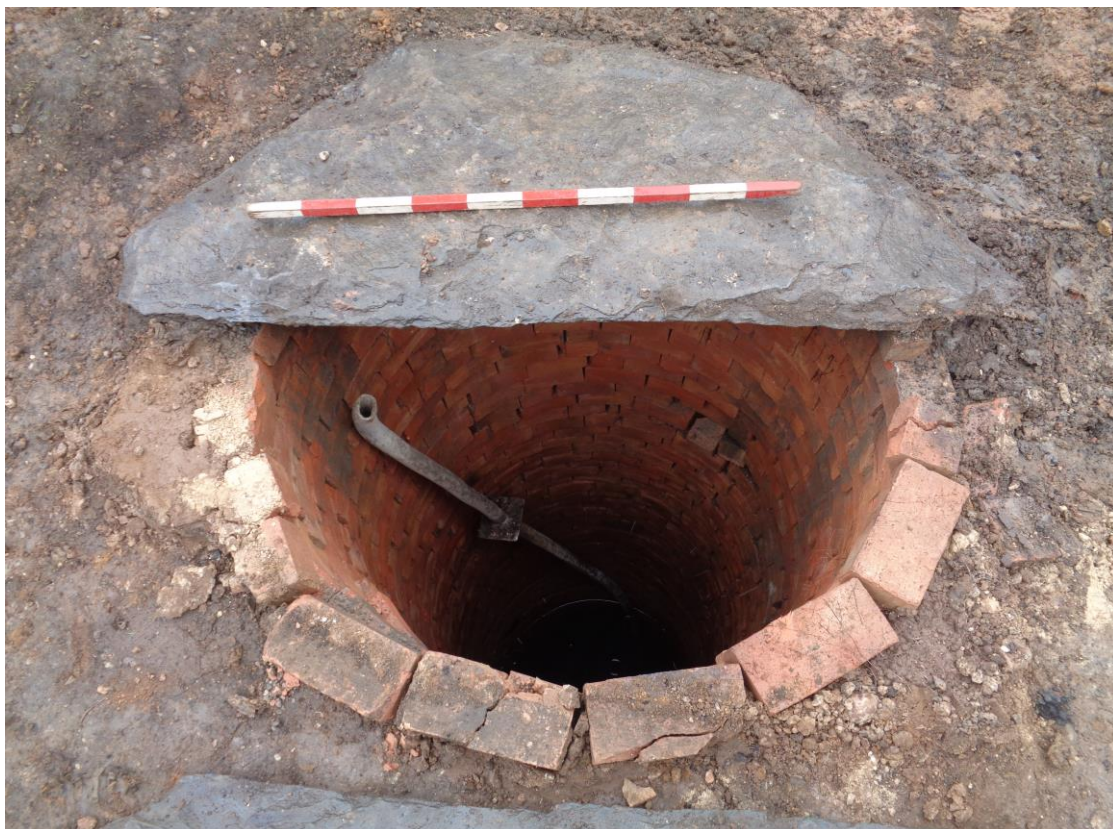
*Plate 24: detail of brick well and lead pipe*

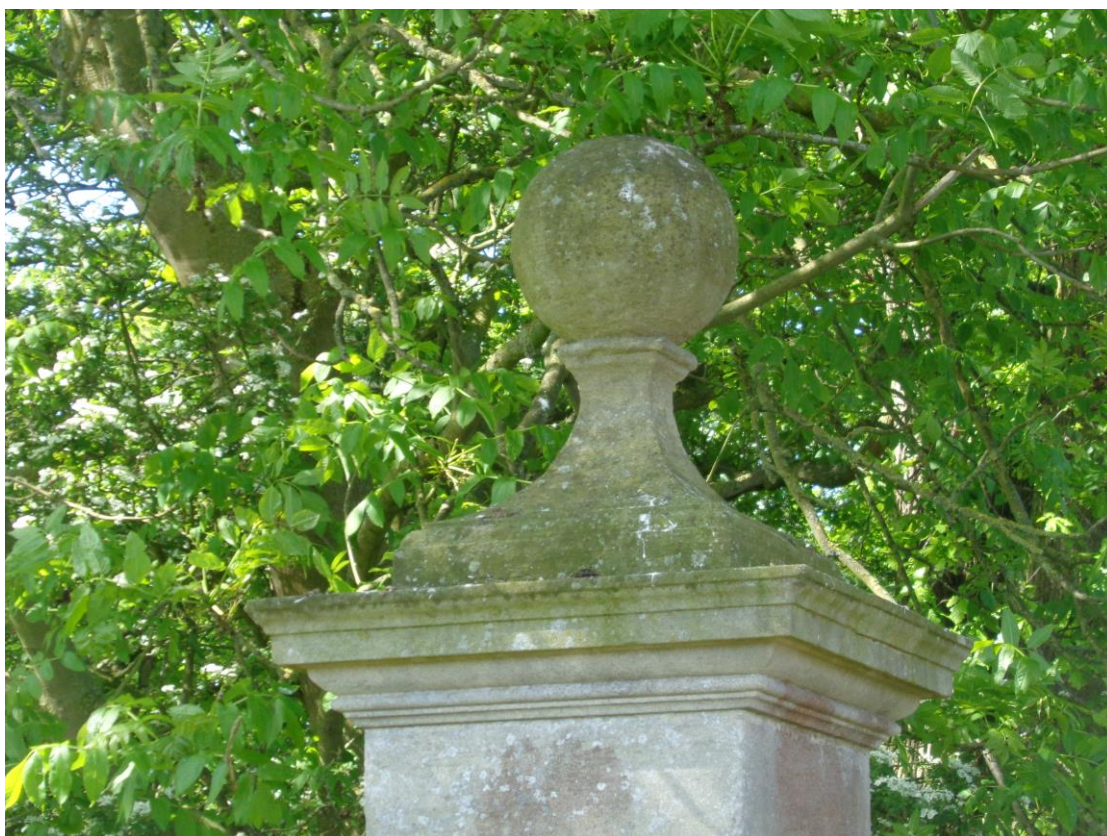
*Plate 29: Detail of the ball-finial on the southernmost gate-pier, from northeast, see also Plate 22 for location of south gate-piers.*
