STOKE LANE, STOKE GOLDING

PHASE II SITE APPRAISAL  
FOR  
DAVIDSONS DEVELOPMENTS LTD

**Project Ref:**  
P9032/F.1

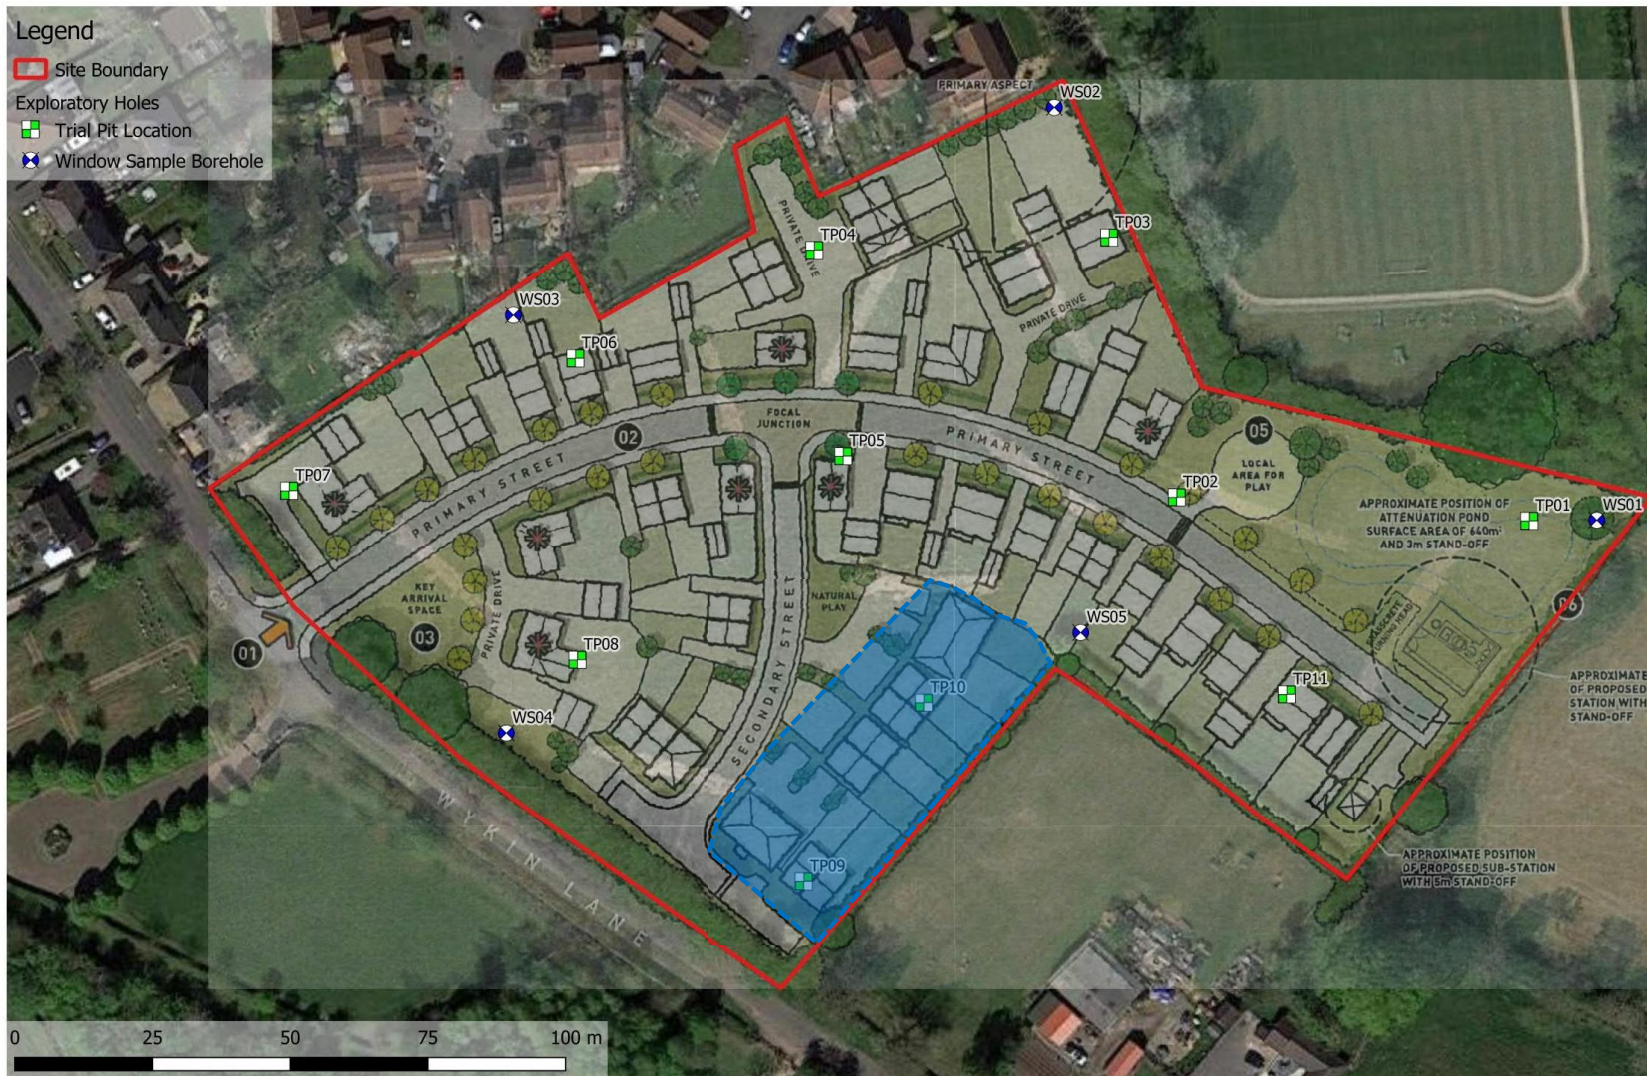
| Foundation Zone Plan | Appendix L |

N.B. Foundations in the south of the site (TP06-TP11) need to be kept shallow due to 'soft silt bands' at depth. If deeper than 1.5m begl, then rafts or piles may be required.

Where proposed levels and stress force foundation depths too close to the deeper soft silt bands, then alternative foundations such as rafts or piles may be required due to reduced bearing capacities and increased settlements. Once the proposed layout and site levels are finalised, further investigation is recommended to confirm competency of the silt deposits and proposed foundation types. Foundations deeper than 1.5m begl in the south of the site are most likely to need alternative foundations.

It is considered likely that trench fill foundations, founded within the natural cohesive or granular strata, will be suitable for the proposed residential development. The founding strata are likely to mainly comprise generally firm to stiff sandy silty clay or a limited area of medium dense gravelly clayey silty sand. In general, foundation depths of around 0.9m begl are expected for the vast majority of the development. Foundation depths of up to 1.8m begl in granular strata may be required in part of the site due to unsuitable deposits from shallow depths. Deepening for trees will be required where some plots are located close to the existing hedgerows / trees. See Appendix L for a foundation zone plan.
