## **Updated Bat Preliminary Roost Assessment and associated nocturnal surveys for Hinckley and District Hospital, Mount Road, Hinckley, Leicestershire, LE10 1AG**

Project: Hinckley and District Hospital, Mount Road, Hinckley

Deliverable: External PRA, Bat nocturnal surveys (x2 dusk emergence, x1 dawn re-entry, x6 surveyors), internal PRA, report

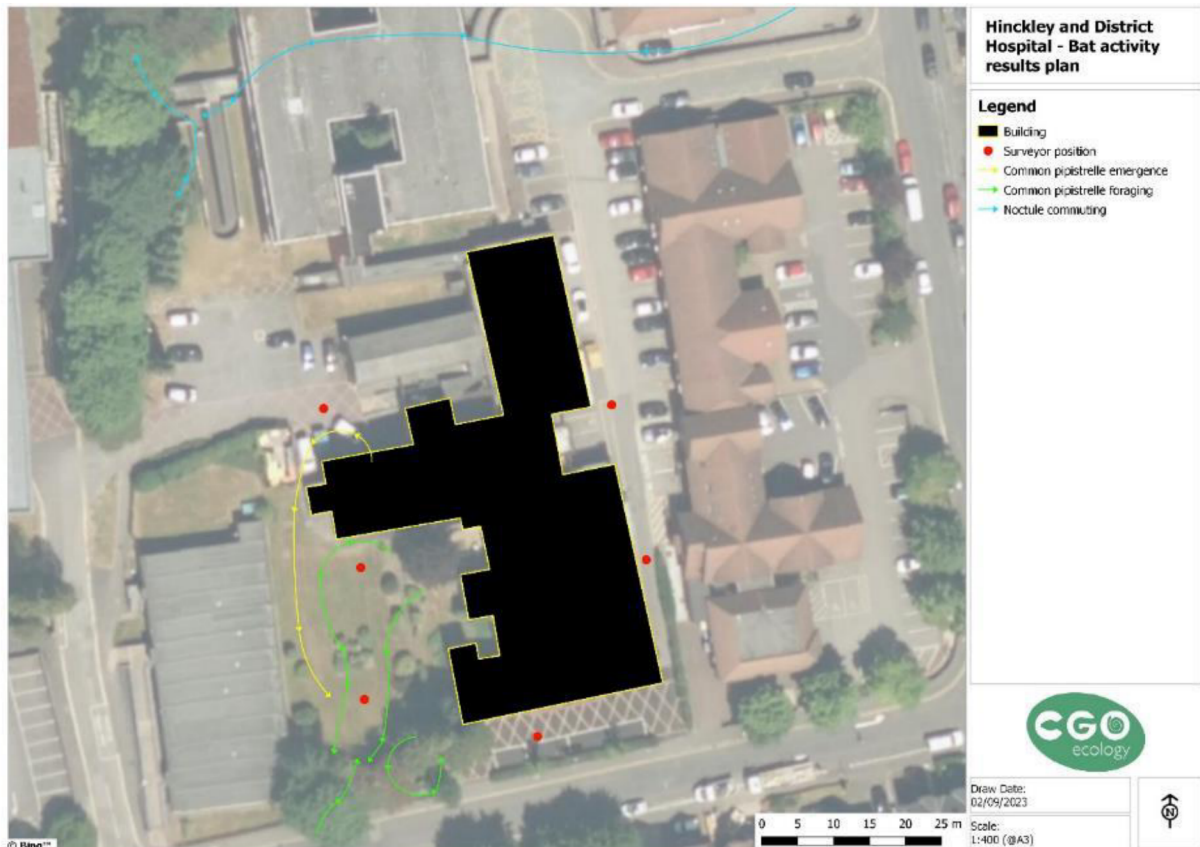
Figure 2 – Summary of survey results, including current buildings, areas of bat activity.

Bat activity was comparable on all surveys, being mostly limited to distant passes of noctule (*Nyctalus noctula*) bats employing nearby tree lines as way markers, and small numbers (one or two) common pipistrelle (*Pipistrellus pipistrellus*) foraging above vegetation beyond the light spill to the west of the building (See Figure 2 below).

A possible emergence of a non-echolocating bat, most likely common pipistrelle, emerged from beneath a tile on the northern aspect of the building at the beginning of the August dusk (see above in Figure 2). A single bat emerged and foraged briefly in the area to the west of the

building before commuting beyond the site. It is likely that this represents an occasional day roost for a single bat.

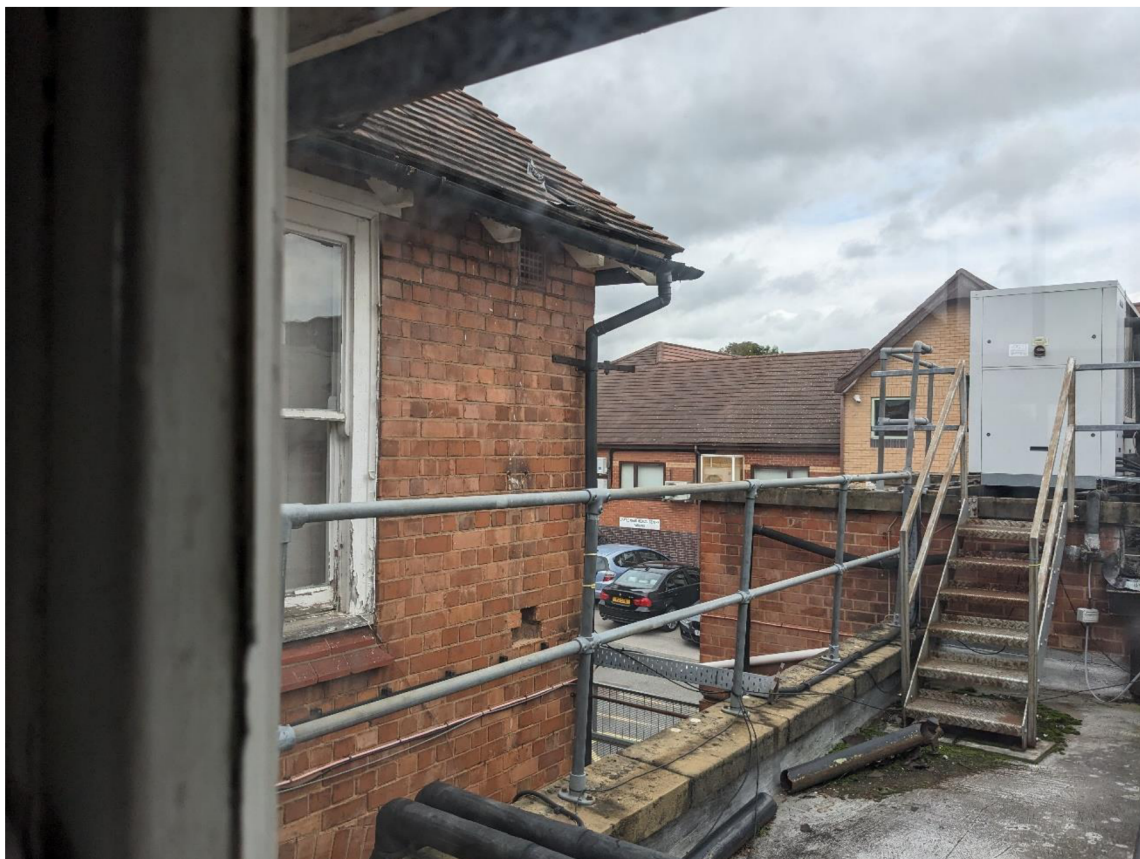
Plate 9 – Notable gaps in brickwork and disused vents.

The building comprises a multi-level red brick (in stretcher bond formation) building roofed with pan tiles capped with bullnose or arrow ridge tiles. Pitched roofs are located on the north, south, and west aspects, and flat roofs on the east. Several external features with potential for roosting bats were recorded during the external PRA. These comprised lifted cladding, gaps in tiles and access and egress points such as disused vents. Little was found to have changed since the previous PRA (Hood, 2019).

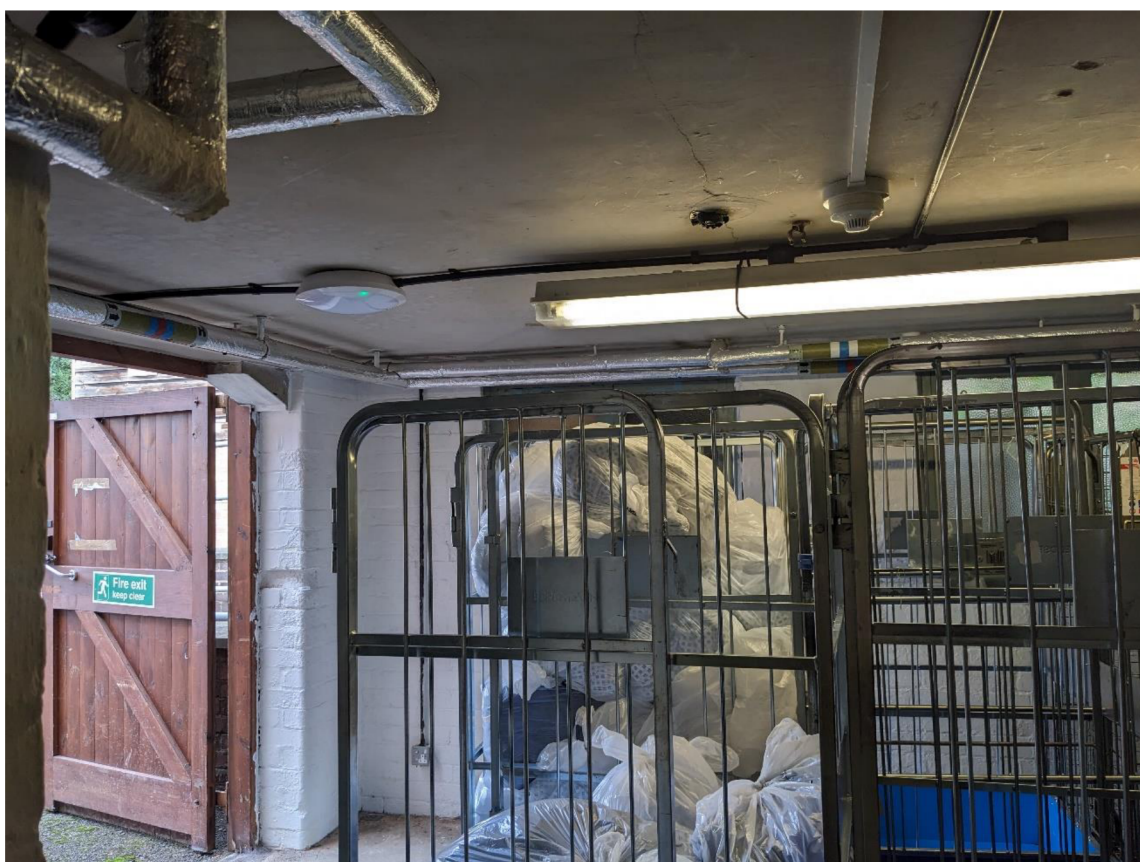
Plate 10 – Entrance to basement area.

The basement area was fully accessible and while conditions were acceptable for bats, only one potential access point was discovered near the main entrance (north).

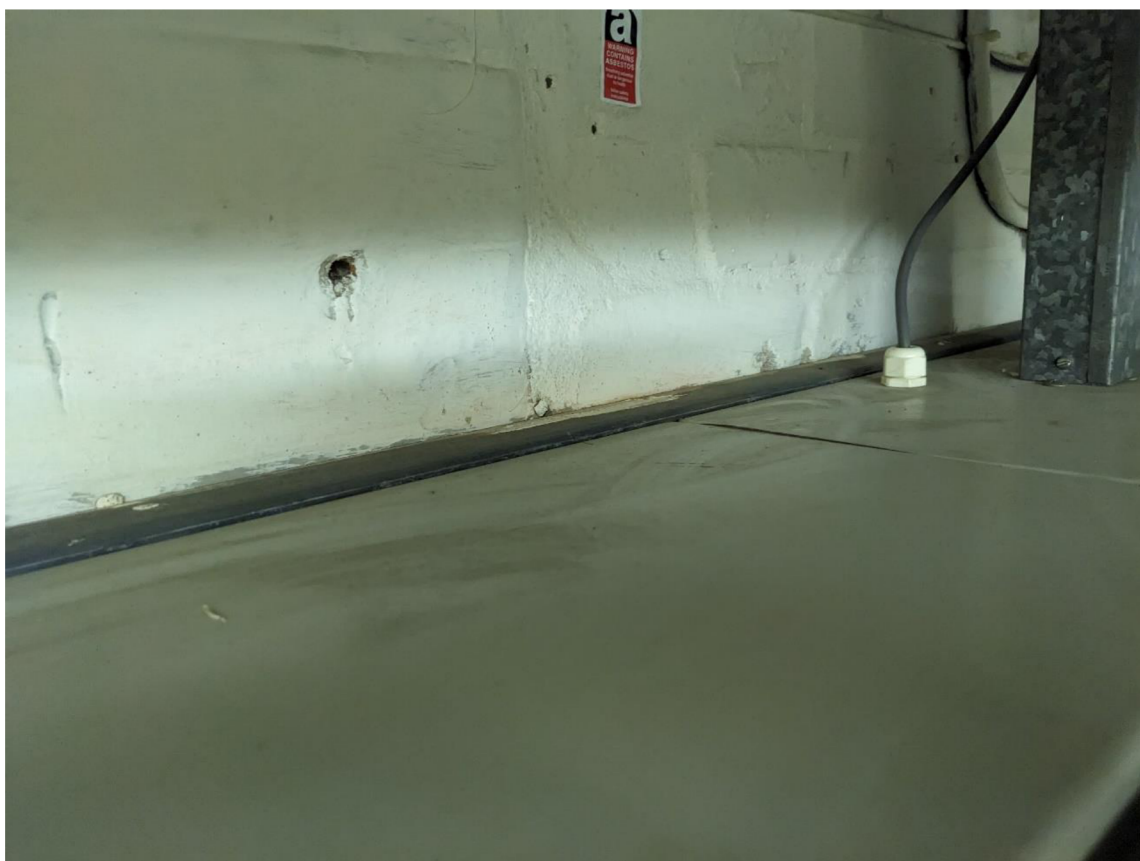
Plate 12 – Example of cabinet tops in basement area with no guano present.

No bats or evidence thereof, such as feeding remains or aggregations of guano, were discovered. The areas were dry and of consistent temperature and considered to have High potential for roosting or resting bats.

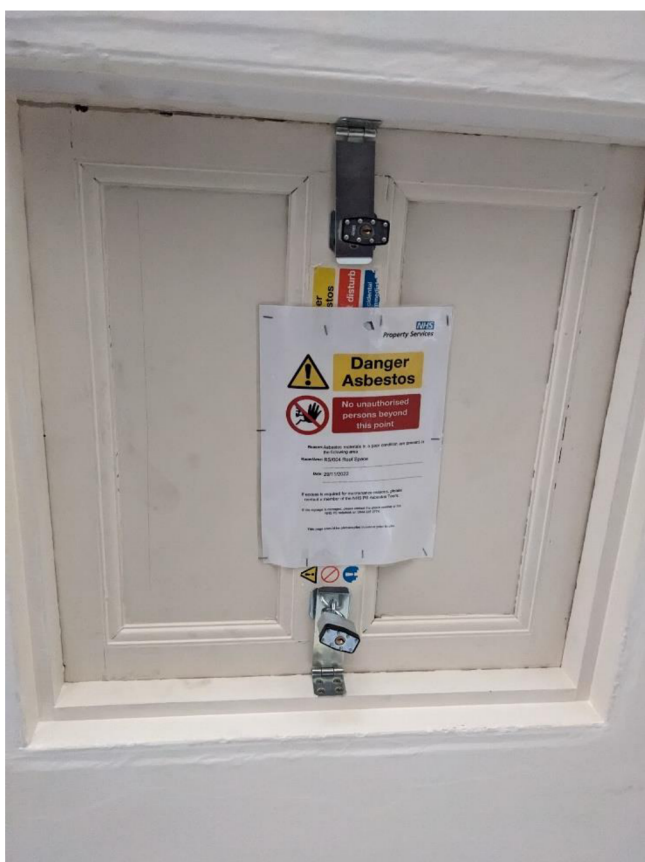
Plate 14 – Loft closed due to asbestos risk.

Only one loft area was accessible due to the presence of Asbestos. Not all areas were fully accessible due to the lack of floorboards. The area is comprised of a main loft with three annexes. Dimensions of these were 20m x 4m x 3m (L, W, H) for the main loft chamber, 5m x 4m x 3m for the northern chamber, 5m x 4m x 3m for the northwestern chamber, and 10m x 4m x 3m for the eastern chamber. All were functionally linked with the loft access located centrally to all. Beams were exposed and internal lighting was limited.
