| Report Title | Site Investigation & Ground Assessment |

# LAND SOUTH OF WATLING STREET, HINCKLEY

## Site Investigation & Ground Assessment

**REPORT REF:** BEK-23005-1 (Rev D)

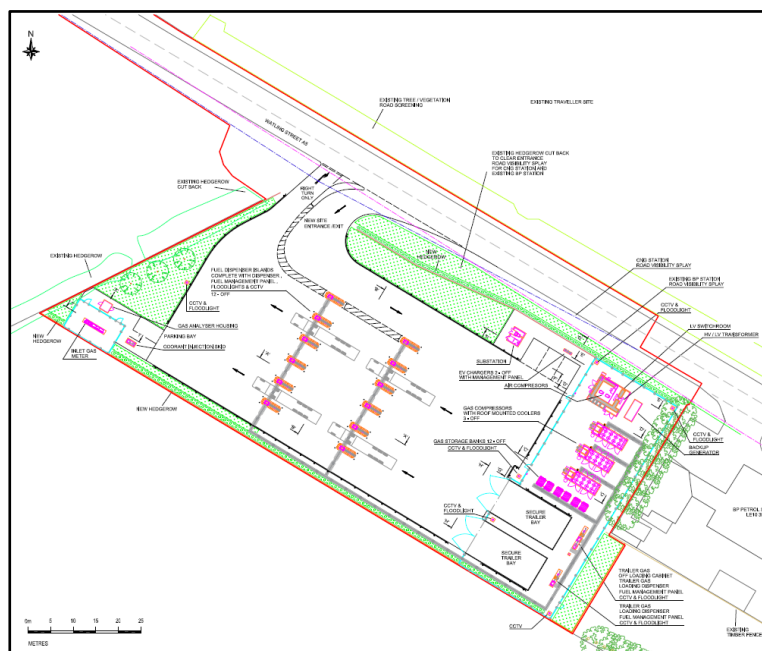
**Figure 1: Site Layout Plan**

1.2.2 A sketch of the proposed site plan is provided on CNG Fuels drawing 'Proposed CNG Station Site Layout Plan', a copy of which is presented in Appendix D. An extract from that drawing is presented in Figure 1:

1.2.1 The report has been prepared to support a planning application for the construction of a biomethane gas vehicle fuelling facility comprising 12 fuelling islands. Infrastructure including gas storage banks, compressors and backup generator are proposed to be located on the eastern boundary. The site will be predominantly hard surfaced, however, landscaping will be added on raised islands between the site and the A5 and on the northern boundary.

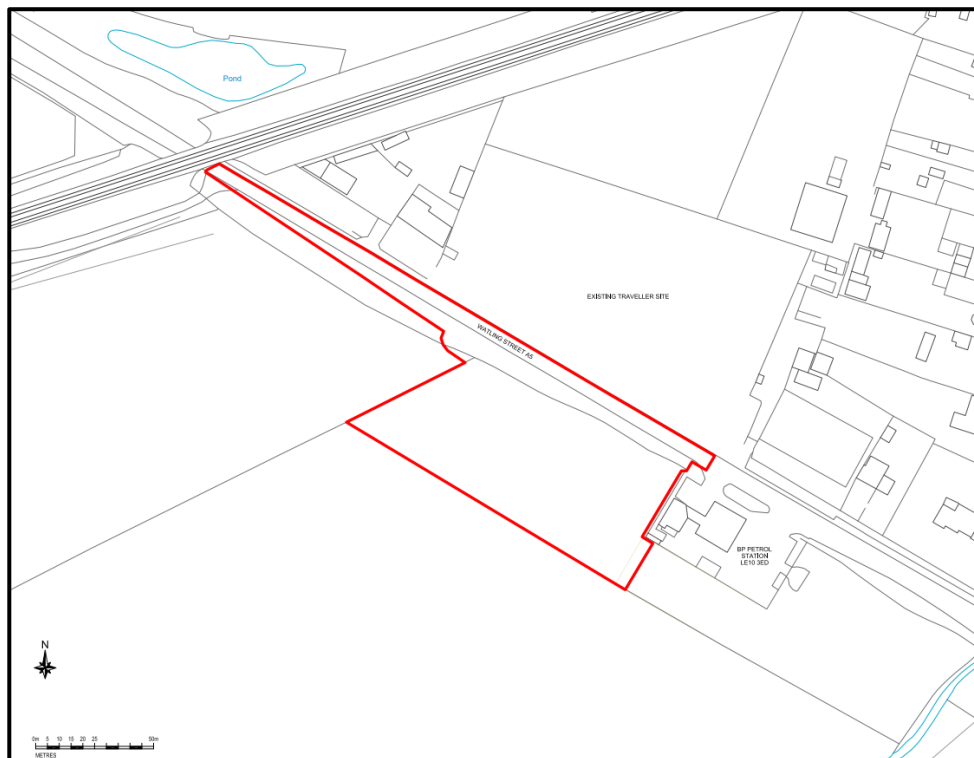
**Figure 2: Site Boundary (Red) and Surrounding Area**

2.1.2 The site currently forms part of a wider greenfield plot currently comprising flat grassland that is understood to be used for grazing.

2.1.3 The site is shown within Figure 2 below.

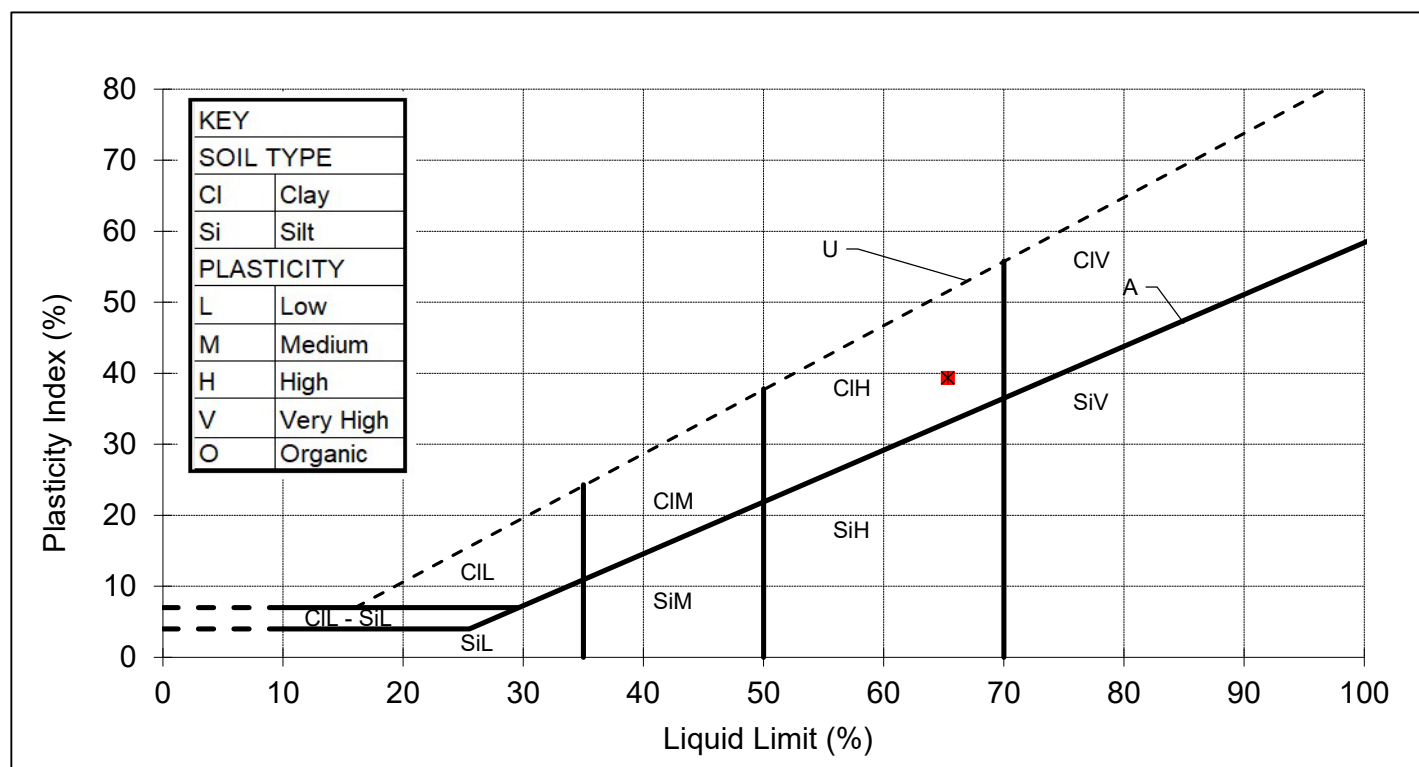
| Natural Moisture Content (%) | Liquid Limit (%) | Plastic Limit (%) | Plasticity Index (%) | Passing 425 micron (%) |
|---|---|---|---|---|
| 28.9 | 65 | 26 | 39 | 100 |

- 5.5 Clay samples were taken from borehole WS1, WS3 & WS7. Atterberg testing was undertaken in the laboratory conditions to determine the plasticity index of the clay. The result is presented in Appendix C. The modified plasticity index for the sample was calculated in accordance with NHBC guidance and summarised in Table 5 below.

- 5.6 The plasticity results indicate that the soil can be categorised to be of high volume change potential, requiring a minimum foundation formation depth of 1.05 m below existing or proposed ground level, whichever is the lower, in areas where clay soils are present. Adjustments to formation depths, to comply with LABC requirements and NHBC Ch.4.2 guidance, may be required where trees are within influence of new structures.

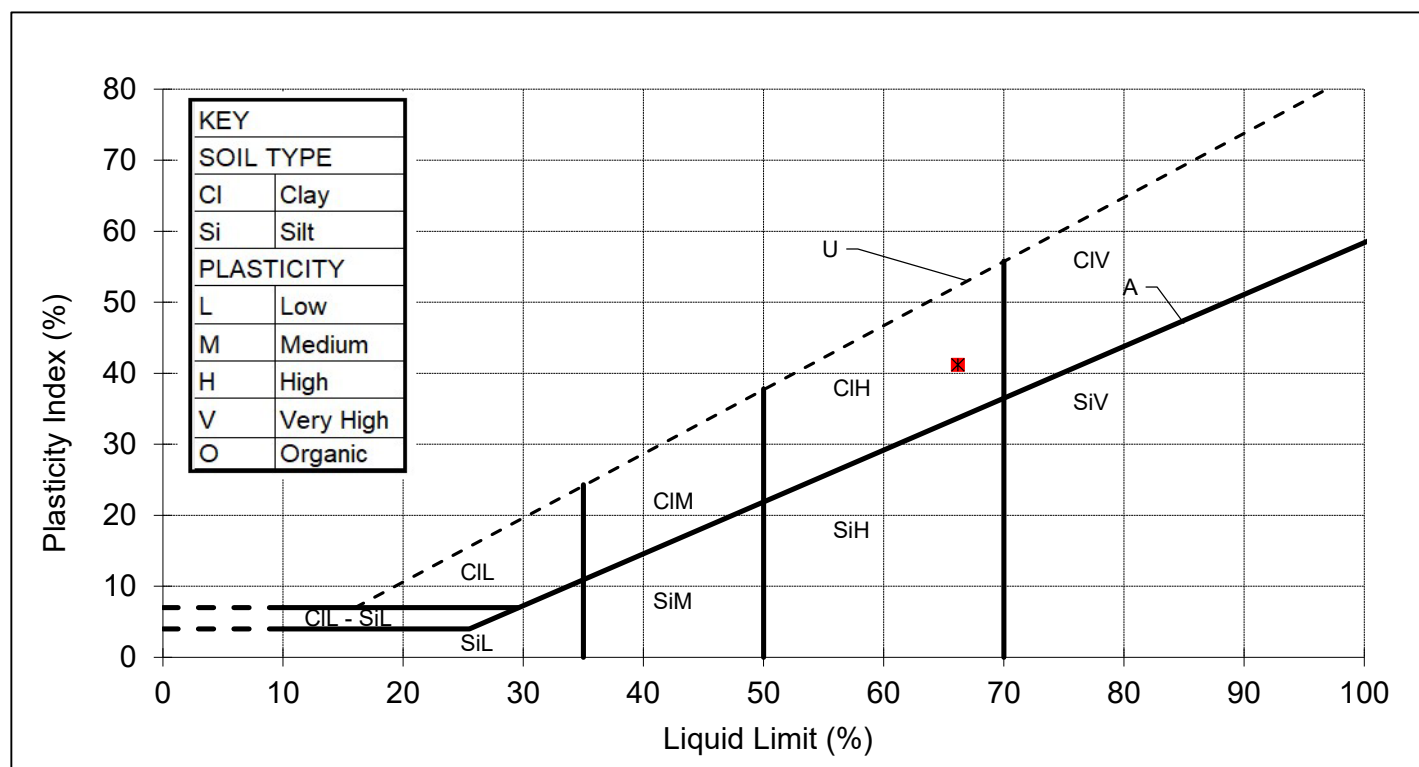
| Natural Moisture Content (%) | Liquid Limit (%) | Plastic Limit (%) | Plasticity Index (%) | Passing 425 micron (%) |
|---|---|---|---|---|
| 29.8 | 66 | 25 | 41 | 100 |

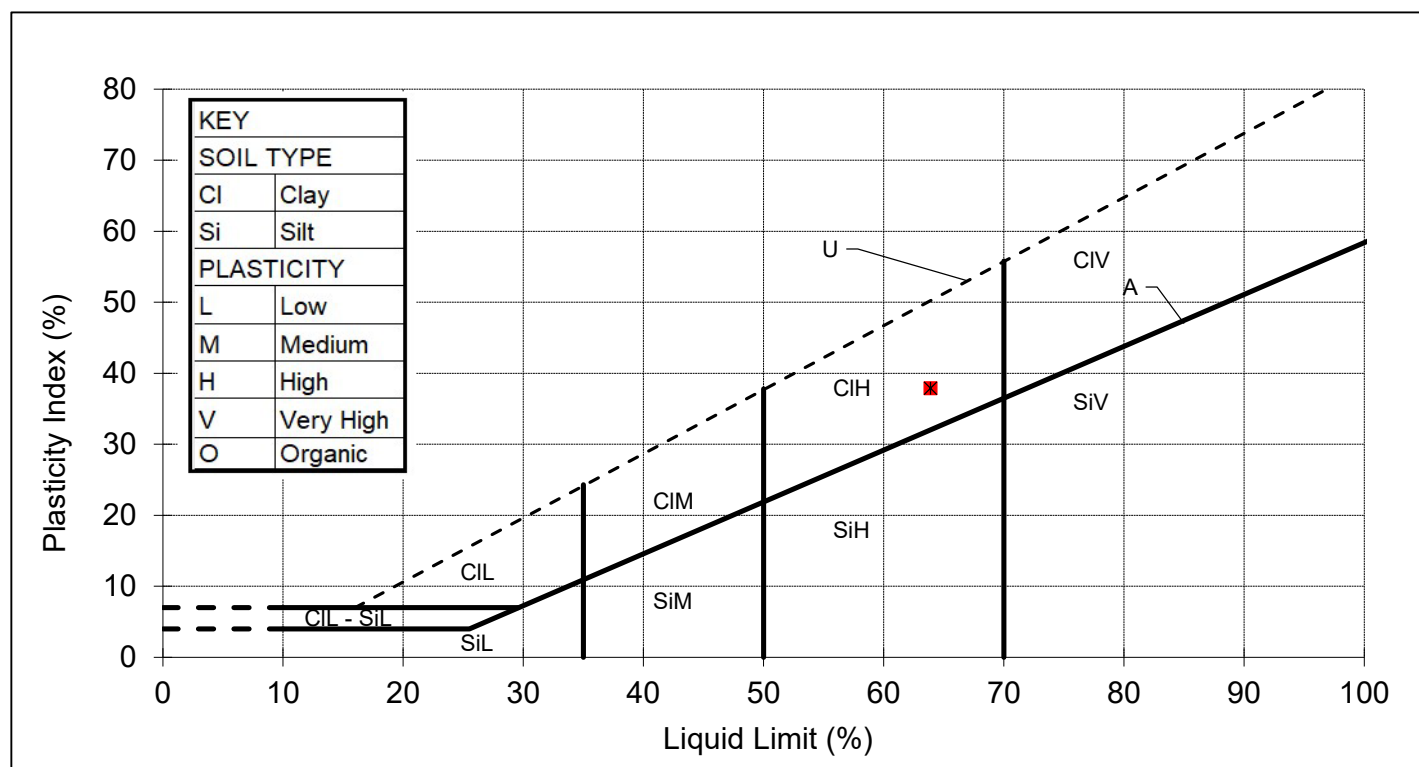
| Natural Moisture Content (%) | Liquid Limit (%) | Plastic Limit (%) | Plasticity Index (%) | Passing 425 micron (%) |
|---|---|---|---|---|
| 29.8 | 64 | 26 | 38 | 100 |

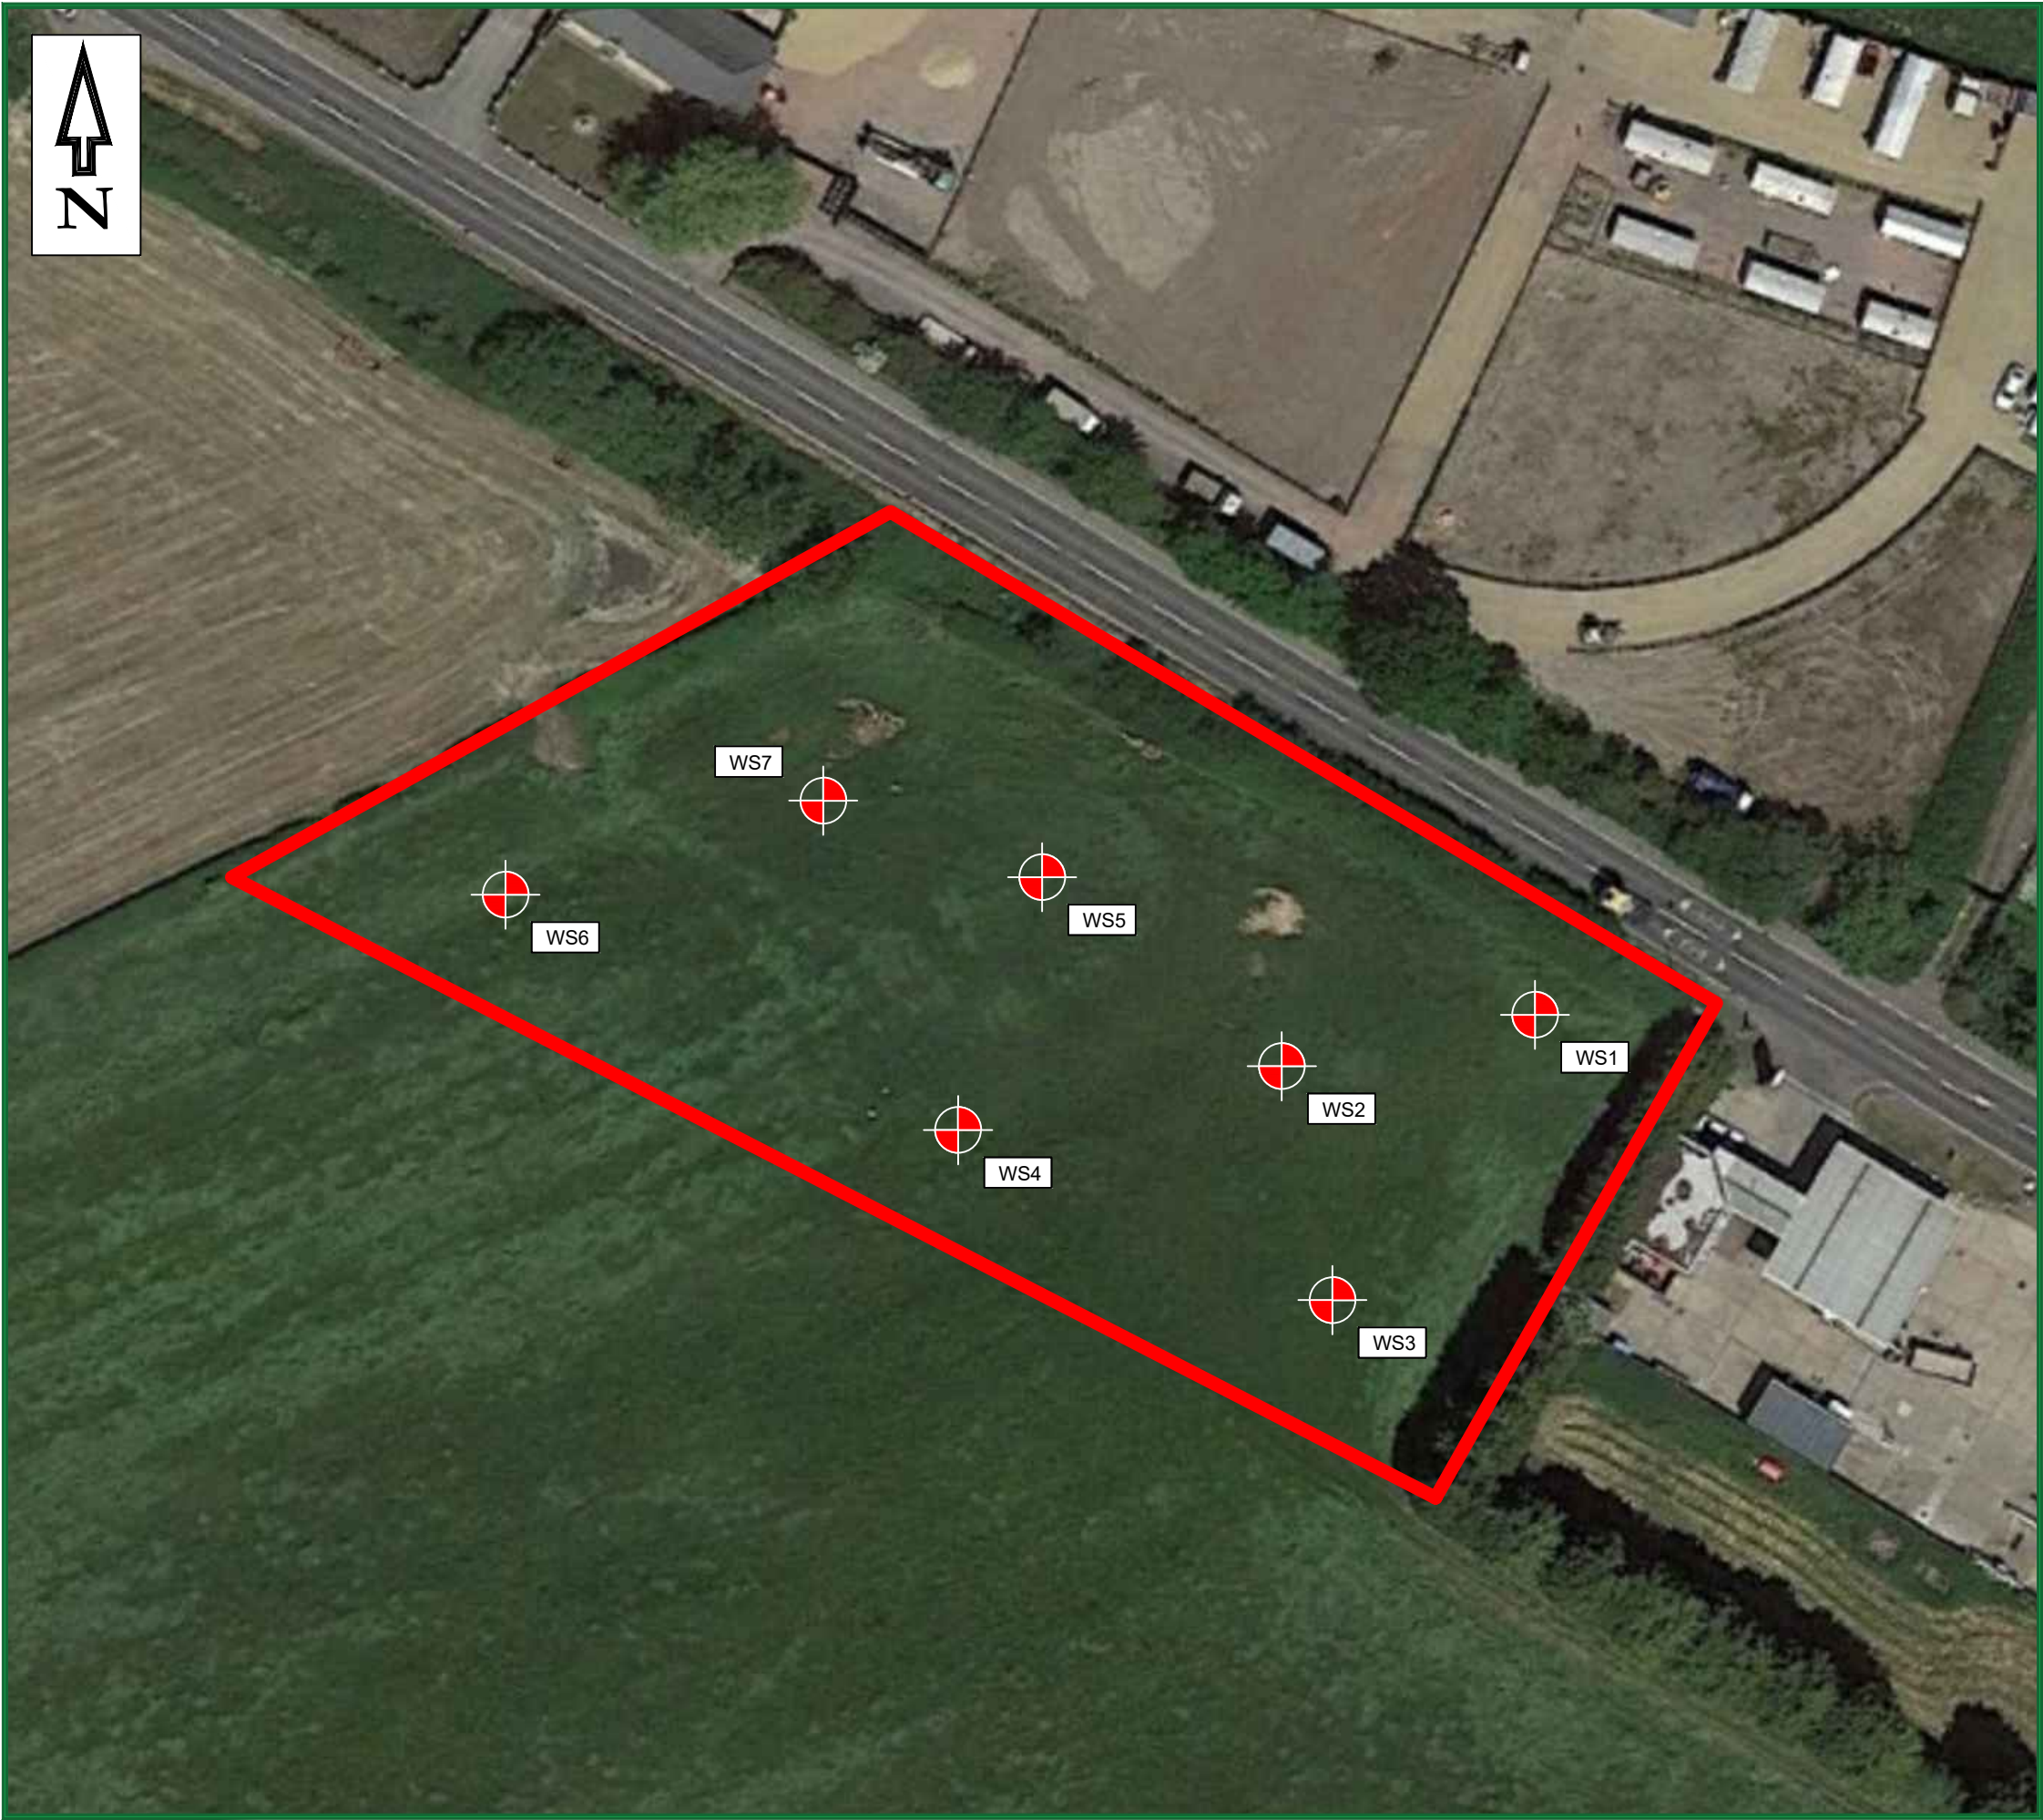
3.1.3 All exploration locations were set out by the site engineer and the exploratory locations are illustrated on BEK Drawing No 23005-3 presented in Appendix D.

3.2.1 Seven window sample boreholes were drilled using a window sample borehole rig to a maximum depth of 5.45 m. Borehole locations were set out by the site engineer in order to establish representative conditions at the site. In-situ testing (SPTs) were carried out in each of the boreholes.
