Land South of Sacheverell Way
Groby

**Phase I Desk Study Report
For
Bloor Homes East Midlands**

| Project No: D44049 | | Date: 13 th August 2024 | |

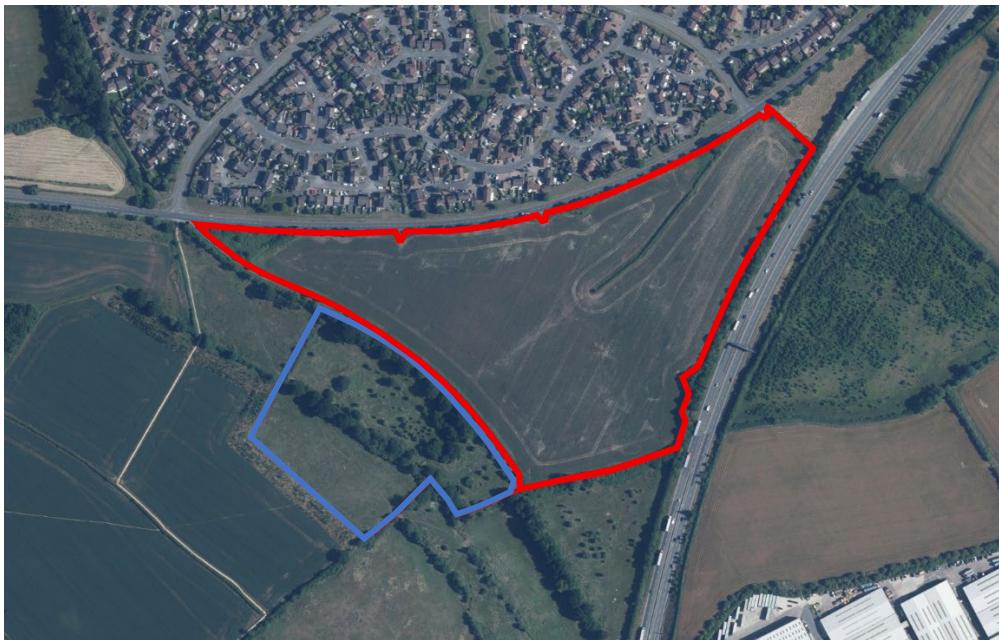
Figure 1: Aerial photograph of the site (2023 image)

An aerial photograph of the site, obtained from the Landmark Analysis tool commissioned as part of our works, is presented in Figure 1 on the next page, with the current OS mapping plan for the site and surrounding area presented in Figure 2.

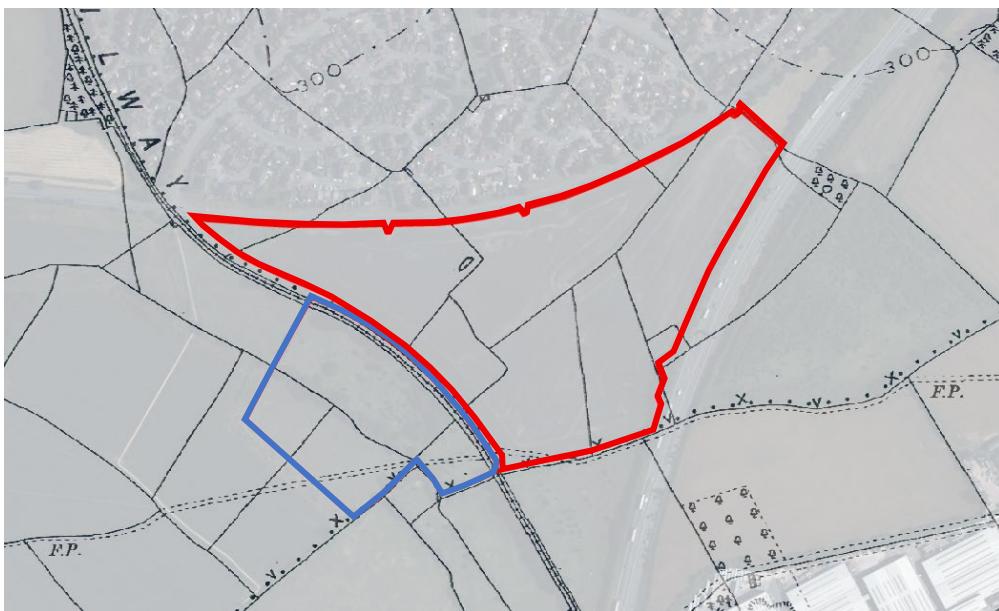
Figure 3: Current Aerial Imagery Overlain with 1904 Historical Map Data

The site comprises a series of undeveloped fields. The south-western portion of the site is separated from the remainder of the site by a railway line. A watercourse passes through the south-western portion of the site. An excavation is present just within 250m of the south-eastern site boundary.

The following pictures (Figures 3 to 6) shows overlays of the historical map publications from 1904, 1930-31, 1973 and 1992, as shown on current aerial imagery.

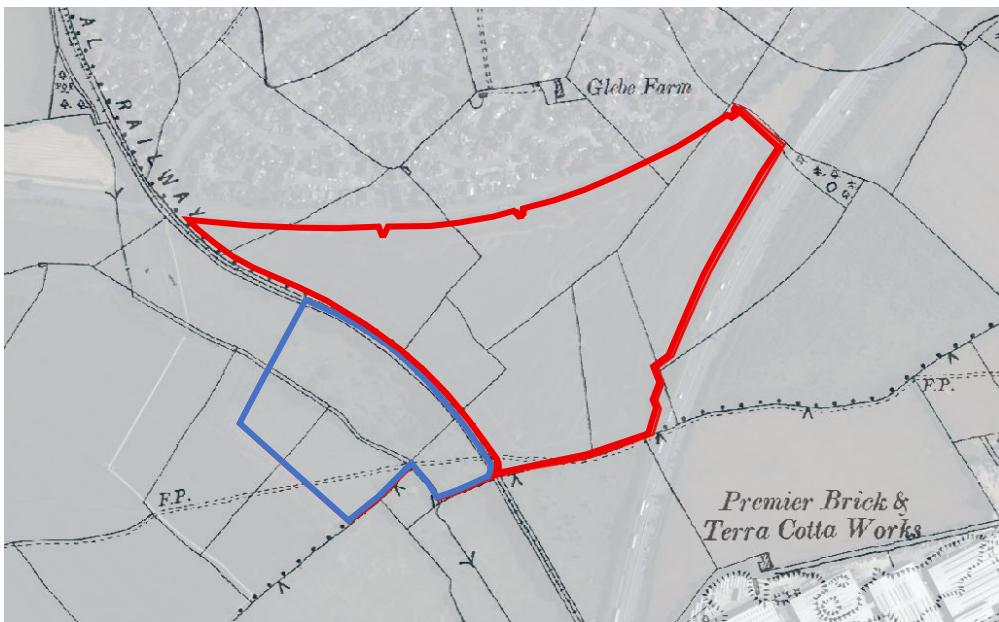
Figure 4: Current Aerial Imagery Overlain with 1930-31 Historical Map Data

Excavations to the south-east of the site are indicated to be part of a brick and terra cotta works.

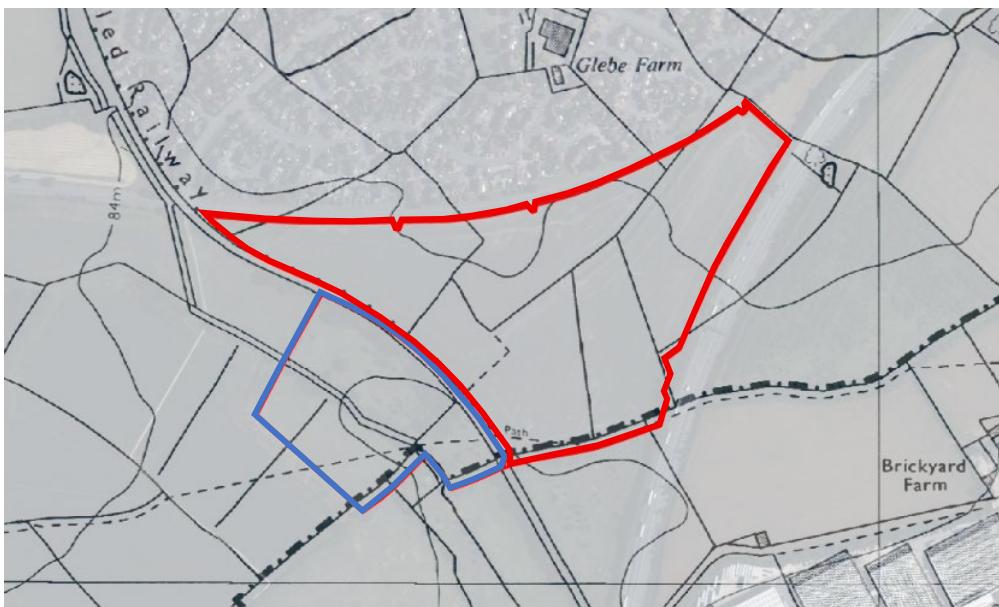
Figure 5: Current Aerial Imagery Overlain with 1973 Historical Map Data

The area of the former Works to the south-east of the site has been partially developed with commercial properties (later identified as Mill Lane Industrial Estate). The excavations associated with the former Works are no longer present (presumably infilled).

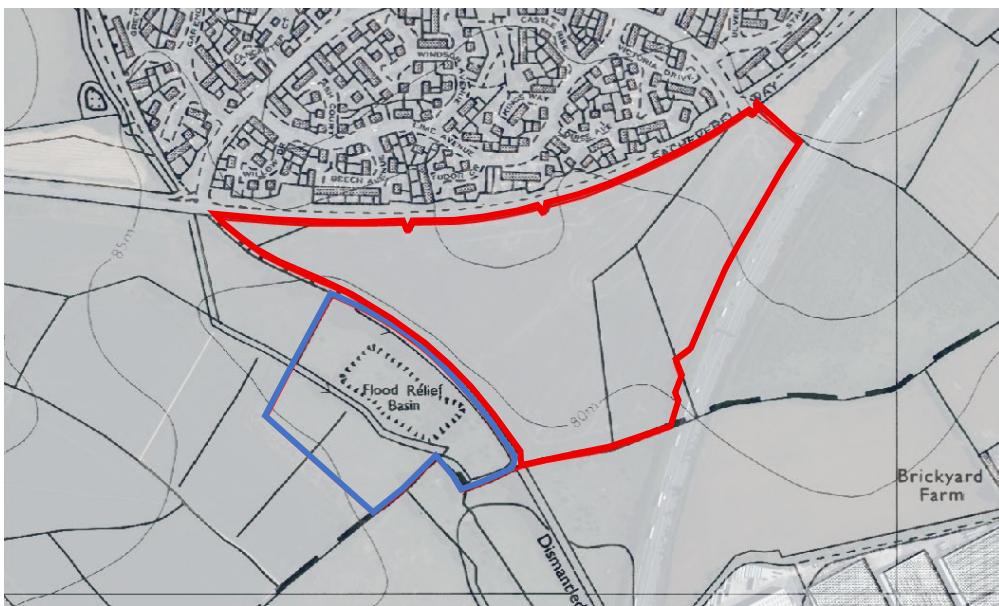
Figure 6: Current Aerial Imagery Overlain with 1992 Historical Map Data

Several of the field boundaries within the site are no longer present. Residential development has taken place to the north of the site beyond Sacheverell Way. The south-western portion of the site includes a Flood Relief Basin.

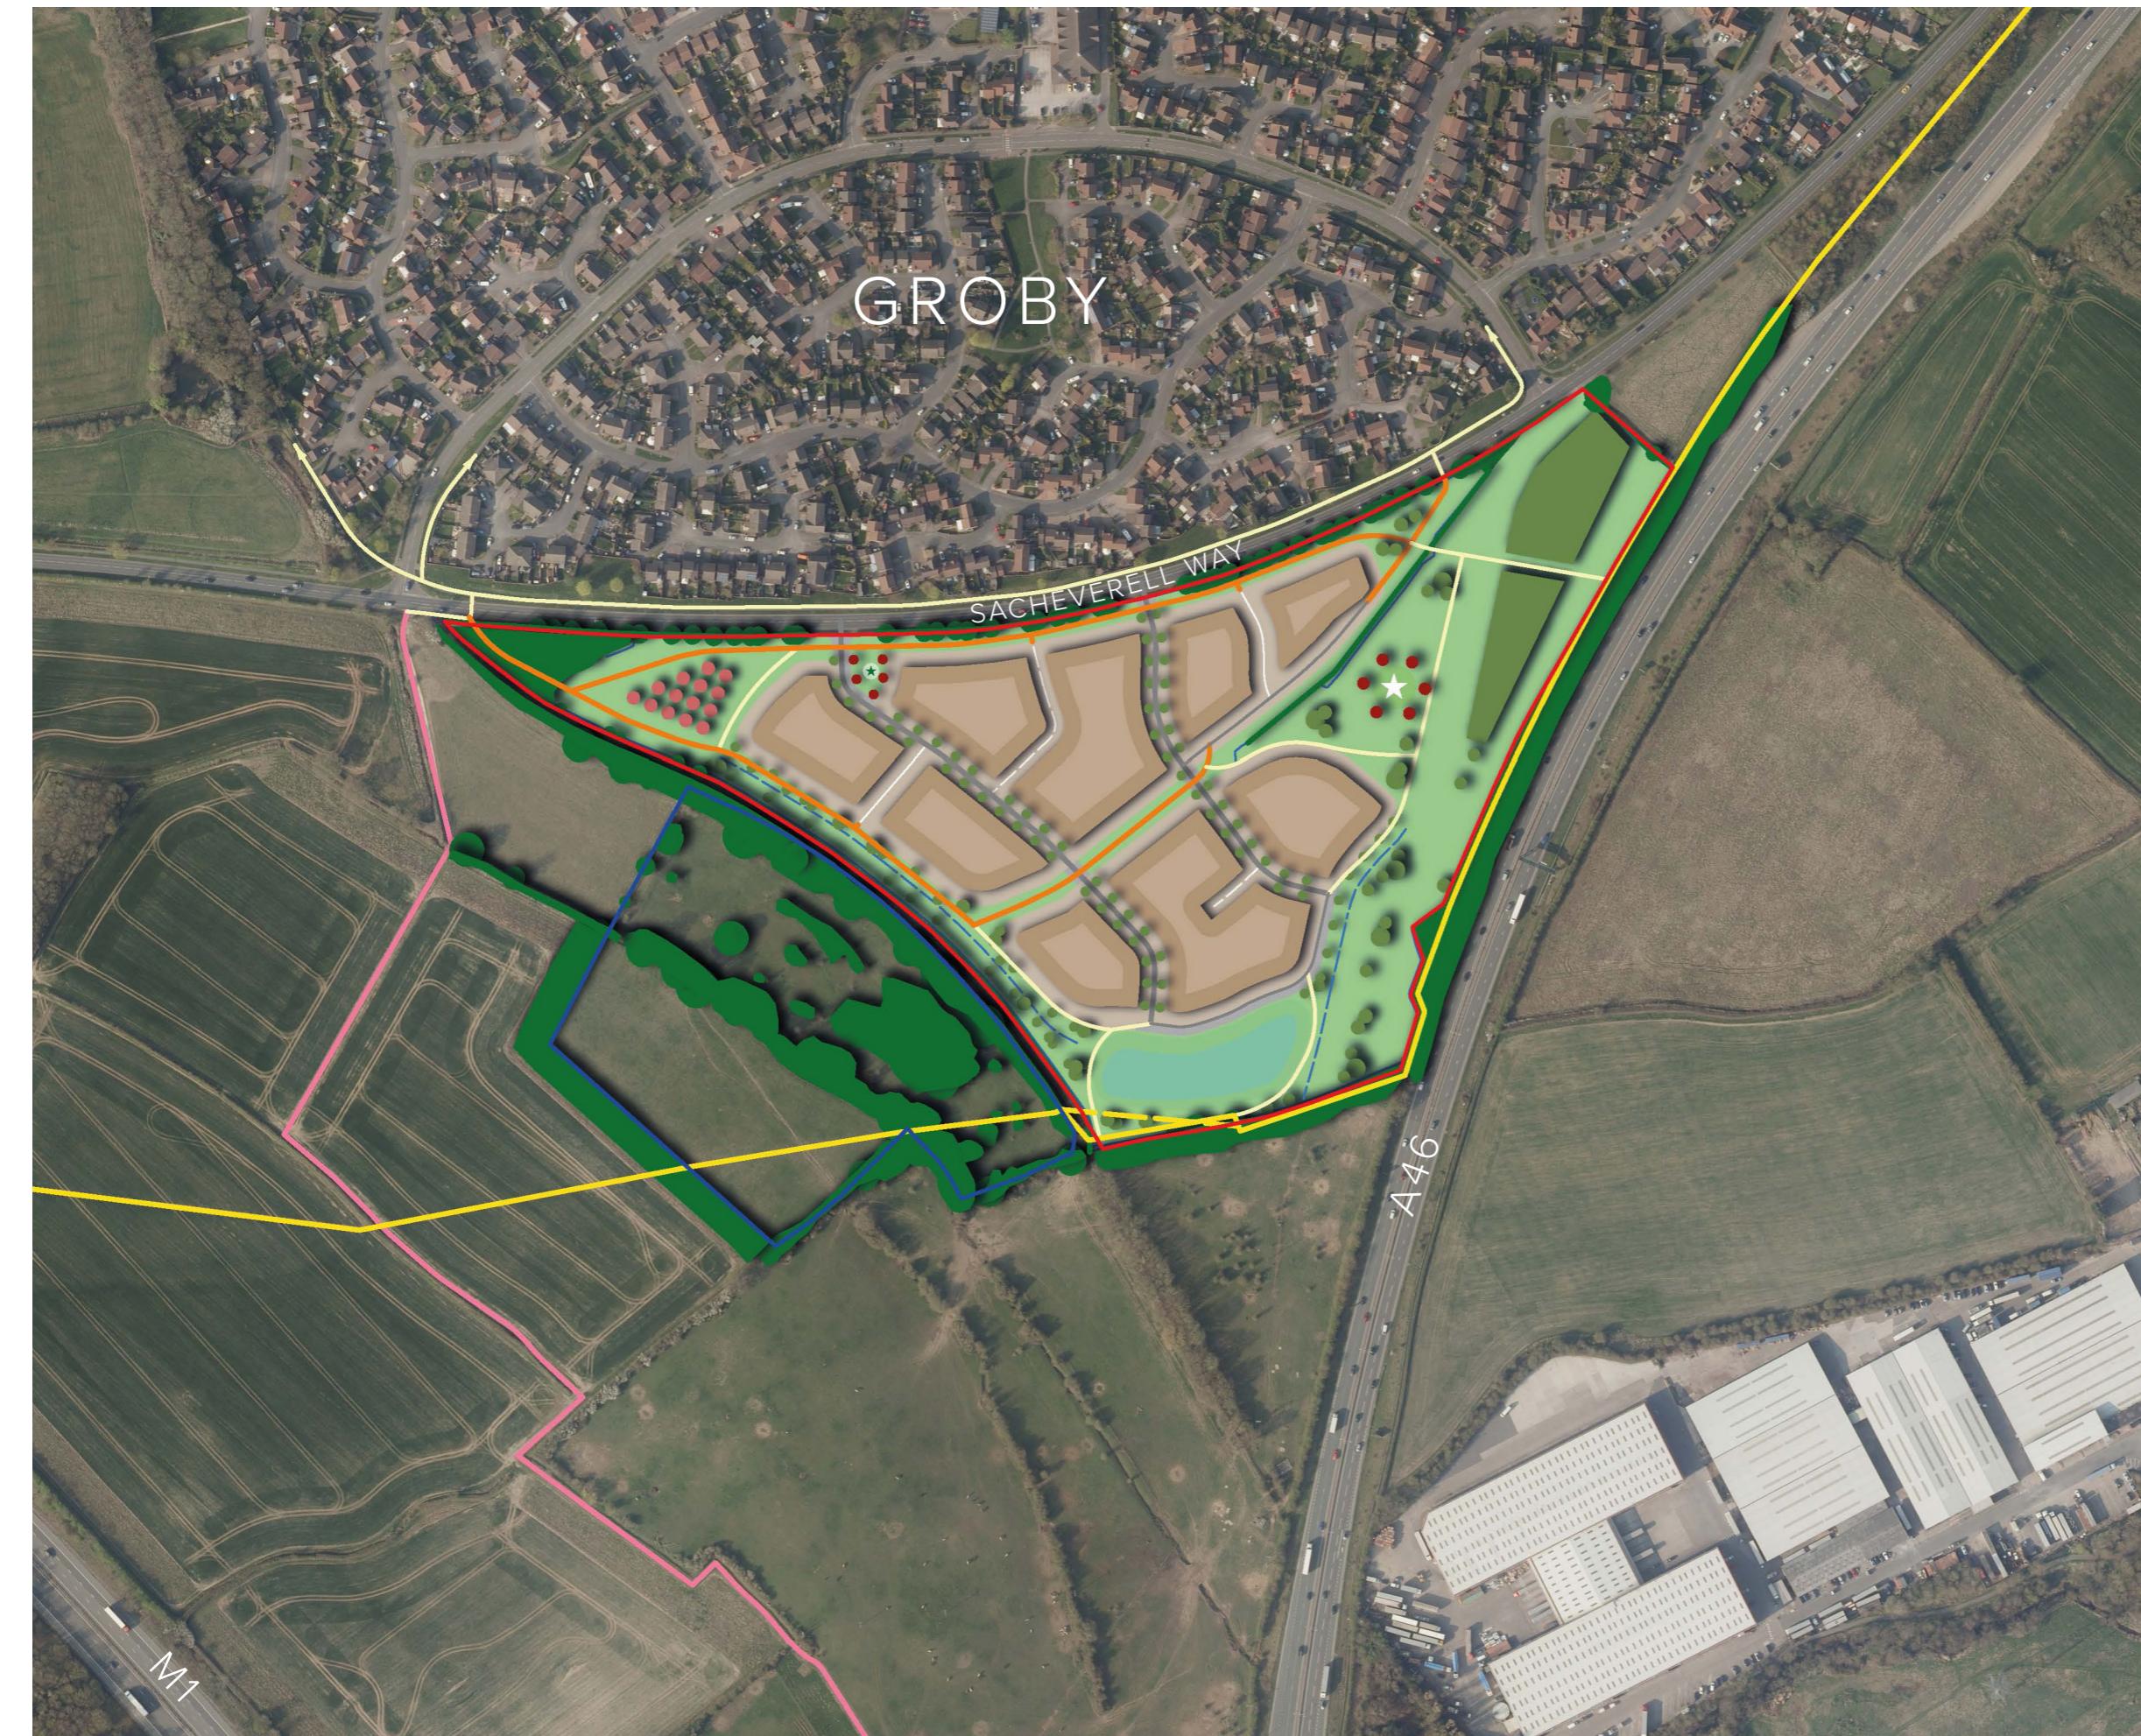
Initial Masterplan

We further understand that it is proposed to develop the main body of the site with low-rise residential properties with associated private gardens. The proposed development also includes attenuation ponds and areas of public open space. The south-western portion of the site (to the south-west of the existing track, as shown within the blue line) is to remain undeveloped. The initial masterplan has been provided by the Client, a copy of which is included in Appendix II.

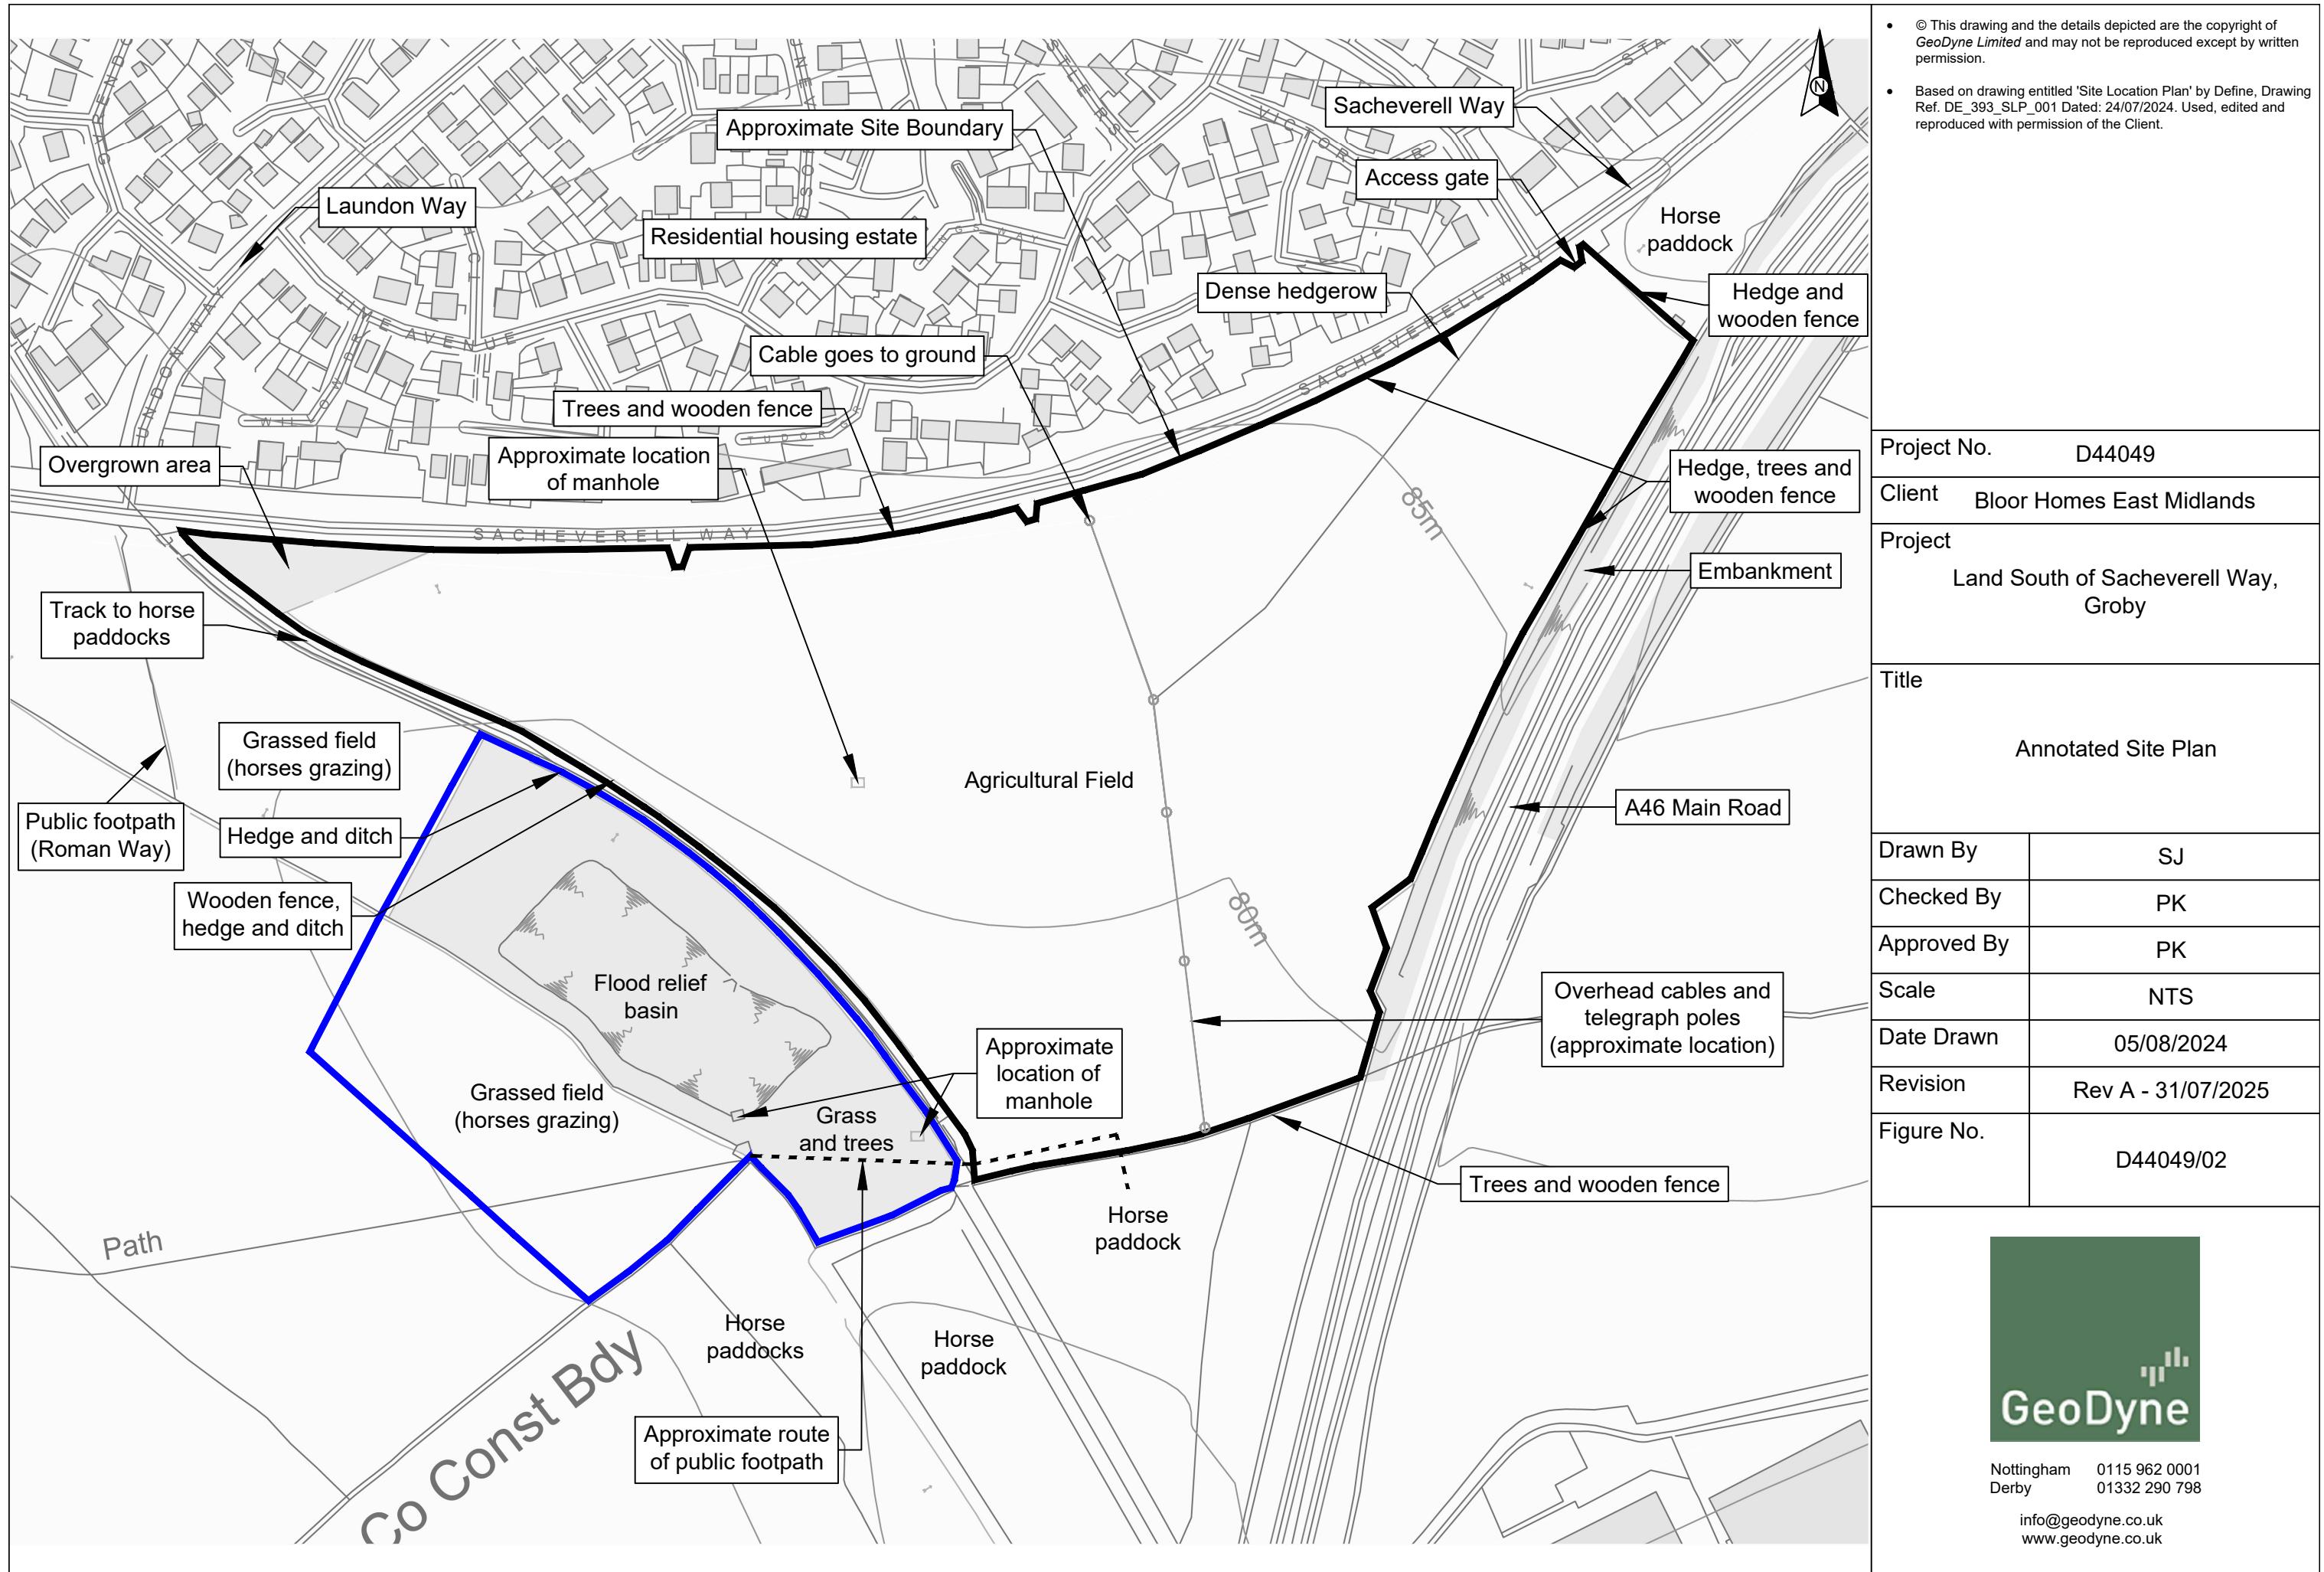
Annotated Site Plan
(Figure No. D44049/02)

The Annotated Site Plan in Appendix III of this report (Figure No. D44049/02) shows the main features of the site and immediate surrounding area. General views of the site are included on the plans in Appendix IV of this report (Figure Nos. D44049/03a and D44039/03b).
