## Phase 2: Site Investigation

**Former Leisure Centre, Hinckley**

**M25-040**

## PHASE 2 SITE INVESTIGATION REPORT

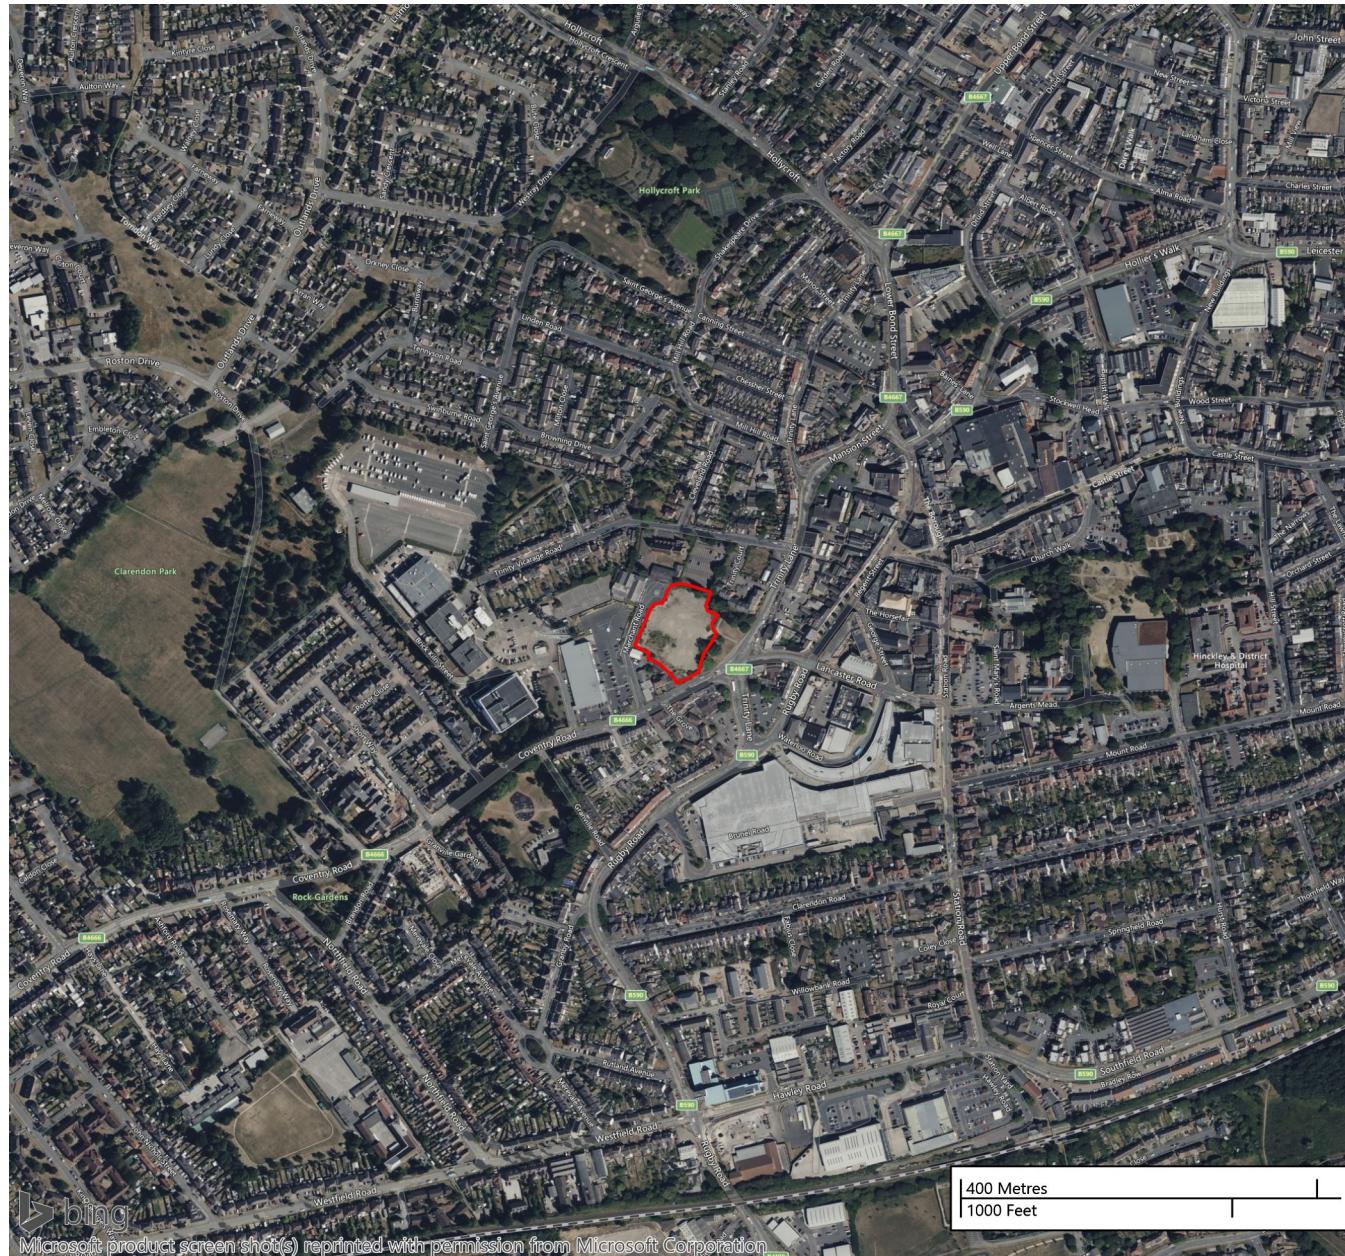
The site investigation described in this report was carried out by Solmek to the instructions of Green4Planning on The Former Hinckley Leisure Centre LE10 0BY (Figure 1).

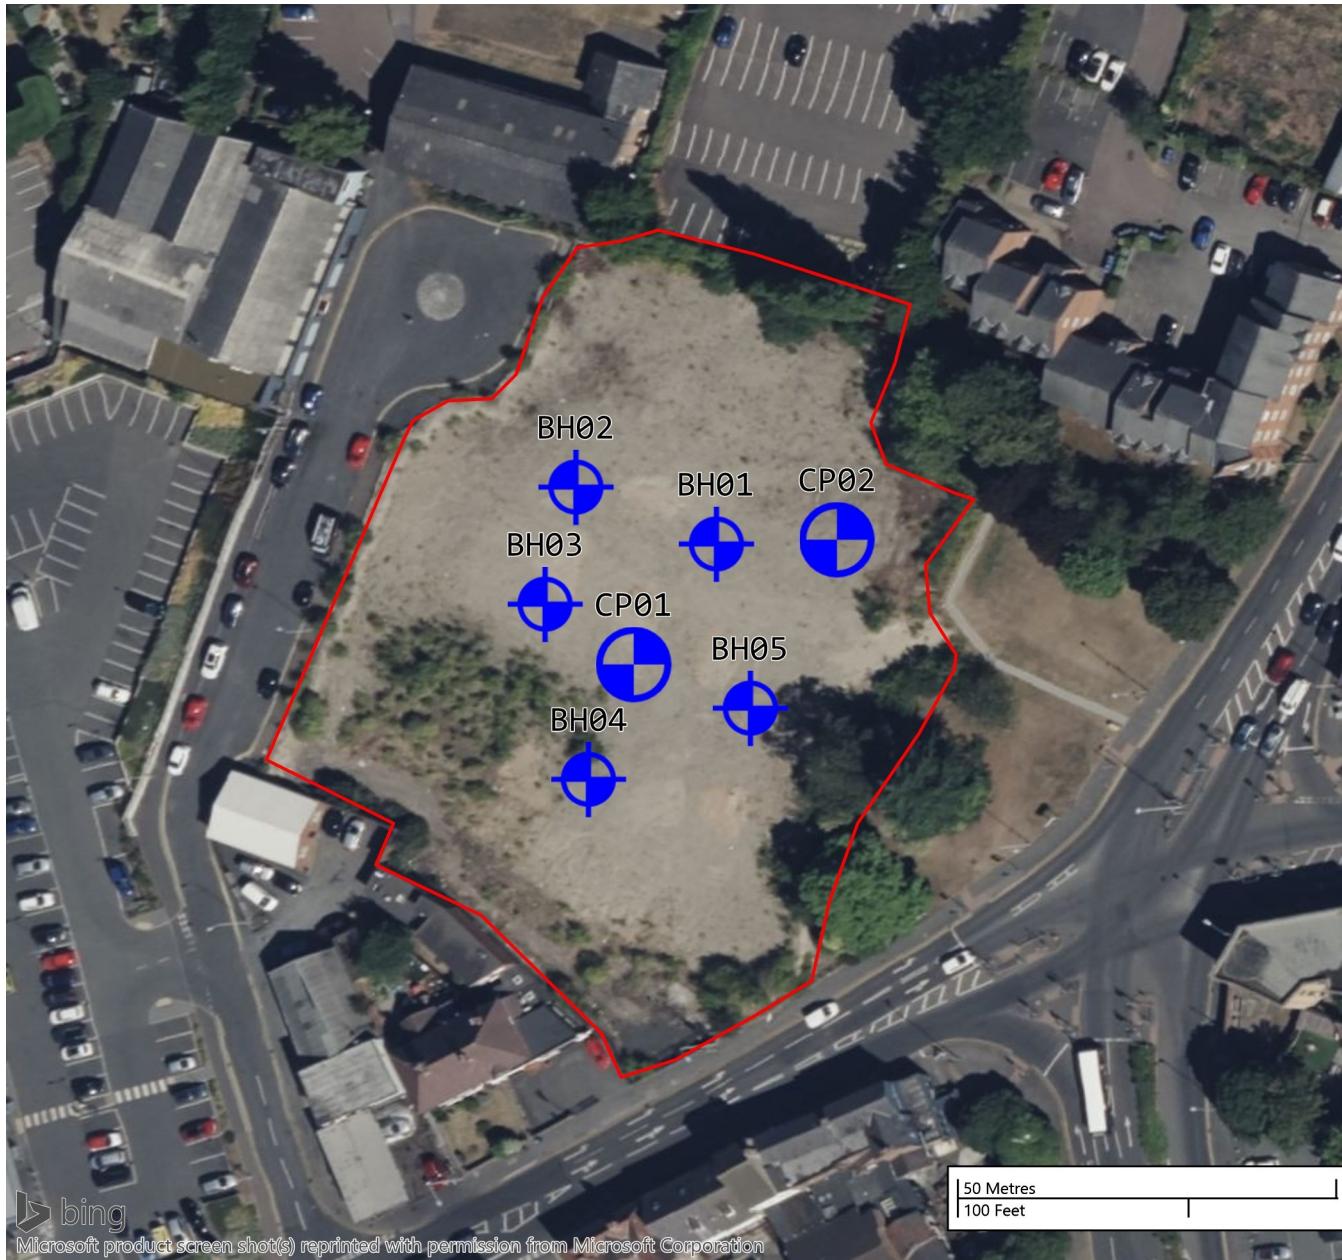
- 2no cable percussive boreholes (CP01 & CP02) to a maximum depth of 20.00m bgl.
- 5no small percussive boreholes (BH01 to BH05 inclusive) to a maximum depth of 5.45m bgl.
- Gas monitoring wells were installed in CP01 and BH's 01 & 03.
- Insitu testing in the exploratory positions as Standard Penetration Tests (SPTs).
- Retrieval of samples for geotechnical and chemical testing.

A plan showing the location of the boreholes and trial pits can be found in Appendix A (Figure 2).

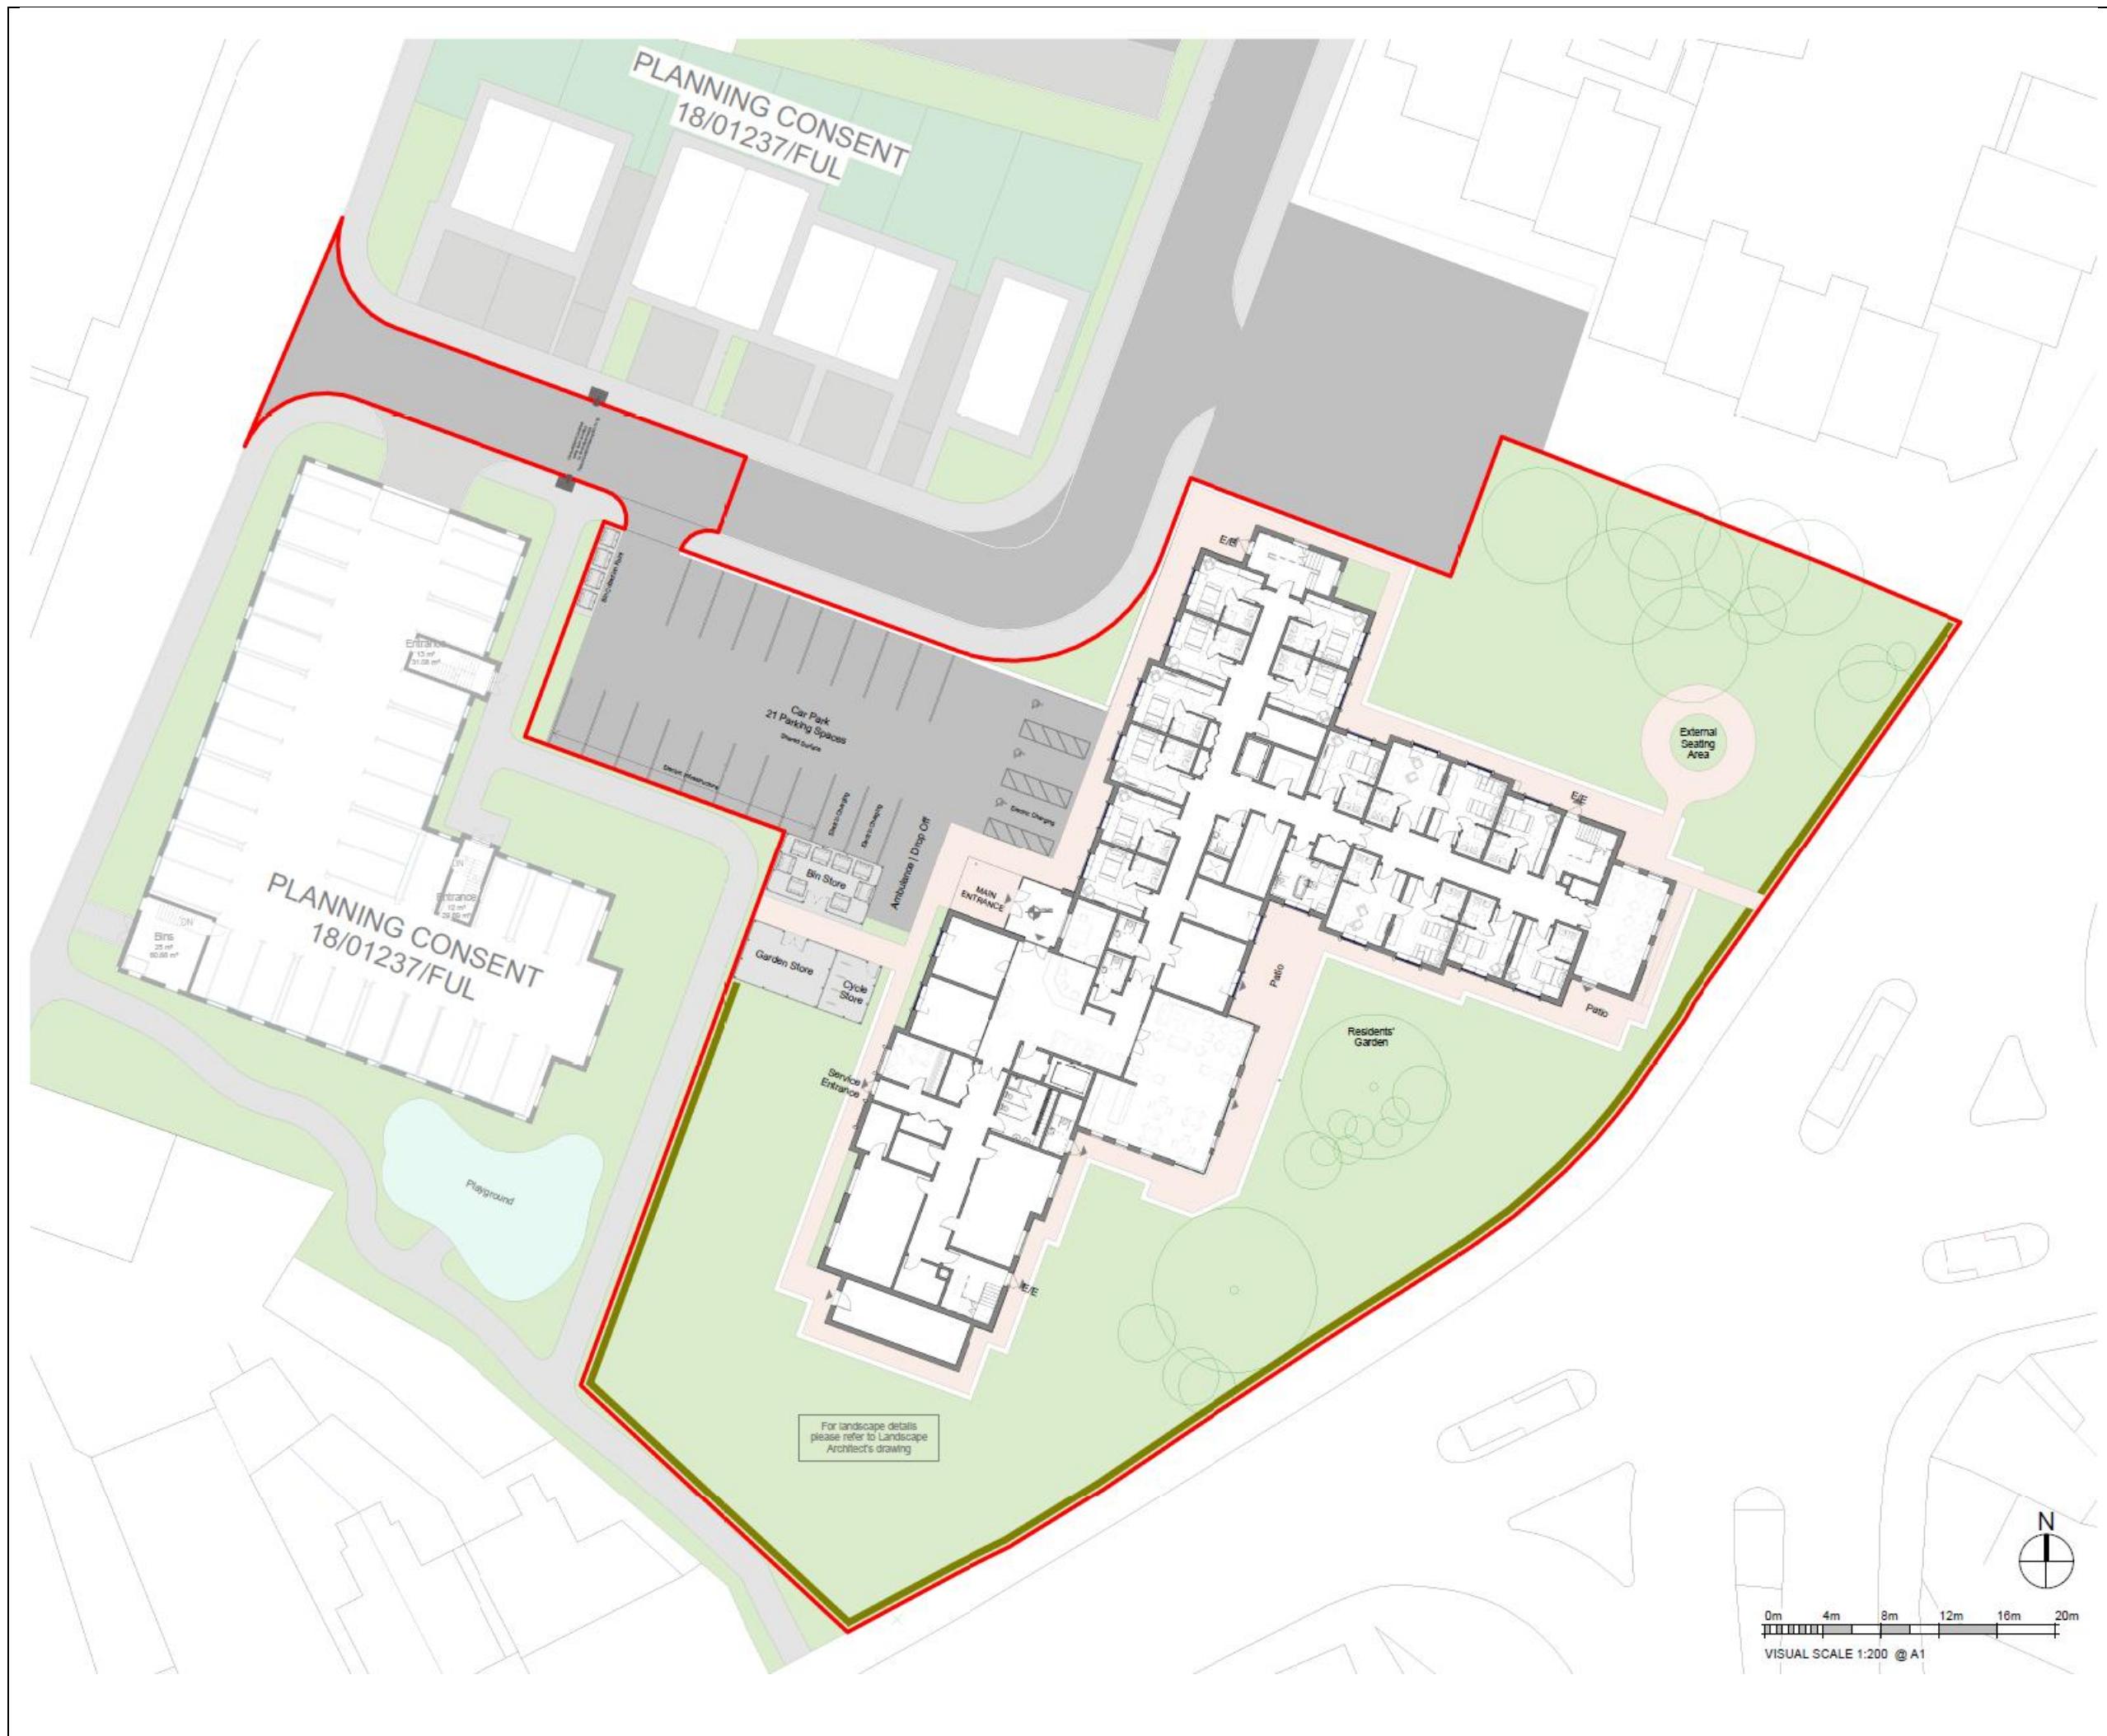
The site is expected to be developed with new residential units including semidetached housing, apartments and a care home area. All units have associated parking and soft landscaping. The proposed layout is shown as Figure 3.

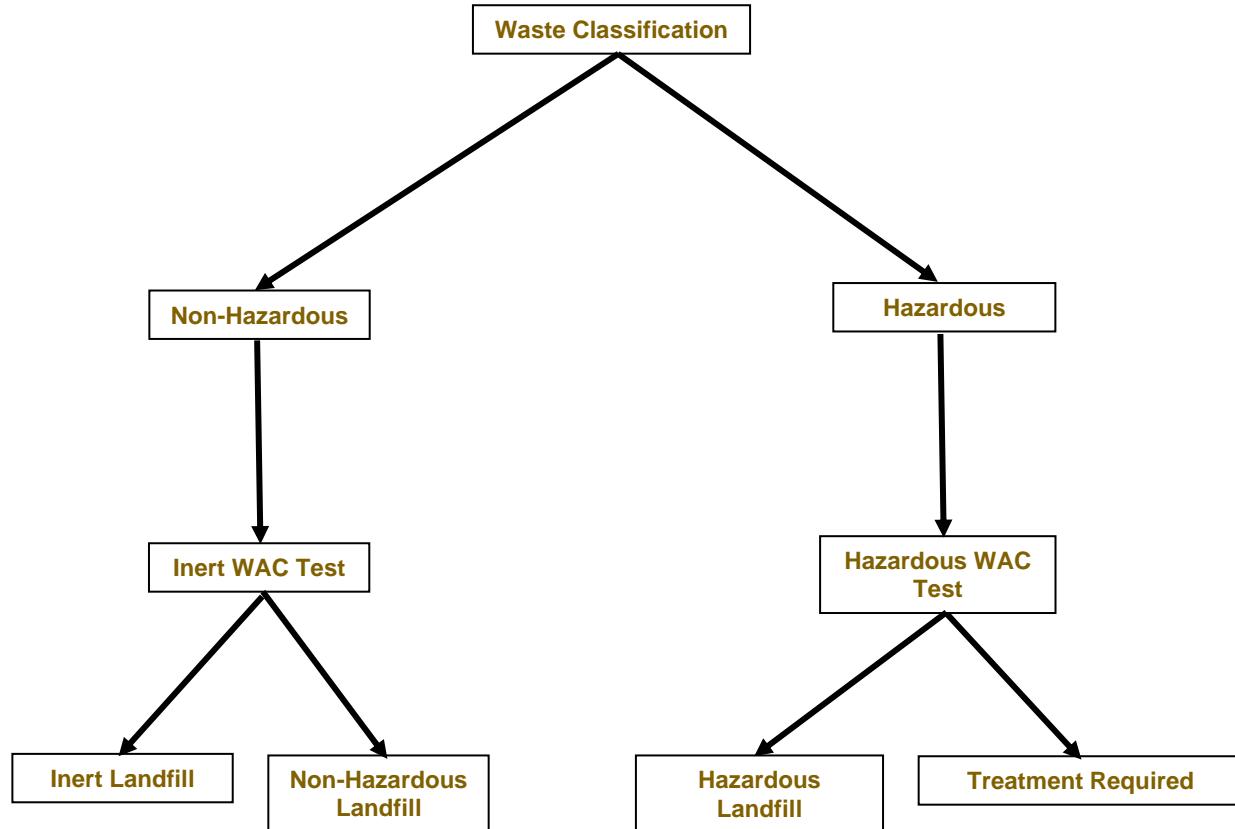
The below flow chart provides further information on the waste classification process.
