# ARBORICULTURAL ASSESSMENT & METHOD STATEMENT

**David Wilson Homes (East Midlands)**

**Land East of Barwell Common,  
Barwell**

**February 2026**

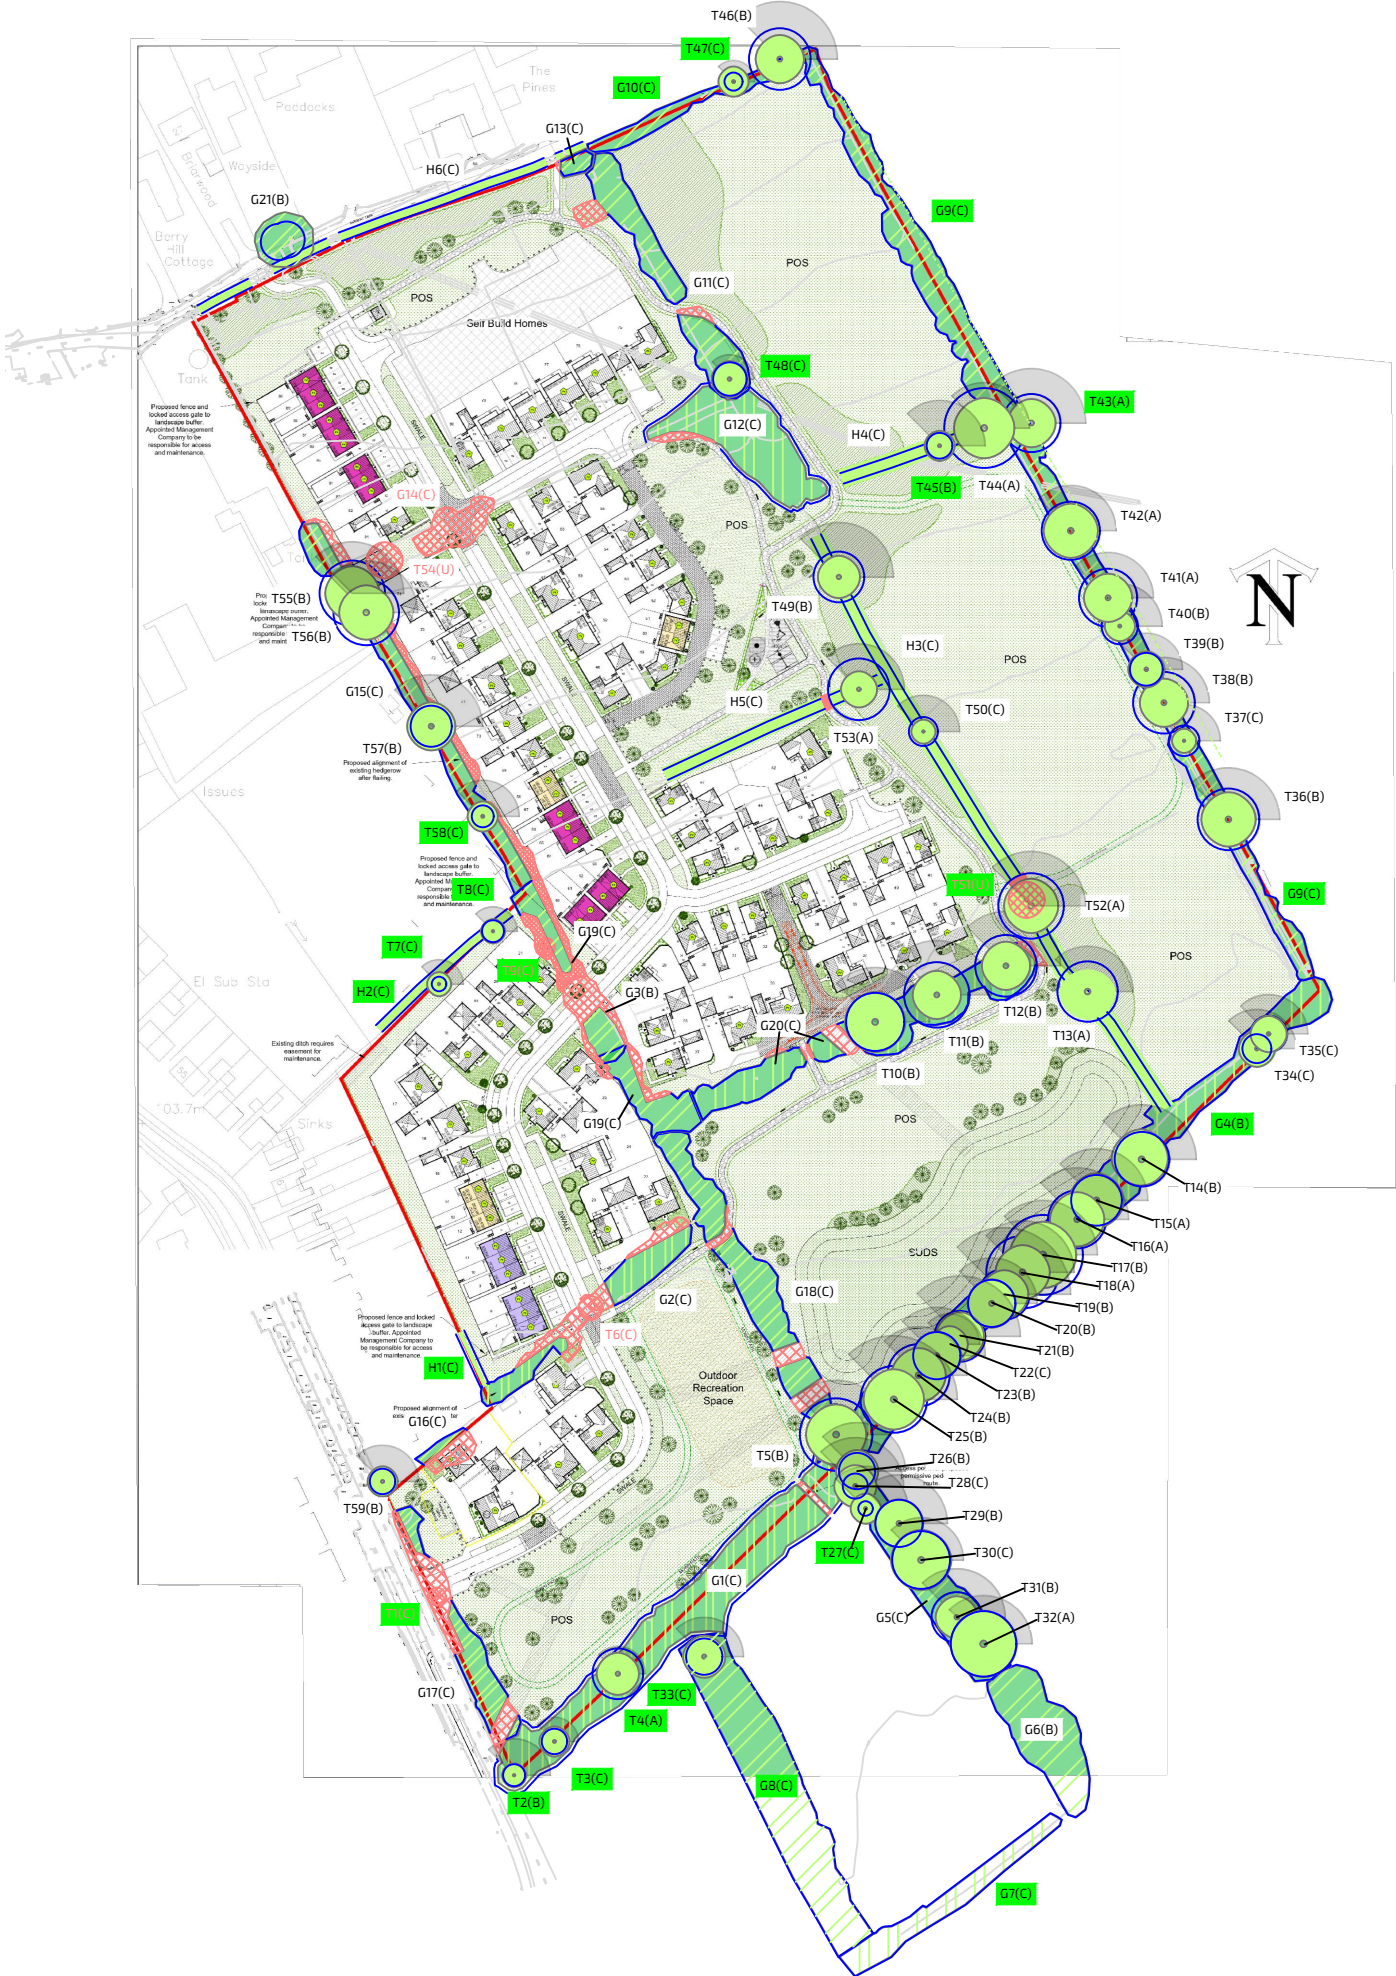
- Tree/Group to be Retained
- Tree/Group proposed to be removed subject to relevant permissions
- Category U - Unsuitable for retention on arboricultural grounds
- Hedgerow Proposed to be Retained and Incorporated into the New Development
- Hedgerow proposed to be removed subject to relevant permissions
- Root Protection Area (Shown for retained trees only)
- Tree / Group Positioned by Topographical Survey  
 Tree / Group Positioned by Aerial Imagery
- Individual / Group Number to be Removed and BS 5837:2012 Category
- Indicative Shade Pattern (in accordance with BS5837:2012 where appropriate)

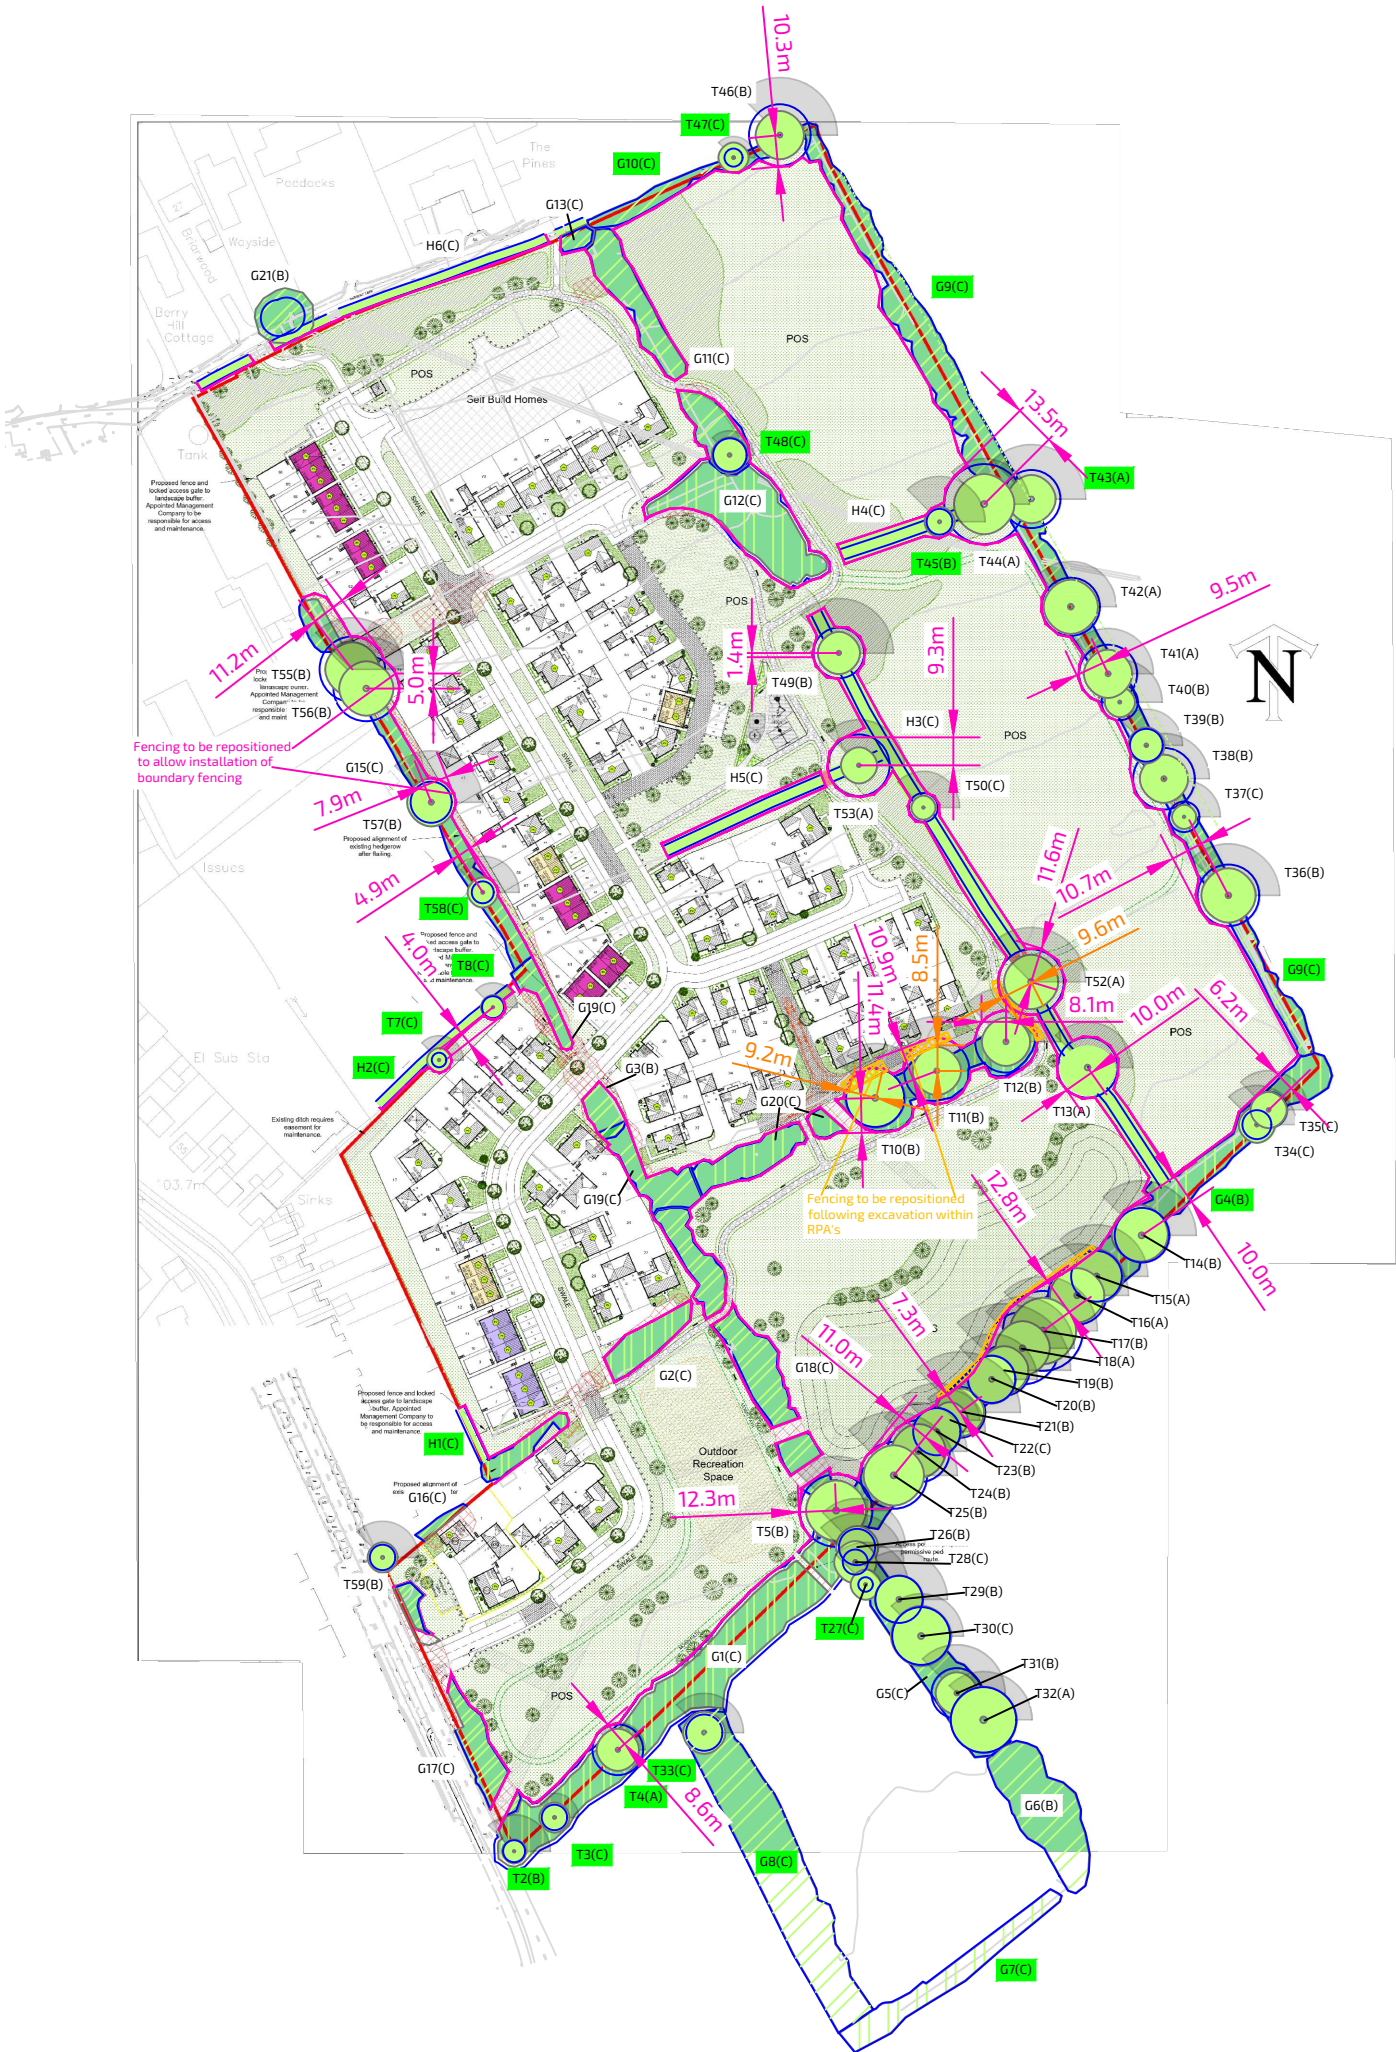
- Tree/Group to be Retained
- Hedgerow Proposed to be Retained and Incorporated into the New Development
- Root Protection Area
- Tree / Group Positioned by Topographical Survey  
 Tree / Group Positioned by Aerial Imagery
- Indicative Shade Pattern (in accordance with BS5837:2012 where appropriate)
- Line of Primary Protective Barriers (and distance from tree or retained structure)
- Line of Secondary Protective Barriers (and distance from tree or retained structure)
- Area of Excavation to be Supervised by the ACoW

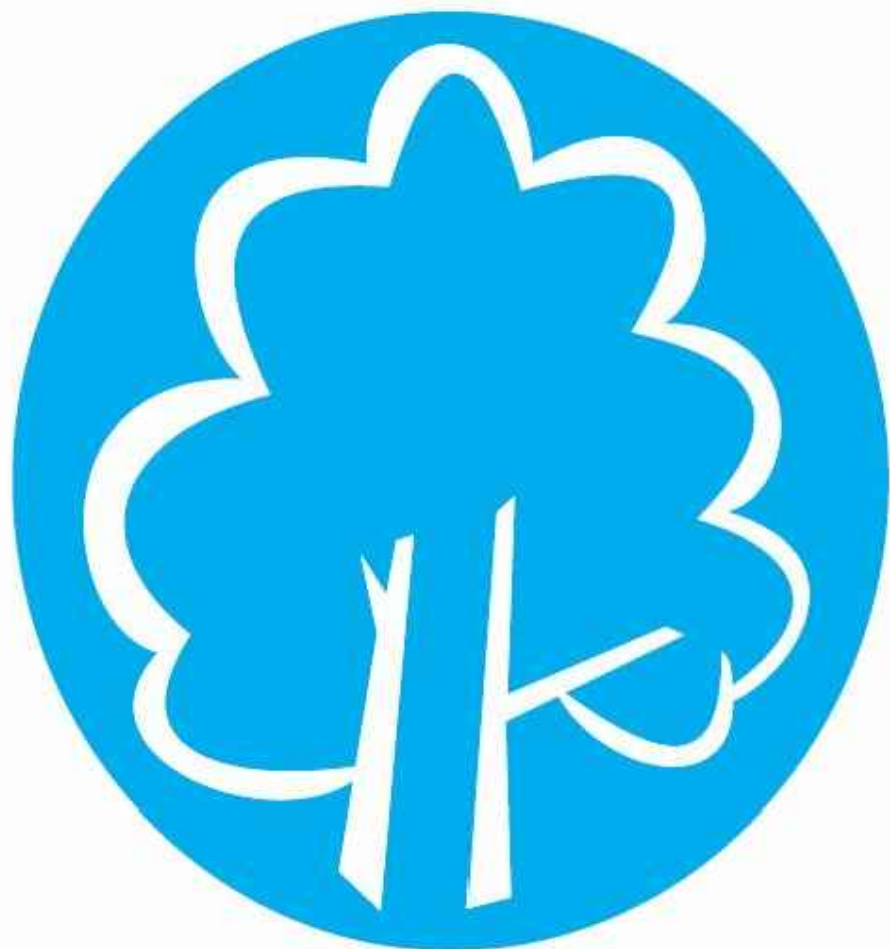
**PROTECTIVE FENCING. THIS  
FENCING MUST BE  
MAINTAINED IN ACCORDANCE  
WITH THE APPROVED PLANS  
AND DRAWINGS FOR THIS  
DEVELOPMENT.**

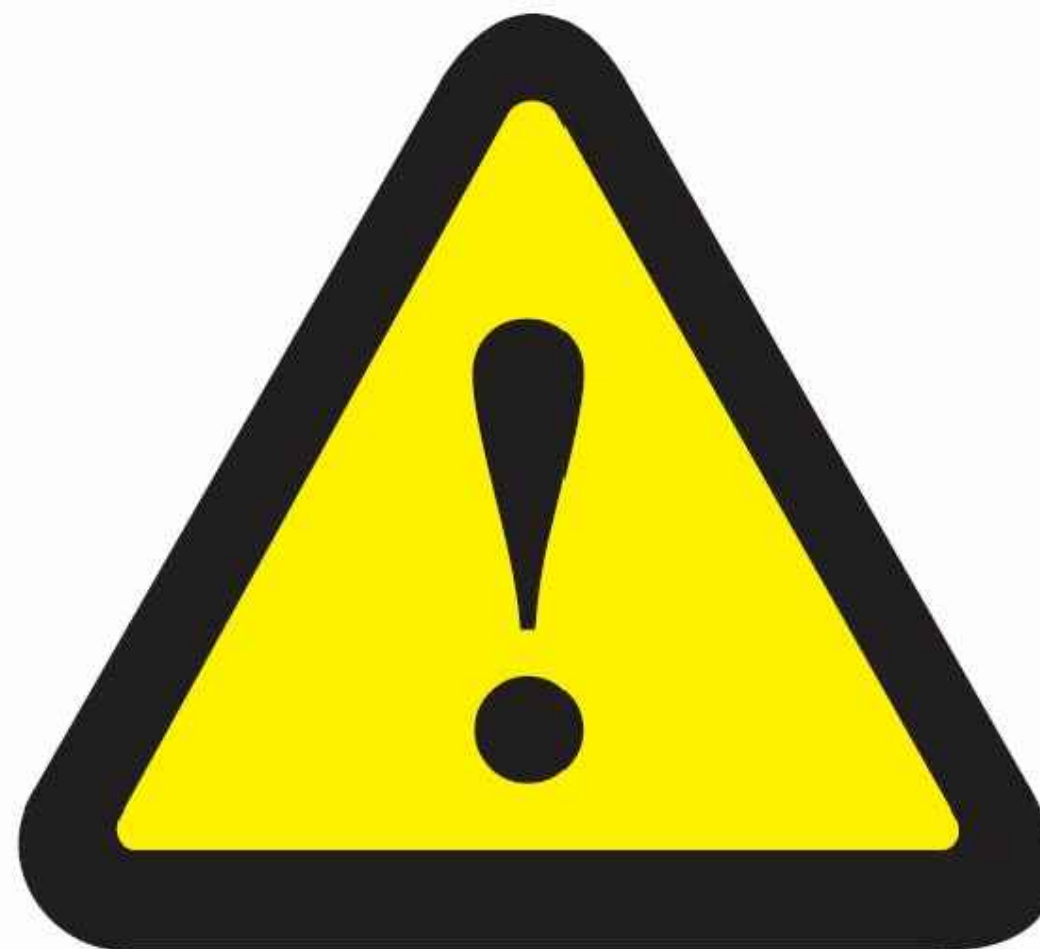
**TREE PROTECTION AREA  
KEEP OUT !**

**(TOWN & COUNTRY PLANNING ACT 1990)  
TREES ENCLOSED BY THIS FENCE ARE PROTECTED BY  
PLANNING CONDITIONS AND/OR ARE THE SUBJECTS OF A  
TREE PRESERVATION ORDER.  
CONTRAVENTION OF A TREE PRESERVATION ORDER MAY  
LEAD TO CRIMINAL PROSECUTION**
