LAND ADJACENT TO 18 BURTON ROAD  
(A444), TWYXCROSS, LEICESTERSHIRE  
Stage 1 Road Safety Audit  
J190644

# Land adjacent to 18 Burton Road (A444), Twycross, Leicestershire

Stage 1 Road Safety Audit  
J190644

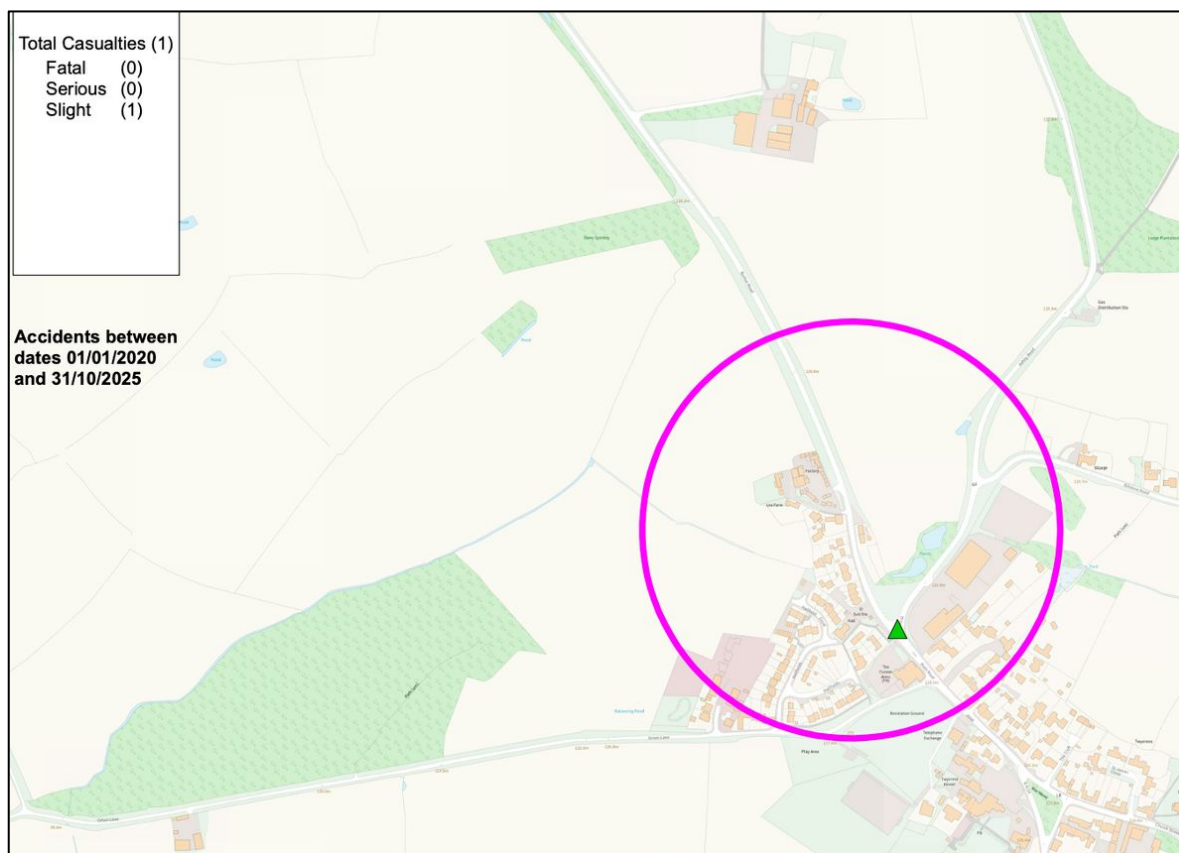
1.4.1 The A444 Burton Road is a single carriageway road of an approximate width of 5.6 metres in the vicinity of the site. It is subject to a 30mph speed limit which increases to the national speed limit c. 95 metres north of the site. A footway and street lighting are provided on the western side.

1.4.2 In the vicinity of the site, the horizontal alignment of Burton Road is meandering, where there are gentle right-hand and left-hand bends. The vertical alignment has a gentle incline in the northbound direction.

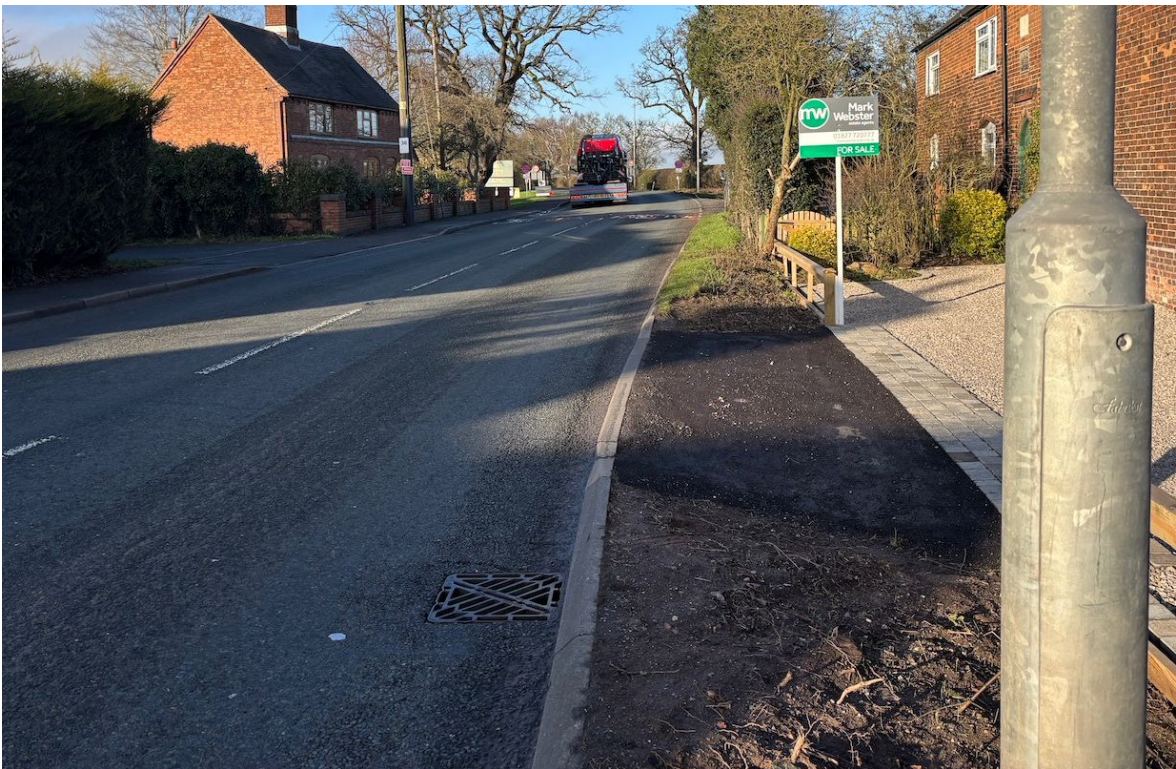
| Problem 1 | |
|---|---|
| Location | Site access |
| Summary | Risk of side swipe collisions |
| <p>The visibility splays shown for the new crossover appear to encroach onto the boundary of No.18 (to the north) and vegetation to the south. There are no proposals to remove any vegetation within the visibility splays. This may cause approaching vehicles not to be detected by an exiting vehicle (and vice versa). This may result in side swipe collisions between passing and exiting vehicles.</p> | |

| Problem 1 | |
|---|---|
| Recommendation | Cut back / maintain vegetation to be outside of visibility splays. |

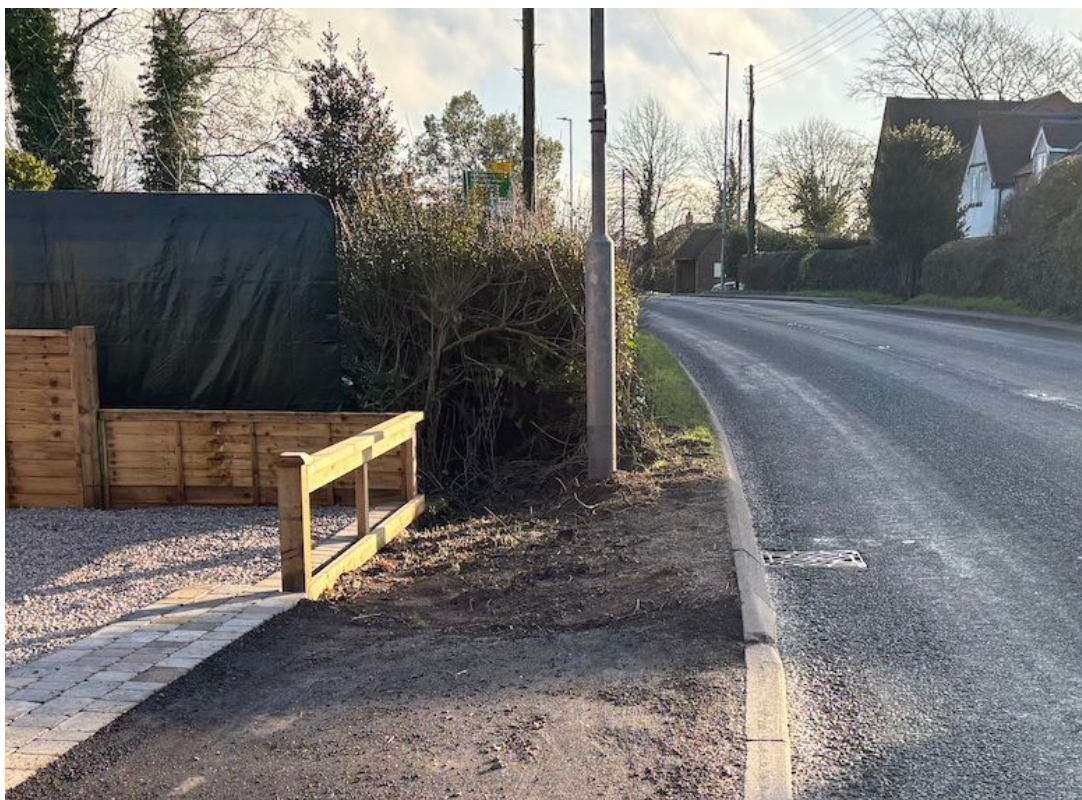
### Problem 2

**Location** New footway

**Summary** Risk of pedestrian falls

A new footway is proposed to the north of the street light. There is a level difference between the carriageway and the site. The new footway may cause an increased level difference at the back of the footway when installed. This may result in pedestrian injury should they wander from the footway.

**Recommendation** Provide restraint feature or extend level surface at the back of the footway.

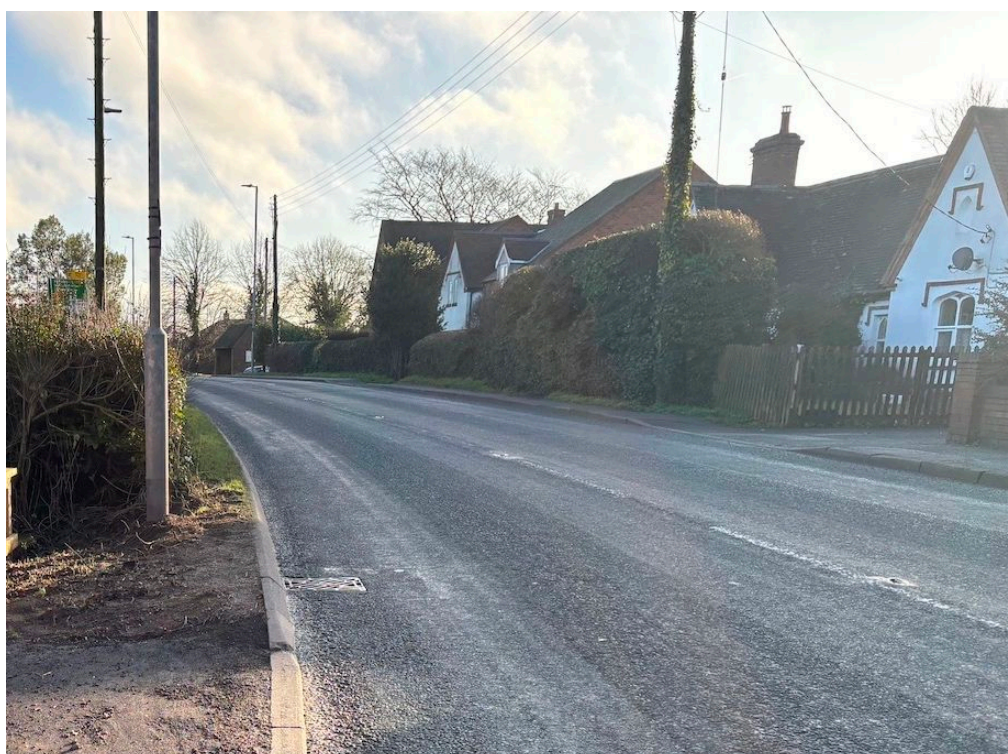
- 4.1.1 This section of the report provides the following commentary on issues identified for the scheme proposals that are considered by the Audit Team not to be raised as a problem within the Stage 1 Road Safety Audit.
- 4.1.2 The new footway is proposed to have HB kerbs installed. It is noted that the existing kerbing along the eastern side of Burton Road are splayed kerbs. It would be prudent to amend the kerb type at the detailed design stage.

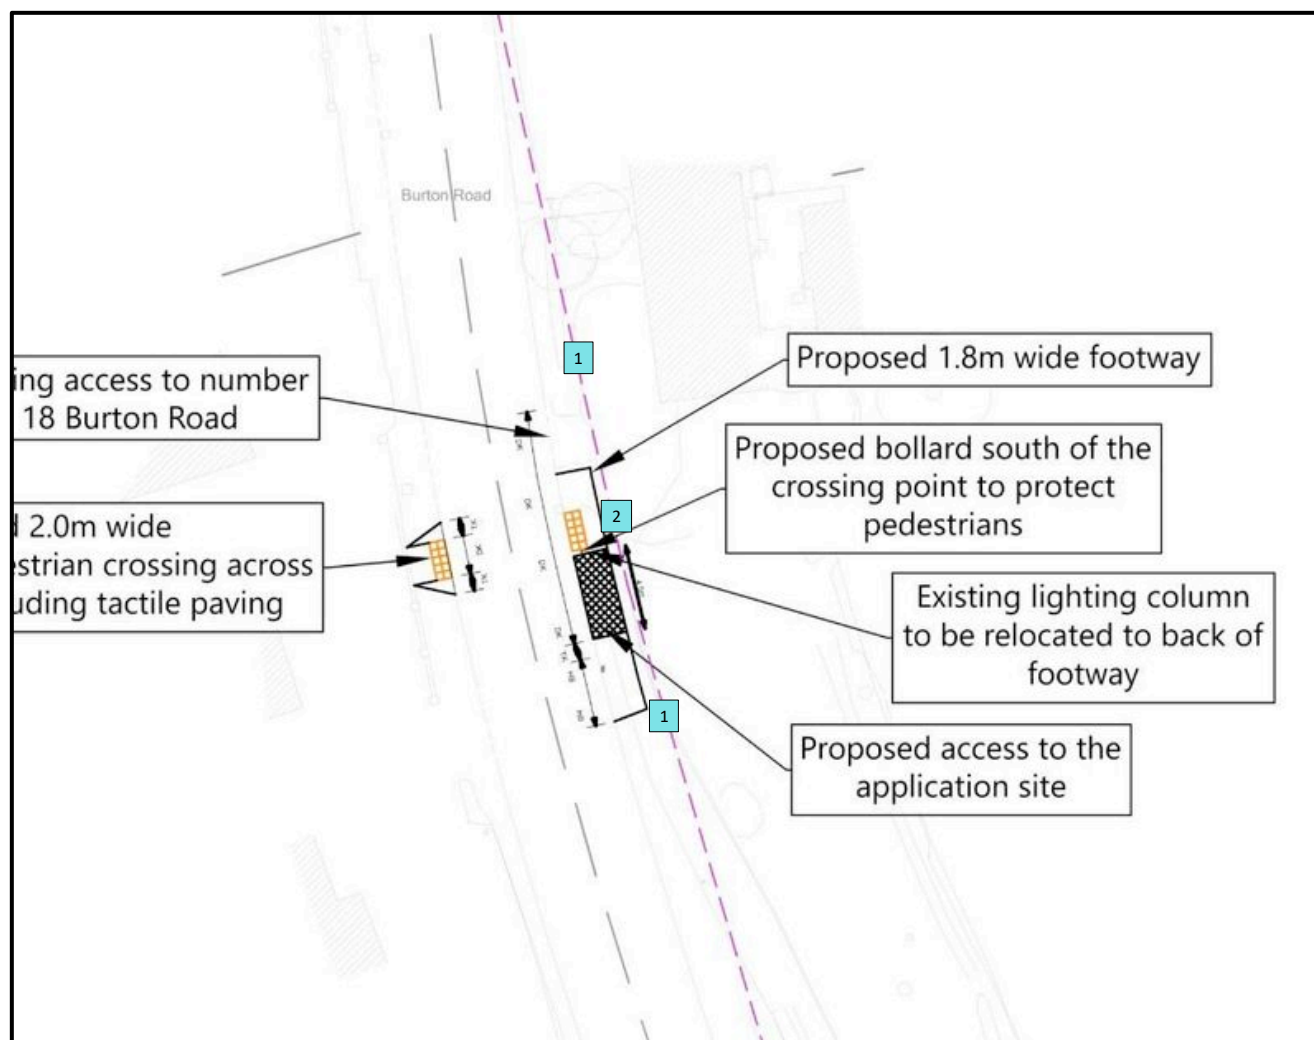
## Appendix C Problem Location Plan

- 1.8.4 The submitted design drawings have been annotated to show the location of problems identified during this Stage 1 Road Safety Audit, which are shown at **Appendix C**.
