## **Phase II Geo-Environmental Assessment**

### **Basin Bridge Bungalow**

Hinckley Lane  
Higham on the Hill  
Nuneaton  
Leicestershire  
CV13 6JL

**EPS Project Reference:** UK23.6353b

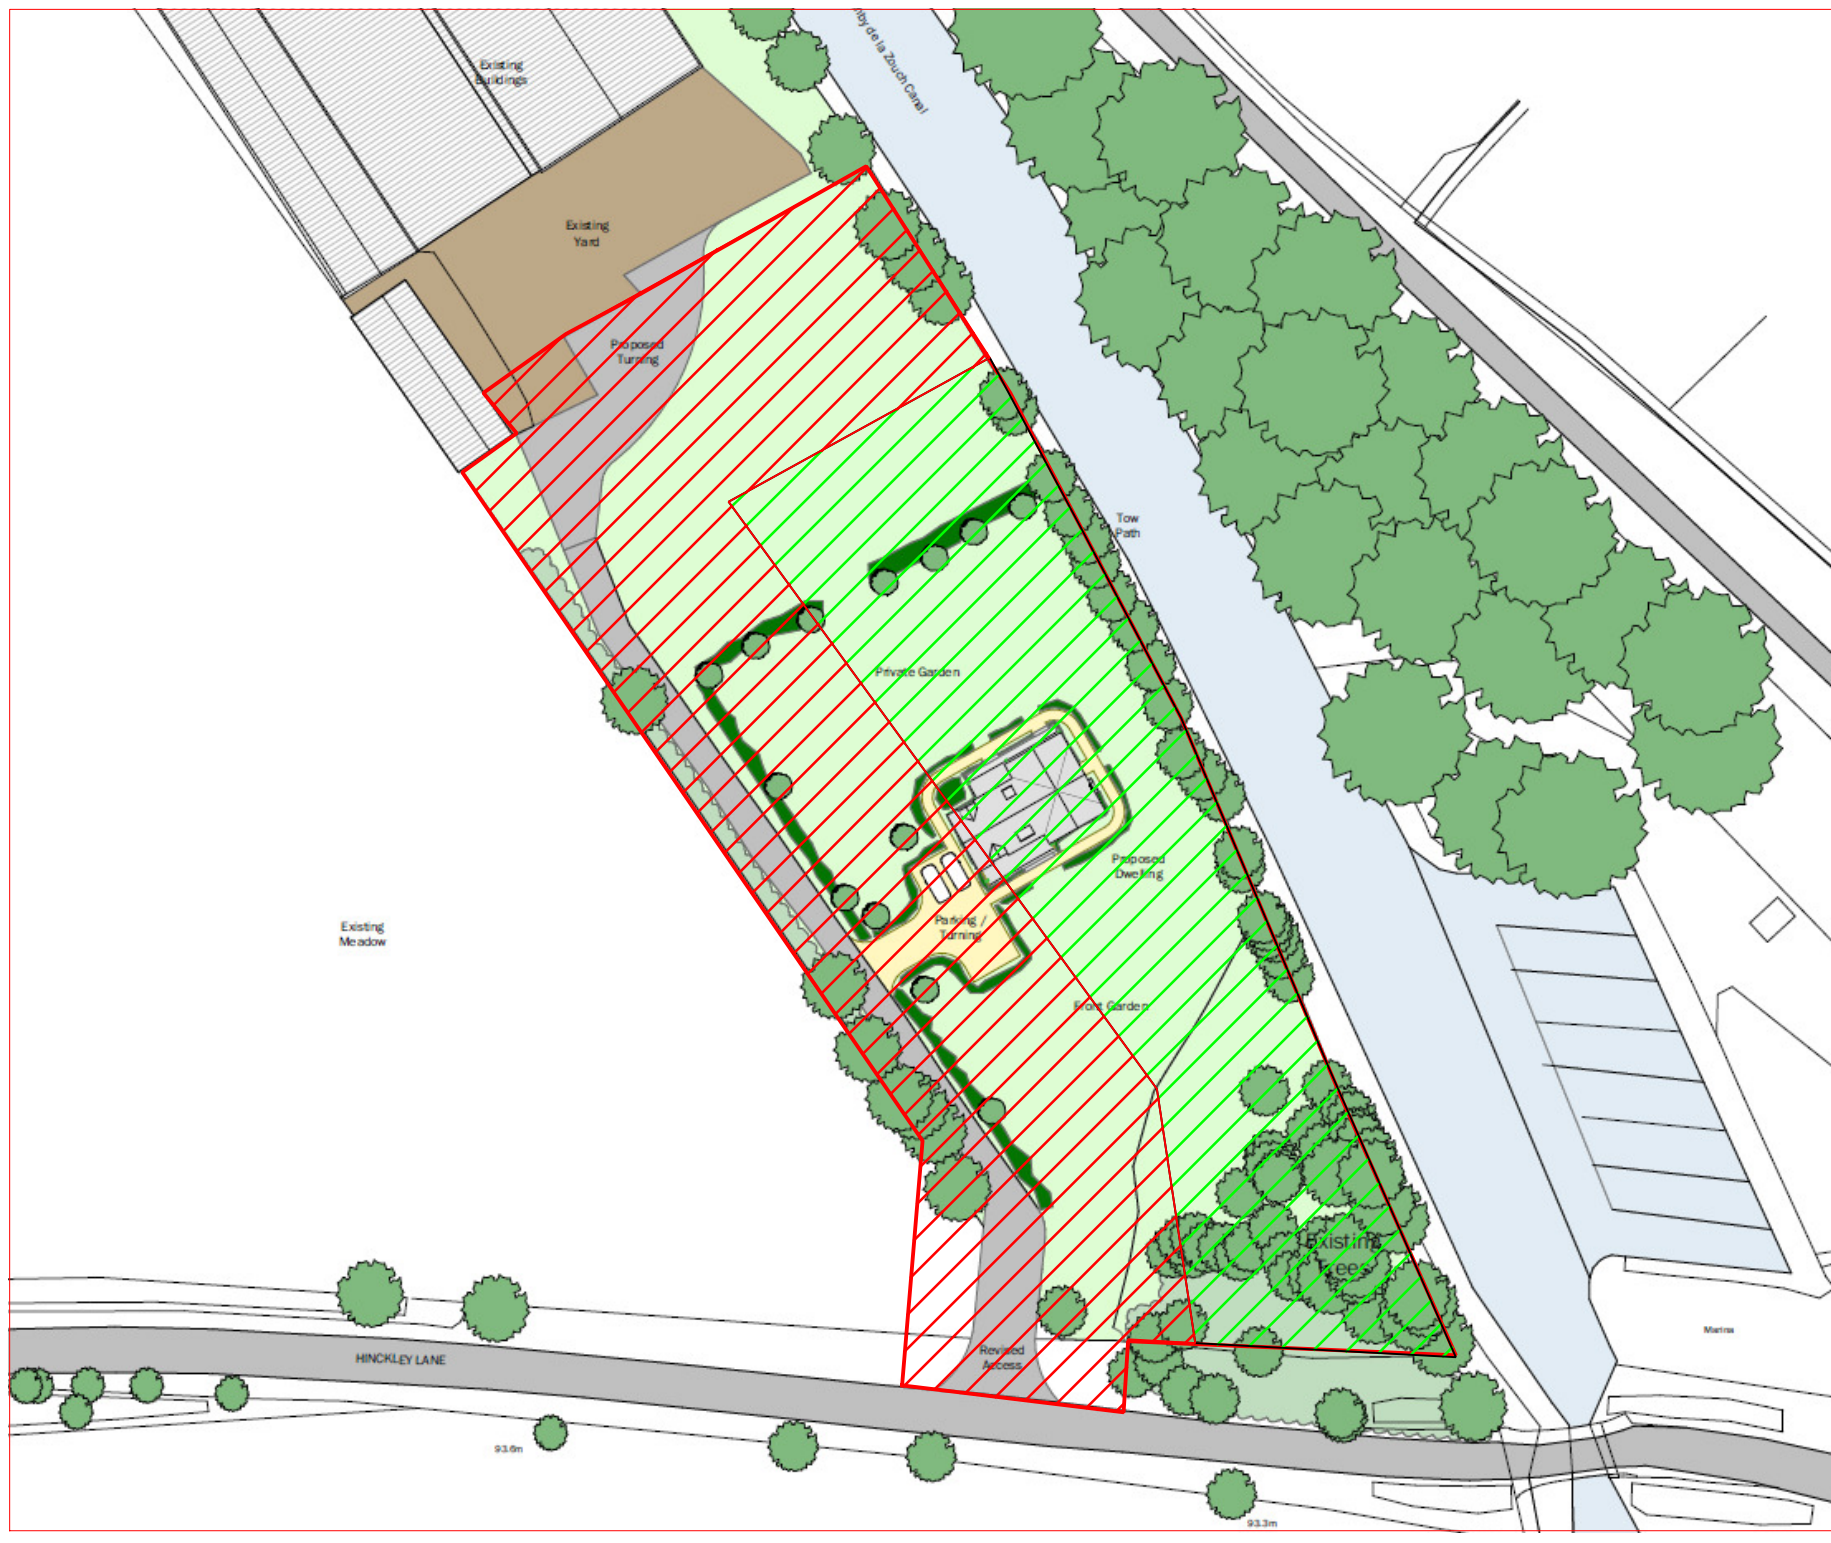
- KEY:
- SITE BOUNDARY
  - APPROX. EXTENT OF MADE GROUND REQUIRING SOURCE REMOVAL & FULL 600MM OF COVER
  - APPROX. EXTENT OF MADE GROUND REQUIRING REDUCED 300MM COVER SYSTEM

Based on the findings of the risk assessment, the proposed cover system thickness can be reduced to **300mm** in the eastern section of the plot (as highlighted by the extent of the green hatching on **Figure 3** of this report). This is to account for the distribution of similar infilled soils in this area, which although have been found to be less severe both visually during the intrusive works and through laboratory analysis, do still have the potential to hold significant impacts of similar contaminants of concern.

It should be noted that cover soils are unlikely to be required across the entire eastern section, with only natural materials recovered in trial holes close to the boundary (i.e. TP01, TP02 and TP09) and therefore in the interests of promoting sustainability and not removing and replacing soils unnecessarily, it is recommended that excavations in this area only extent to sections where infilled soils containing evidence of constriction debris and plastic waste are noted. EPS can provide assistance during future remedial works to guide the extent of the excavations if required.

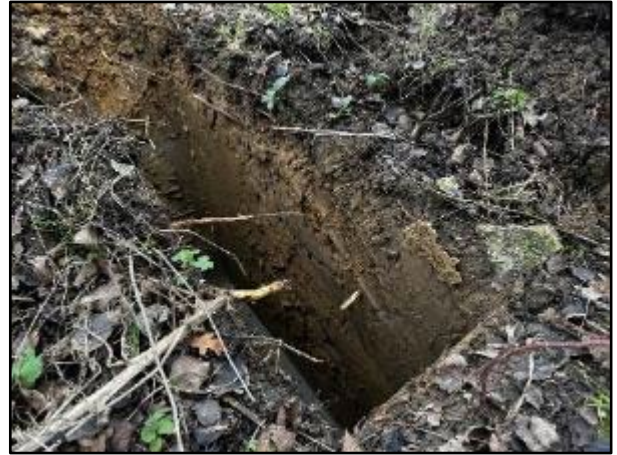
A limited thickness of topsoil was encountered from the surface in TP01, TP02 and TP09 beneath the grass covering and was observed as a dark brown, silty clay with active roots/ rootlets and progressed to around 0.2m depth. These locations were all formed just inside the eastern boundary of the property.

**Photo 4** – A photo of the trial pit excavated at TP01 near the south east corner.

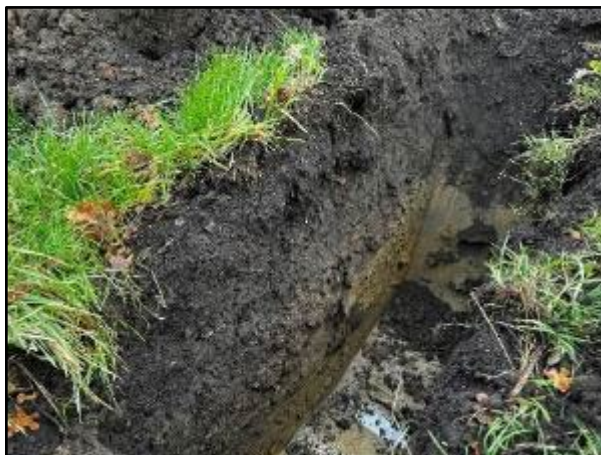
**Photo 5** – A photo of TP03 where made ground was recovered.

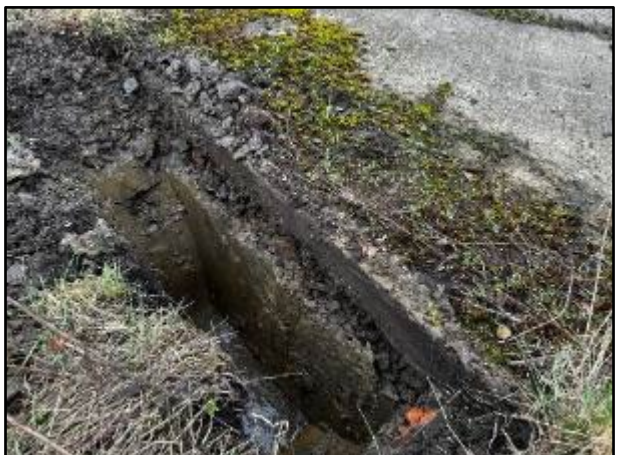
**Photo 6** – The trial pit at TP10 showing the surfacing profile and underlying made ground.
