**A Level 2 Historic Building Survey at  
37 High Street and 2A main Street,  
Desford,  
Leicestershire  
NGR: SK 47878 03357**

ULAS Report No 2025-026

| <b>Site Name:</b> | 37 High Street and 2A Main Street, Desford, Leicestershire |
| <b>Planning Ref:</b> | 23/00711/FUL |

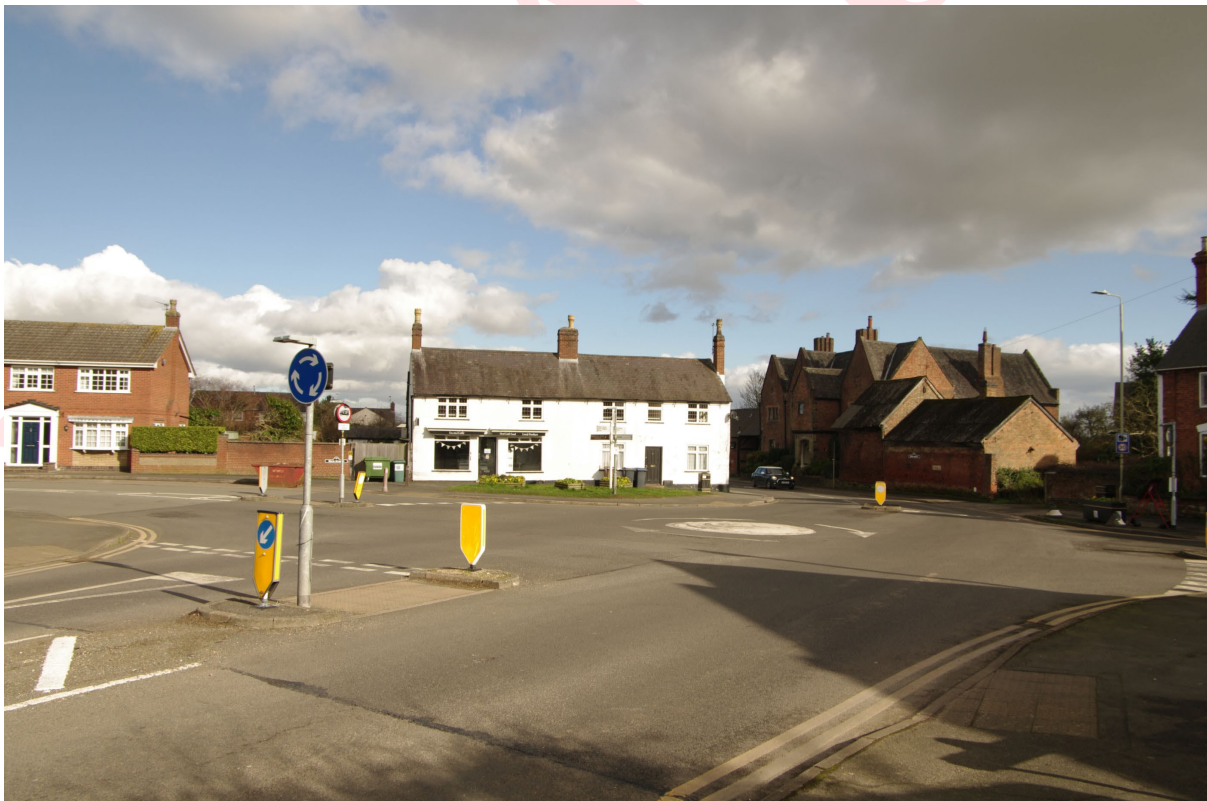
Figure 5: View of the surveyed building seen from Manor Road

Looking east. Main Street on the left High Street centre right. The white painted surveyed building consists of Number 2A Main Street on the left and 37 High Street on the right. The grade II\* listed Manor House can be seen on the right of the picture

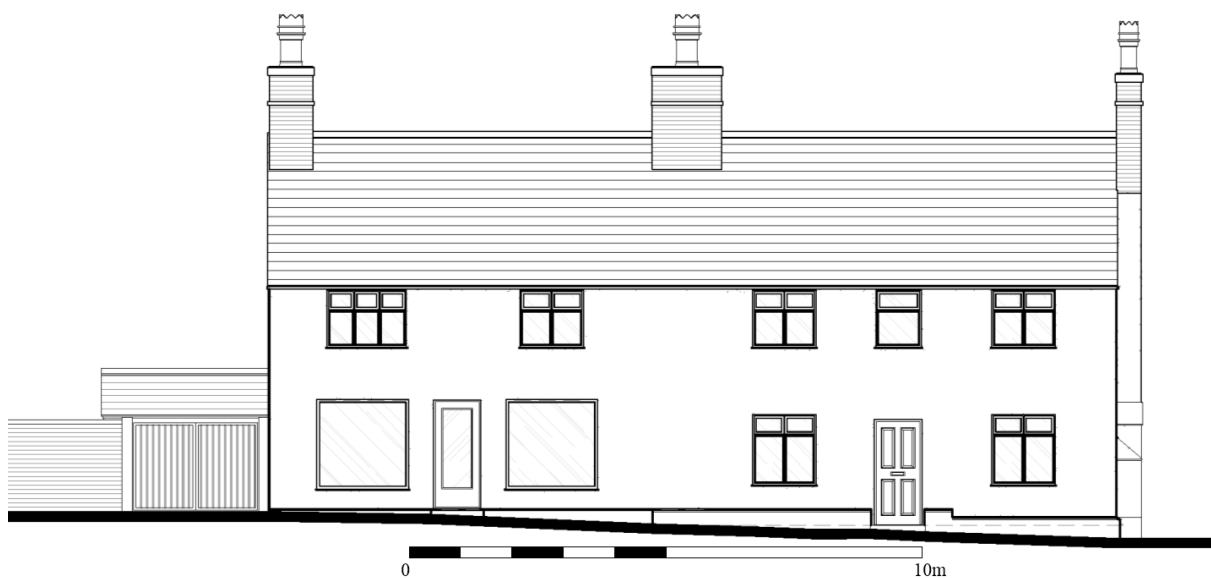
Figure 9: South-west facing elevation

The south-west facing elevation is the principal elevation of the building. There is a clear difference between the two halves of the building made more prominent by the conversion of Number 2A to a bank and, latterly, a café. Number 37 High Street (the southern end of this elevation) has three first floor windows with its central window not quite centrally located which suggests a possible difference internally. Between the doorway of 37 and the ground floor window to the north are two parallel cracks in the render which may hide structural alterations or, possibly, timber framing.

Modified from drawing supplied by client. The small northern extension is hidden in this drawing by the gate and brick wall on the left (see plans later in this report)

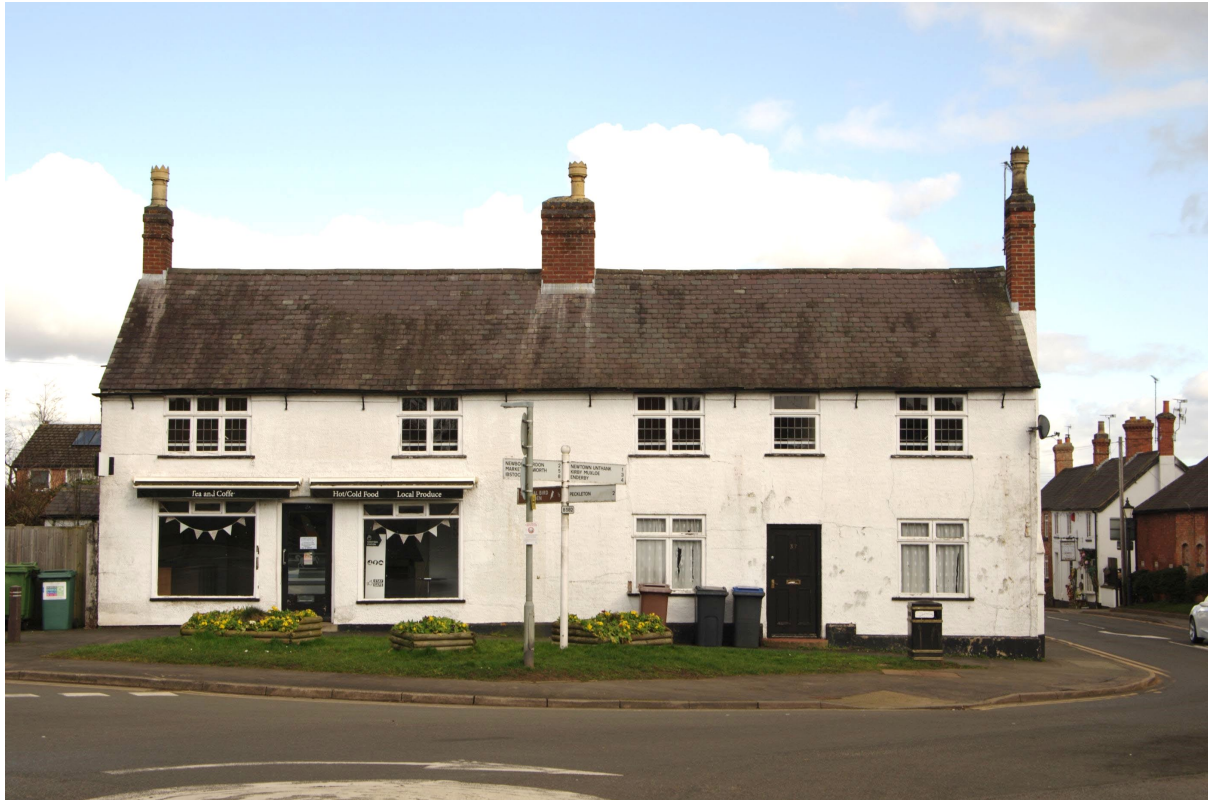
Figure 10: South-west facing elevation

Looking north-east. Number 2A Main Street with the large ground floor windows is the range to the left of the road signs, 37 High Street is to the right. The first floor of Number 37 extends for the full length of the building

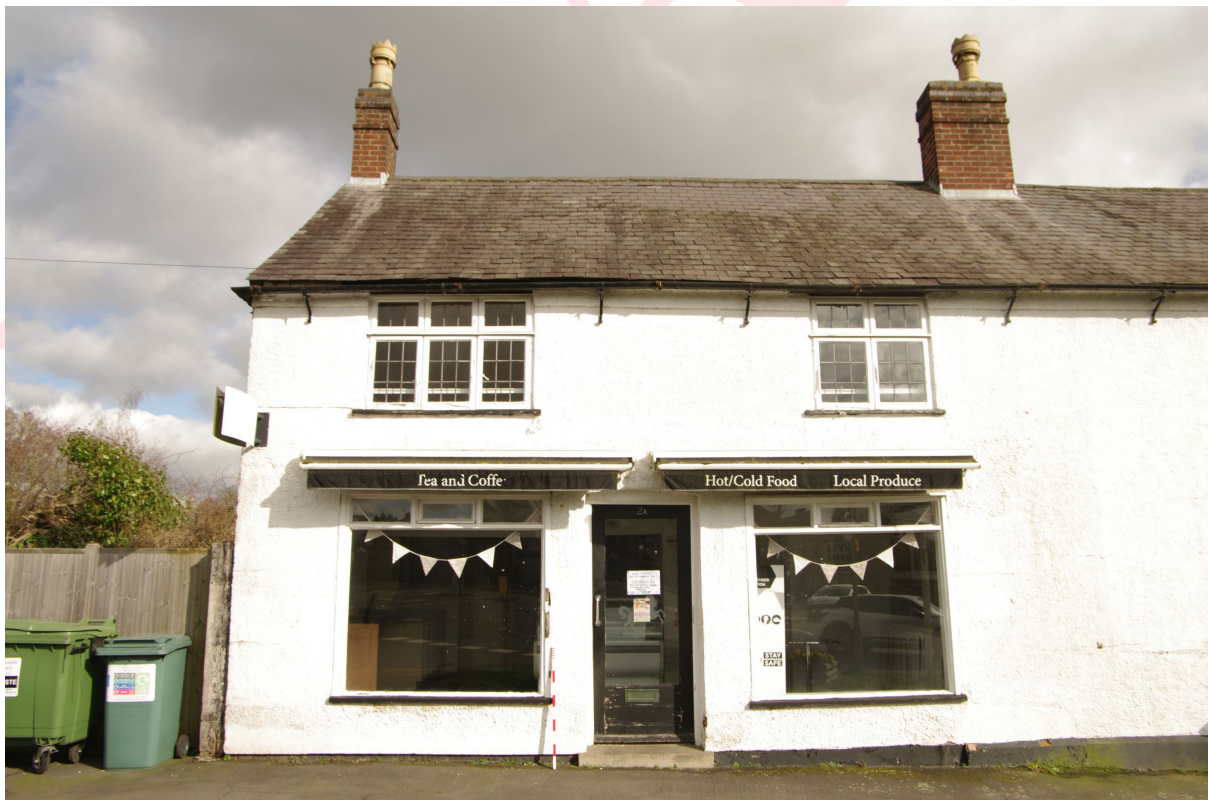
Figure 11: SW facing elevation, Number 2A Main Street

Looking north-east. 1m scale. The single storey pitched-roof extension on the north-west gable end is behind the wooden gate on the left

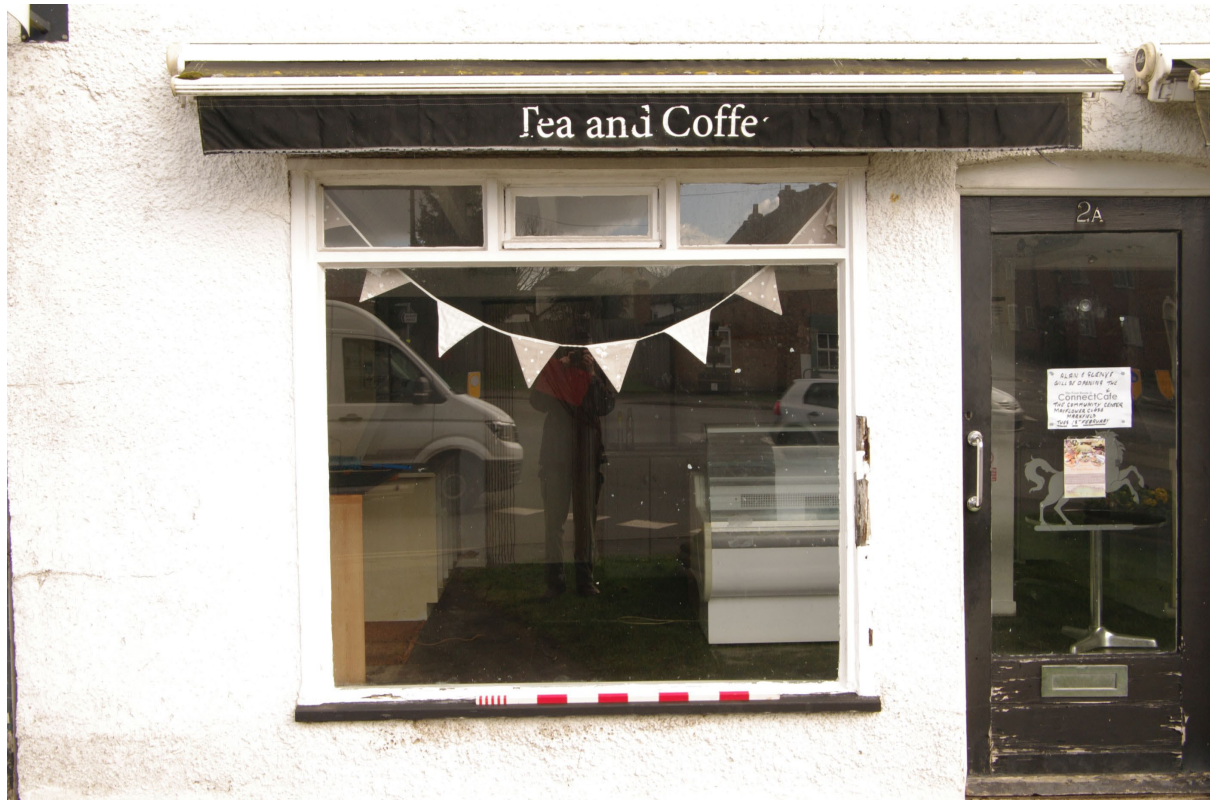
Figure 12: SW facing elevation, No 2A, ground floor window and door detail  
Looking north-east. 1m scale. Note the Lloyds Bank logo on the door

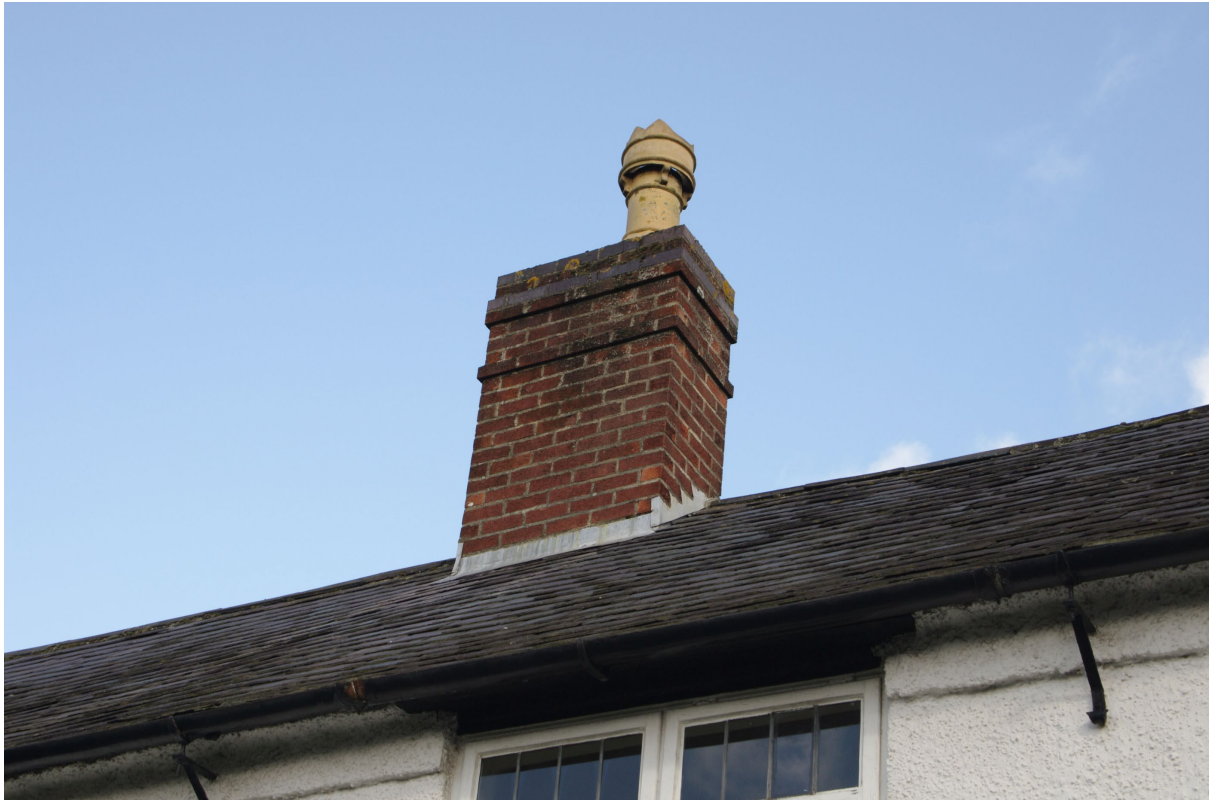
Figure 16: Central chimney stack seen from SW elevation  
Only one pot belonging to No 37 remains despite being a double flue stack

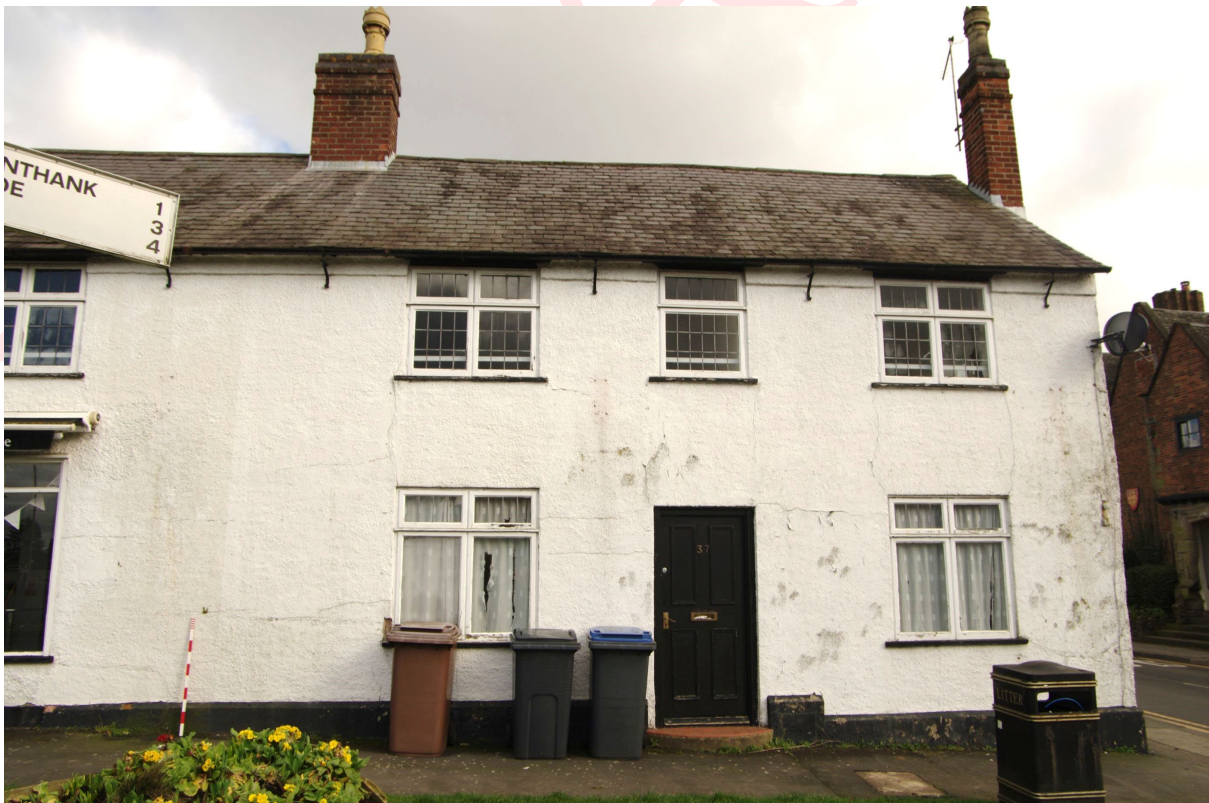
Figure 17: SW facing elevation of Number 37 High Street  
Looking north-east. 1m scale. High Street can be seen on the right

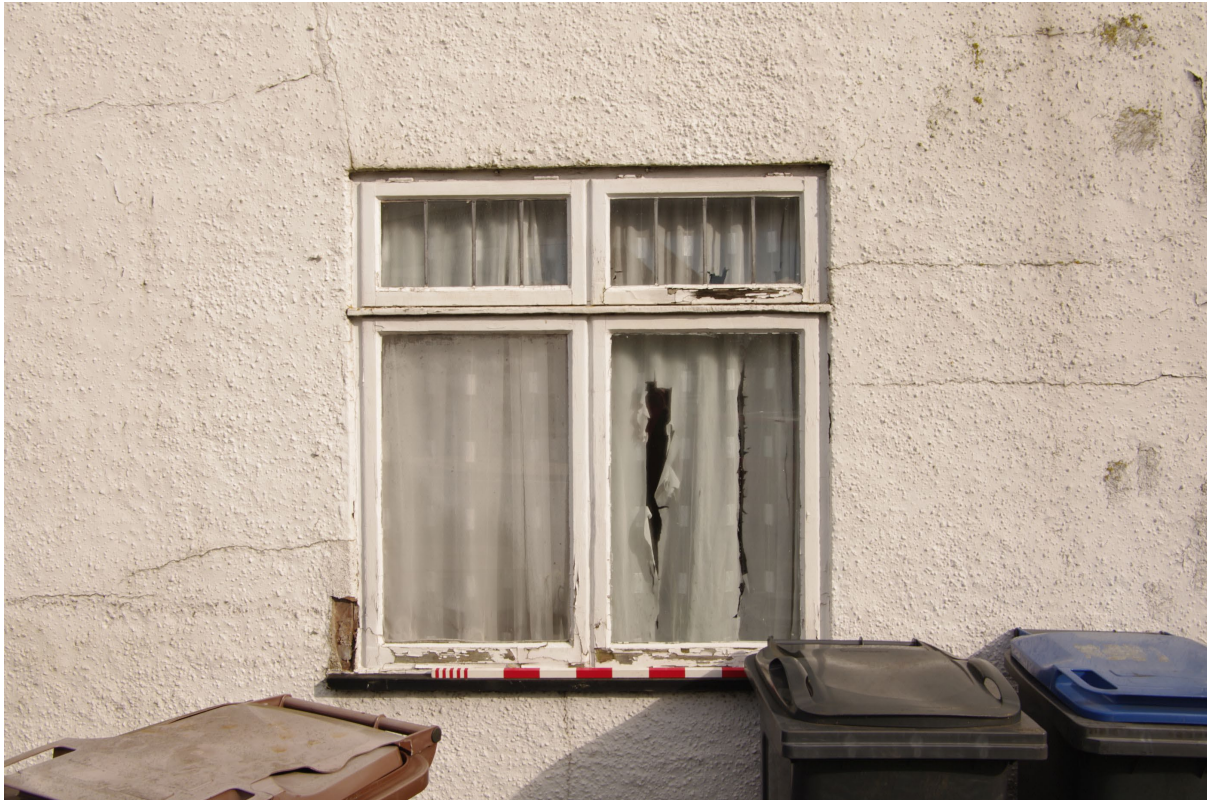
Figure 18: SW facing elevation of No 37, ground floor window detail to left of door  
Looking north-east. 1m scale. Note the parallel cracks in the render which may point to joints, or possible timberwork, within the wall structure

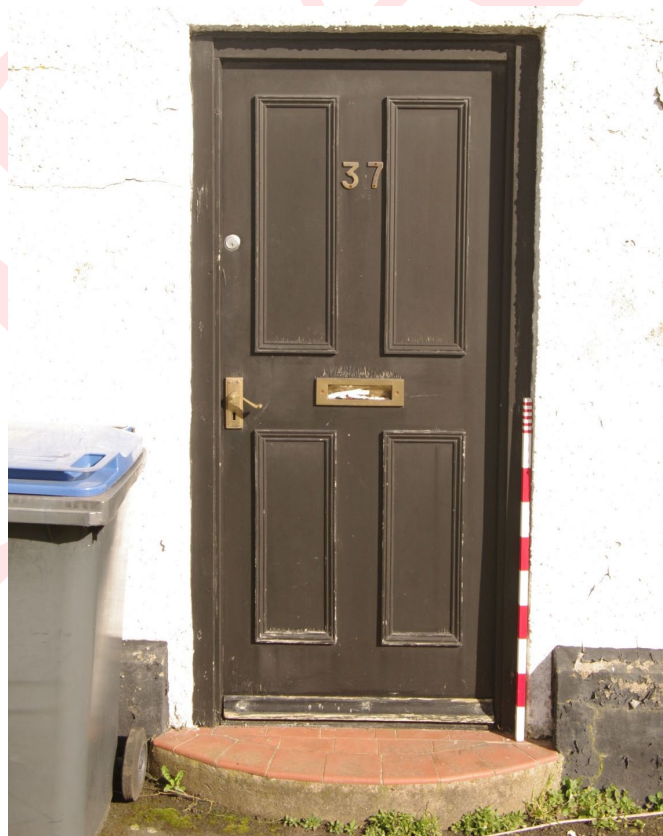
Figure 19: SW facing elevation of No 37, door detail  
Looking north-east. 1m scale

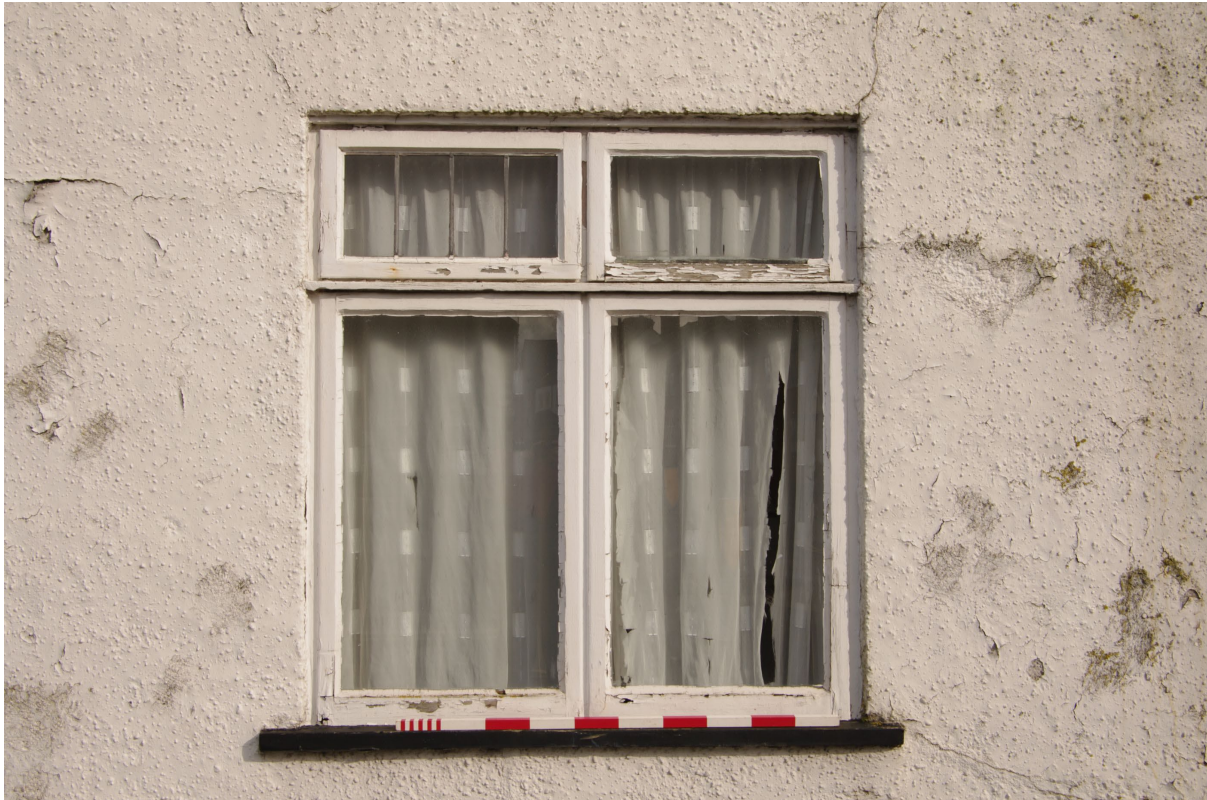
Figure 20: SW facing elevation of No 37, ground floor window detail to right of door  
Looking north-east. 1m scale

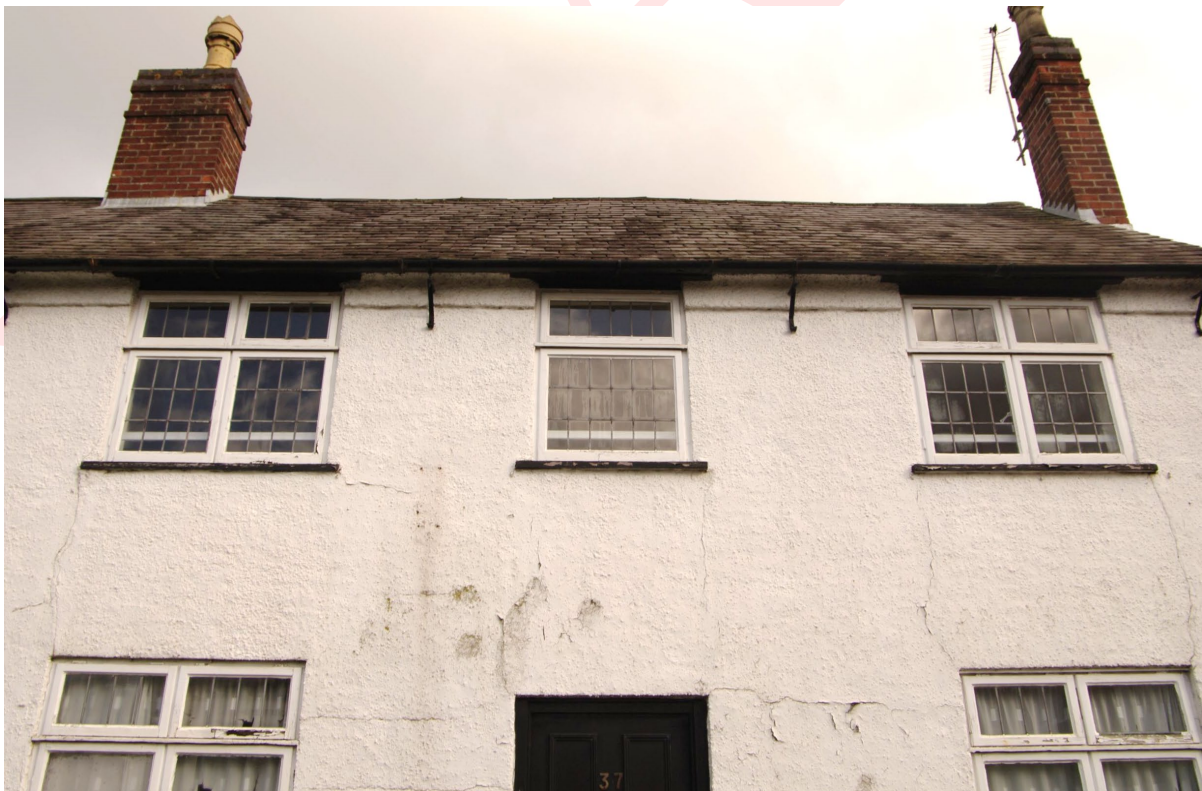
Figure 21: SW facing elevation of No 37, first floor window detail  
Looking north-east. As with No 2A these first floor windows have leaded panes

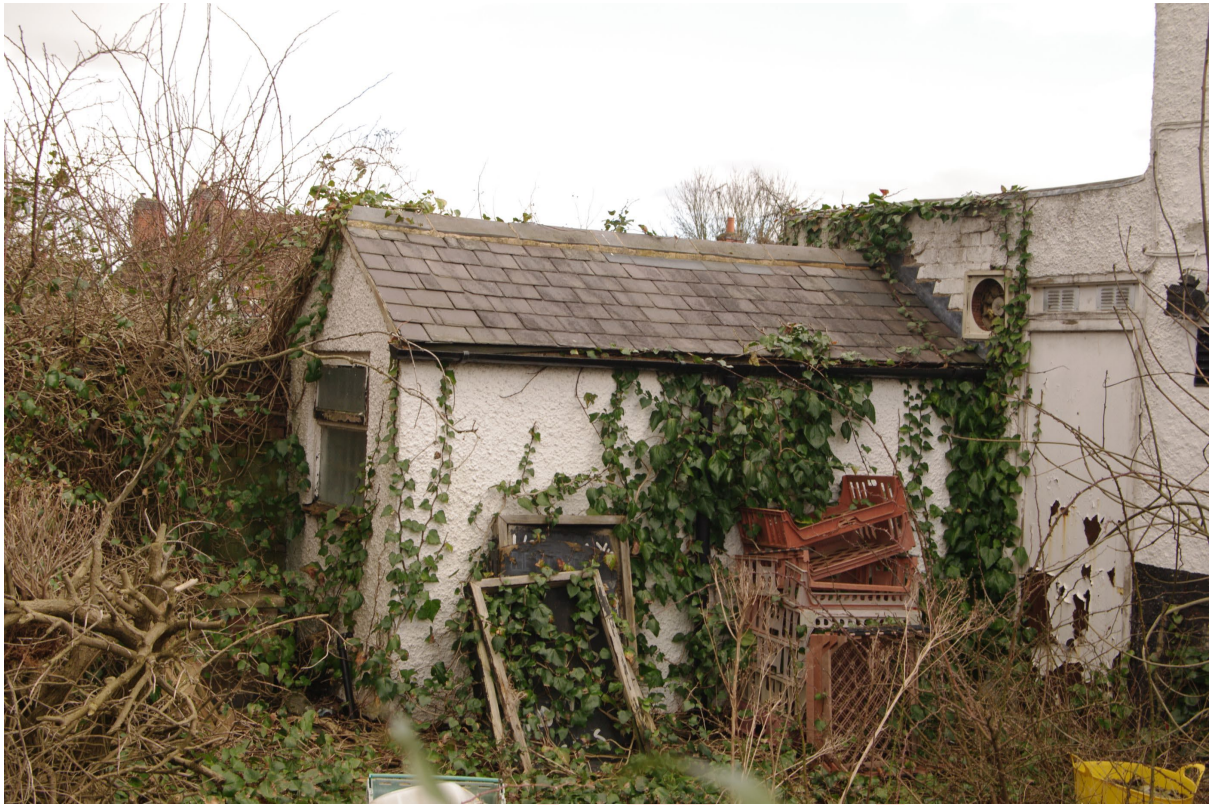
Figure 22: SW facing elevation of the extension on the NW side of the building  
Looking south-east. Note how it joins with the flat-roofed rear extension

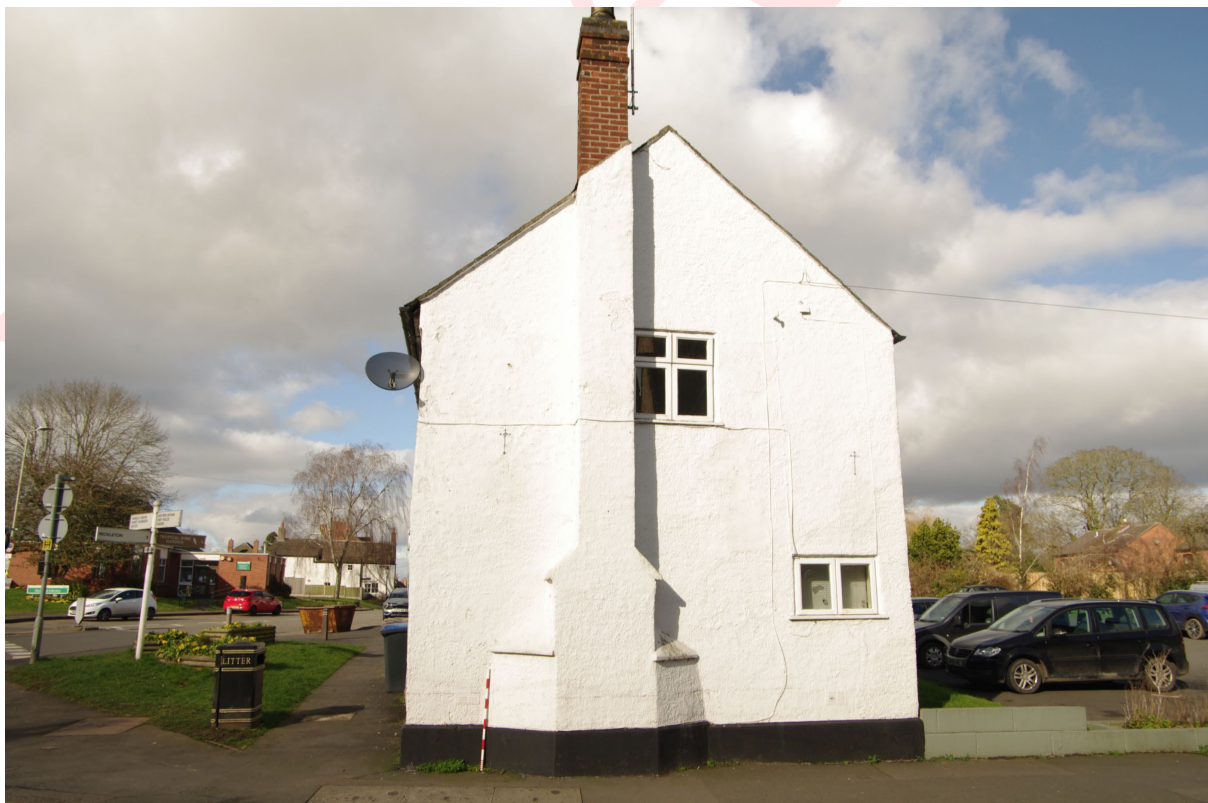
Figure 24: South-east facing elevation of 37 High Street

Looking north-west. 1m scale. Main Street on the left

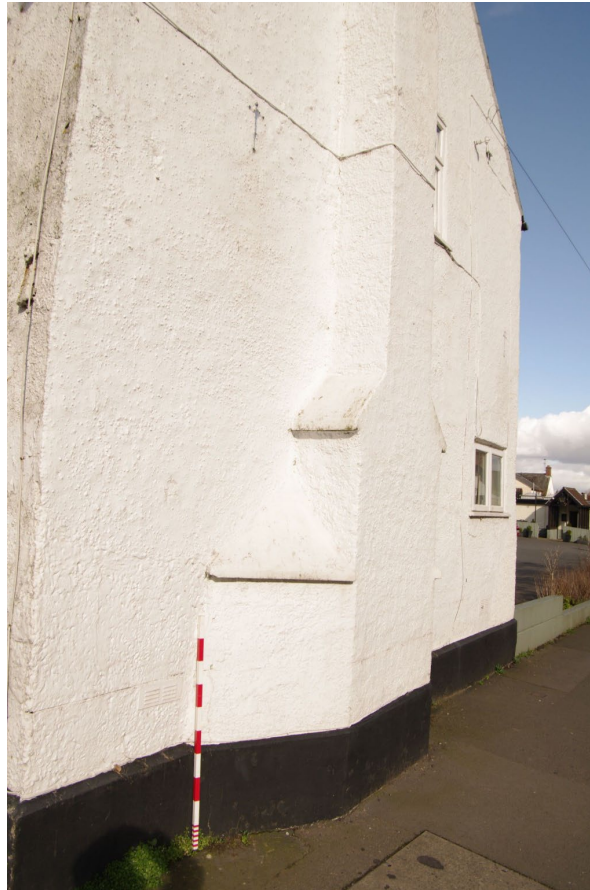
Figure 25: SE facing elevation chimney breast detail  
Looking north. 1m scale

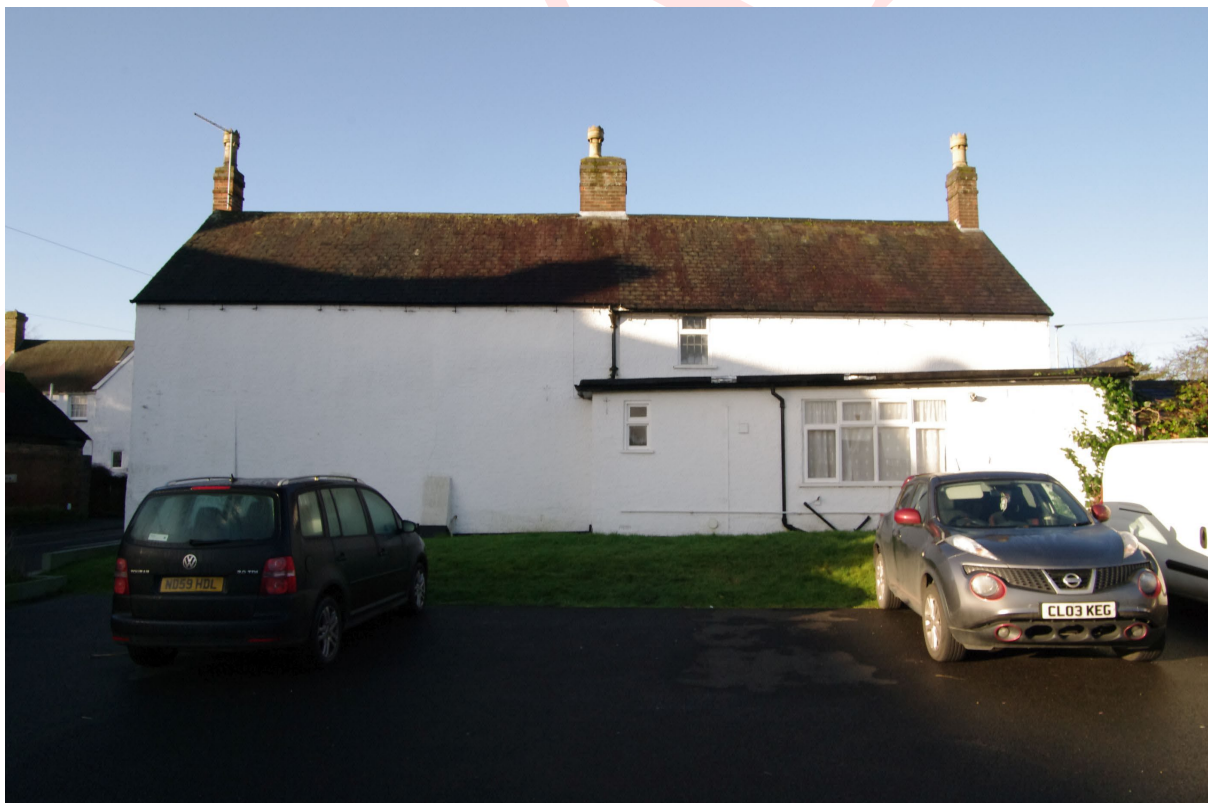
Figure 27: North-east facing elevation  
Looking south-west. Note the single storey extension to the right and lack of window and door openings on this elevation

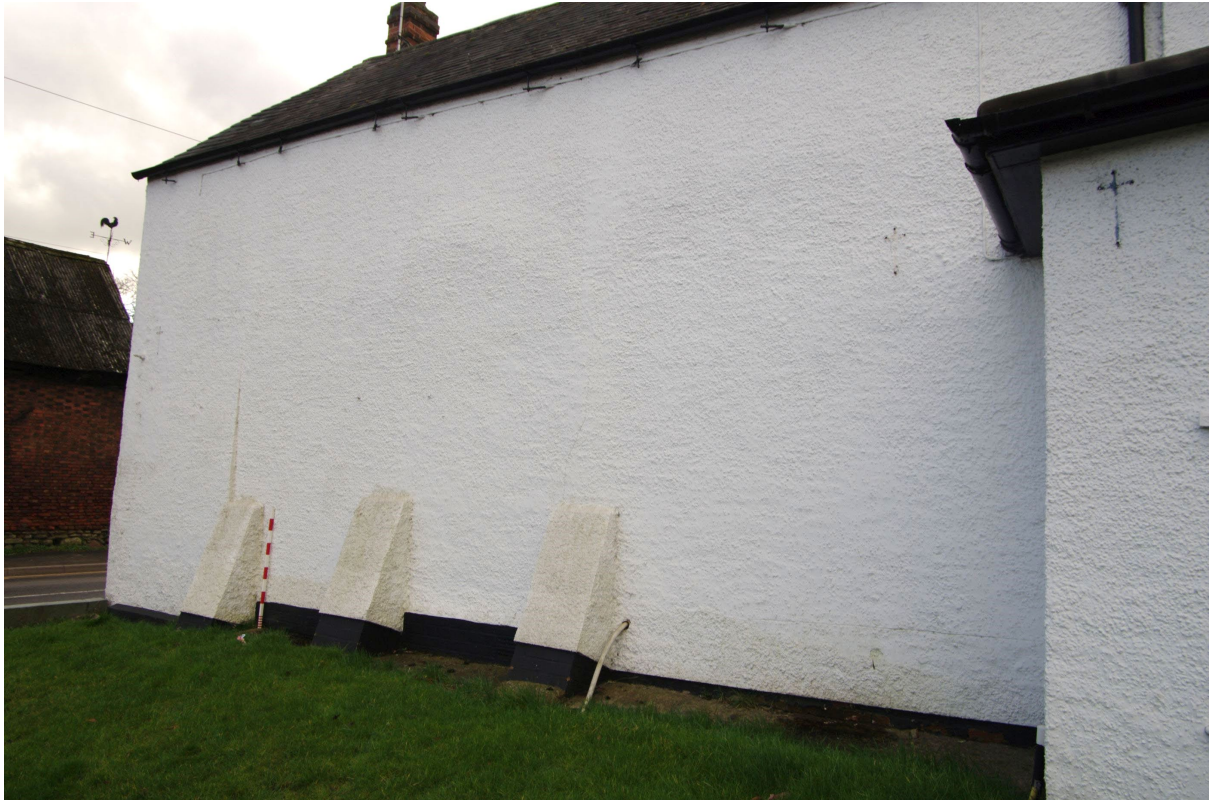
This elevation appears to have been extended at some time as there is a small step in the wall line close to the southern corner of the building. Further evidence of this is seen internally. The flat-roofed extension is built at a different angle to the rest of the building and follows the alignment of the now-demolished range in the car park. At first floor level just above the southern end of the extension is a second step out in the wall line and a slight change in the

Figure 28: NE facing elevation, southern end with step in the wall line  
Looking south. The step can be seen as a line just beyond the left hand buttress. 1m scale

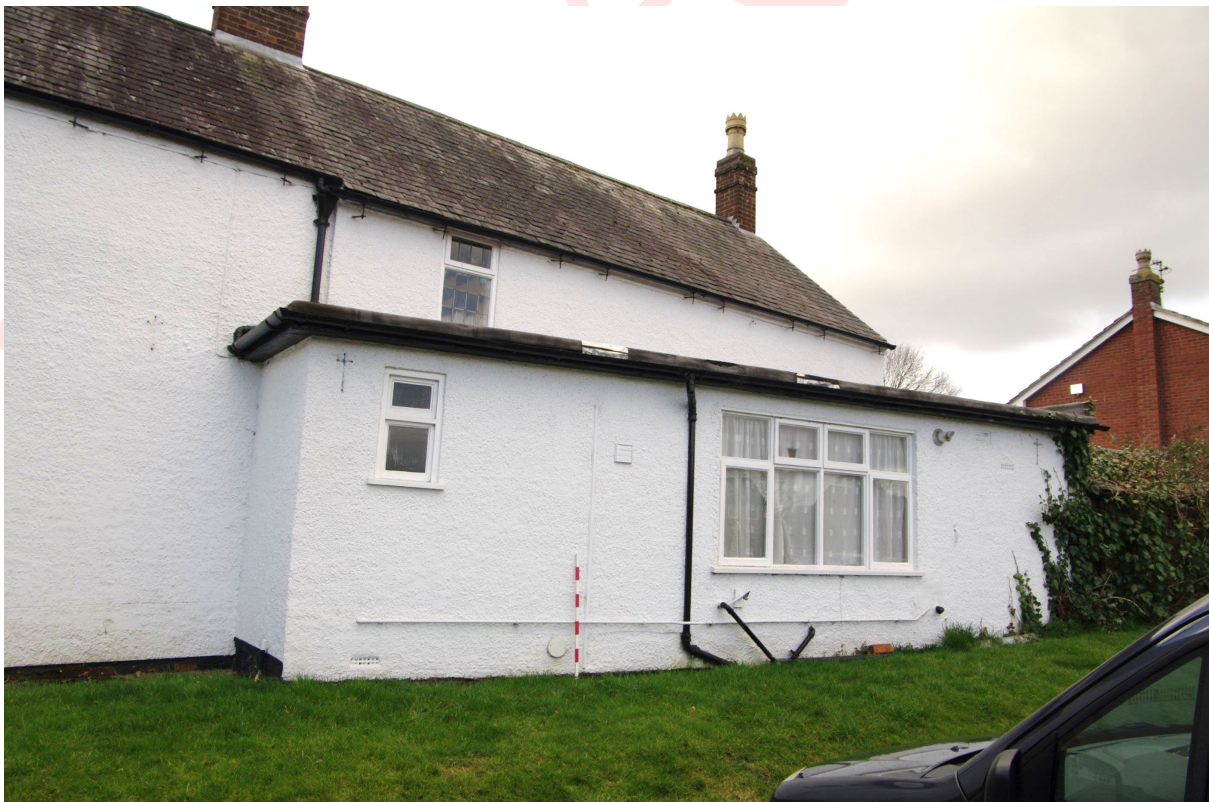
roof eaves level which again indicates another phase. Internally this step can be seen as a thickening of the wall of the northern end of the building and where some timberwork ends. The smaller pitched-roof extension extending out from the north-west facing gable end can just be seen through dense vegetation.

Figure 29: NE facing elevation, flat-roofed extension  
Looking north-west. Note the step in wall and eaves line to the right of the first floor downpipe. 1m scale

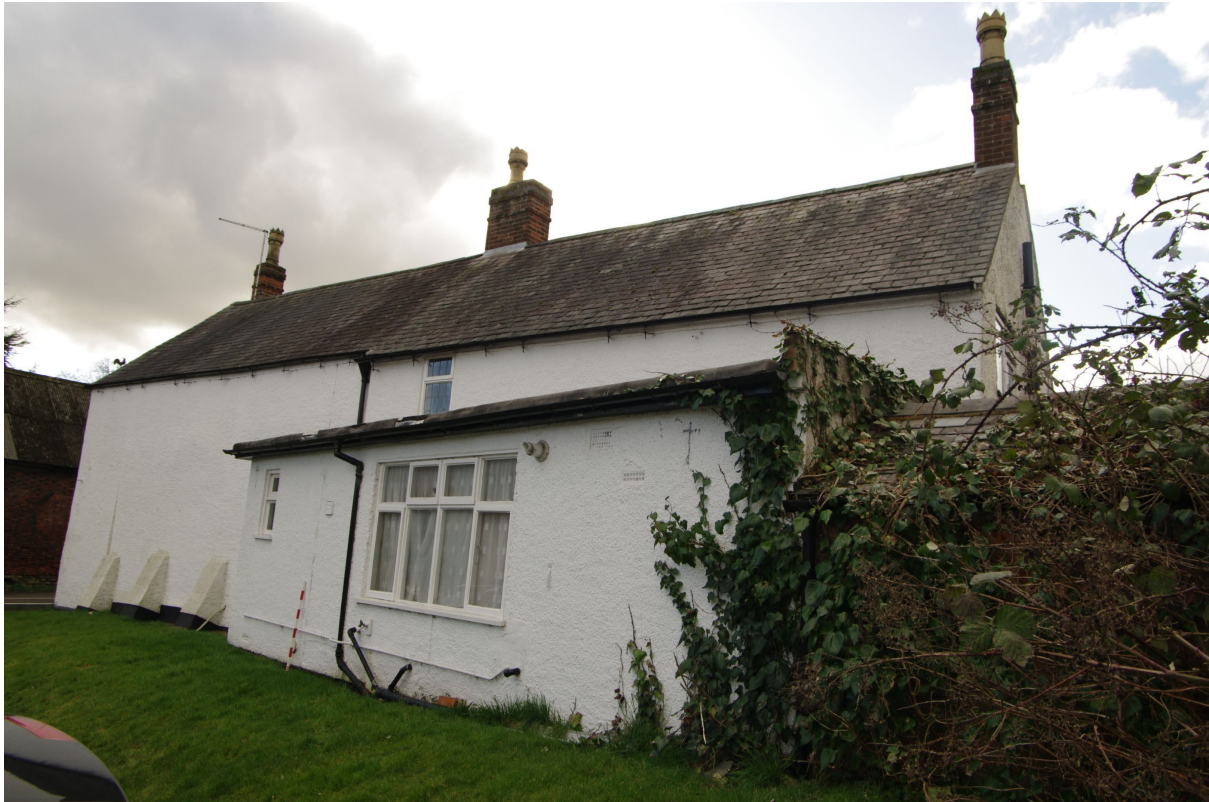
Figure 30: NE facing elevation and extensions

Looking south. The extension extending from the NW facing gable end can be seen in the vegetation on the right. 1m scale

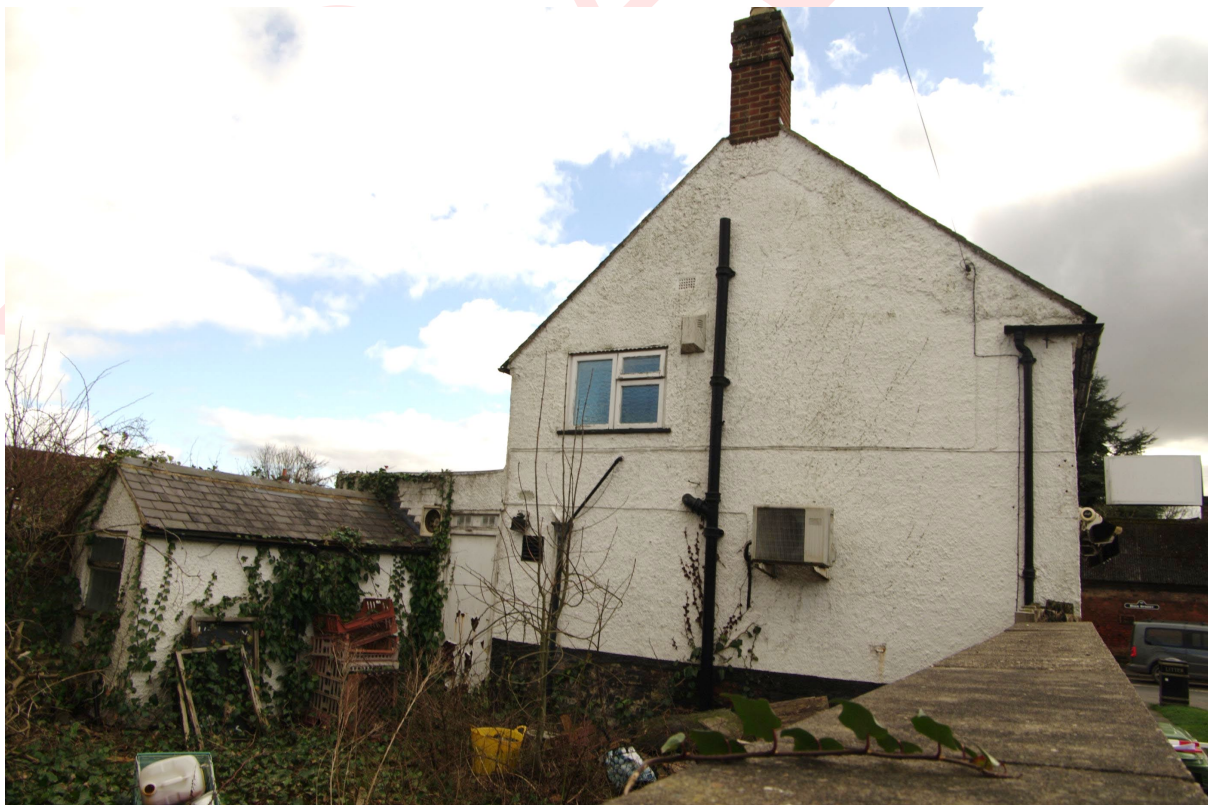
Figure 32: North-west facing elevation  
Looking south-east. Note the small extension on the left

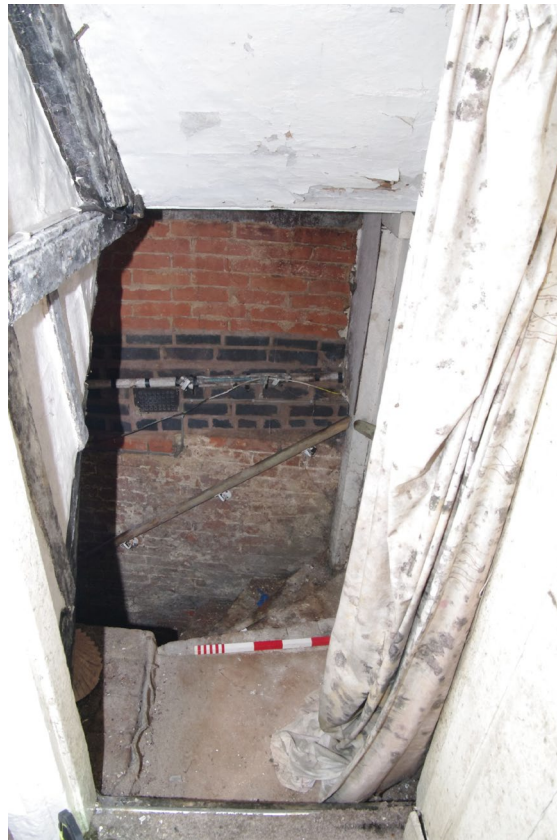
The cellar is accessed via a set of brick stairs from Room G4

Figure 34: Cellar steps seen from ground floor Room G4  
Looking north-east. 0.5m scale

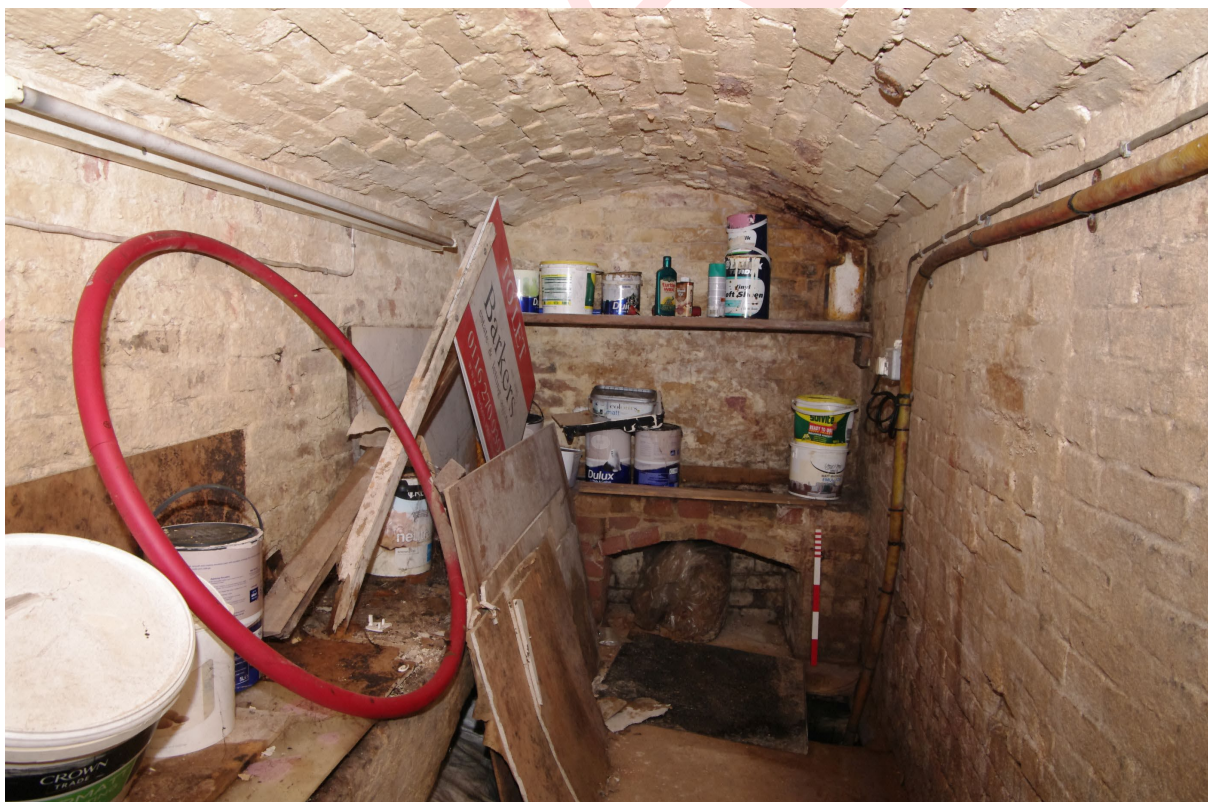
Figure 35: Cellar, general view  
Looking north-west. 0.5m scale

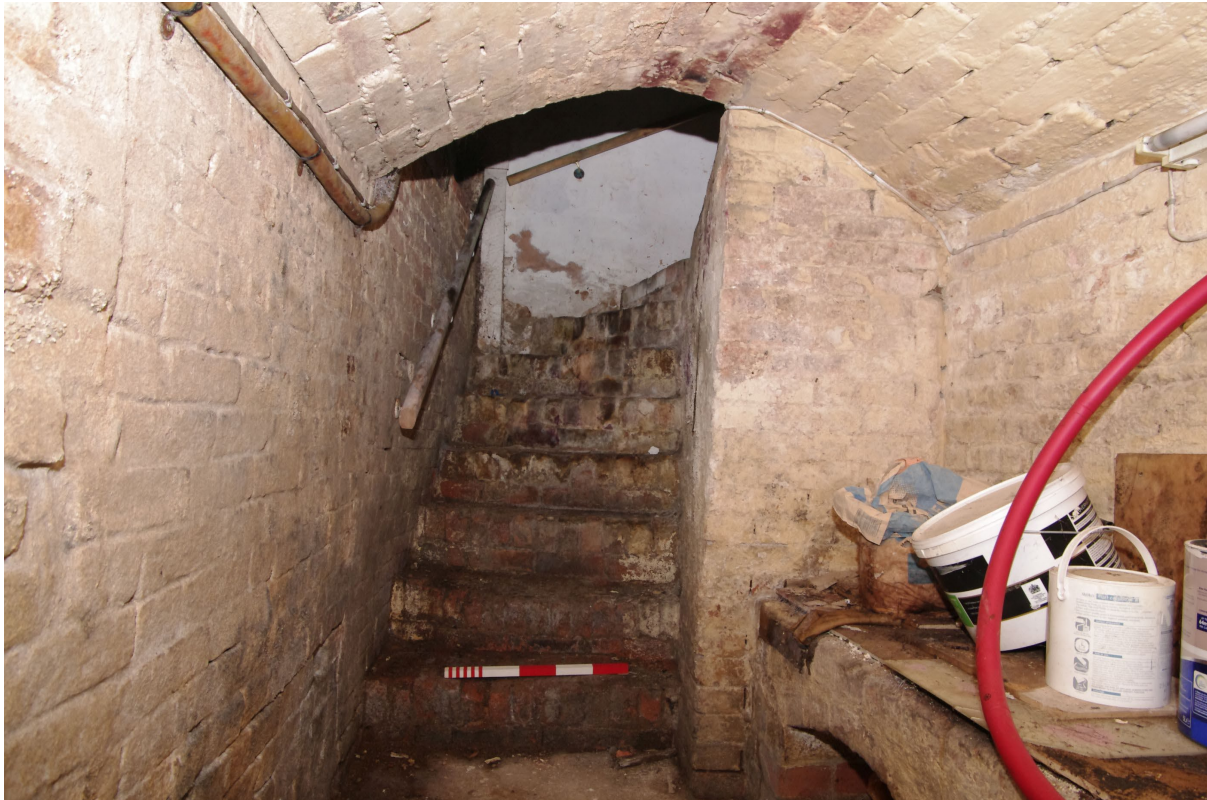
Figure 36: Cellar steps  
Looking south-east. Note brick-arched thrall on the right. 0.5m scale

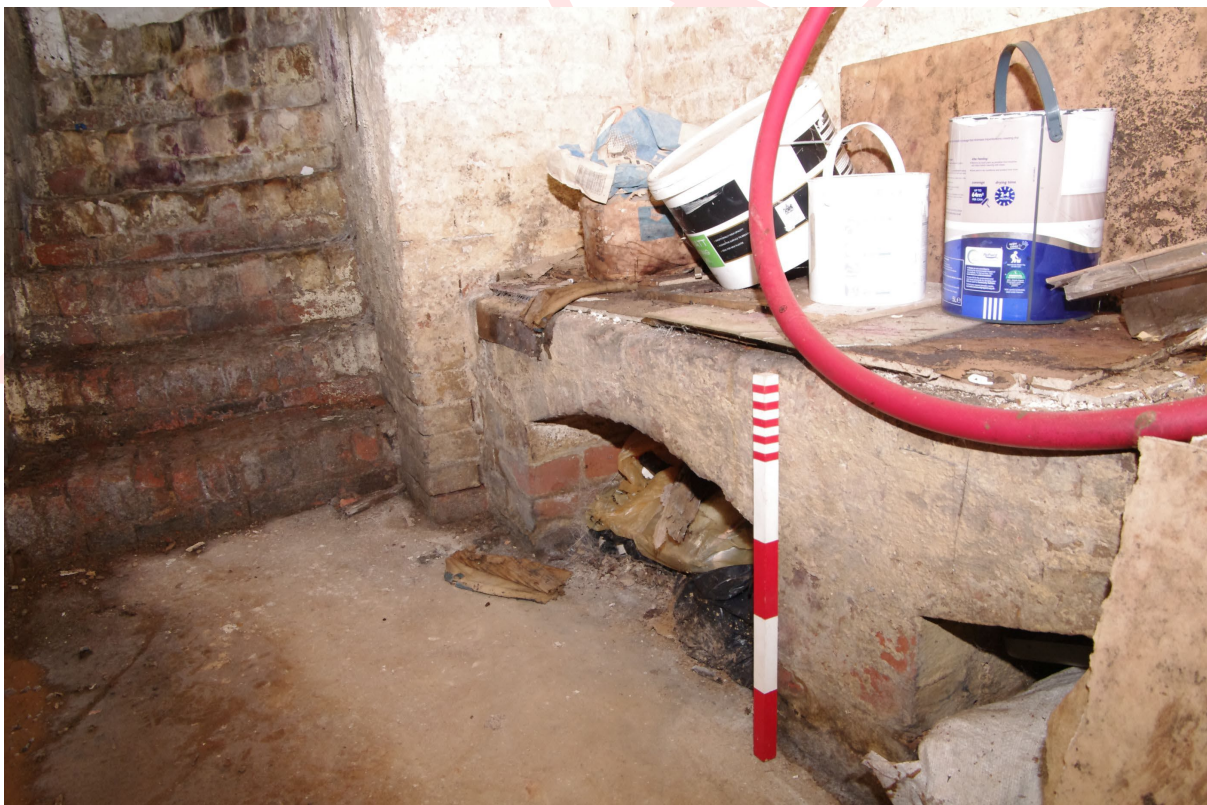
Figure 37: Cellar thrall detail  
Looking south. 0.5m scale

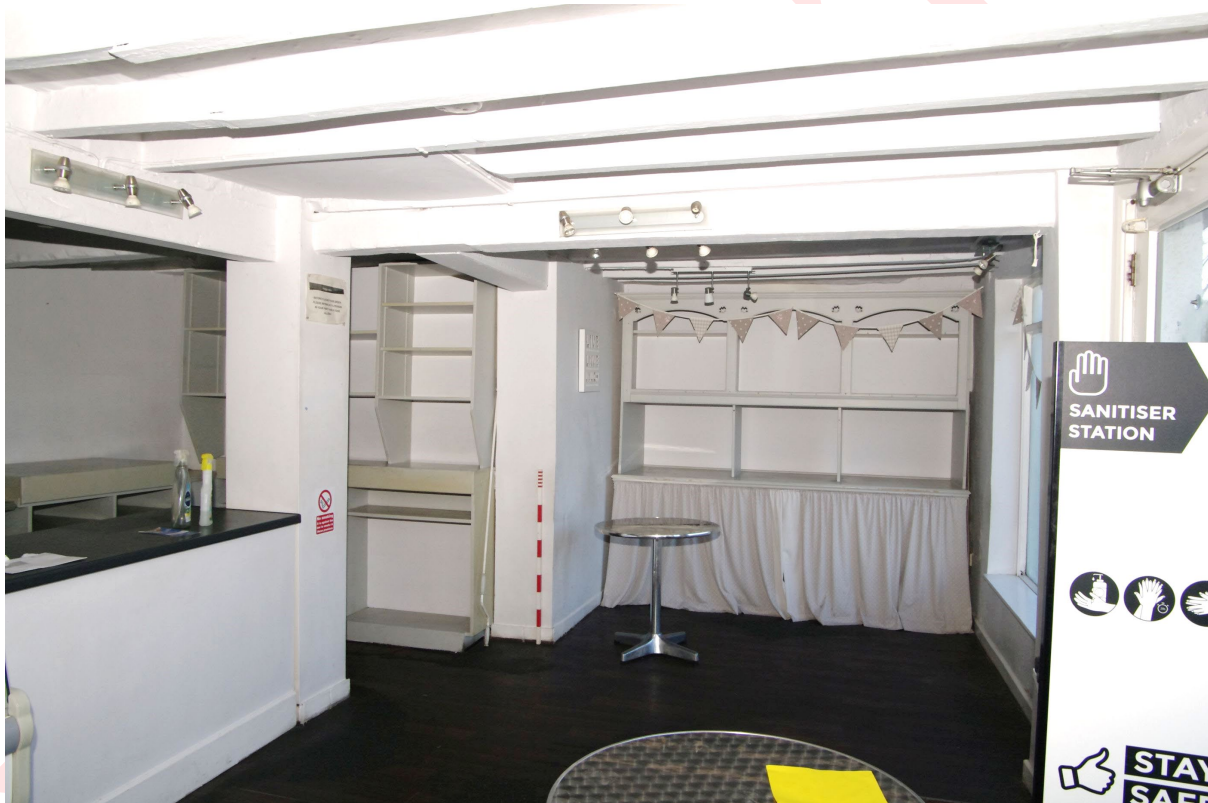
Figure 39: Room G1 general view

Looking east. The front door is on the right behind the sanitizer station. Note the board between the ceiling joists which marks the location of the former staircase. A former dividing wall behind the 1m scale has been truncated. Another truncated wall (slightly offset) can be seen at the end of the counter
