**A Level 2 Historic Building Survey at  
37 High Street and 2A main Street,  
Desford,  
Leicestershire  
NGR: SK 47878 03357**

ULAS Report No 2025-026

| <b>Site Name:</b> | 37 High Street and 2A Main Street, Desford, Leicestershire |
| <b>Planning Ref:</b> | 23/00711/FUL |

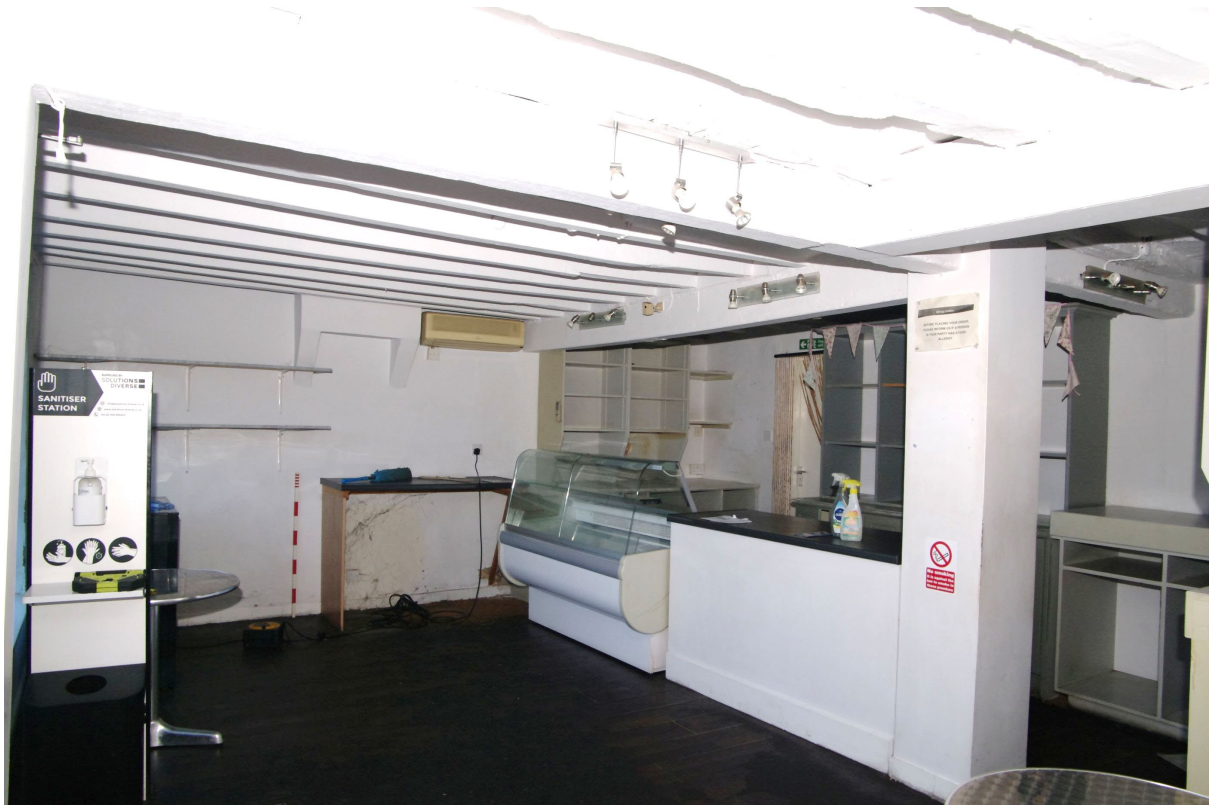
Figure 40: Room G1 general view

Looking north. Note the truncated chimney breast and now-removed fireplace above the 1m scale

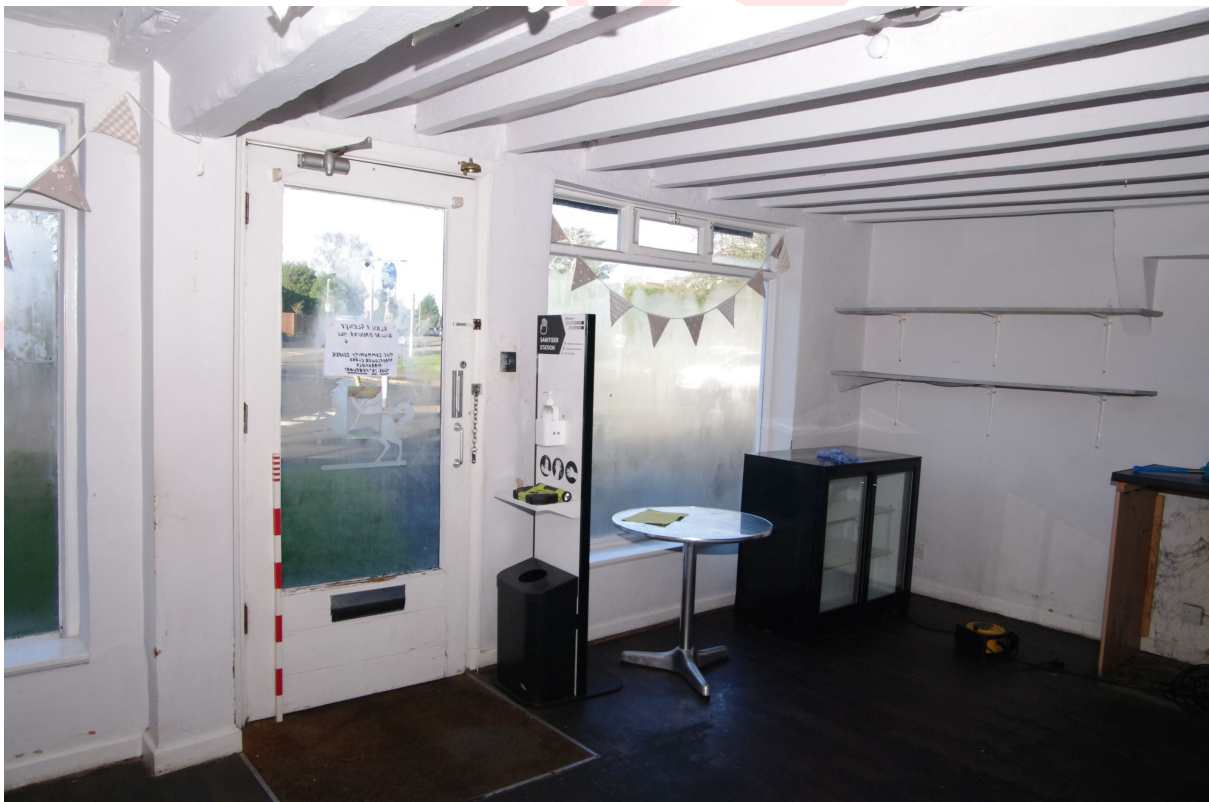
Figure 41: Room G1 general view

Looking west. 1m scale. Note the truncated dividing wall and supporting beam to the left of the door

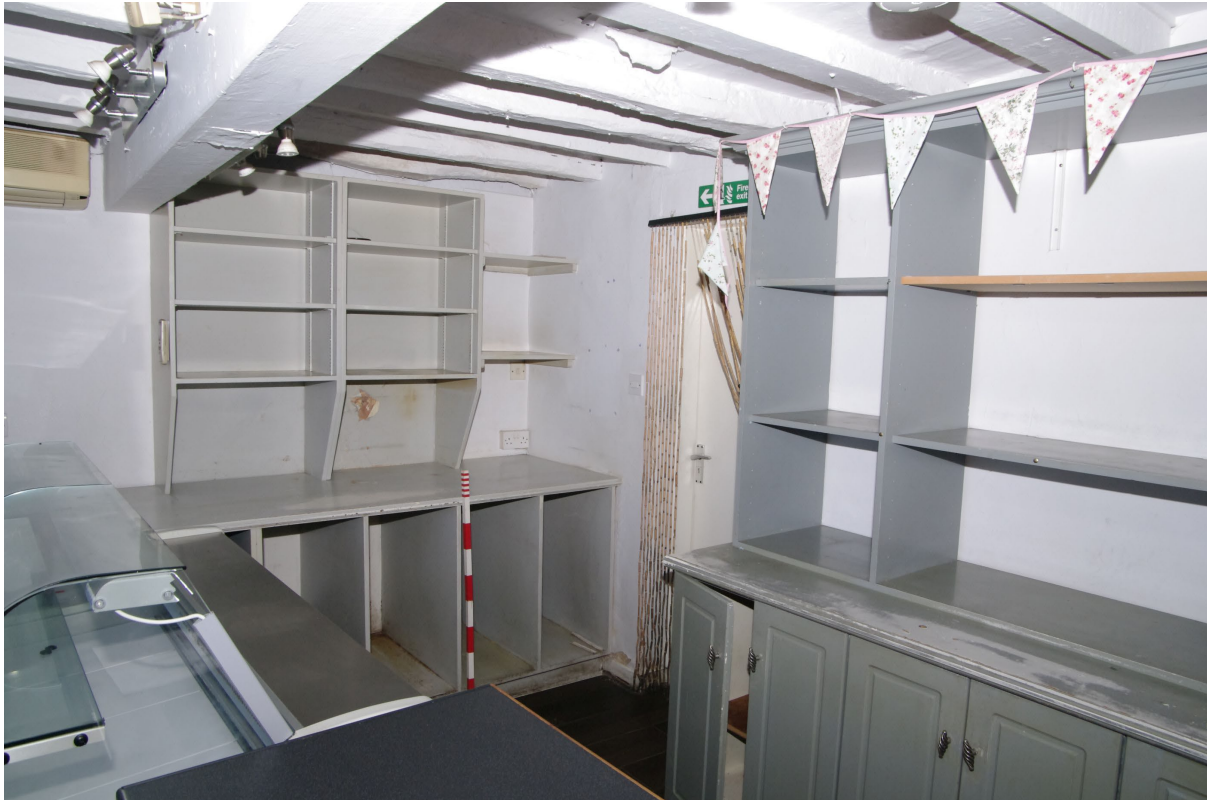
Figure 42: Rear of Room G1

Looking north. The doorway to G2 and G3 is on the right. The former wall line is seen in the large supporting beam top left. 1m scale

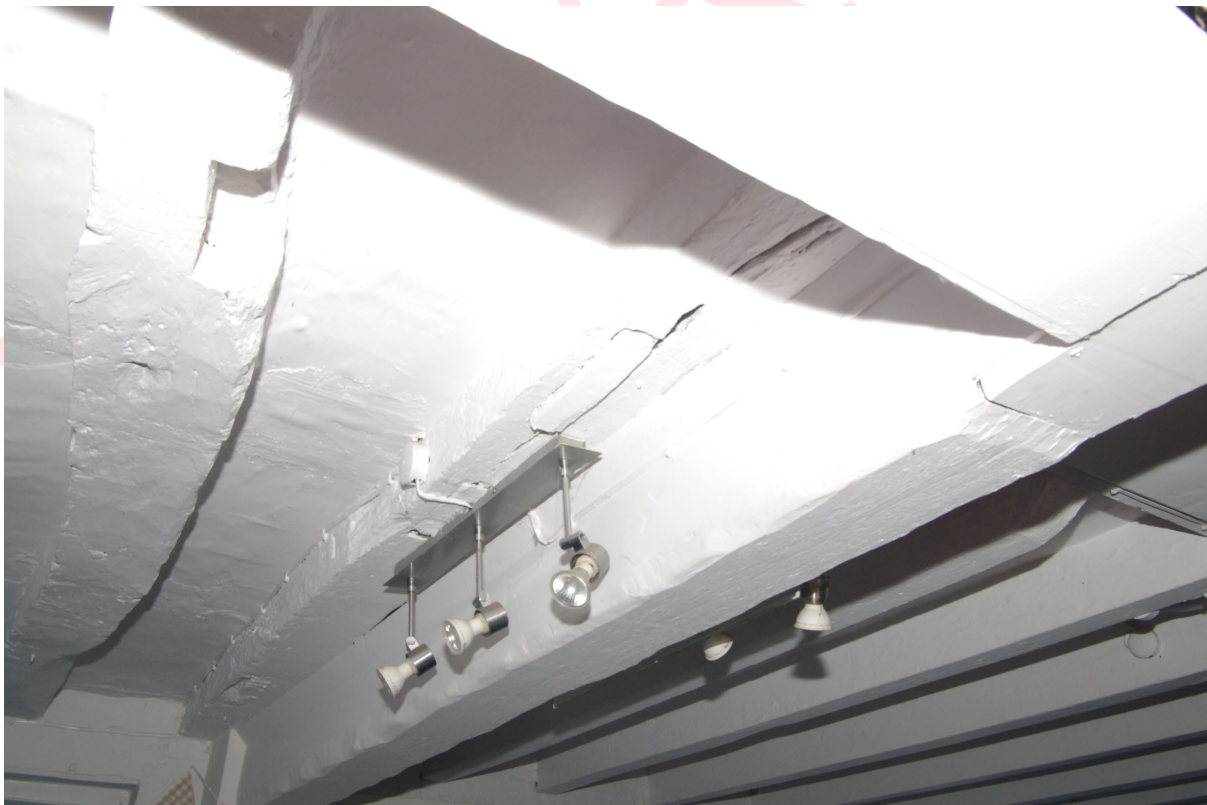
Figure 43: Room G1, reused timbers as ceiling joists

Looking west. Note the slight chamfer in the main beam on the right and the boarded opening for the stairs in the foreground

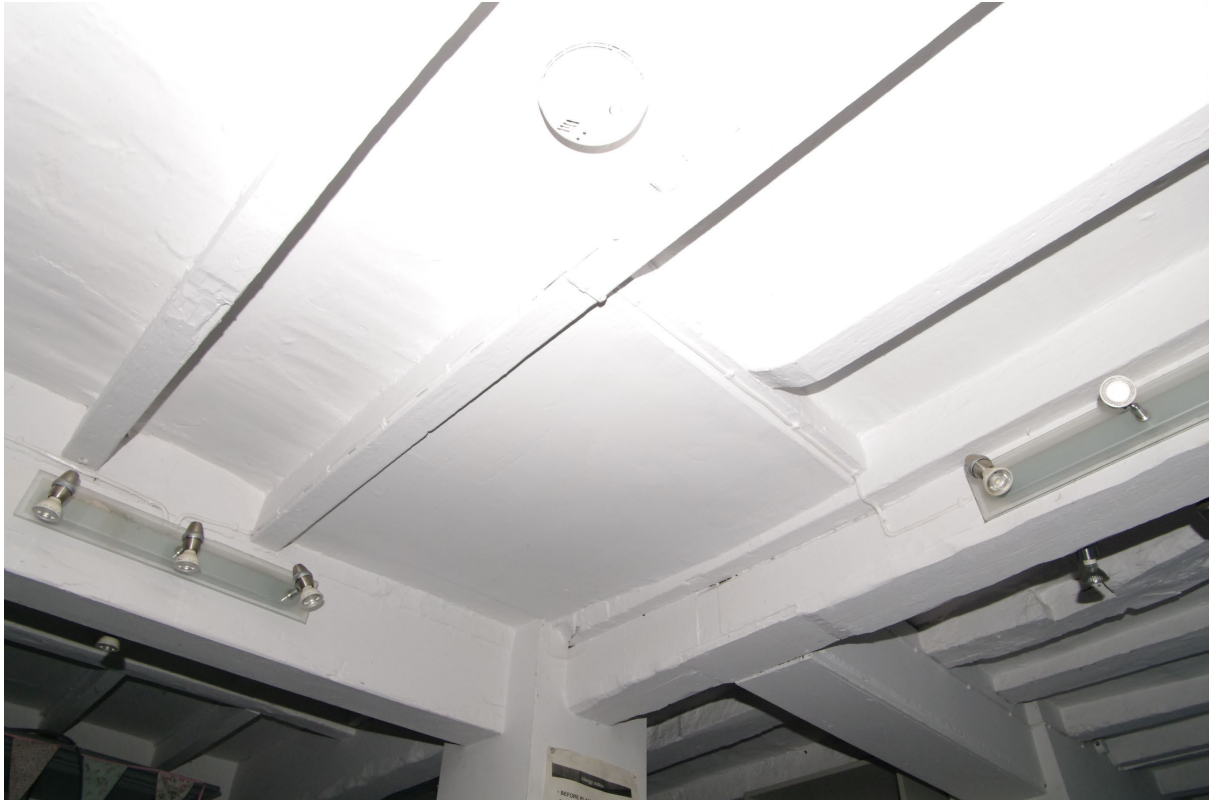
Figure 44: Room G1, location of former staircase up to first floor  
Looking east

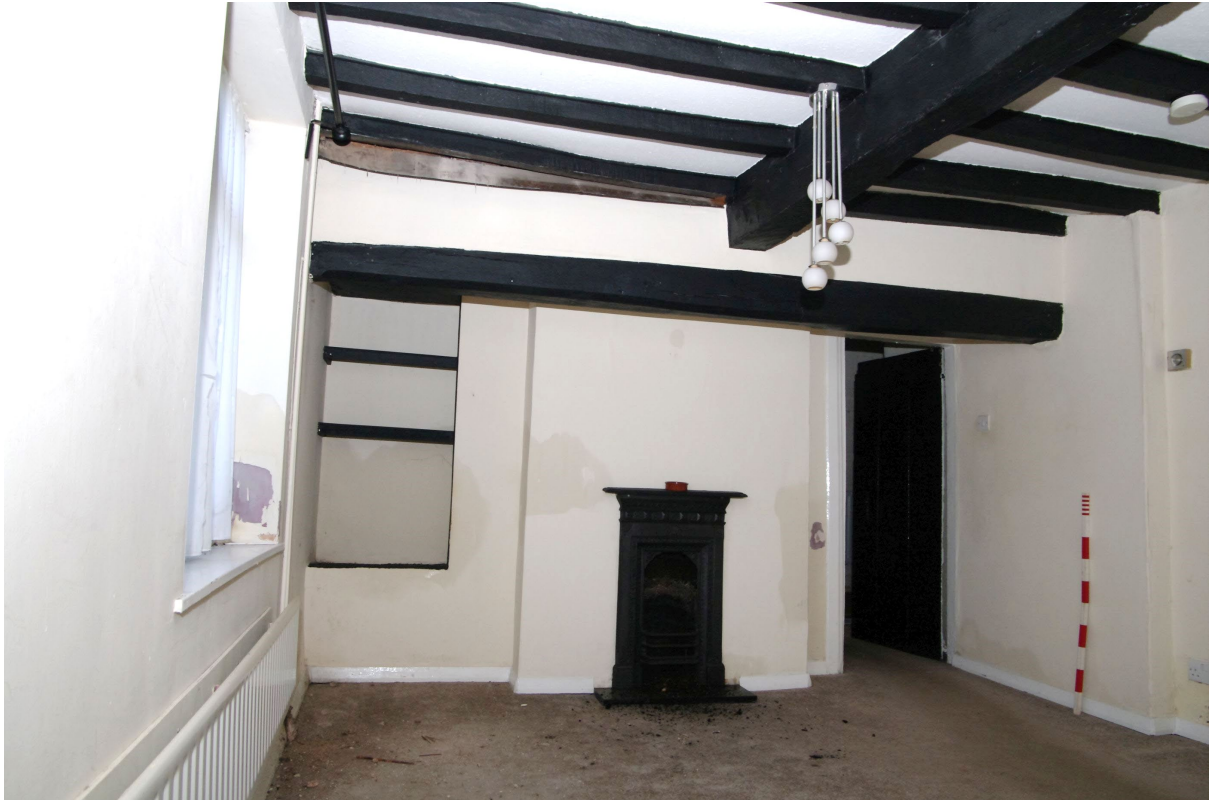
Figure 47: Room G4, fireplace on northern wall.  
Looking north-west. The original fireplace was much larger. Doorway to G6 on the right. 1m scale

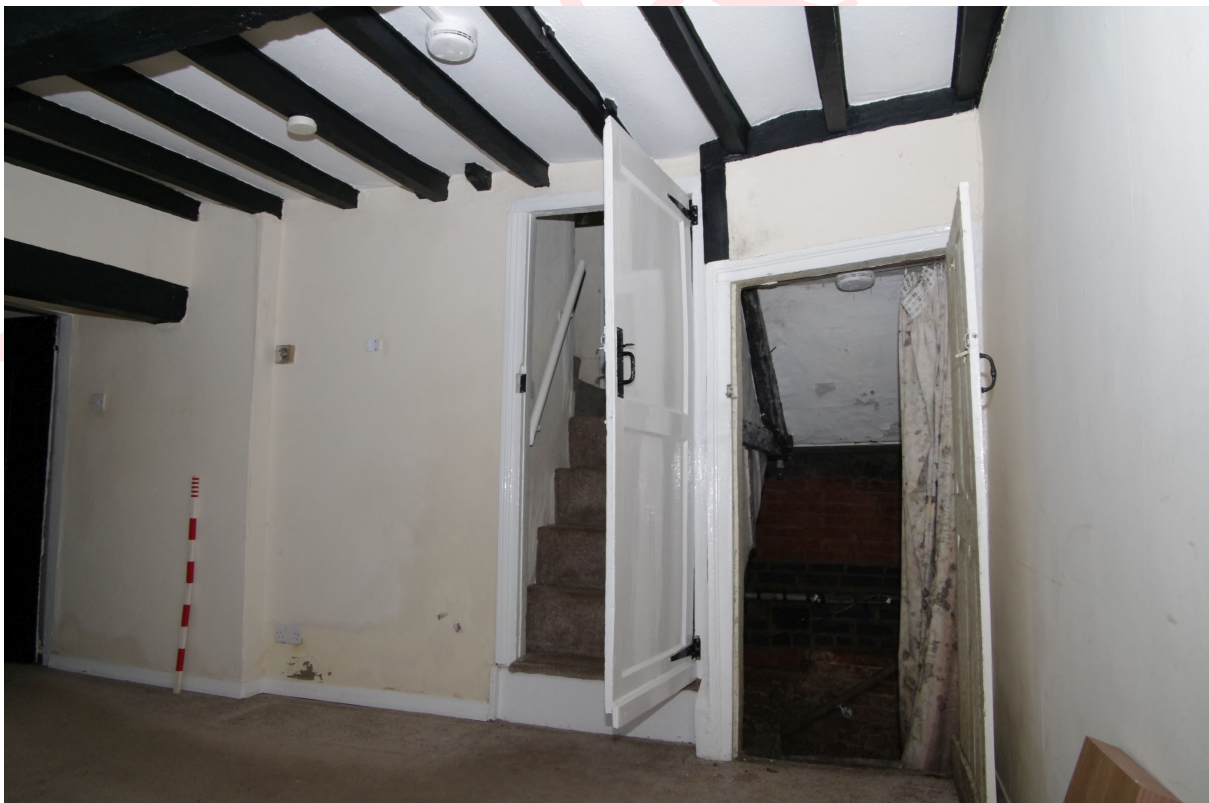
Figure 48: Room G4, doors to first floor stairs and cellar  
Looking north-east. Note the change in wall thickness to the right of the 1m scale

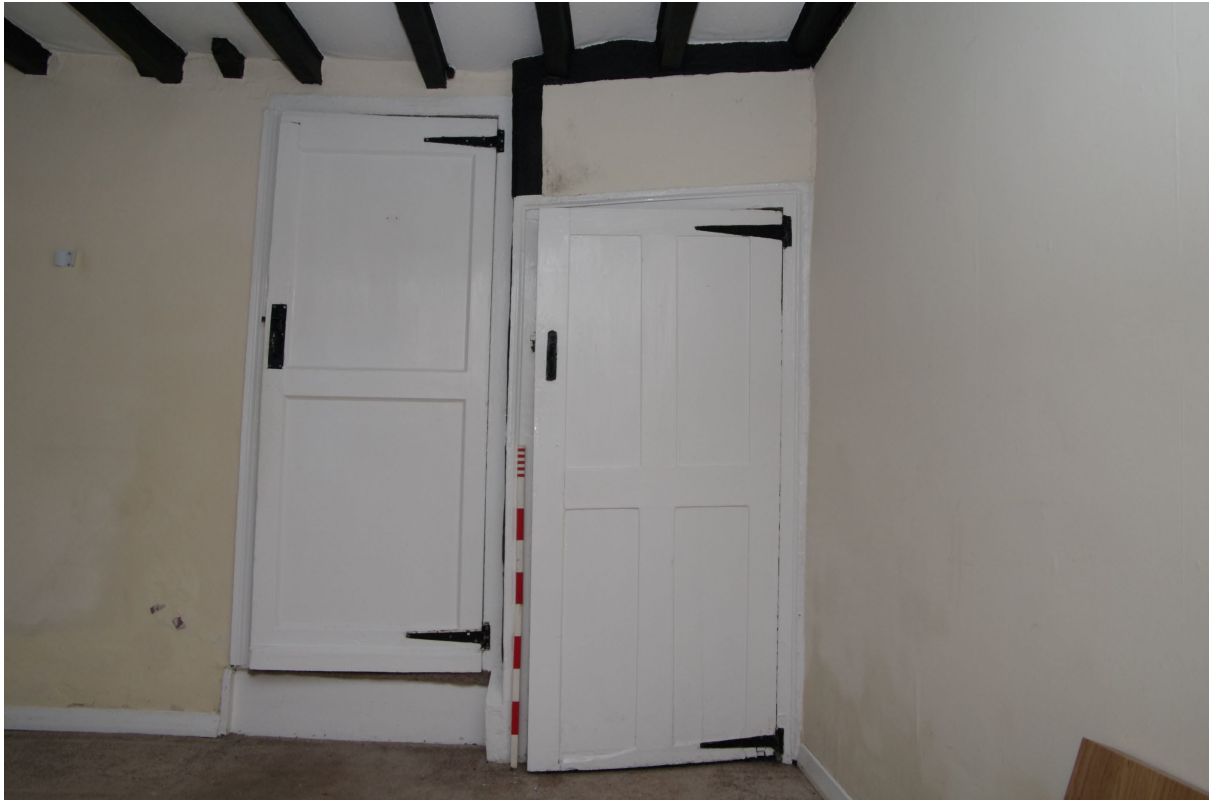
Figure 49: Room G4, doors to first floor stairs and cellar  
Same view as previous picture but with doors closed. 1m scale

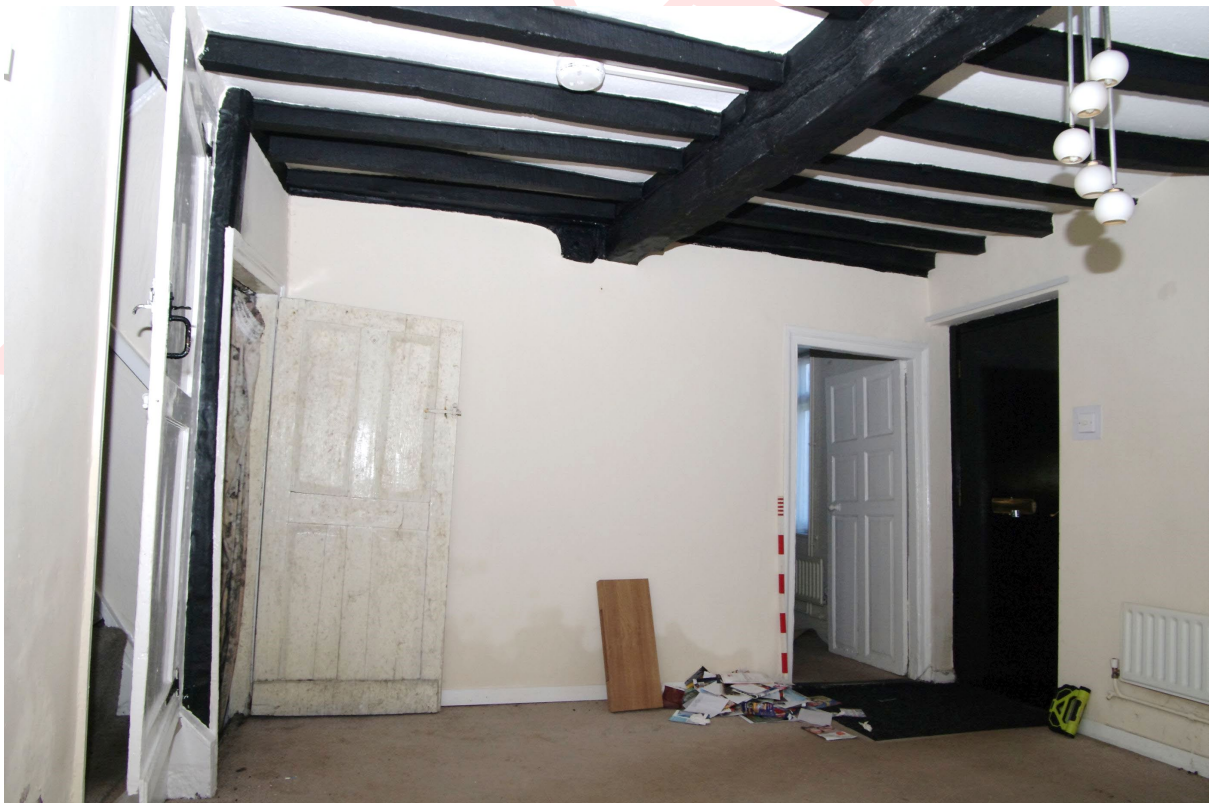
Figure 50: Room G4, southern wall  
Looking south. Doorway to Room G5 to right of 1m scale. Front door on far right. Stairs and cellar doors are on the left

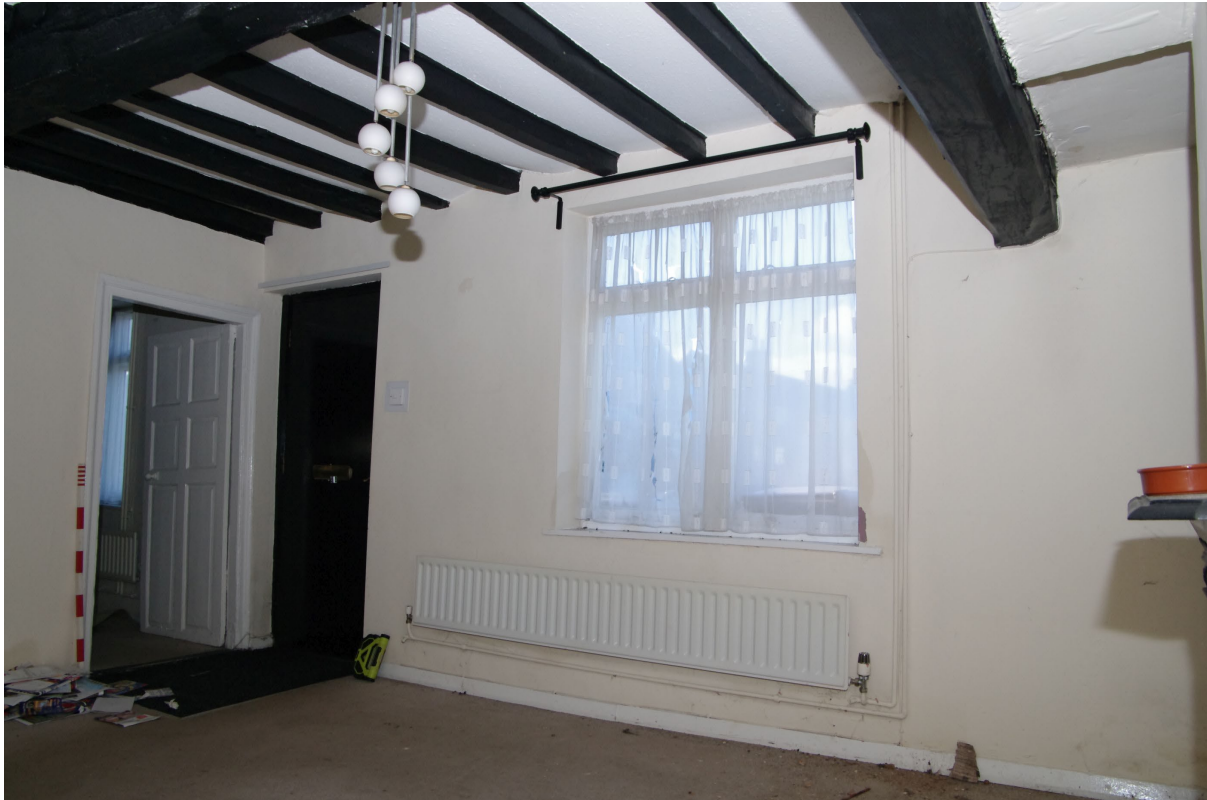
Figure 51: Room G4, western wall  
Looking south-west. 1m scale

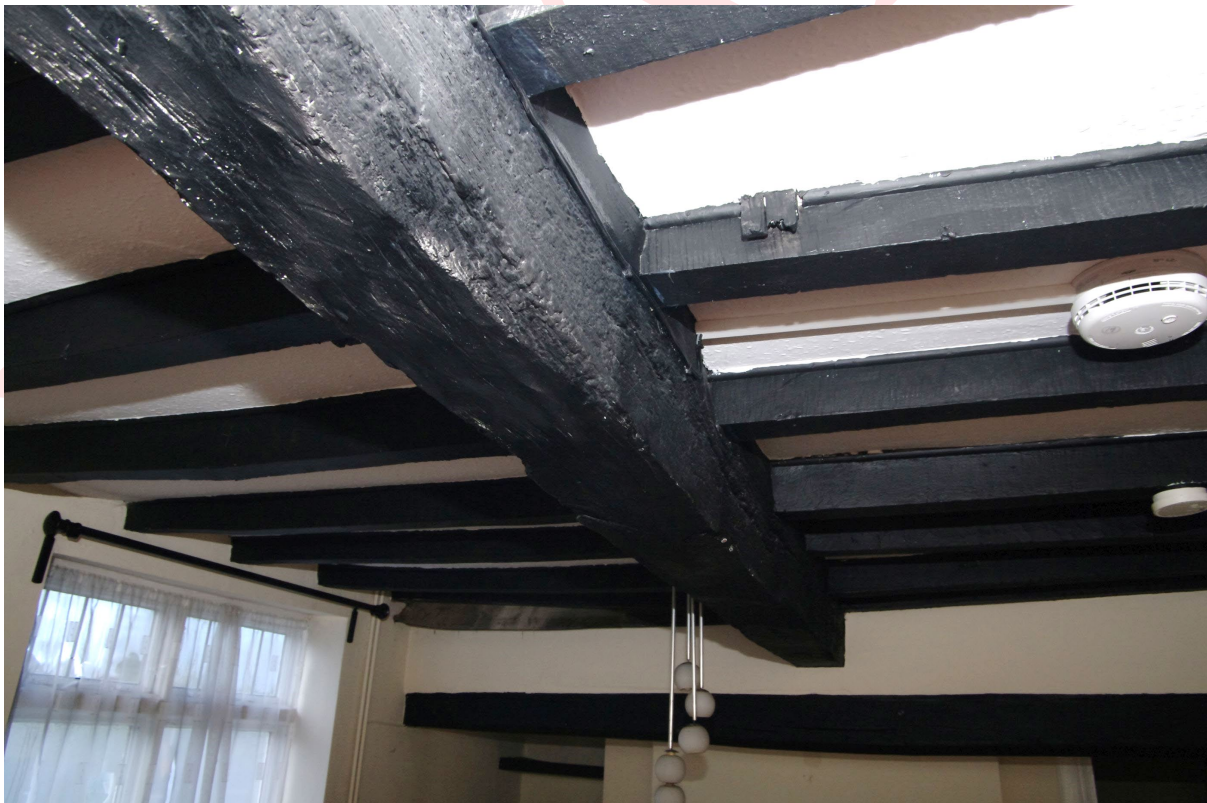
The room has a substantial axial beam running from south-east to north-west across the room. As well as being shaped there is evidence of some working by an adze or similar tool but no evidence of any formal chamfered work. There are a number of sawn-off wooden pegs indicating former use elsewhere. Many of the ceiling joists appear to be machine sawn replacements but some have evidence of being reused from elsewhere with evidence of redundant sockets. There is also a substantial bressumer beam running across the fireplace which suggests that the room originally had a significantly larger fireplace and hearth. At the time of the survey the fireplace was a modern reproduction.

Figure 52: Room G4, axial beam detail  
Looking north-west south-east
