The historical building recording undertaken by ULAS at Numbers 2A High Street and 37 Main Street in March 2025 has provided a permanent record of the building prior to any works being undertaken.

The results of this level 2 survey allow for a tentative general outline of the probable building phases as shown in Figure 103 below. The earliest phase of the building is that containing clear evidence of box framing which includes the central part of the building along with the rear south-eastern corner of Number 37. Further exploratory work may include the south-western corner of Number 37 (i.e., all of 37) but at present no box framing is visible beneath the internal plaster and the external render. The next key phase includes most of Number 2A and the first floor above it. There is no box framing apparent in this part of the building and, as such this may be as late as the early to mid-19th century. No bricks were visible to measure

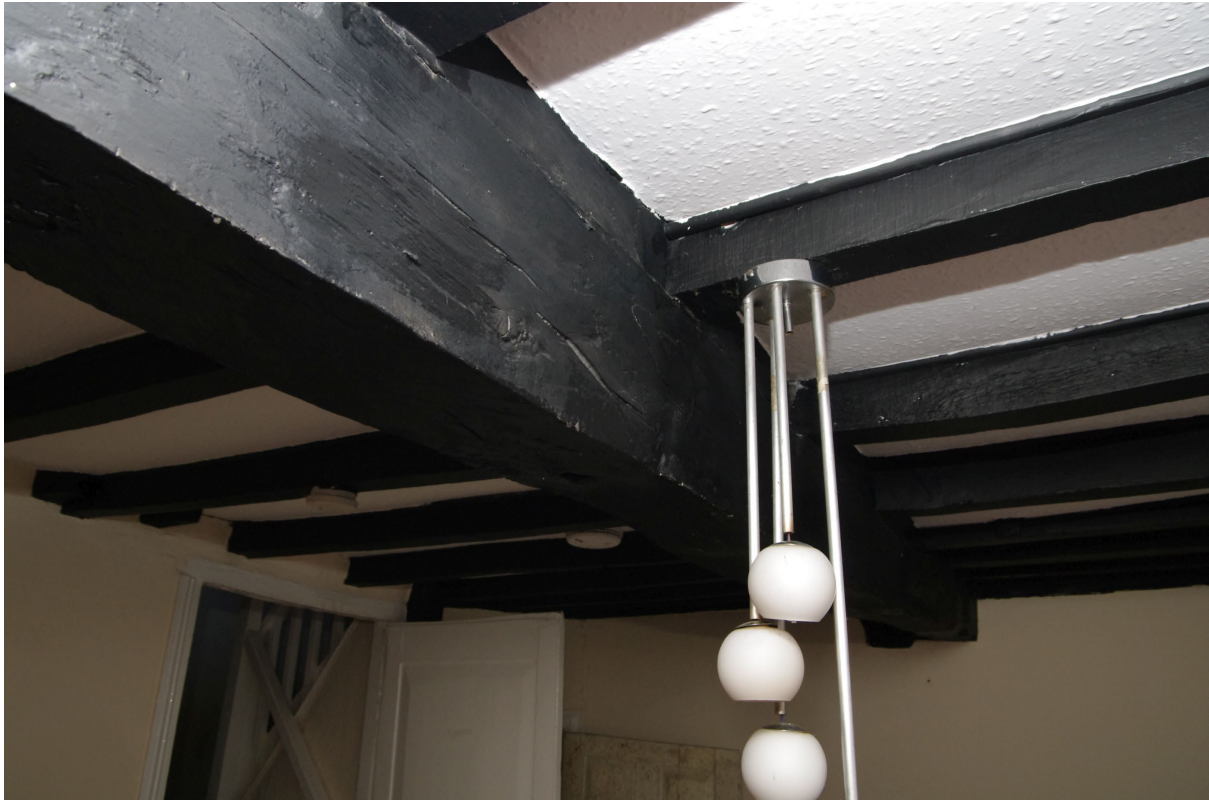
Figure 53: Room G4, axial beam detail  
Looking south-east

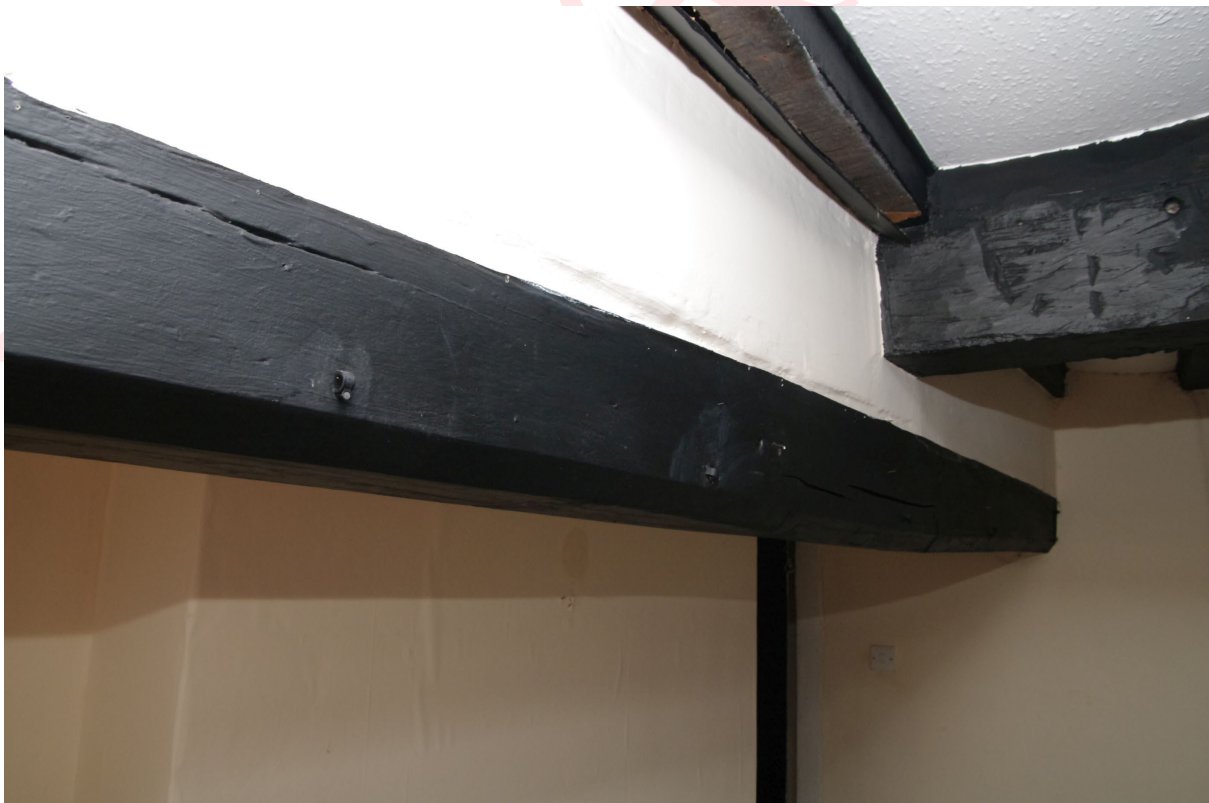
Figure 54: Room G4, bresumer beam detail  
Looking north-east

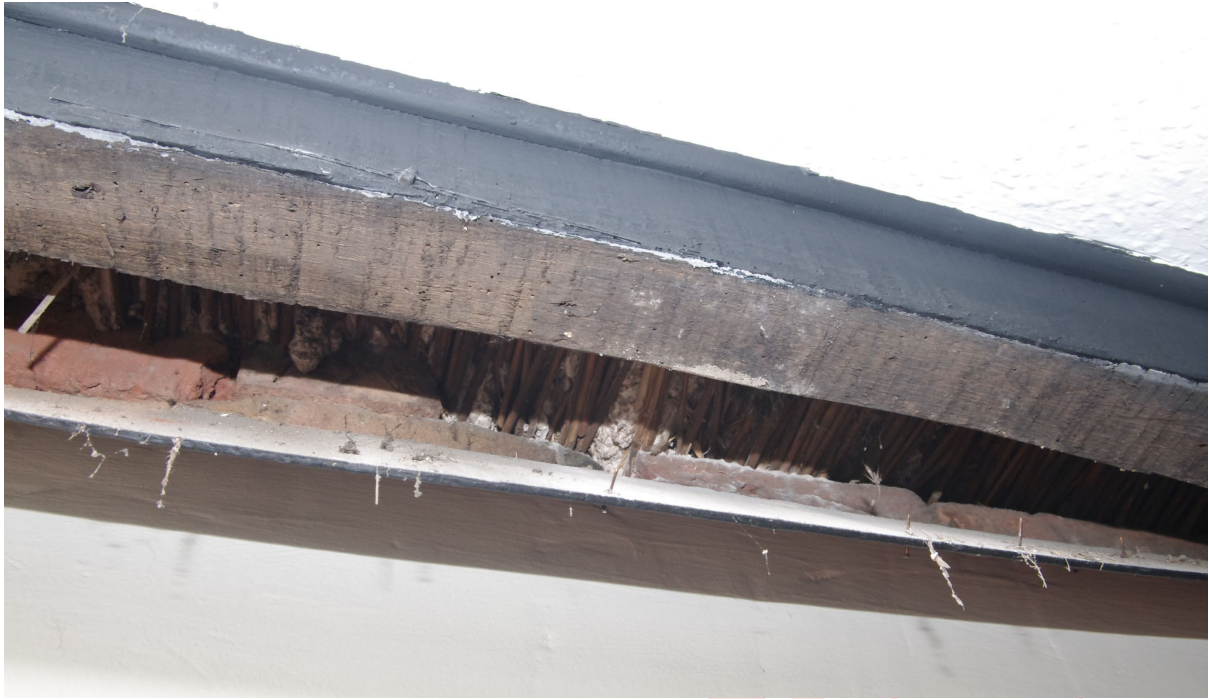
Figure 55: Room G4, underside of reed and gypsum floor detail behind bresumer beam  
Looking north-east up towards the ceiling

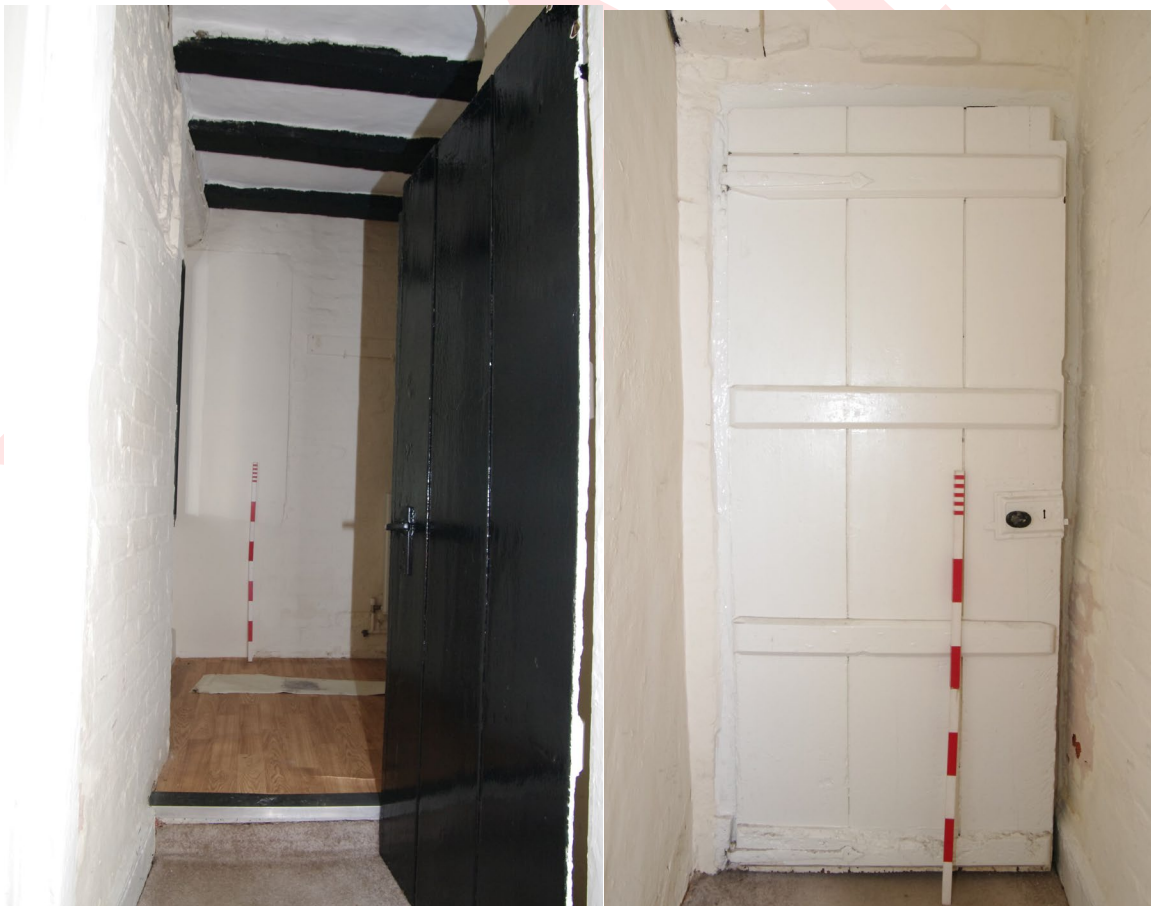
Figure 56: Room G4, doorway to Room G6 and flat-roofed extension  
The door is made of three wide planks. Left picture: Looking north-west. Right picture shows the northern face of the door. 1m scale

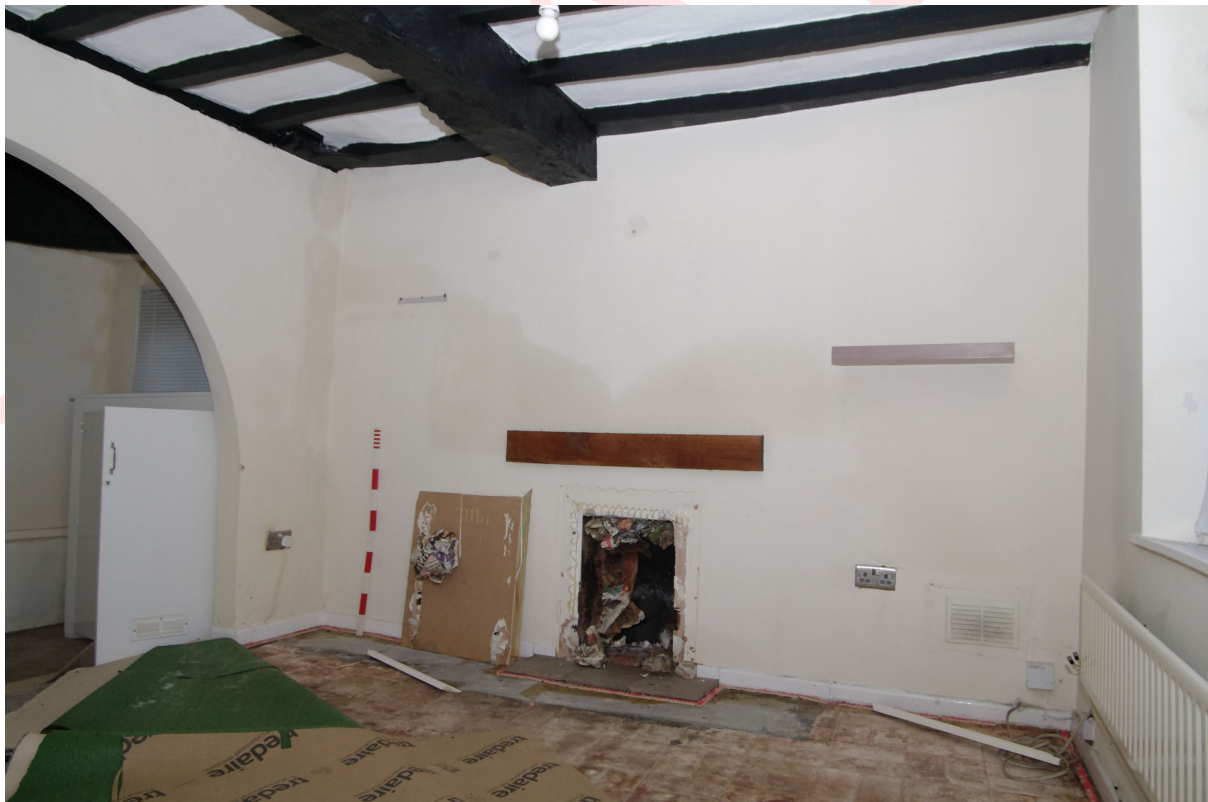
The fireplace opening is small and modern. The exterior wall, as discussed, has a wide chimney breast and base so there is, presumably, a wider opening hidden behind the wall plaster. The floor in the main room is red brick. From the investigation work in Room G1 the brick is likely to rest on a clay base.

Figure 57: Room G5, fireplace  
Looking south. Note the archway on the left. 1m scale

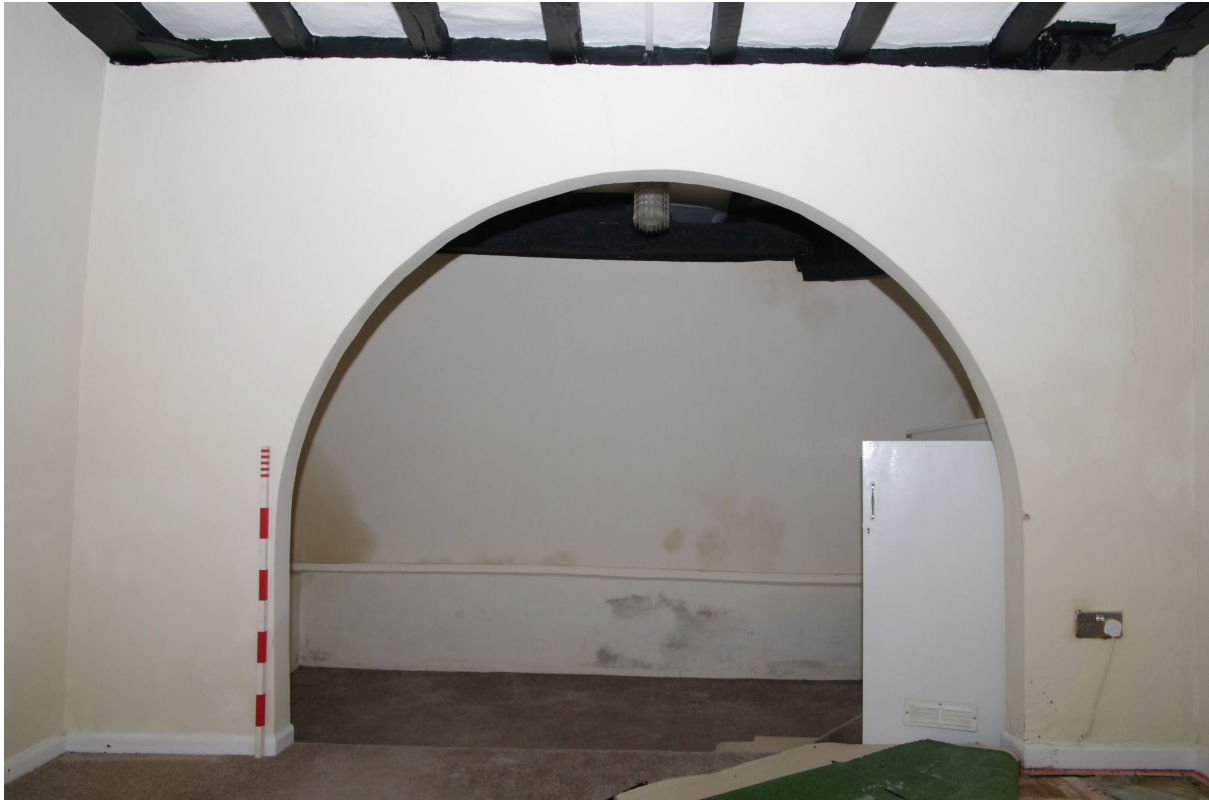
**Figure 58: Room G5 archway**  
Looking north-east. Note the step down in floor level beyond the arch. 1m scale

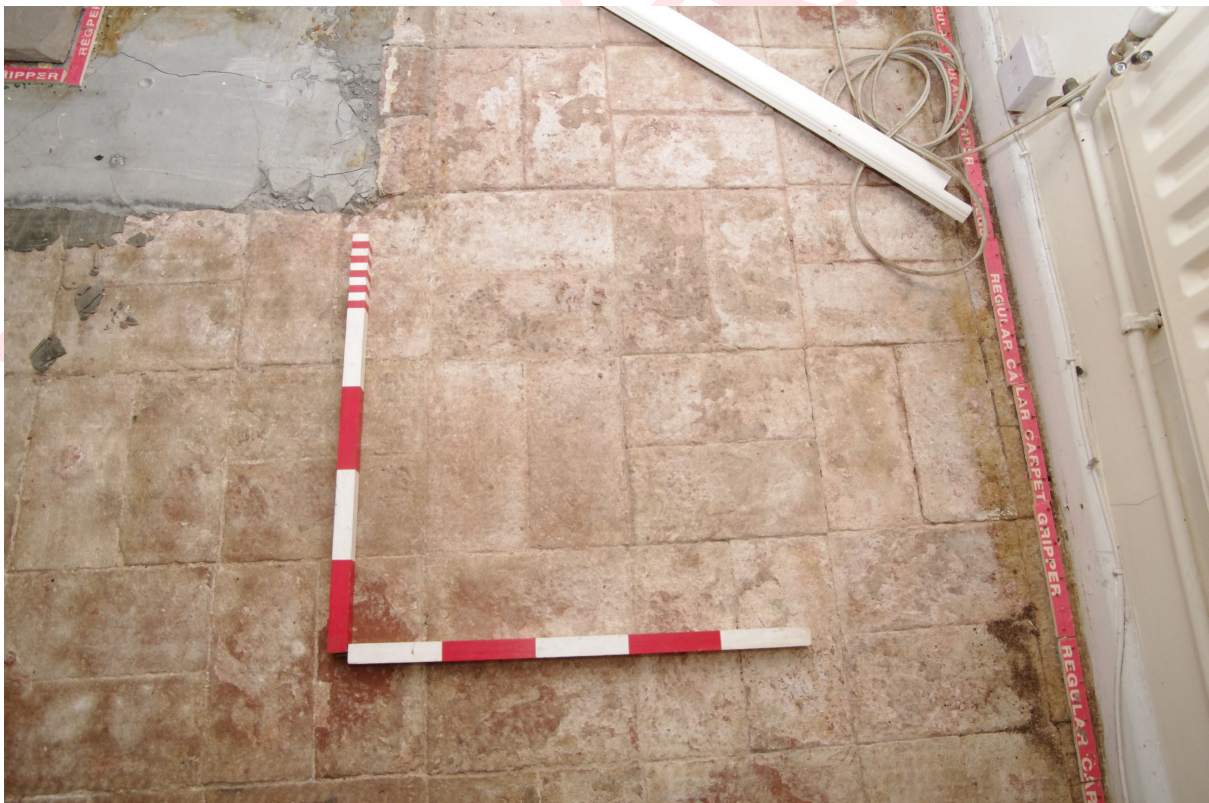
Figure 64: Room G5, brick floor detail  
2 x 0.5m scales

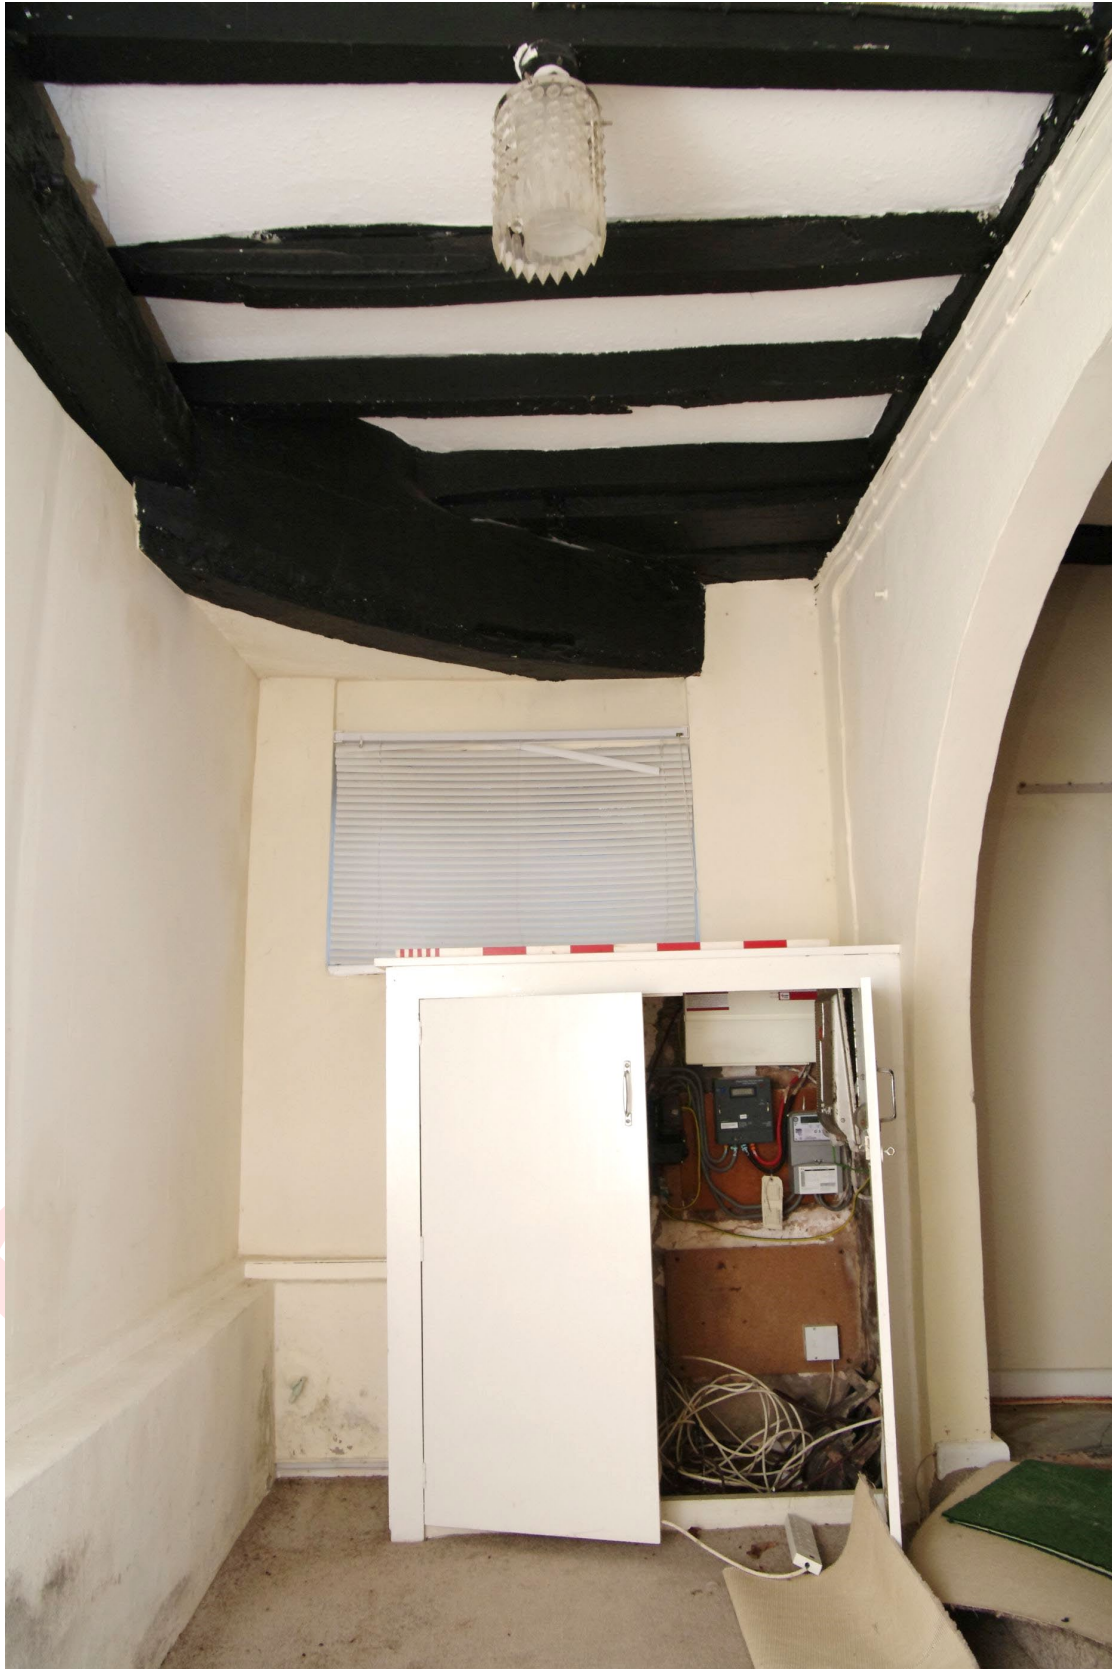
Figure 65: Room G5, within arched area

Looking south-east. Note the substantial beam across the corner and the thickened wall base to the left. The floor steps up from this area into the main part of the room. The change in wall angle can be seen in a slight shadow on the extreme left. 1m scale

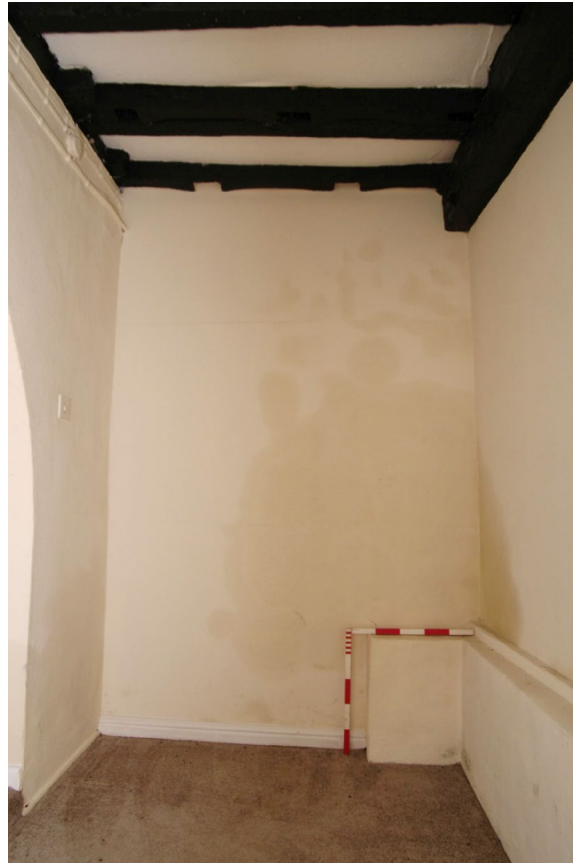
Figure 66: Room G5, within arched area  
Looking north-west. Note the thickened wall base and where it stops. Also the reused ceiling rafters. 2 x 0.5m scales

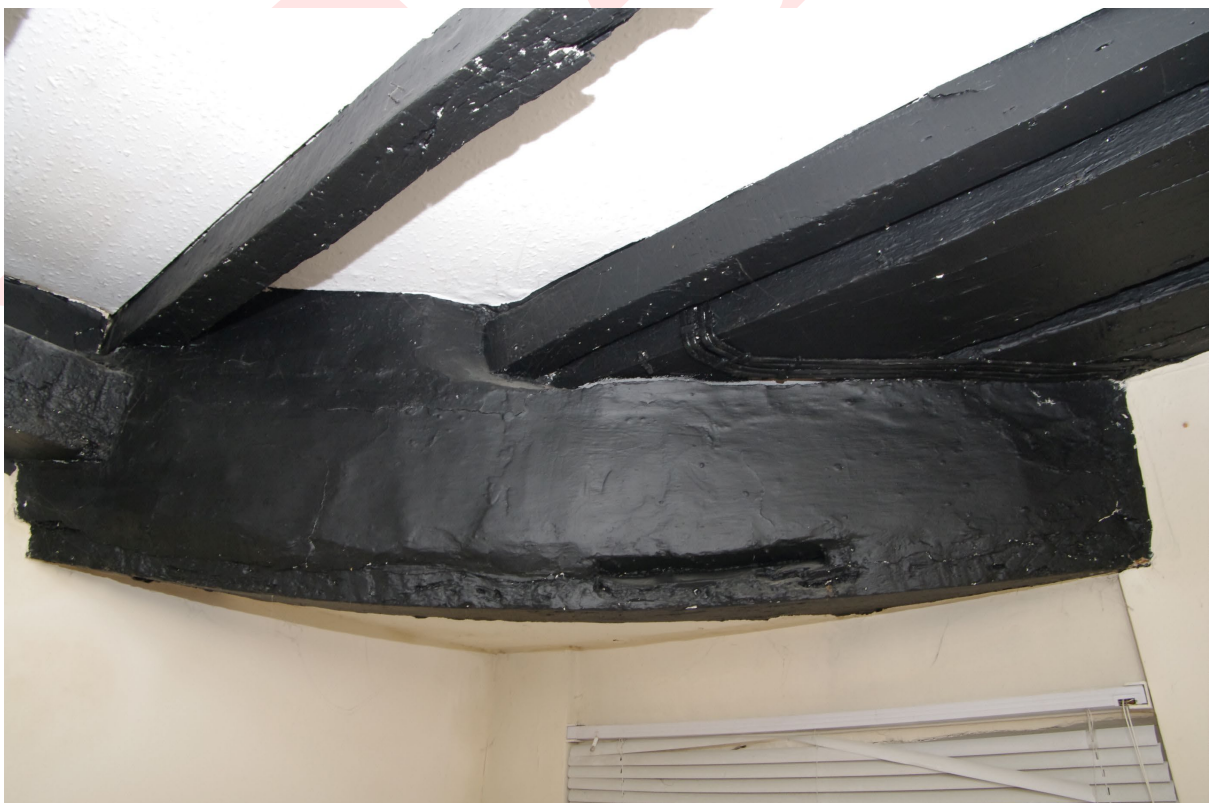
Figure 67: Room G5 within arched area, corner timber detail  
Looking east. The redundant sockets indicate reuse from elsewhere

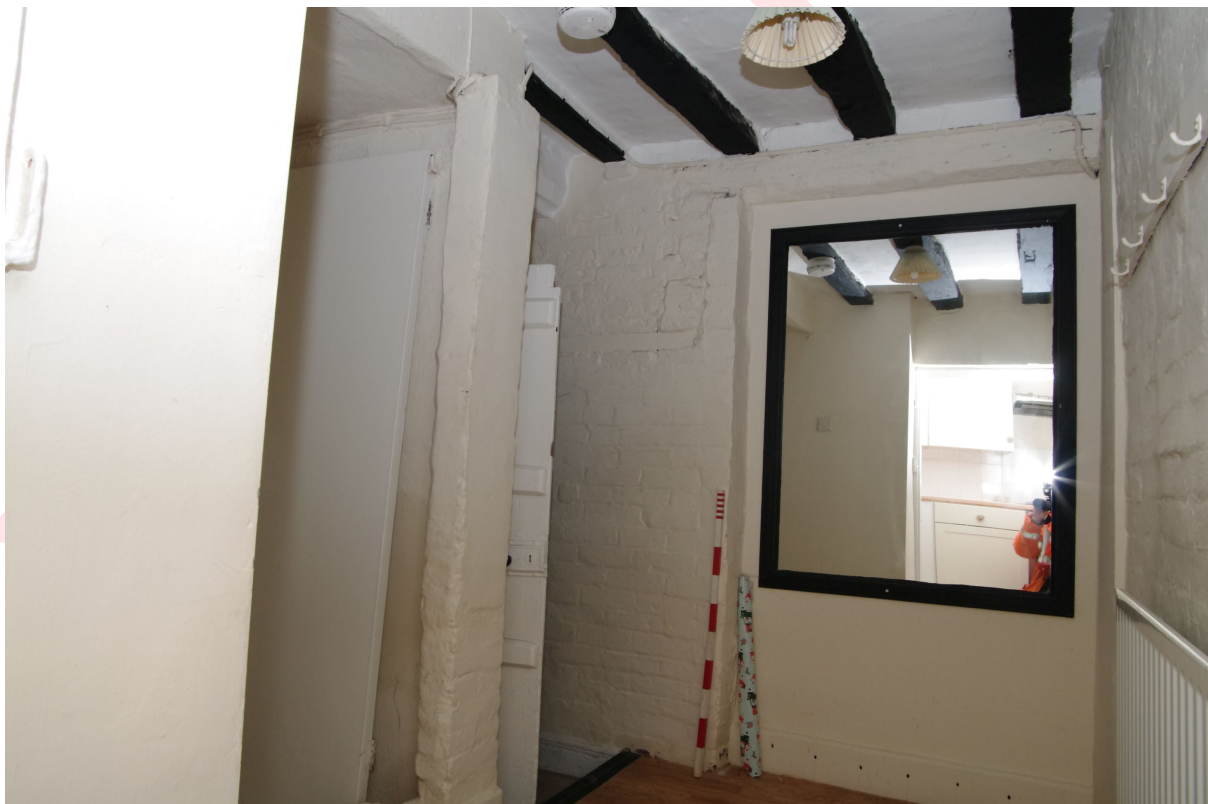
Figure 68: Room G6 and doorway to G4

Room G6 forms a corridor and storage area beneath the stairs to the first floor. It seems likely that this part of the building, along with the flat-roofed extension, always formed part of Number 37 although there is a thinner section of wall in the north-west which may be a possible blocked doorway leading into Number 2A in this area.

Looking south. Note the step down to the doorway to G4 and the possible blocked doorway to G1 behind the mirror. 1m scale

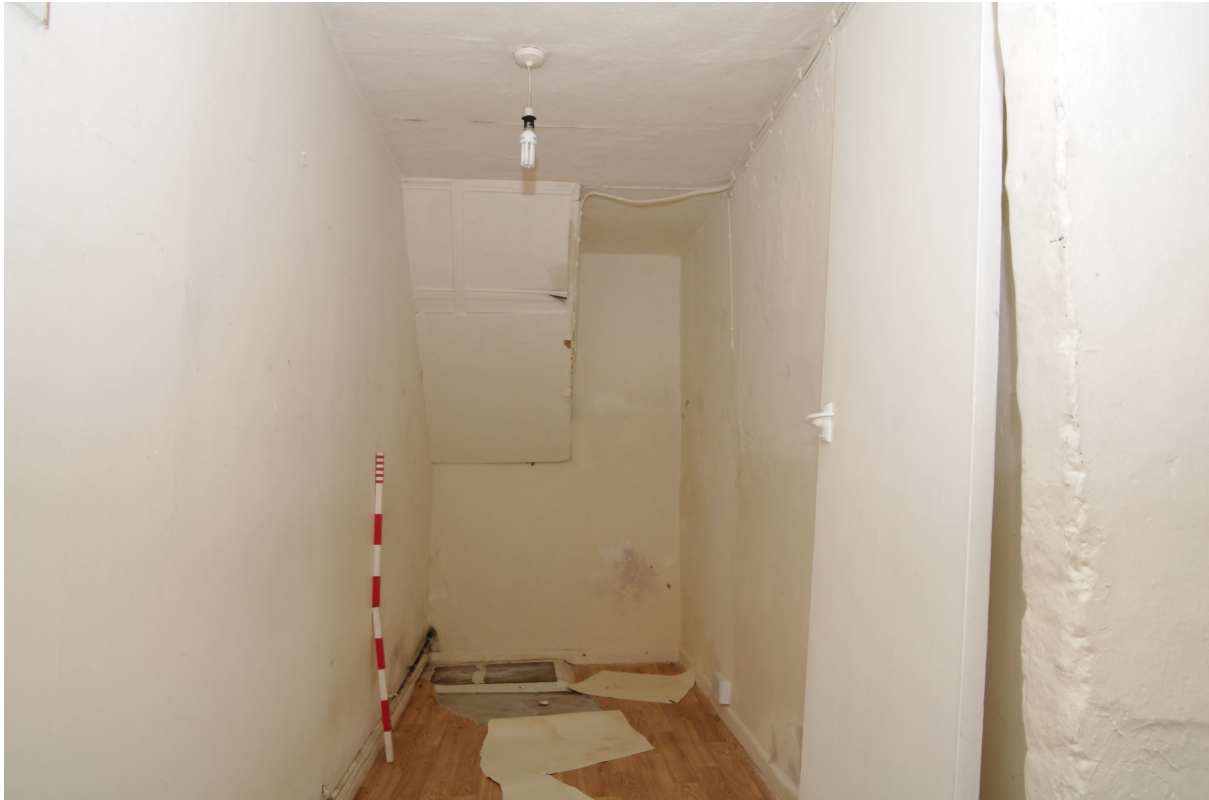
Figure 69: Room G6, space above the cellar and beneath the first floor landing  
Looking south-east. Note the narrow sloping section which is the underside of the stairs. 1m scale

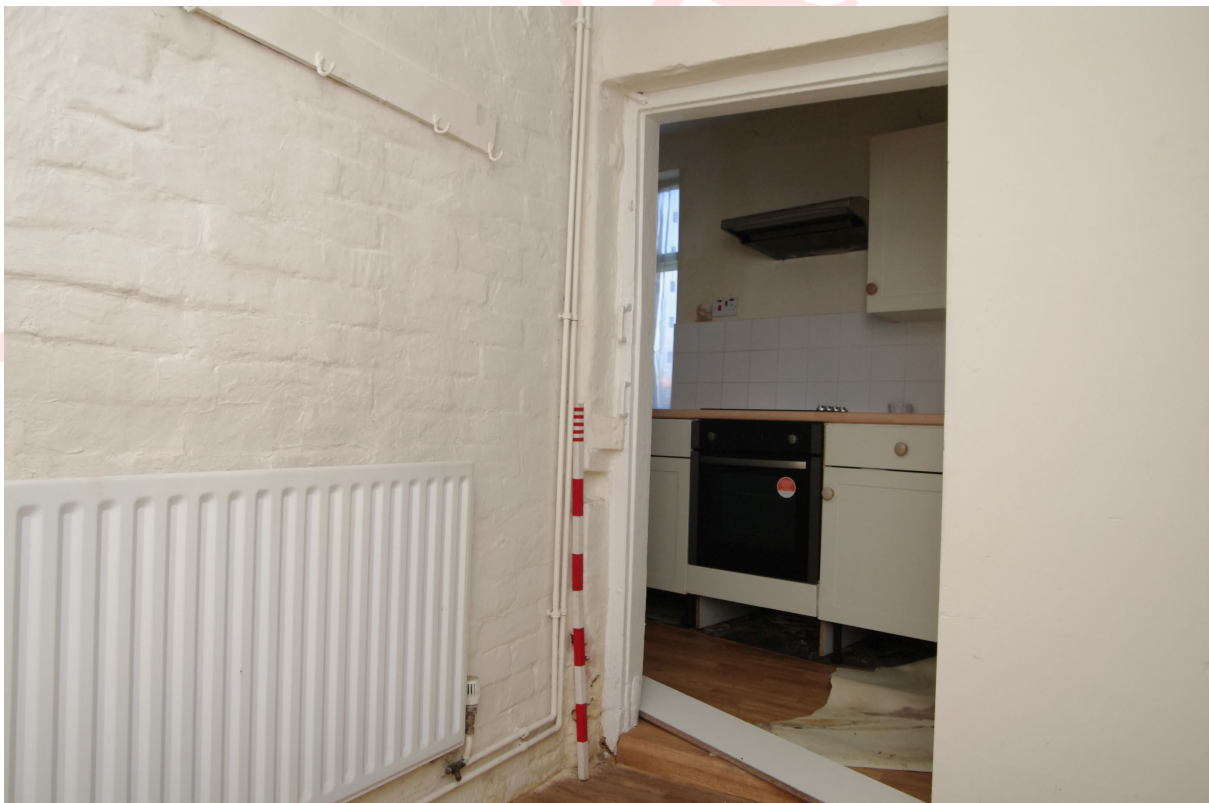
Passing through a wooden three-plank door the floor level steps up at this point following the slight rise in land up towards the north. The painted brick walls to the north and west are irregular and possibly of a number of phases. The eastern part of G6 is formed by an enclosed space which sits above the cellar and beneath the first floor stairs and landing. A doorway with a substantial frame along with brackets and sockets for holding security bars to hold the door shut leads out into the flat-roofed extension Room G7. The presence of the brackets suggests that this was once an outside door.

Figure 70: Room G6 looking towards doorway to G7  
Looking north. Note the brackets on the door frame. 1m scale

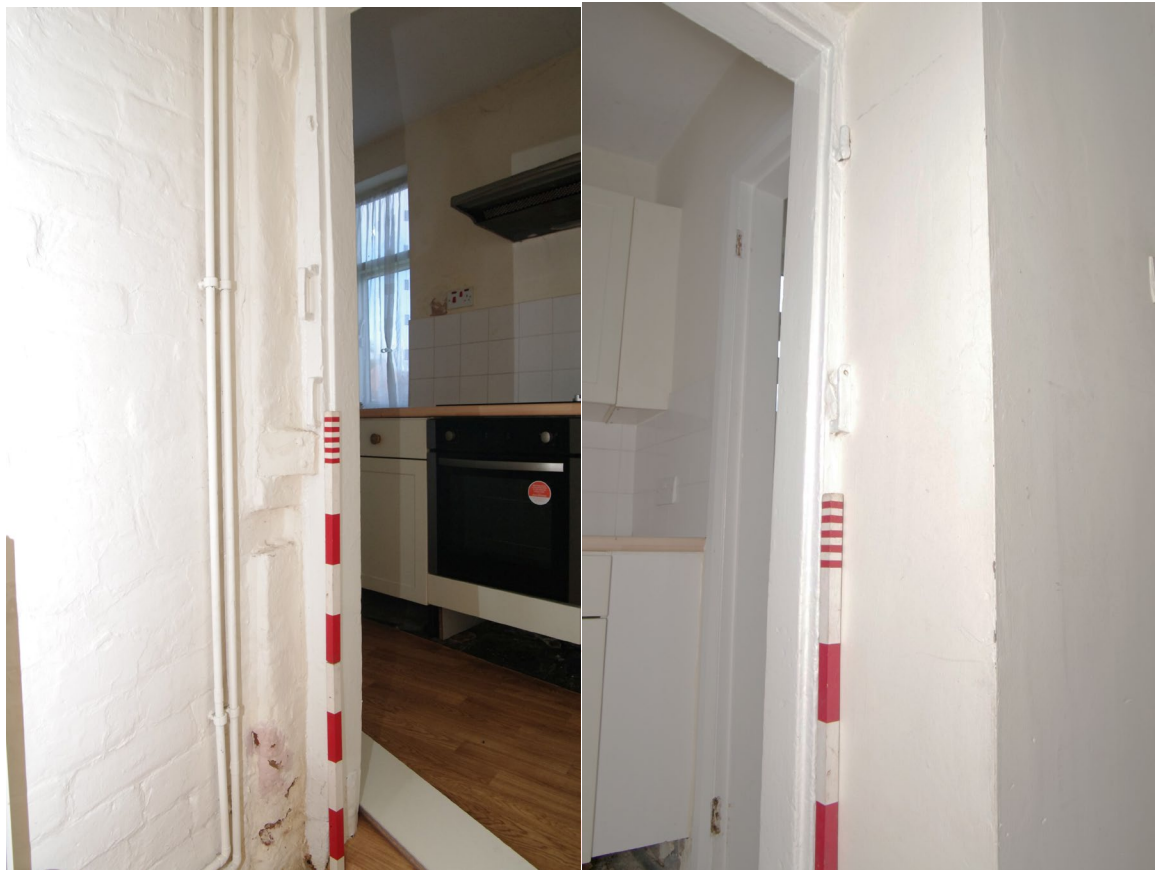
Figure 71: Room G6, doorframe detail  
Left: north side, right: south side. Both pictures looking north-east from G6

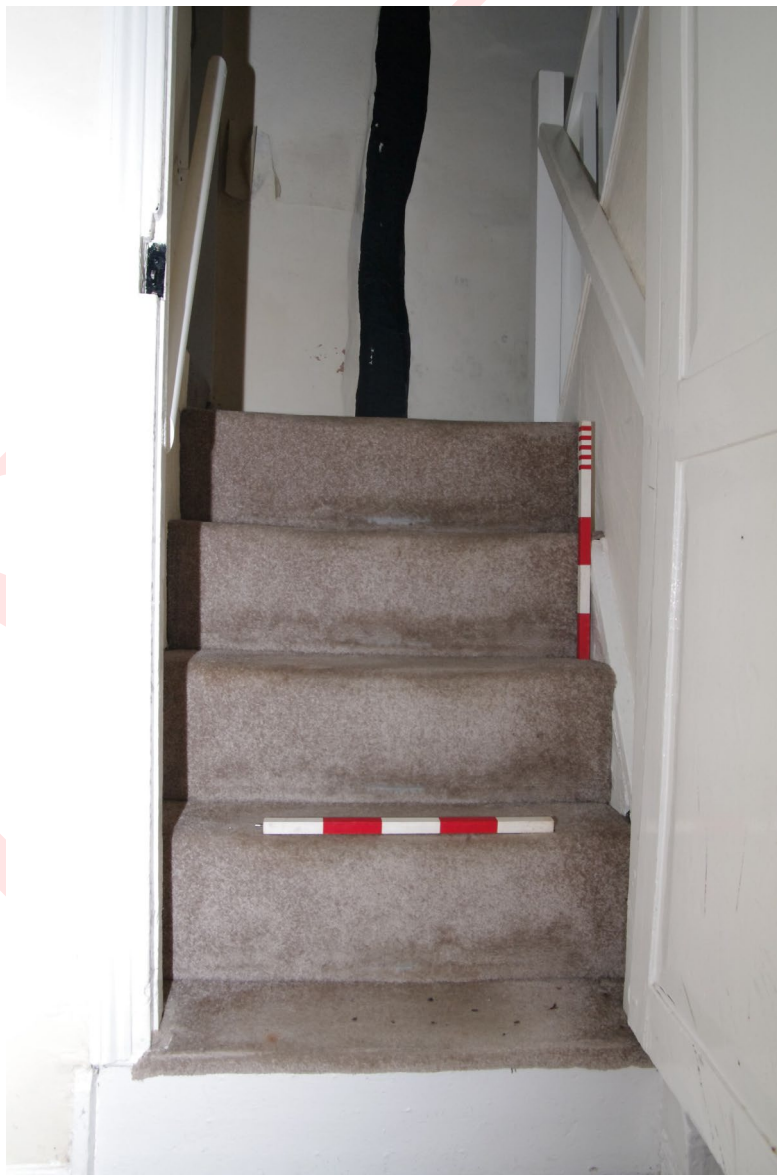
Figure 75: First flight of steps up to first floor  
Looking north-east. 2 x 0.5m scales

The stairs to the first floor are located in ground floor room G4 where a set of five very steep steps leads up to a small and narrow landing F1 with further steps leading up steps in both directions. Most internal walls are timber and plaster partition walls but a number of exposed beams are visible within the wall structure, especially around Rooms F1 to F4 which hint at a timber-framed origin to this part of the building. With the exception of one small area all of the floors are gypsum laid on a bed of reeds.

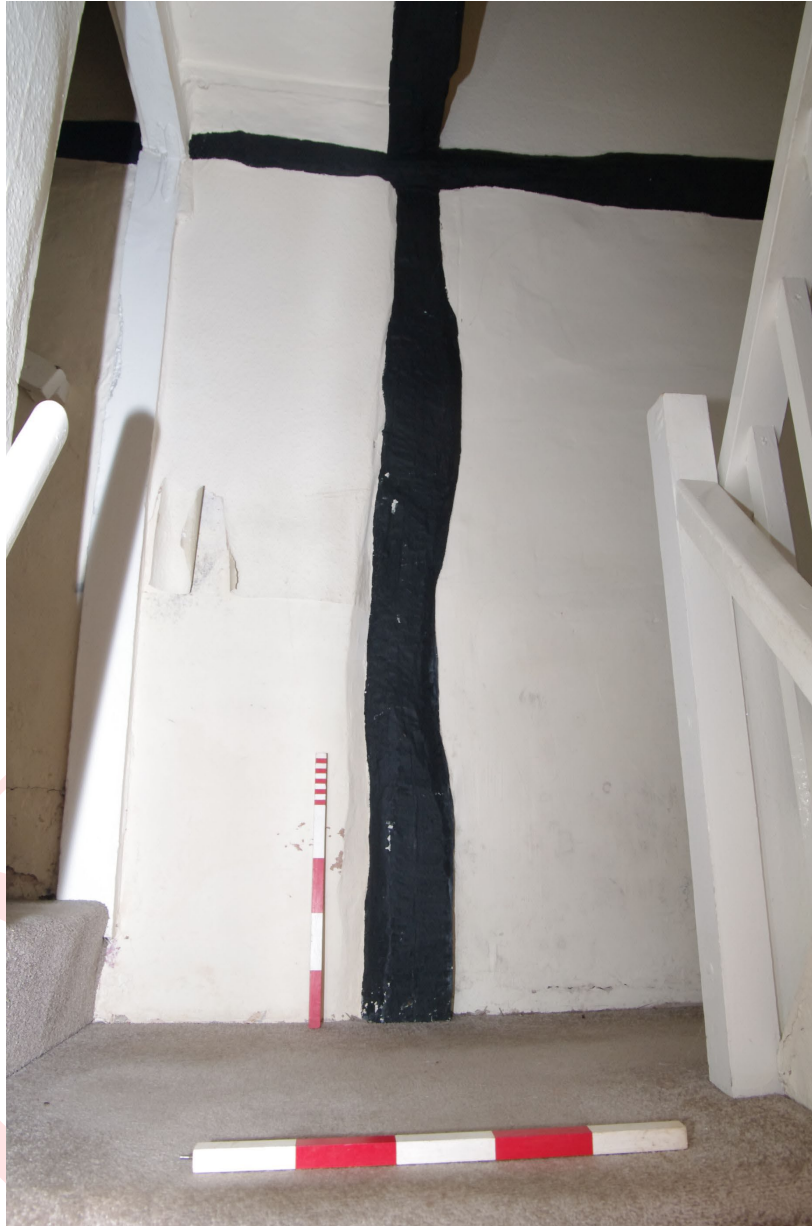
Room F1 is a small intermediate landing leading to F2 and F3 to the south and landing F8 to the north. Two half sets of stairs lead up from this area. In the wall is a large upright supporting timber resembling part of a box-frame set into the wall. A further horizontal timber extends westwards through Room F3 and across the full width of the building.

Figure 76: Room F1 timbers in the wall  
Looking north-east. Steps up to F8 on the left. 2 x 0.5m scales

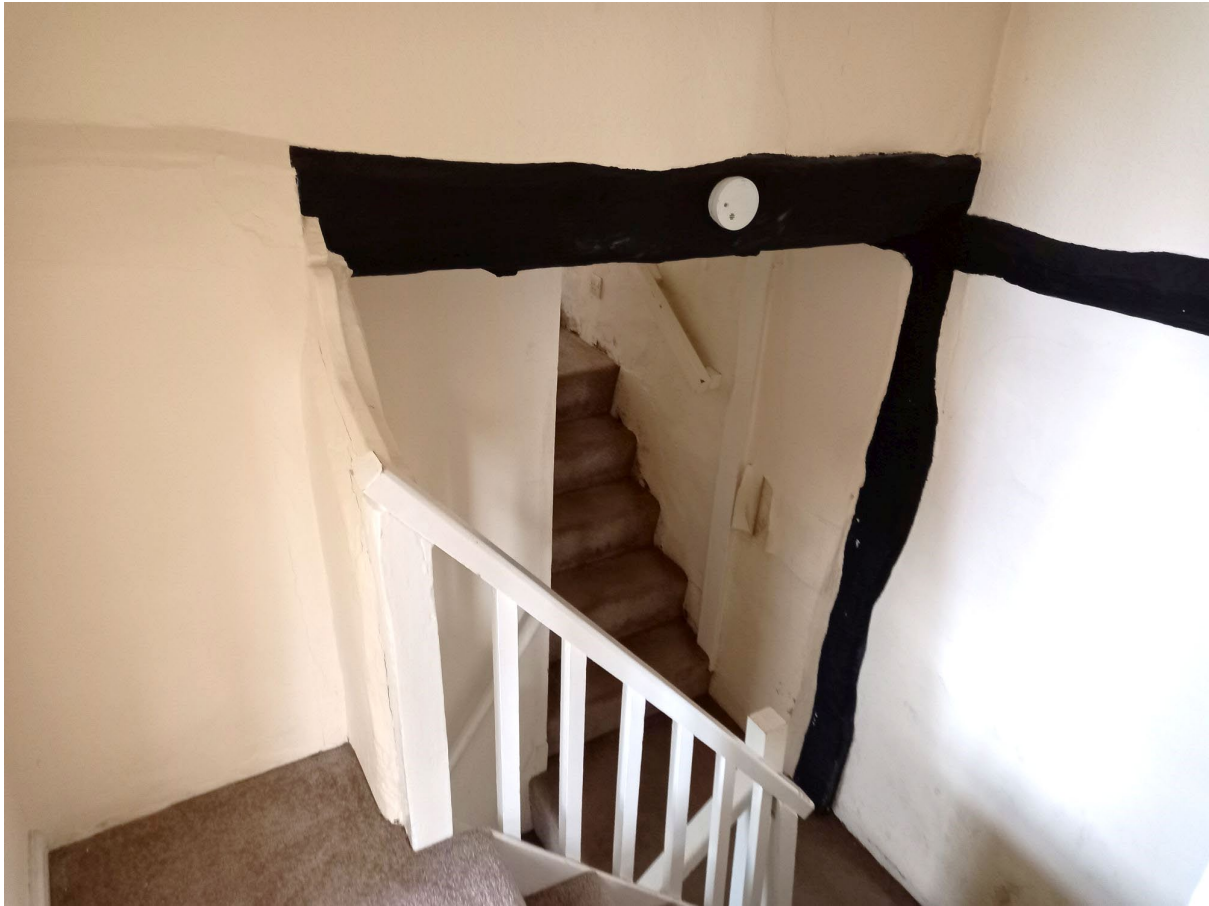
Figure 77: Room F1, timber frame

Looking north. The horizontal timber on the left continues through Room F3 and across the width of the building. Steps to F8 centre right

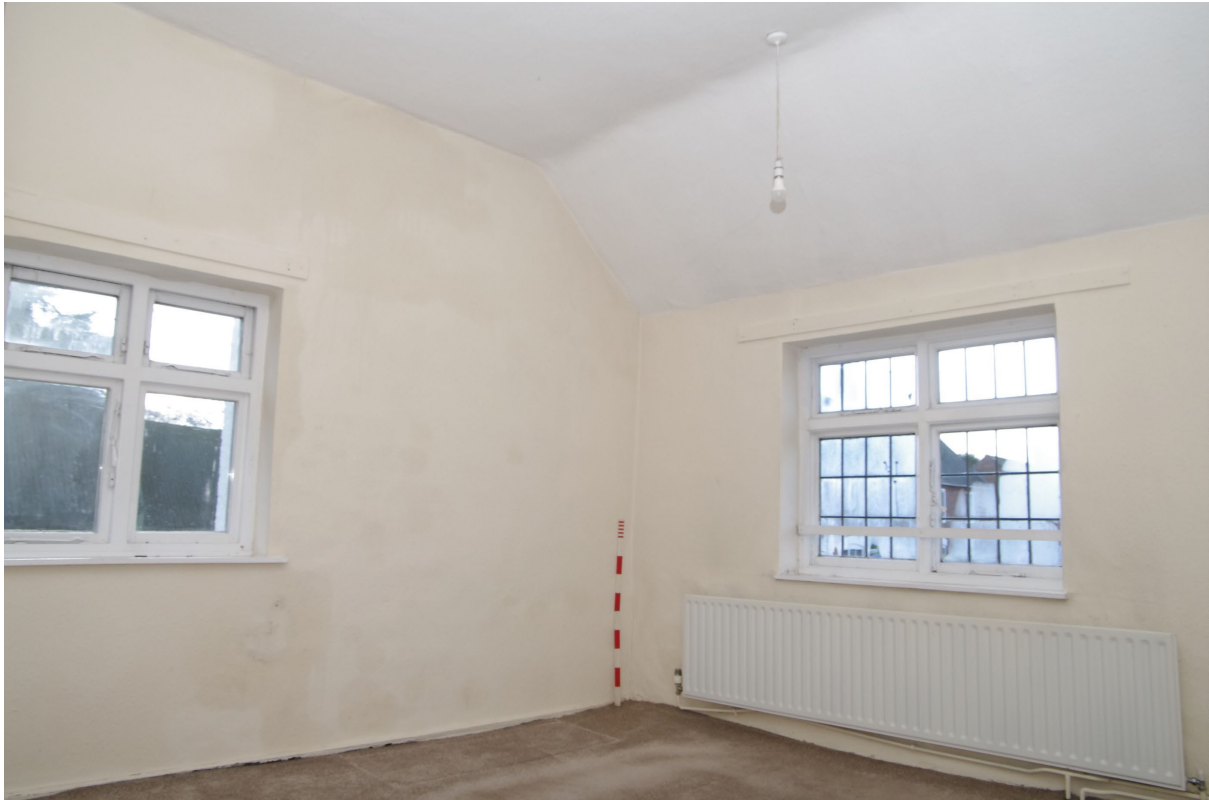
Figure 80: Room F2, general view  
Looking south-west. 1m scale

Room F2 is the southernmost room of the building and is reached via a half set of stairs from F1. As with all first floor rooms it is set partially into the roofline with the ceiling sloping in on the front and rear sides. The walls and ceiling are plastered with no evidence of any structural timbers except for a continuation of the box-frame along the eastern side of the room. These timbers continue from F1 and are hidden within a set of built-in wardrobes. The door into the room is a 20th century paneled door. The floor is gypsum and the window on the west wall is a leaded casement whilst the window on the south has a similar style of casement but is not leaded and does not have chamfered woodwork.

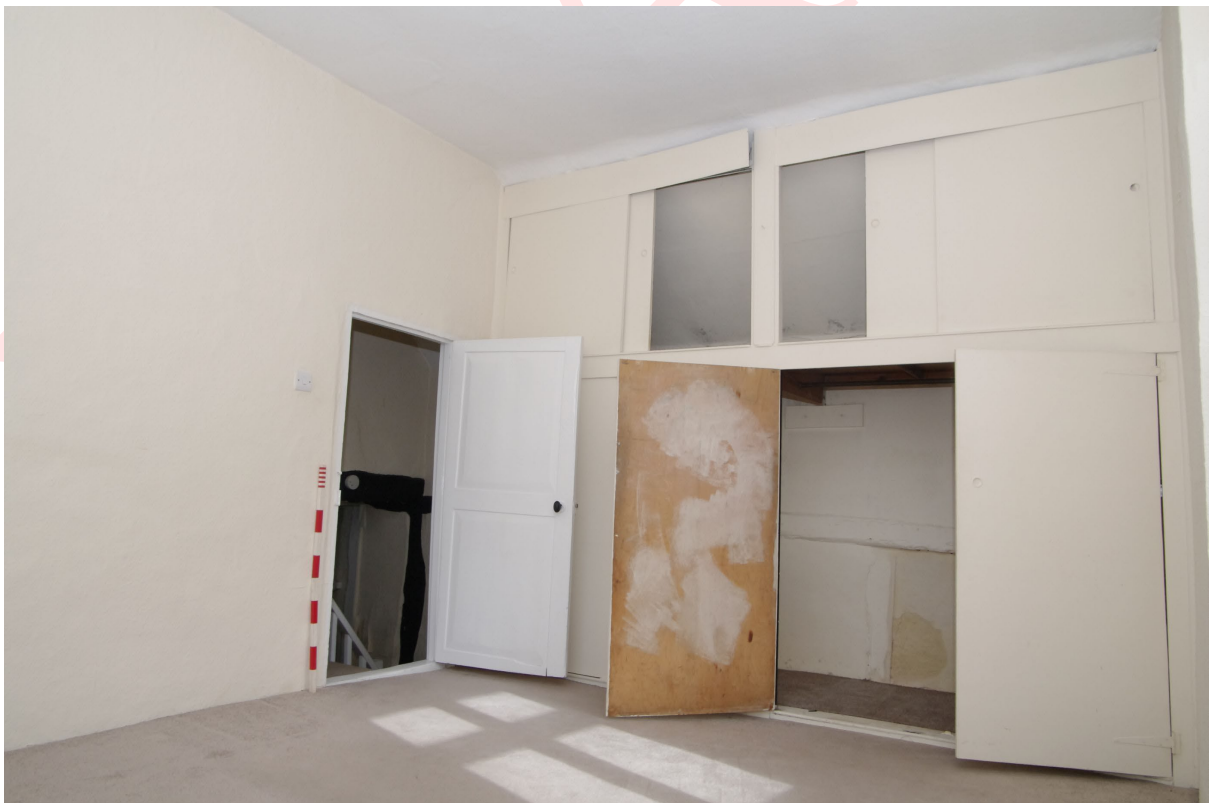
Figure 81: Room F2, general view  
Looking north-east. Note the timber frame within the wardrobe. 1m scale

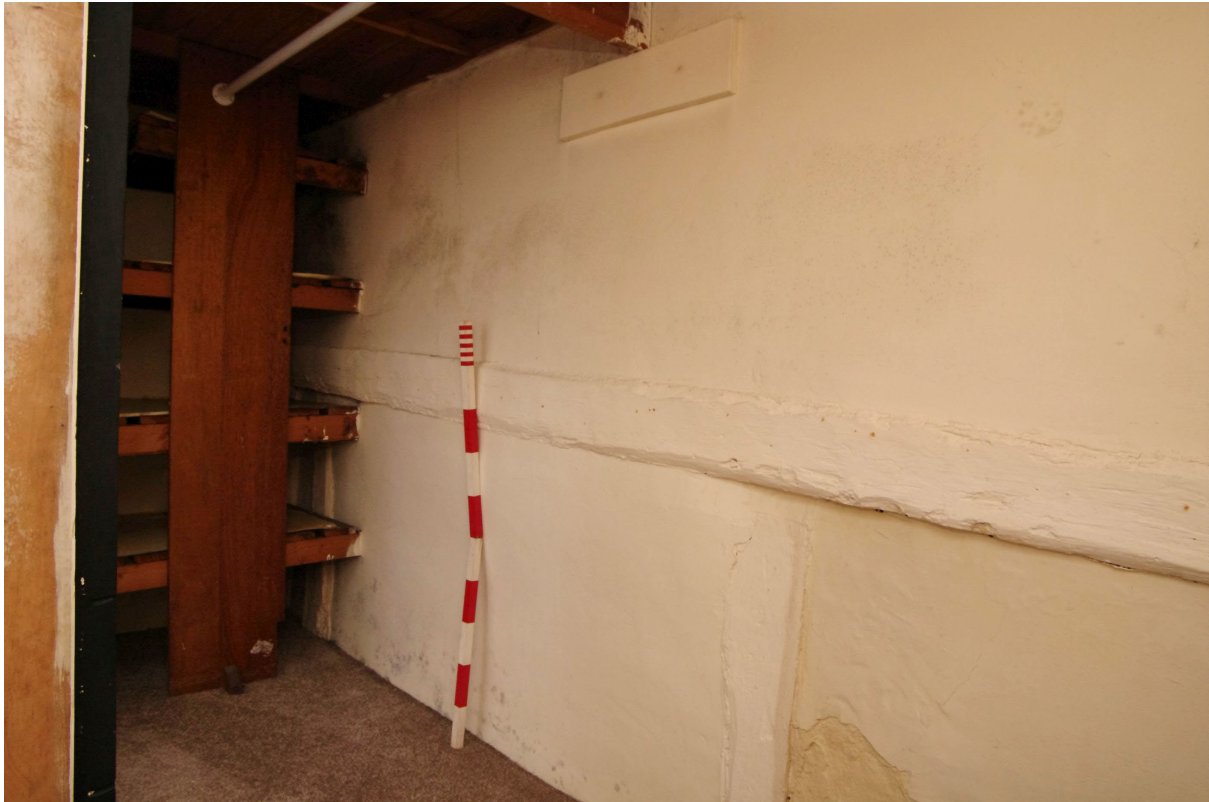
Figure 82: Room F2, timber frame on eastern wall  
Looking north-east. This continues through to Room F1. 1m scale

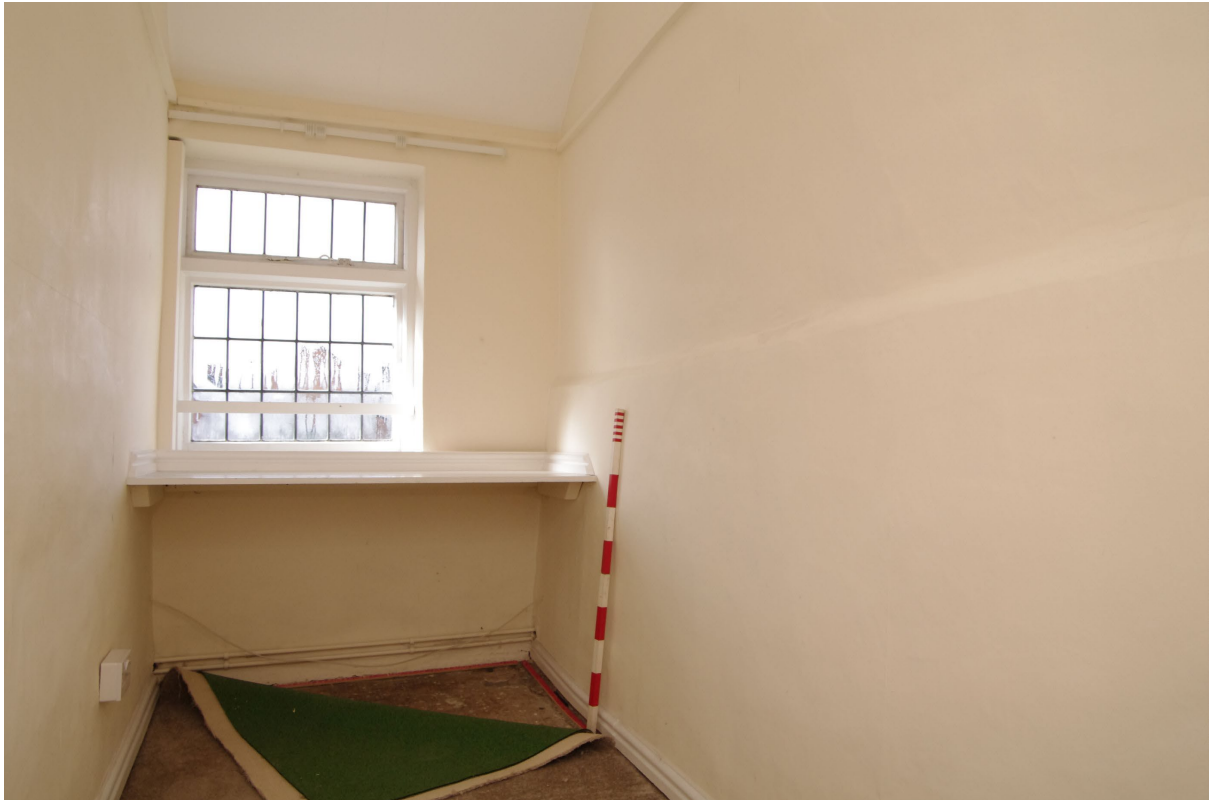
Room F3 is reached by the same half set of stairs leading up to F2. This room is unusually narrow and has a single offset casement window at its western end. The northern wall has a continuation of the timber frame seen in F1. Here a single timber can be seen sitting on top of a thickened and slightly irregular masonry wall. This is masonry rather than a plaster and lath internal wall which is seen elsewhere in the building. It is possible therefore that at one time this may have been an external wall although there is no corresponding wall in the ground floor room below (G4). The floor is gypsum.

Figure 85: Room F3, general view  
Looking west. Note the top of the timber beam just above the tip of the 1m scale
