The historical building recording undertaken by ULAS at Numbers 2A High Street and 37 Main Street in March 2025 has provided a permanent record of the building prior to any works being undertaken.

The results of this level 2 survey allow for a tentative general outline of the probable building phases as shown in Figure 103 below. The earliest phase of the building is that containing clear evidence of box framing which includes the central part of the building along with the rear south-eastern corner of Number 37. Further exploratory work may include the south-western corner of Number 37 (i.e., all of 37) but at present no box framing is visible beneath the internal plaster and the external render. The next key phase includes most of Number 2A and the first floor above it. There is no box framing apparent in this part of the building and, as such this may be as late as the early to mid-19th century. No bricks were visible to measure

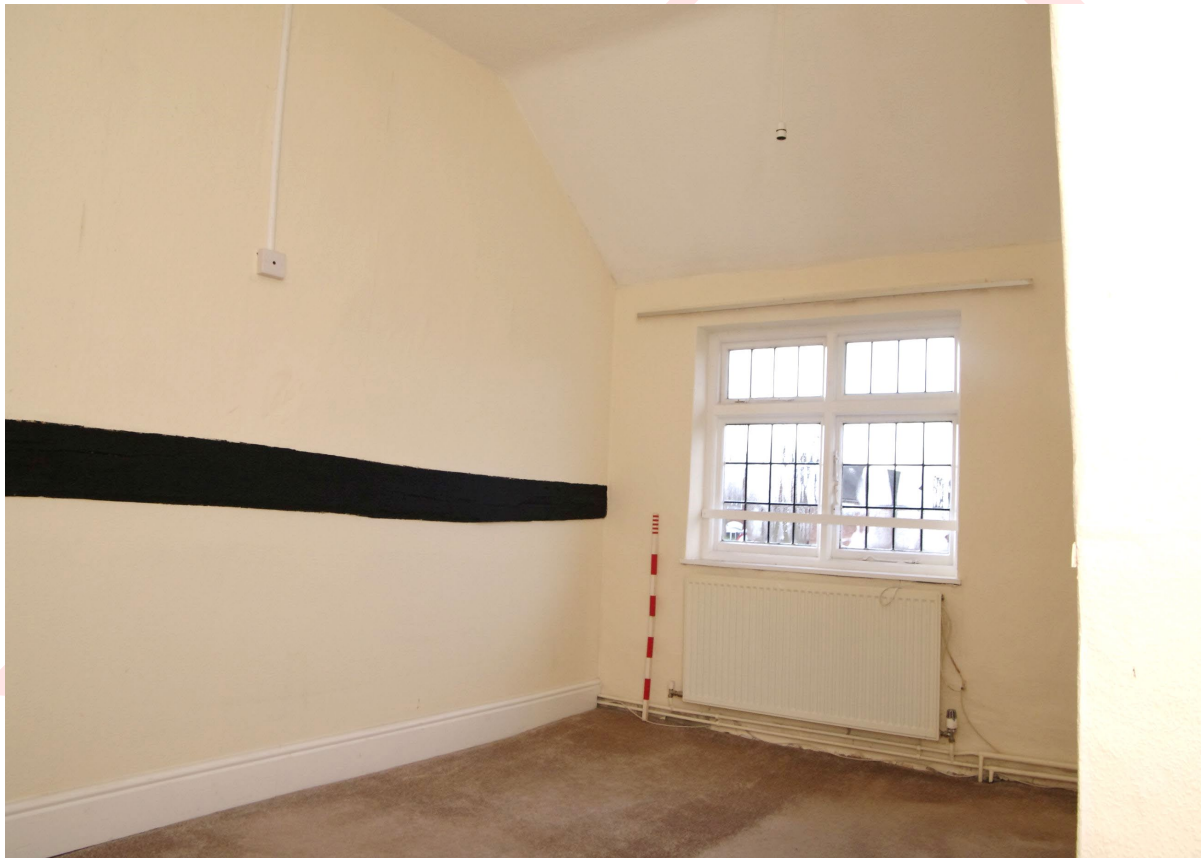
Figure 87: Room F4, general view

Room F4 is located at the top of the half set of stairs leading up from F1 and is accessed from the landing corridor F8. The southern wall of this room is formed by the timber and masonry wall seen in Room F3. The horizontal timber in this room is fully exposed and has a number of sawn-off wooden pegs. These may be redundant from use elsewhere or they may be pegs holding bracing timbers which are hidden behind the plaster within the wall structure.

Looking south. The timber beam forms part of the wall with Room F3. See next figure. 1m scale

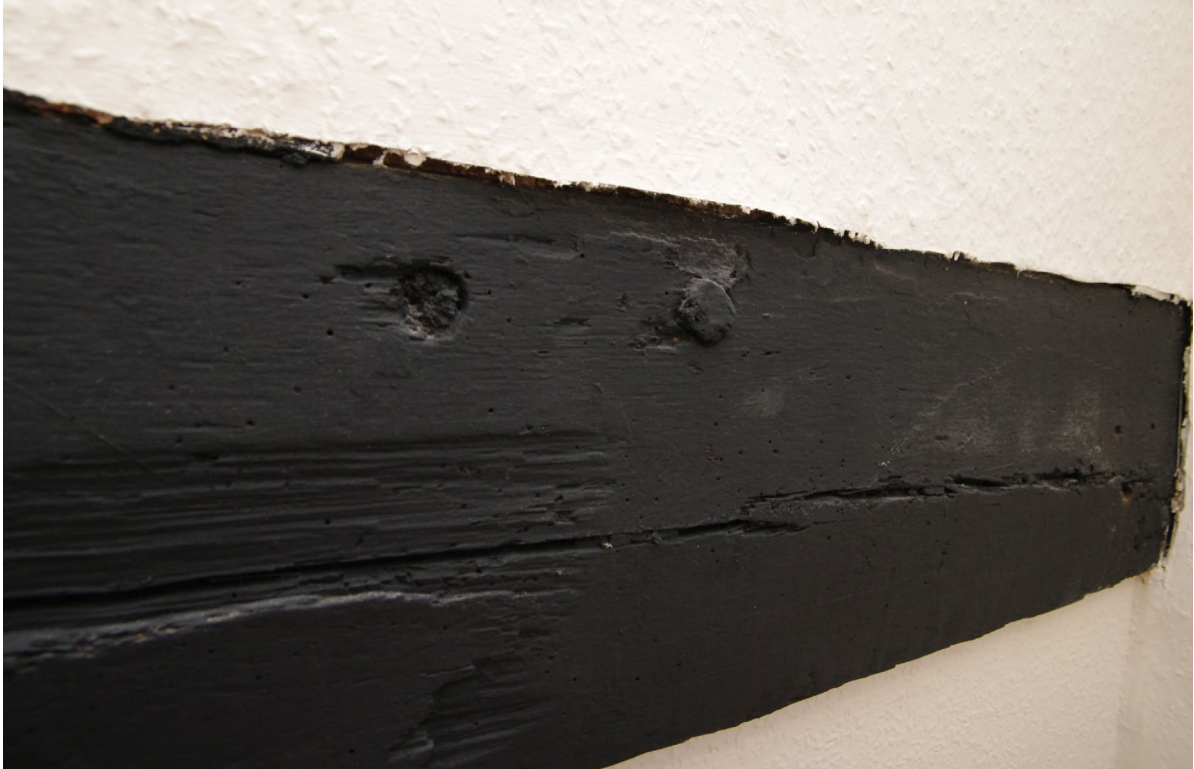
Figure 88: Room F4, detail of wooden pegs in the timber beam

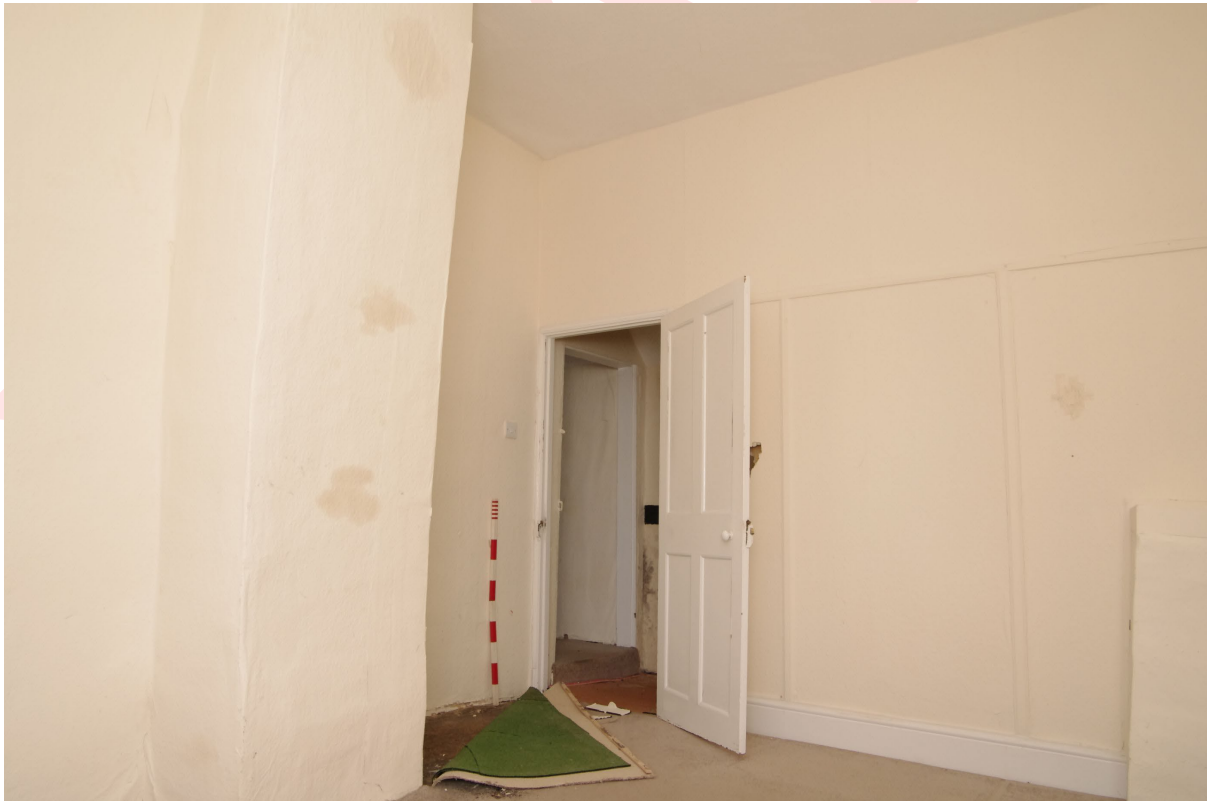
Although the chimney breast impinges into this room there is no evidence of a blocked fireplace and it seems more likely that the double-flue chimney served the ground floor room and adjacent room F5.

Figure 89: Room F4, general view  
Looking north. Note chimney breast on the left. 1m scale

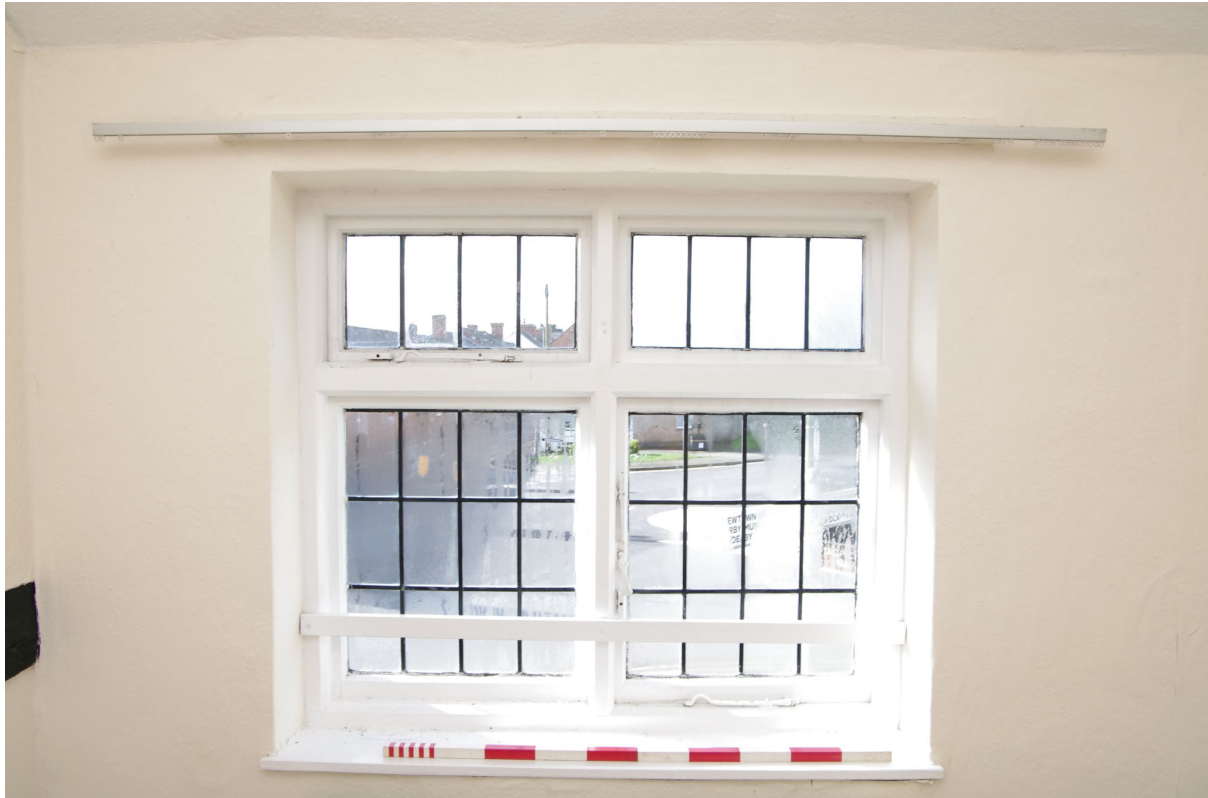
Figure 90: Room F4, window detail  
Looking south-west. 1m scale

The window in this room is a casement window with leaded lights as seen in the other first floor rooms. The door is a four-paneled door and may be late 19th or, more likely, 20th century in date. The floor is gypsum.

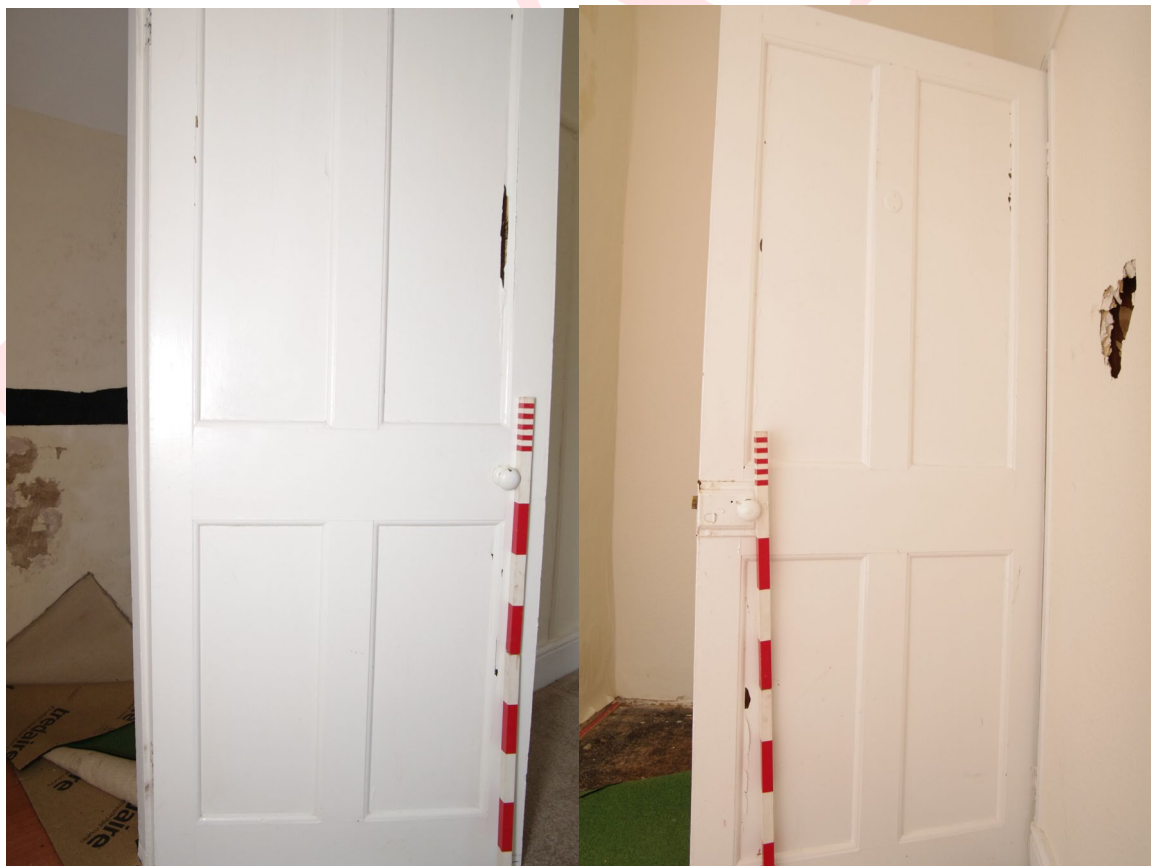
Figure 91: Room F4 door detail  
Left: landing facing side, right: internal face. 1m scale

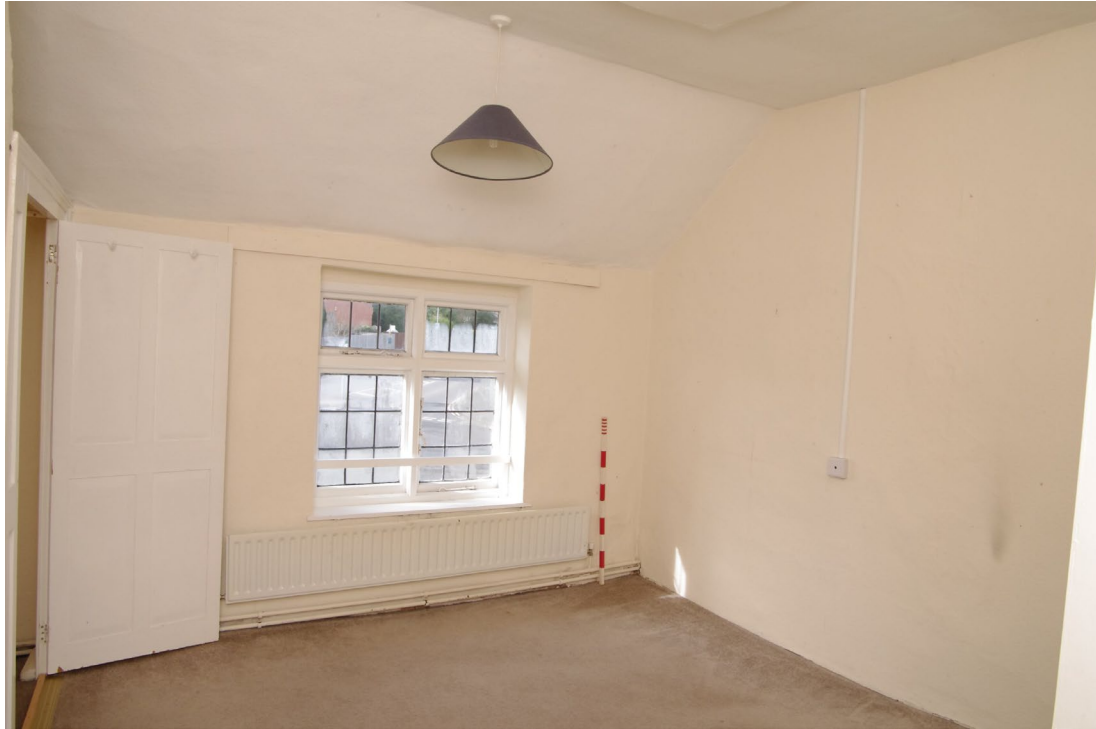
Figure 92: Room F5, general view  
Looking west. 1m scale

Room F5 is a fairly large room with no structural details on view. It has a leaded casement window and a replacement modern door leading out to the landing. There is evidence in the plasterwork of a small blocked fireplace. The floor is gypsum.

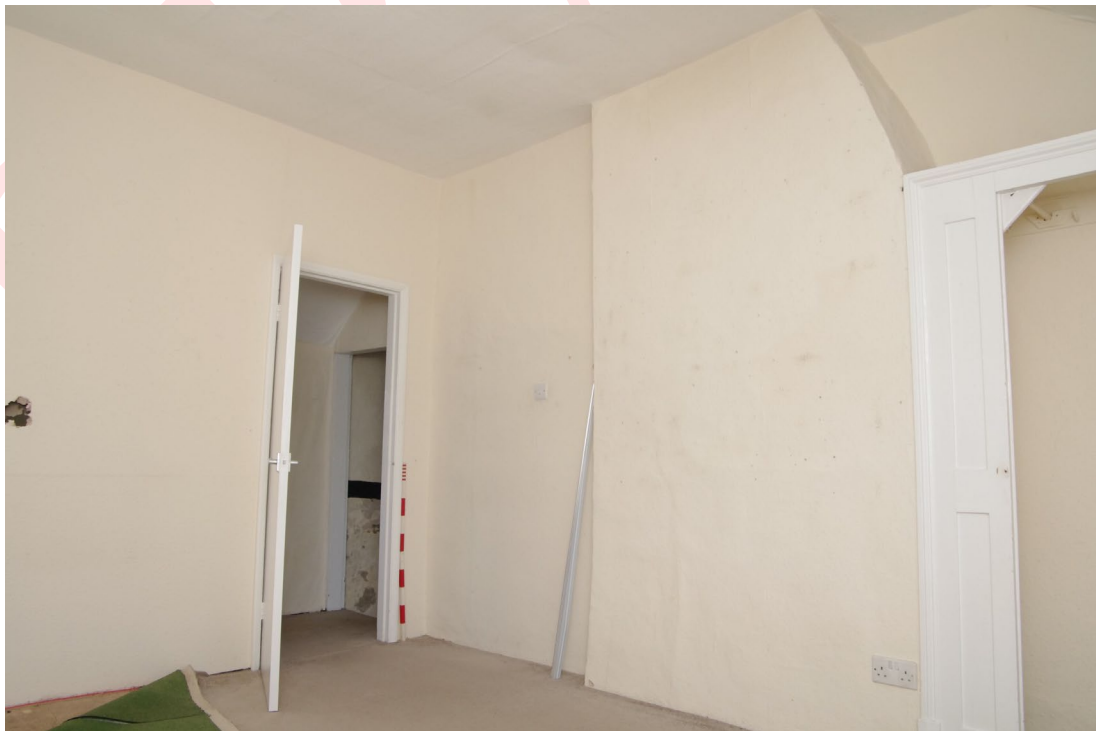
Figure 93: Room F5, general view  
Looking east. Note the mark on the chimney breast of a former blocked fireplace. 1m scale

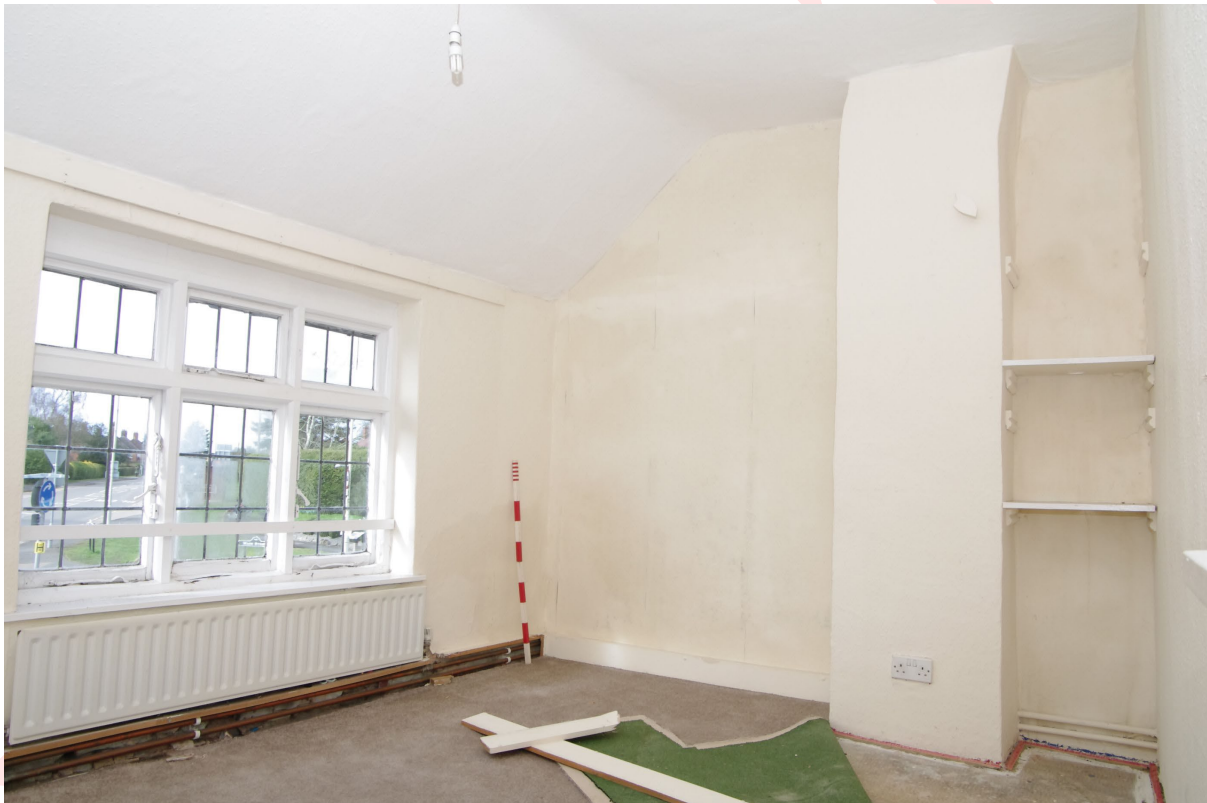
Figure 94: Room F6, general view  
Looking north-west. 1m scale

Room F6 is the northernmost first floor room of the building and lies above the ground floor room belonging to Number 2A. Although lacking in any original features or structural construction evidence it retains the single-flue chimney breast which has been truncated in the ground floor room below. There is no evidence of a blocked hearth and it is more likely that the hearth was on the ground floor. It has a leaded casement window as seen in the other rooms on this floor. The door is a modern replacement. The surround to the door has two large panes of obscured glass which have been painted over. The reason for this glasswork is not clear. It seems likely that the eastern wall, which divides this from F7 bathroom is a later inserted wall and that the north-eastern corner of the building has been re-jigged. This is further discussed in the section on Room F8 below. The room has a gypsum floor.

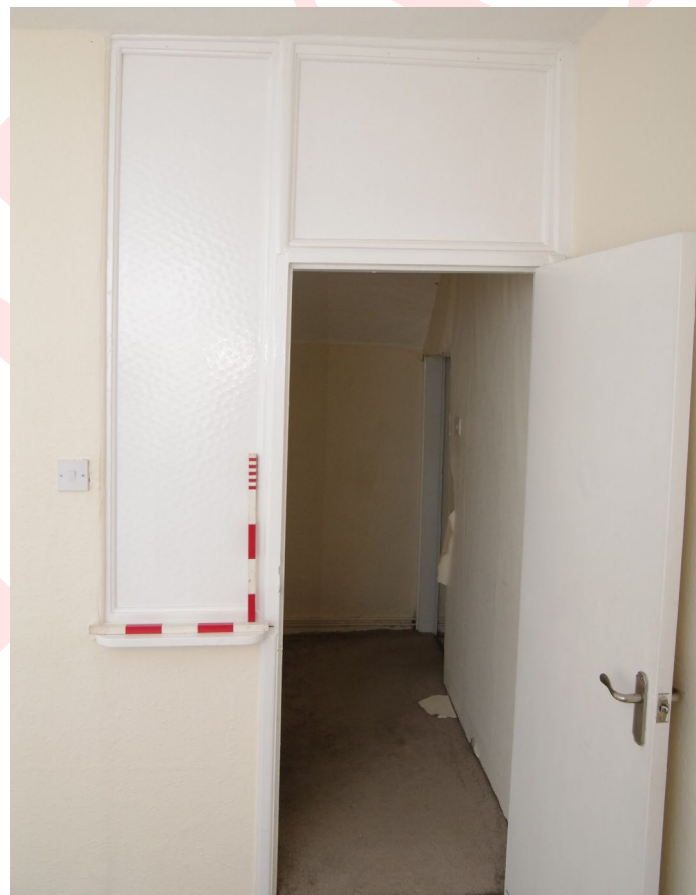
Figure 96: Room F6, doorway detail  
Looking north-east. The two recessed panels are painted-over glass. 2 x 0.5m scales

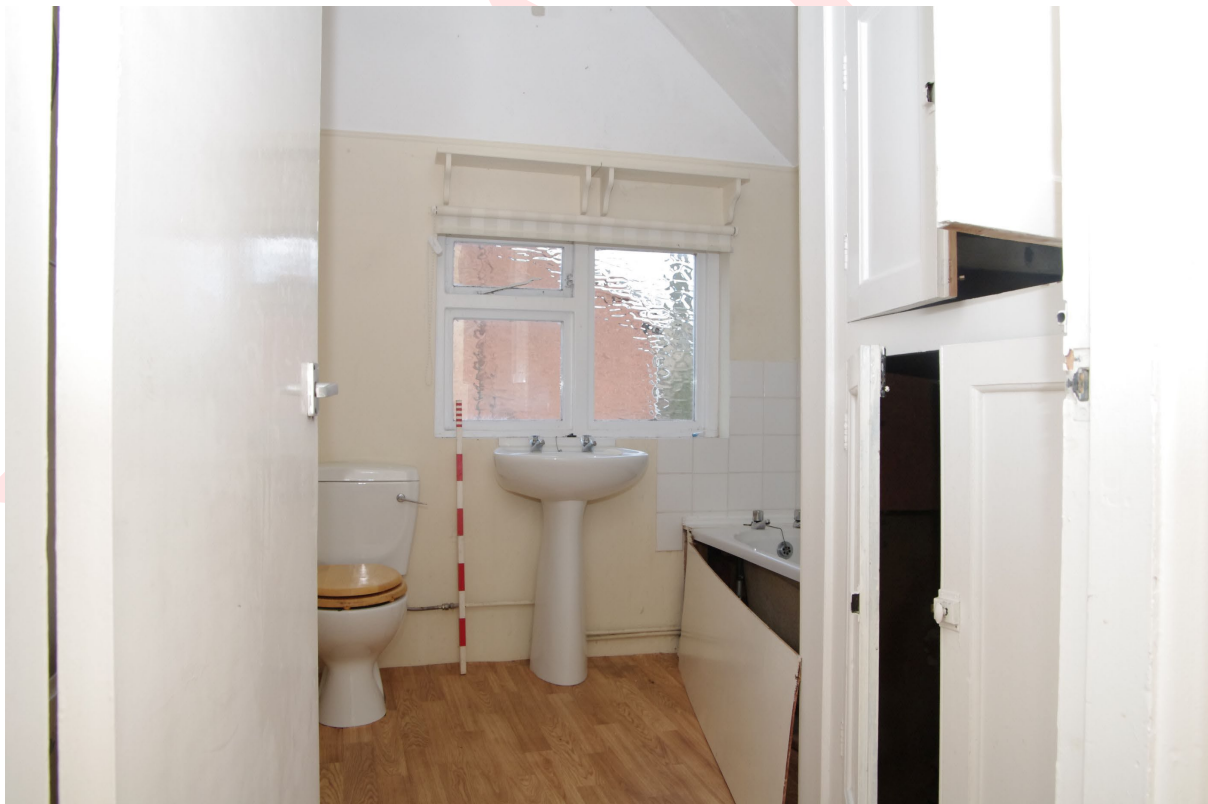
Figure 97: Room F7, general view  
Looking north-west. 1m scale

Room F7 is a modern inserted bathroom with a modern door and bathroom fittings. The window is a modern casement window and may be a late insertion. An open loft hatch in this room shows that the roof structure, in this part of the building at least, has a simple common rafter construction.

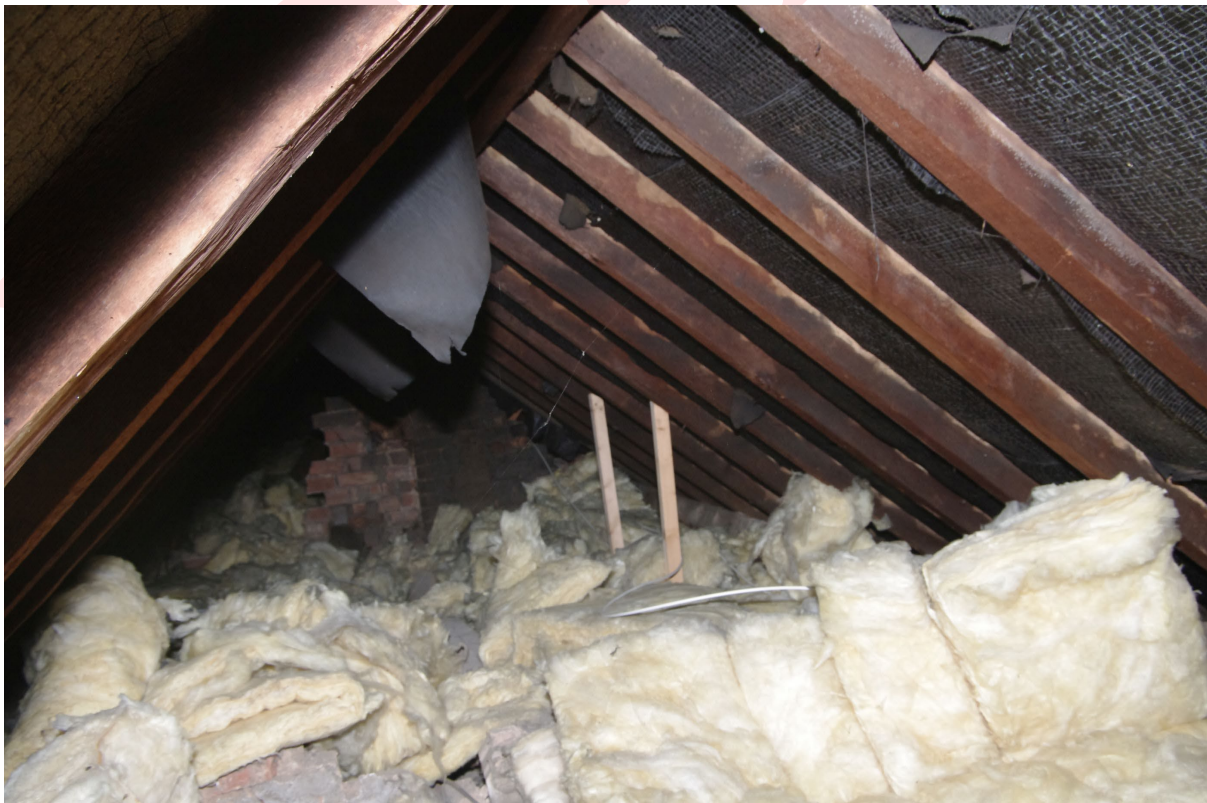
Figure 99: Room F7, roof space  
Looking south-west through loft hatch in F7

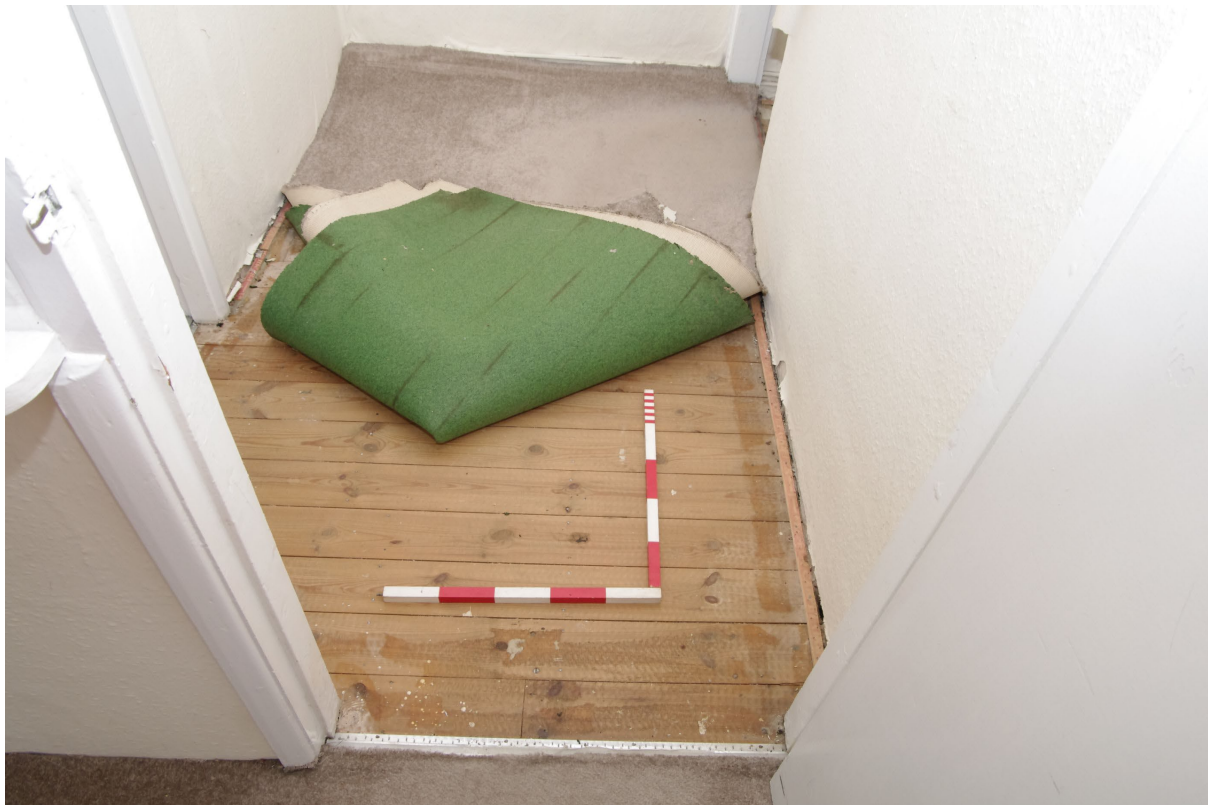
It seems likely that this room has been altered significantly as the landing, which is part of F8, has a wooden floor and would have been where the stairs came up from Room G1. This is the only wooden floor in the building. Although the original layout is unclear it is probable that there was a small landing either side of the stairs and that the wall of F7 would have been located slightly further east than it is at present.

Figure 100: Room F8, location of former stairs from G1  
Looking north-east from the doorway of F6. The doorway to bathroom F7 is on the left. 2 x 0.5m scales

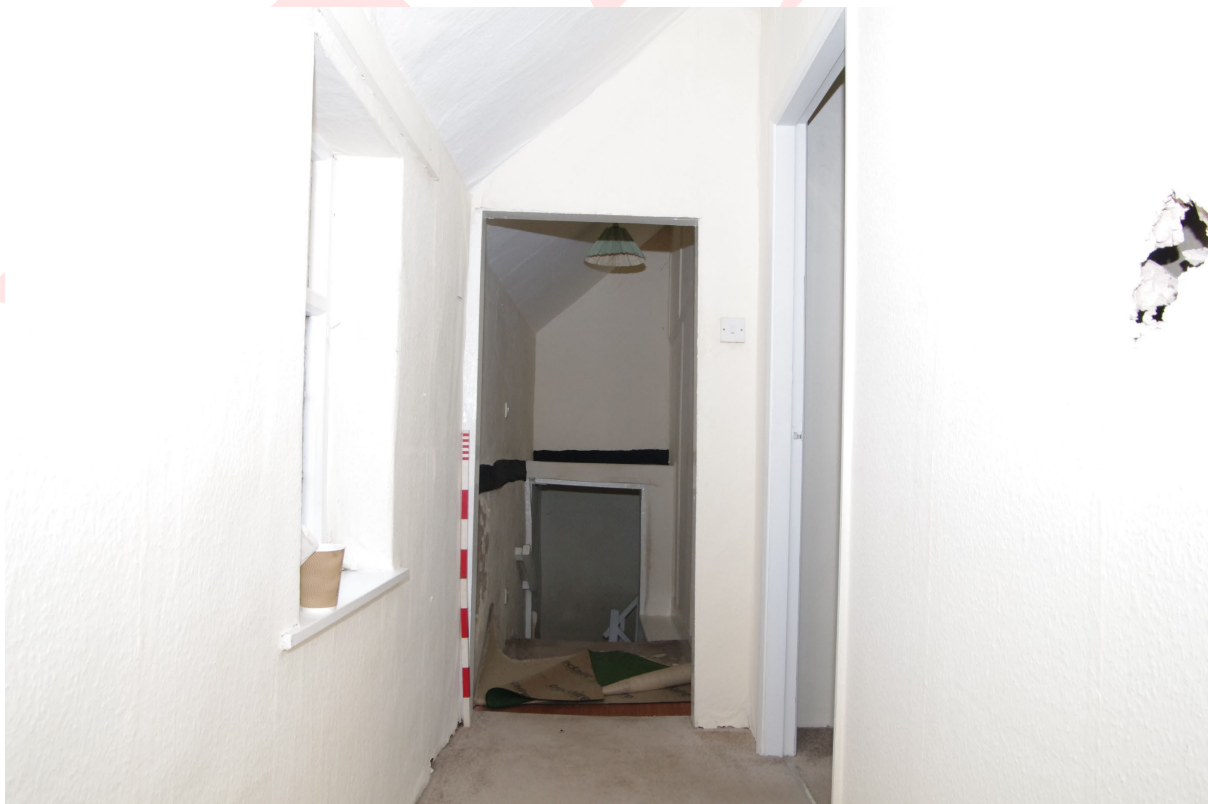
Figure 101: Room F8, general view  
Looking south-east. Stairs down to ground floor in the distance. Door to F5 to the right. 1m scale

Room F8 is a long corridor or landing running from the stairs northwards to Rooms F7 and 8. It uses the same wall line as the cellar. It is unclear if the landing would have stopped before reaching the removed staircase down to G1. Part of the timber frame seen around the stairs in F1 continues in the outer wall of F8 as far as the northern wall of Room F4. This corresponds with the step in wall and roofline seen on the north-west facing elevation. There is a single casement window looking out over the roof of the single storey extension with no other openings on this wall on either the ground or first floors.

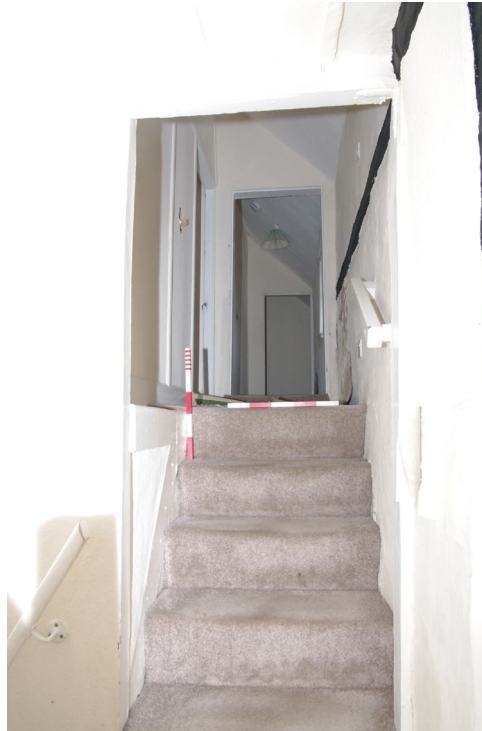
Figure 102: Stairs up to Room F8

Looking north-west. Note the timber framing continuing along the wall. 2 x 0.5m scales

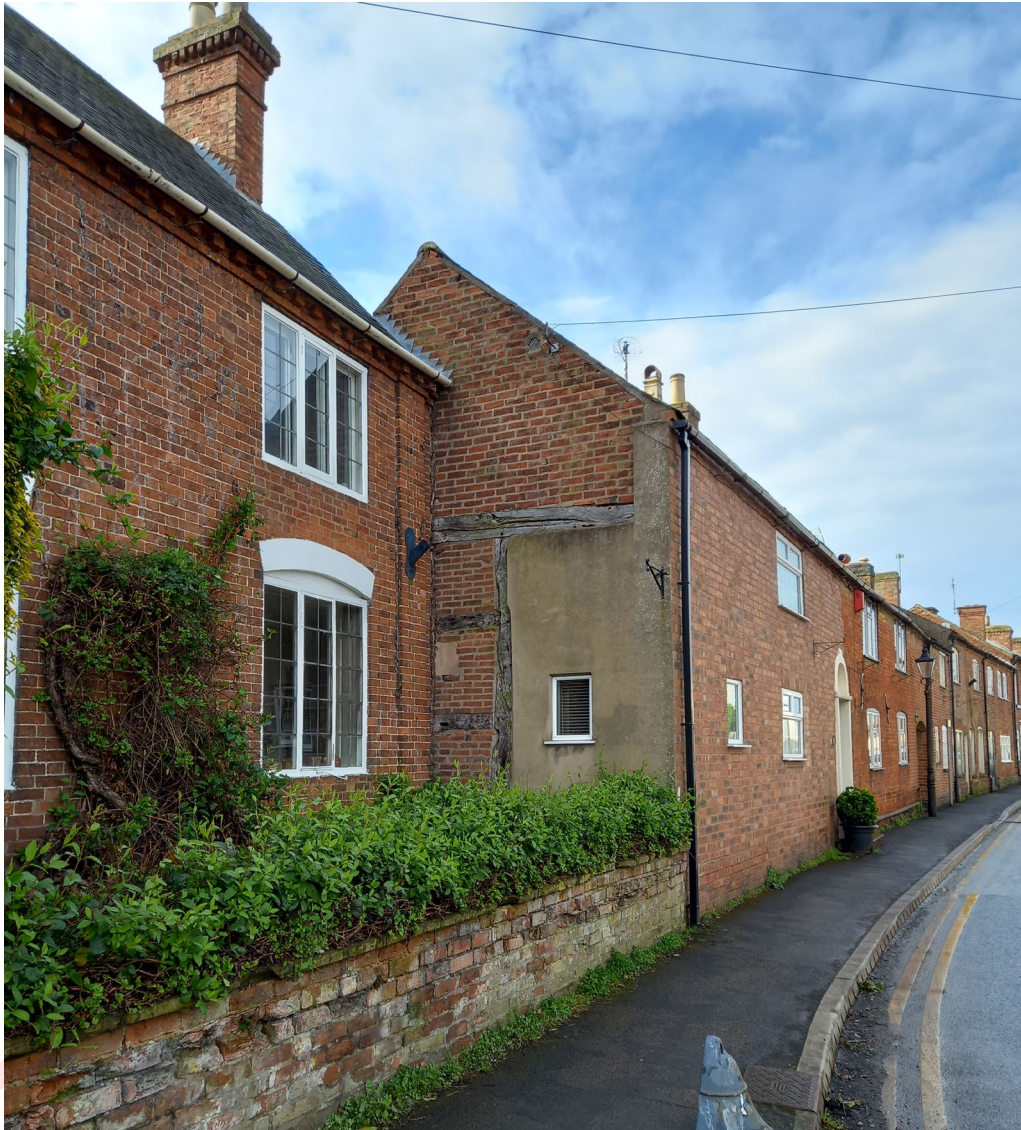
The use of timber box frame and brick infill construction in Desford is not unusual with a number of houses showing evidence of this construction method. Many earlier examples are built on a medieval stone base but later structures are built in the same fashion as Numbers 37 and 2A are. In this case however the use of render has hidden the origins of this building.

Figure 104: Example of a box framed house on Kirkby Road, Desford
