**LAND NORTHEAST OF M1  
JUNCTION 22,  
MARKFIELD,  
LEICESTERSHIRE**

**WHITWICK ROAD/A50  
WESTBOUND SLIP ROAD**

**ROAD SAFETY AUDIT REPORT**

Document: Stage 1 Road Safety Audit

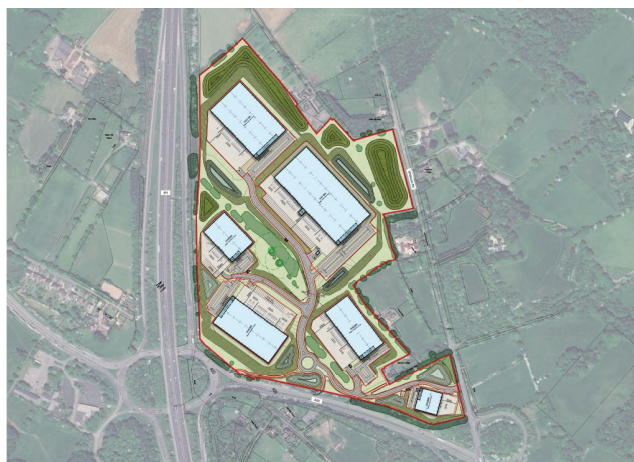
**Figure 1: Proposed Site Layout Master Plan**

- 1.1 This report results from a Stage 1 Road Safety Audit carried out on the highway works associated with a proposed Industria/Storage (B2/B8) development on land located to the northeast of M1 Junction 22, Markfield in Leicestershire.
- 1.2 The proposed development provides a total of 65,000m<sup>2</sup> Gross Internal Floor Area (GFA) arranged as six units with accesses taken from the A50 via an on and off slip road arrangement and a separate egress only on to Whitwick Road. The proposed site layout and respective accesses are shown in Figure 1.
