## SITE INVESTIGATION REPORT

| REPORT NUMBER | GAM001 |
| SITE ADDRESS | 7 THE LAURELS, LE67 9HA |

TRIAL PIT REF: TP1

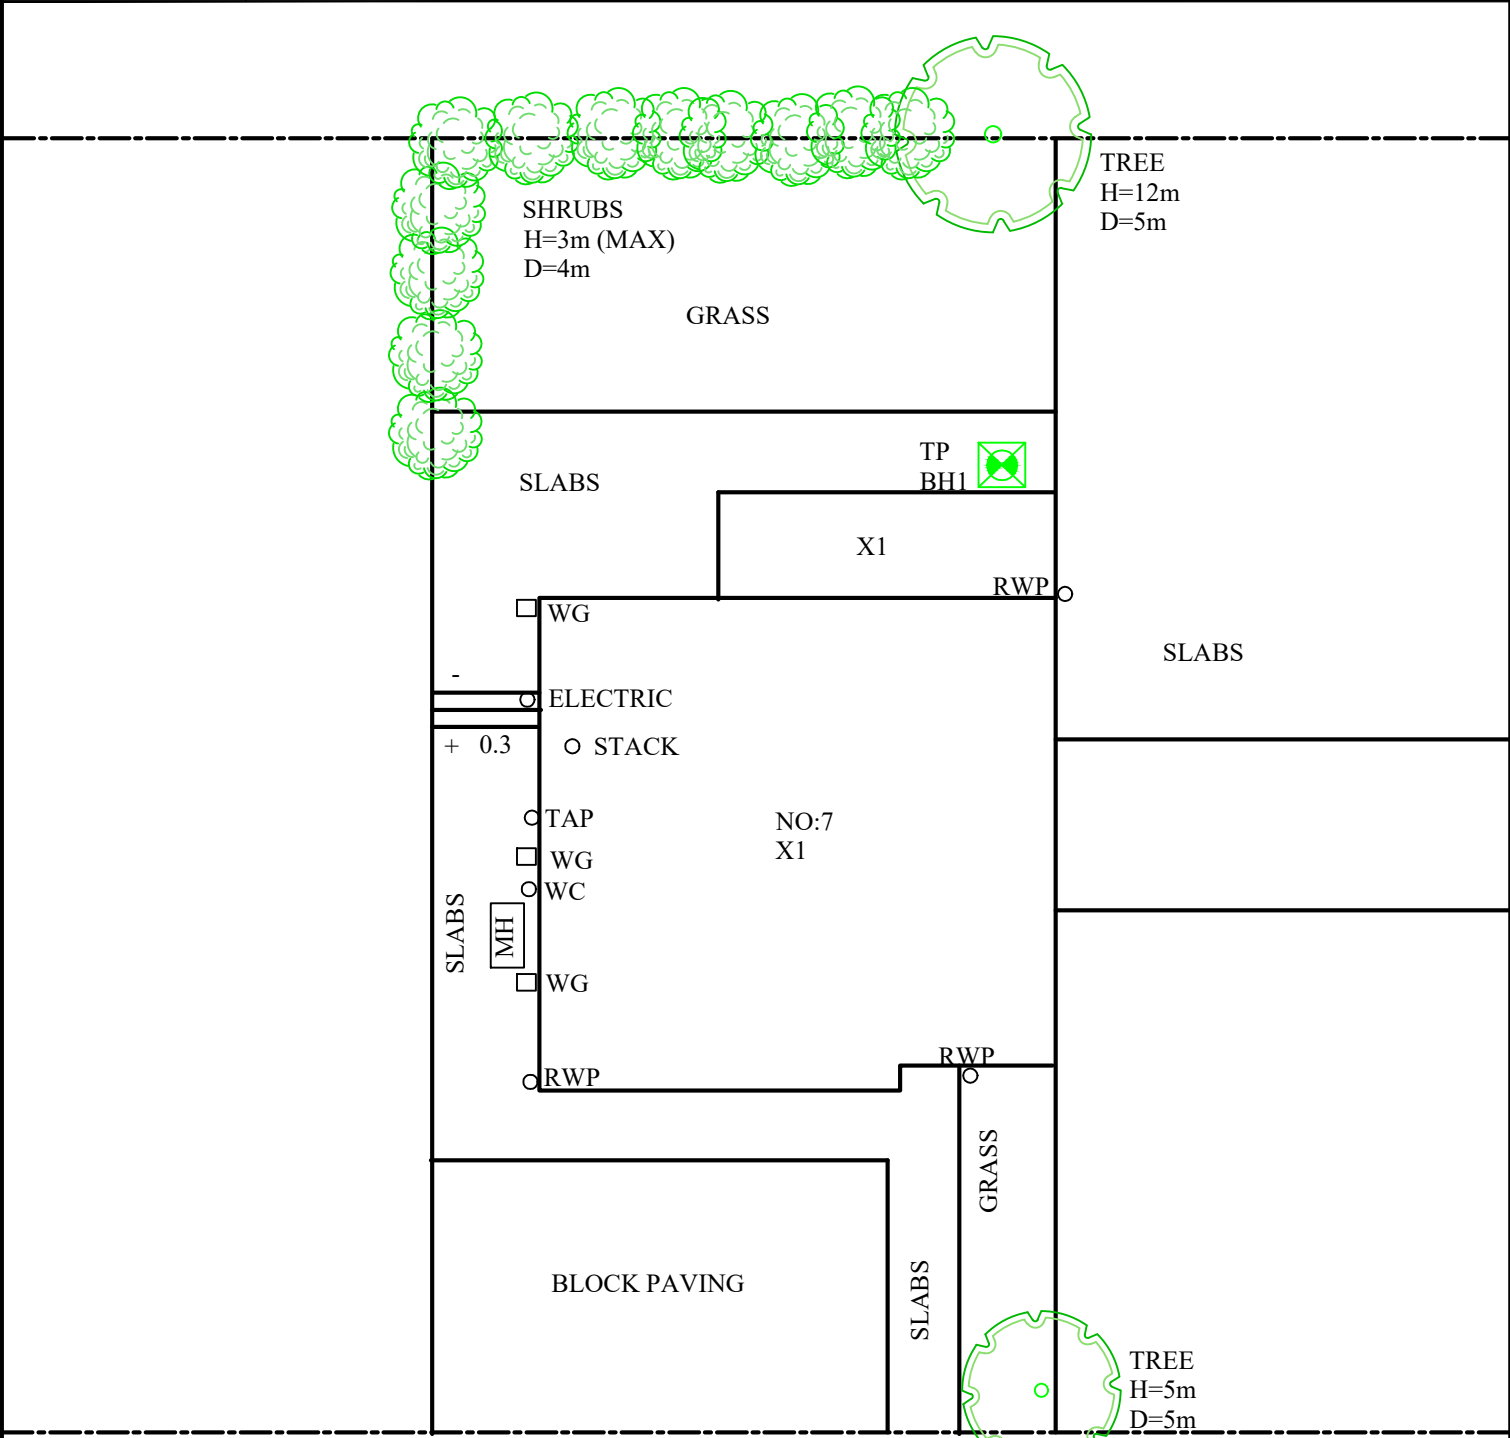
ON SITE TREE IDENTIFICATION FOR GUIDANCE ONLY. NOT AUTHENTICATED.

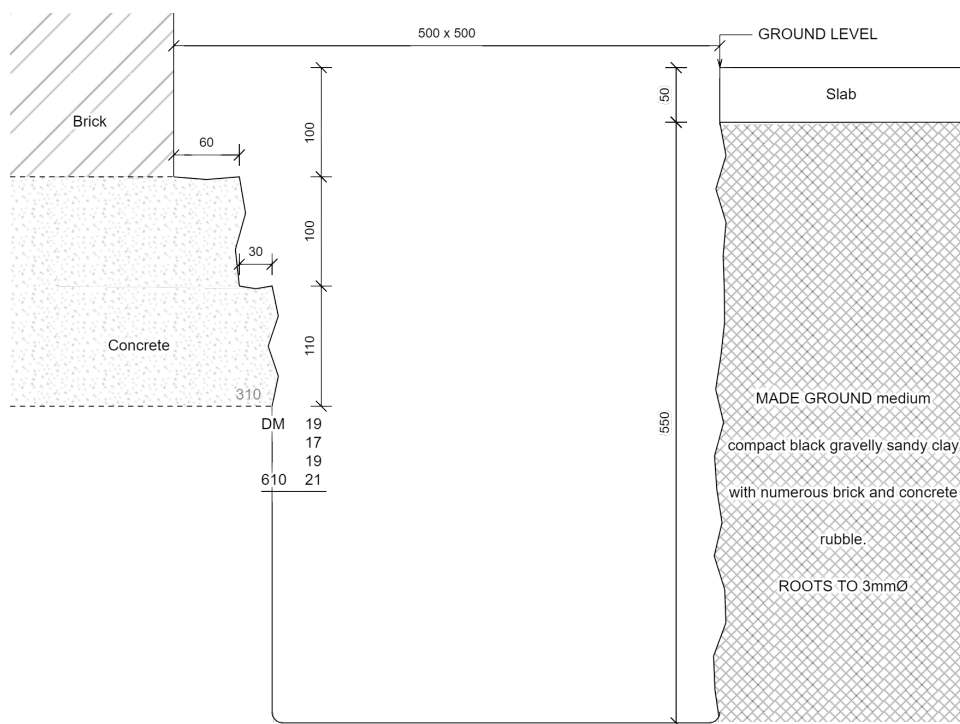
For Strata below 600mm see Bore Hole log

Curved steel pin driven 200mm under concrete foundation at 310mm below ground level.
