Hinckley Phase 4  
Leicestershire

**Combined Phase I Desk Study and  
Phase II Exploratory Investigation  
For  
Bloor Homes East Midlands**

**GeoDyne Limited**  
9 Brunel Parkway, Pride Park  
Derby DE24 8HR

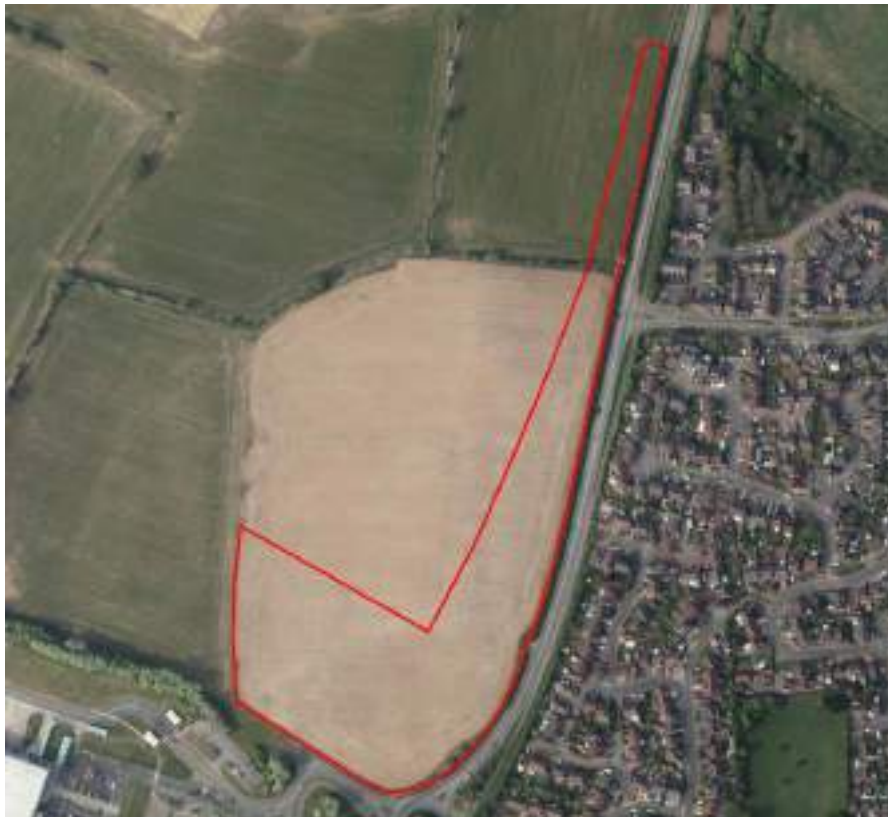
**Figure 1:** Aerial photograph of the site (2022 image)

An aerial photograph of the site, obtained from the Landmark Analysis tool commissioned as part of our works, is presented in Figure 1 on the next page, with the current OS mapping plan for the site and surrounding area presented in Figure 2.

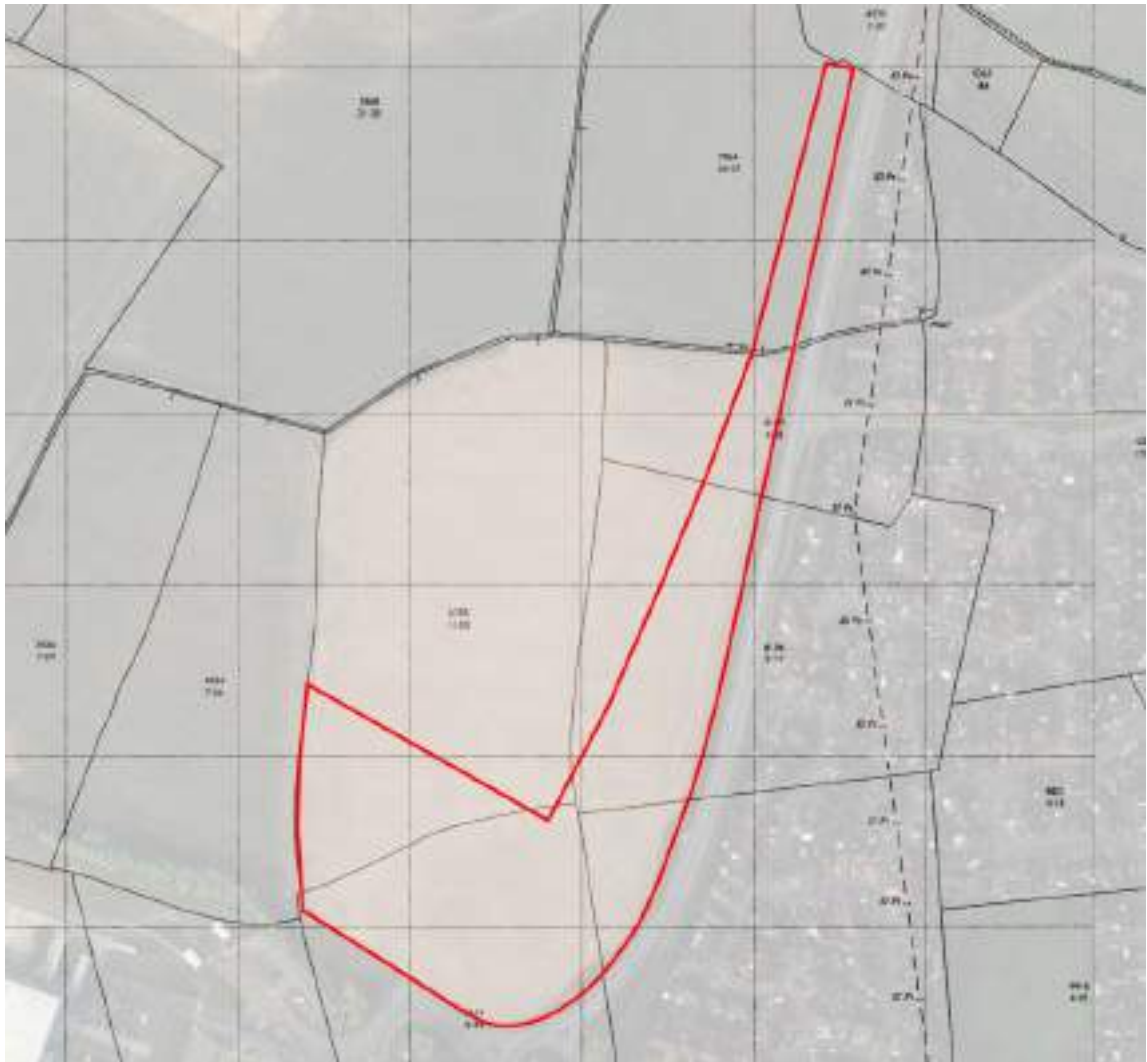
**Figure 4:** Current Aerial Imagery Overlain with 1963 Historical Map Data.

Figure 4 shows the site and its surrounding area to remain essentially unchanged. The cluster of buildings which comprise Tithe Farm are no longer shown to the north of the site.

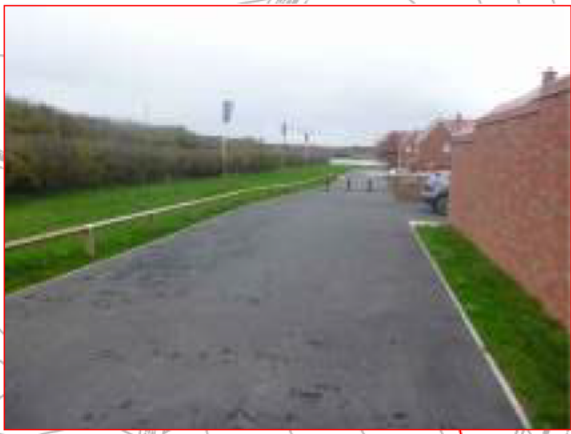
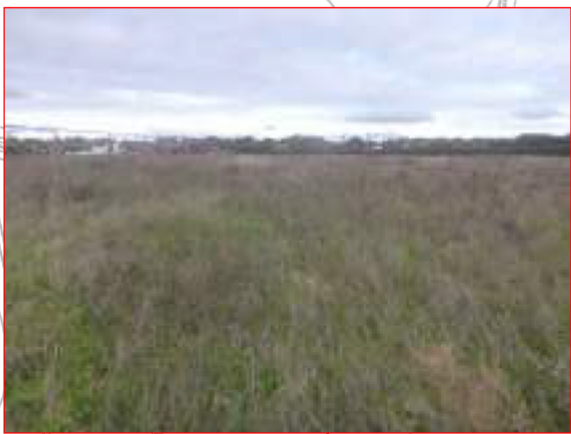
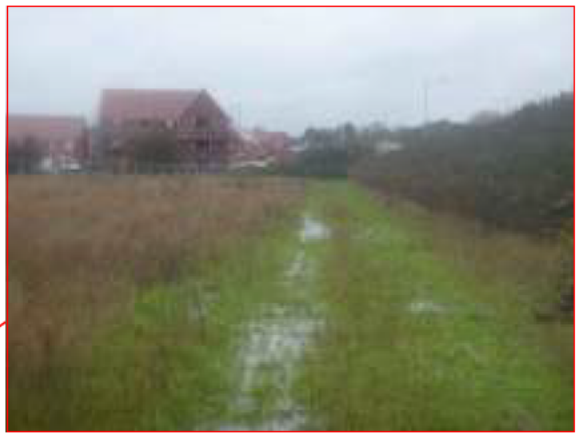
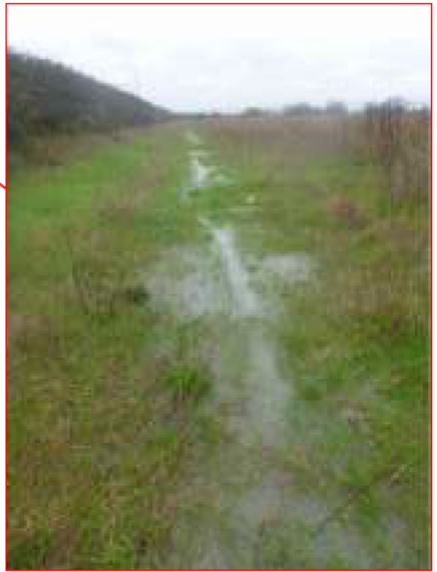
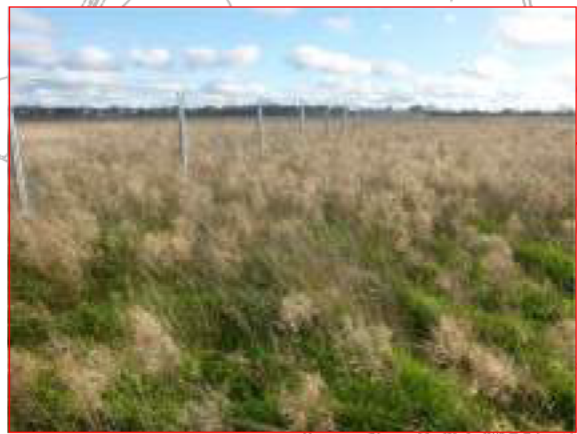
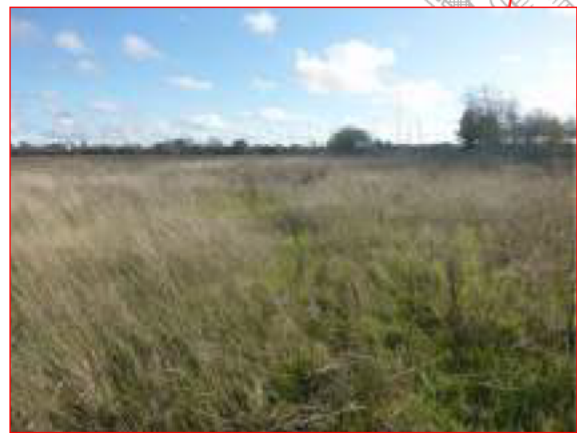
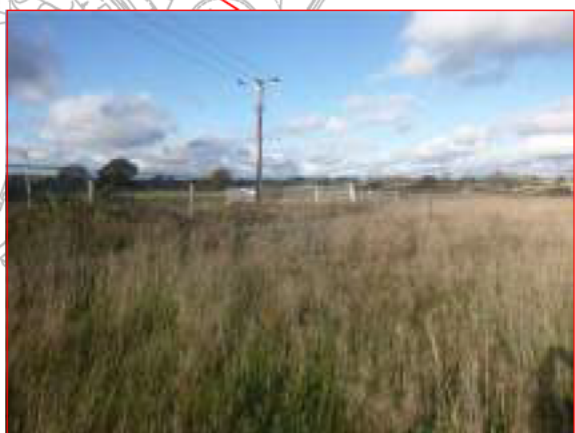
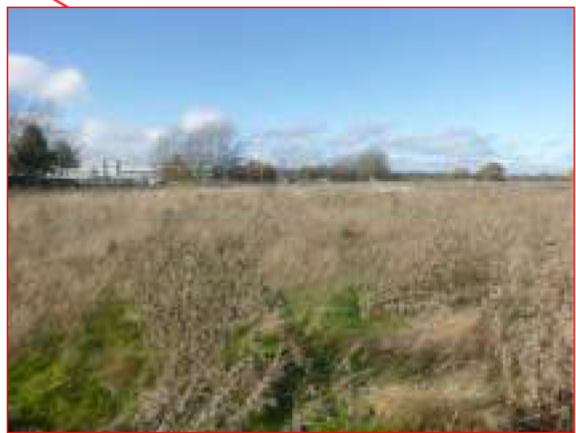
**Site Plan Showing General Site Views  
(Figure No. D42153/03)**

At the time of our walkover (November 2022), the majority of the site comprised the southeastern extent of a sensibly level larger grass field which was overgrown with weeds. Stubble was noted locally, indicative of the field having formerly been used for arable farming. The site was waterlogged with standing water observed across much of its extent.
