| Project | Hinckley Phase 4 | Scale | NTS |
| Title | WS2 - Recovered cores | Rev. | |

Contract Title: Hinckley Phase 4

## FINAL ANALYTICAL TEST REPORT

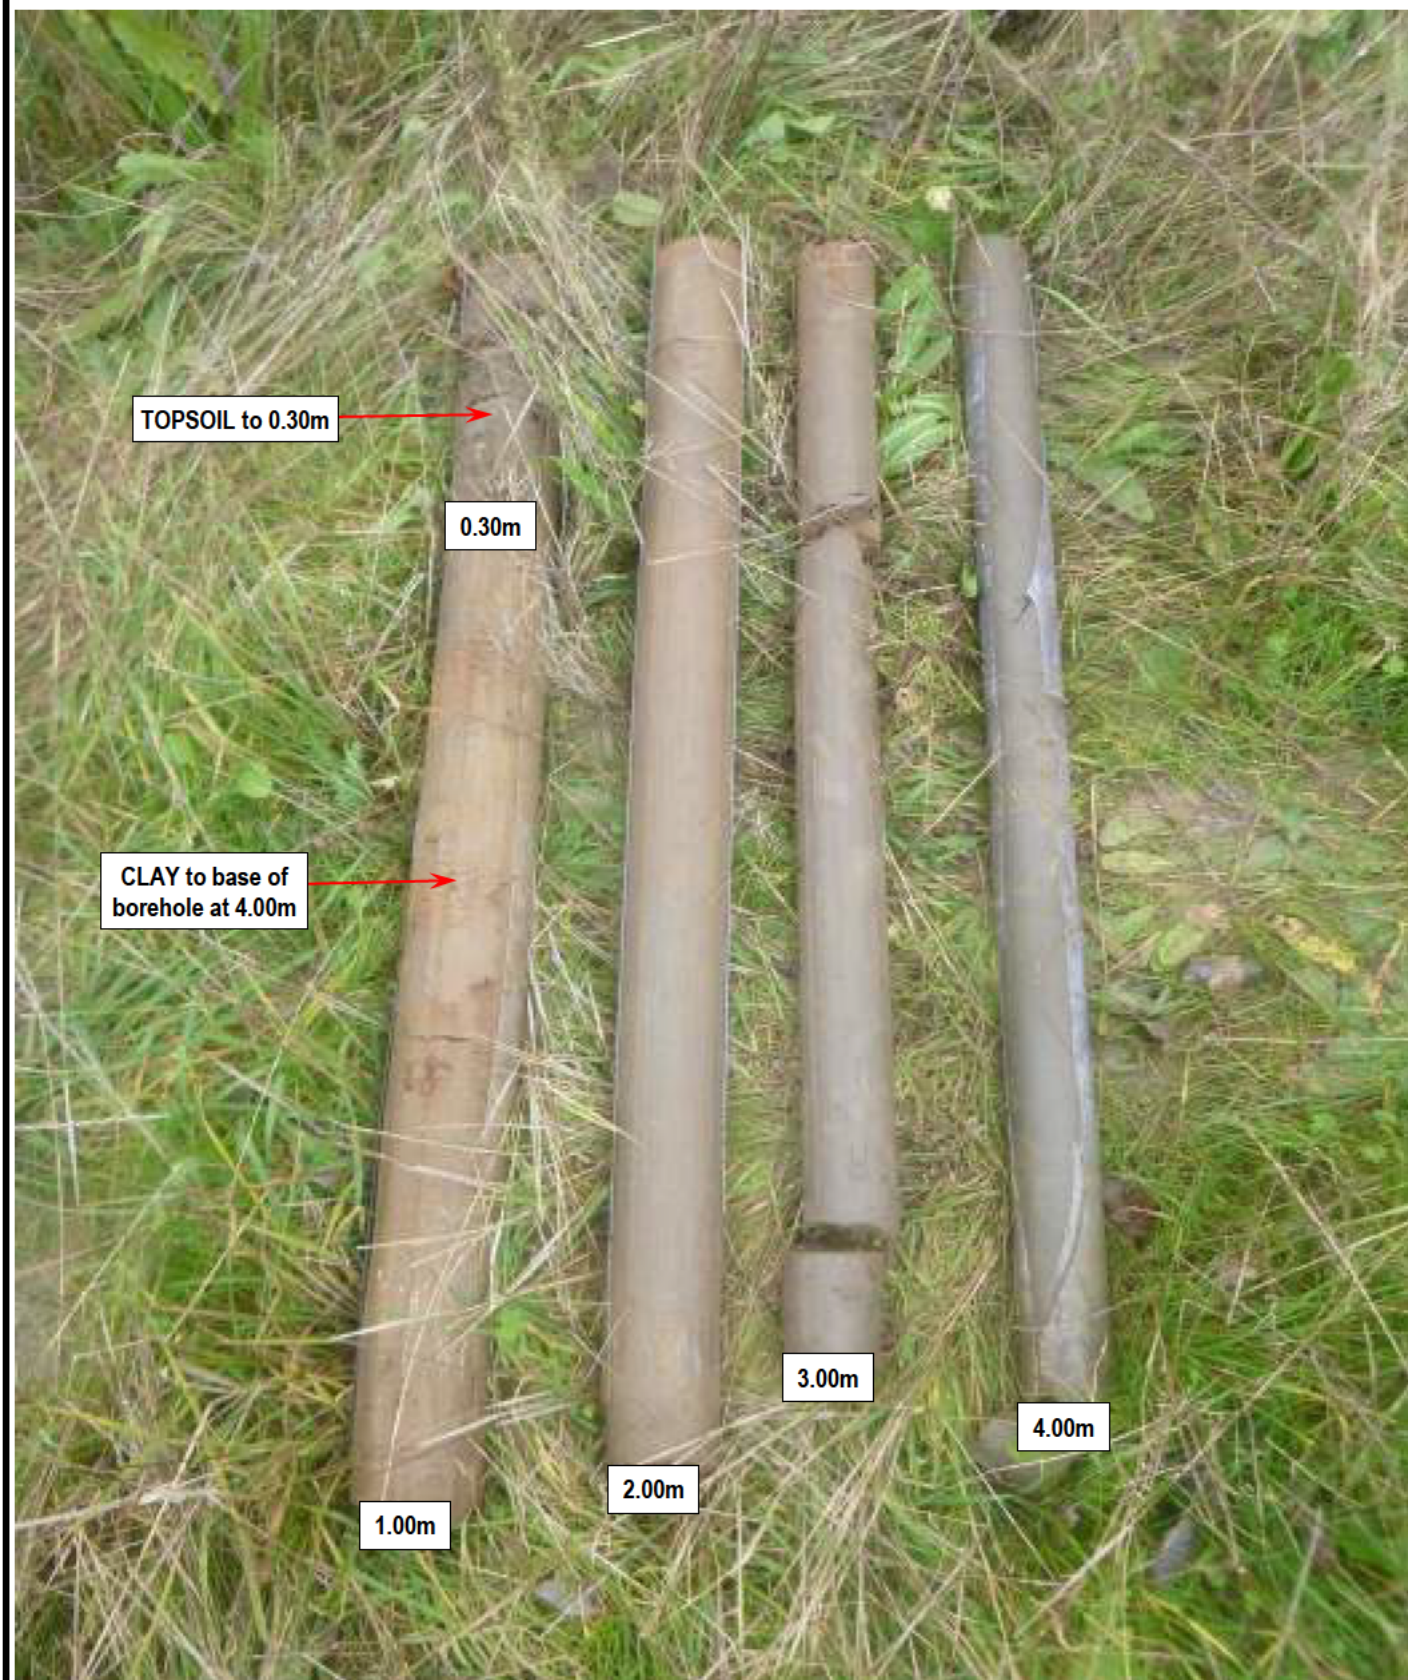
| | | Plate No. | 17 |

| Title | WS3 - Recovered cores | Rev. | |
