## **Dusk emergent bat survey**

**Little India Restaurant**

**7 Main Street, Peckleton**

Surveyor: Dr. Stefan Bodnar BSc (Hons) PhD MCIEEM NE bat class license (level 2 survey)

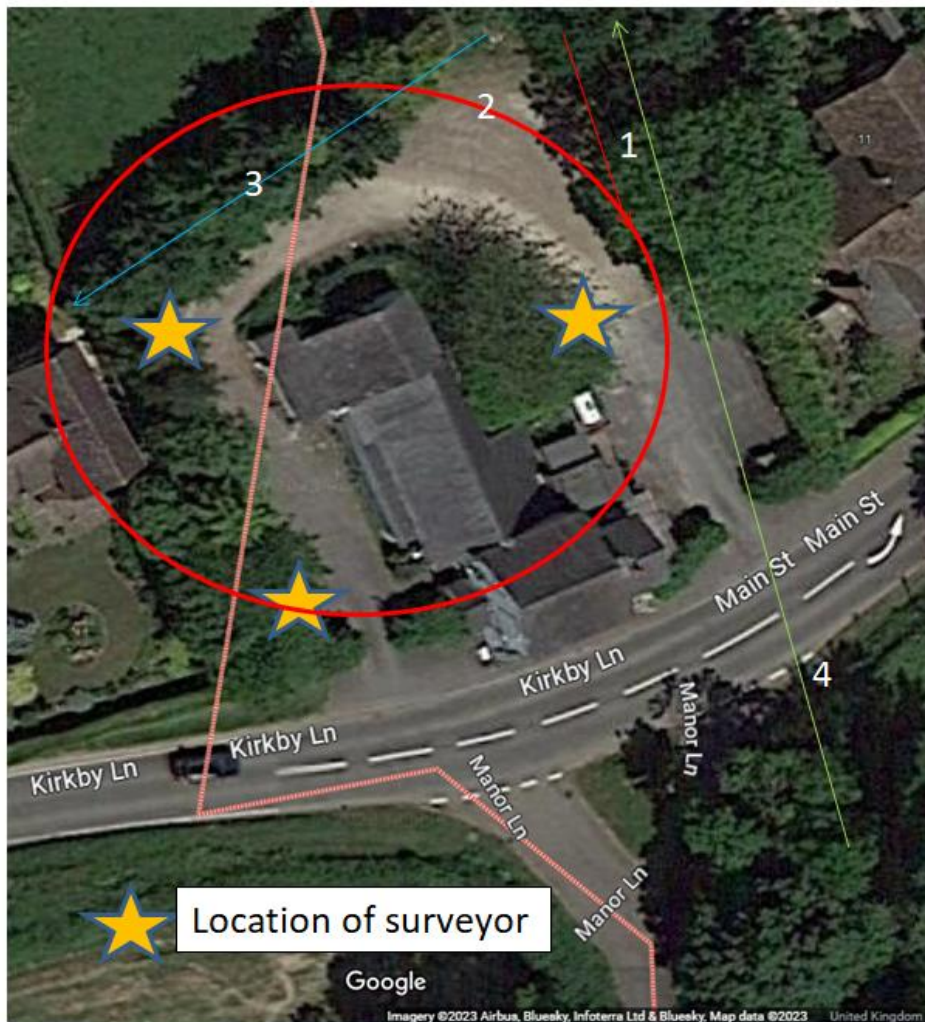
Minimum count: Two Common pipistrelle, 2 Brown long eared bats, 1 Noctule, were noted during the survey. No bats were emergent from, or reentering, any building on site.

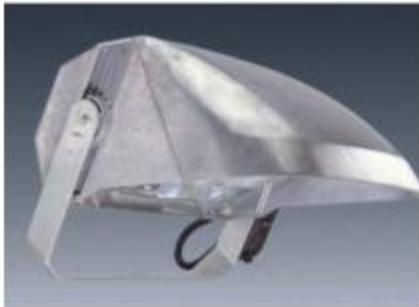
**Double Asymmetric Luminaire**

- **FORAGING AND COMMUTING Type of lamp (light source)** The impact on bats can be minimised by the use of low pressure sodium lamps or high pressure sodium instead of mercury or metal halide lamps where glass glazing is preferred due to its uv filtration characteristics.
- **Luminaire and light spill accessories** Lighting should be directed to where it is needed and light spillage avoided. This can be achieved by the design of the luminaire and by using accessories such as hoods, cowls, louvres and shields to direct the light to the intended area only. Planting can also be used as a barrier or manmade features that are required within the build can be positioned so as to form a barrier. **Suitable examples shown below:**

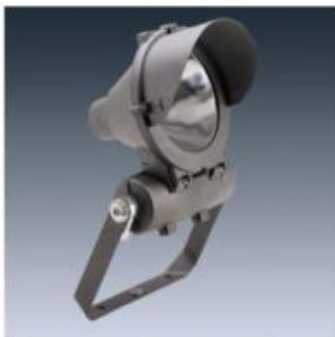
**Cowl (or Hood)**

- **Aim of light** The light should be aimed to illuminate only the immediate area required by using as sharp a downward angle as possible. This lit area must avoid being directed at, or close to, any bats' roost access points or flight paths from the roost. A shield or hood can be used to control or restrict the area to be lit. Avoid illuminating at a wider angle as this will be more disturbing to foraging and commuting bats as well as people and other wildlife.

- **Suitable types shown below (note that these are wall mounted and directed downwards)**
