## Phase 2: Site Investigation

**Former Leisure Centre, Hinckley**

**M25-040**

## PHASE 2 SITE INVESTIGATION REPORT

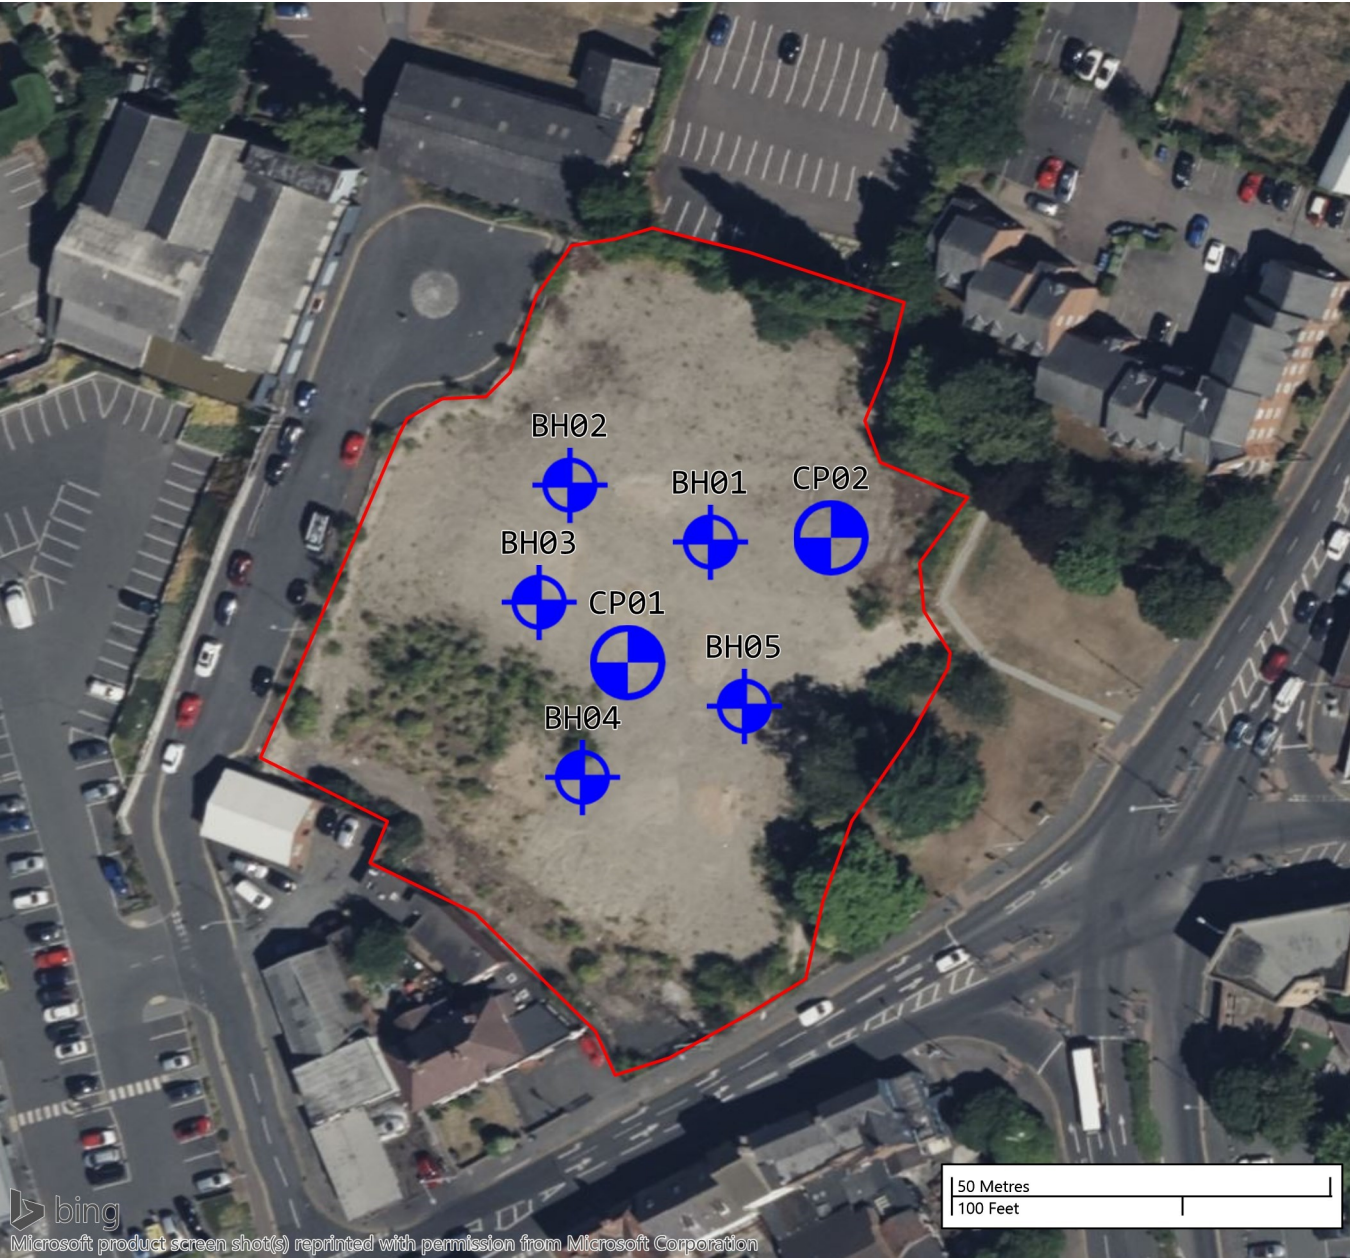
A plan showing the location of the boreholes and trial pits can be found in Appendix A (Figure 2).

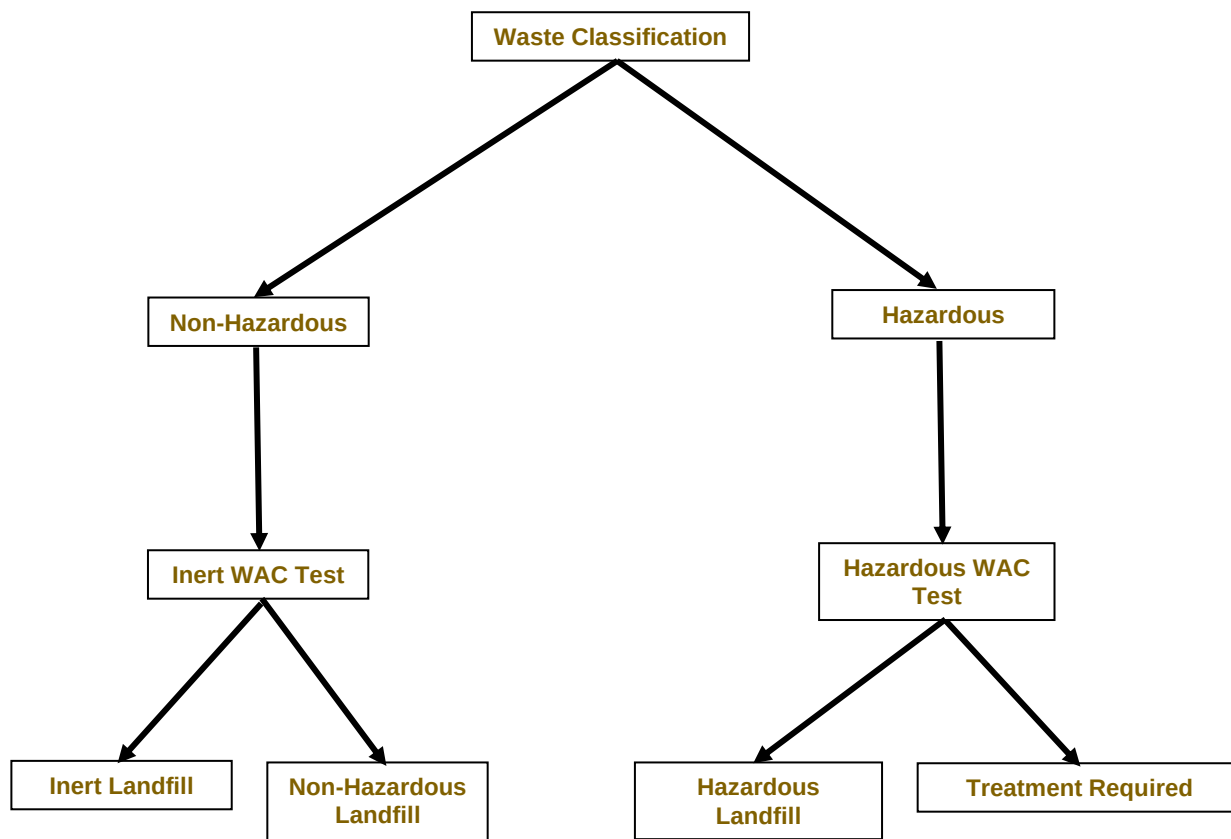
The below flow chart provides further information on the waste classification process.

During the site strip and construction activities, material may be required to be removed from site. Any such material would require classification, in line with Environment Agency Technical Guidance *Waste Classification: Guidance on the classification and assessment of waste (2015)*. This would classify the material as either Non-Hazardous or Hazardous Waste.

Once the material has been classified, determining the suitable landfill for disposal is governed by landfill directive Waste Acceptance Criteria (WAC) testing, with landfills categorized as Inert Waste, Stable Non-Reactive Hazardous Waste and Hazardous Waste. The WAC testing relates to materials that are to be exported from a site/development to landfill, and do not directly relate to human health specifically. The testing results are generally presented as certificates which can be used by site owners/contractors etc, which should be presented to the accepting waste facility or waste contractor.
